ROTTERDAM WHARF

EXTRACT FROM PUBLISHED
GEOLOGICAL SURVEY MAP
(MINING INFORMATION)

INVASIVE WEEDS SURVEY

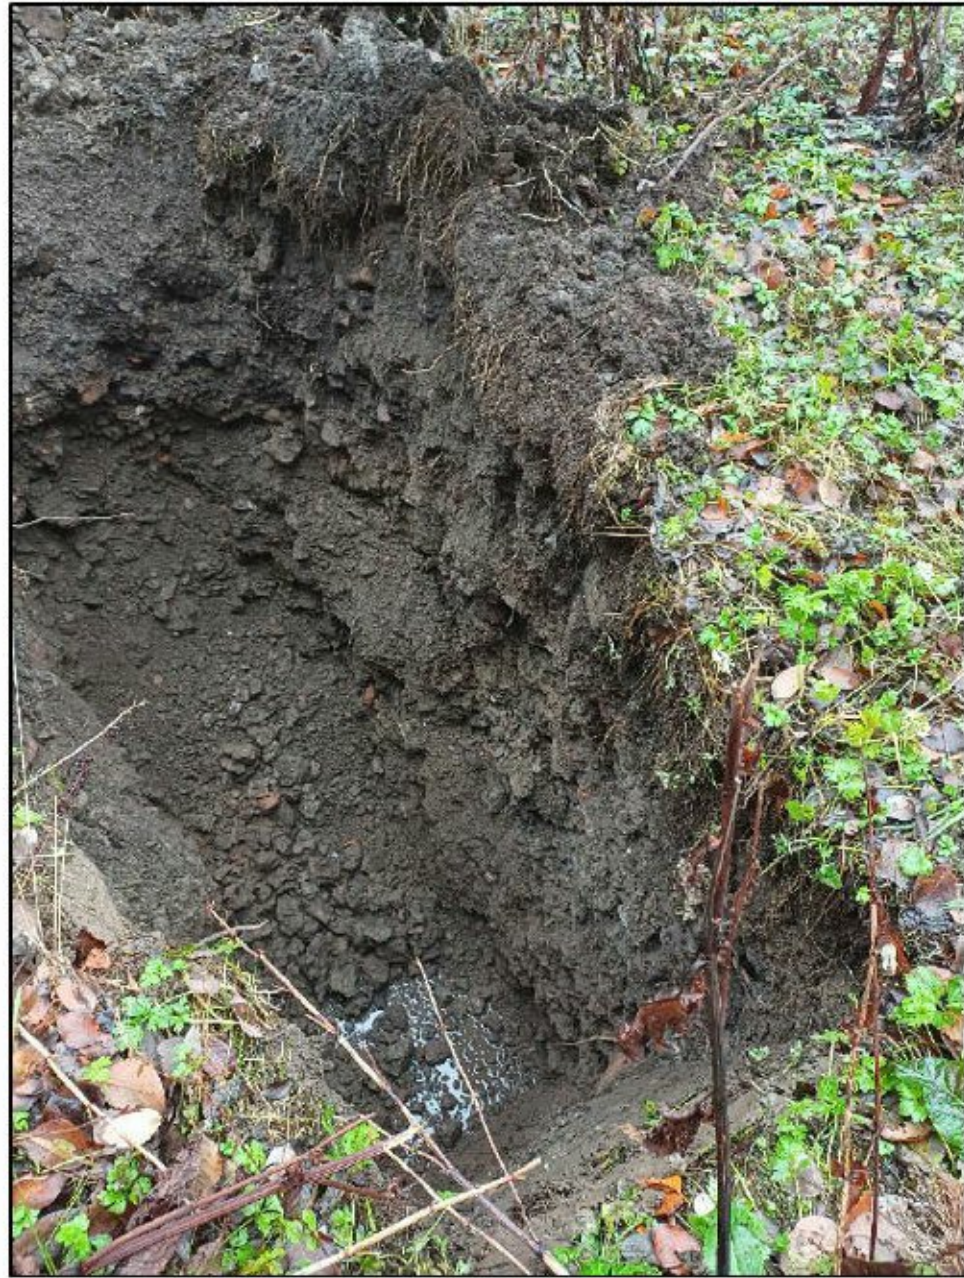
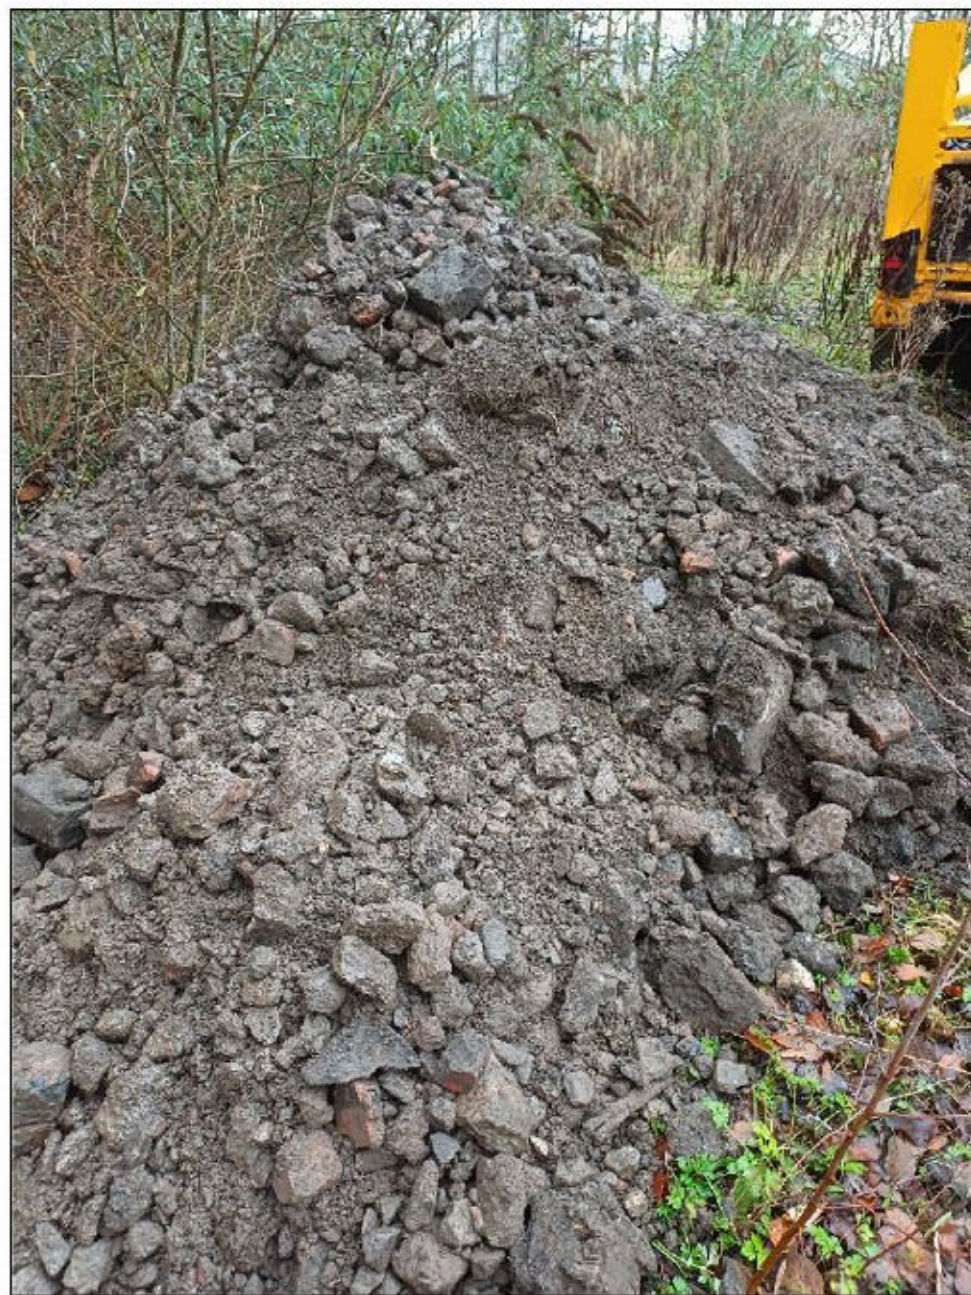
TP05

Depth	Sample/Tests	Water Depth (m)	Field Records	Level (mOD)	Depth (m) (Thickness)	DESCRIPTION	Legend
0.40	TJ				(1.60)	MADE GROUND: Blackish brown, sand and gravel with sub rounded to sub angular gravels and cobbles with broken red brick, broken reinforced concrete, ceramic and plastic.	
1.00	TJ			40.69	1.60		
1.70	TJ				(1.10)	MADE GROUND: Brown clayey, gravelly sand with broken red brick, broken reinforced concrete, ceramic and plastic.	
2.60	TJ			39.59	2.70		
				39.39	(0.20) 2.90	MADE GROUND: Concrete Slab.	
3.50	TJ				(0.80)	Firm blueish grey slightly silty, gravelly CLAY.	
				38.59	3.70

Remarks 1. Strength and characteristics assessed by onsite engineer only. 2. Pit terminated at 3.5 m under engineers instruction. 3. Wall collapse recorded at 0.60 m. 4. No groundwater ingress was recorded. 5. No visual or olfactory evidence of contamination.	Plan

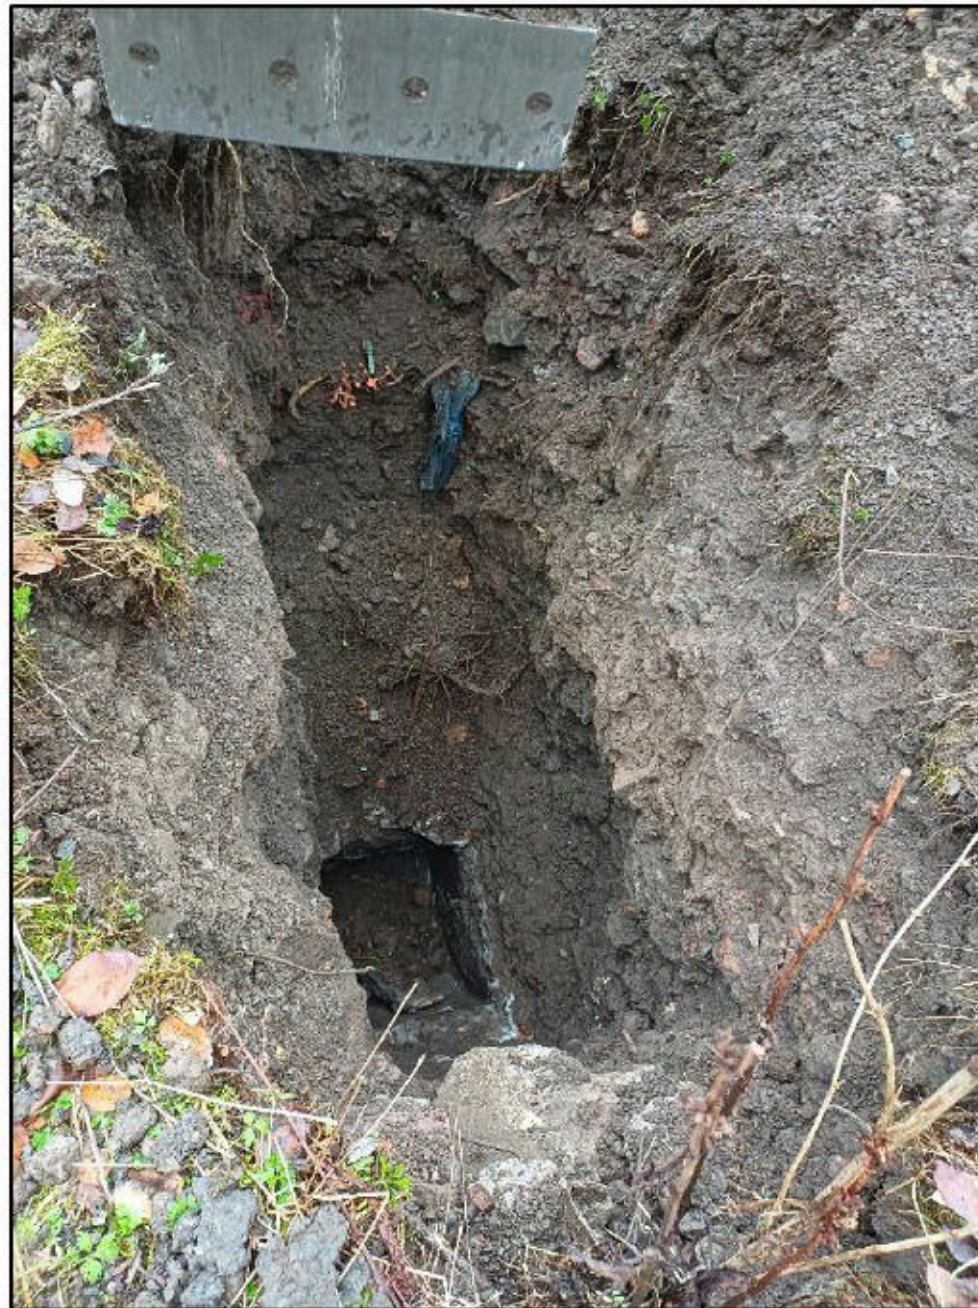
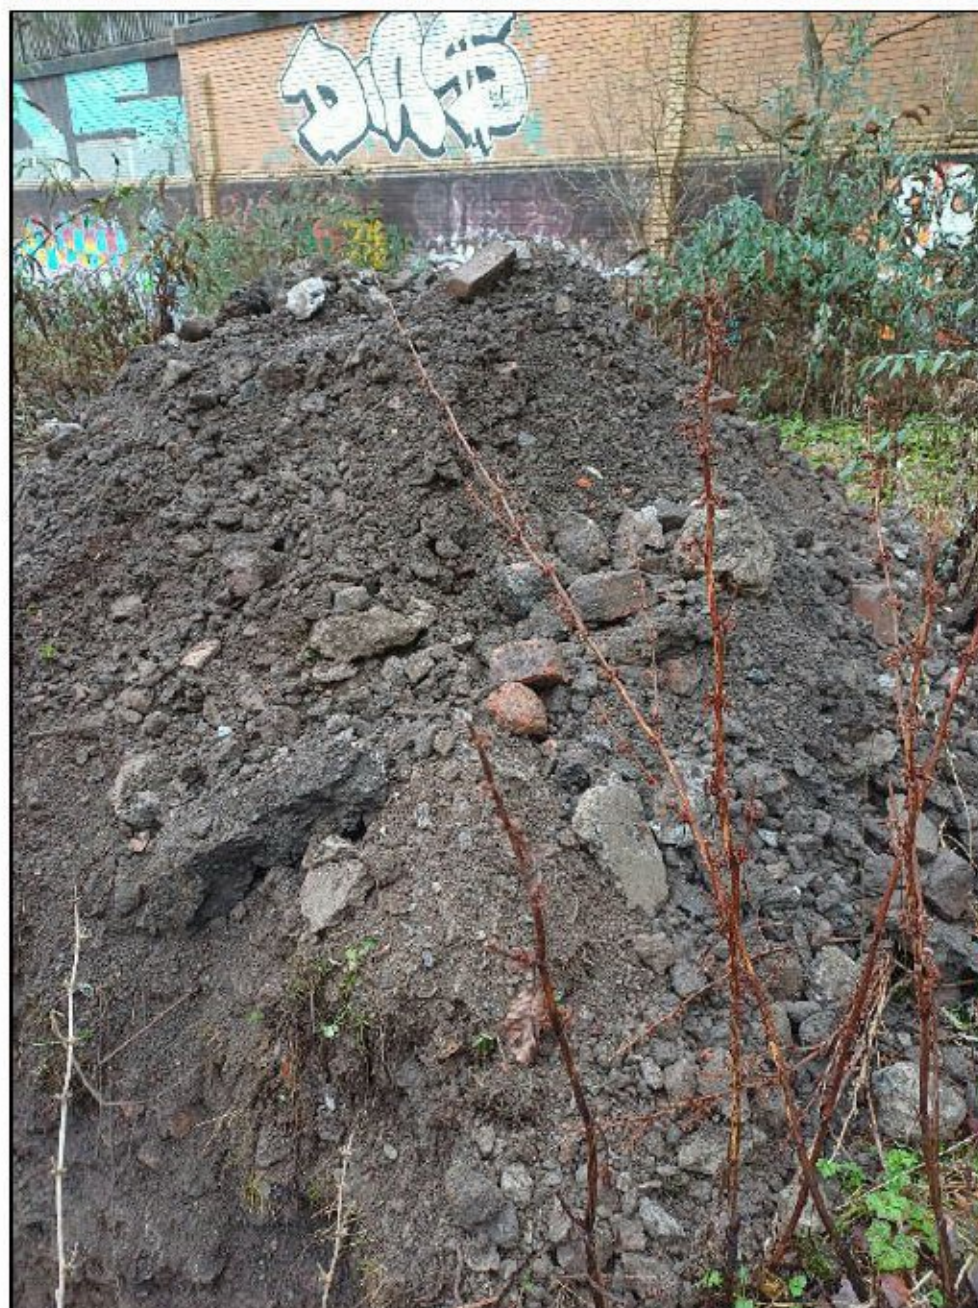
TP06

Depth	Sample/Tests	Water Depth (m)	Field Records	Level (mOD)	Depth (m) (Thickness)	DESCRIPTION	Legend
0.40	TJ				(2.30)	MADE GROUND: Brown, loose to medium dense, sand and gravel with rounded cobbled and coarse to fine sub angular gravels with metal, glass, red bricks, ceramic fragments and plastic rubbish bags.	
1.50	TJ			39.99	2.30		
2.50	TJ			39.59	(0.40) 2.70	MADE GROUND: Brown, sandy, gravelly clay with broken red brick and ceramic fragments.

Remarks 1. Strength and characteristics assessed by onsite engineer only. 2. Pit terminated at 2.70 m due to concrete obstruction at base. 3. Wall collapse recorded at 0.60 m. 4. No groundwater ingress recorded. 5. No visual or olfactory evidence of contamination.	Plan

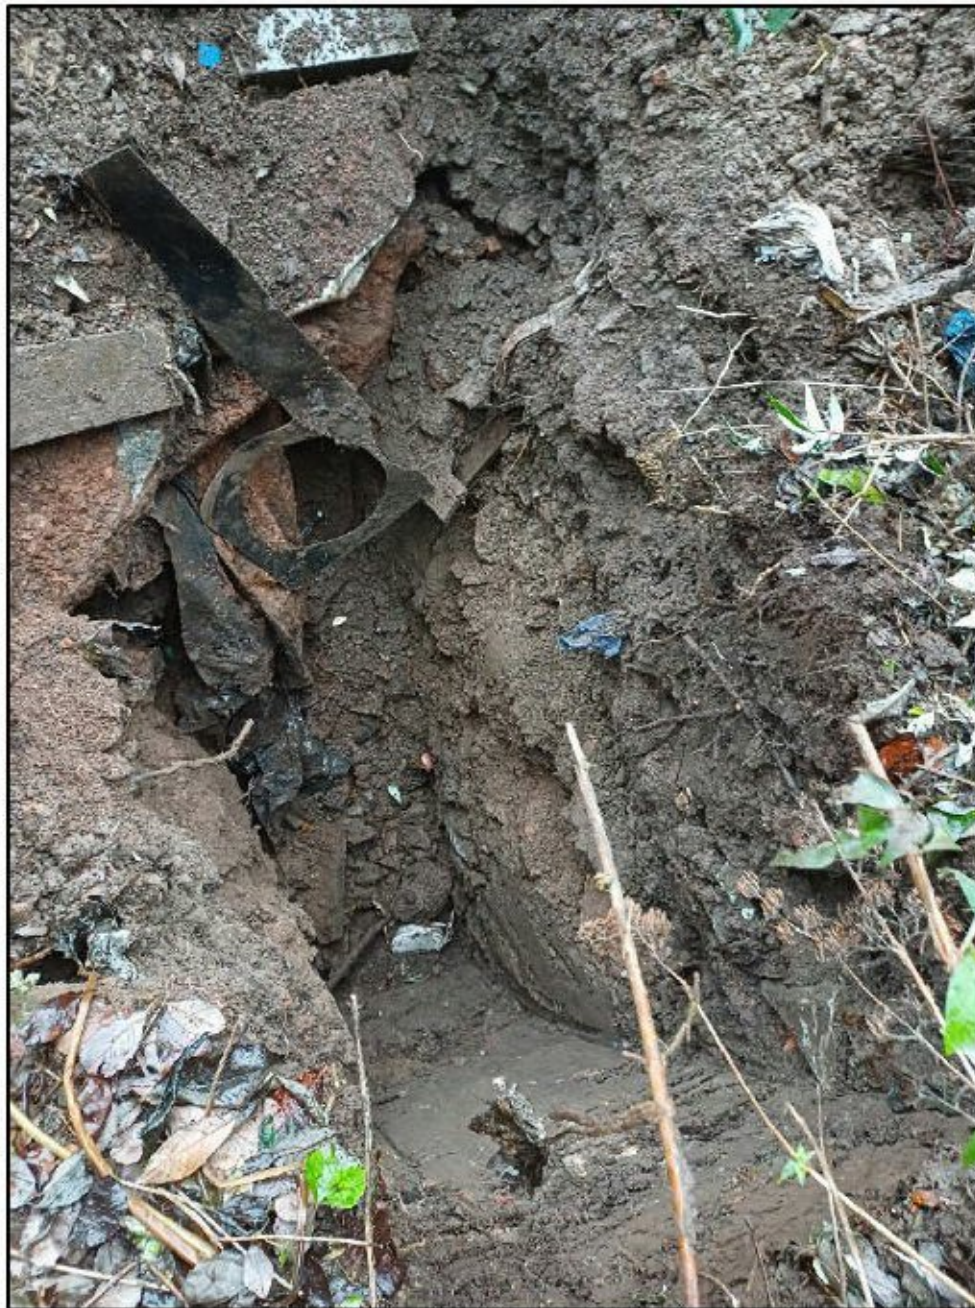
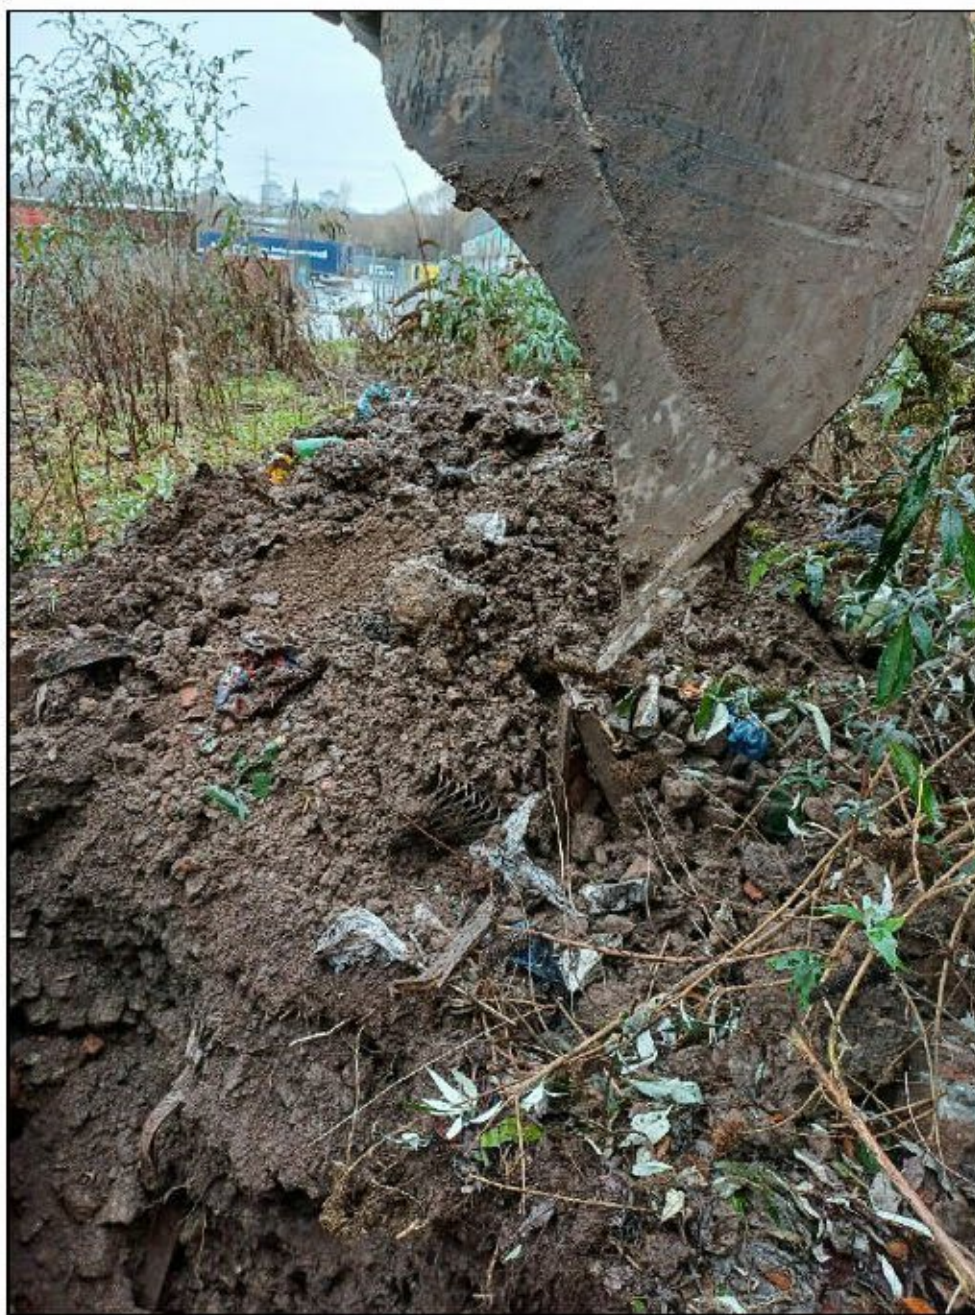
TP07

Depth	Sample/Tests	Water Depth (m)	Field Records	Level (mOD)	Depth (m) (Thickness)	DESCRIPTION	Legend
0.40	TJ			41.44	0.80	MADE GROUND: Blackish brown, gravelly sand with broken red brick and ceramic.	
1.10	TJ			39.94	2.30	MADE GROUND: Brown sand and gravel with frequent sub-angular cobbles and gravels with frequent broken red bricks and timber fragments.

Remarks 1. Strength and characteristics assessed by onsite engineer only. 2. Pit terminated at 2.30 m due to concrete obstruction at base. 3. Pit was stable at termination. 4. No water ingress recorded. 5. No visual or offactory evidence of contamination.	Plan 	
	All dimensions in metres Scale 1:25	Logged By MF
