**Appendix A**

**Site Walkover Survey  
(Mason Evans Partnership, September 2023)**

## WALKOVER SURVEY RECORD

**Project Name: Rotterdam Wharf**

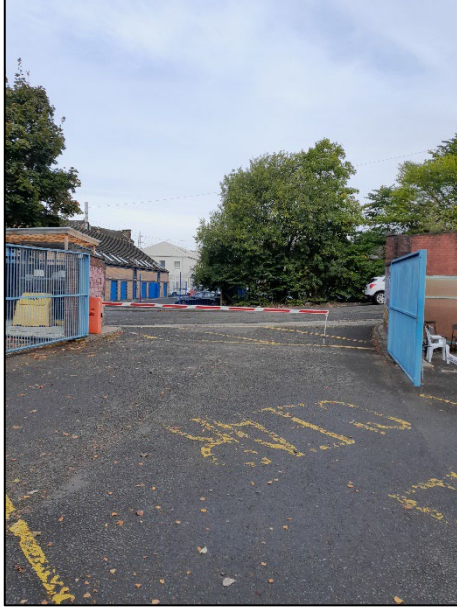
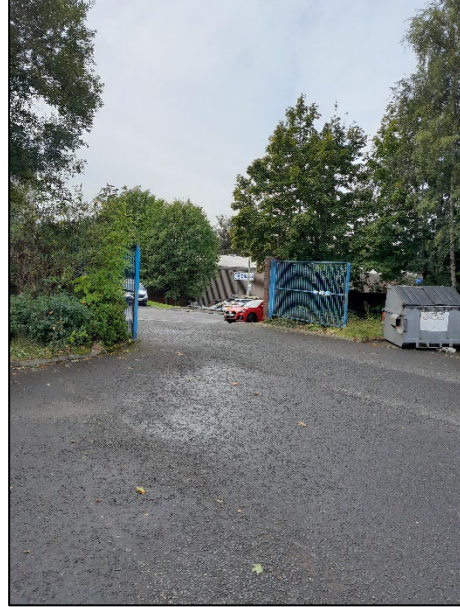
Access into the site, both from the north and south

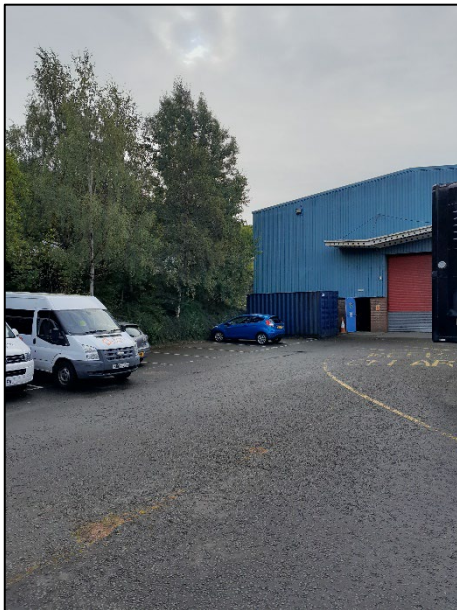
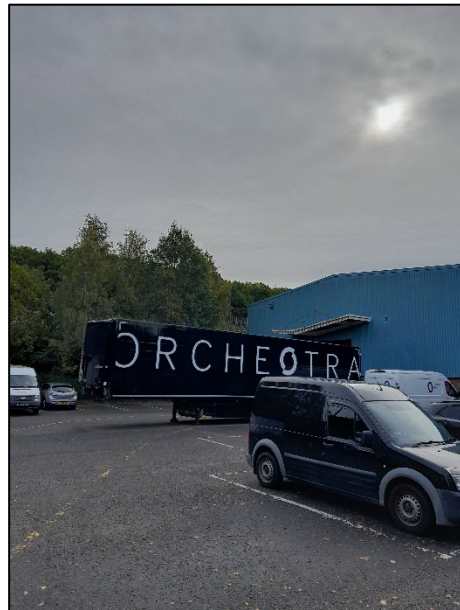
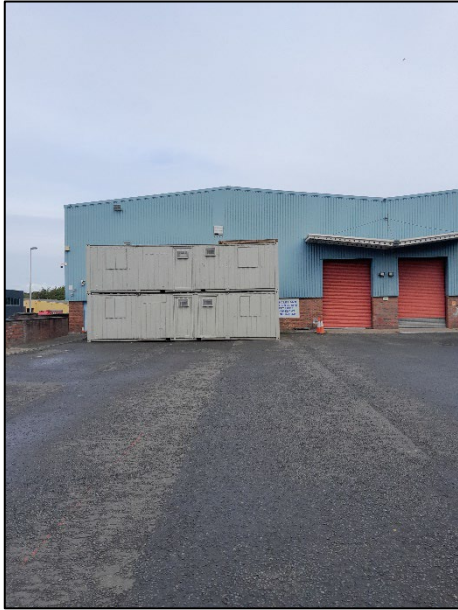
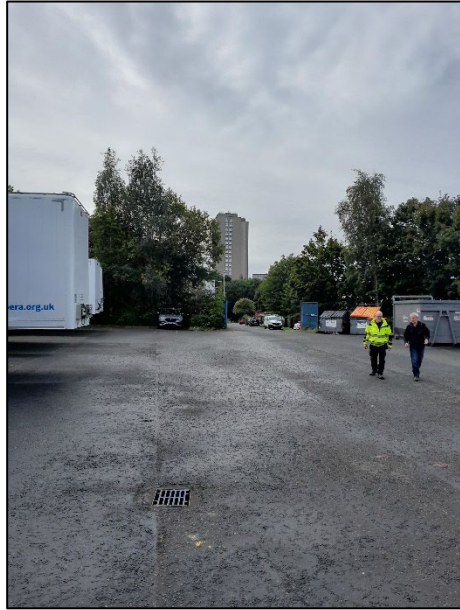
Existing car park areas within the north and south

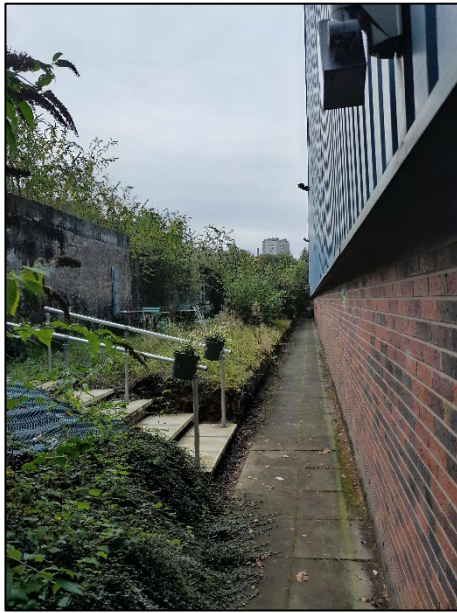
Narrow strip between the existing building and the concrete yard to the east

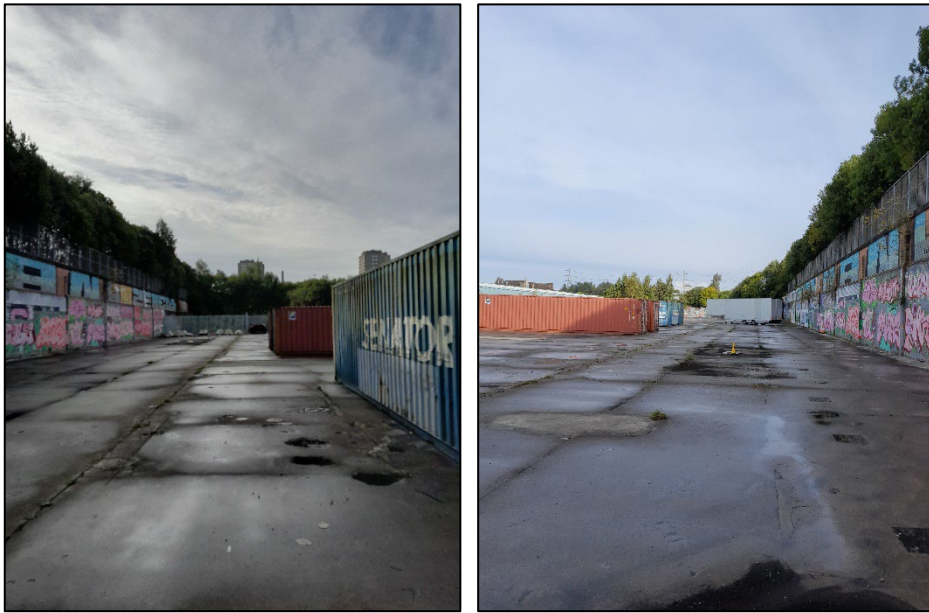
Concrete yard within the eastern area

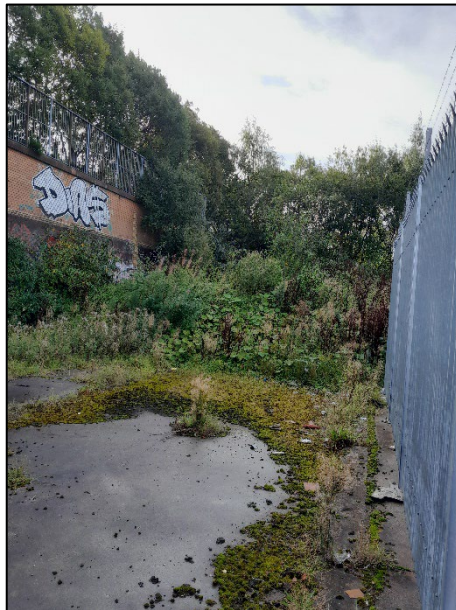
Vegetated area within the southern site area (fenced off)

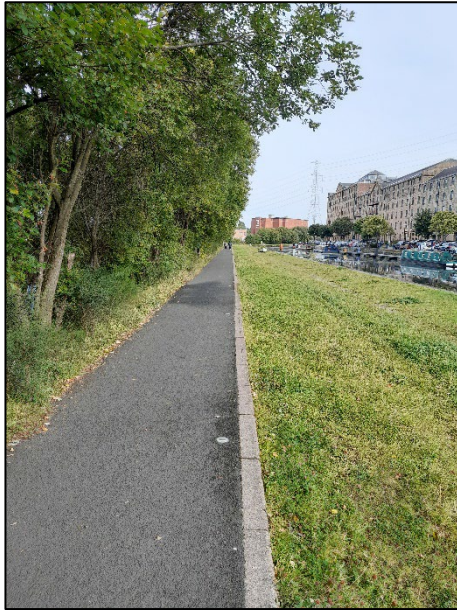
Canal pedestrian walkway to the immediate east of the site
