2nd Floor, 9 Turnberry Rd, GLASGOW, G11 5AG

Reasons for replacement are:

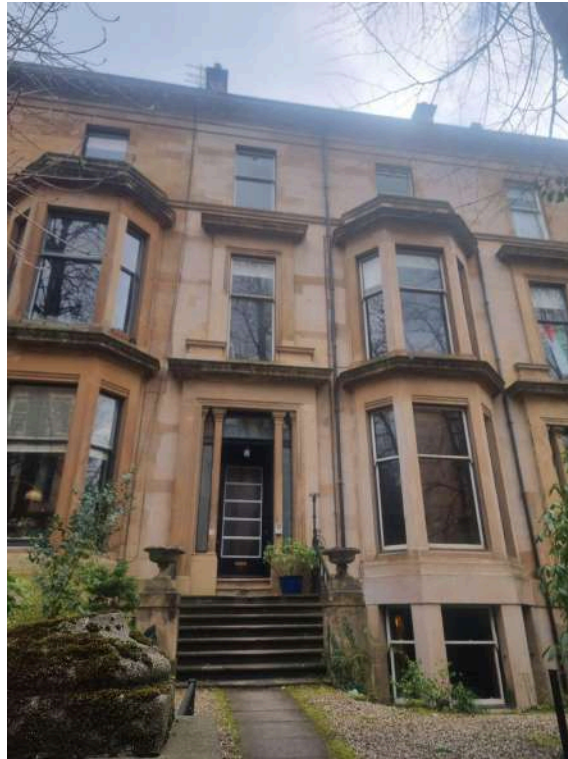
We propose replacing the existing sash and case windows with newly manufactured hardwood timber sash and case windows that will be manufactured in a like for like formation. Horn detail would be lifted from the existing windows to preserve the established style to the front elevation of the property.

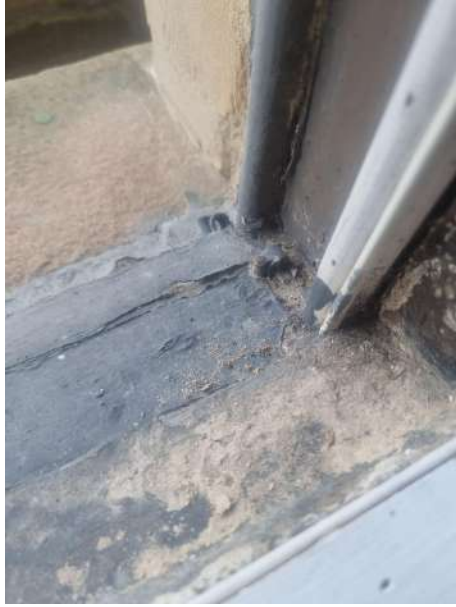
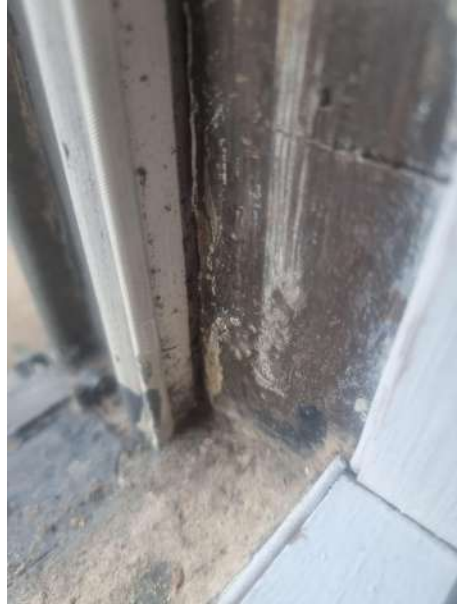
Rotting sill and casement woodwork

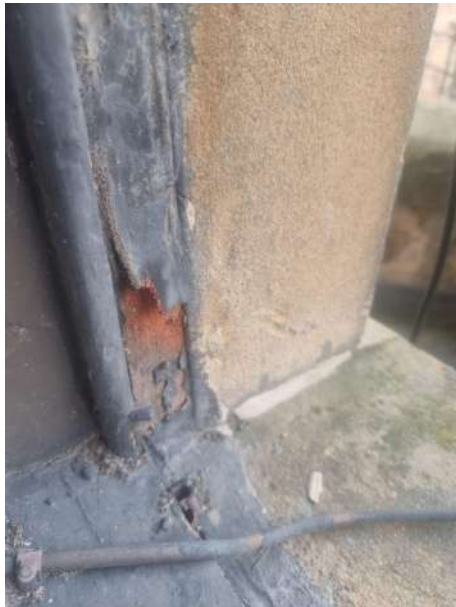
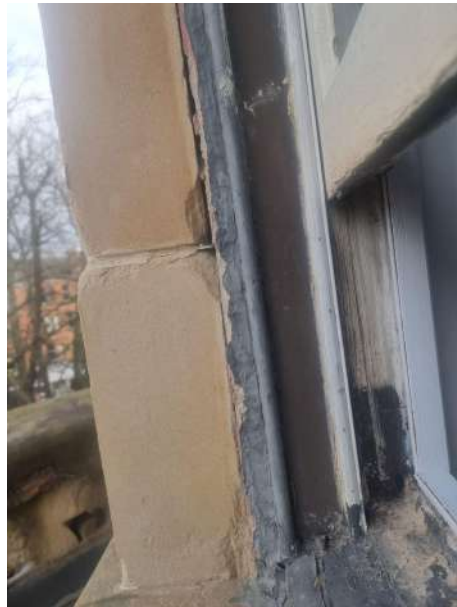
Broken and failing mastic is allowing water to get behind the stonework and into the casement woodwork

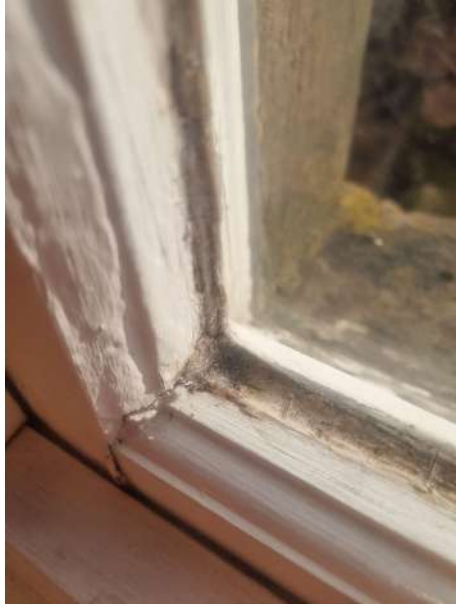
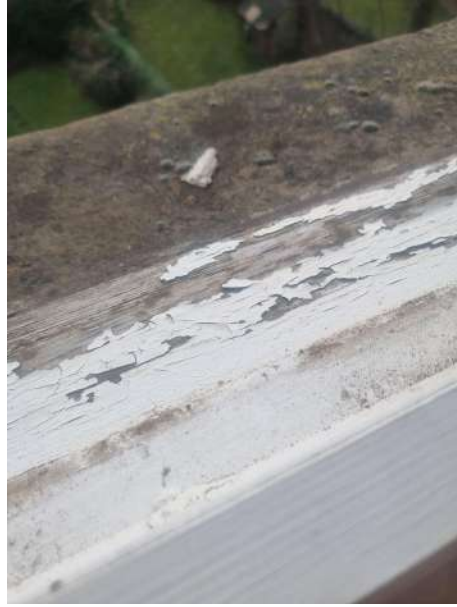
The first photo shows where the bottom rail has previously been replaced due to issues with rotting.
The second photo shows a bare sill which is beginning to rot

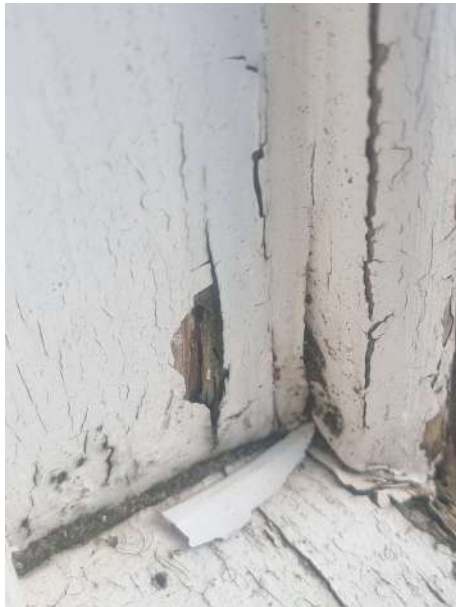
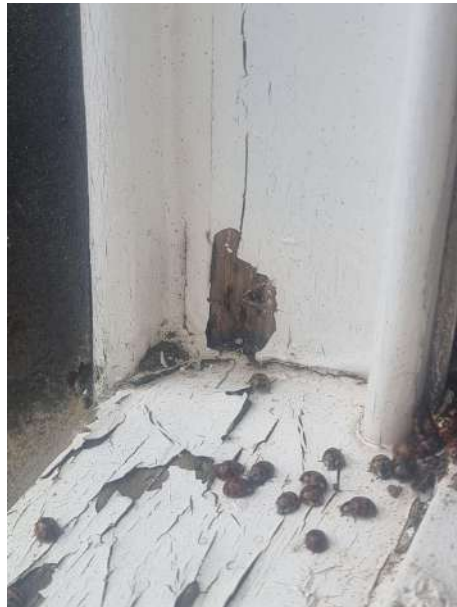
Rotting casement woodwork

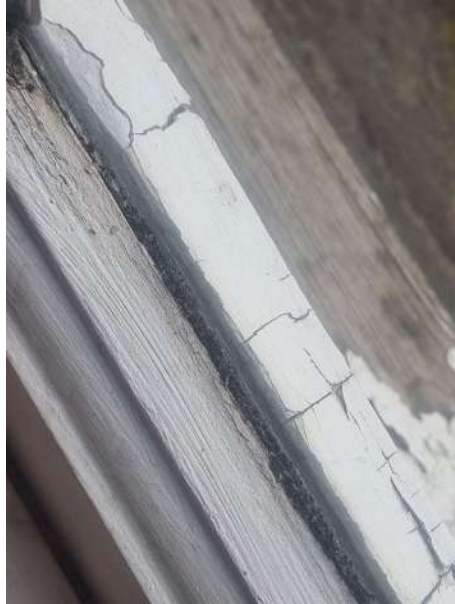
Broken exterior putty is allowing water to enter the woodwork

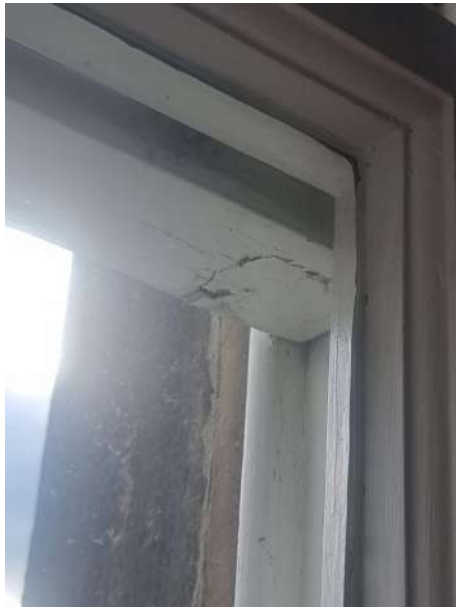
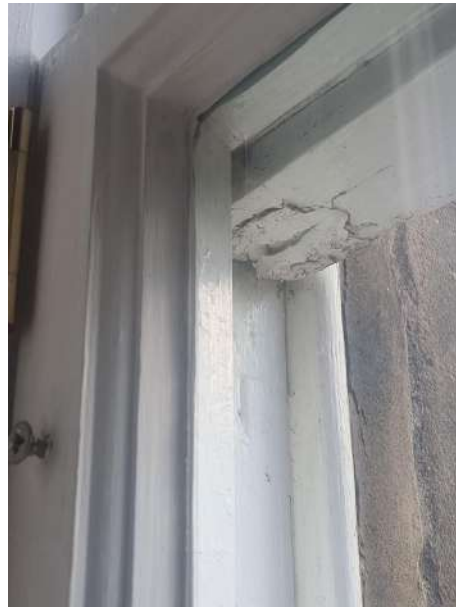
Failing top sash tenon joints

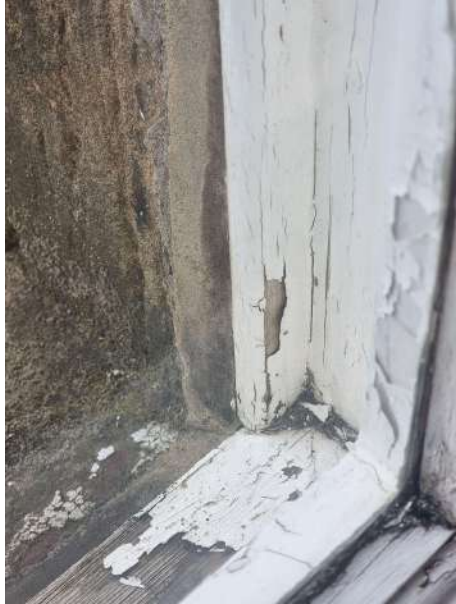
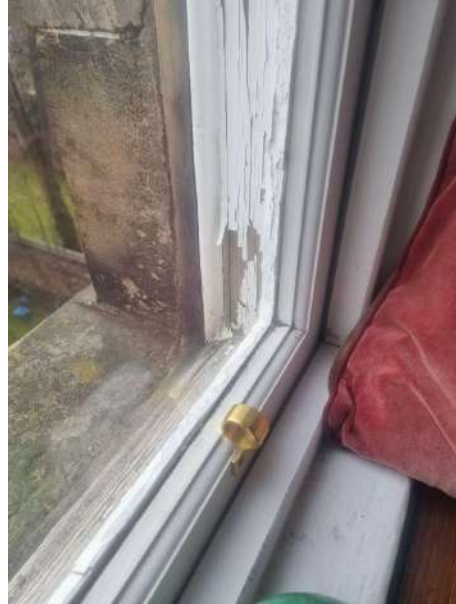
Rotting sill, baton rod and casement woodwork

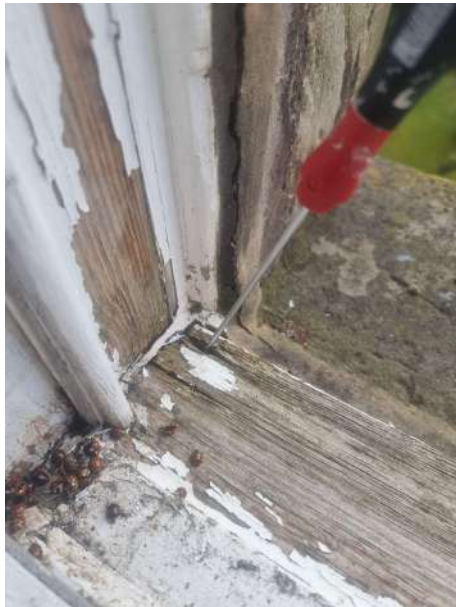
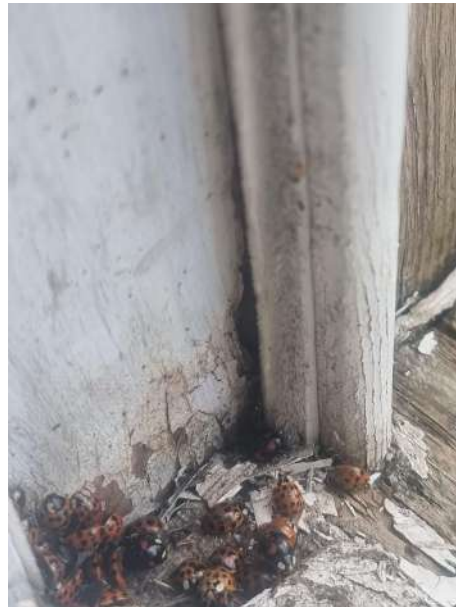
The first photo shows the sill is rotten. The second photo shows gaping behind the parting bead which will allow water to enter. It also shows that the window has previously been refurbished as a brush pile has been added to the parting bead. When the windows are replaced, the draught proofing seals will be routed into the sashes so that the windows will keep their traditional look.

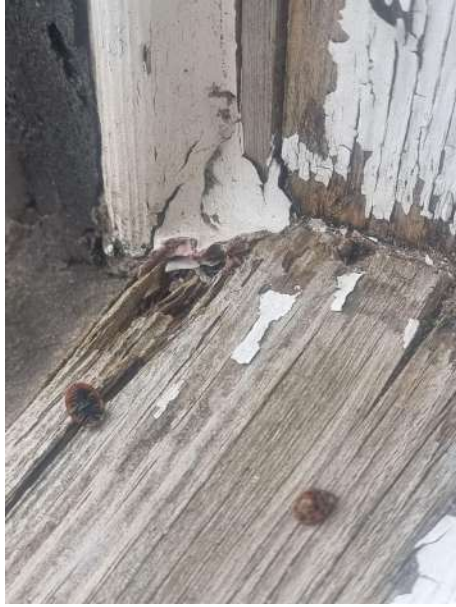
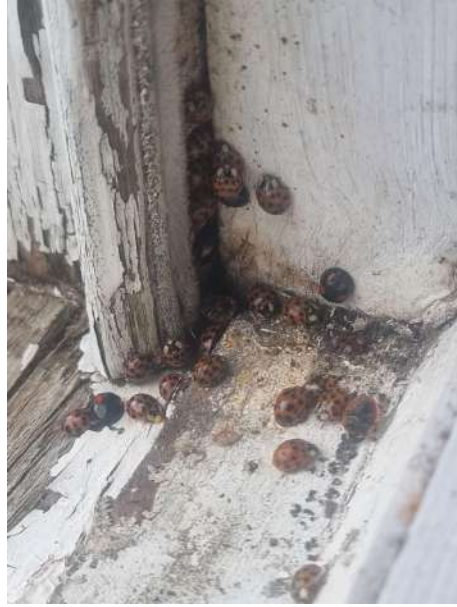
Rotting sill, casement and parting bead woodwork

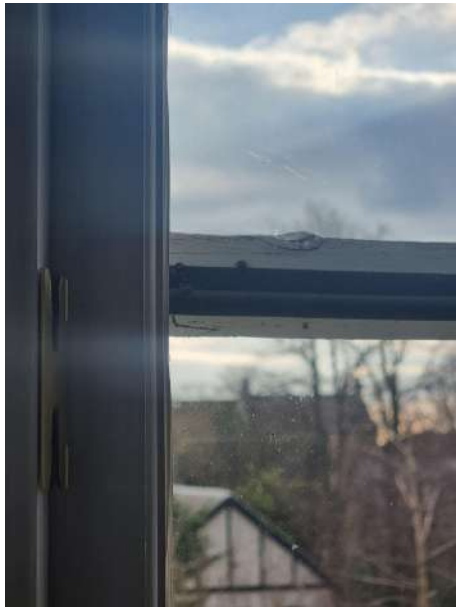
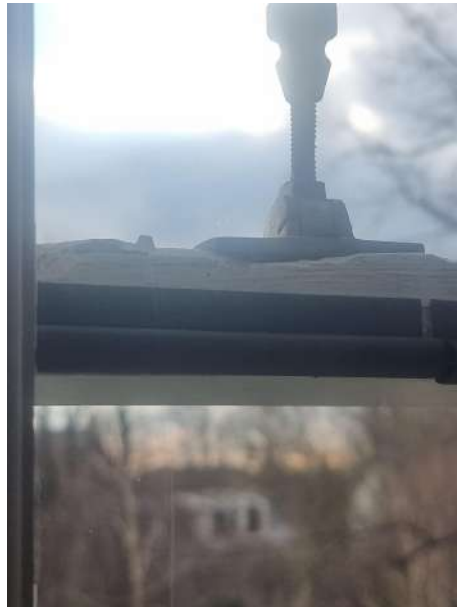
The midrail woodwork is broken and deteriorating in areas. The client has also added a seal to the mid rail as a temporary measure to stop wind and water entering the property.
