Tree Management Report

Wigan Golf Club

25/03/2024

Job Ref: 1934

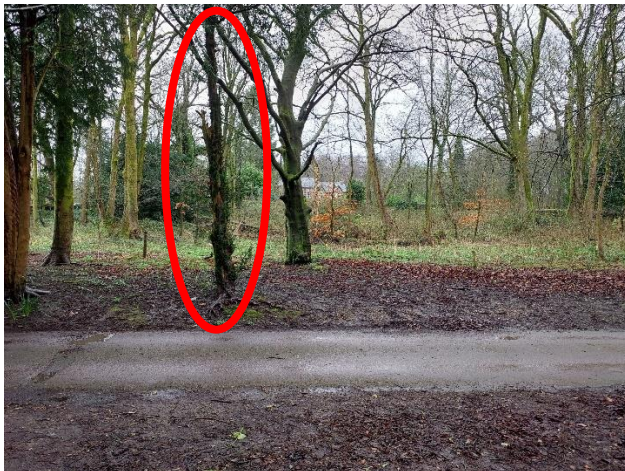
| Job Ref: | 1934 | | Survey Date: | 25-Mar-2024 | | Surveyor: | Gary Marsden | | | | Site Address: | Wigan Golf Course + Club House | | VTA site survey | | | | |
|---|---|--|---|---|---|---|---|---|---|---|--|--|--|--|--|---|---|---|
| Tree | T136 | English yew (<i>Taxus baccata</i>) | 1 | 30 | 15 | N:3 E:3 S:3 W:3 | Mature | Good | Good | 40+ Years | _ No significant visual defects. | No significant visible fungus present at the time of inspection. | No significant visible Pests or Disease present at the time of inspection. | Owned by the client. Target # - Road Target # - Open Space | YES | Remove tree to improve area for additional parking spaces | 25-Sep-2024 (6 Months) | 2 Years |

Works recommended.

The surfacing of the car parking spaces will incorporate load distribution cellular systems with a porous structure to minimise impact on tree roots. Specific details will be provided to the club on the method of construction in a separate report on receipt of a consent to carry out the works.

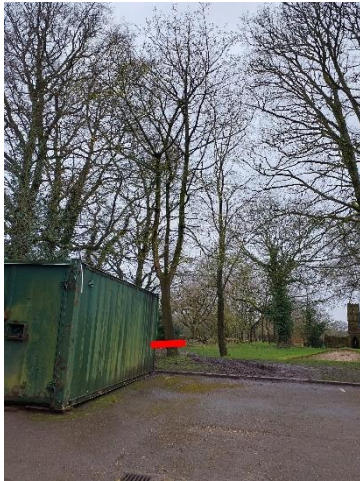
Airflow and light are needed to improve the condition of the putting green and there is a need of the club to increase the area of the green.

| Job Ref: | 1934 | | Survey Date: | 25-Mar-2024 | | Surveyor: | Gary Marsden | | | | Site Address: | Wigan Golf Course + Club House | | VTA site survey | | | | |
|---|---|--|---|---|---|---|---|---|---|---|--|--|--|--|--|---|---|---|
| Tree | T178 | Norway maple (<i>Acer platanoides</i>) | 1 | 40 | 12 | N:4 E:4 S:4 W:4 | Early Mature | Good | Good | 40+ Years | _ No significant visual defects. | No significant visible fungus present at the time of inspection. | No significant visible Pests or Disease present at the time of inspection. | Owned by the client. Target # - Parking / driveway Target # - Open Space | YES | _ Remove tree to ground level. _ Stump grind. | 25-Sep-2024 (6 Months) | 2 Years |

- Removal of T178, T179, T180, T181, G203 (shrubs and Yew).
- Pruning of T108, T110, T112.

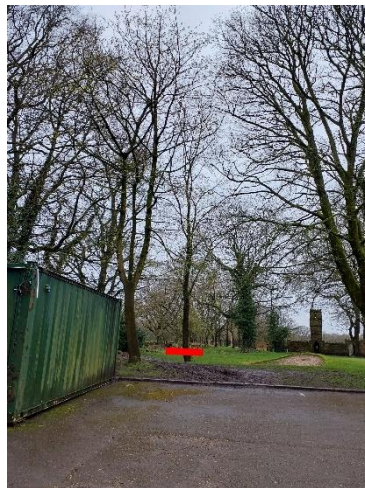
| Job Ref: | 1934 | | Survey Date: | 25-Mar-2024 | | Surveyor: | Gary Marsden | | | Site Address: | Wigan Golf Course + Club House | | VTA site survey | | | | | |
|---|---|---|---|---|---|---|---|---|---|---|---|--|--|--|---|--|---|---|
| Tree | T179 | Sycamore (<i>Acer pseudoplatanus</i>) | 1 | 40 | 12 | N:4 E:4 S:4 W:4 | Early Mature | Good | Good | 40+ Years | _ No significant visual defects. | No significant visible fungus present at the time of inspection. | No significant visible Pests or Disease present at the time of inspection. | Owned by the client. Target # - Parking / driveway Target # - Open Space | YES | _ Remove tree to ground level. _ Stump grind. | 25-Sep-2024 (6 Months) | 2 Years |

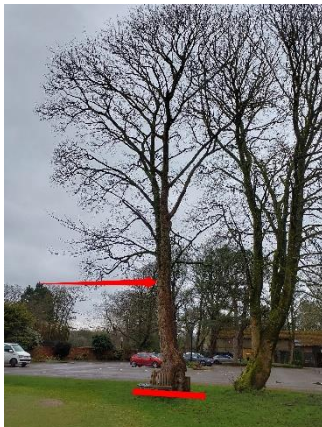
| Job Ref: | 1934 | | Survey Date: | 25-Mar-2024 | | Surveyor: | Gary Marsden | | | Site Address: | Wigan Golf Course + Club House | | VTA site survey | | | | | |
|---|---|---|---|---|---|---|---|---|---|---|---|--|--|--|---|--|---|---|
| Tree | T181 | Sycamore (<i>Acer pseudoplatanus</i>) | 1 | 60 | 18 | N:4 E:4 S:4 W:4 | Mature | Good | Fair | 40+ Years | _ Void / cavity within root / buttress area _ Stem decay. _ Lost co dominant stem. | No significant visible fungus present at the time of inspection. | No significant visible Pests or Disease present at the time of inspection. | Owned by the client. Target # - Parking / driveway Target # - Open Space | YES | _ Remove tree to ground level. _ Stump grind. | 25-Sep-2024 (6 Months) | Not Applicable |

- pruning of trees T200, T201, T180, T181, G203.
- Thinning of lower canopies and self-seeded trees within G202

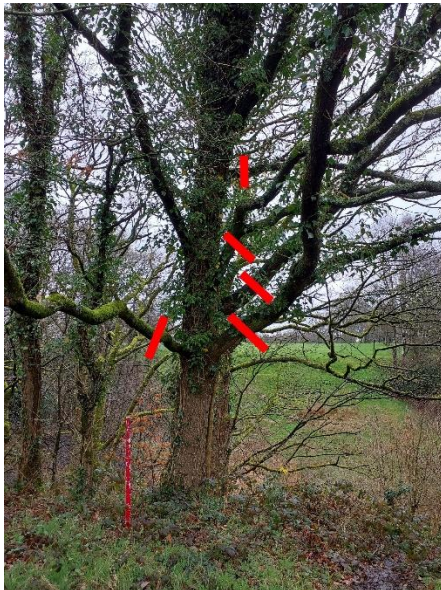
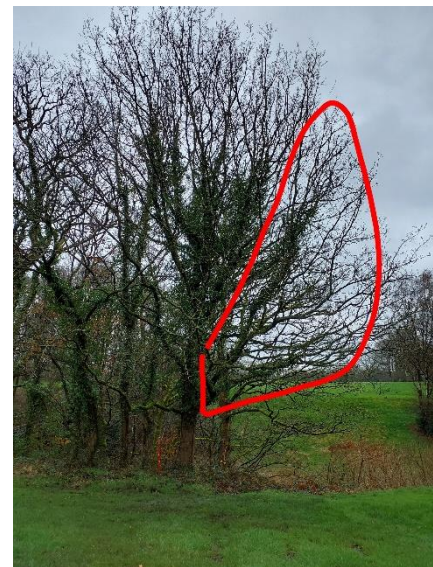
T200

When players are teeing off from the 18th tee and players are walking from the 6th tee along the fairway there have been reported and documented incidents when there have been near misses when players have been close to being struck by a golf ball in flight, if sight lines could be improved this would improve visibility and allow players to see the potential for shots being taken and to wait until the area is clear and safe for them to proceed.

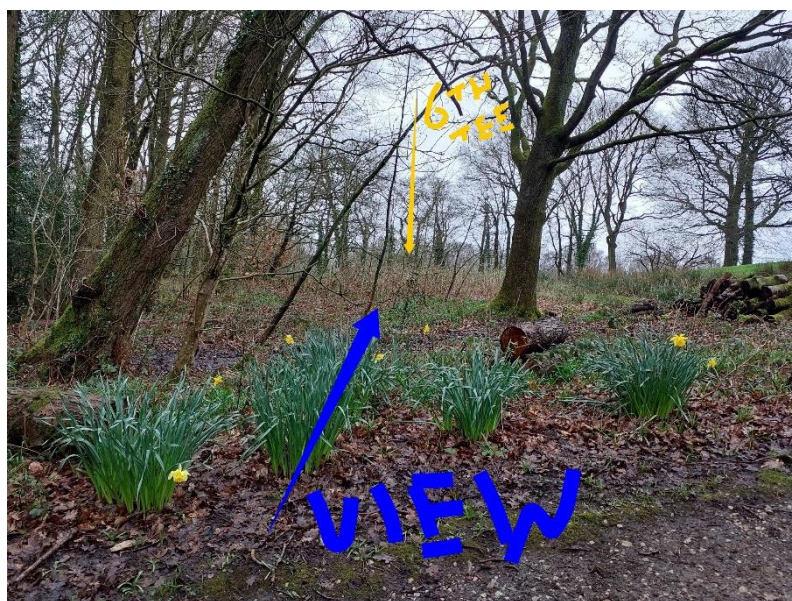
When players are teeing off from the 6th tee and players are walking from the 18th tee over the footbridge to get to the fairway there have been reported and documented incidents when there have been near misses when players have been close to being struck by a golf ball in flight, if sight lines could be improved this would improve visibility and allow players to see the potential for shots being taken and to wait until the area is clear and safe for them to proceed.

| Job Ref: | | 1934 | | Survey Date: | | 25-Mar-2024 | | Surveyor: | | Gary Marsden | | Site Address: | | Wigan Golf Course + Club House | | VTA site survey | | | |
|---|---|---|---|---|---|---|---|---|---|---|--|--|--|---|--|---|---|---|--|
| Small Tree | G206 | Mixed species (Mixed species) | 1 | 10 | 4 | N:0 E:0 S:0 W:0 | Young | Good | Good | 10+ Years | _ No significant visual defects. | No significant visible fungus present at the time of inspection. | No significant visible Pests or Disease present at the time of inspection. | Owned by the client. Woodland tree. Target # - Open Space | YES | Thin out low vegetation and self seated saplings to improve visibility towards 6th tee. | 25-Sep-2024 (6 Months) | 2 Years | |

- Lifting of lower canopies and thinning of self-seeded trees within G206.

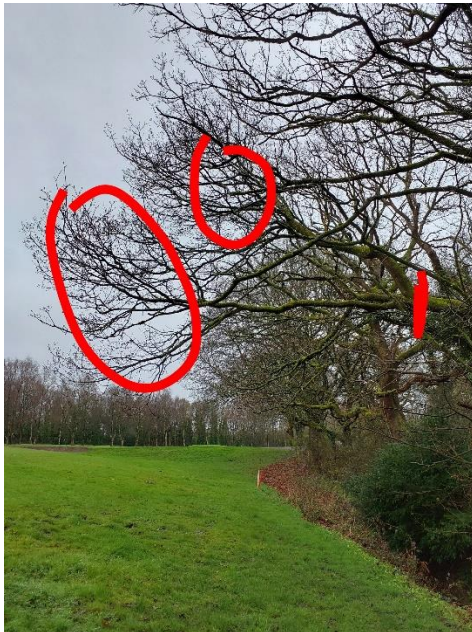
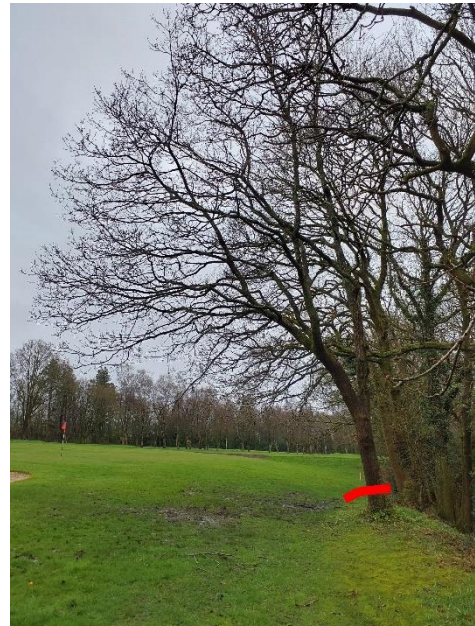
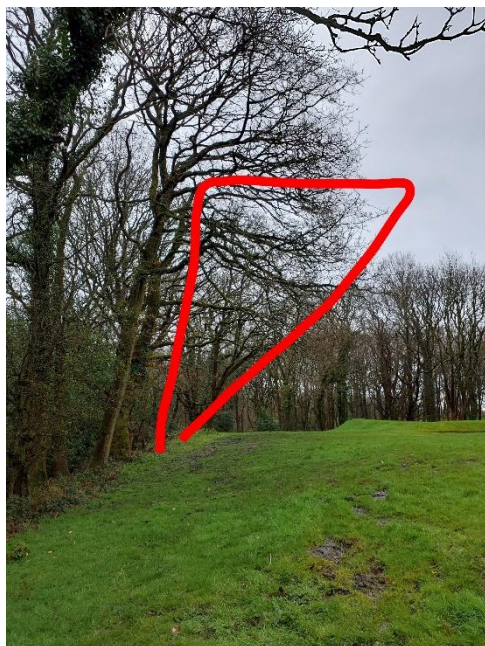
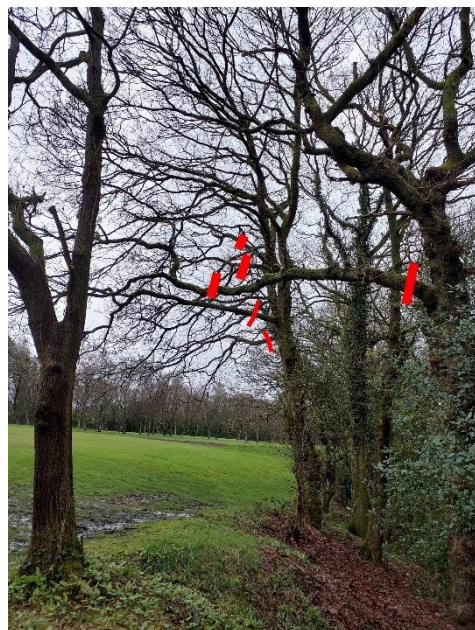
G194

Airflow and light are needed to improve the condition of the 17th tee and reduce encroachment over the approach fairway.

- Pruning of the canopies of G194.
- Removal of T195, T197, G199.
- Limb removal of T196, T198.

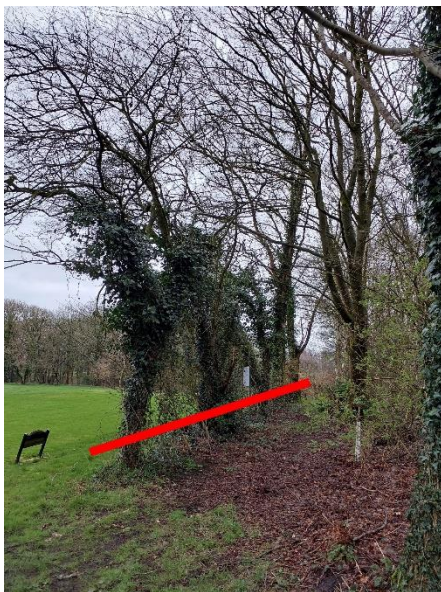
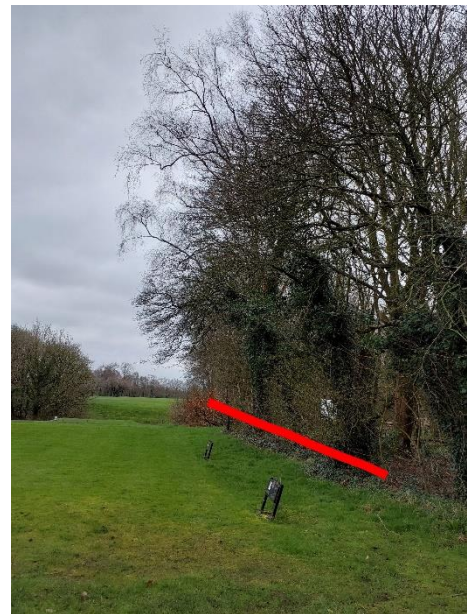
G204

Airflow and light are needed to improve the condition of the 18th tee and reduce encroachment over the tee and fairway.

- Removal of H205, G204.

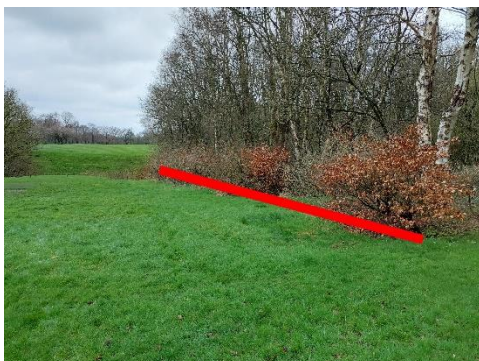
| Job Ref: | 1934 | | Survey Date: | 25-Mar-2024 | | Surveyor: | Gary Marsden | | | | Site Address: | Wigan Golf Course + Club House | | VTA site survey | | | | |
|---|---|--|---|---|---|---|---|---|---|---|--|--|--|--|--|---|---|---|
| Hedge | H205 | Common beech x20 (<i>Fagus sylvatica</i>) | 20 | 10 | 4 | N:2 E:2 S:2 W:2 | Young | Good | Good | 40+ Years | _ No significant visual defects. | No significant visible fungus present at the time of inspection. | No significant visible Pests or Disease present at the time of inspection. | Owned by the client. Target # - Open Space | YES | _ Remove tree to ground level. _ Stump grind. | 25-Sep-2024 (6 Months) | Not Applicable |

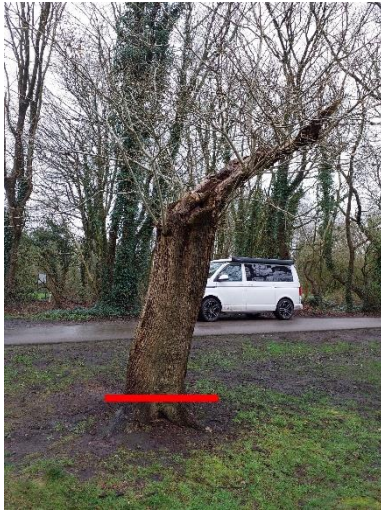
Additional tree found with crack in stem and poor form and aesthetically poor on approach road to club house – request off head groundsman to remove tree.

| Job Ref: | | 1934 | | Survey Date: | | 25-Mar-2024 | | Surveyor: | | Gary Marsden | | Site Address: | | Wigan Golf Course + Club House | | VTA site survey | | | |
|---|---|---|---|---|---|---|---|---|---|---|--|--|--|---|--|---|---|---|--|
| Tree | G207 | Oak (Quercus sp.) | 1 | 50 | 4 | N:1 E:1 S:1 W:1 | Mature | Poor | Collapsing | <10 years | _ Lost main stem. _ Storm damage. _ Lost limbs. _ Poor form. | No significant visible fungus present at the time of inspection. | No significant visible Pests or Disease present at the time of inspection. | Owned by the client. Roadside tree. Target # - Open Space | YES | _ Remove tree to ground level. _ Stump grind. | 25-Sep-2024 (6 Months) | Not Applicable | |
