Sash Window Surveys Edinburgh

Condition Survey Report

Address:
2a Brunswick Street
Edinburgh
EH7 5JD

Category A Listed

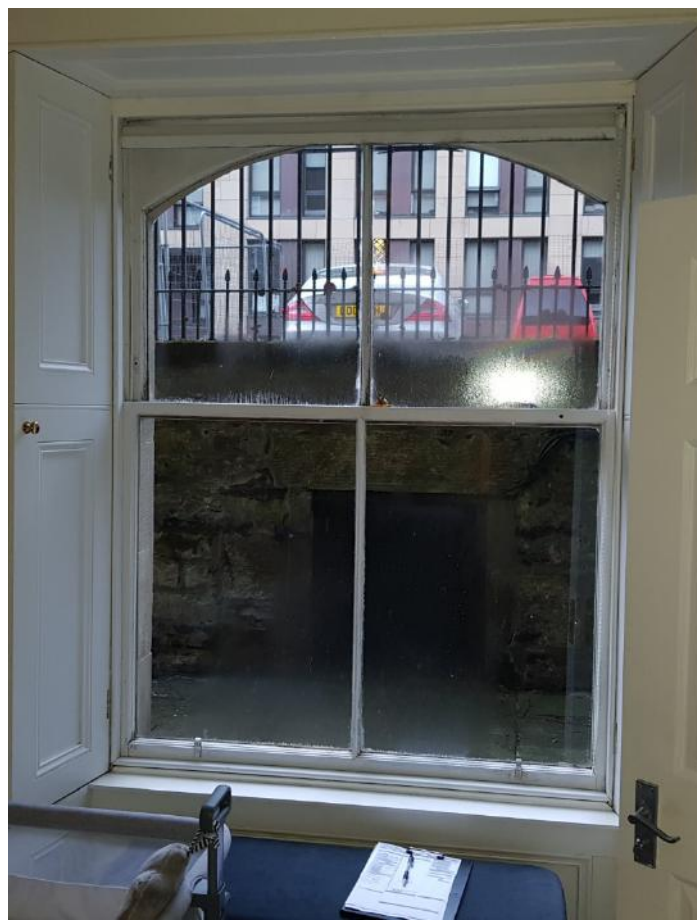
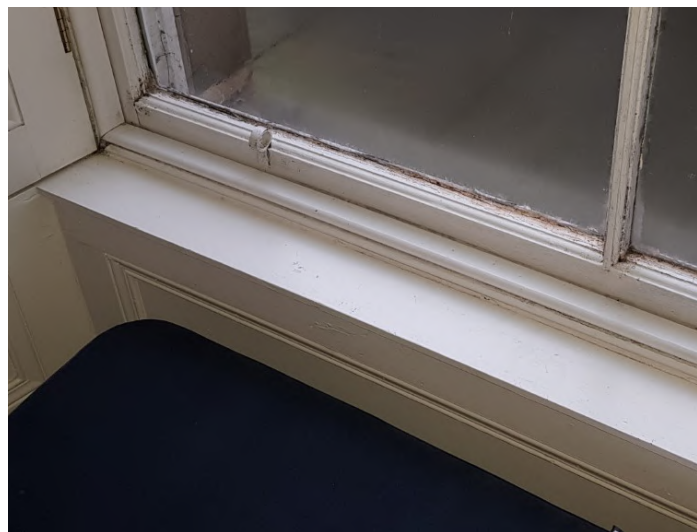
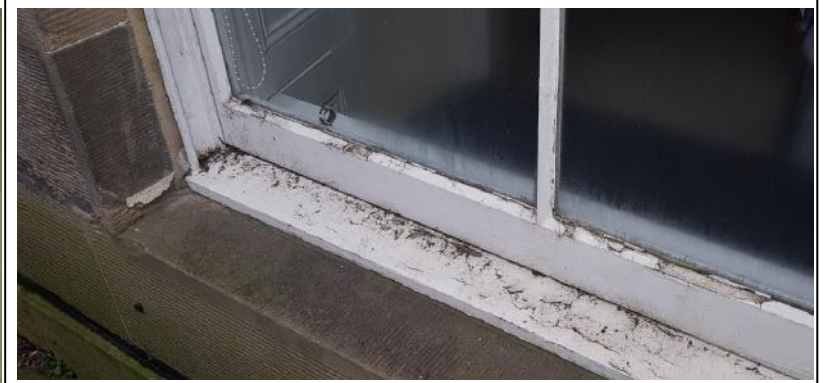
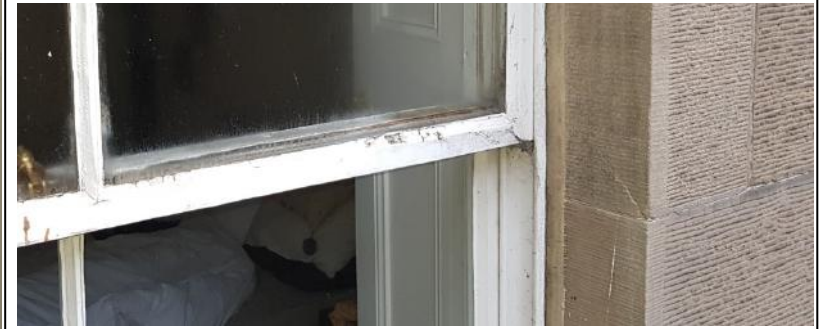
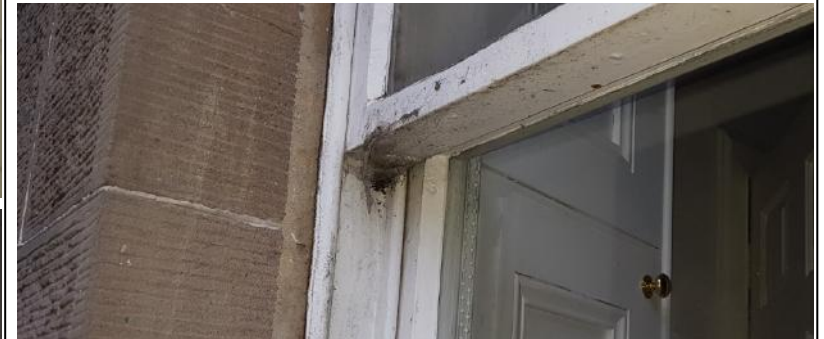
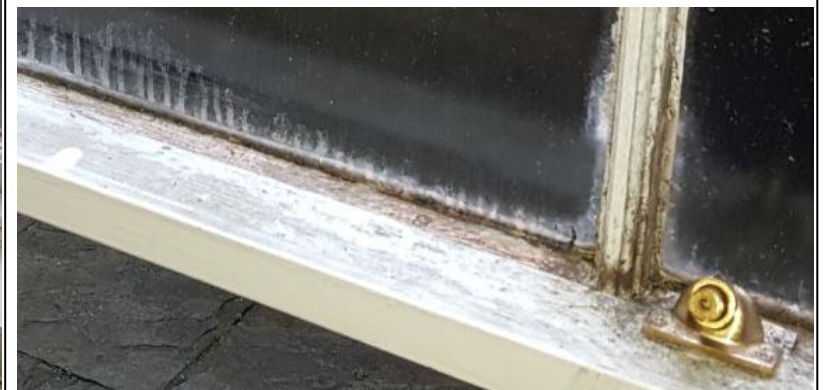
| Elevation | Floor | No. | Room |
|---|---|---|---|
| Front | BF | W1 | Front Bed 1 |

- Sashes are non-historic and of more recent construction
- Heavy condensation damage to horizontal rails and internally
- Compromised putty to the exterior with moisture ingress towards sash timbers
- Cracking of paint along the joins is indicative of shrinkage/swelling and a weakening of the structure.
- Compromised join to upper sash meeting rail
- Existing astragals unsuitable for installation of IGUs
- Moisture permeation of the horizontal rails and extending to the lower stiles.

Like-for-like replacement custom-fitted with Slimline IGUs

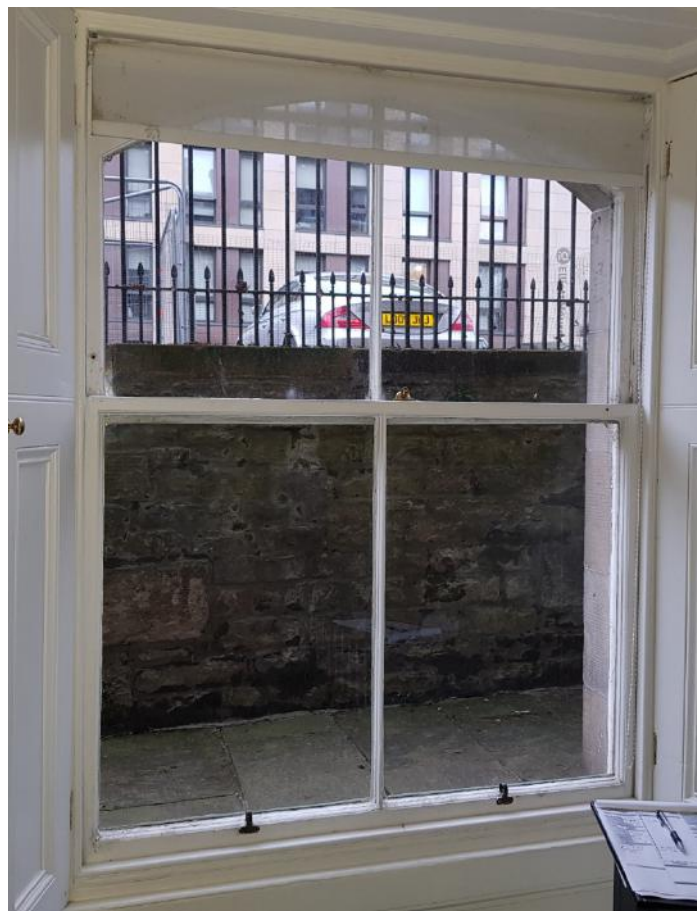
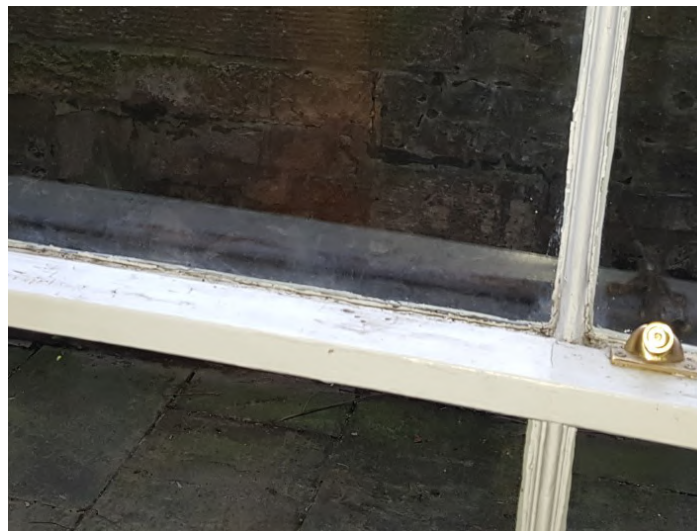
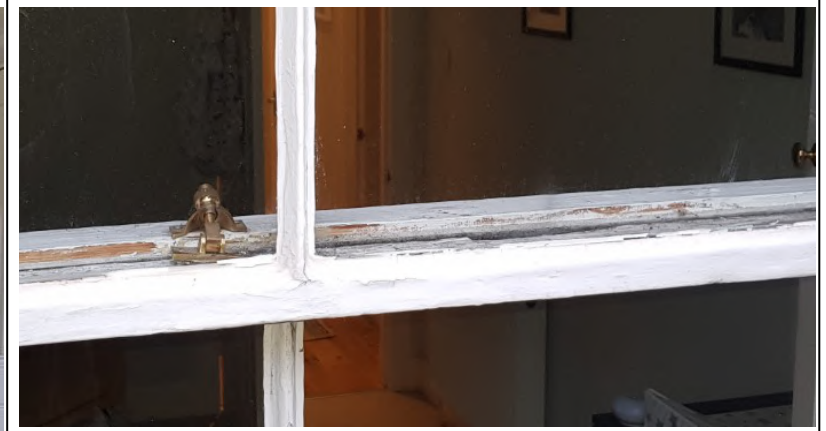
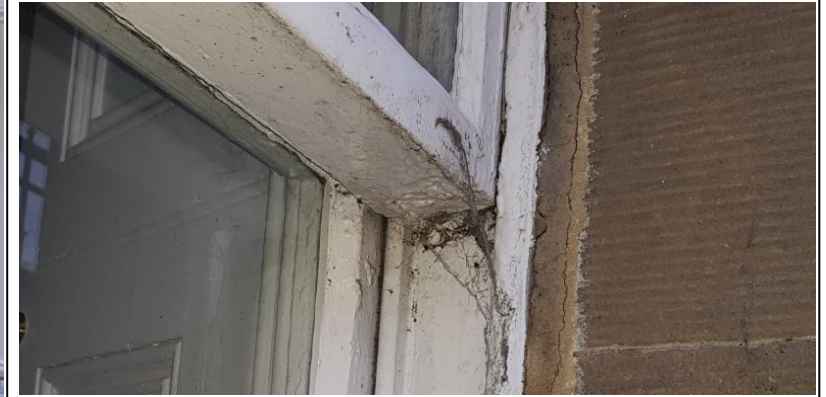
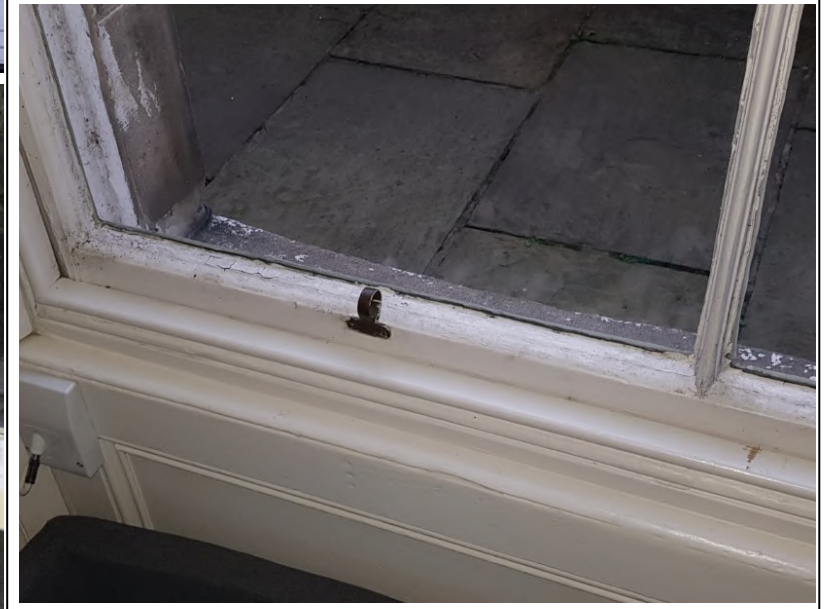
| Elevation | Floor | No. | Room |
|---|---|---|---|
| Front | BF | W2 | Front Bed 2 |

- Condensation damage to horizontal rails and internally
- Compromised putty to the exterior with moisture ingress towards sash timbers
- Cracking of paint along the joins is indicative of shrinkage/swelling and a weakening of the structure.
- Compromised join to upper sash meeting rail
- Significant loss of moulding detail due to previous repairs/filling/sanding, especially on lower rails
- Upper sash has undergone re-glazing which has been destructively carried out, leaving the perimeter timbers uneven.
- Previous patch repairs work visible under the paint coatings which have been back-filled with putty.
- Existing astragals unsuitable for installation of IGUs
- Moisture permeation of the horizontal rails and extending to the lower stiles.

Like-for-like replacement custom-fitted with Slimline IGUs

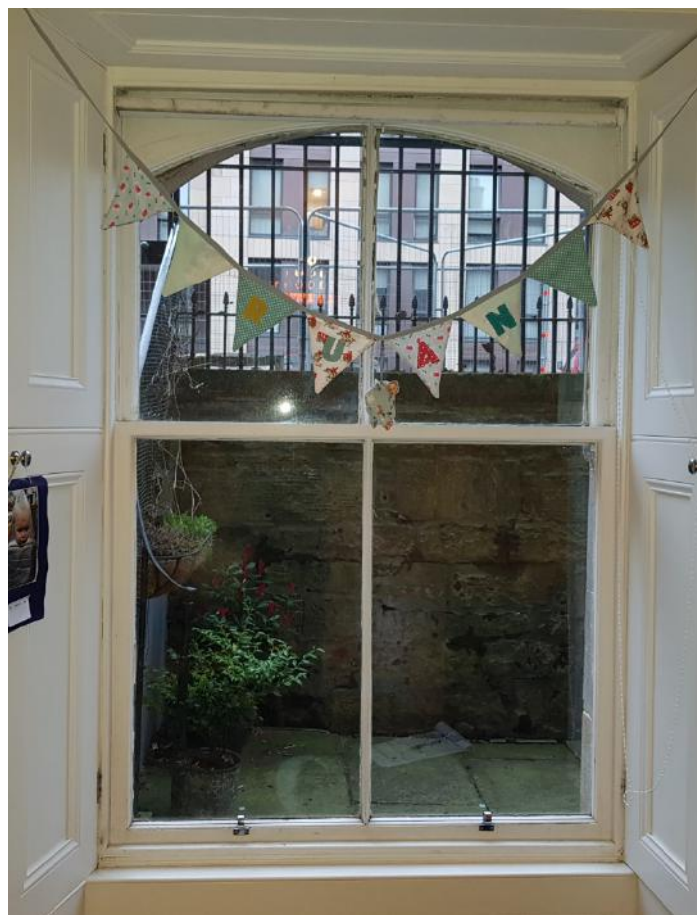
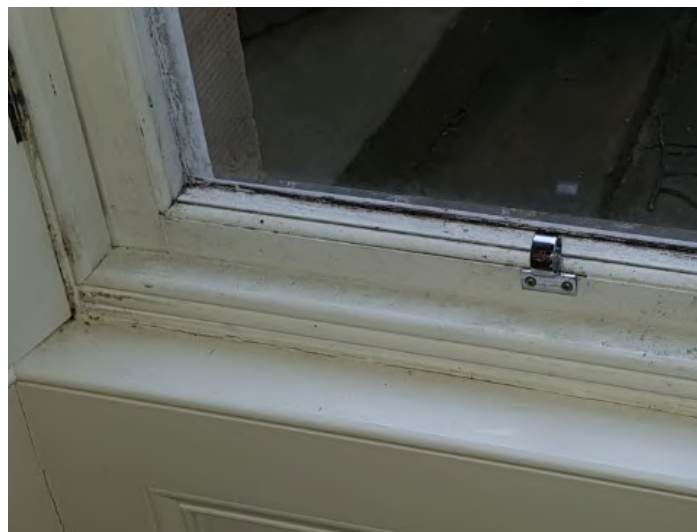
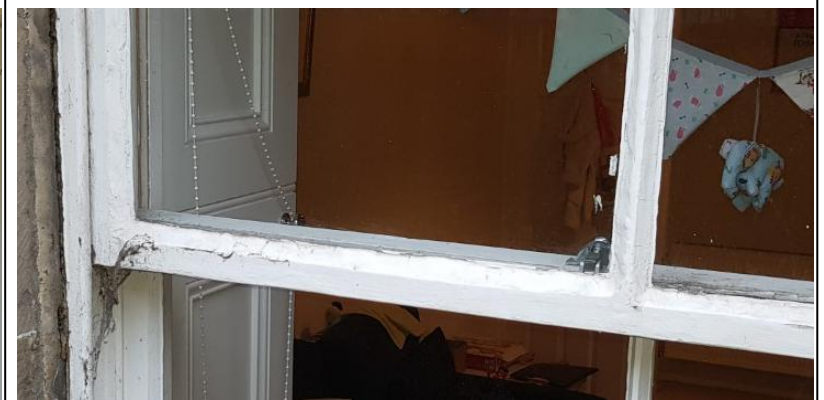
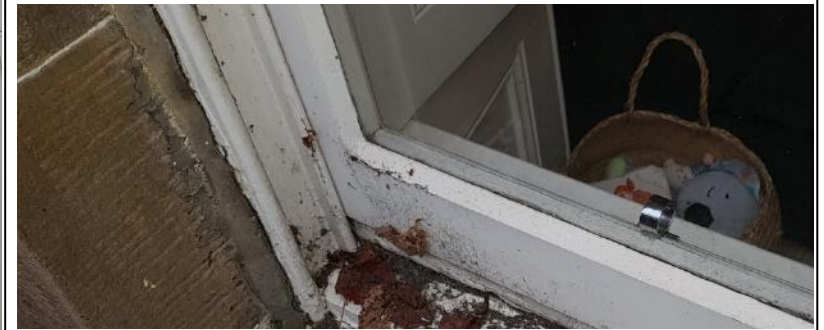
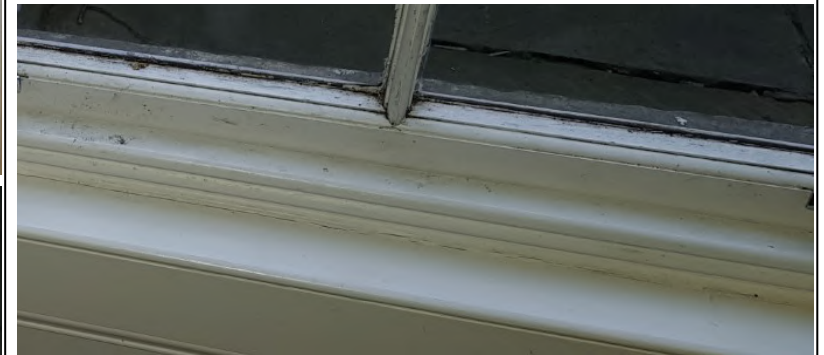
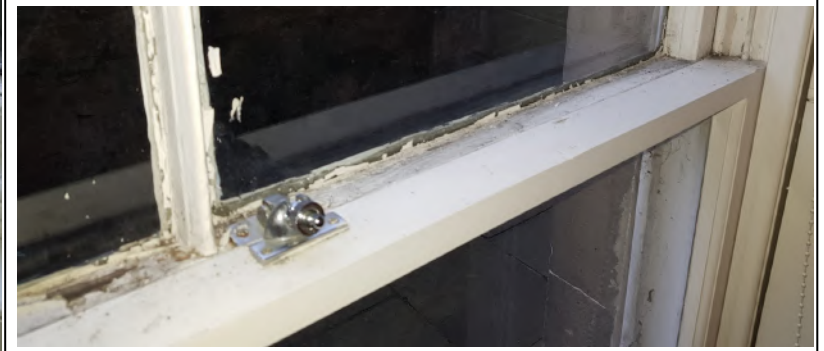
| Elevation | Floor | No. | Room |
|---|---|---|---|
| Front | BF | W3 | Play Room |

- Heavy condensation damage to horizontal rails and internally
- Lower sash is of more recent construction with sharply defined moulding detail and lack of overpainting.
- Compromised putty to the exterior with moisture ingress towards sash timbers
- Cracking of paint along the joins is indicative of shrinkage/swelling and a weakening of the structure.
- Compromised join to upper sash meeting rail
- Significant loss of moulding detail due to previous repairs/filling/sanding, especially on lower rails
- Existing astragals unsuitable for installation of IGUs
- Upper sash has undergone re-glazing which has been destructively carried out, leaving the perimeter timbers uneven.
- Moisture permeation of the horizontal rails and extending to the lower stiles.

Like-for-like replacement custom-fitted with Slimline IGUs

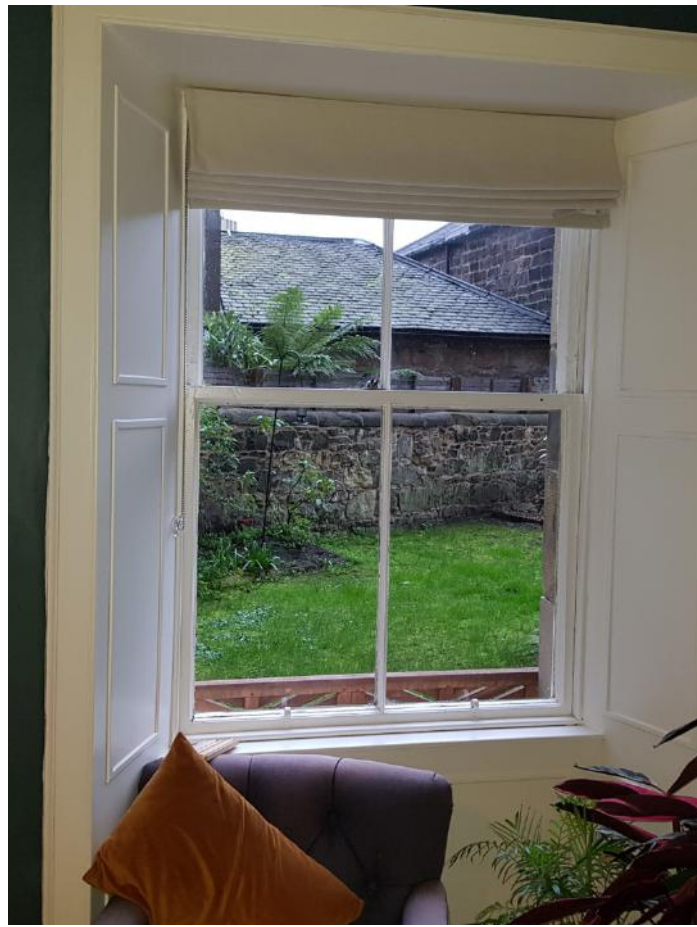
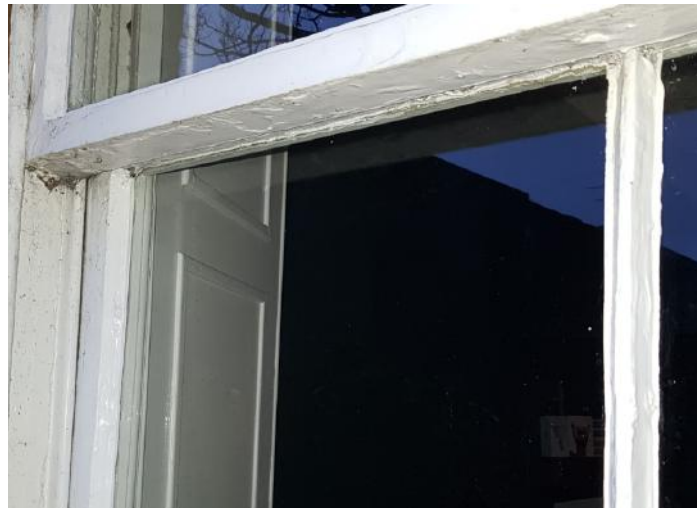
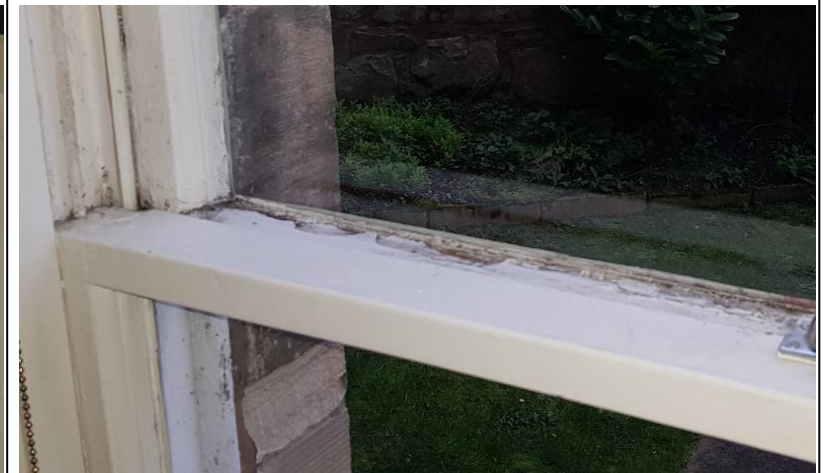
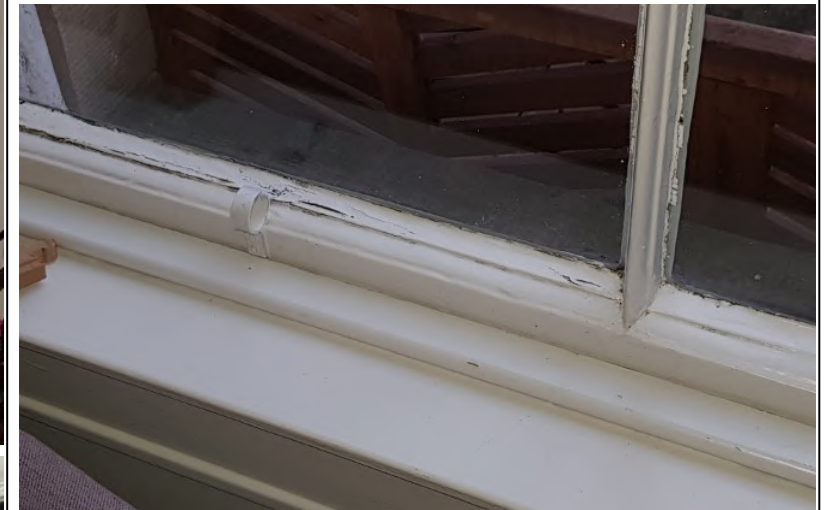
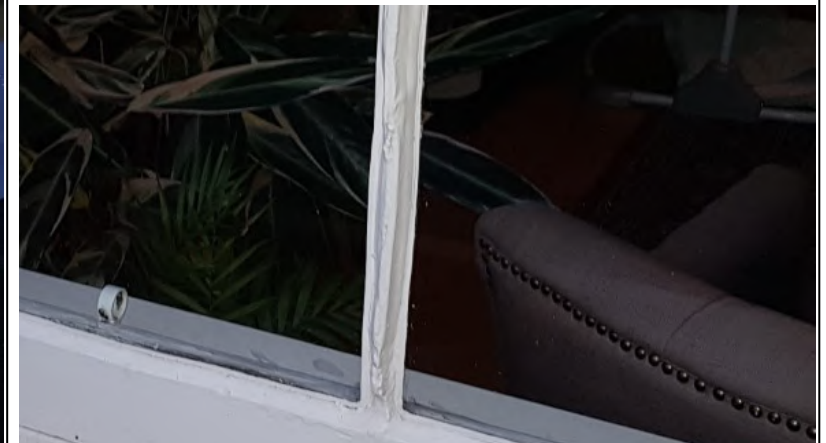
| Elevation | Floor | No. | Room |
|---|---|---|---|
| Rear | BF | W4 | Lounge |

- Heavy condensation damage to horizontal rails and internally
- Compromised putty to the exterior with moisture ingress towards sash timbers
- Cracking of paint along the joins is indicative of shrinkage/swelling and a weakening of the structure.
- Existing astragals unsuitable for installation of IGUs
- Lower sash has undergone re-glazing which has been destructively carried out, leaving the perimeter timbers uneven.
- Moisture permeation of the horizontal rails and extending to the lower stiles.

Like-for-like replacement custom-fitted with Slimline IGUs

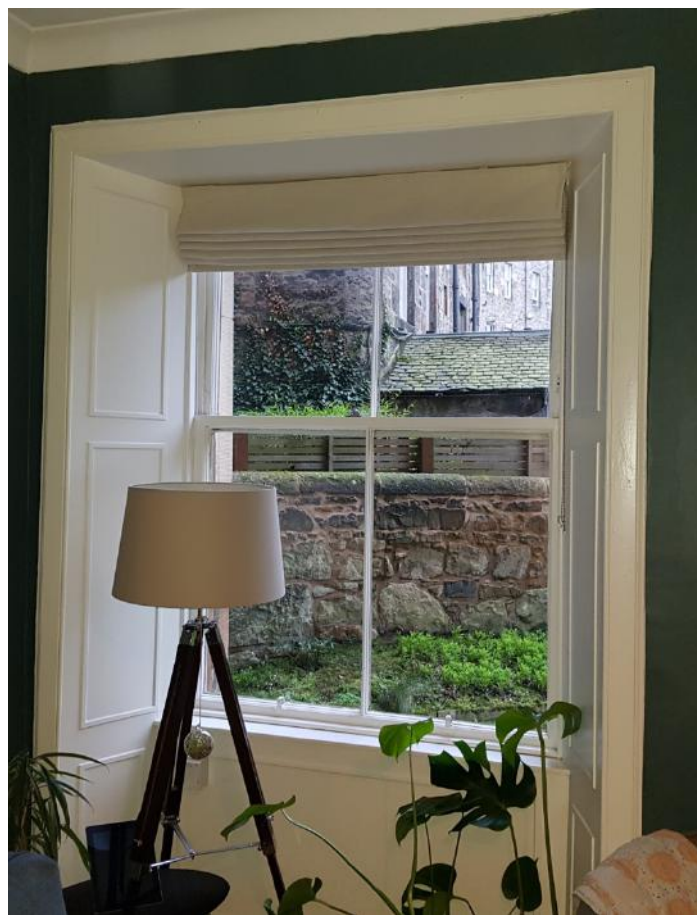
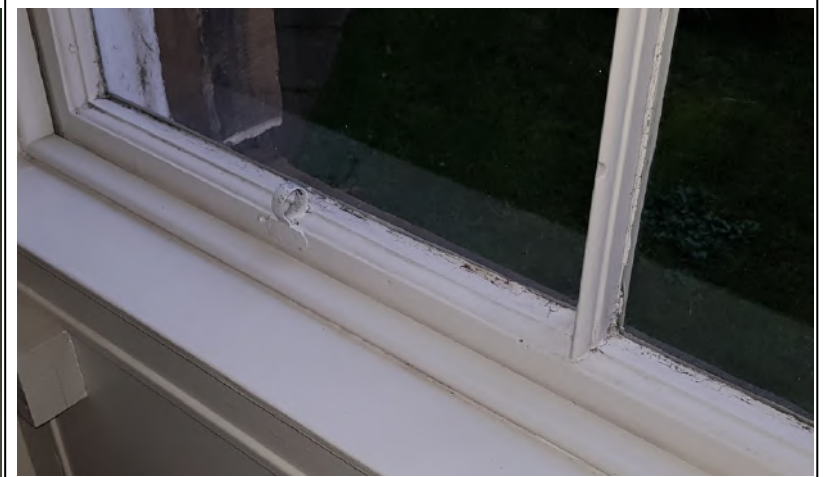
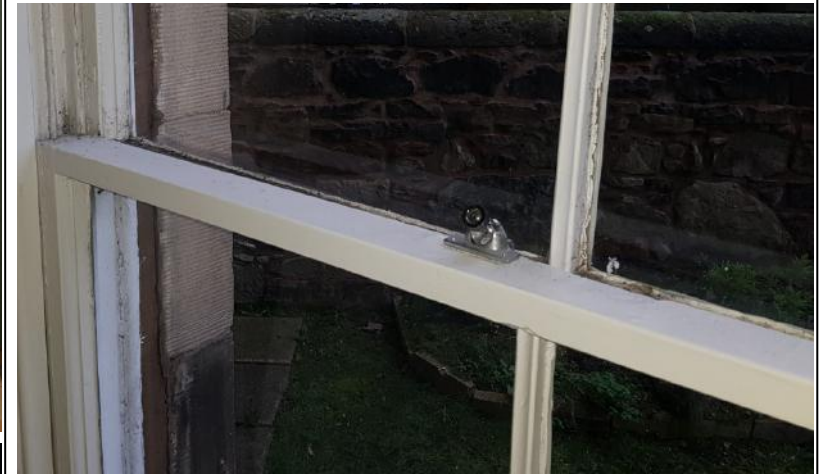
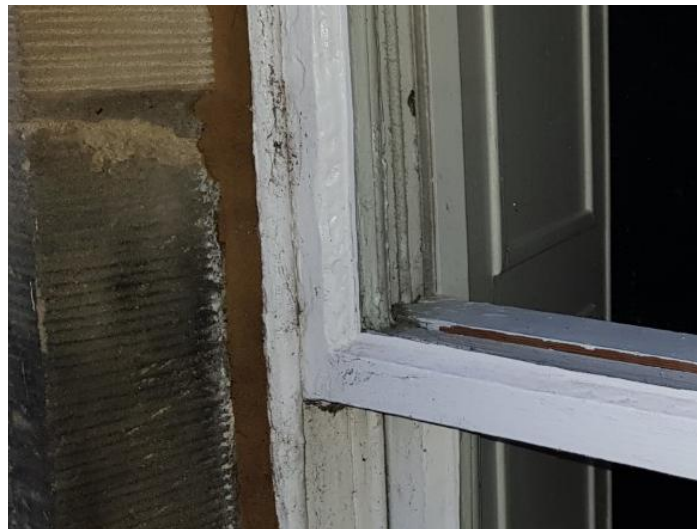
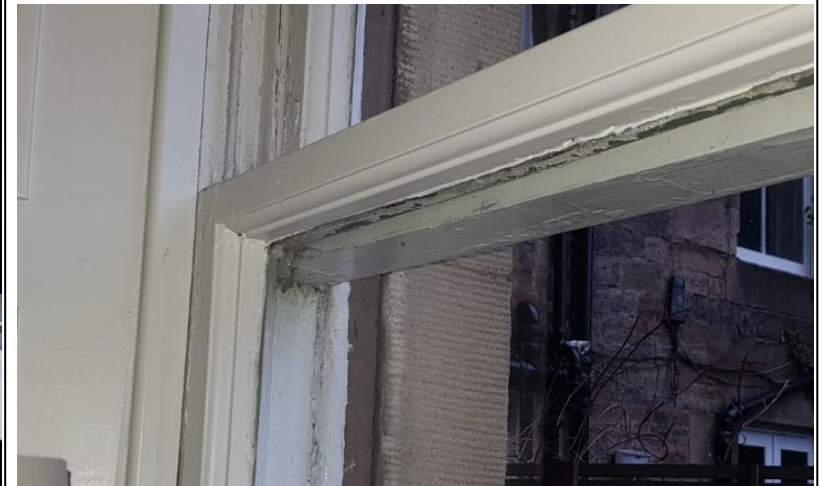
| Elevation | Floor | No. | Room |
|---|---|---|---|
| Rear | BF | W5 | Lounge |

- Condensation damage to horizontal rails and internally
- Compromised putty to the exterior with moisture ingress towards sash timbers
- Cracking of paint along the joins is indicative of shrinkage/swelling and a weakening of the structure.
- Compromised join to upper sash meeting rail
- Existing astragals unsuitable for installation of IGUs
- Moisture permeation of the horizontal rails and extending to the lower stiles.

Like-for-like replacement custom-fitted with Slimline IGUs

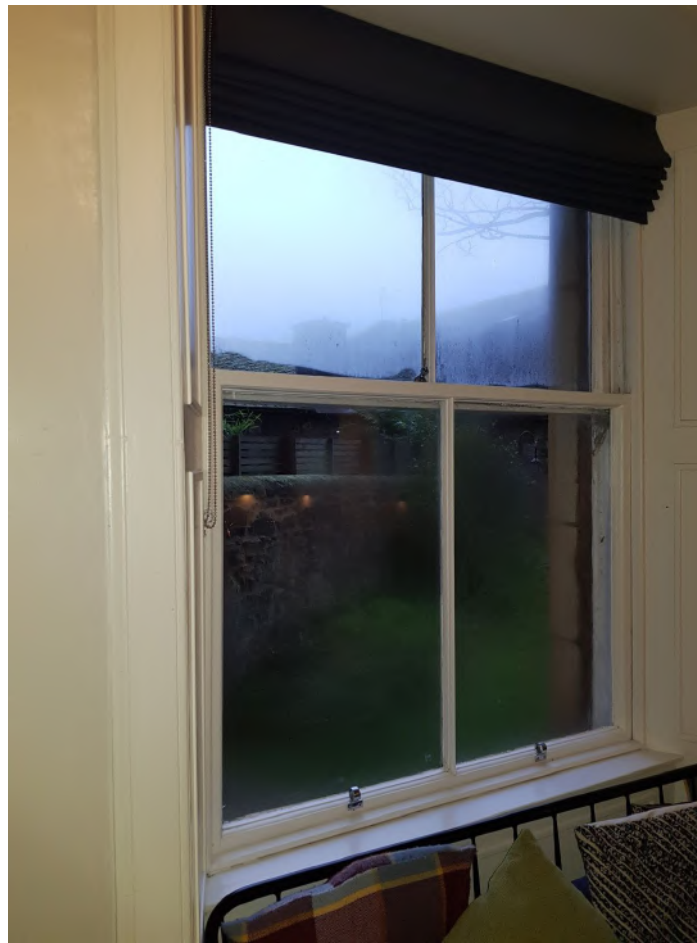
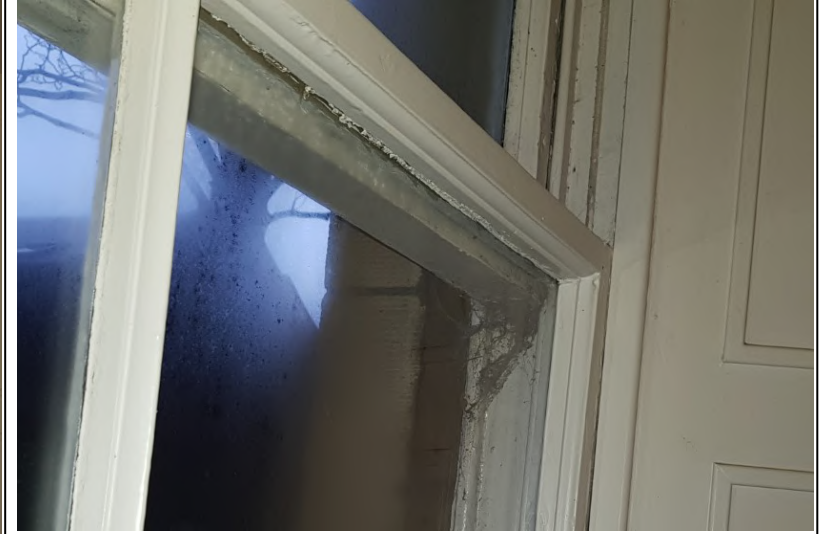
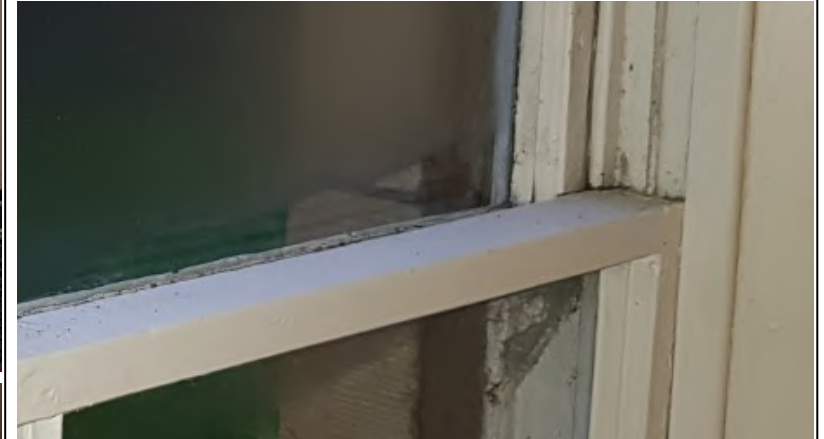
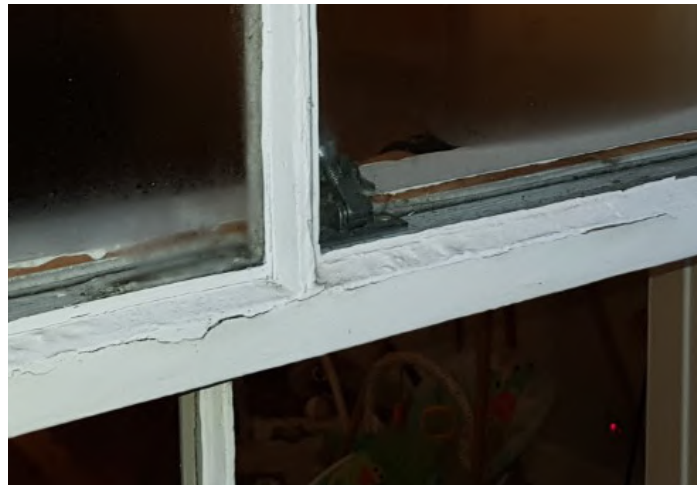
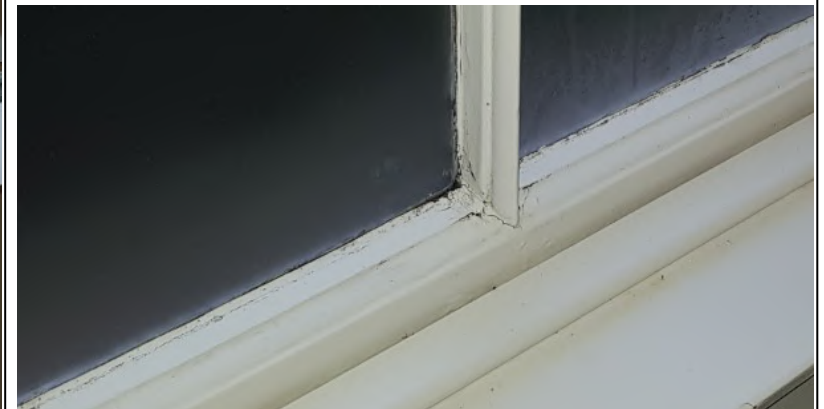
| Elevation | Floor | No. | Room |
|---|---|---|---|
| Rear | BF | W6 | Kitchen |

- Condensation damage to horizontal rails and internally
- Compromised putty to the exterior with moisture ingress towards sash timbers
- Cracking of paint along the joints is indicative of shrinkage/swelling and a weakening of the structure.
- Compromised join to upper sash meeting rail
- Existing astragals unsuitable for installation of IGUs
- Moisture permeation of the horizontal rails and extending to the lower stiles.

Like-for-like replacement custom-fitted with Slimline IGUs

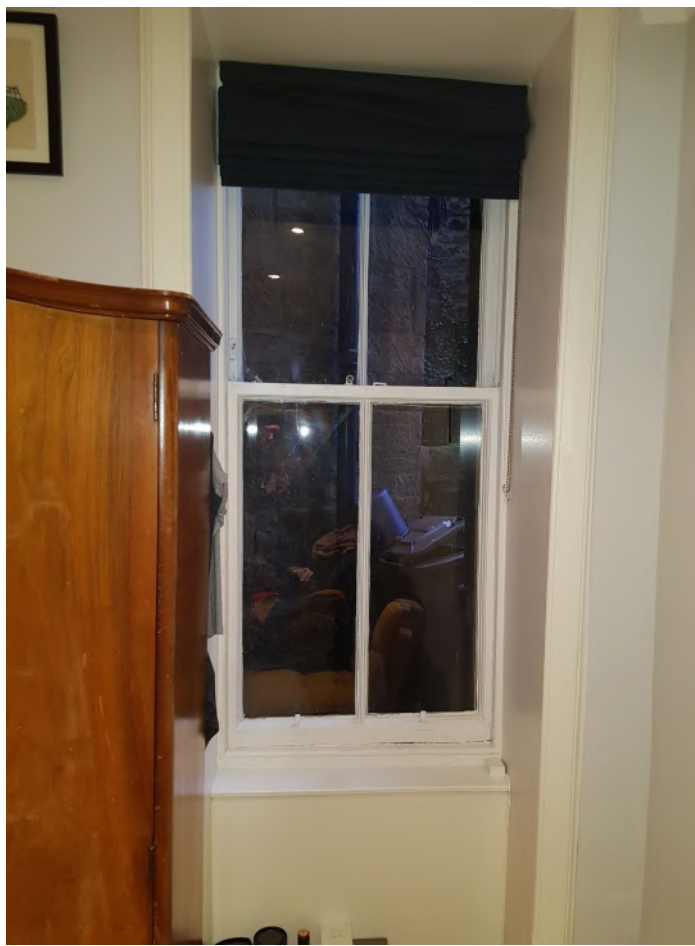
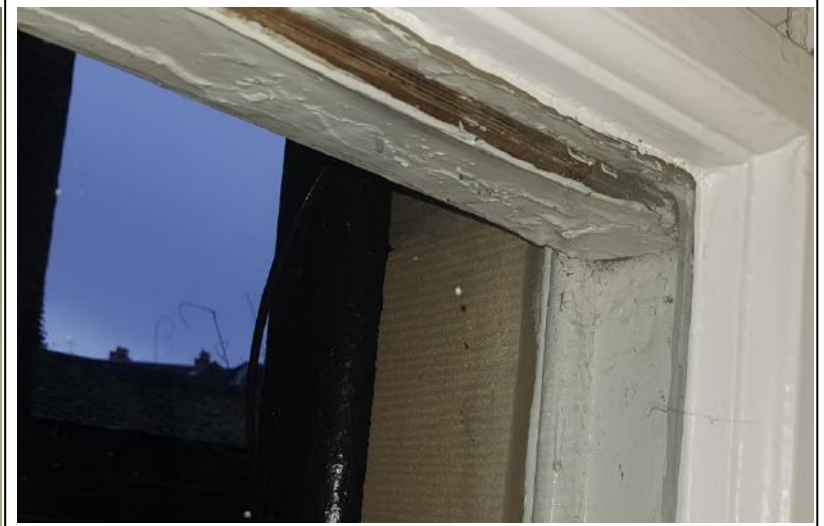
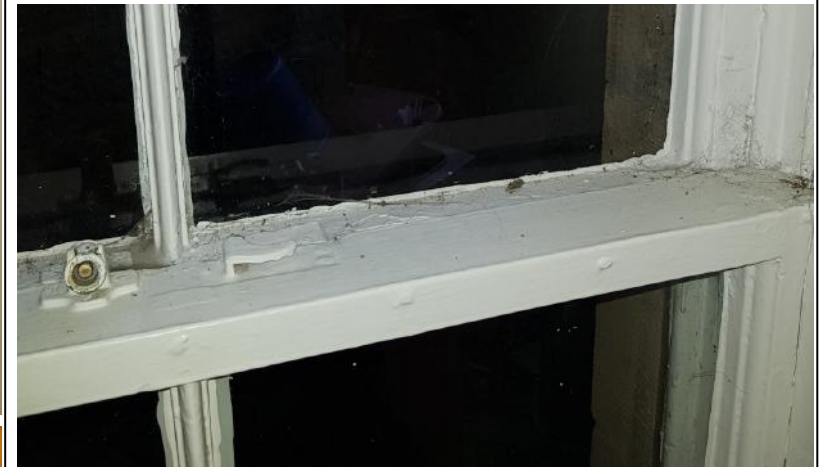
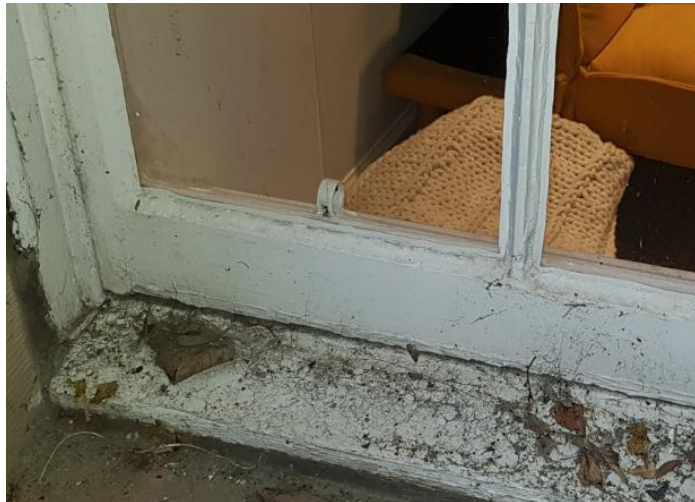
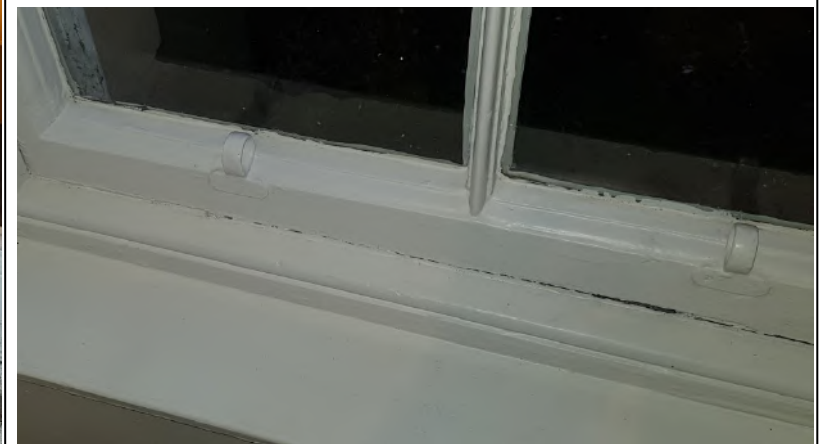
| Elevation | Floor | No. | Room |
|---|---|---|---|
| Rear | BF | W7 | Rear Bed |

- Condensation damage to horizontal rails and internally
- Compromised putty to the exterior with moisture ingress towards sash timbers
- Cracking of paint along the joins is indicative of shrinkage/swelling and a weakening of the structure.
- Existing astragals unsuitable for installation of IGUs
- Compromised join to upper sash meeting rail
- Moisture permeation of the horizontal rails and extending to the lower stiles.

Like-for-like replacement custom-fitted with Slimline IGUs

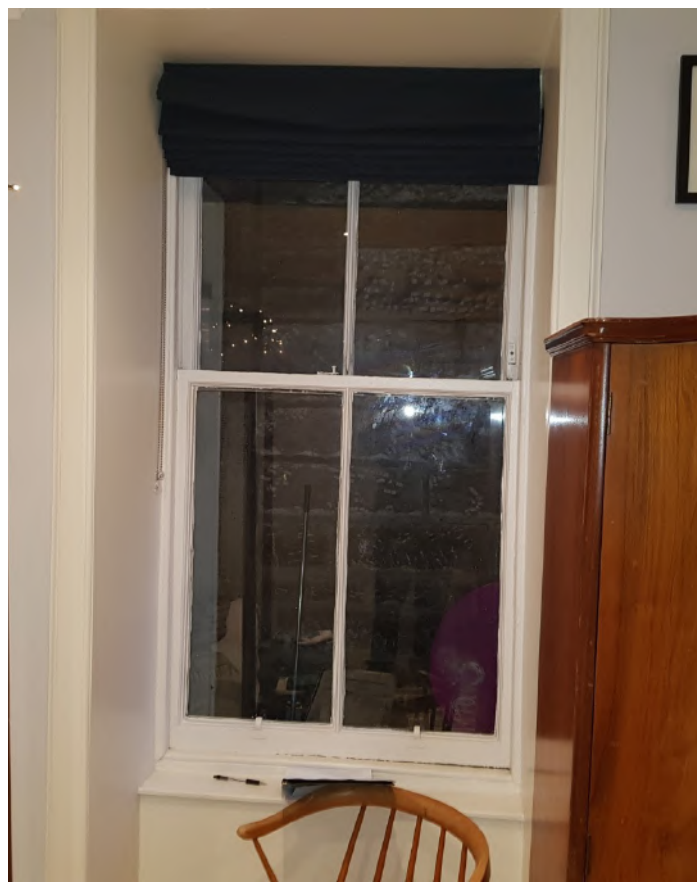
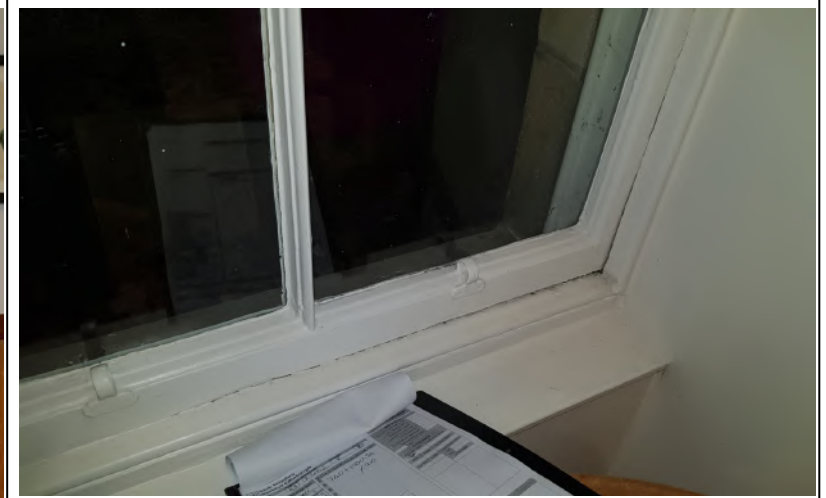
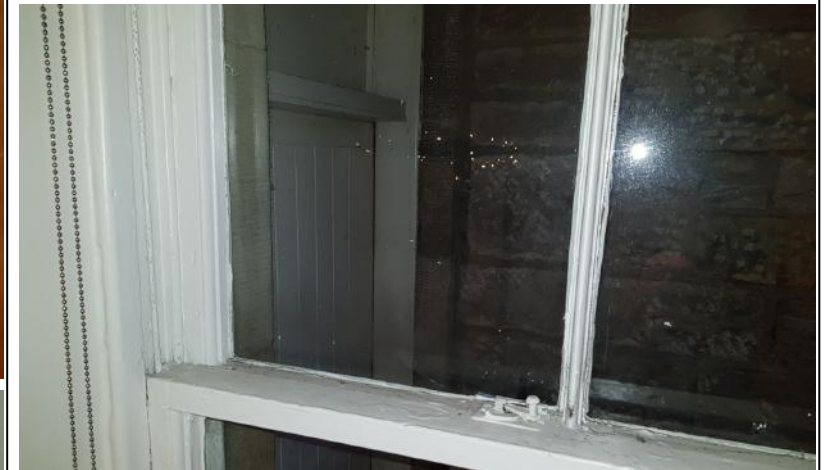
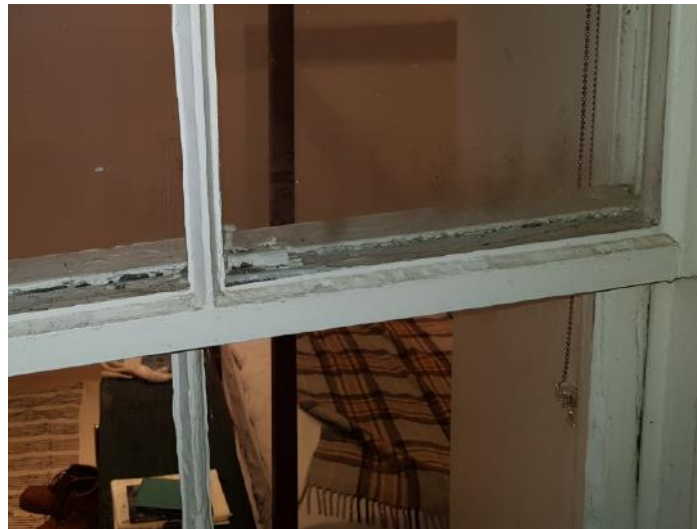
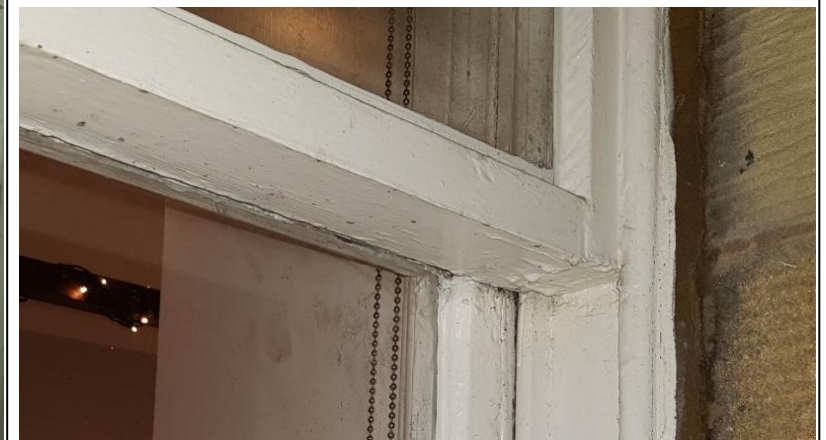
| Elevation | Floor | No. | Room |
|---|---|---|---|
| Rear | BF | W8 | Rear Bed |

- Condensation damage to horizontal rails and internally
- Compromised putty to the exterior with moisture ingress towards sash timbers
- Cracking of paint along the joins is indicative of shrinkage/swelling and a weakening of the structure.
- Existing astragals unsuitable for installation of IGUs
- Moisture permeation of the horizontal rails and extending to the lower stiles.

Like-for-like replacement custom-fitted with Slimline IGUs
