CFA STRUCTURES LTD

Our Ref: CFS19-242/HWF/LA

RE: 49 REGENT ROAD, LOSTOCK, BOLTON

Further to your request to examine the garage/office annex at the above property we attended site on 12th November and report as follows:-

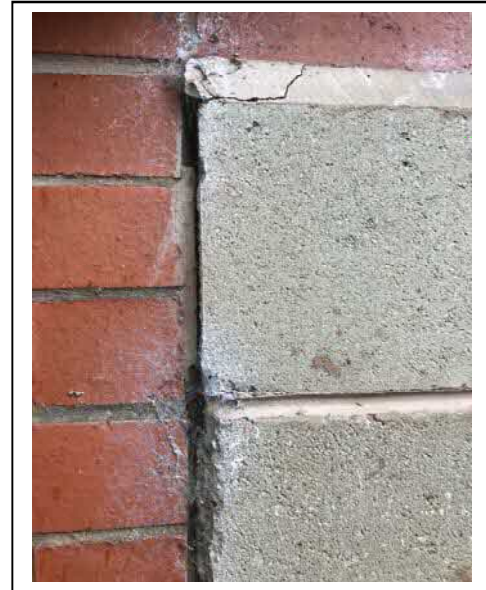
Internal inspection of the garage revealed that the slab to the garage section has heaved and cracked and further significant cracking was also recorded in the partition wall between the garage and the office area. Unfortunately, due to the presence of stored items, the internal face of the left-hand elevation (fronting onto the access road) could not be fully inspected. The dense hedge and sycamore tree also prevented clear inspection of the external elevation, but nominal cracking was noted at the front left-hand corner of the garage.

Cracking over garage door (top left-hand corner)

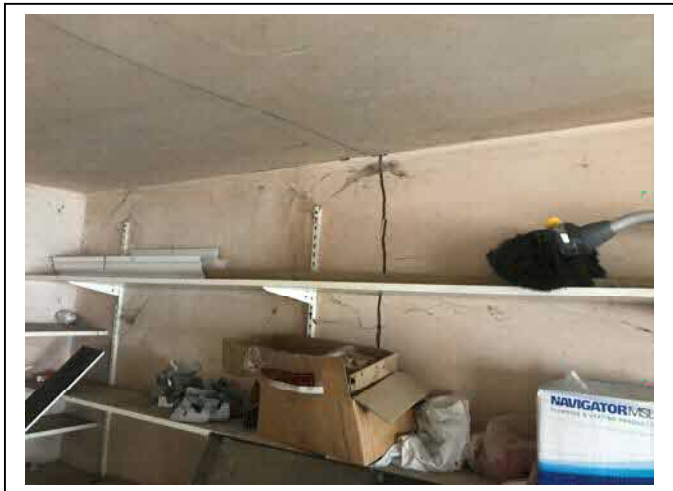
Based on the crack patterns and the heave in the slab it is considered that the most likely cause of the cracking and heave is the proximity of the sycamore tree. The damage may be a result of swelling/shrinkage of the clay under the foundations as a direct result of the tree roots affecting the moisture content within the clay, or maybe due to the mechanical forces set up from the expanding root ball of the tree.

Internal crack in the partition wall between garage/office and ceiling

In order to repair the defects and provide a long-term solution to the current problems it is considered that the simple option would be to demolish the wall that fronts on to the verge and rebuild it off new foundations, deep enough to eliminate the effect of the tree roots. However, the deep excavations will be within the root protection zone and hence are likely to adversely affect or kill the tree. Furthermore, the slab within the garage will need to be taken up and replaced with a new slab incorporating a 150mm void beneath it. Therefore, new footings will be required on the opposite (right hand wall) to provide support to the new suspended floor and this may necessitate demolition of the right-hand wall to allow deeper footings to be cast.

Given the above, and assuming the tree is to be kept, the most robust solution would be to fully demolish the building and construct it off piled, shallow foundations that will minimize the disturbance to the tree roots. The construction can also be detailed to eliminate future problems that associated with continued tree and hedge growth.

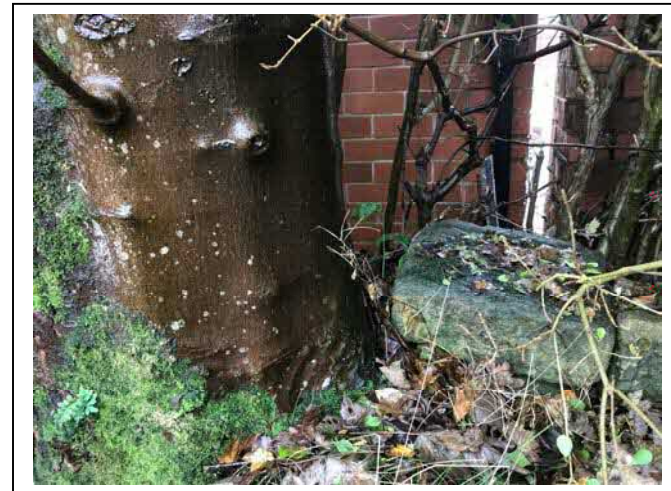
On the evidence recorded, it is considered that these defects will only get worse with time as the tree continues to grow. Ideally, the tree should be removed to prevent further mechanical damage from expanding root ball, but this may cause further problems as the ground is likely to swell due to the absent tree no longer removing water from the clay.

Proximity of the sycamore tree to left-hand side wall.
