# STRUCTURAL APPRAISAL

# **CLASS Q PLANNING PERMISSION**

# SITE B – BARNS 8 AND 10 TREMAYNE FARM, CROWAN, CAMBORNE, CORNWALL TR14 9NB

**Project** : 2023.204

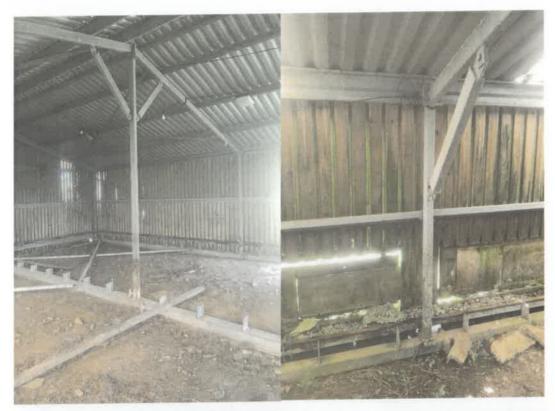
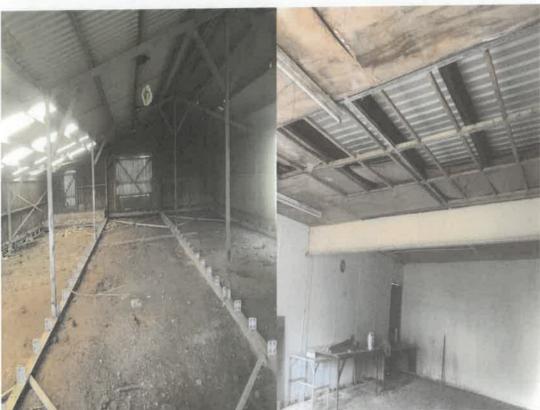
Photos 10-11 Typical View Showing Knee Brace Connection Rafter to Stanchion
