**The Hill, Barns**  
Burrington

## Structural Condition Report

Prepared by: Michael Humphreys BEng CEng MStructE  
March 2024  
224034

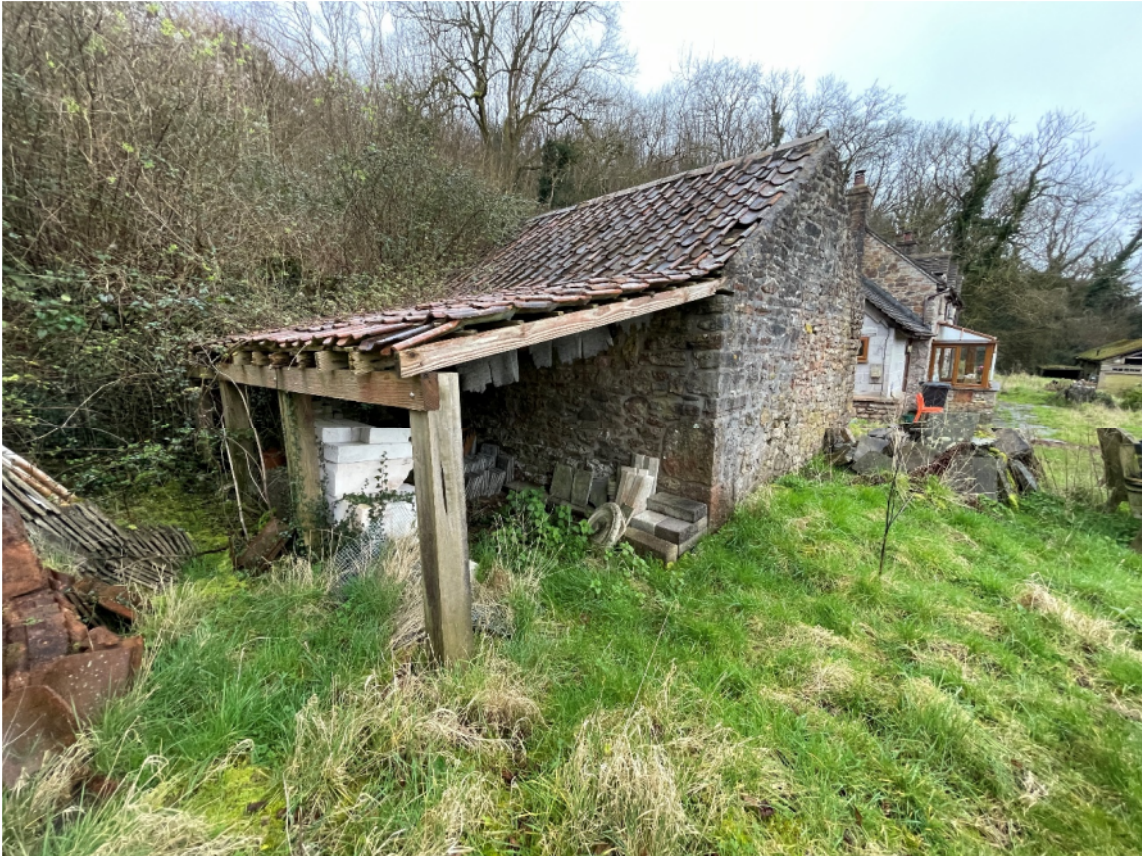
Photograph 3 – Outbuilding 2, lean-to from north-east

- 3.9. The remaining roof timbers over the main space appear to be performing adequately.
- 3.10. Timbers to the lean-to roof have been exposed to extensive water ingress due to the lack of roof felt which has caused significant rot. Even without development, this roof should be removed and replaced with new timbers and covering.
