Date: 23<sup>rd</sup> November 2023  
Ref: C8785E/8486/AS/AS

## GROUND GAS VERIFICATIONS – STEPHENSON ROAD, PETERLEE (PLOTS 23 TO 28, 31 AND 47 TO 59)

## Gas Protection Verification Photographs

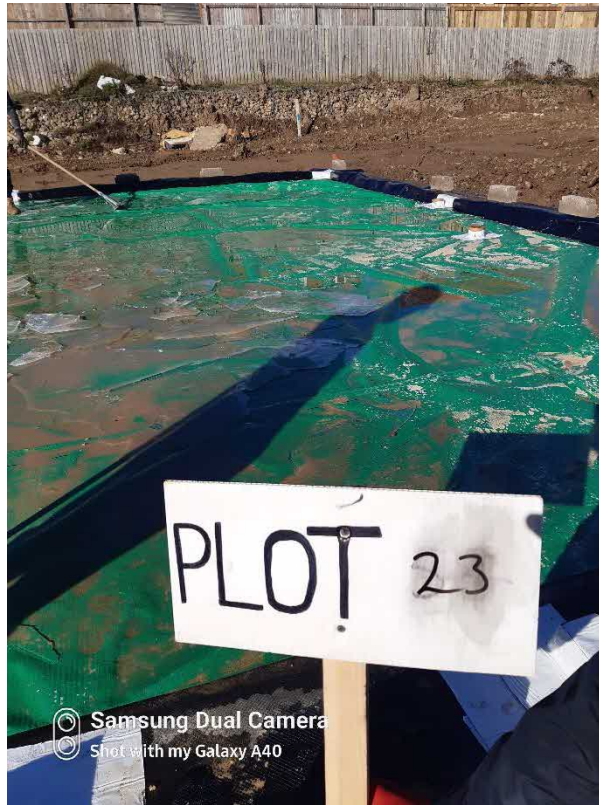
01 C8785E 03.04.23 Plot 23 and 24 Overview (client photo)

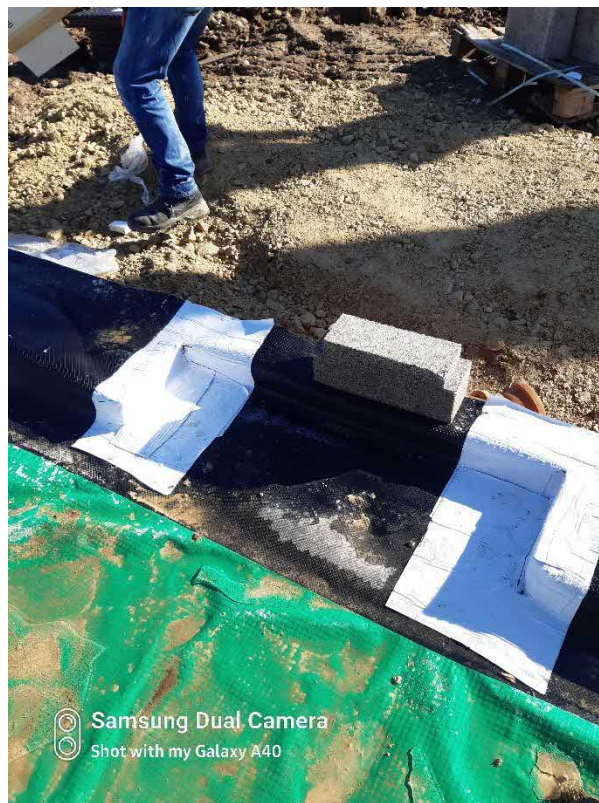
02 C8785E 03.04.23 Plot 23 and 24 Corners (client photo)

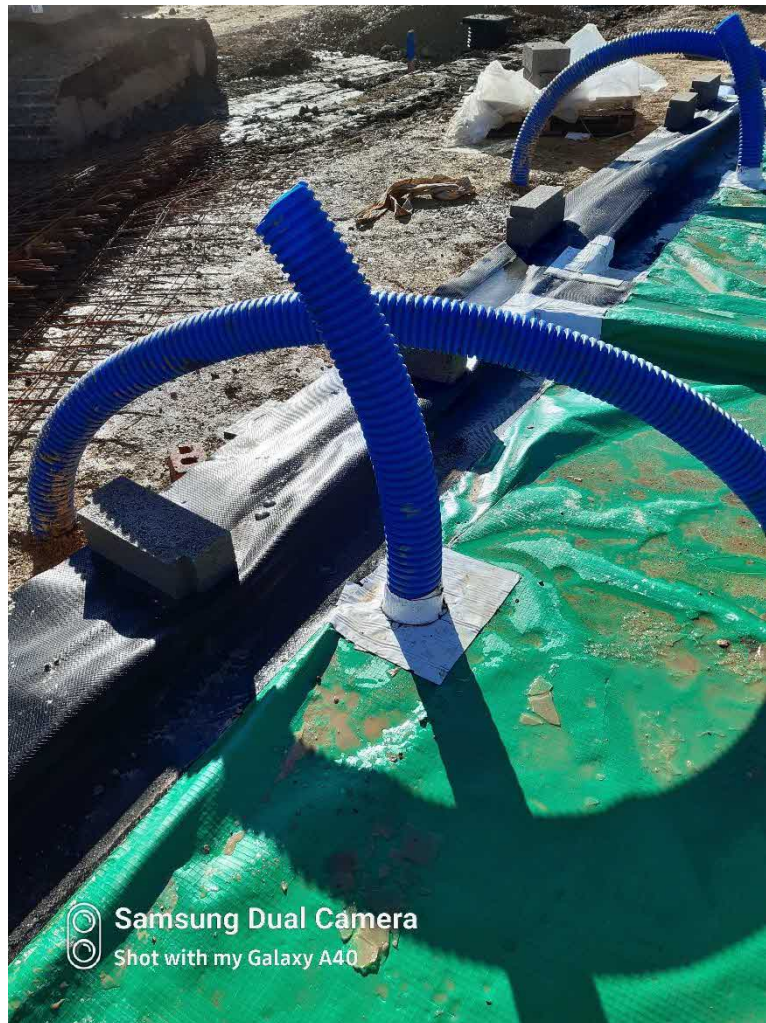
03 C8785E 03.04.23 Plot 23 and 24 Service Entry Ducts (client photo)

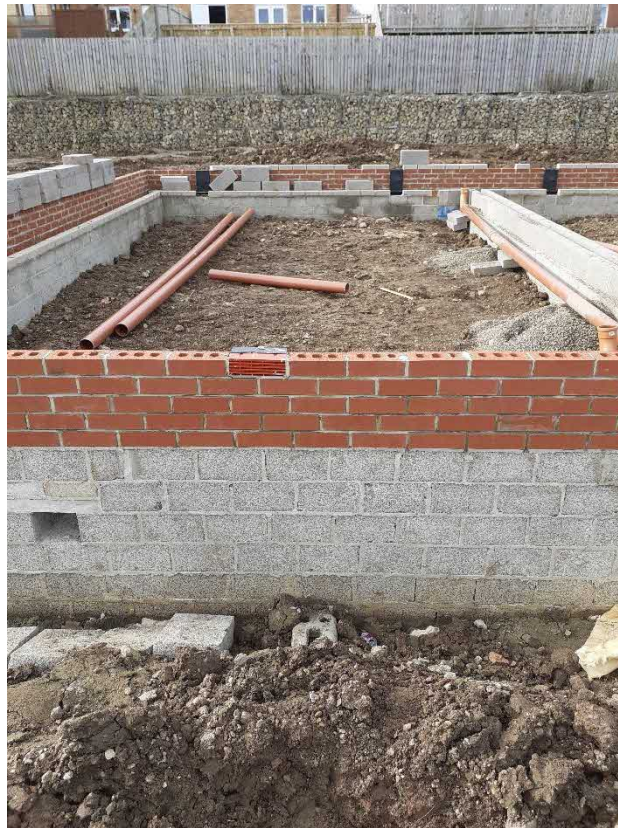
01 C8785E 20.02.23 Plot 25 Void Space (client photo)

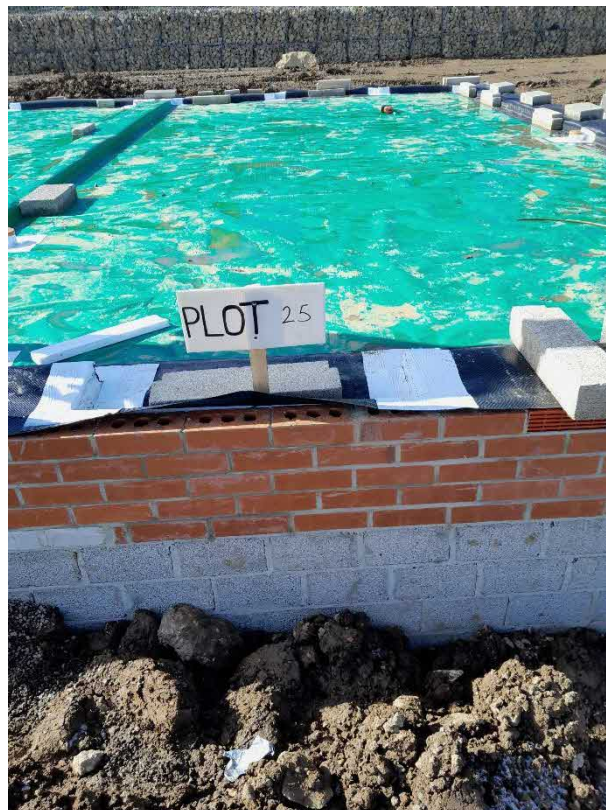
02 C8785E 07.03.23 Plot 25 Overview (client photo)

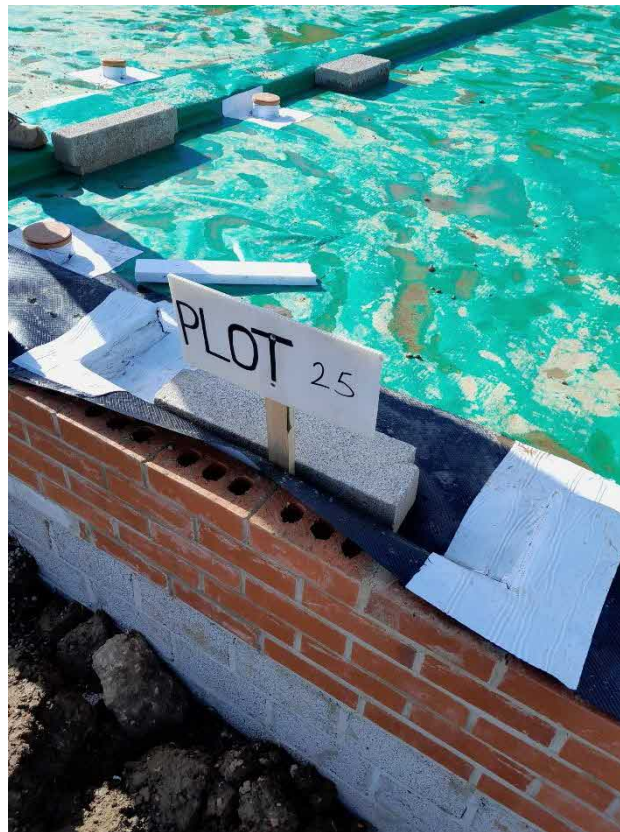
03 C8785E 07.03.23 Plot 25 Corners (client photo)

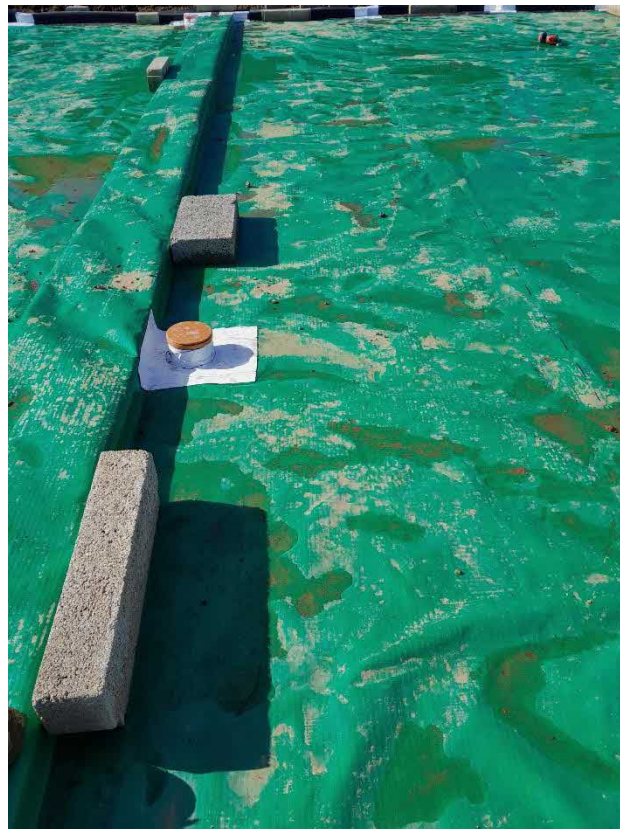
04 C8785E 07.03.23 Plot 25 Overview and Service Entry Duct (client photo)

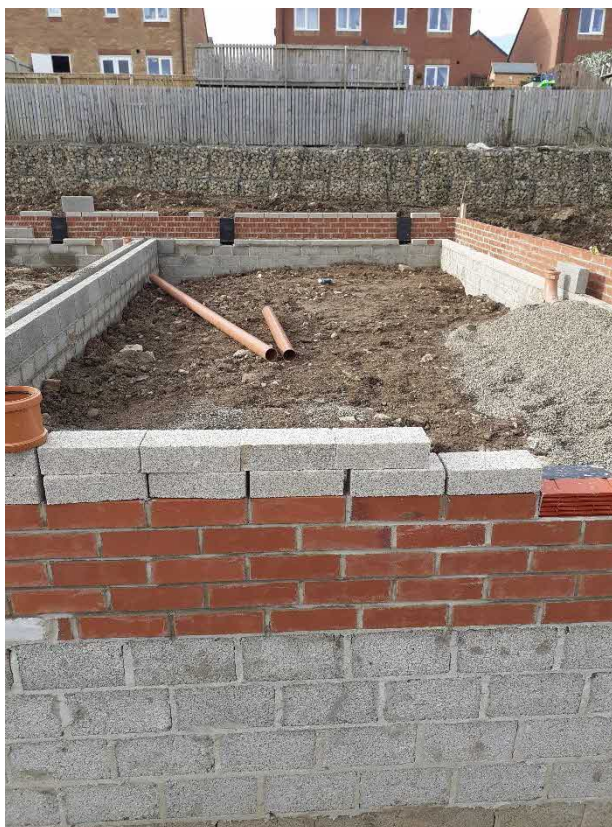
05 C8785E 20.02.23 Plot 25 Void Space (client photo)

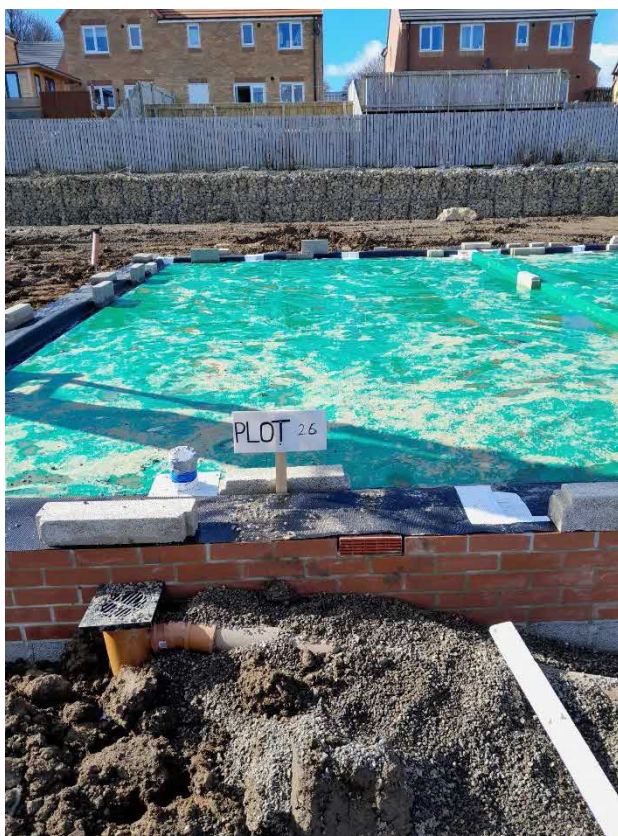
06 C8785E 07.03.23 Plot 26 Overview (client photo)

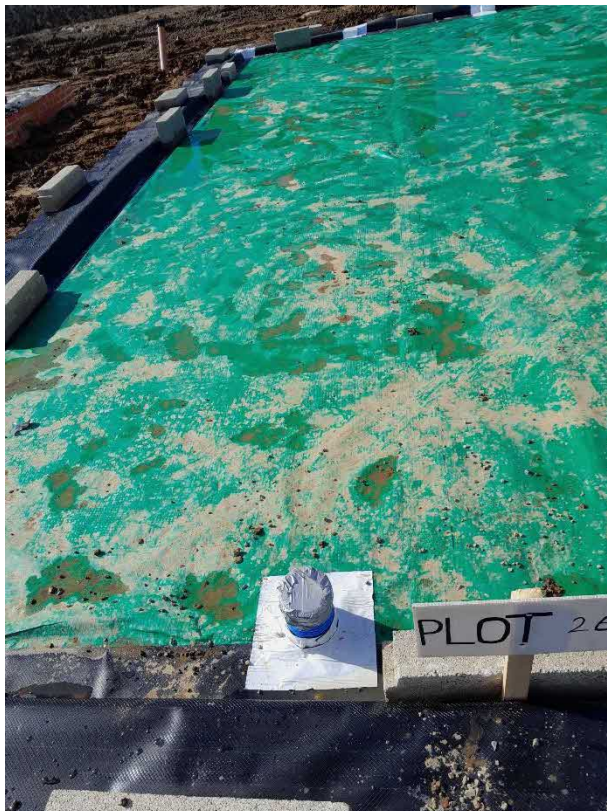
08 C8785E 07.03.23 Plot 26 Overview and Service Entry Duct (client photo)

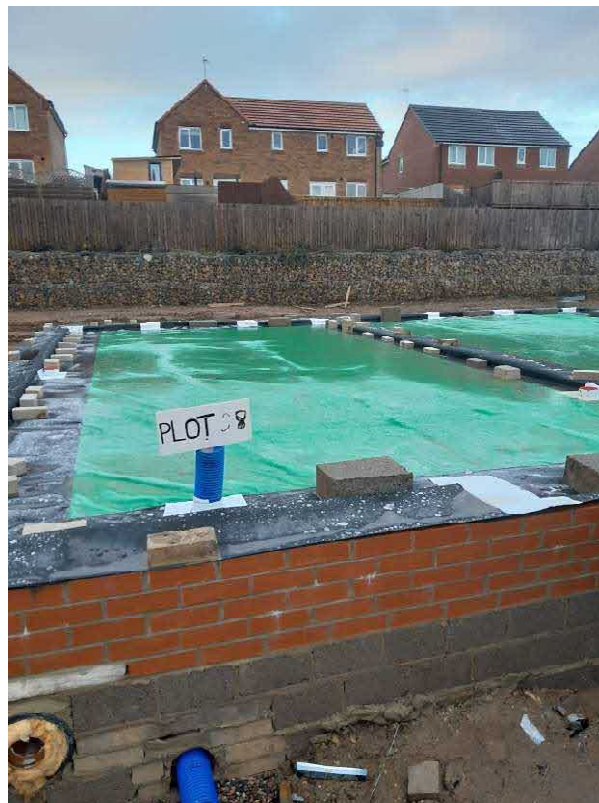
02 C8785E 07.12.22 Plot 28 Overview (Client photo)

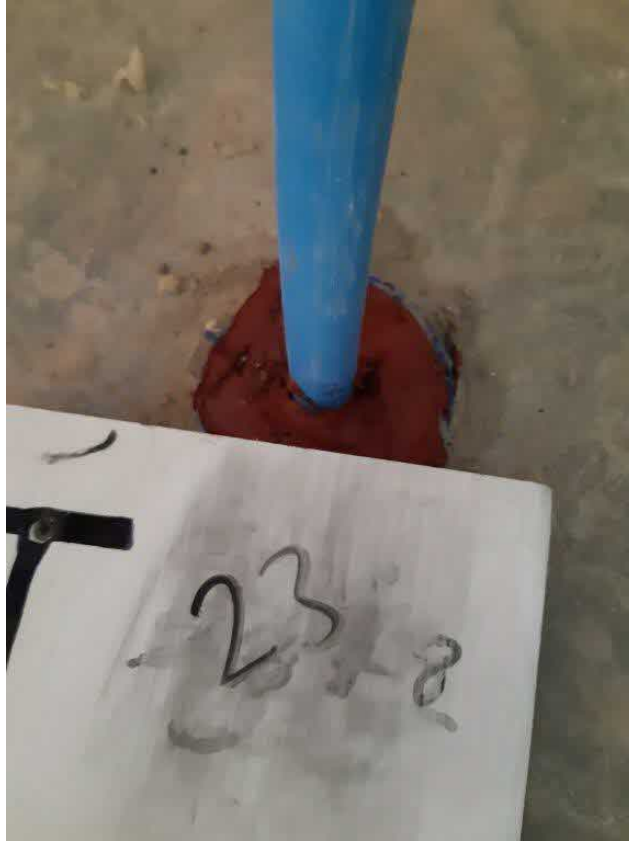
01 C8785E 15.09.23 Plot 23 Service Entry Seal (client photo)

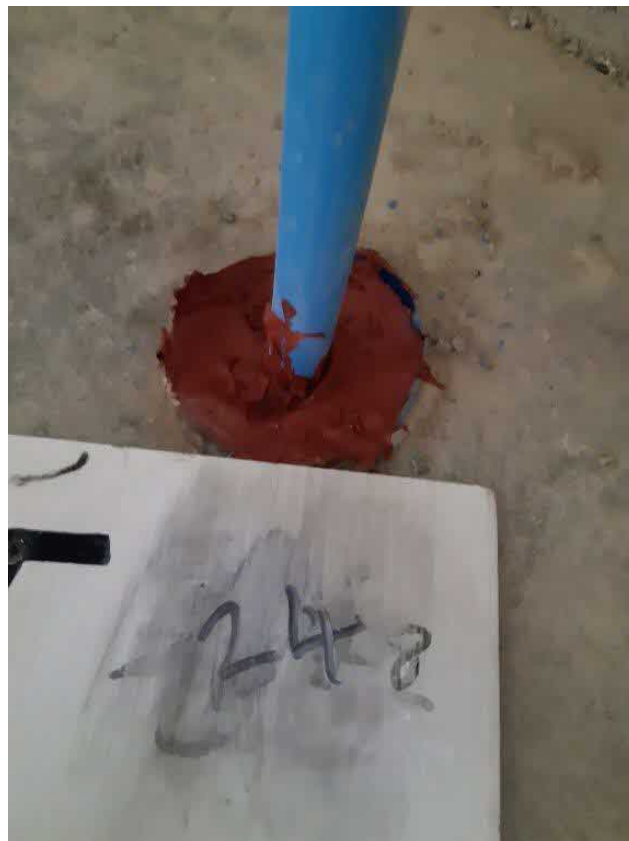
02 C8785E 15.09.23 Plot 24 Service Entry Seal (client photo)

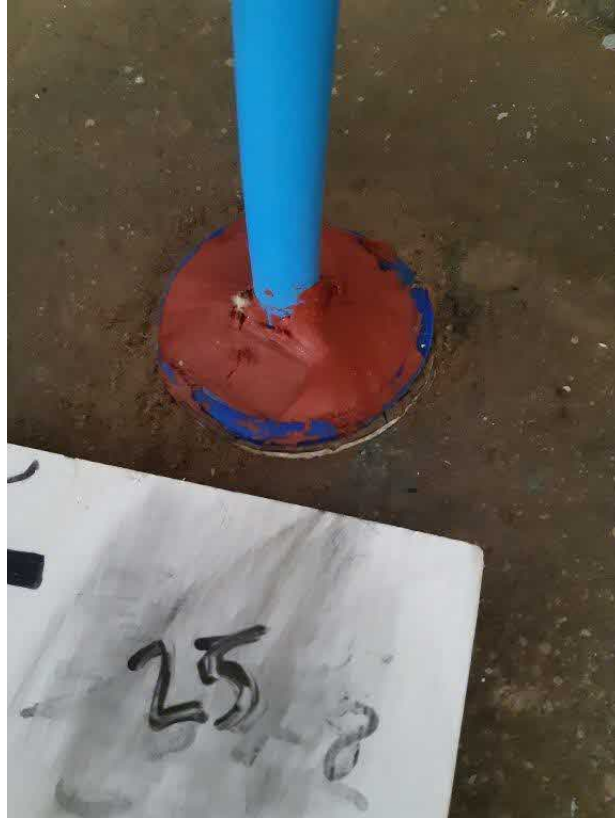
03 C8785E 15.09.23 Plot 25 Service Entry Seal (client photo)

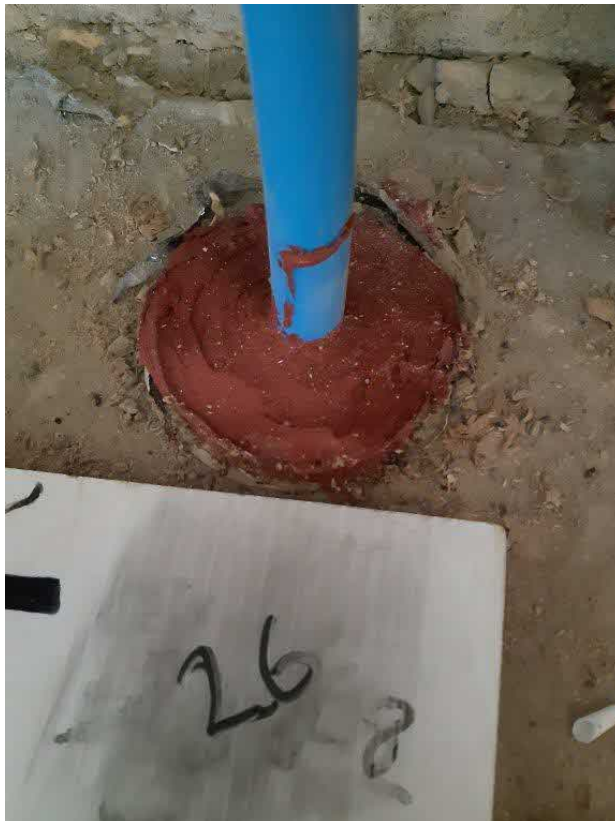
04 C8785E 15.09.23 Plot 26 Service Entry Seal (client photo)

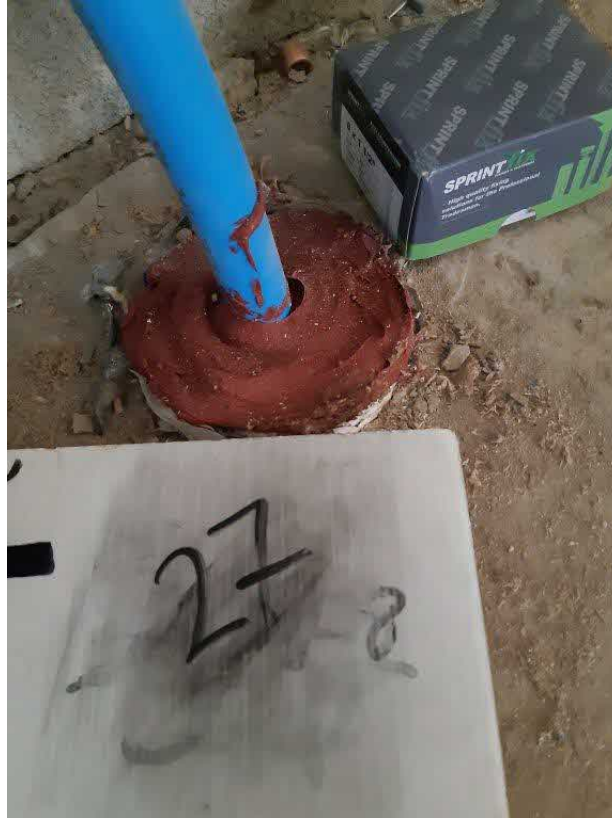
05 C8785E 15.09.23 Plot 27 Service Entry Seal (client photo)

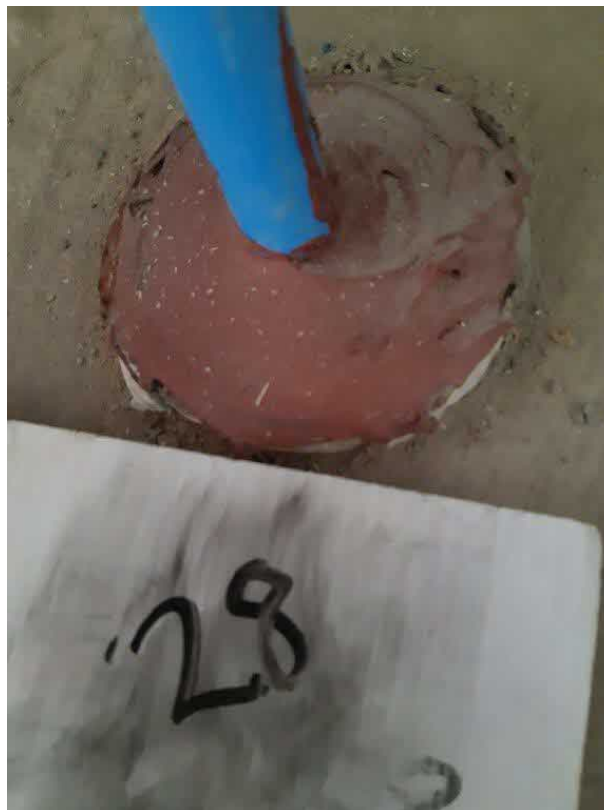
06 C8785E 15.09.23 Plot 28 Service Entry Seal (client photo)

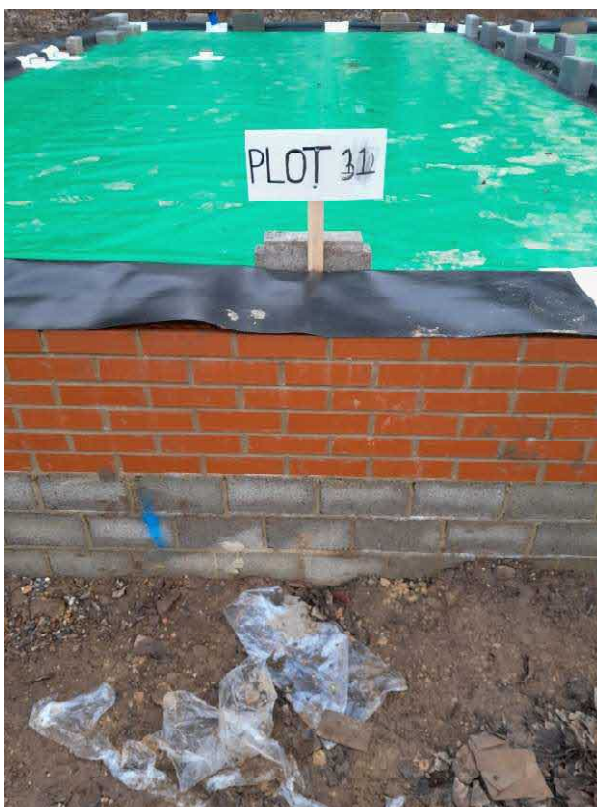
02 C8785E 23.01.23 Plot 31 Overview (client photo)

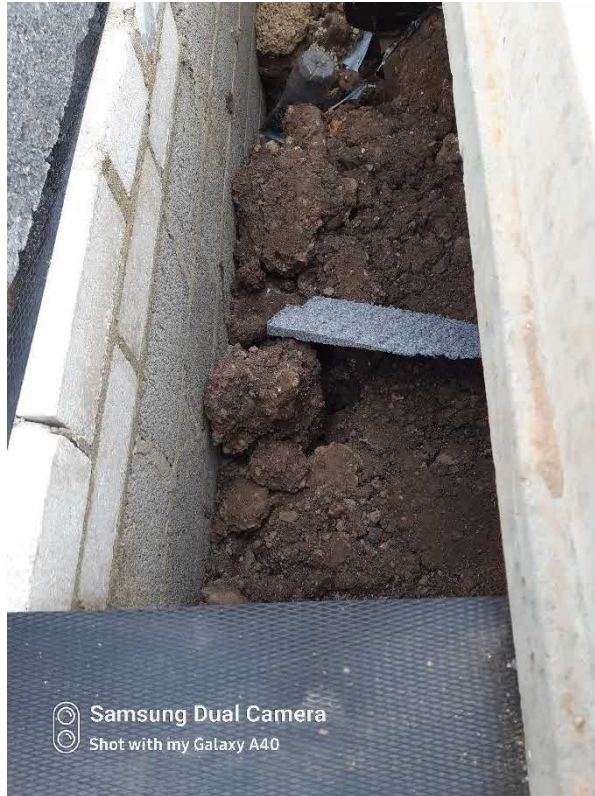
1.2	Gas membrane type	Solshield Ultra membrane with Solcourse along wall bases.
1.3	Gas membrane condition	Very good overall condition. Limited dirt and no damage observed.

1.4	Joining tape product	Details at corners and service penetrations using self-adhesive membrane.
1.5	Lapping design	Welded seams.
1.6	Laps, welds and joints seals	All laps, corner and service penetration seals in good condition.

01 C8585E 19.01.22 Plot 47 Void Space (client photo)

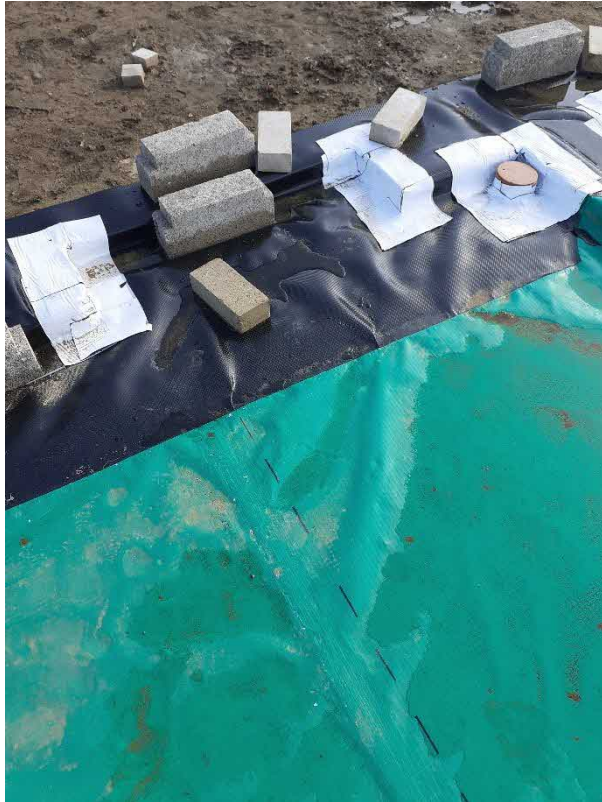
03 C8585E 29.09.22 Plot 47 Corners

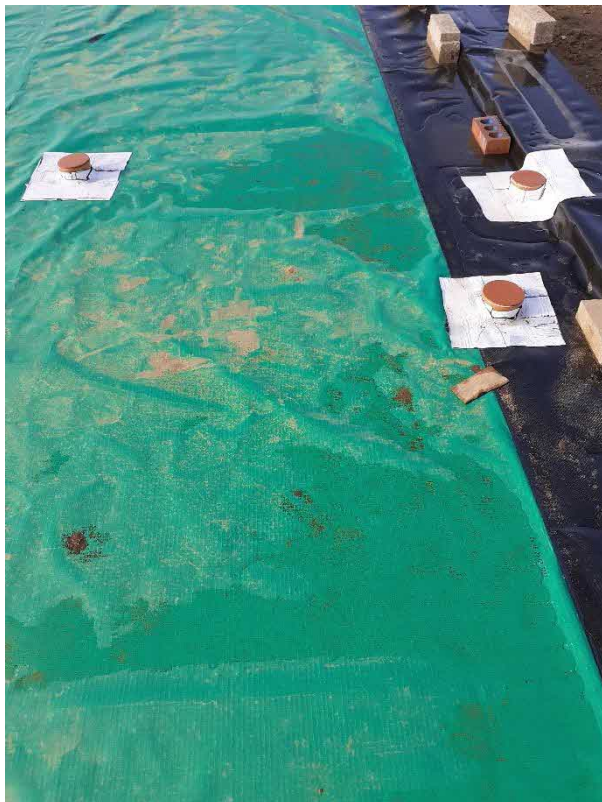
04 C8585E 29.09.22 Plot 47 Service Entry Ducts

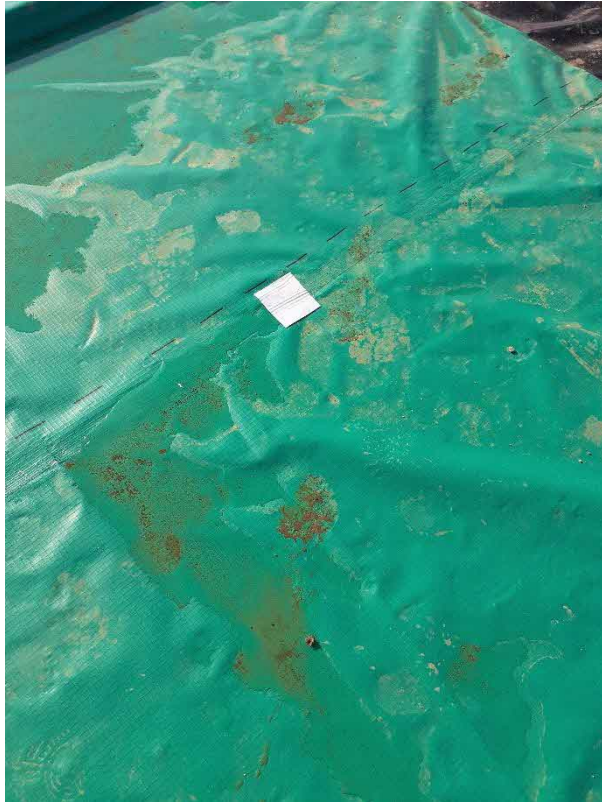
05 C8585E 29.09.22 Plot 47 Repair

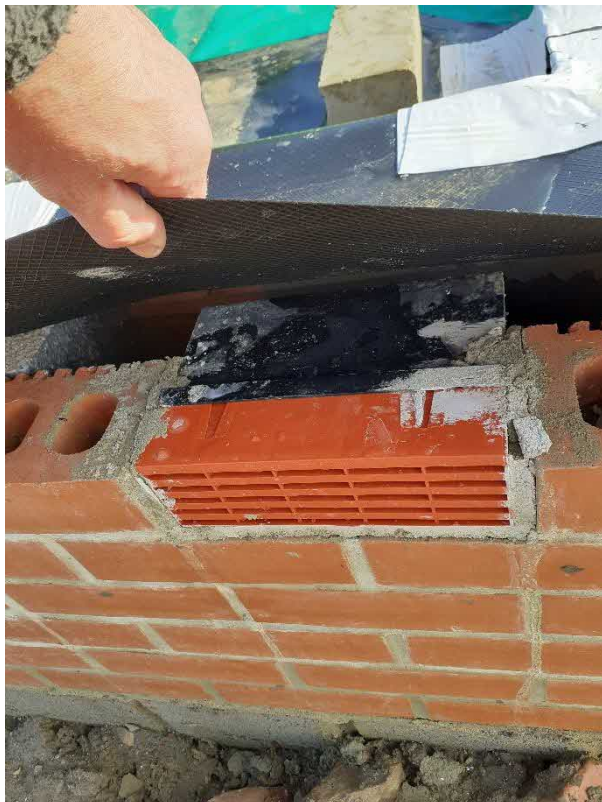
06 C8585E 29.09.22 Plot 47 Void Space Vent

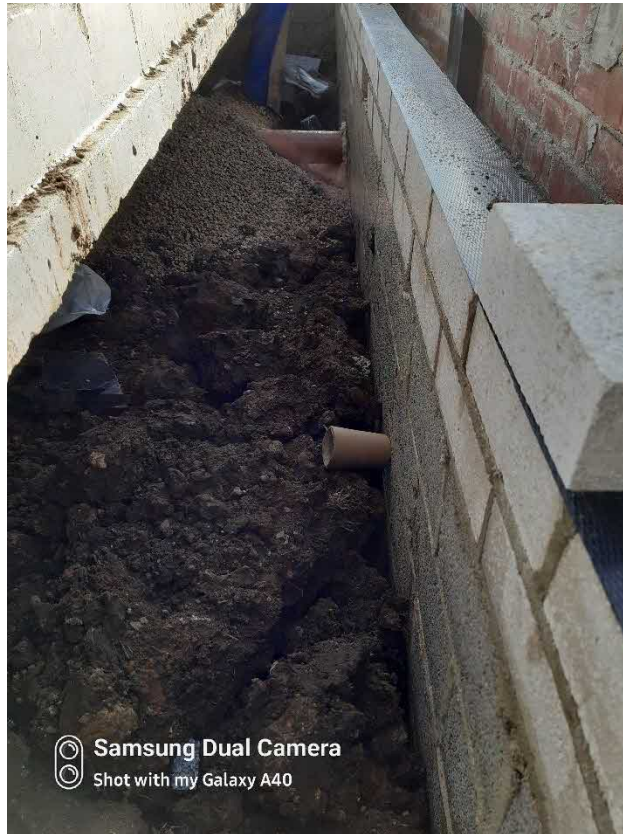
1.2	Gas membrane type	Solshield Ultra membrane with Solcourse along wall bases.
1.3	Gas membrane condition	Very good overall condition. Limited dirt and no damage observed.

1.4	Joining tape product	Details at corners and service penetrations using self-adhesive membrane.
1.5	Lapping design	Welded seams.
1.6	Laps, welds and joints seals	All laps, corner and service penetration seals in good condition.

01 C8585E 19.01.22 Plot 48 Void Space (client photo)

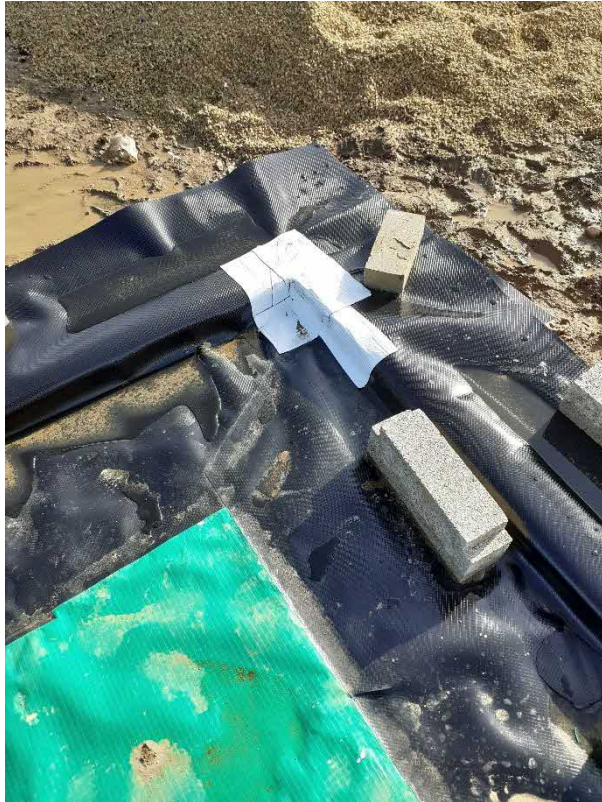
03 C8585E 29.09.22 Plot 48 Corner

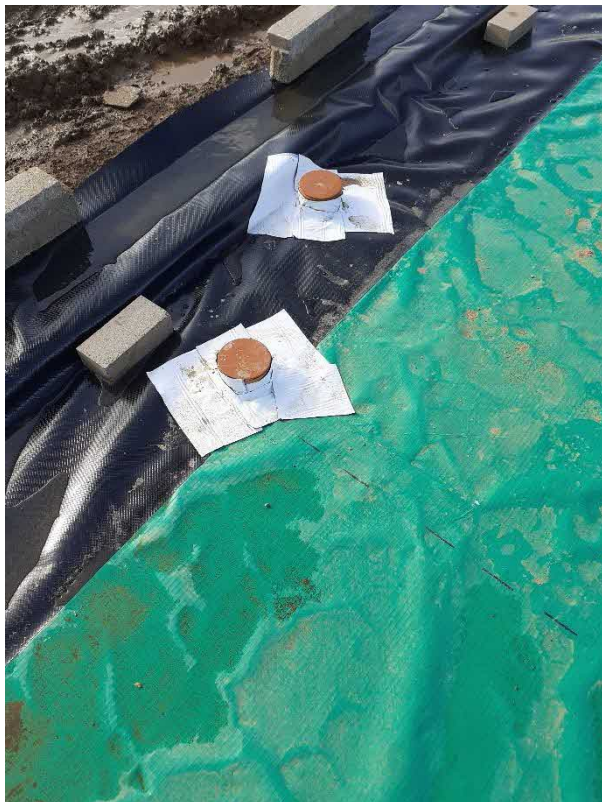
04 C8585E 29.09.22 Plot 48 Service Entry Ducts

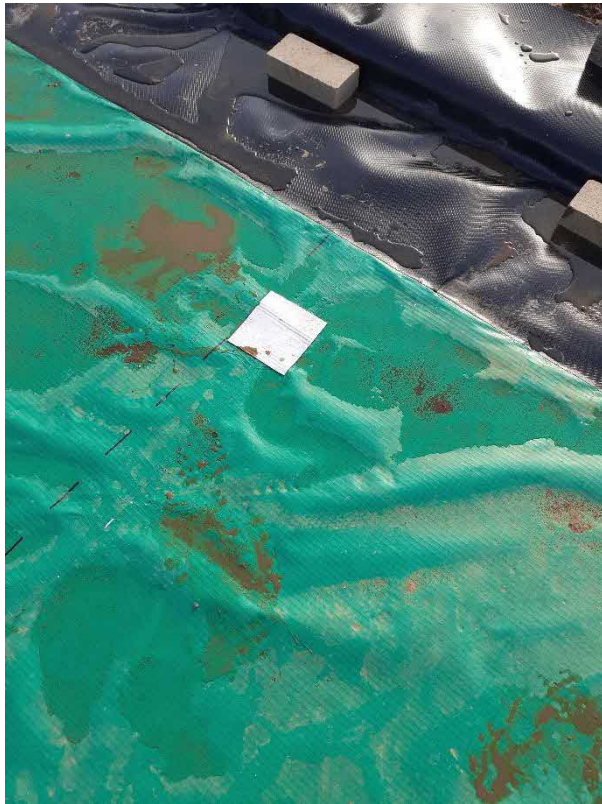
05 C8585E 29.09.22 Plot 48 Repair

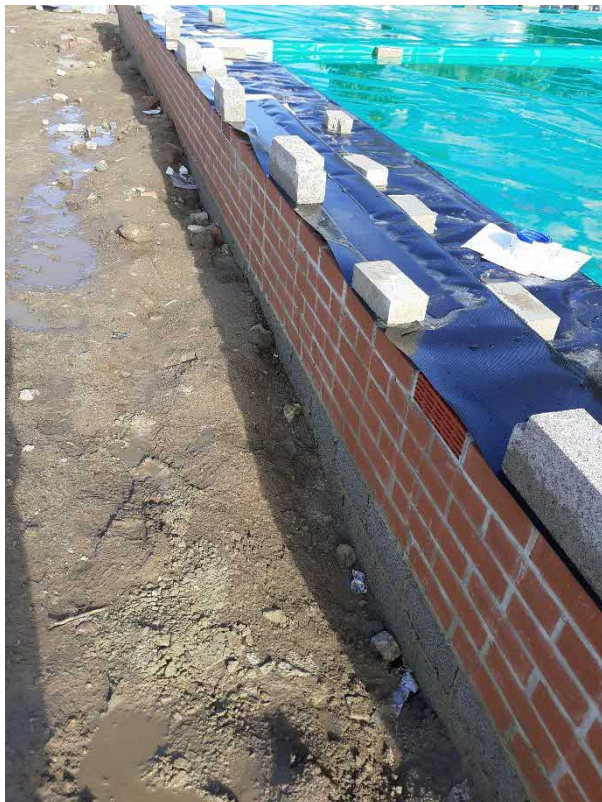
05 C8585E 29.09.22 Plot 48 Void Space Vents

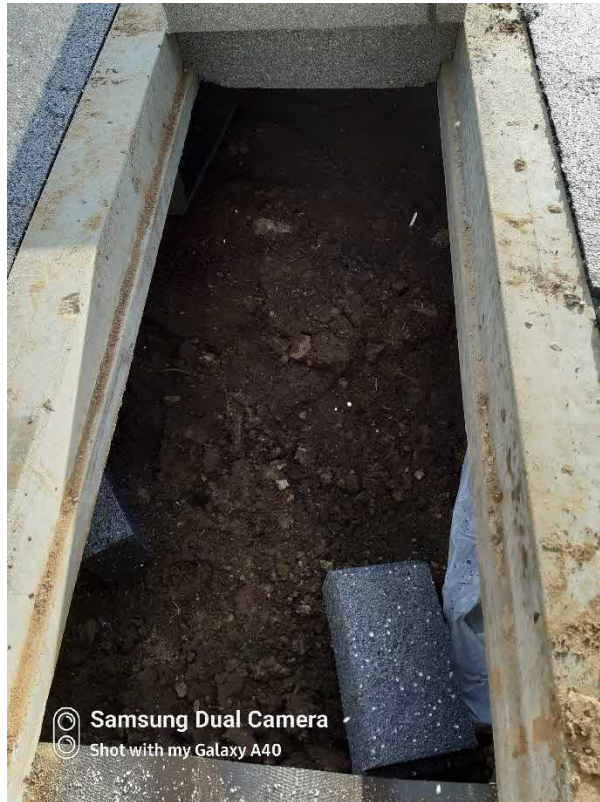
1.2	Gas membrane type	Solshield Ultra membrane with Solcourse along wall bases.
1.3	Gas membrane condition	Very good overall condition. Limited dirt and no damage observed.

1.4	Joining tape product	Details at corners and service penetrations using self-adhesive membrane.
1.5	Lapping design	Welded seams.
1.6	Laps, welds and joints seals	All laps, corner and service penetration seals in good condition.

01 C8585E 19.01.22 Plot 49 Void Space (client photo)

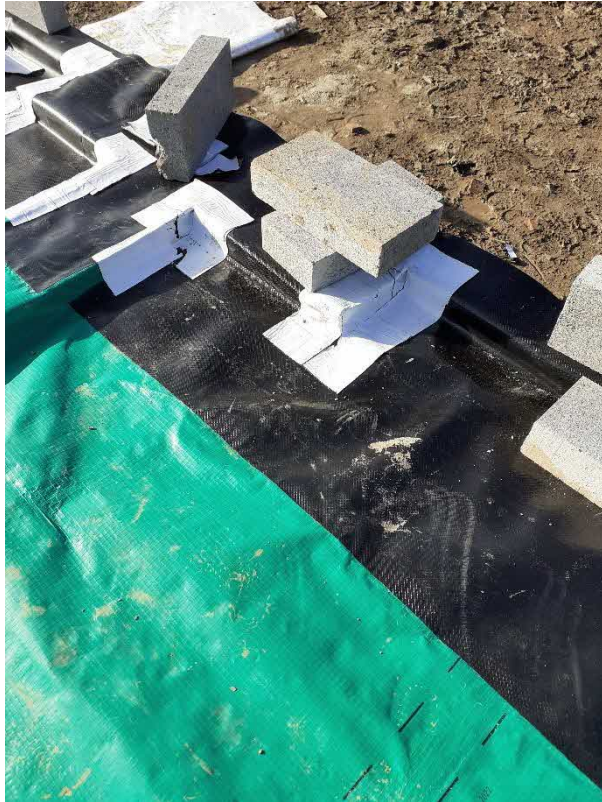
03 C8585E 29.09.22 Plot 49 Corners

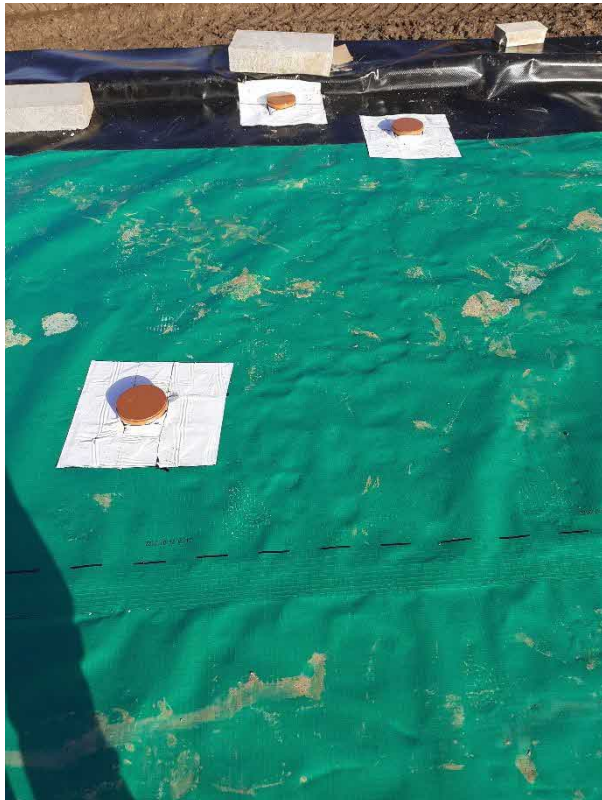
04 C8585E 29.09.22 Plot 49 Service Entry Ducts

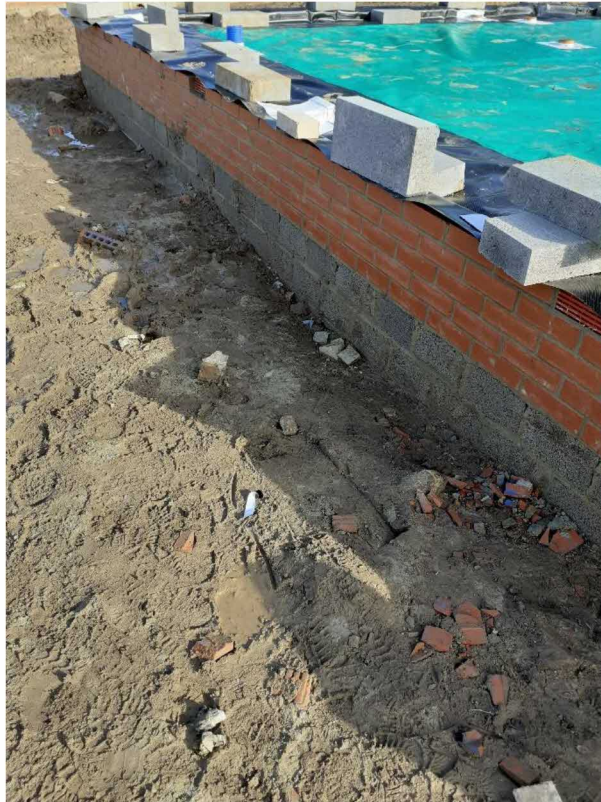
05 C8585E 29.09.22 Plot 49 Void Space Vents

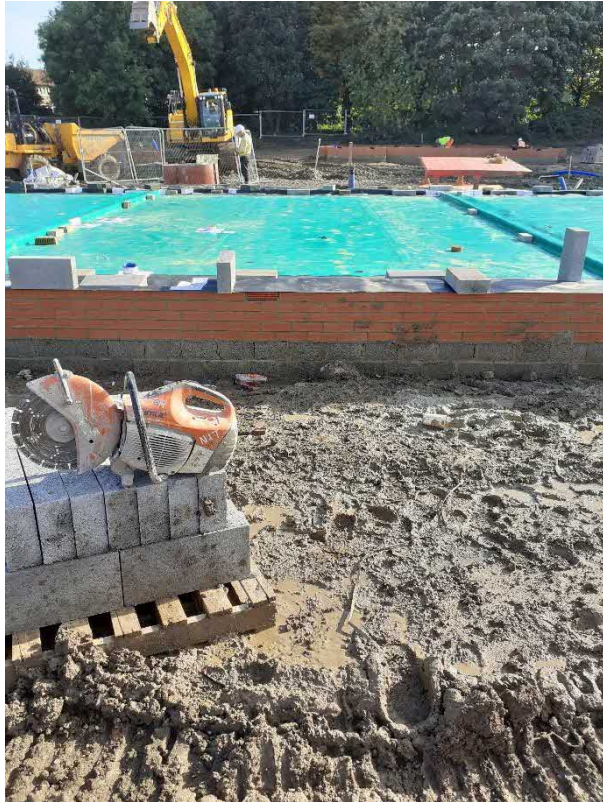
1.2	Gas membrane type	Solshield Ultra membrane with Solcourse along wall bases.
1.3	Gas membrane condition	Very good overall condition. Limited dirt and no damage observed.

1.4	Joining tape product	Details at corners and service penetrations using self-adhesive membrane.
1.5	Lapping design	Welded seams.
1.6	Laps, welds and joints seals	All laps, corner and service penetration seals in good condition.

01 C8585E 29.09.22 Plot 50 Overview

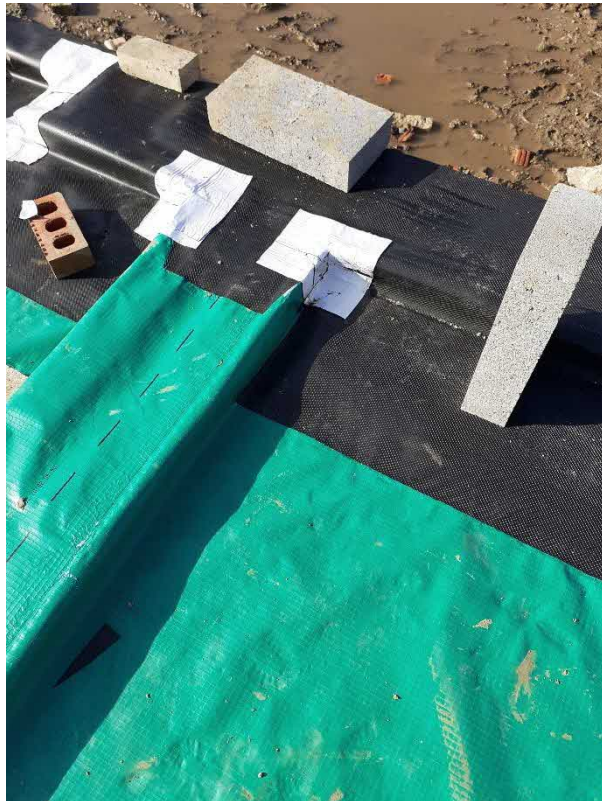
02 C8585E 29.09.22 Plot 50 Corners

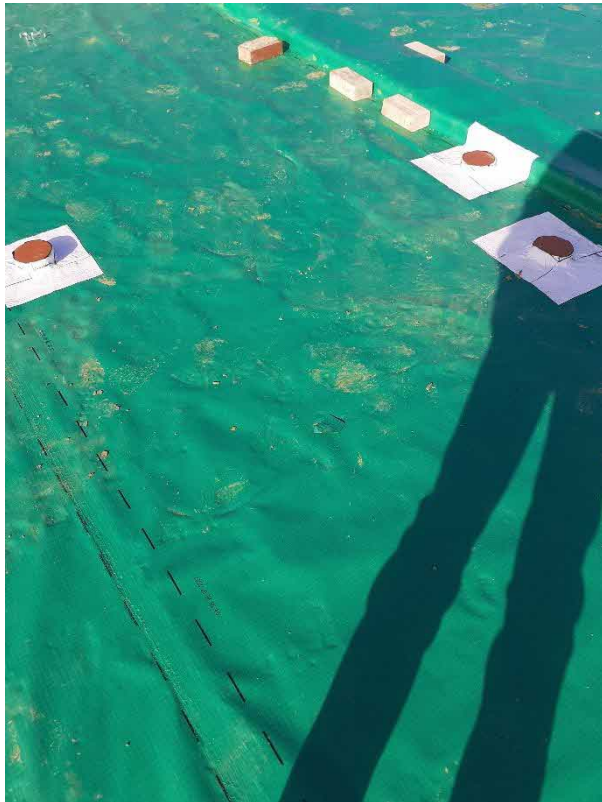
03 C8585E 29.09.22 Plot 50 Service Entry Ducts

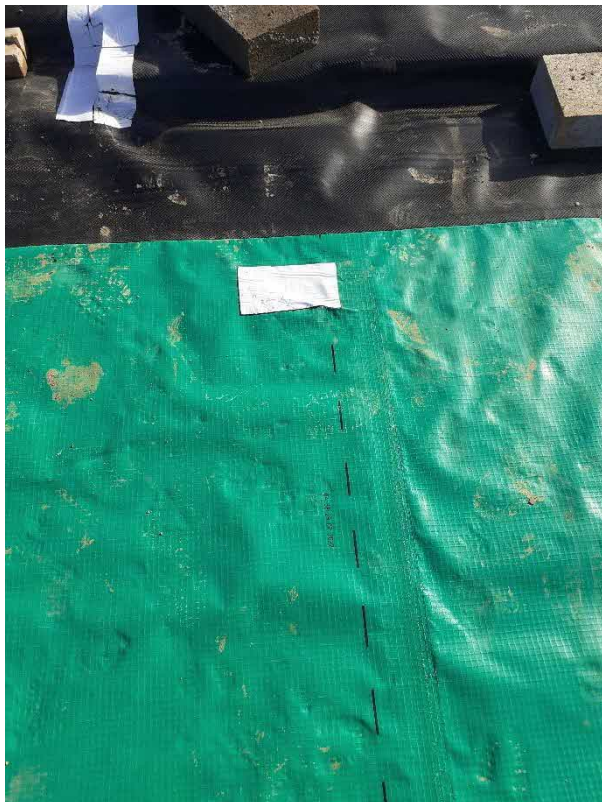
04 C8585E 29.09.22 Plot 50 Repair

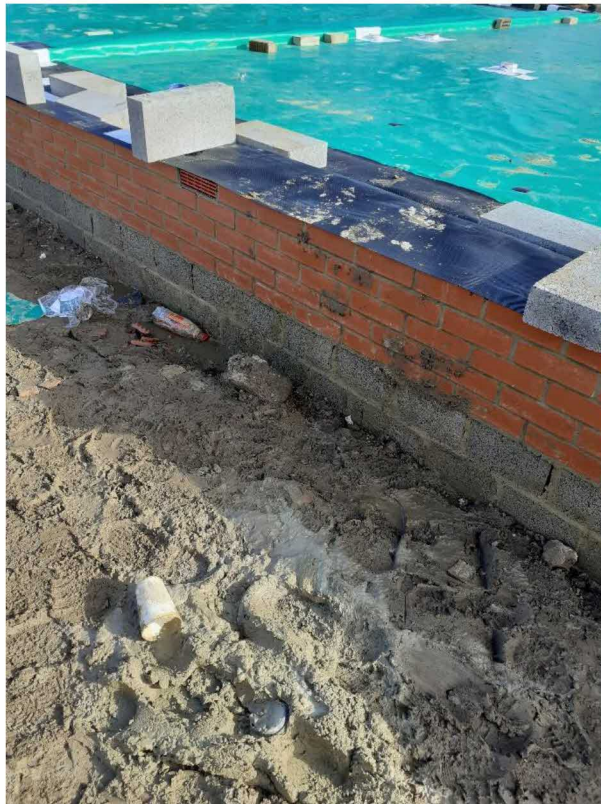
05 C8585E 29.09.22 Plot 50 Void Space Vents

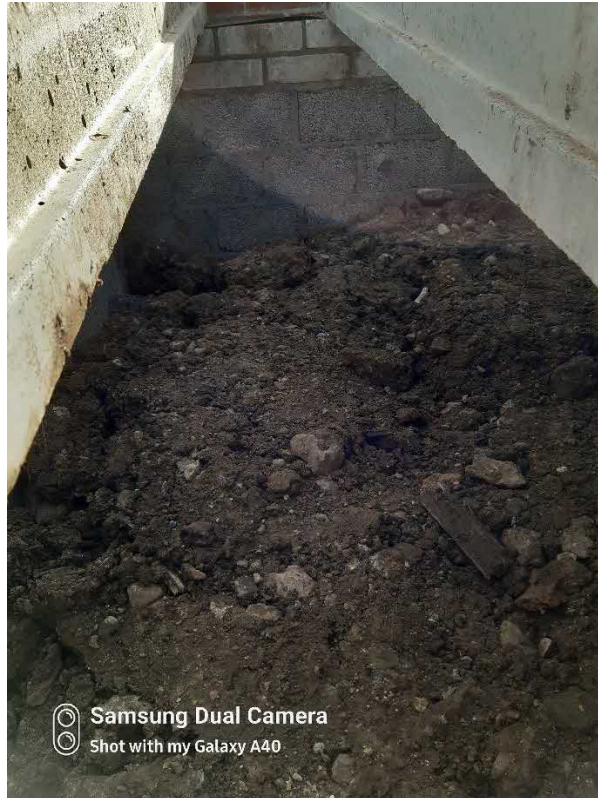
1.2	Gas membrane type	Solshield Ultra membrane with Solcourse along wall bases.
1.3	Gas membrane condition	Very good overall condition. Limited dirt and no damage observed.

1.4	Joining tape product	Details at corners and service penetrations using self-adhesive membrane.
1.5	Lapping design	Welded seams.
1.6	Laps, welds and joints seals	All laps, corner and service penetration seals in good condition.

01 C8585E 19.01.22 Plot 51 Void Space (client photo)

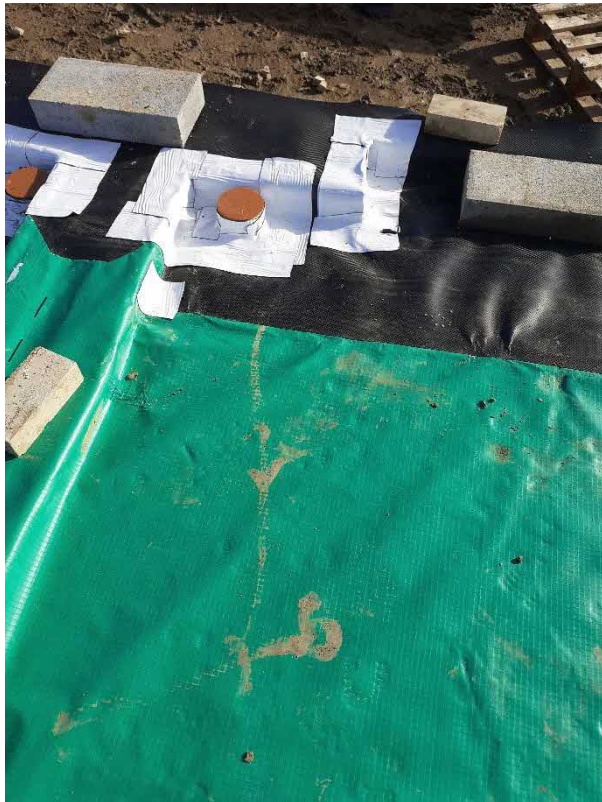
03 C8585E 29.09.22 Plot 51 Corners and Service Entry Duct

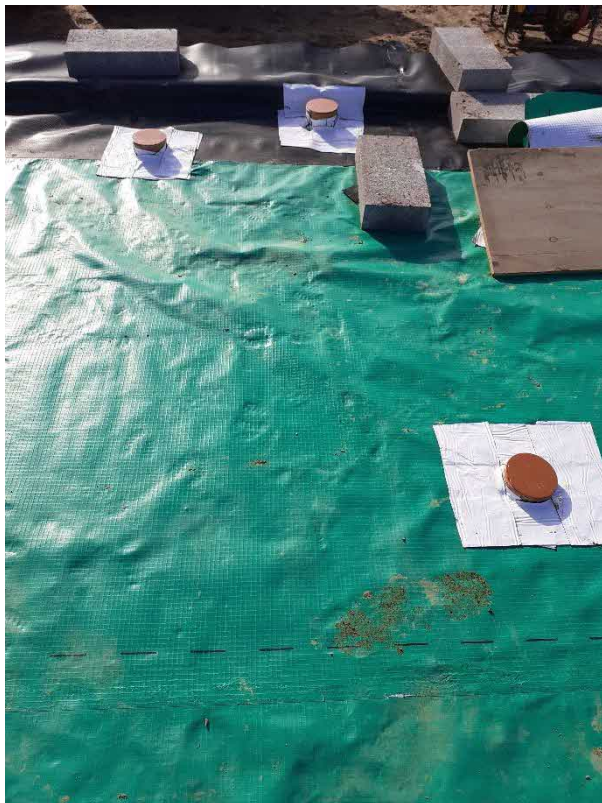
04 C8585E 29.09.22 Plot 51 Service Entry Ducts

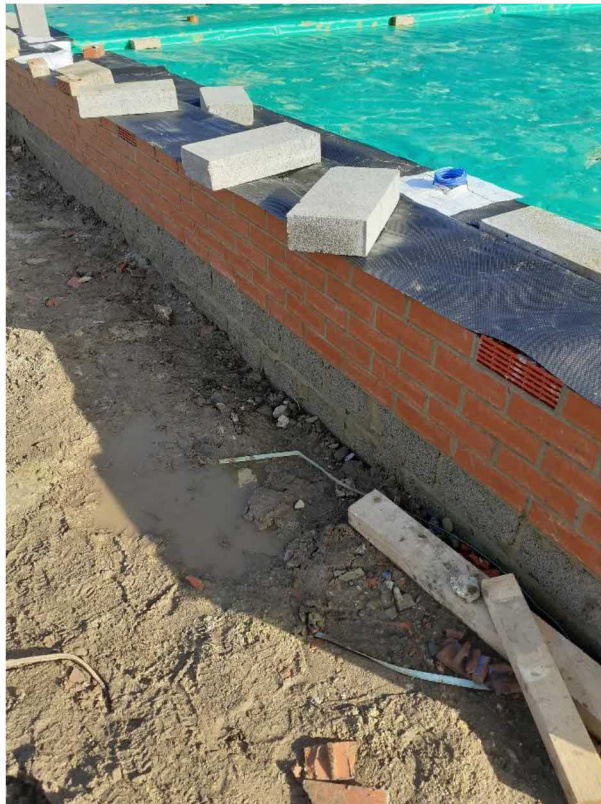
05 C8585E 29.09.22 Plot 51 Void Space vents

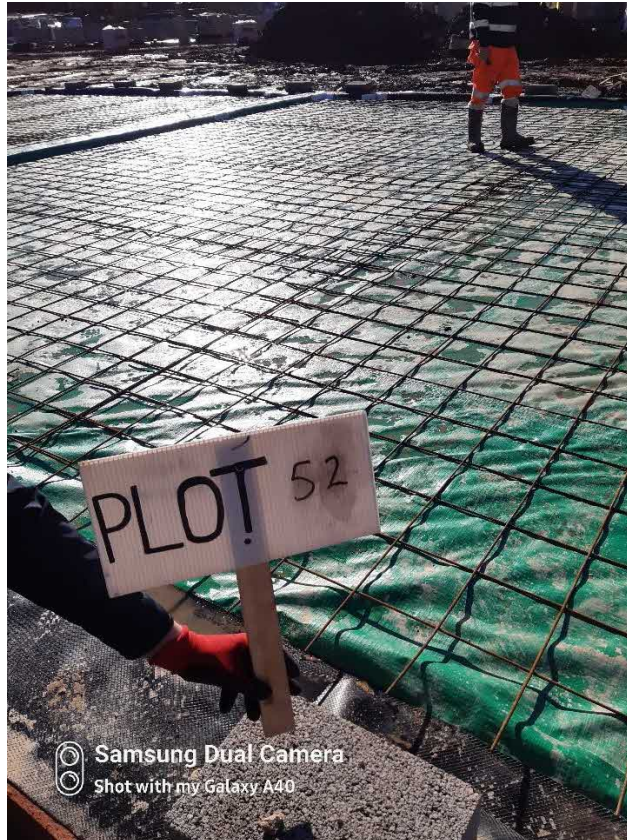
01 C8785E 03.04.23 Plot 52 Overview (client photo)

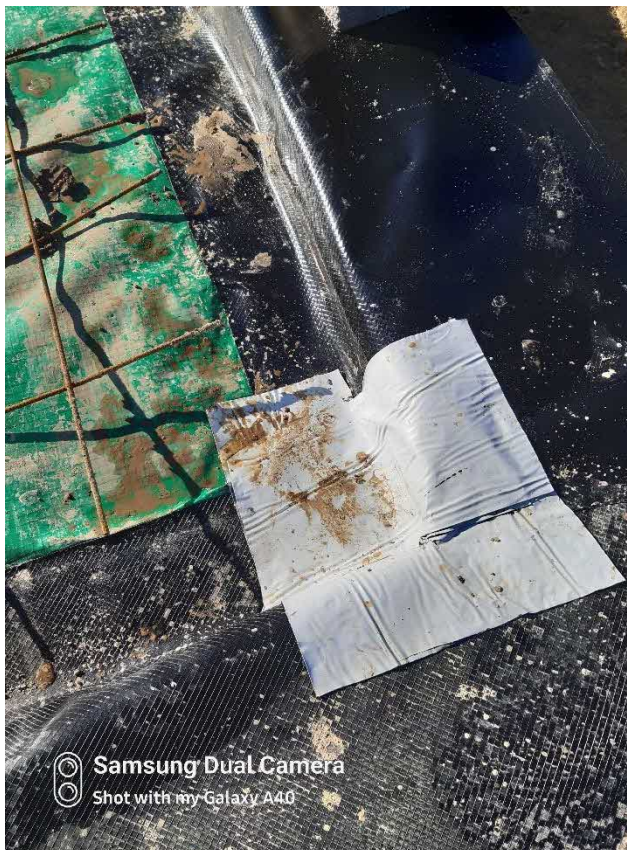
02 C8785E 03.04.23 Plot 52 Corner (client photo)

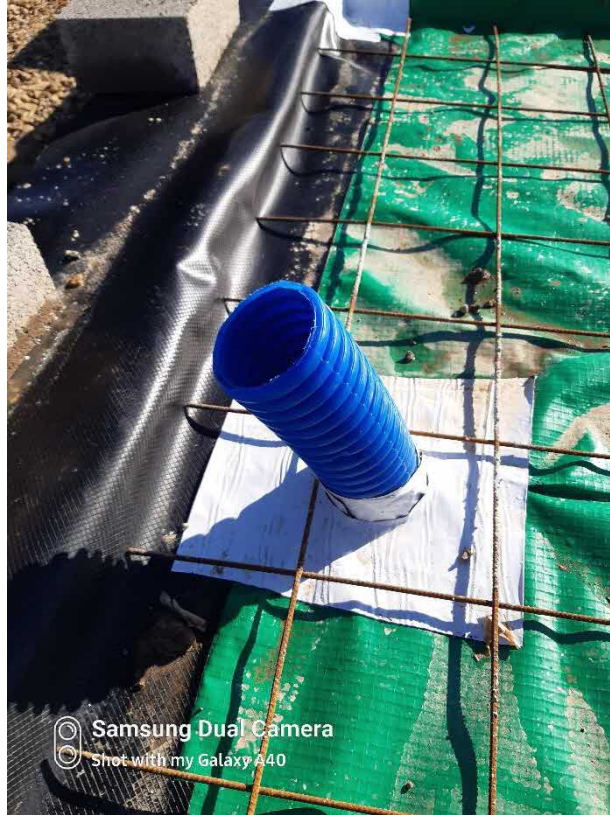
03 C8785E 03.04.23 Plot 52 Service Entry Duct (client photo)
