Date: 23<sup>rd</sup> November 2023  
Ref: C8785E/8486/AS/AS

## GROUND GAS VERIFICATIONS – STEPHENSON ROAD, PETERLEE (PLOTS 23 TO 28, 31 AND 47 TO 59)

## Gas Protection Verification Photographs

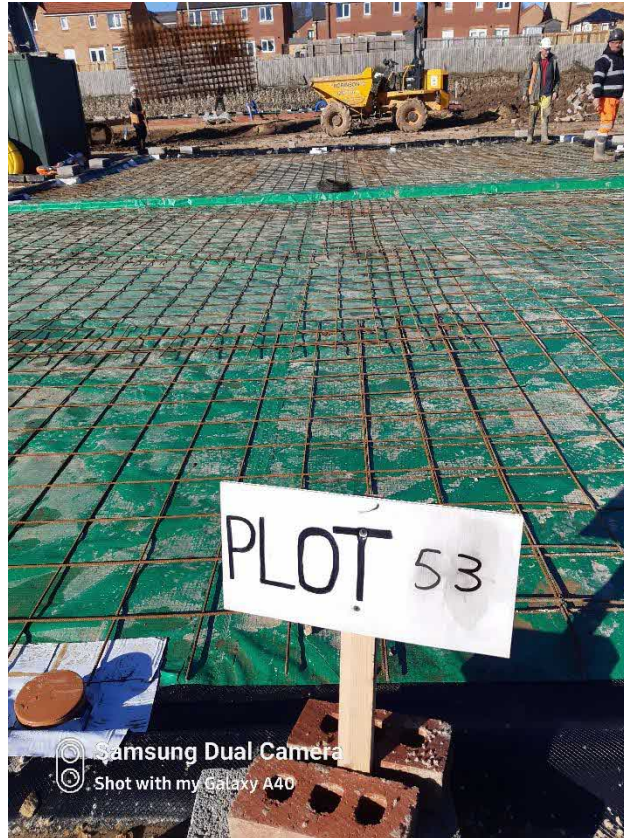
01 C8785E 03.04.23 Plot 53 Overview (client photo)

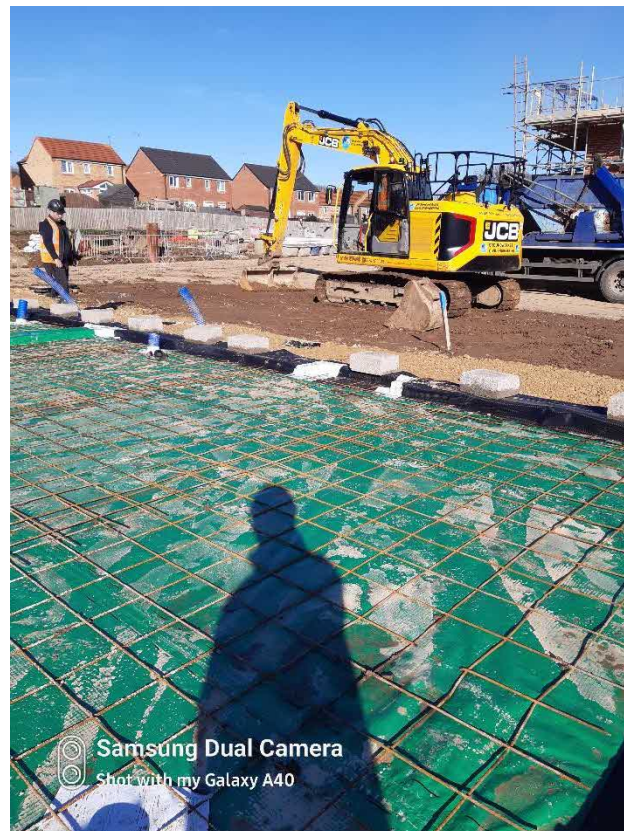
02 C8785E 03.04.23 Plot 53 Overview and Corners (client photo)

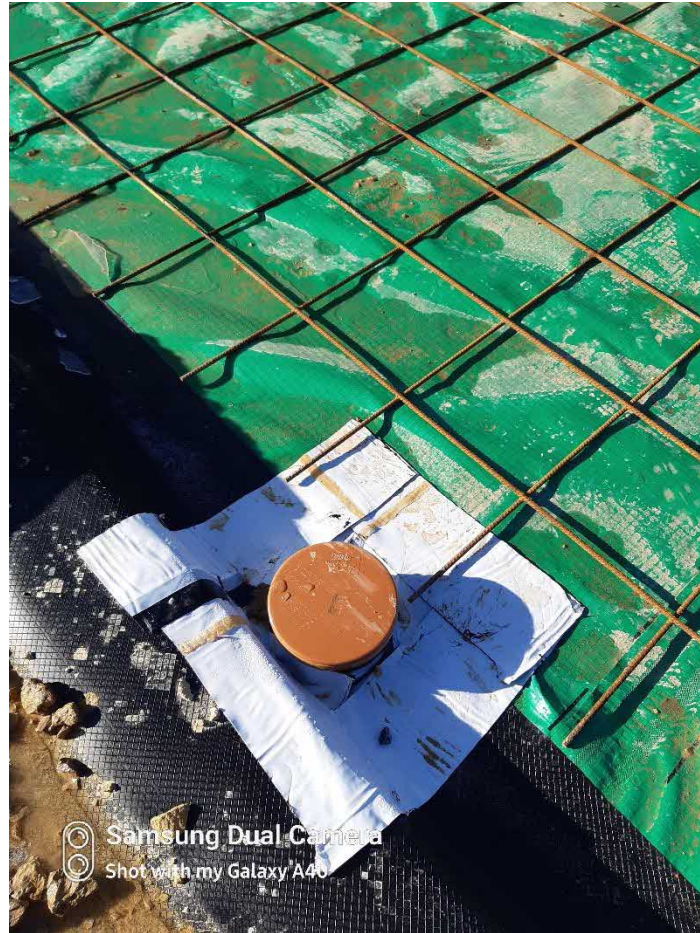
03 C8785E 03.04.23 Plot 53 Service Entry Duct (client photo)

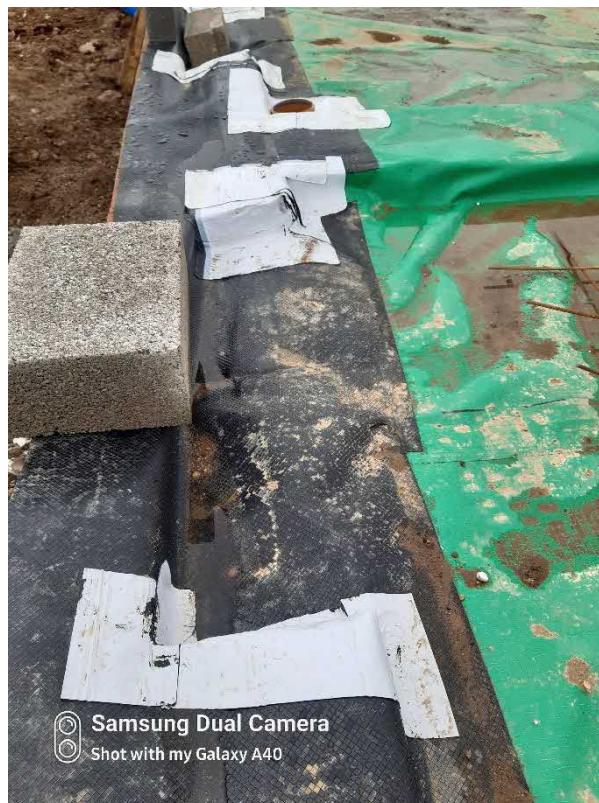
02 C8785E 29.03.23 Plot 54 Corners (client photo)

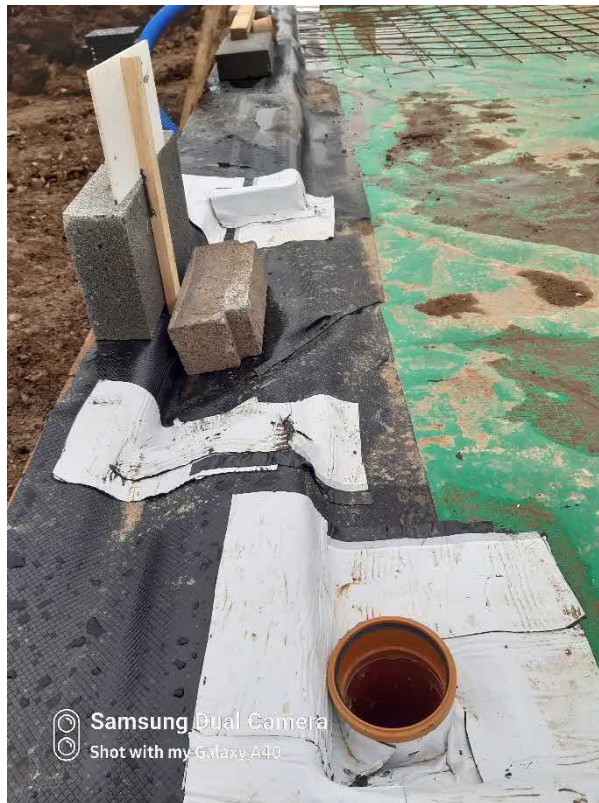
02 C8785E 29.03.23 Plot 55 Corners and Service Entry Duct (client photo)

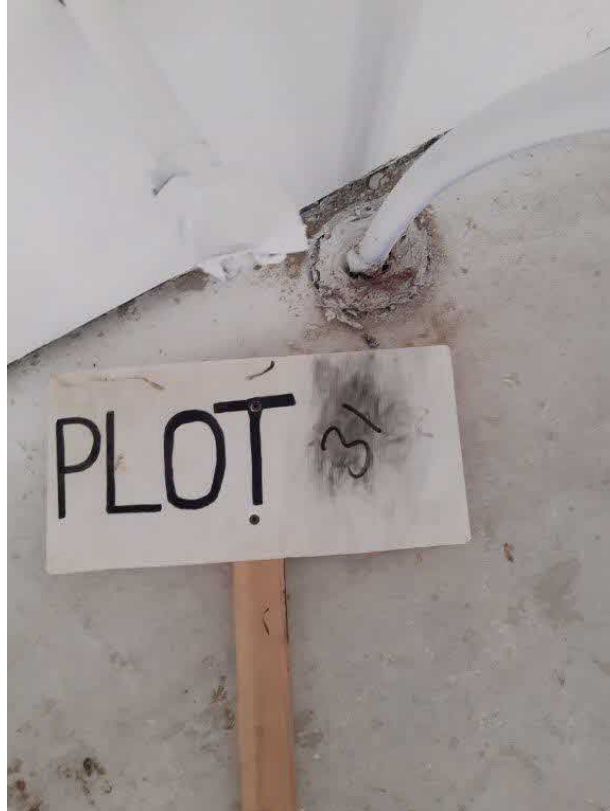
01 C8785E 10.11.23 Plot 31 Service Entry Seal (client photo)

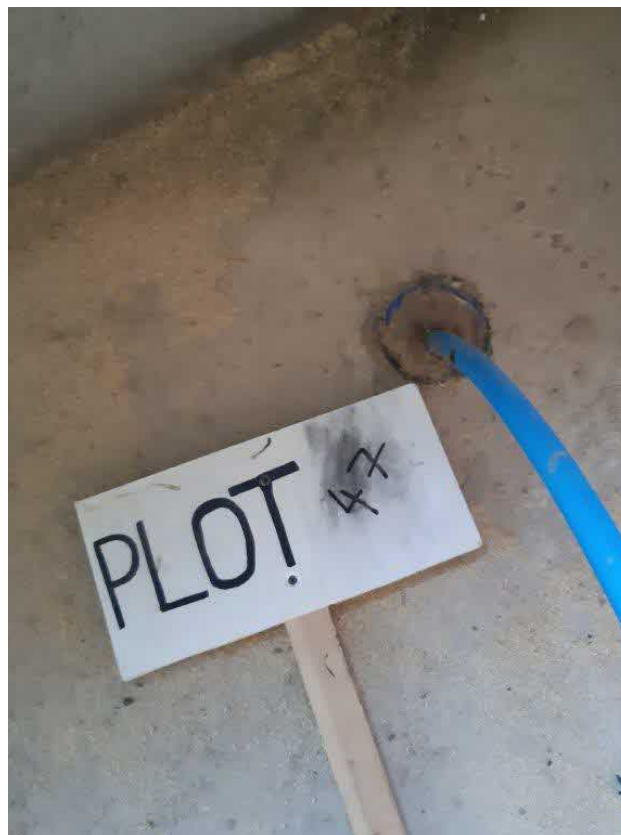
02 C8785E 10.11.23 Plot 47 Service Entry Seal (client photo)

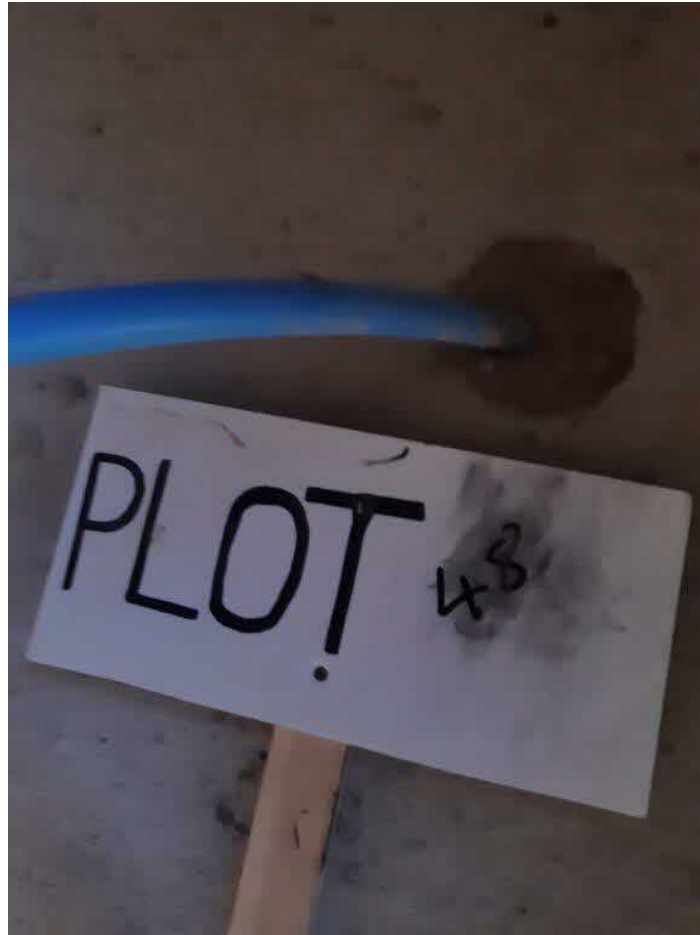
03 C8785E 10.11.23 Plot 48 Service Entry Seal (client photo)

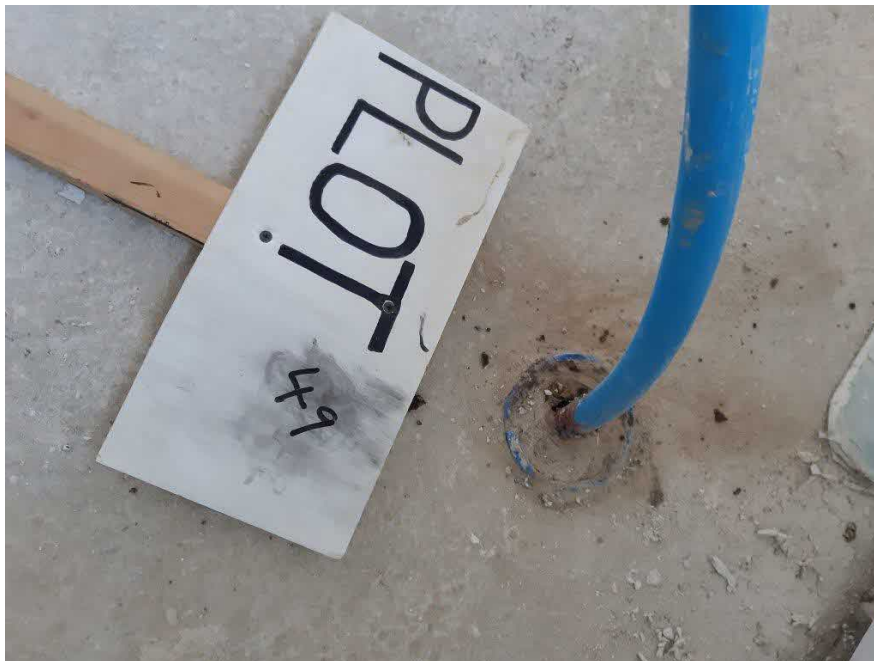
04 C8785E 10.11.23 Plot 49 Service Entry Seal (client photo)

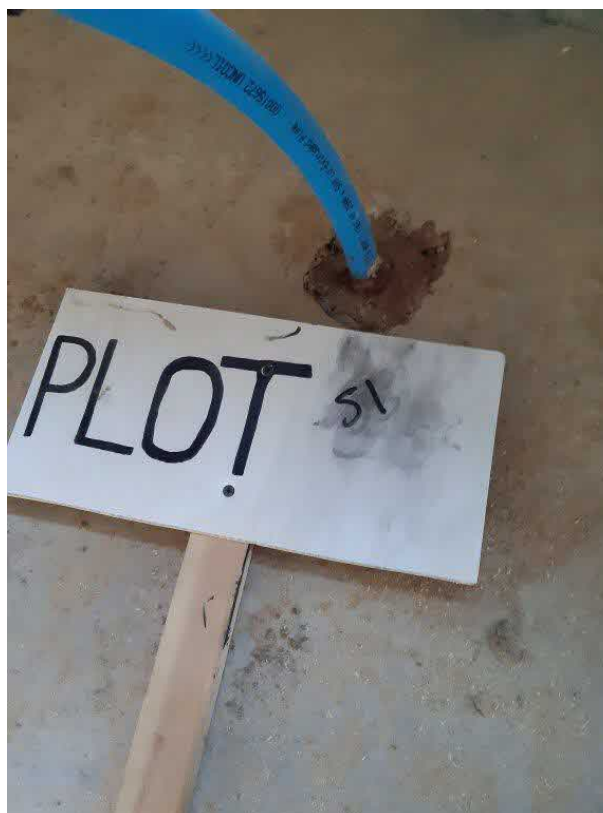
06 C8785E 10.11.23 Plot 51 Service Entry Seal (client photo)

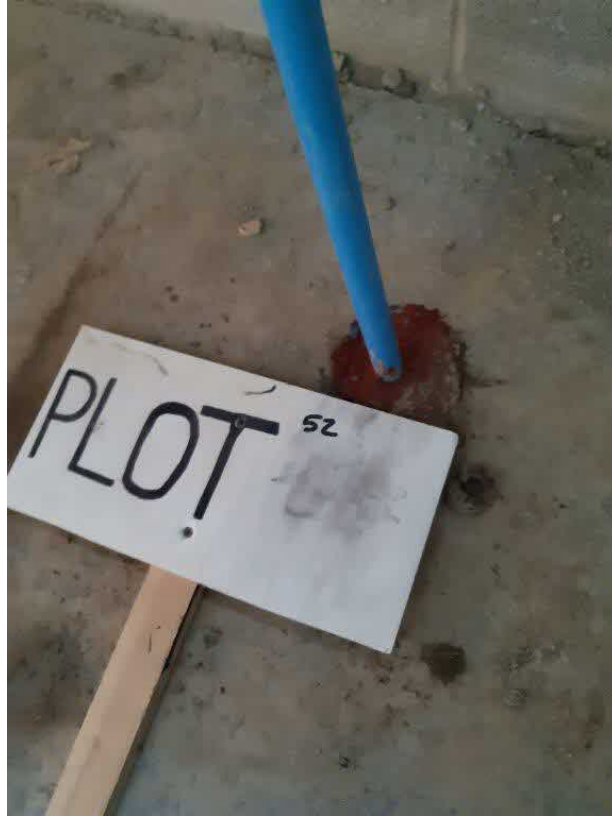
07 C8785E 10.11.23 Plot 52 Service Entry Seal (client photo)

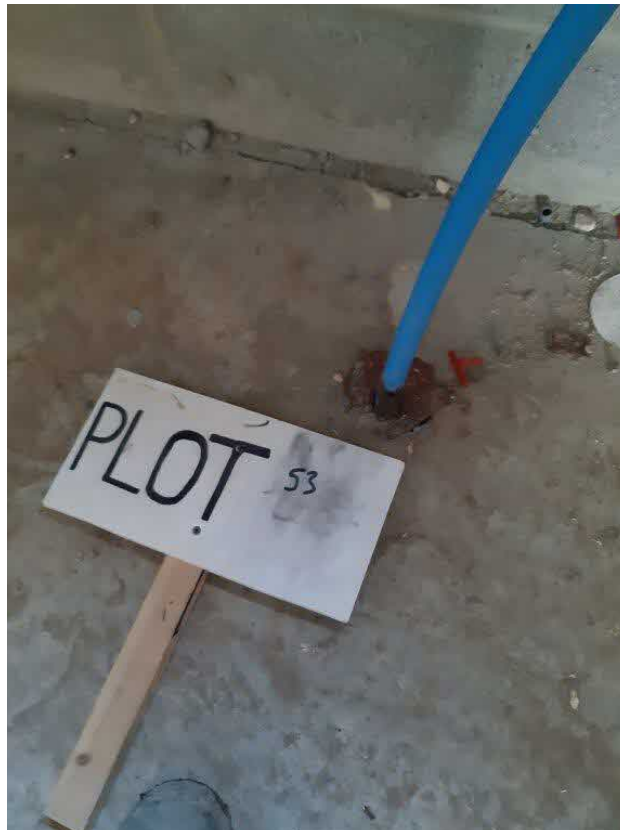
08 C8785E 10.11.23 Plot 53 Service Entry Seal (client photo)

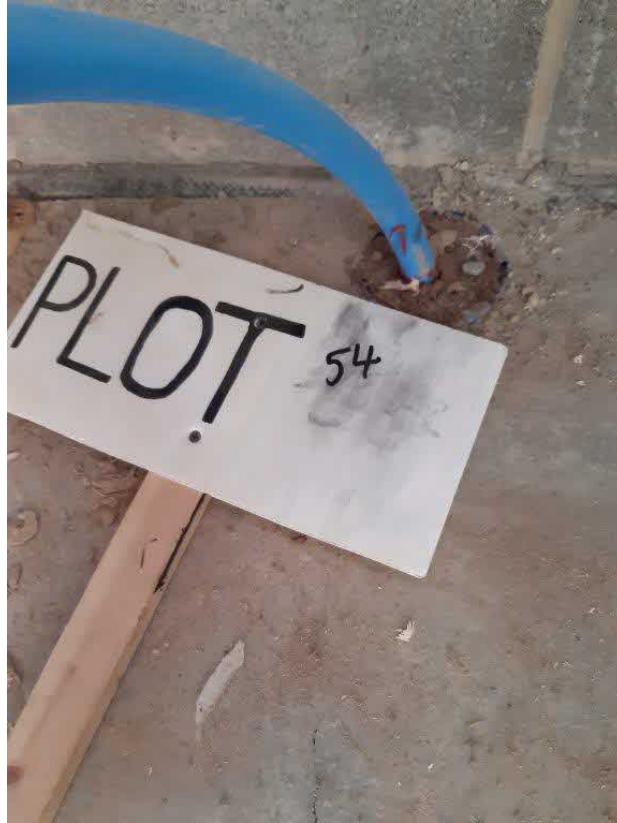
09 C8785E 10.11.23 Plot 54 Service Entry Seal (client photo)

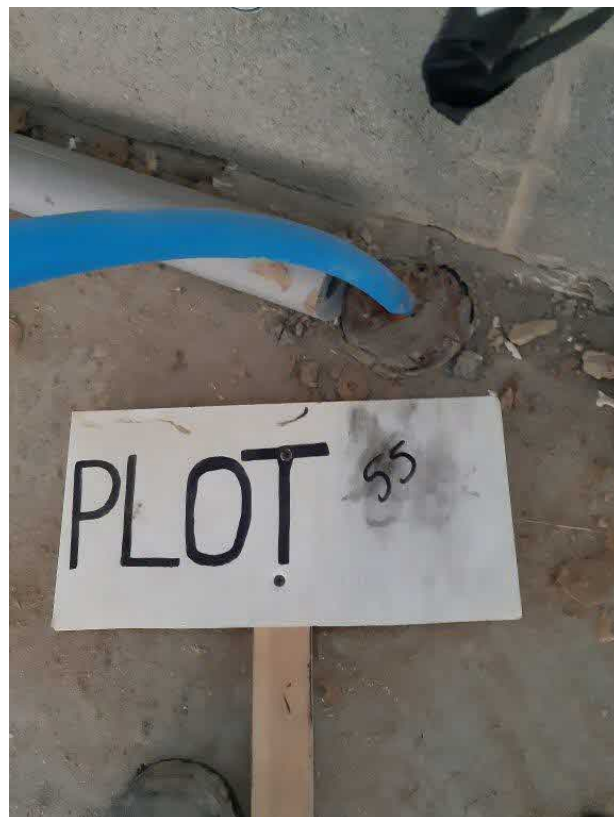
10 C8785E 10.11.23 Plot 55 Service Entry Seal (client photo)

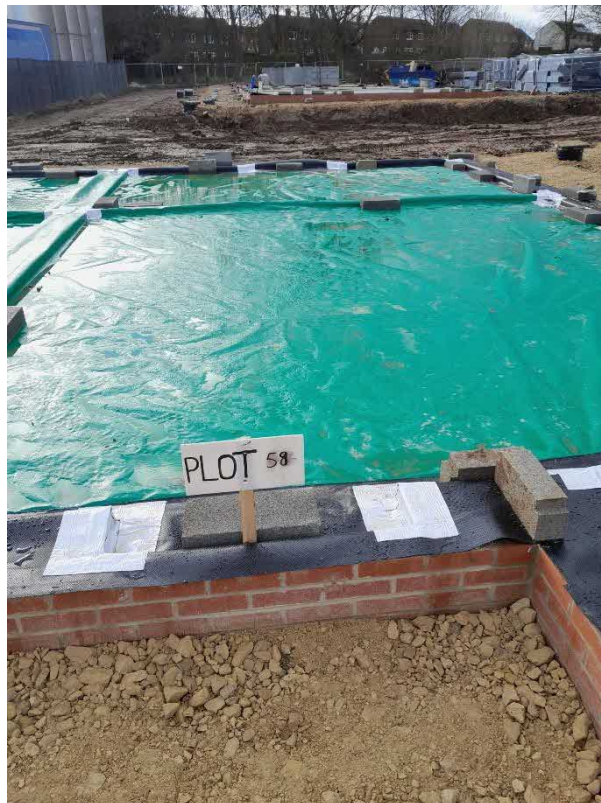
02 C8785E 24.03.23 Plot 58 Overview and Corners (client photo)

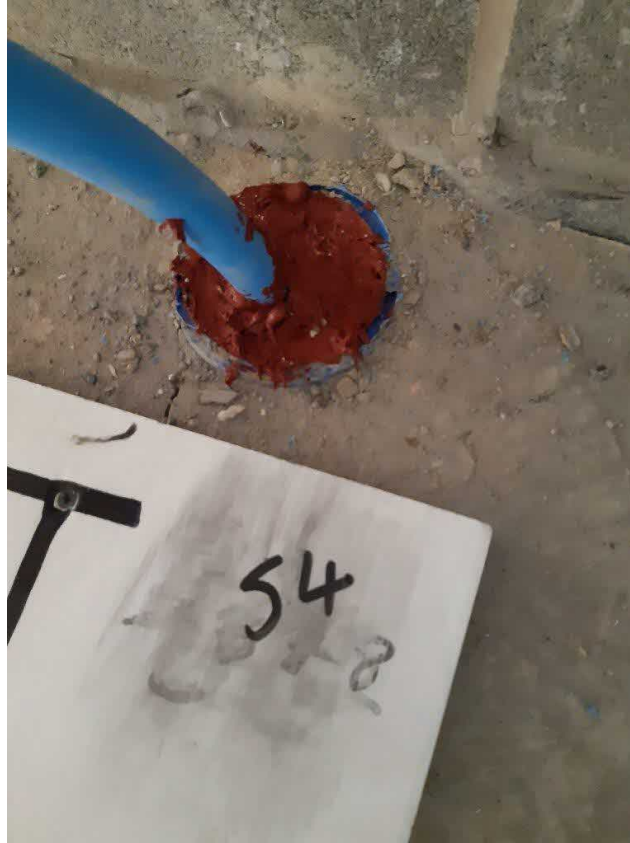
01 C8785E 15.09.23 Plot 54 Service Entry Seal (client photo)

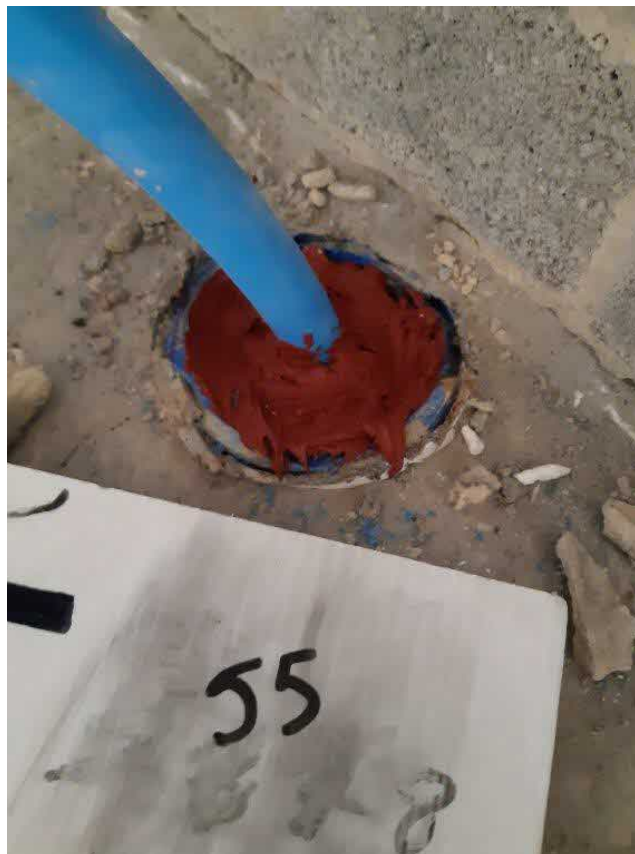
02 C8785E 15.09.23 Plot 55 Service Entry Seal (client photo)

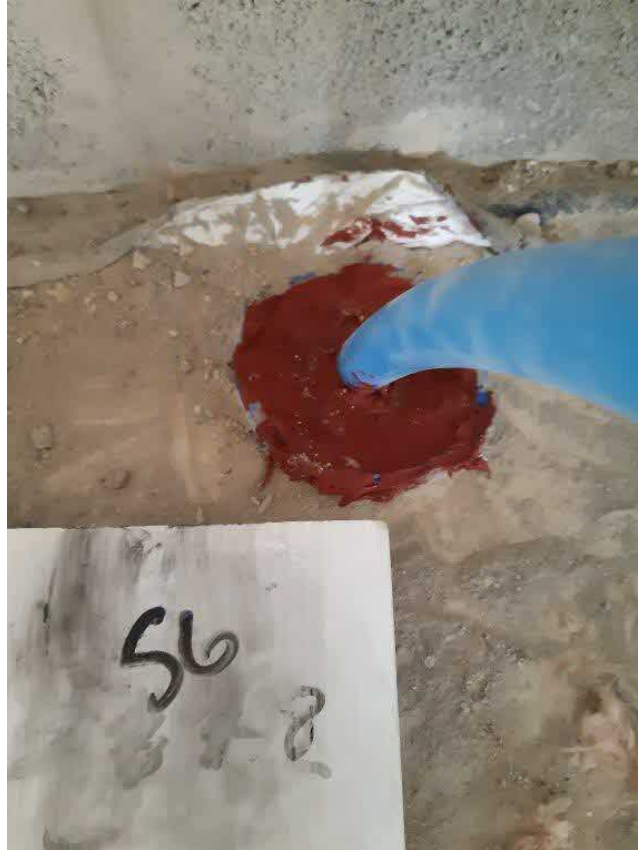
03 C8785E 15.09.23 Plot 56 Service Entry Seal (client photo)

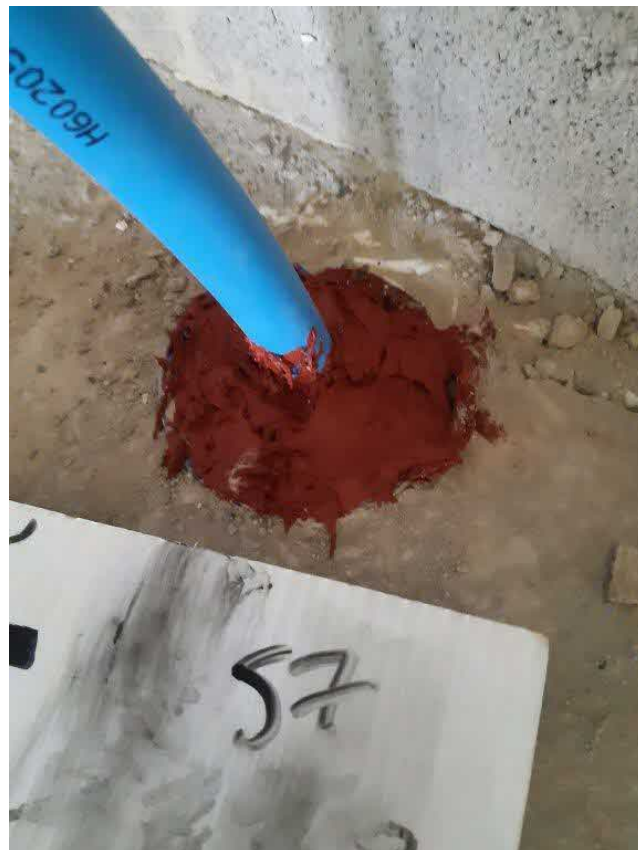
04 C8785E 15.09.23 Plot 57 Service Entry Seal (client photo)

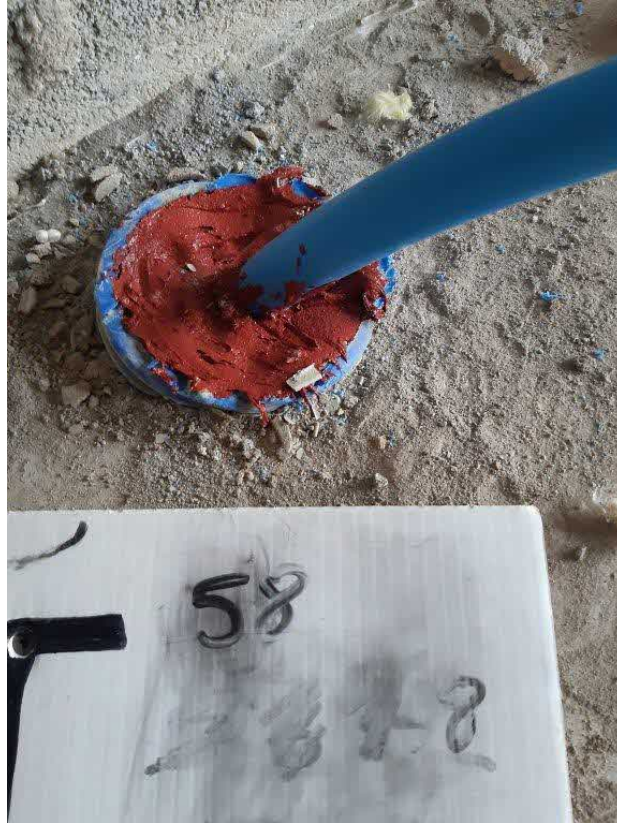
05 C8785E 15.09.23 Plot 58 Service Entry Seal (client photo)

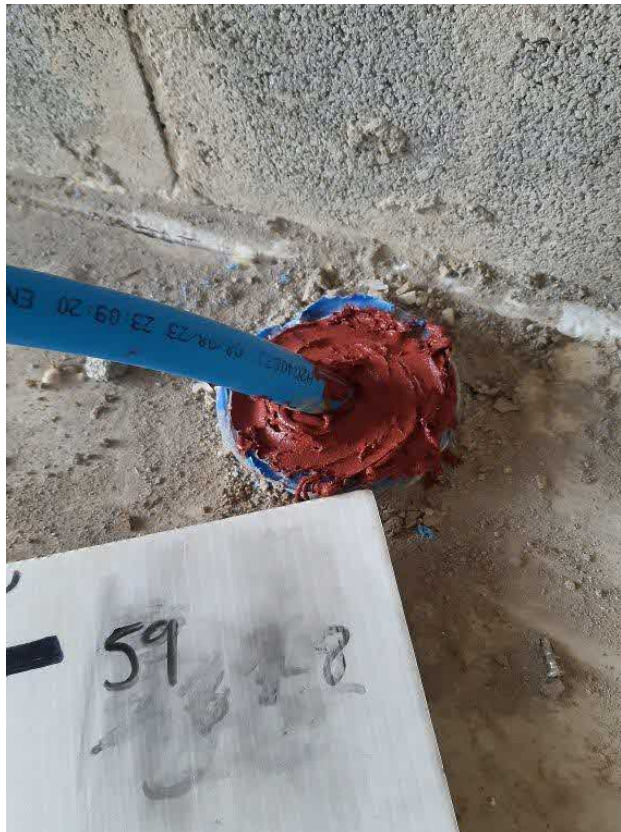
06 C8785E 15.09.23 Plot 59 Service Entry Seal (client photo)
