Flat 1, 8 Grosvenor Crescent, Glasgow, G12 9AE

We propose replacing the existing sash and case windows with newly manufactured hardwood timber sash and case windows that will be manufactured in a like for like formation. Horn detail would be lifted from the existing windows to preserve the established style.

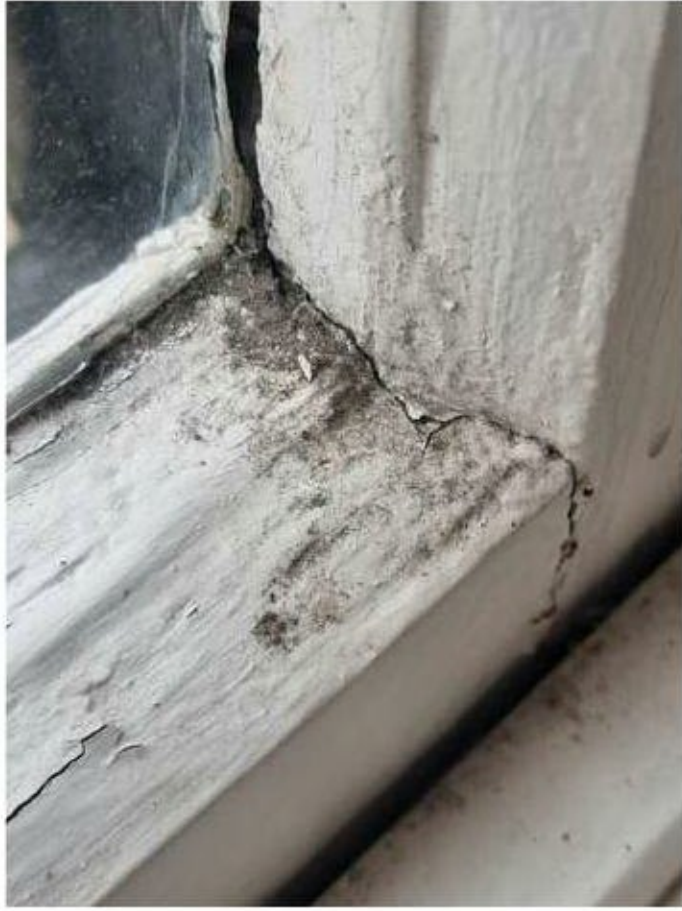
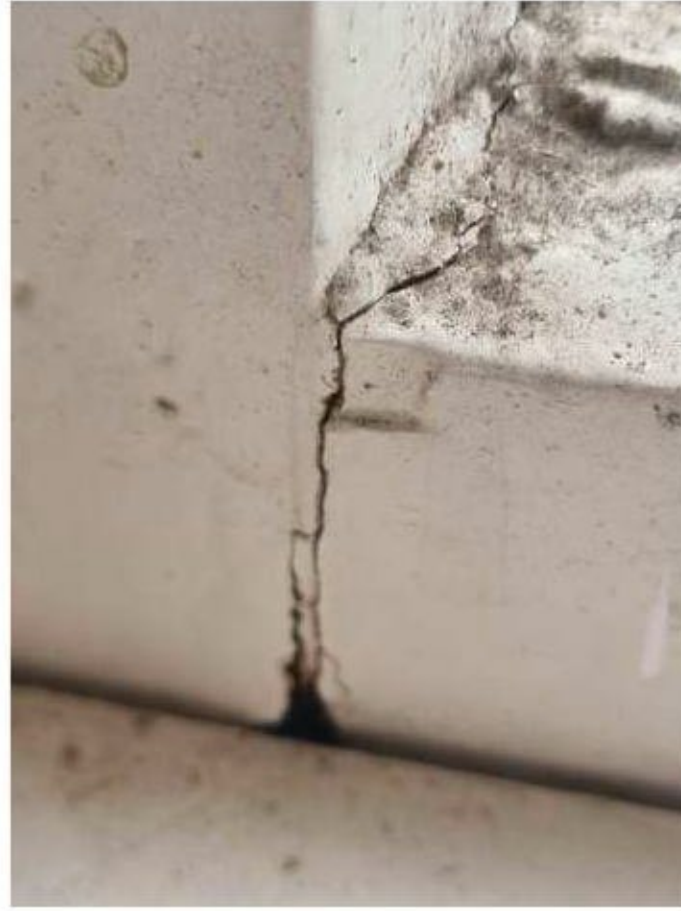
Tenon joints are splitting

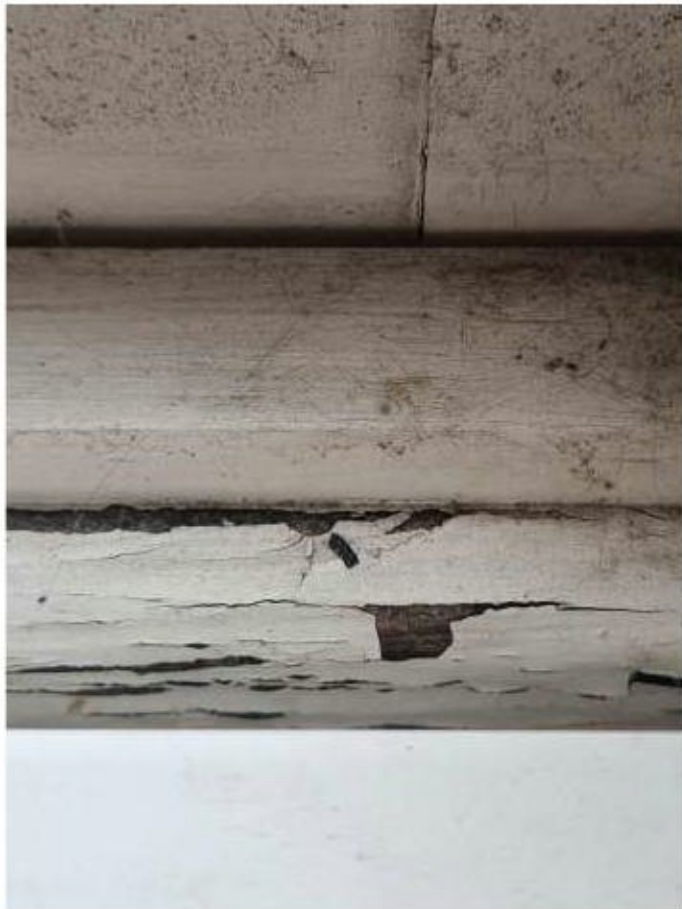
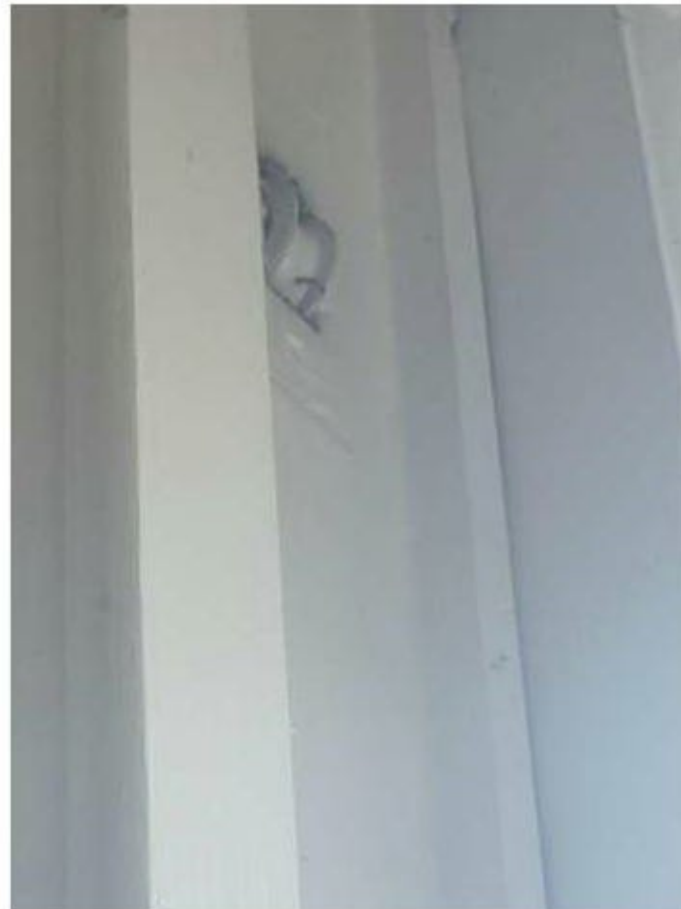
Internal wood is bare and showing signs of rotting. Rope is missing from a few windows and therefore they are non-operational.

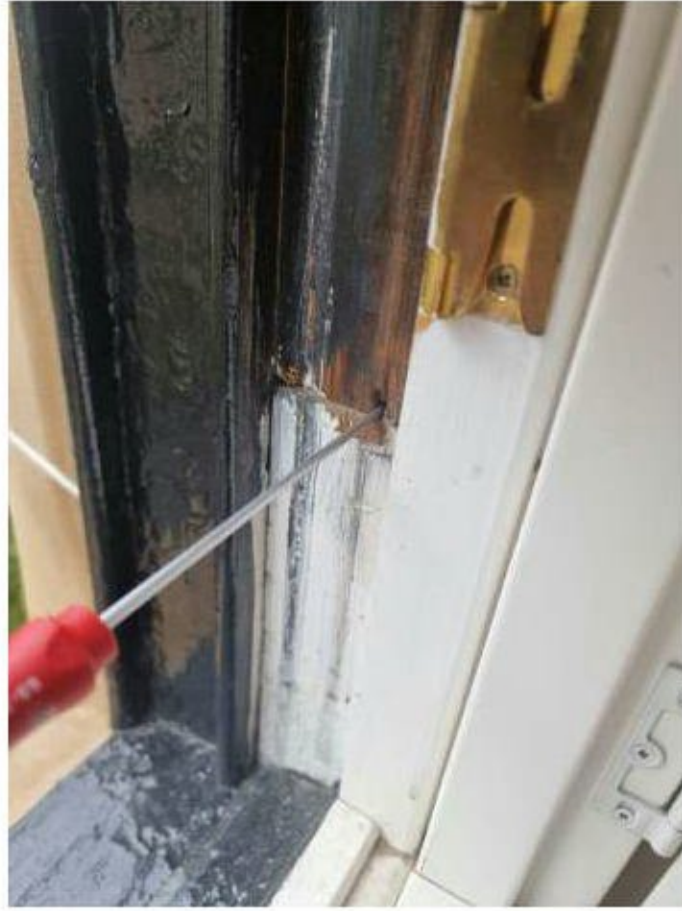
Rotting pulley pocket and casement woodwork.

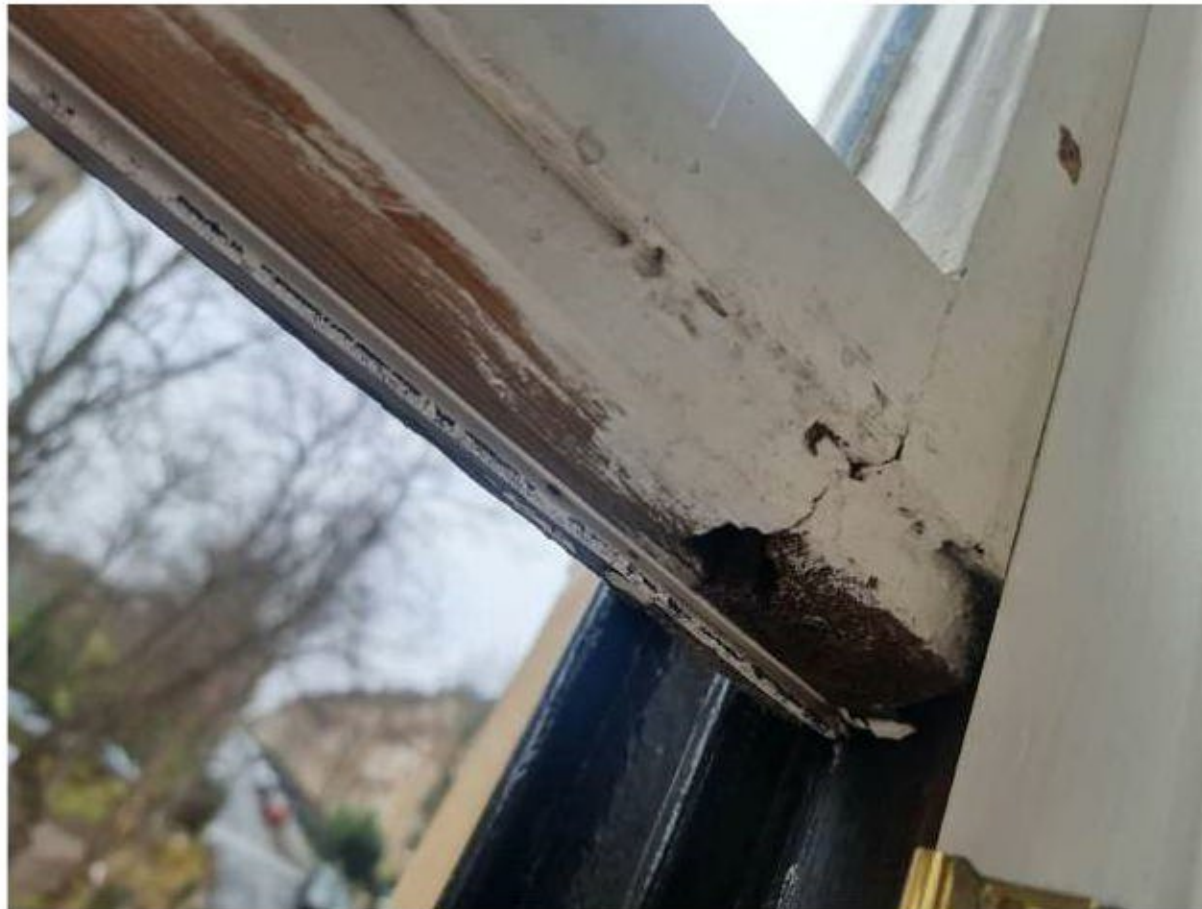
Tenon joint is failing and rotting.

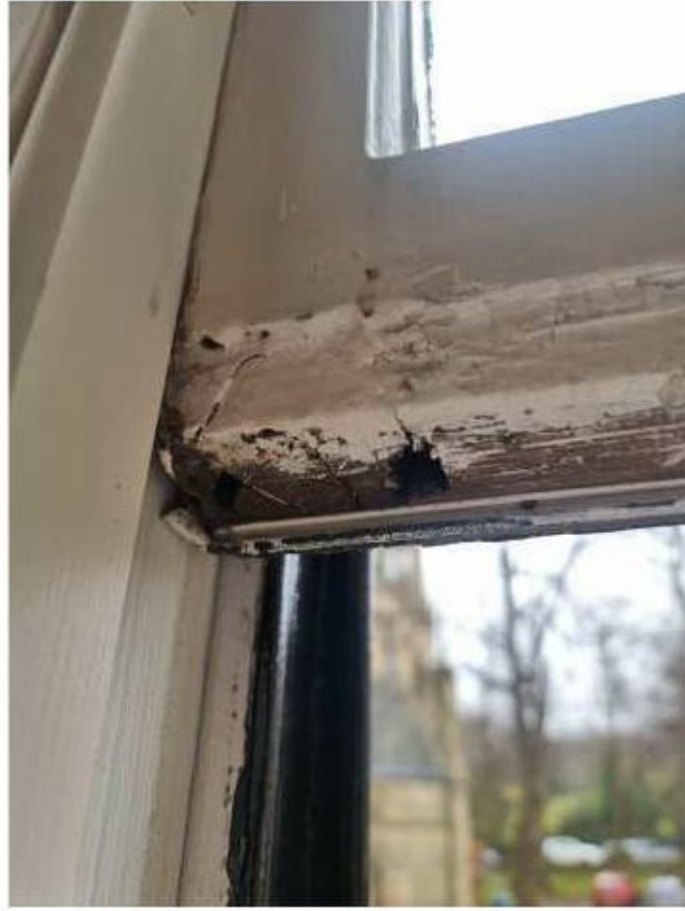
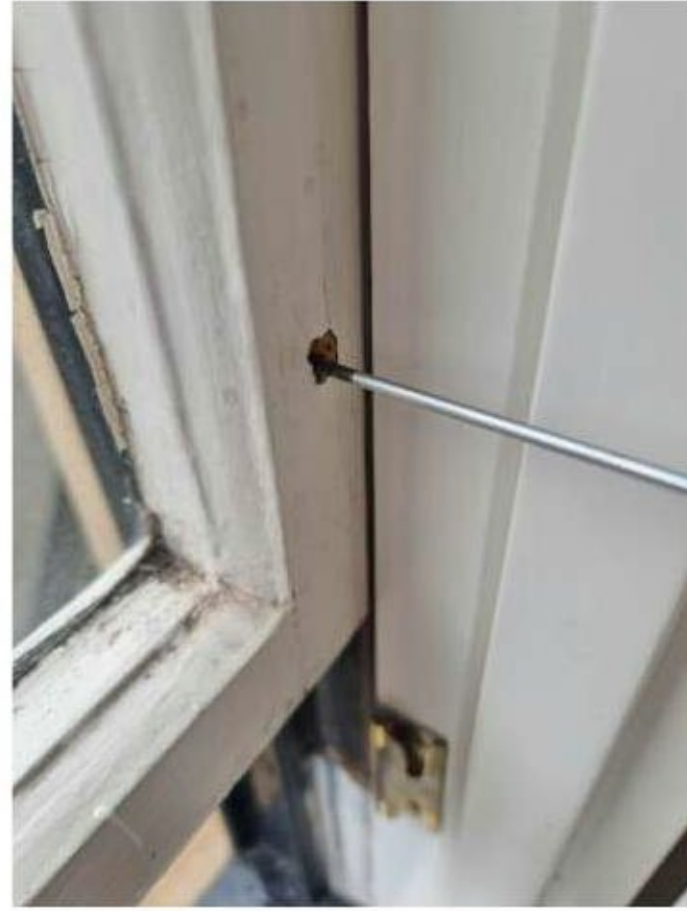
Rotting tenon joint and bottom sash.

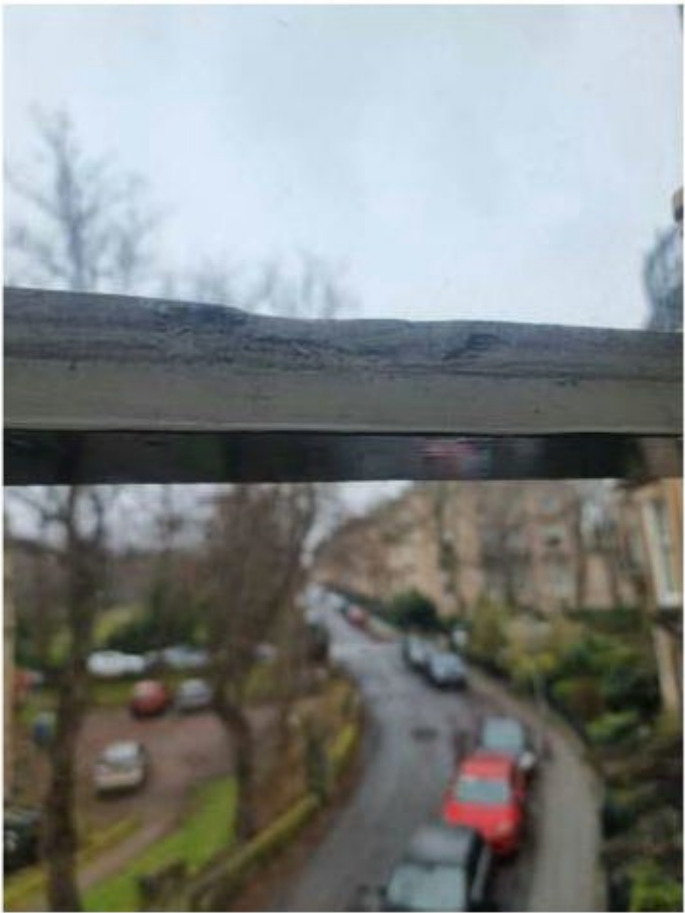
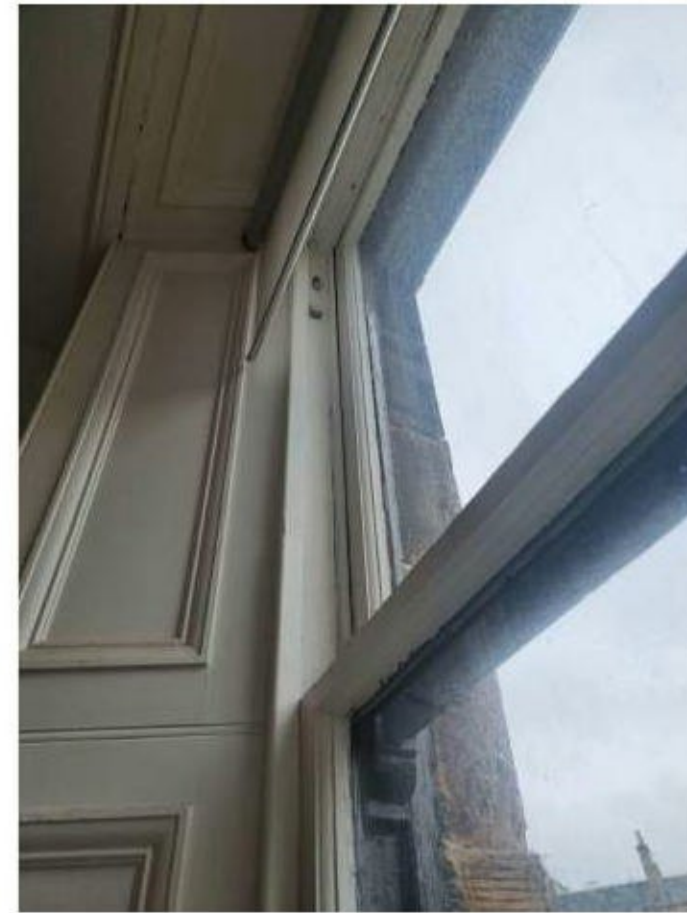
Mid rail woodwork is deteriorating. The second photo shows rope missing from another window.

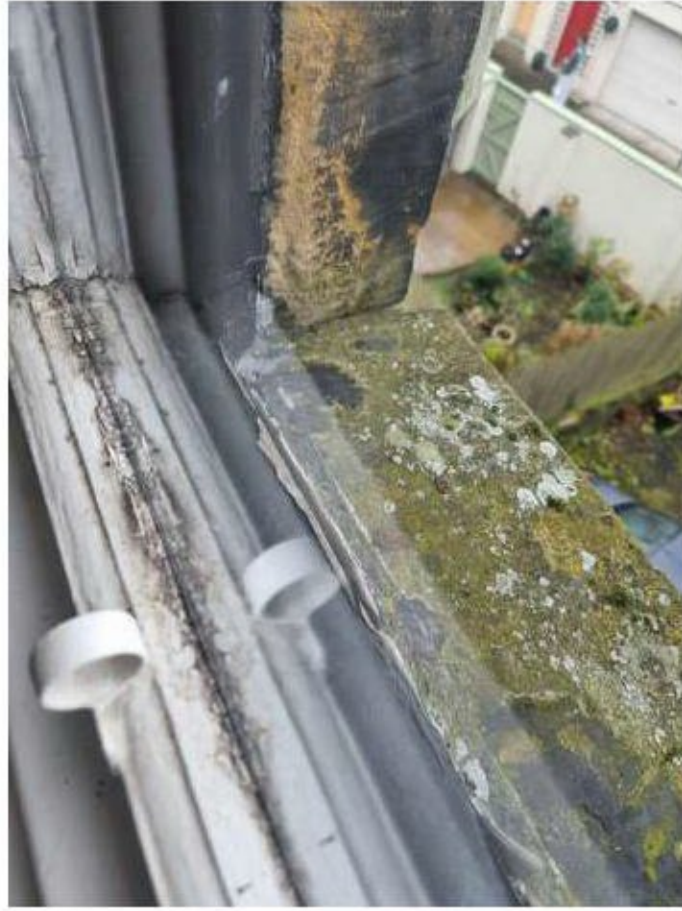
Photo shows deteriorating internal woodwork. The exterior sill is also bare and showing signs of rot. Mastic to the bottom of the casement is no longer present which is allowing water to penetrate the woodwork.

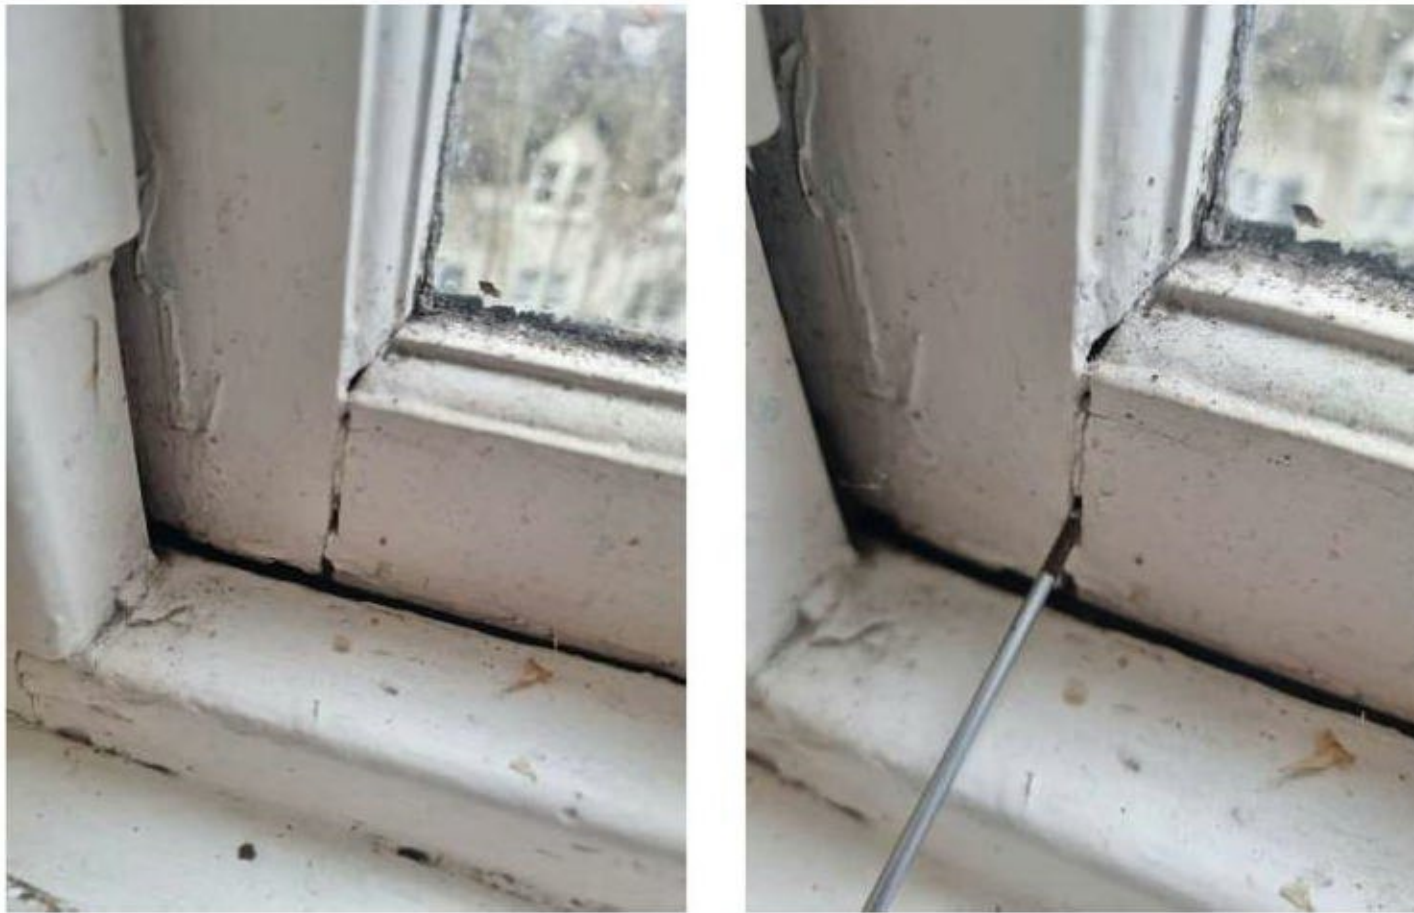
Splitting tenon joint with soft woodwork.

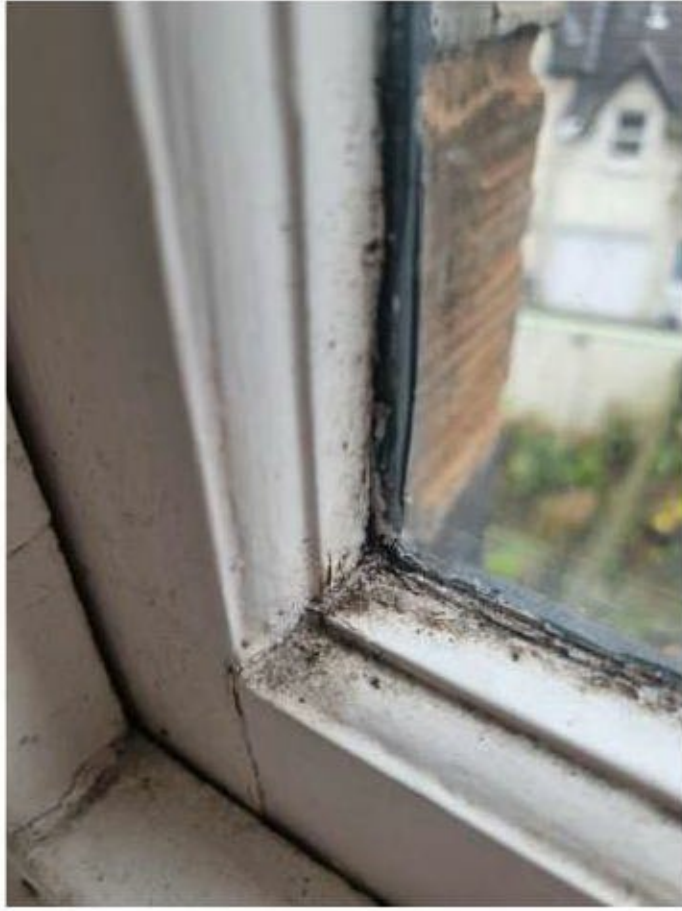
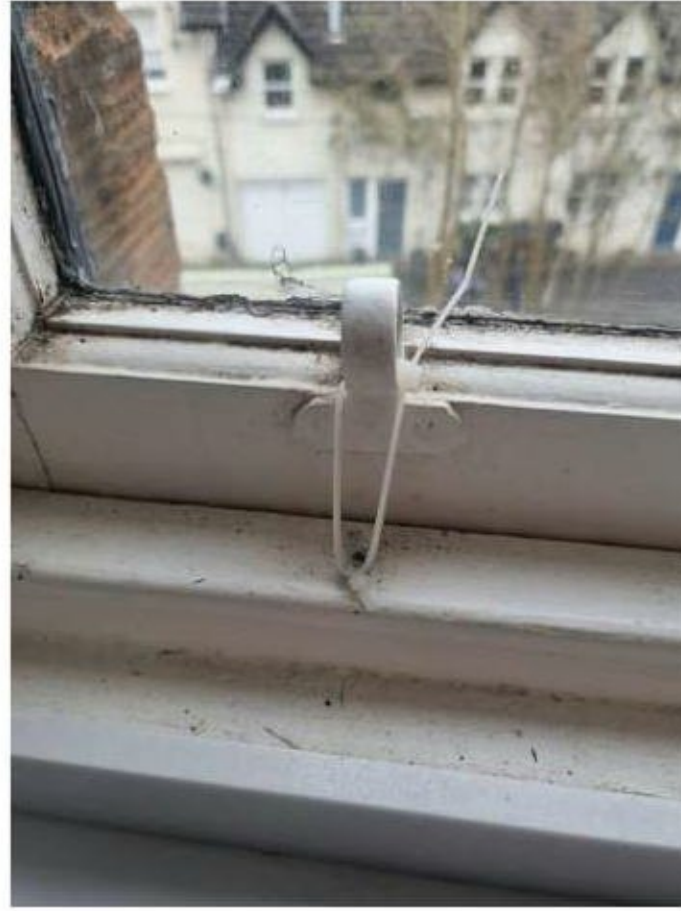
Seals are coming away from the glass which is allowing wind and water to enter the property. The second photo shows that the client is tying the bottom sash to the casement to stop the draught entering the property and the window rattling.

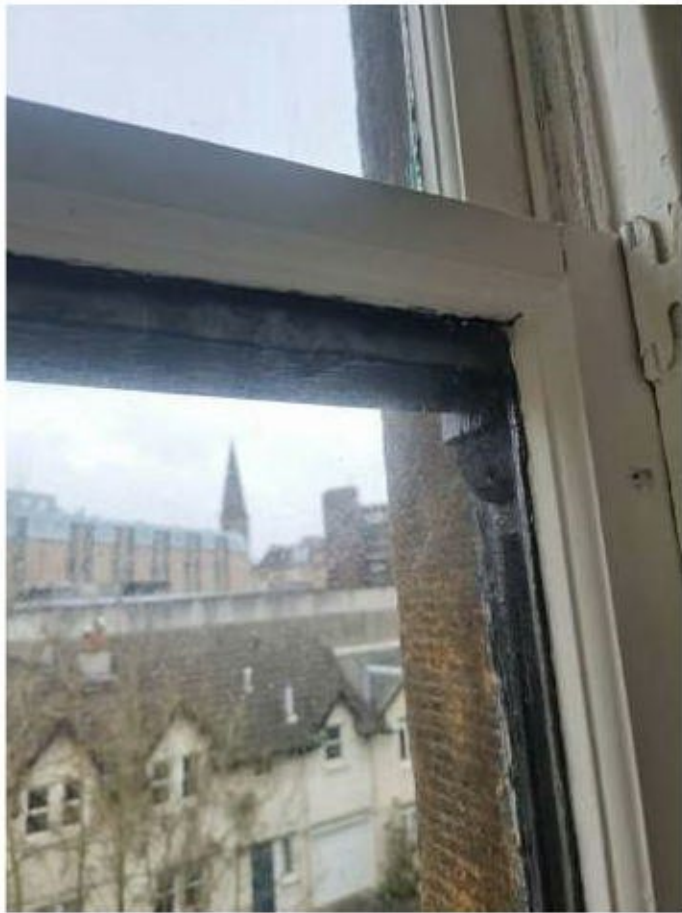
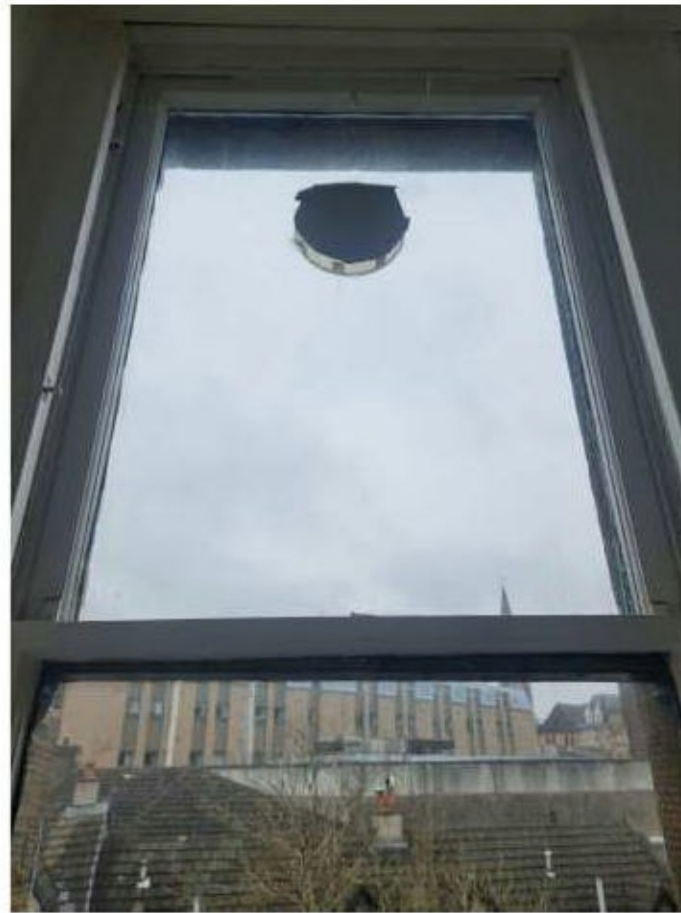
Window is badly out of alignment which is furthering the issue with wind and water entering the property. The second photo is of a fan in the window which would be removed when replacing the windows.

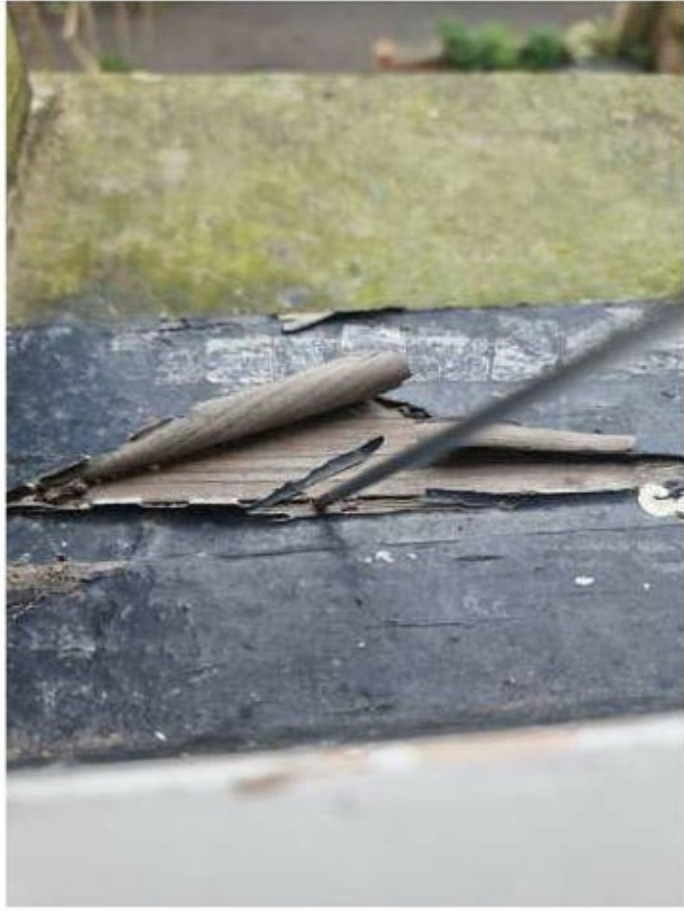
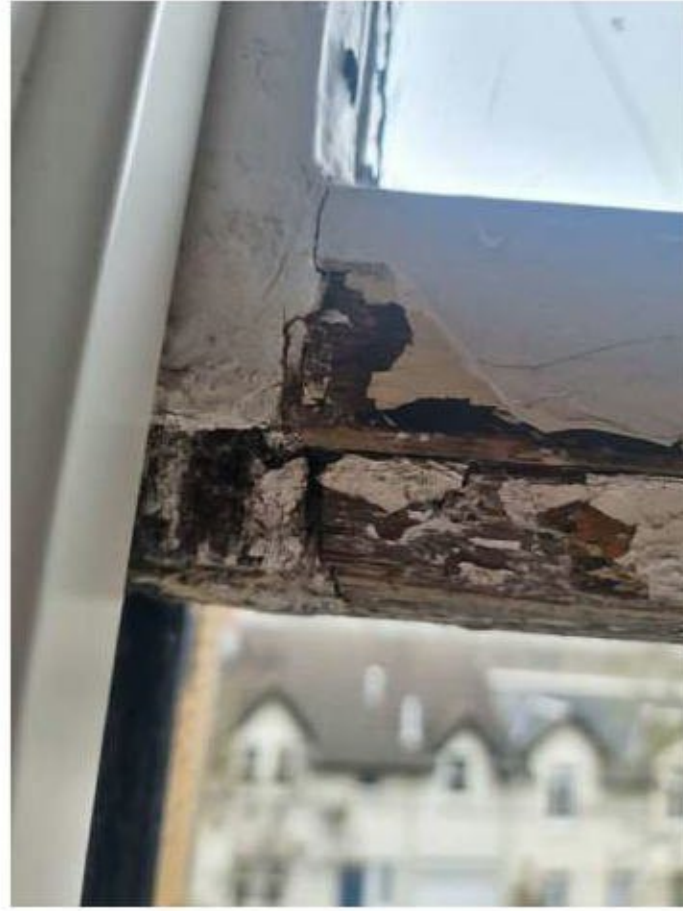
Rotting sill and tenon joint woodwork.

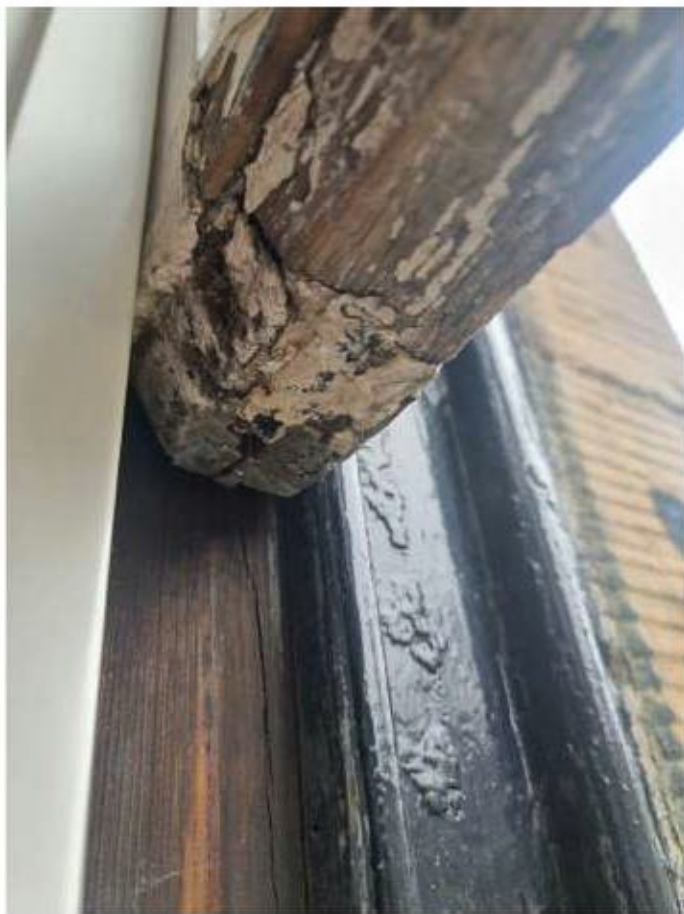
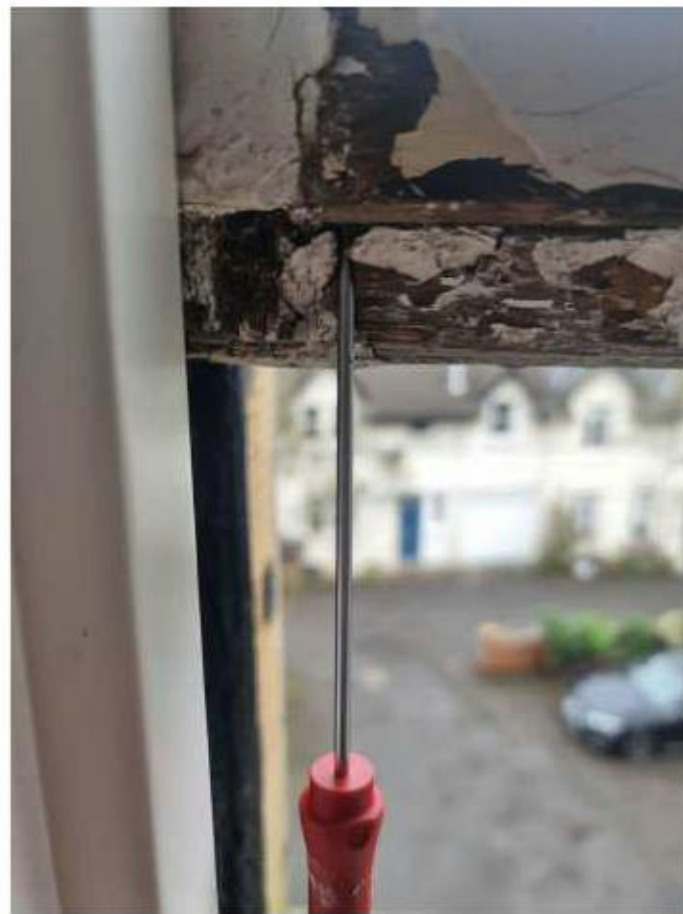
Rotting tenon joint and bottom rail.

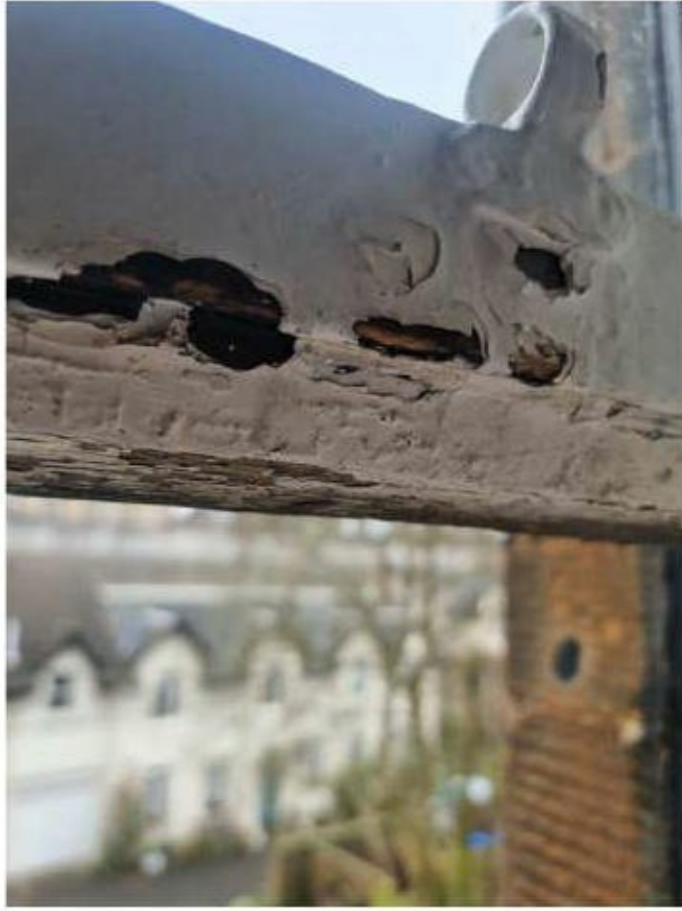
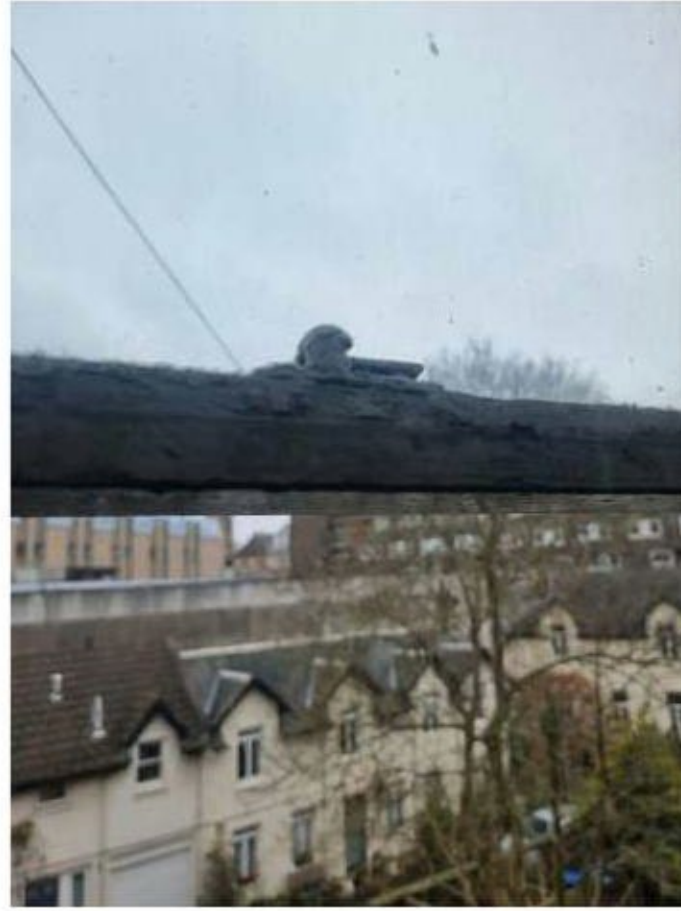
Rotting bottom rail and deteriorating mid-rail.

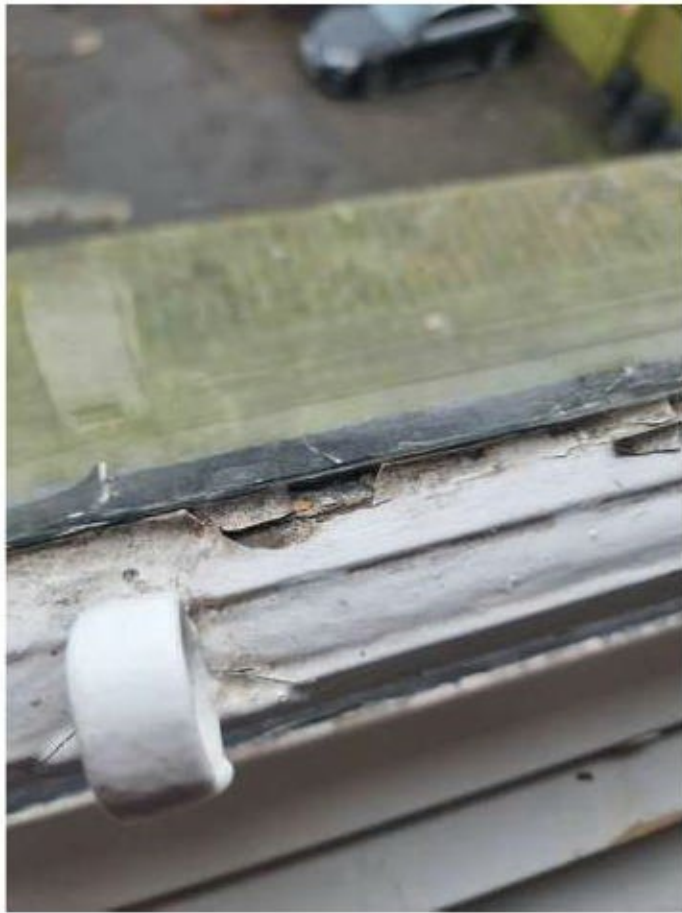
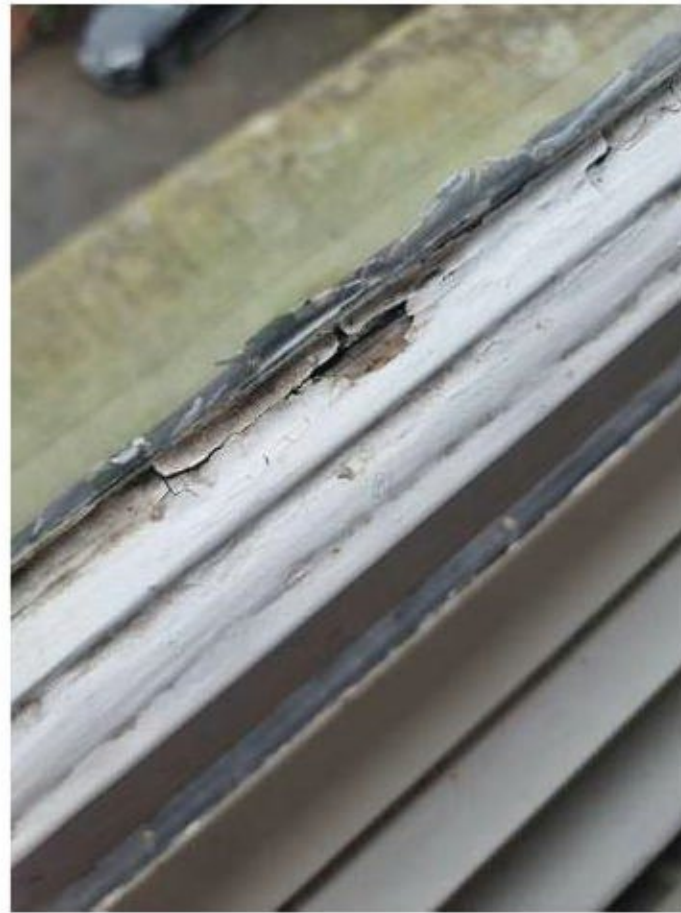
Seals and putty are coming away from the glass and deteriorating in areas. This is allowing water to penetrate the bare woodwork.

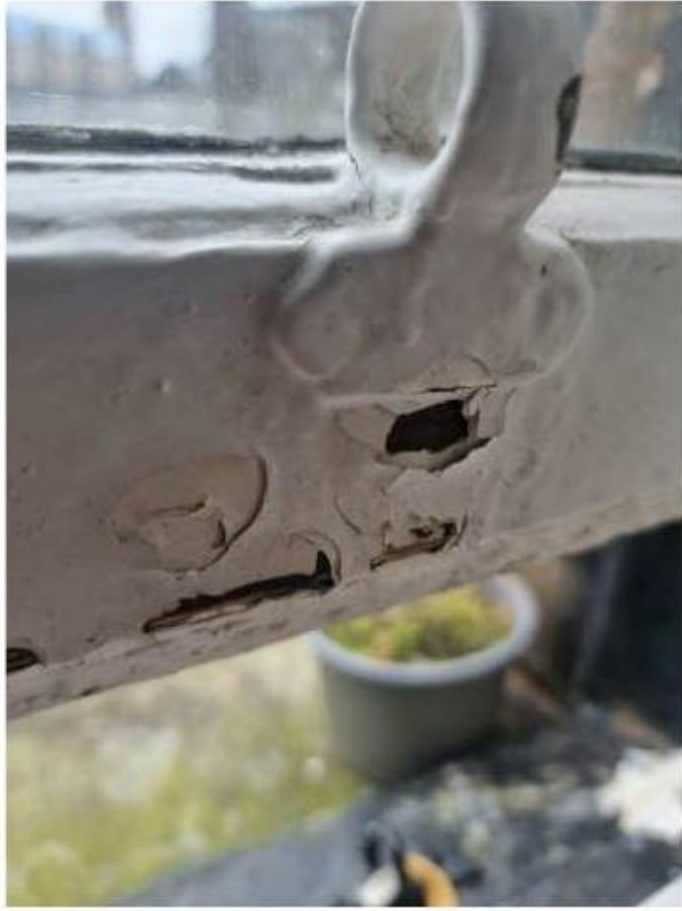
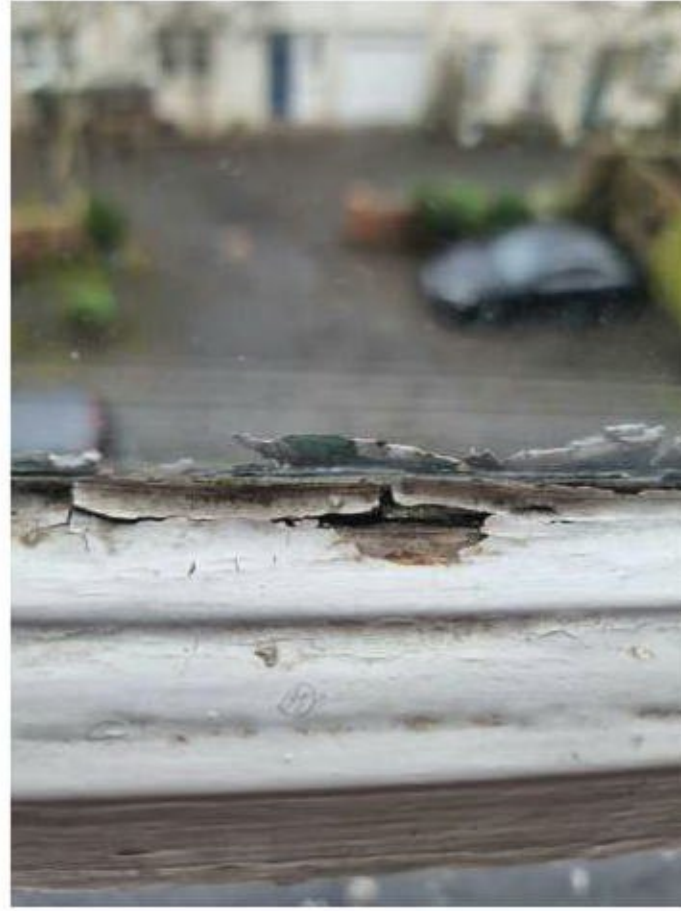
Rotting bottom rail woodwork.

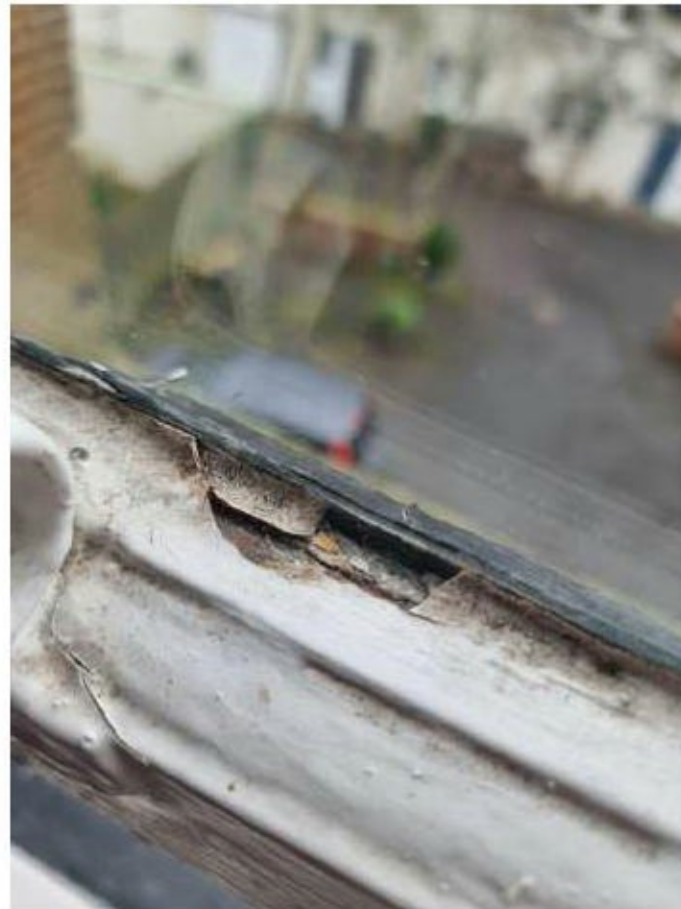
Seals are coming away from the glass.

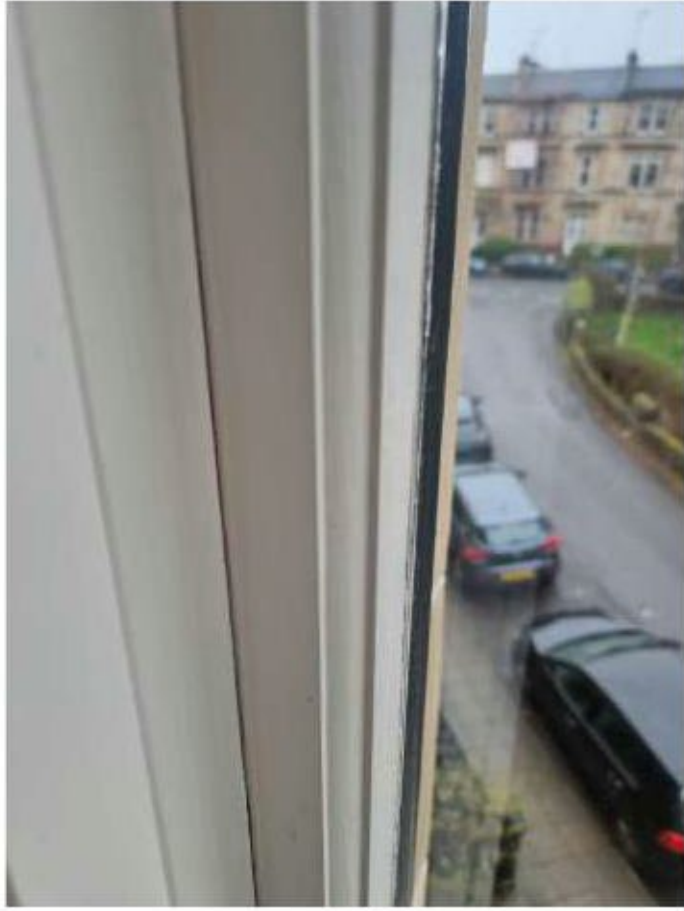
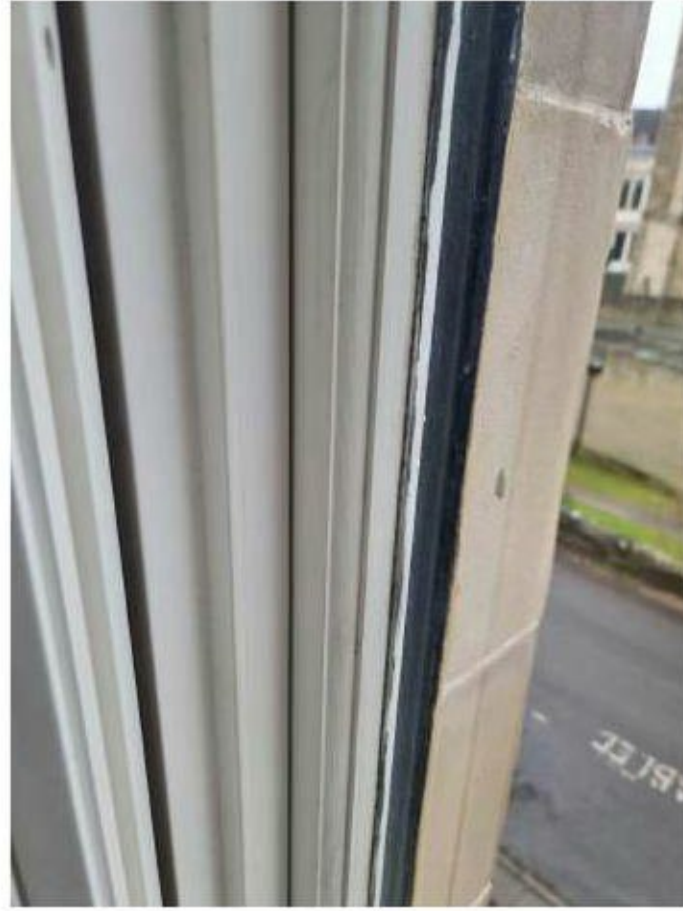
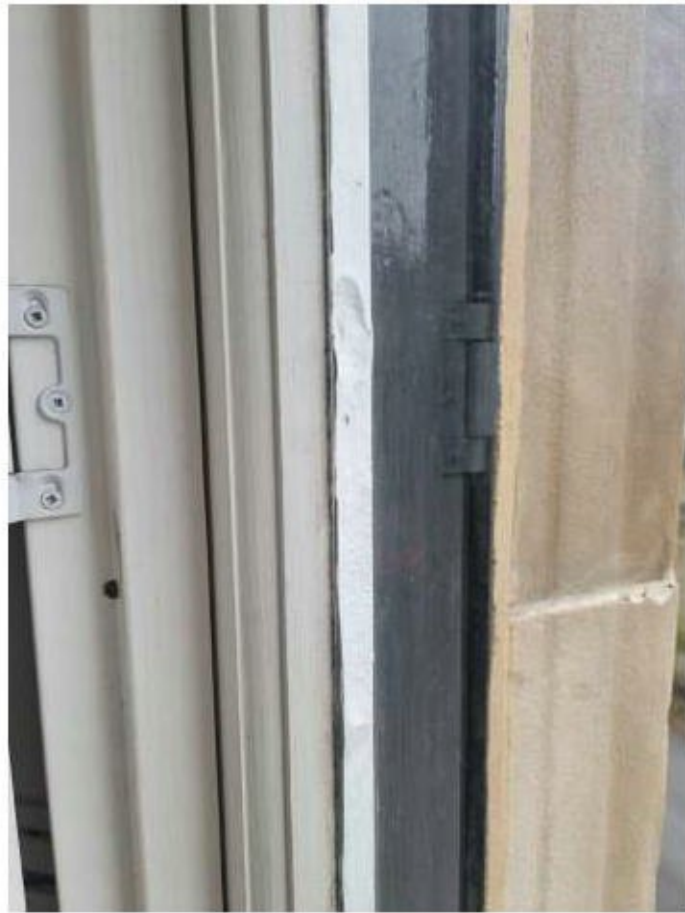
The bottom sashes appear to have already been replaced on two of the windows on the front elevation.
