AJP/23/057  
20 July 2023

**Garnhams Farmhouse, Tannington.  
Engineers Report.**

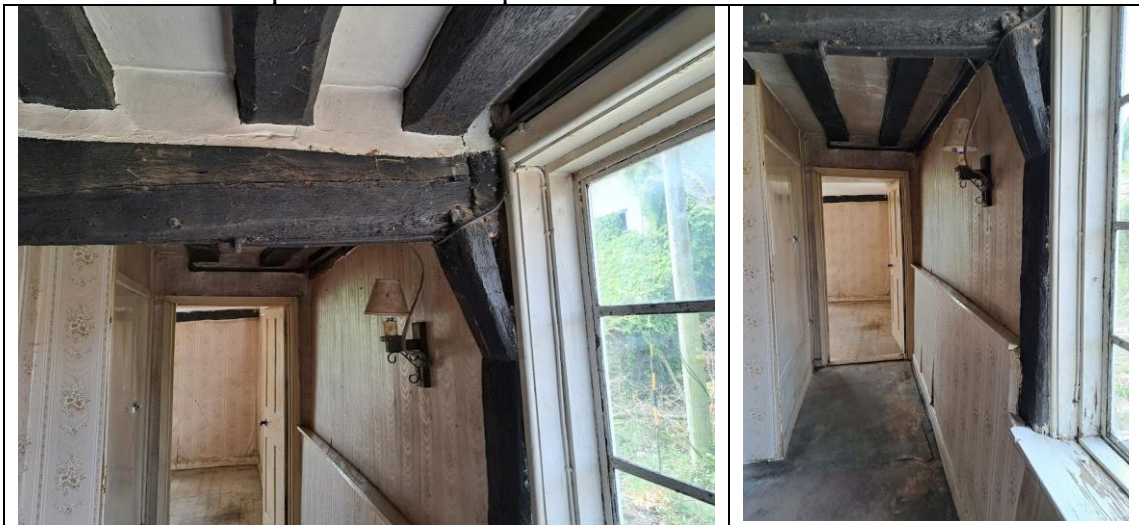
- a). The floor beam connection to post has pulled away and the post foot and plinth lean outwards. The plinth cill board tips outwards.

- a) The beam/post connection will require strapping in order to both improve the vertical support for the beam and prevent further outward movement of the wall. The outward leaning plinth required further investigation to check for sole plate decay. Remedial action such as buttressing of the plinth or local re-building may be necessary.

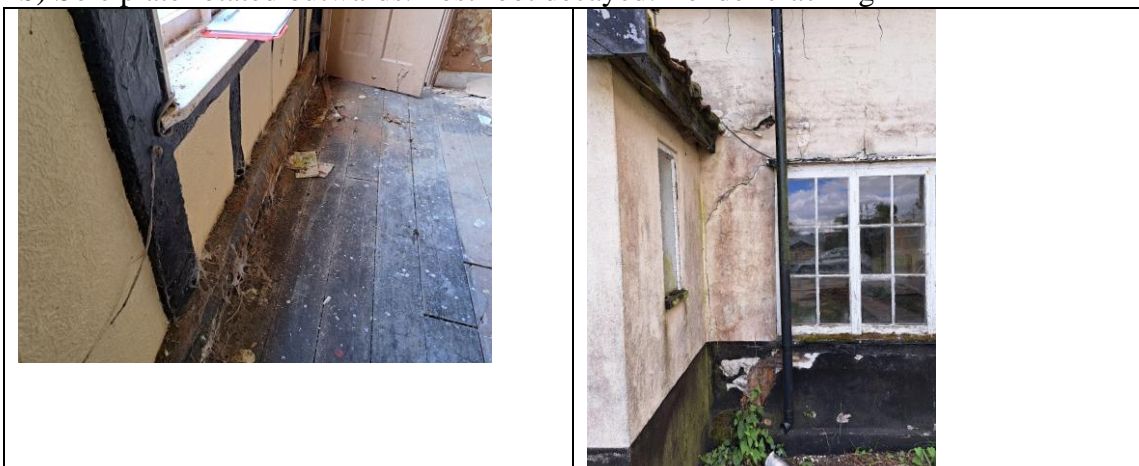
- b) Sole plate rotated outwards. Post foot decayed. Render cracking

- b) c) & k) Decay timbers should be cut back to sound and replaced with new timber (probably green oak) to match using traditional scarfed or lapped joints.

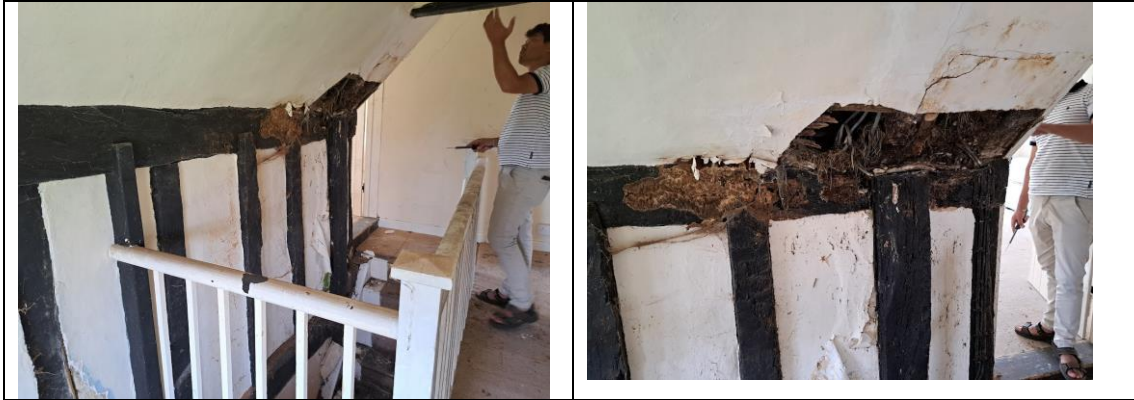
c) Rainwater ingress at base of valley. Wall plate/rafters/post decayed.

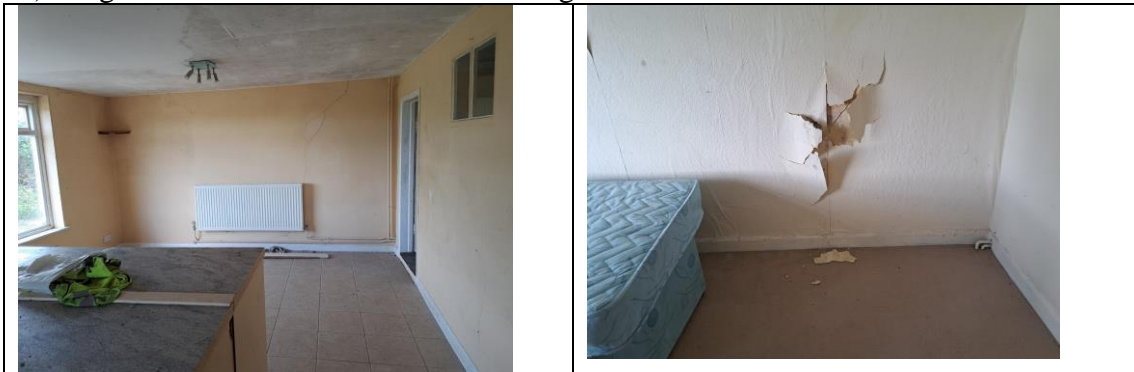
d) Diagonal crack in external wall at both ground floor & 1<sup>st</sup> floor level.

- d) & g) Cracking of plaster/render is associated with differential foundation movement. It is likely that foundations at the north end have been influenced by vegetation growing close to the building. The probe test at MP2 also revealed relatively soft soil extending beneath the footing. The degree of movement is not excessive and it is likely that the clearance of overgrown vegetation along with improvement of rainwater drainage will reduce movement to acceptable levels. We can't be sure that further movement will not cause slight cracking of finishes without long term monitoring, but the need for improvement of foundations is currently not proved.

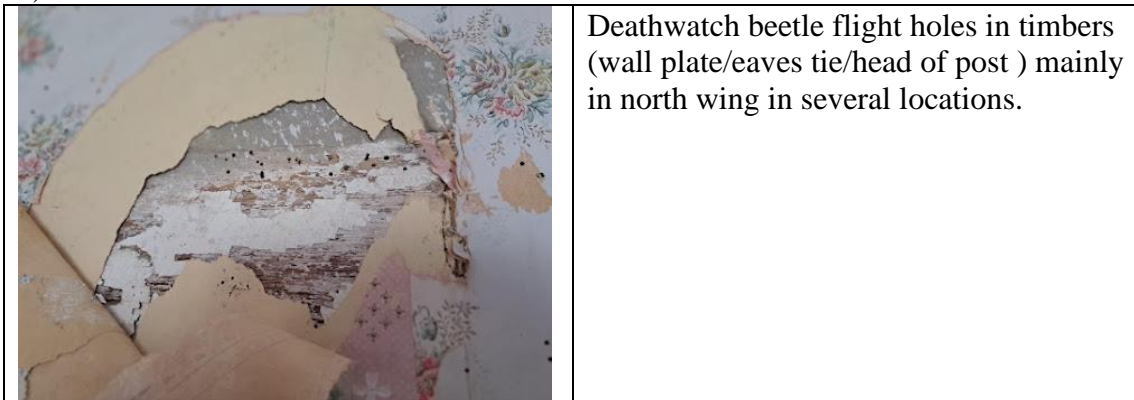
- e) The deathwatch beetles do not appear to have caused structural weakening of timbers. Testing with a steel point indicates that the timbers remain generally sound, but deathwatch can eat out the heart of a section while leaving the surface intact. Hence further inspection by specialists to check for live activity and drilling to check for decay at depth is recommended.

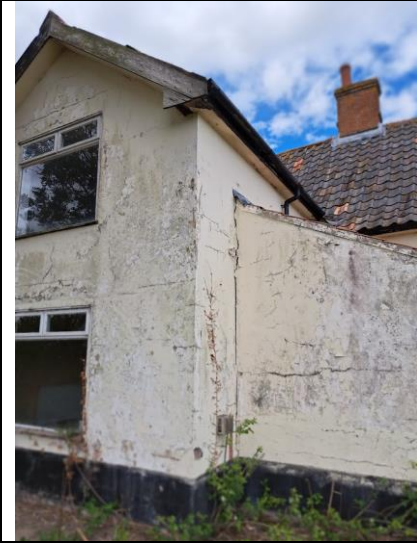
g)

Vertical crack between lean-to extension and 2 storey extension. Crack open at top.

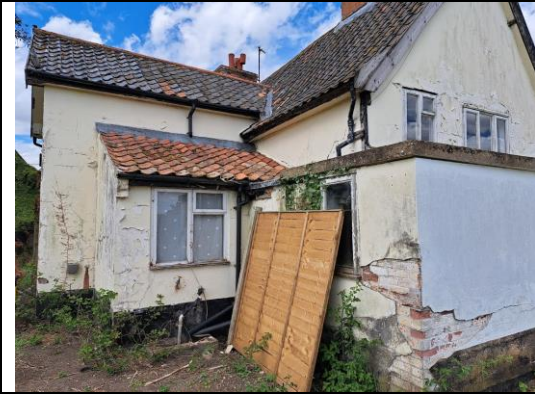
Render generally suffering minor cracking/detachment. Cement render.

- f) Local repair of plinth brickwork is required. Traditional brick repairs using lime mortar and bricks to match.
- g) See d) above
- h) The cement render is relatively rigid on the flexible timber structure. Replacing with a softer lime render is recommended. That will also give access to the outer face of timbers for treatment/repair.

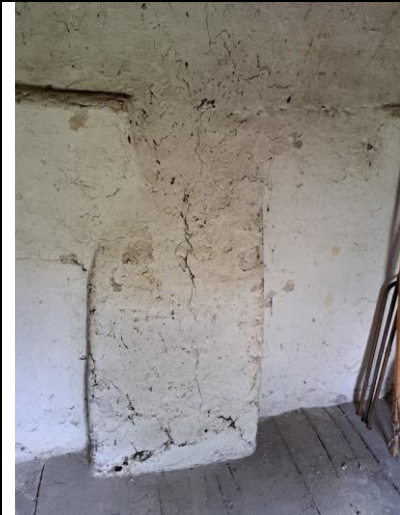
Old vertical crack in side of chimney.

- i) Not used
- j) The old chimney cracking is relatively minor and occurs at a common position between flues. Cracks should be stitched using traditional techniques.

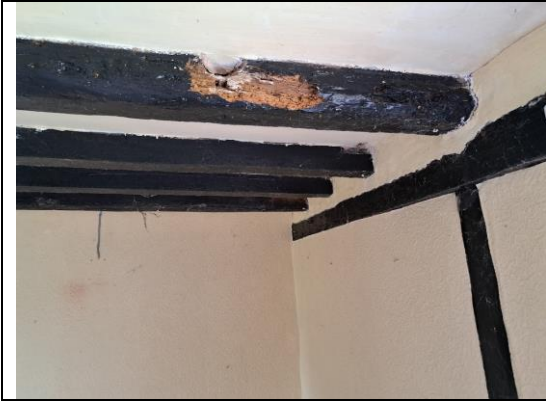
k)

Joist decayed. Furniture beetle attack. Timbers painted black may conceal further decay.

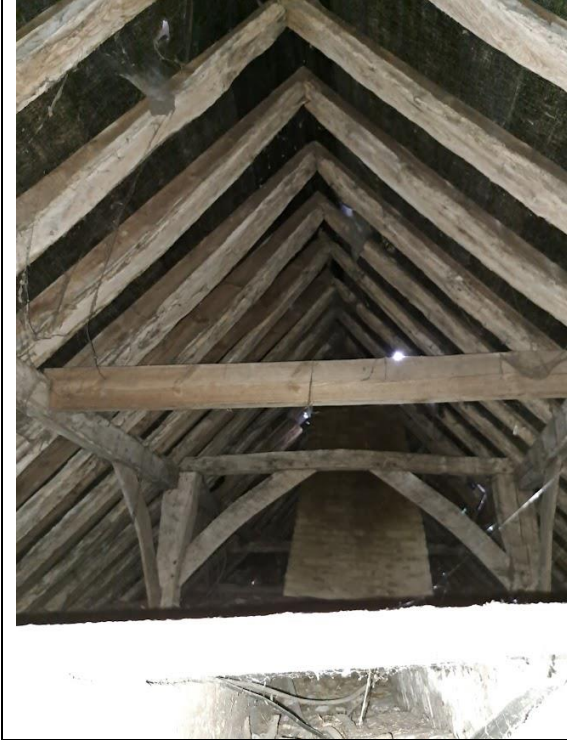
l)

Roof structure has restricted access. No access to east wing roof. Timbers appear sound and well proportioned where visible.

- k) The restricted roof access should be improved for thorough inspection of the roof timbers, but the initial restricted inspection indicates timbers are sound.

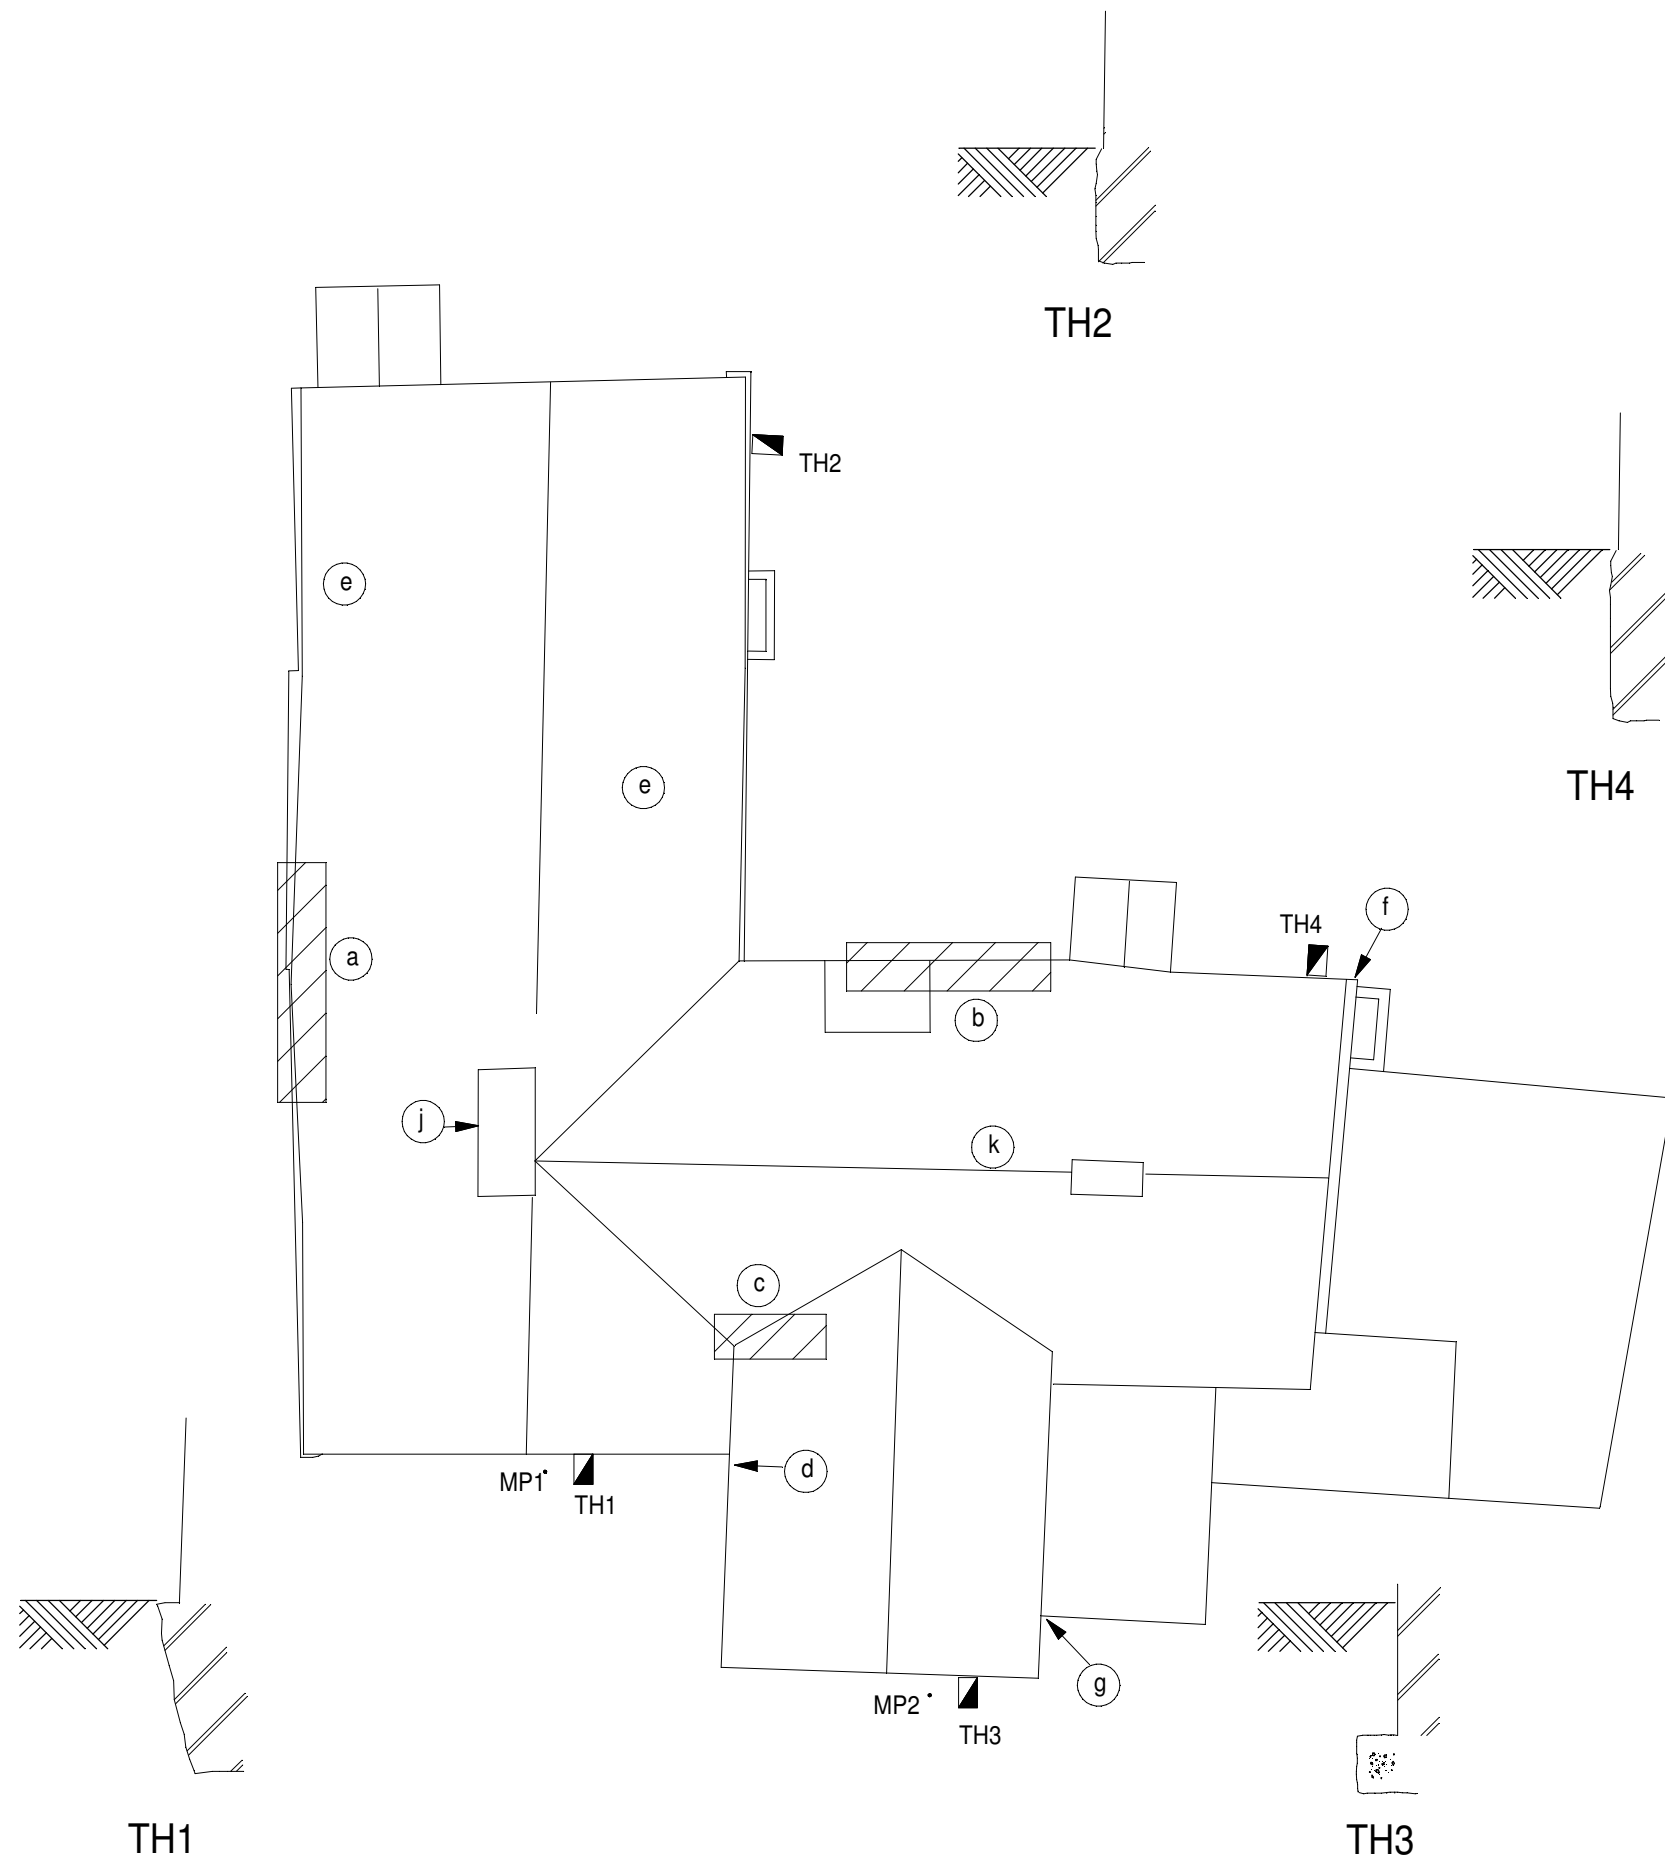
The trial holes reveal traditional shallow brick footings to the main parts, founded at depths of between 0.3-0.45m below ground level in sandy clay subsoil. The later south extension (TH3) has a shallow concrete strip footing founded at 0.45m depth. Probe tests indicate that the soil adjacent TH3 is relatively soft at depths between 0.6-1.0m below ground level.
