Kings Arms, Old Street Haughley, Suffolk

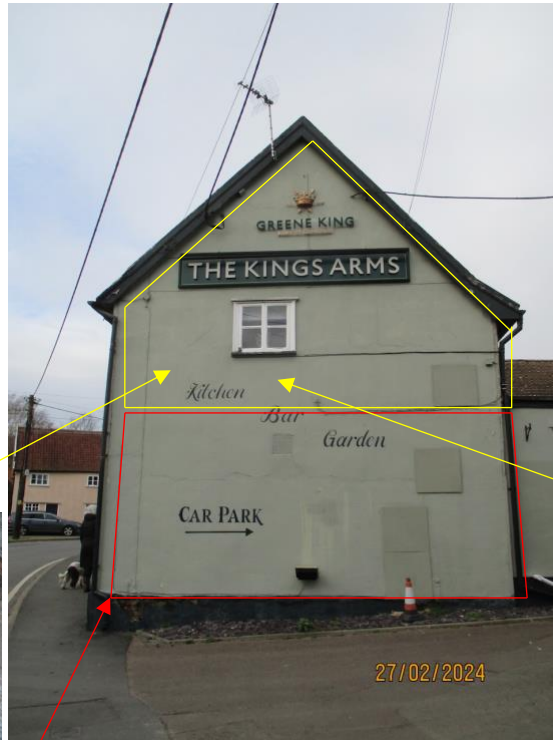
C1980 modern timber framing (yellow outline)

rotting frame under window

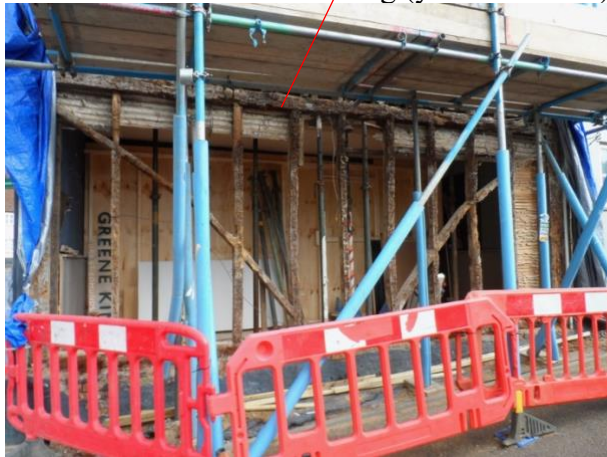
Section of remaining historic timber framing (outline in red above)

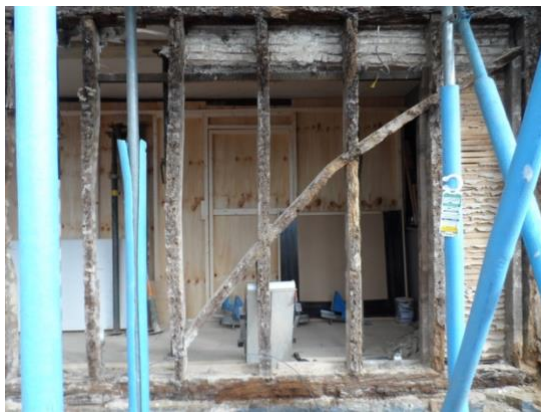
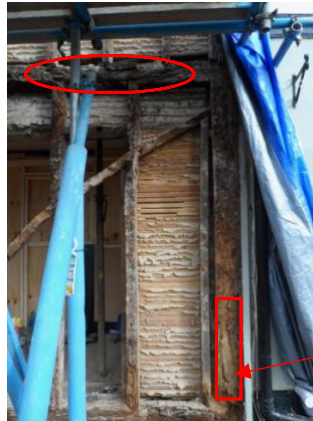
R/H degraded framing to be retained and new frame inserted to support. Red areas marks section of mid rail and base of corner post to be replaced. Remaining mid rail to be retained

with new oak timbers fixed on three sides to provide structural integrity. Remaining corner post to be retained with no additional works required.

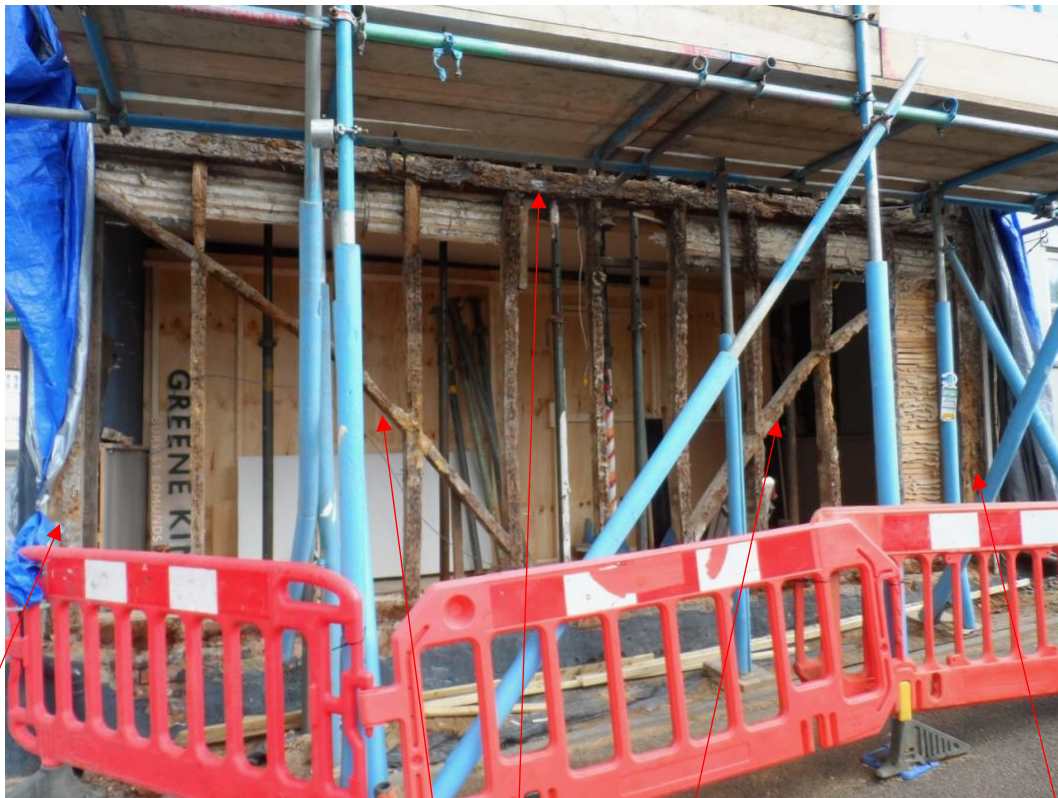
L/H corner post.

Mid rail

R/H corner post

Diagonal brace left and right hand

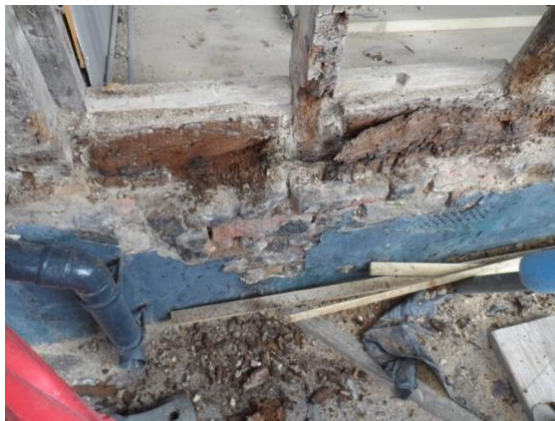
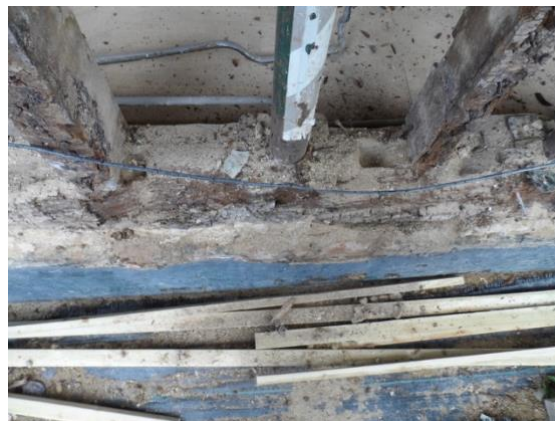
Existing sole plate 75% decayed - plate to be replaced in its entirety. Existing studwork to be tenoned into new sole plate where possible. In all other cases, existing studwork will be supported by new inter-framing (see annotated photo below)

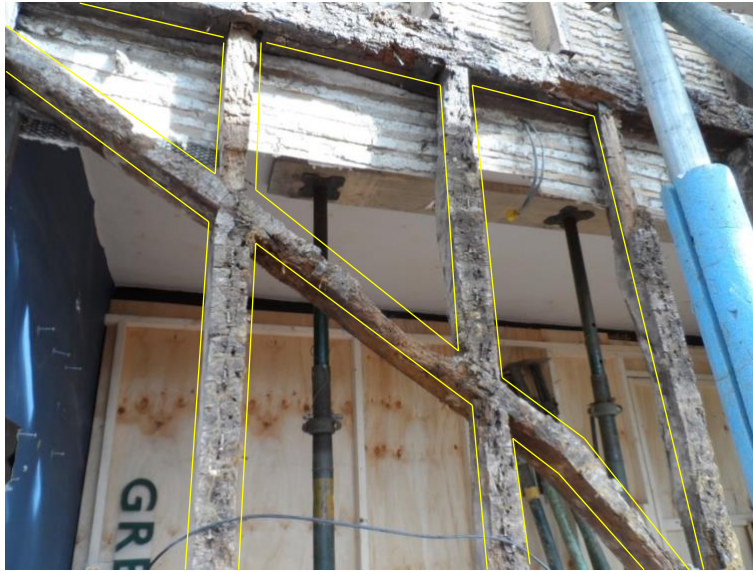
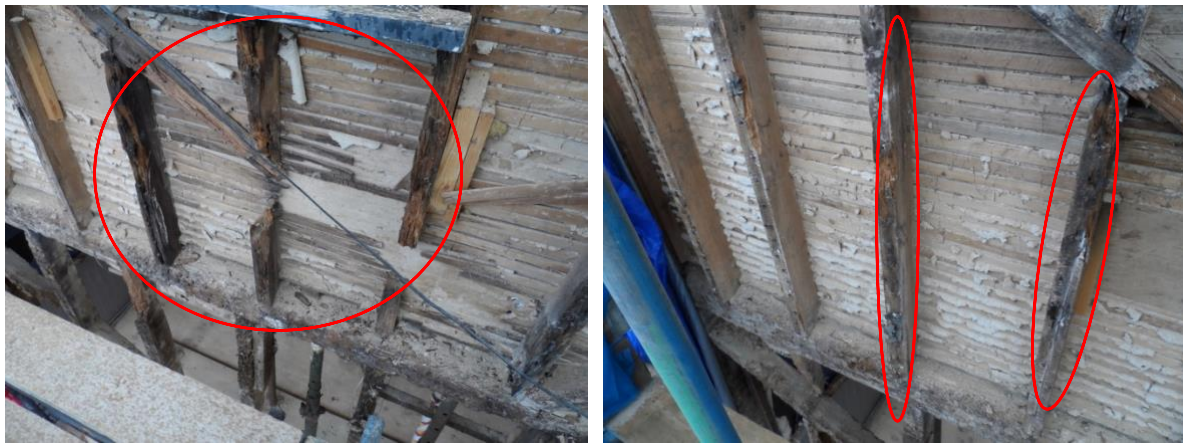
Sections of modern framing below and left of FF window to be replaced using soft wood.

All repairs to corner post, sole plate and mid-rail to be in oak, inter-framing and repairs to FF framing to be in new softwood. Due to the existence of fungal spores, all existing timbers to be treated with Five Start wood preservative as a precaution. New soft wood is pre-treated at production stage. As per approved application details, repaired frame to be over clad with new timber lathing ready to take new lime render. New lime render to be of minimum three coats. Materials supplied by ALC, ANGLIA LIME COMPANY product ready mixed FINELime.
