The Forge, Chillenden, Kent, CT3 1PS

Structural Inspection Report

September 2023

A9853

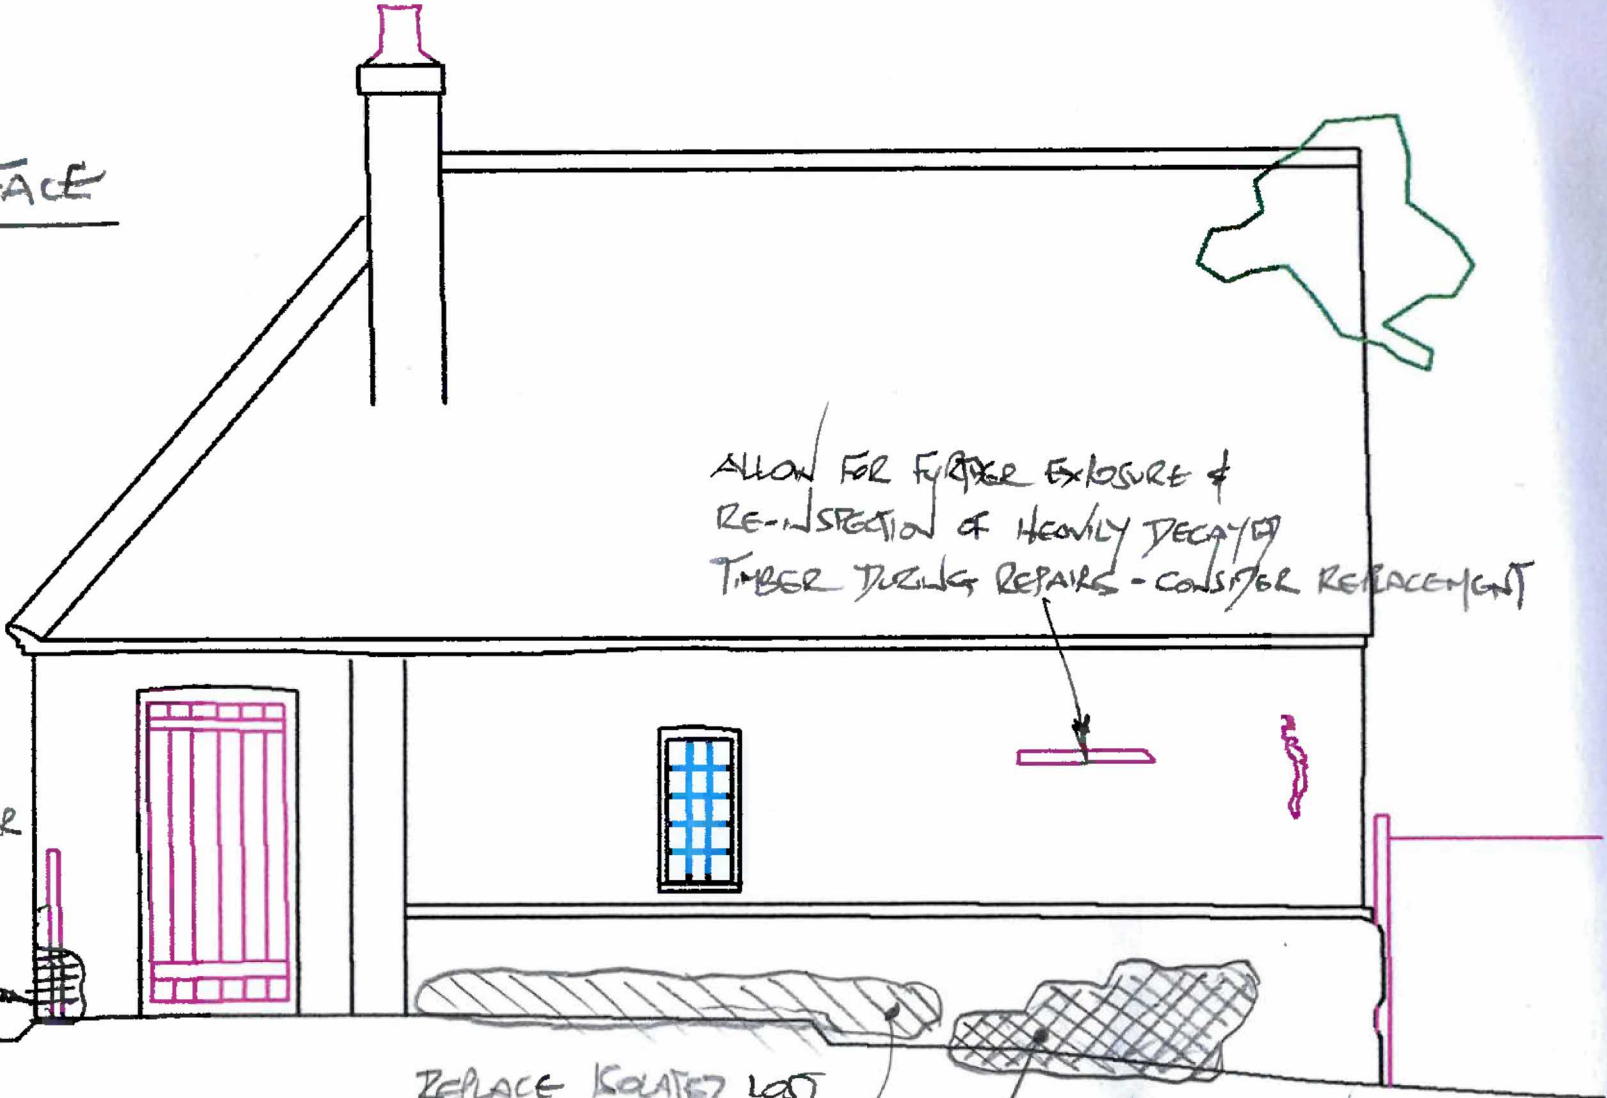
WEST FACE

ALLOW FOR FURTHER EXPOSURE &
RE-INSPECTION OF HEAVILY DECAYED
TIMBER TRUSS REPAIRS - CONSIDER REPLACEMENT

REPOINT CORNER
& REPLACE
3 BRICKS

REPLACE KILN DRIED
BRICKS AT BASE

RECONSTRUCT SIGNIFICANT
LOST BRICKWORK NEAR BASE
