Hydrock Wingates Industrial Estate, Bolton

Ground Investigation Report

For Harworth Estates Property Group Limited

Doc ref:
 15592-HYD-XX-XX-RP-GE-0001

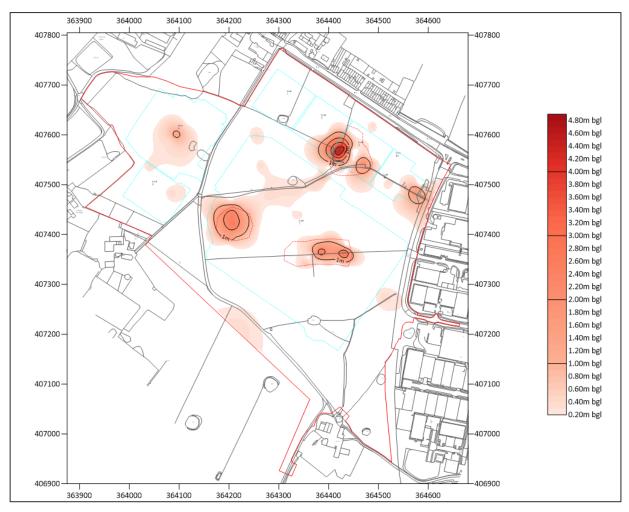
Figure 5-1: Contour plot showing the base of Made Ground (m bgl) includes Hydrock and RSK data. Three landfill areas are also outlined in red.

The material encountered in the northern landfill can generally be described as very soft dark grey and brown slightly clayey slightly sandy gravelly silt or clay with a low to medium cobble content of brick, with bundles of hay, ash, wood, metal, rebar, plastic bags and plastic fragments and glass. Gravel is angular to subrounded fine to coarse of sandstone, coal, concrete, and brick fragments. A strong organic odour from the material was noted.

The material encountered in the central west landfill can generally be described as soft to firm brown sandy gravelly clay with a medium cobble content of sandstone, brick, and tarmacadam, with metal, plastic, timber, carpet fabric, glass and rare pieces of burnt wood. Gravel is angular to subrounded fine to coarse of siltstone, coal, and brick fragments

The material encountered in the central landfill can generally be described as dark brown slightly sandy slightly gravelly silt or sandy gravelly clay with a low boulder content and some fine rootlets. Gravel is angular to subangular fine to coarse of sandstone, coal, brick and rare ceramic fragments.

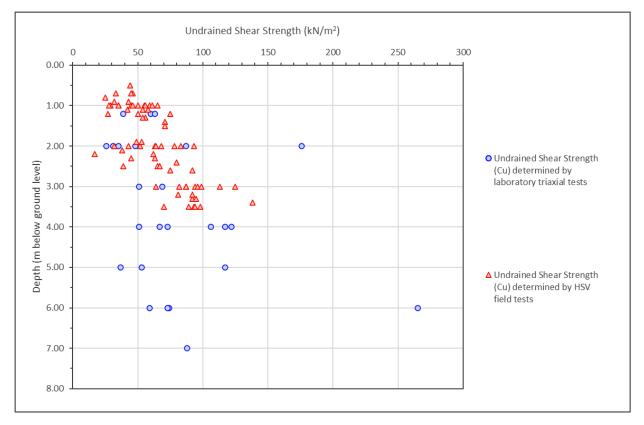
Figure 5-4: Glacial Till undrained shear strength (kN/m²) vs Depth (m bgl)

Figure 5-4 presents the variation in undrained shear strength of the Glacial Till with depth (m bgl) taken from hand vane field tests and laboratory triaxial testing.

Figure 5-4 shows the gradual increase in undrained shear strength with depth in the Glacial Till. Shear strength in the upper 2.0m is shown to range typically between 25 and 60kN/m², and below 3.0m shear strength is shown to range between approximately 50 and 125 kN/m².
