**LBC
Survey**

Address:
33 Upper Gray Street,
Edinburgh, EH9 1SN

Grade B Listed Property

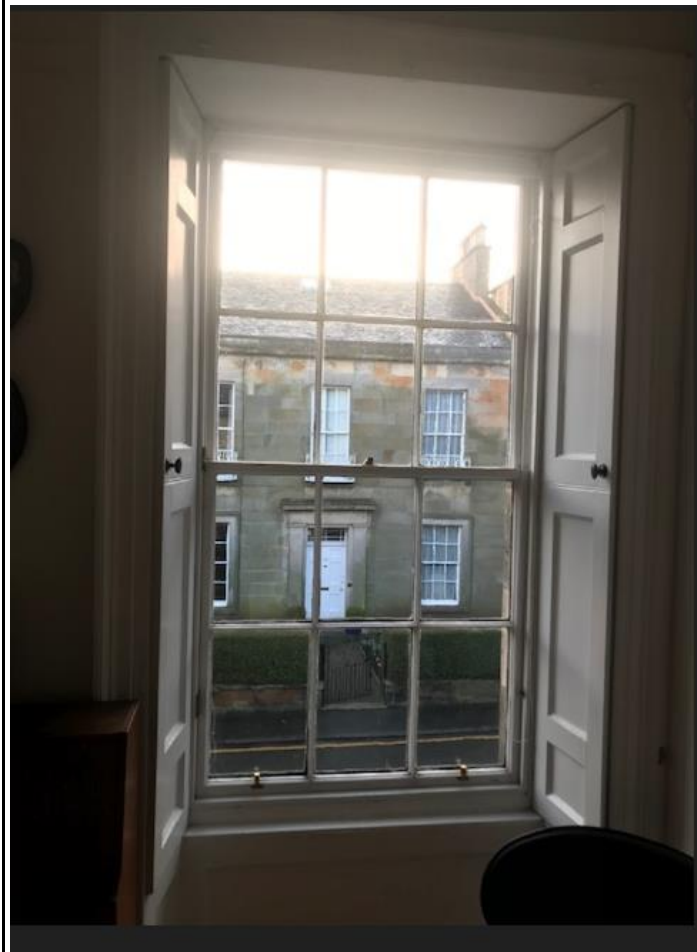
W1 – Lounge Right

Currently 6 over 6 style

- Cracking along glue lines of mortise and tenon joinery indicative of excessive movement
- Cill completely rotten
- External paint and putty has been breached
- Condensation damage to horizontal rails
- Window heavily overpainted

Replacement of existing 6/6 style sashes on a like-for-like basis with new custom fitted 14mm IGU's.

Existing casement to be retained and refurbished.

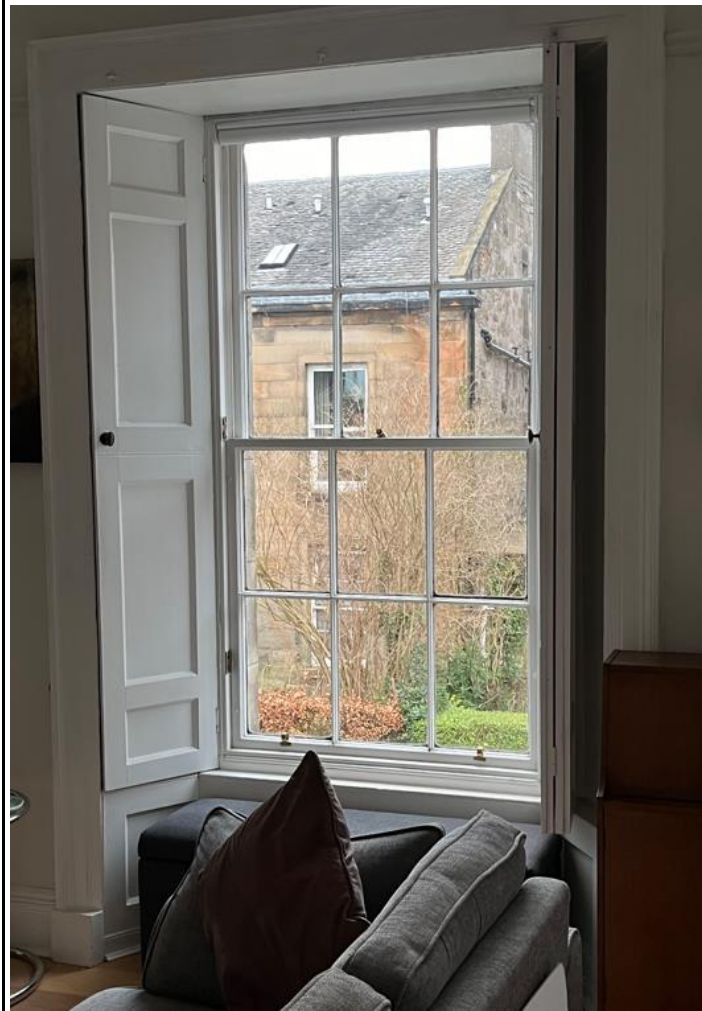
W2 – Lounge Middle

Currently 6 over 6 style

- Cracking along glue lines of mortise and tenon joinery indicative of excessive movement
- Cill completely rotten
- External paint and putty has been breached
- Condensation damage to horizontal rails
- Window heavily overpainted

Replacement of existing 6/6 style sashes on a like-for-like basis with new custom fitted 14mm IGU's.

Existing casement to be retained and refurbished.

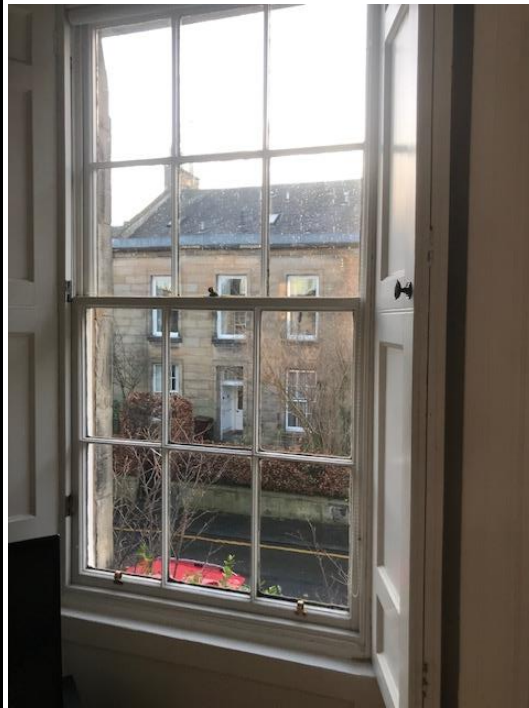
W3 – Lounge Left

Currently 6 over 6 style

- Cracking along glue lines of mortise and tenon joinery indicative of excessive movement
- Cill completely rotten
- External paint and putty has been breached
- Condensation damage to horizontal rails
- Window heavily overpainted

Replacement of existing 6/6 style sashes on a like-for-like basis with new custom fitted 14mm IGU's.

Existing casement to be retained and refurbished.

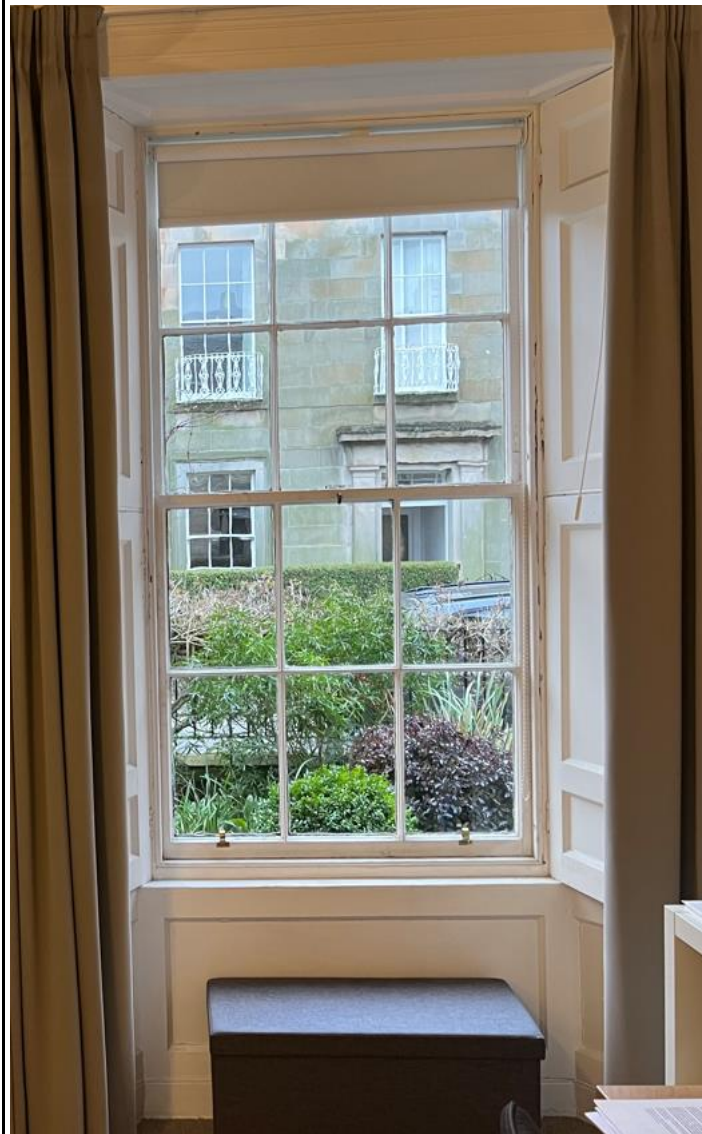
W4 – Ground Floor Right

Currently 6 over 6 style

- Cracking along glue lines of mortise and tenon joinery indicative of excessive movement
- External paint and putty has been breached
- Slight rot in astragal
- Window heavily overpainted

Replacement of existing 6/6 style sashes on a like-for-like basis with new custom fitted 14mm IGU's.

Existing casement to be retained and refurbished.

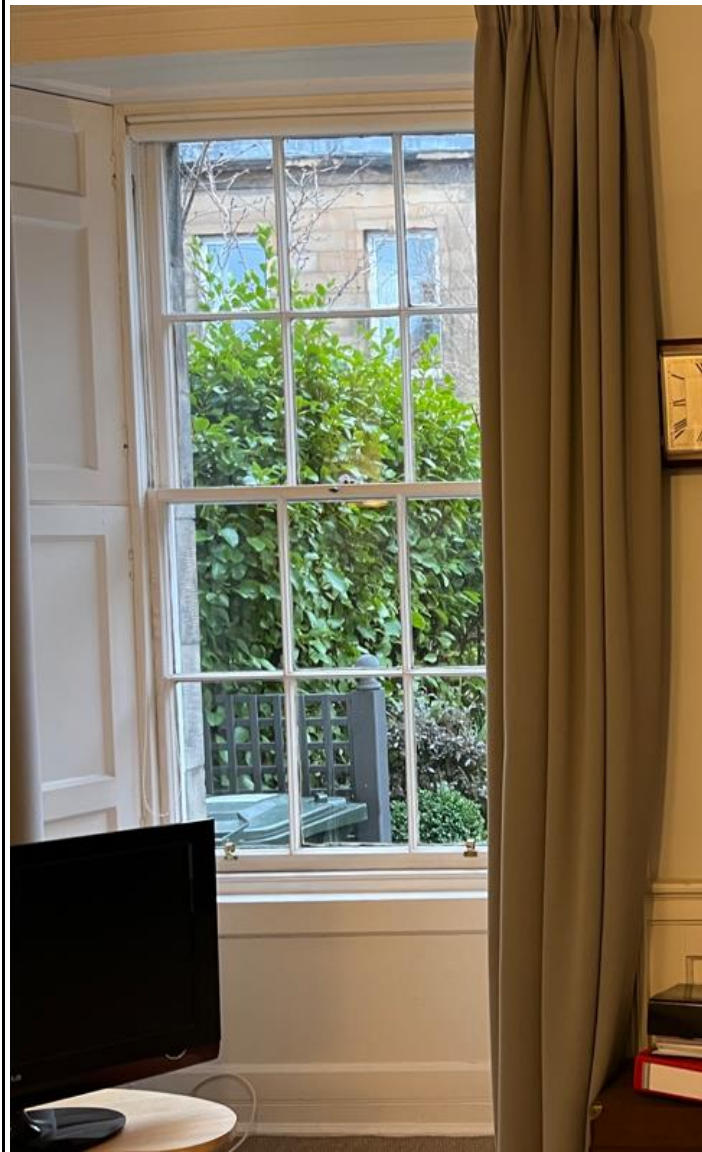
W5 – Ground Floor Left

Currently 6 over 6 style

- Cracking along glue lines of mortise and tenon joinery indicative of excessive movement
- External paint and putty has been breached
- Window heavily overpainted

Replacement of existing 6/6 style sashes on a like-for-like basis with new custom fitted 14mm IGU's.

Existing casement to be retained and refurbished.
