## 2313 - PD - 5200

### Schedule of works to existing doors

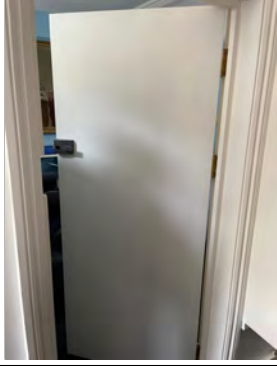
| Door no | Photograph | Proposals |
|---|---|--|
| DG11 | | Modern hollow core door fouls floor finishes. Door to be replaced with a timber panelled door too match adjacent doors |

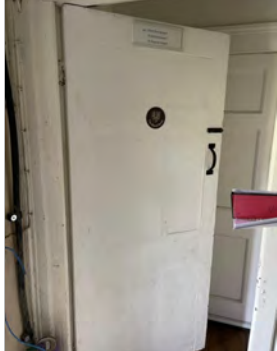
| Door no | Photograph | Proposals |
|---|---|--|
| DG17 | | Door sticks within frame. Door edges to be planed to restore smooth operation |

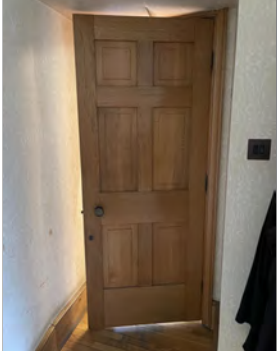
| Door no | Photograph | Proposals |
|---|---|---|
| DG49 | | Door sticks within frame. Door edges to be planed to restore smooth operation |

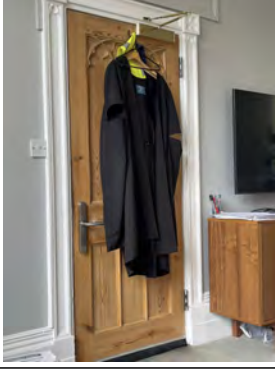
| Door no | Photograph | Proposals |
|---|---|---|
| DF2 | | <p>Splits to top of side rails to be filled with resin</p> <p>Door to be upgraded to improve fire performance:</p> <ul style="list-style-type: none"> <li>-Intumescent paint applied to both sides of leaf</li> <li>-Intumescent card to be applied to panels</li> <li>-Smoke seals and intumescent strips routed into frame</li> <li>-Modifications to frame and rebate to close gaps between the leaf and the frame</li> <li>-Fire door signage added</li> <li>-Closer added</li> <li>-Door eased and adjusted</li> </ul> |

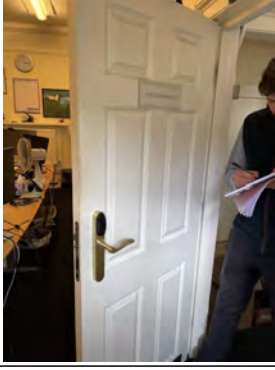
| Door no | Photograph | Proposals |
|---|---|---|
| DF5 | | <p>Make good damage to timber frame</p> <p>Door to be upgraded to improve fire performance:</p> <ul style="list-style-type: none"> <li>-Intumescent paint applied to both sides of leaf</li> <li>-Intumescent card to be applied to panels</li> <li>-Smoke seals and intumescent strips routed into frame</li> <li>-Modifications to frame and rebate to close gaps between the leaf and the frame</li> <li>-Fire door signage added</li> <li>-Closer added</li> <li>-Door eased and adjusted</li> </ul> |

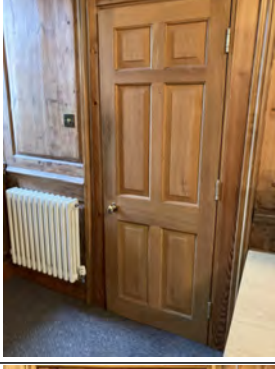
| Door no | Photograph | Proposals |
|---|---|---|
| DF10 | | <p>Door catches on carpet. Plane base of door to ensure it opens freely</p> |

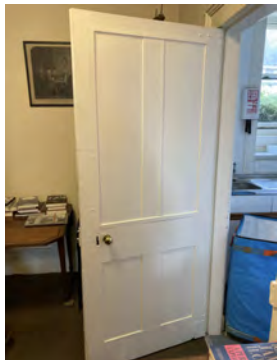
| Door no | Photograph | Proposals |
|---|---|--|
| DF37 | | Previous ironmongery holes poorly filled. Remove poor filling and repairs and splice in new timber where required |

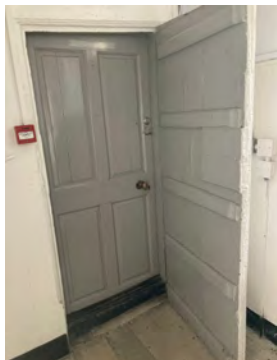
| Door no | Photograph | Proposals |
|---|---|--|
| DF38e | | Door catches floor finish. Plane door base to ensure free movement |

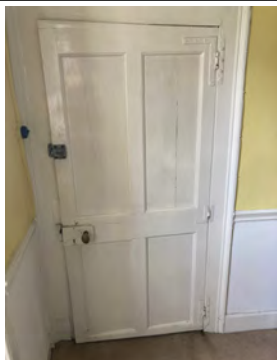
| Door no | Photograph | Proposals |
|---|---|--|
| DF38i | | Fill 2no. splits to top panels with resin<br><br>Door to be upgraded to improve fire performance:<br>-Intumescent paint applied to both sides of leaf<br>-Smoke seals and intumescent strips routed into frame<br>-Modifications to frame and rebate to close gaps between the leaf and the frame<br>-Fire door signage added<br>-Closer added<br>-Door eased and adjusted |

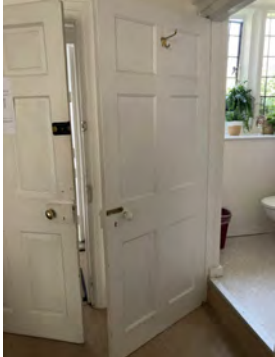
| Door no | Photograph | Proposals |
|---|---|---|
| DF42 | | <p>Door catches to top of frame. Plane door to fit correctly.</p> <p>Door to be upgraded to improve fire performance:</p> <ul style="list-style-type: none"> <li>-Intumescent paint applied to both sides of leaf</li> <li>-Smoke seals and intumescent strips routed into frame</li> <li>-Modifications to frame and rebate to close gaps between the leaf and the frame</li> <li>-Fire door signage added</li> <li>-Closer added</li> <li>-Door eased and adjusted</li> </ul> |

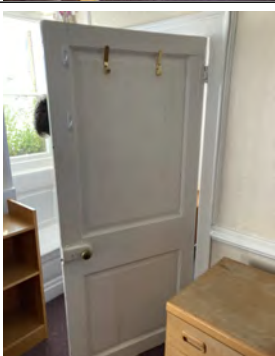
| Door no | Photograph | Proposals |
|---|---|---|
| DF46 | | <p>Door catches on floor. Plane underside of door to ensure smooth operation</p> |

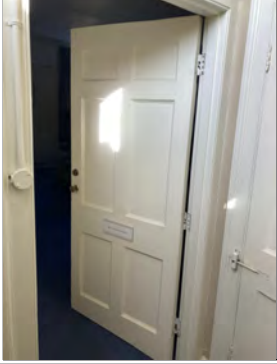
| Door no | Photograph | Proposals |
|---|---|---|
| DS2 | | Resin fill 3no. redundant fixing holes to door. Door catches on floor. Plane underside of door to ensure smooth operation/<br><br>Door to be upgraded to improve fire performance:<br>-Intumescent paint applied to both sides of leaf<br>-Smoke seals and intumescent strips routed into frame<br>-Modifications to frame and rebate to close gaps between the leaf and the frame<br>-Fire door signage added<br>-Closer added<br>-Door eased and adjusted |
