Pembroke College, Old Quad Oxford

Structural Engineering Summary For Planning

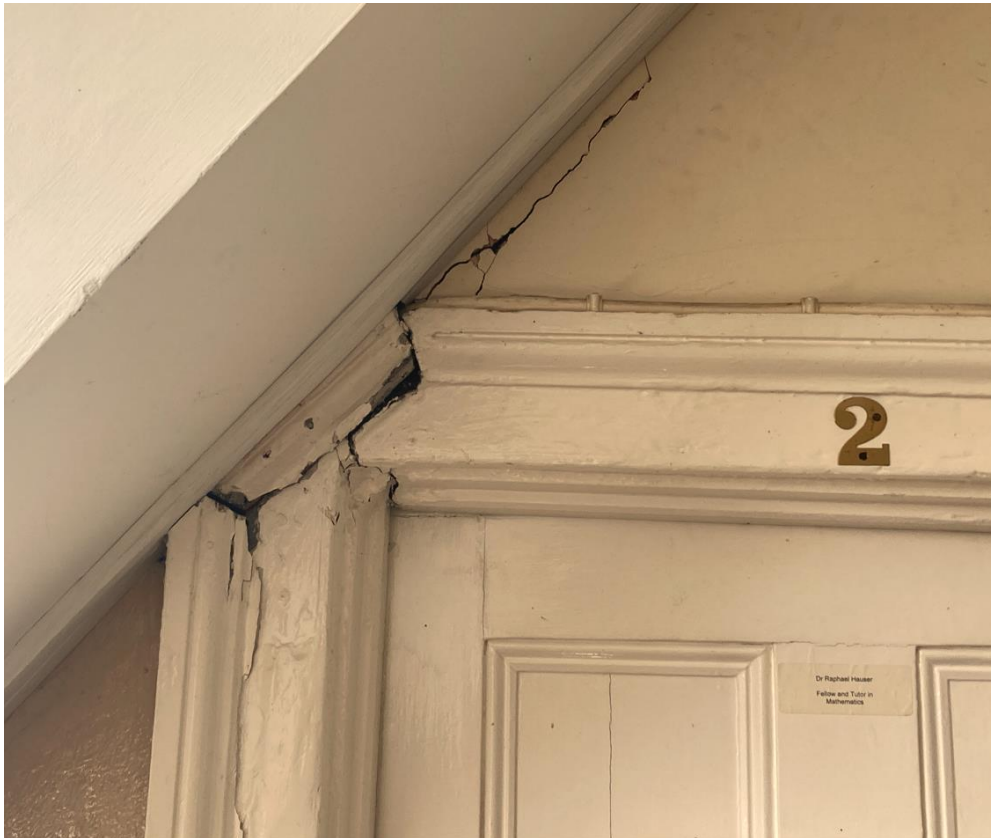
Photograph 1: Cracking above Room 2 on the 2nd floor of Staircase 1

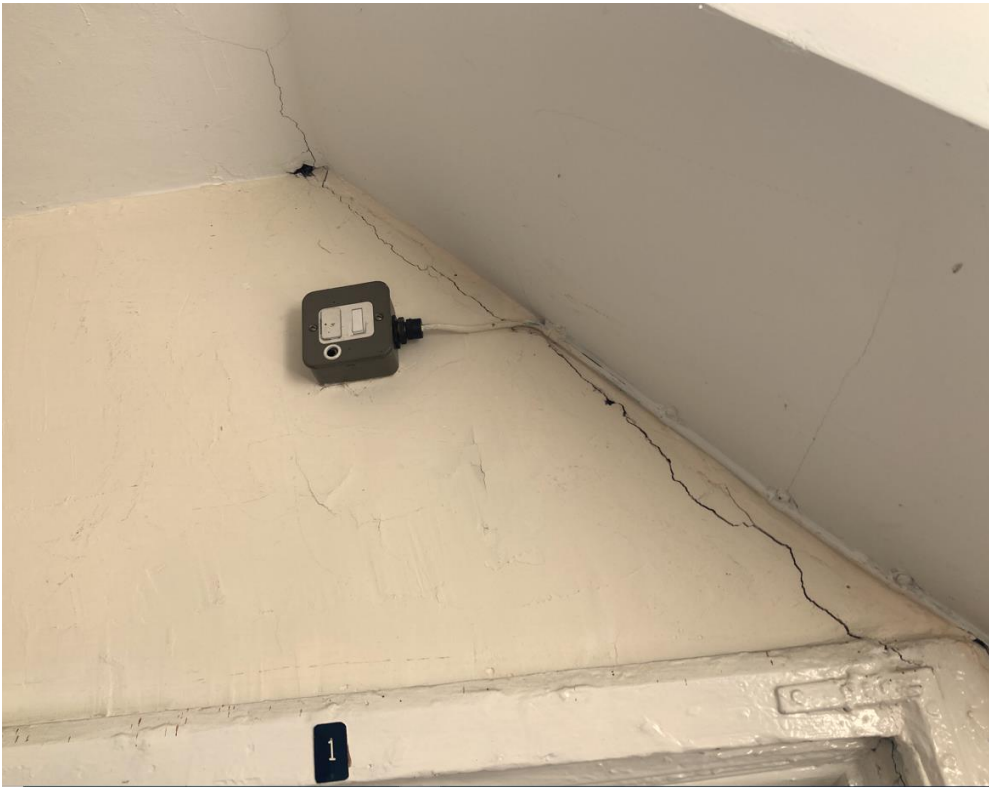
Photograph 2 Crack above door of Room 1

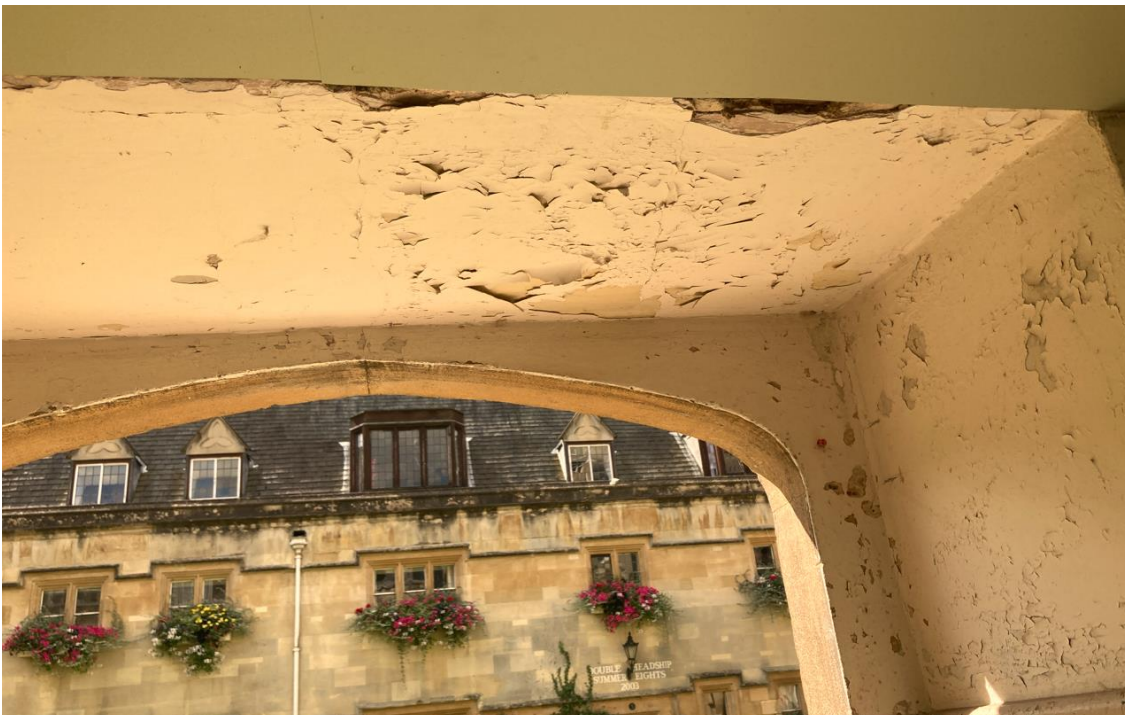
Photograph 3: Ceiling behind entrance arch of Staircase 1 has peeling finishes.

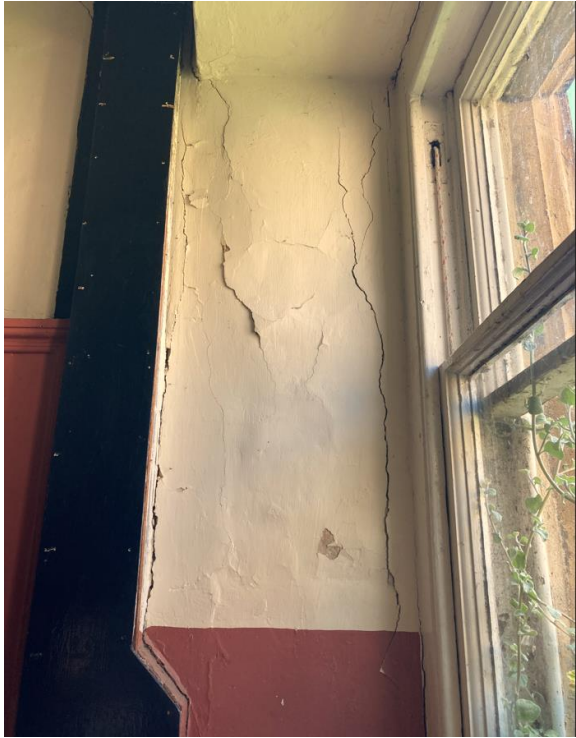
Photograph 4: Cracking in wall on 1st floor landing of Staircase 3

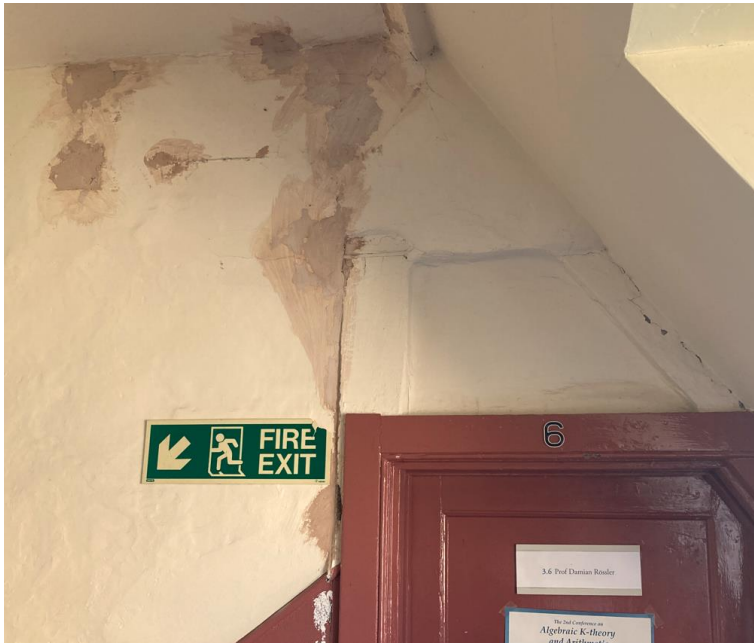
Photograph 5: Remedial works on 2nd floor landing of Staircase 3

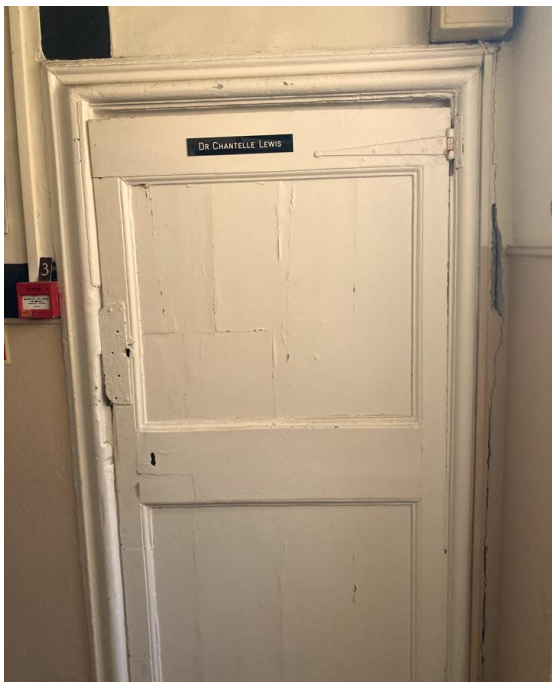
Photograph 6: Crack to right of door on 1st floor Staircase 4

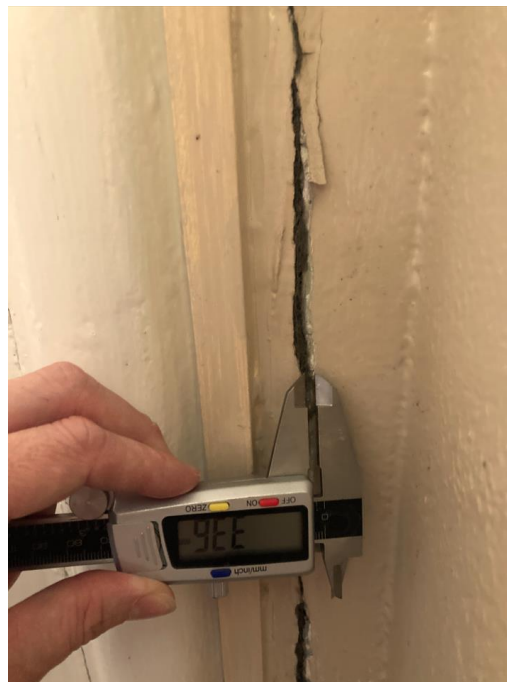
Photograph 7: Measurements of crack 1st floor Staircase 4

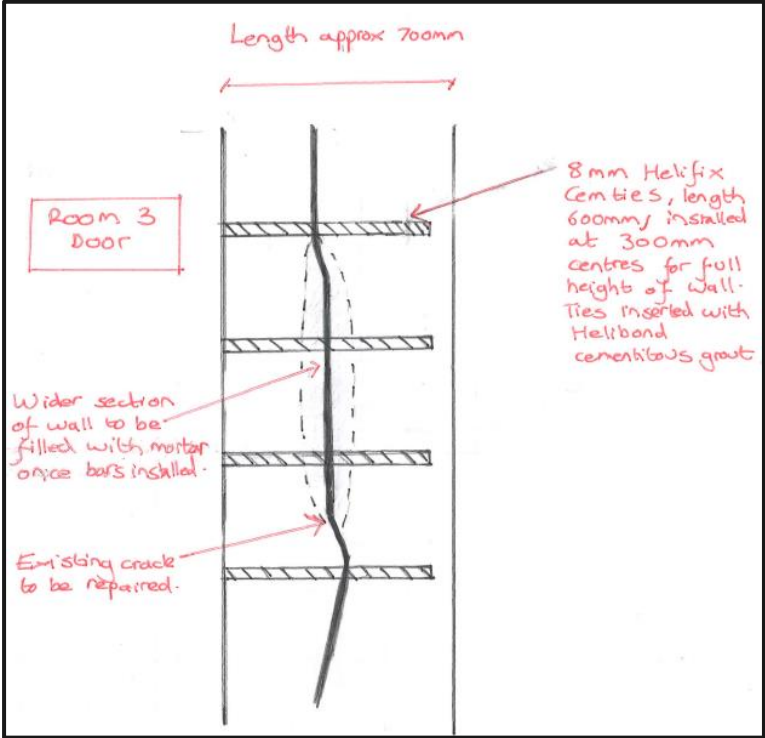
Figure 2: Crack stitching remedial detail

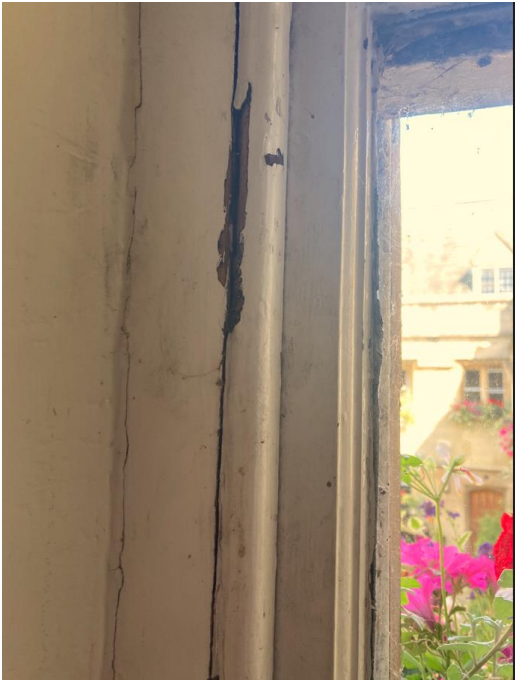
Photograph 8: Section loss in window frame 1st floor Staircase 4

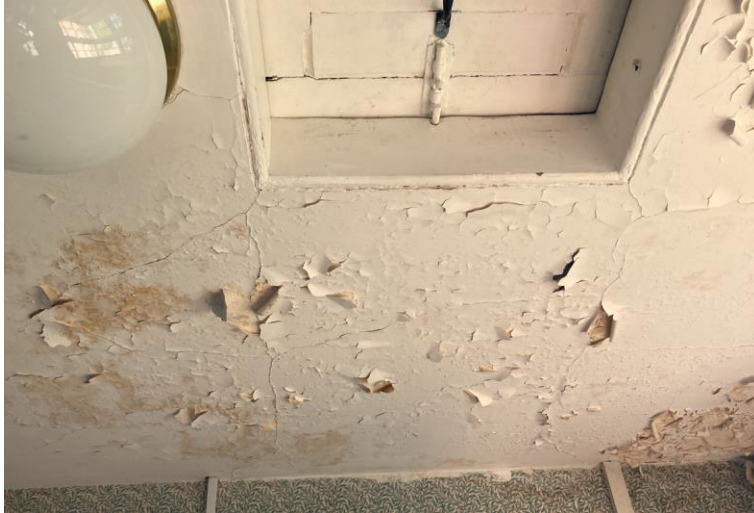
Photograph 9: Paint peeling off ceiling of 2nd floor landing of SCR staircase.

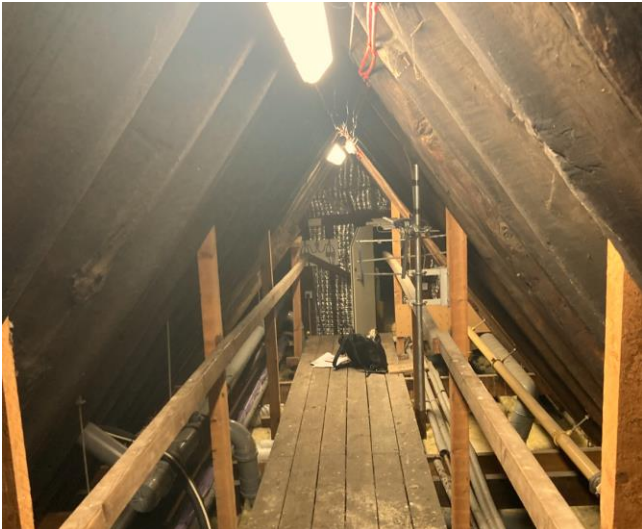
Photograph 10: Timber roof structure above Staircase 2

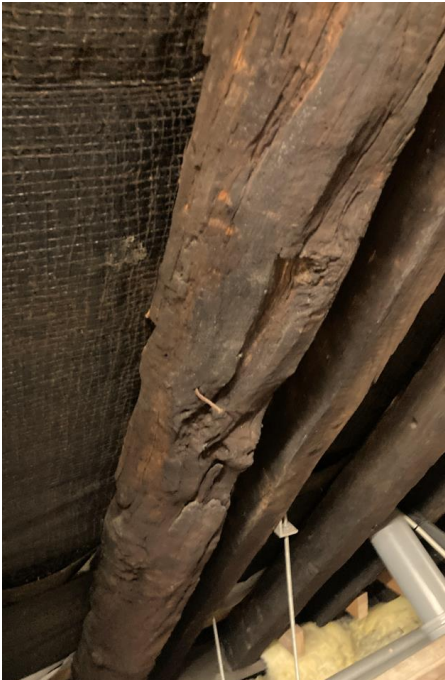
Photograph 14: Timber rafter with section loss

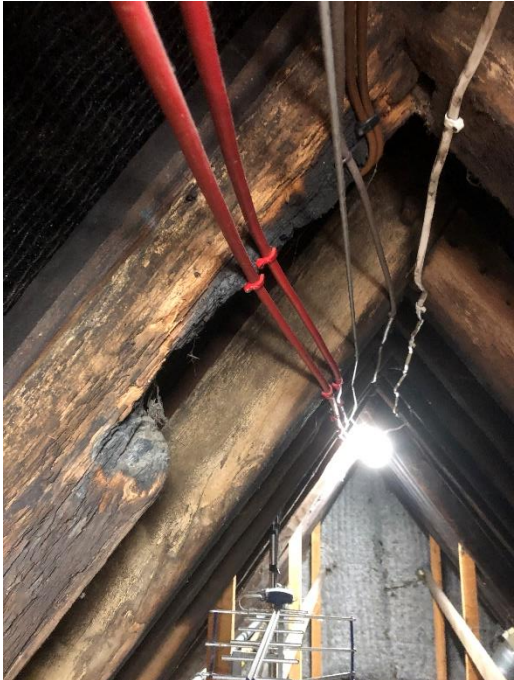
Photograph 15: Fire damage to timber rafter with section loss

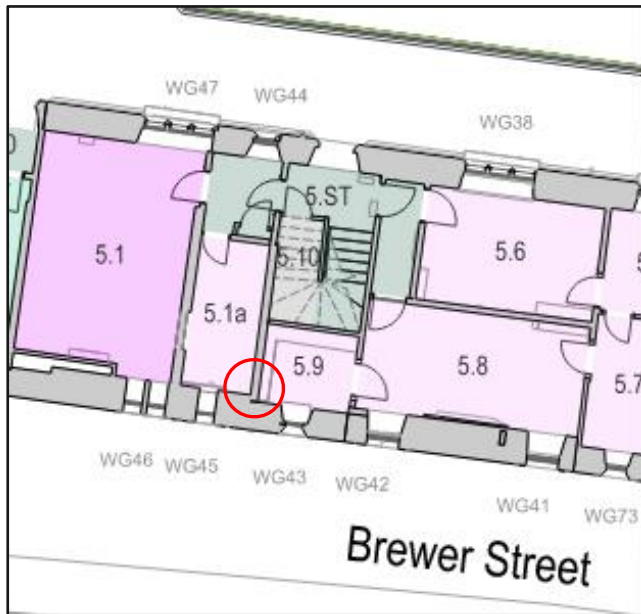
Figure 4: Location of crack

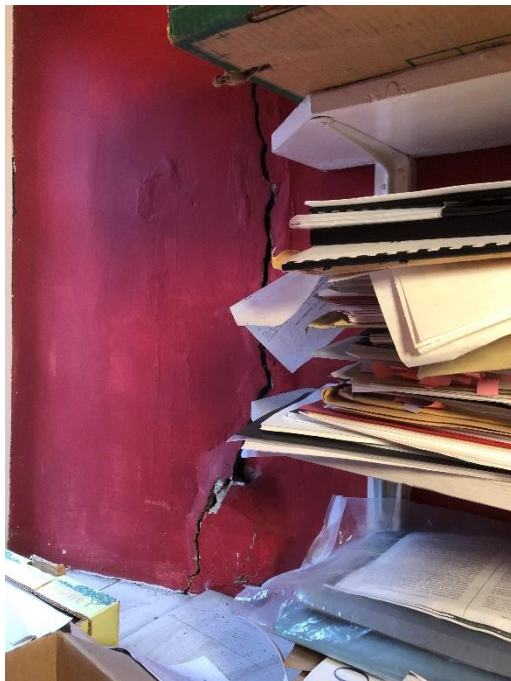
Photograph 16: Crack in cross wall Room 5.9

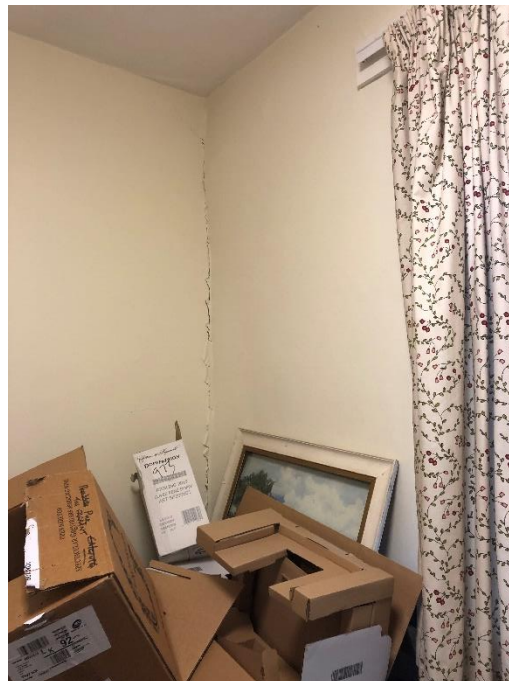
Photograph 17: Crack in cross wall Room 5.1a

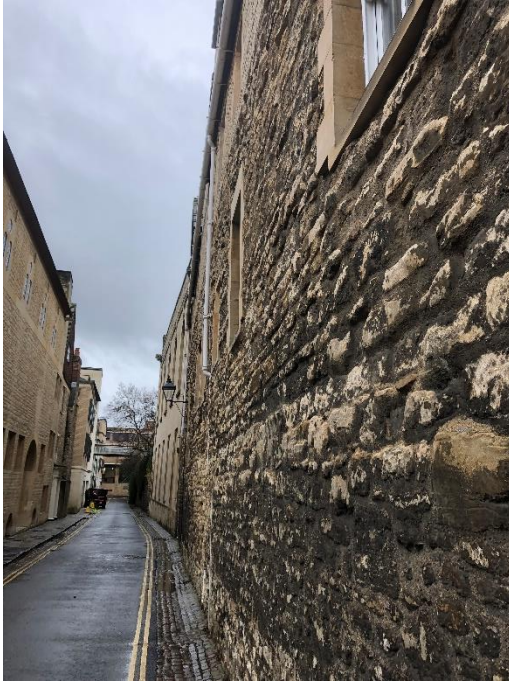
Photograph 18: External Wall Brewer Street

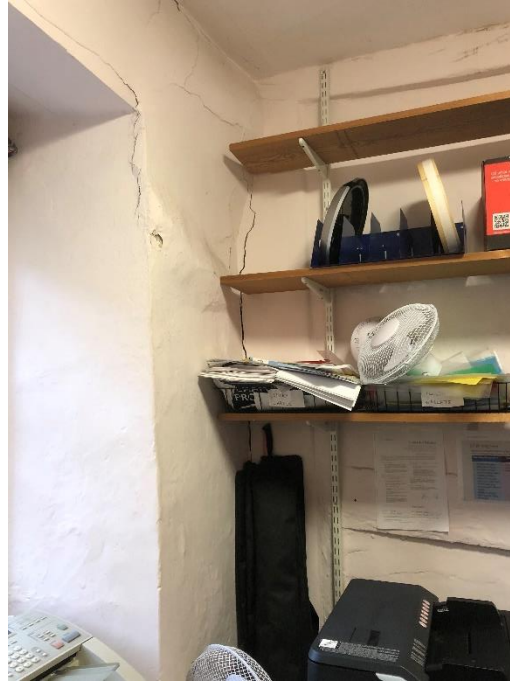
Photograph 19: Further Cracking in Room 5.1a

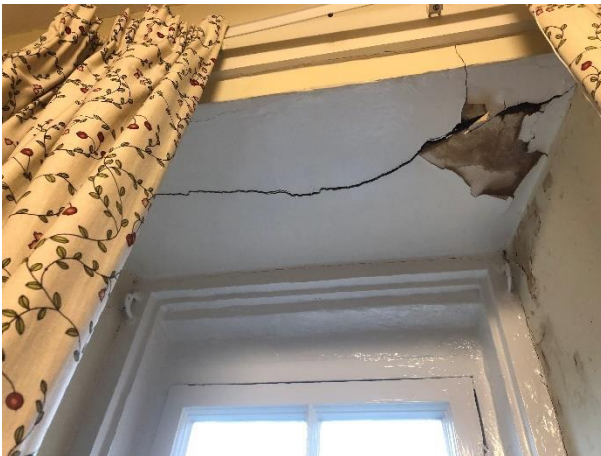
Photograph 20: Cracking to window head in Room 5.1a

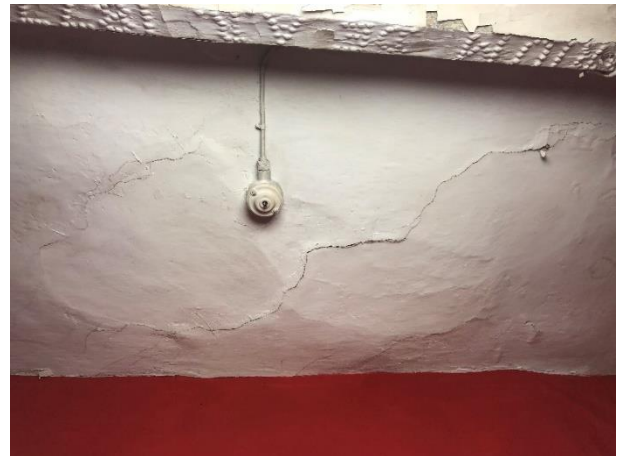
Photograph 21: Cracking to ceiling in Room 5.9

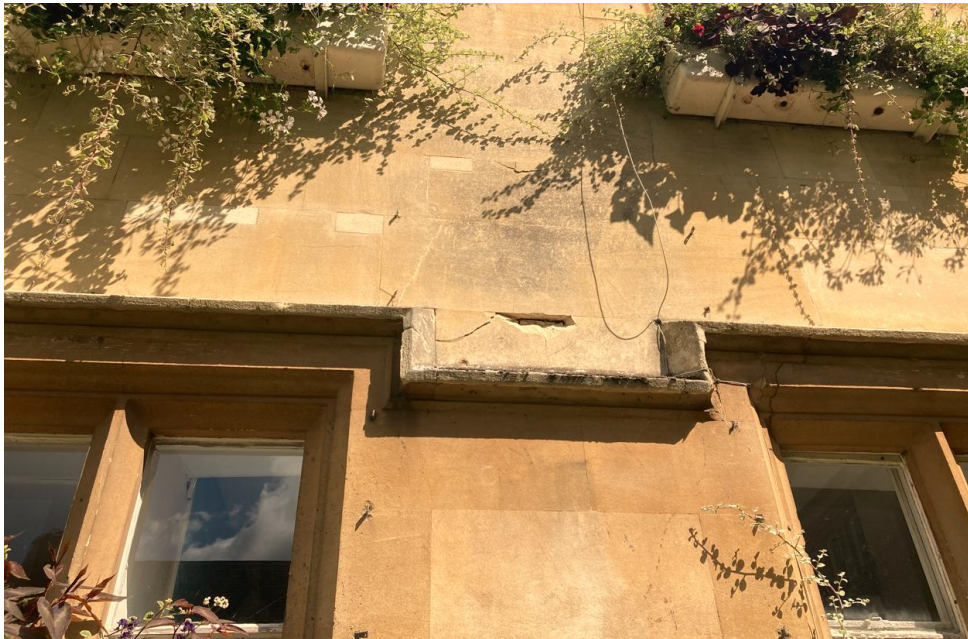
Photograph 22: Section of stone has been lost in wall between Staircase 1 and 2

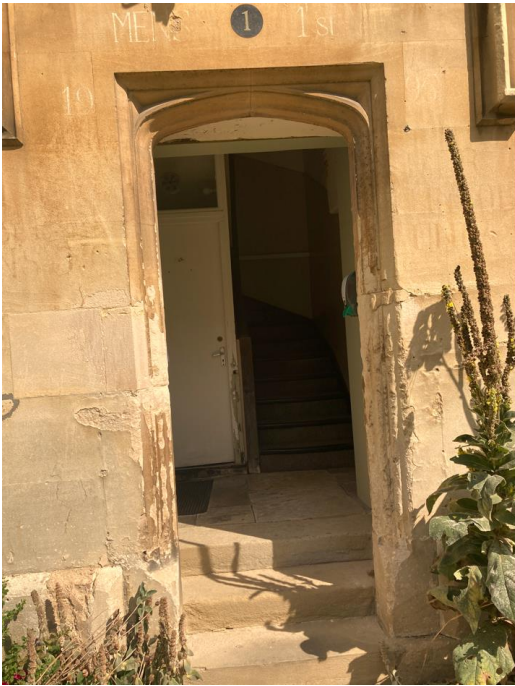
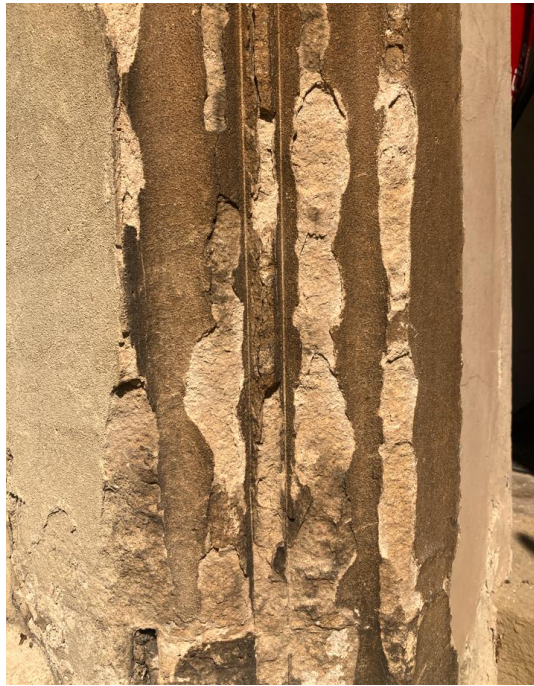
Photographs 23 and 24 Section loss to stonework around entrance of Staircase 1

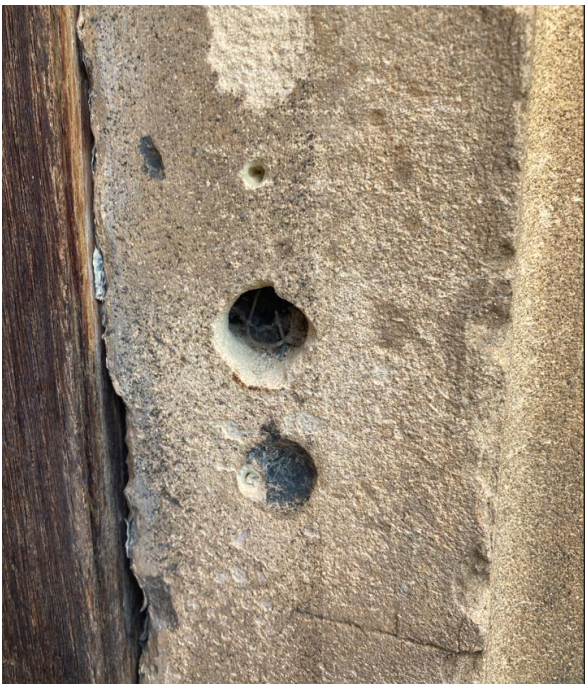
Photograph 25: Stonework next to entrance of Staircase 2

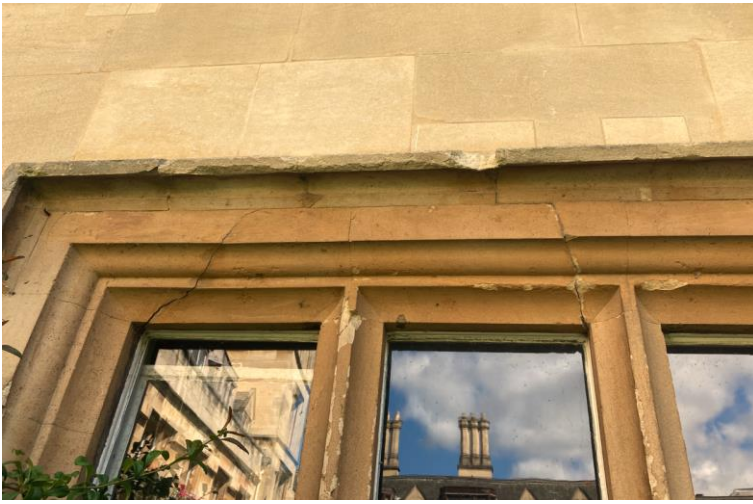
Photograph 26: Crack in lintel above window next to Staircase 3

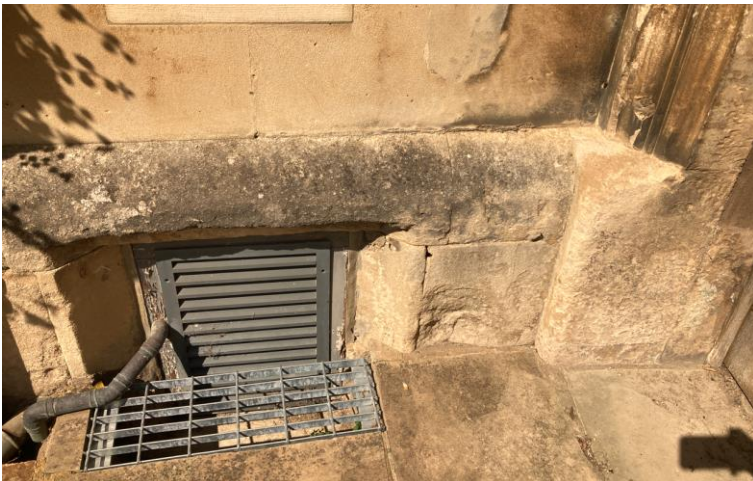
Photograph 27: Erosion to stonework at base of wall
