BURGH LE MARSH WINDMILL – Design Statement

Building: **Burgh le Marsh Windmill**
73 High Street
Burgh le Marsh
Skegness
Lincolnshire
PE24 5JT

Document: Design Statement

Report date: September 2023

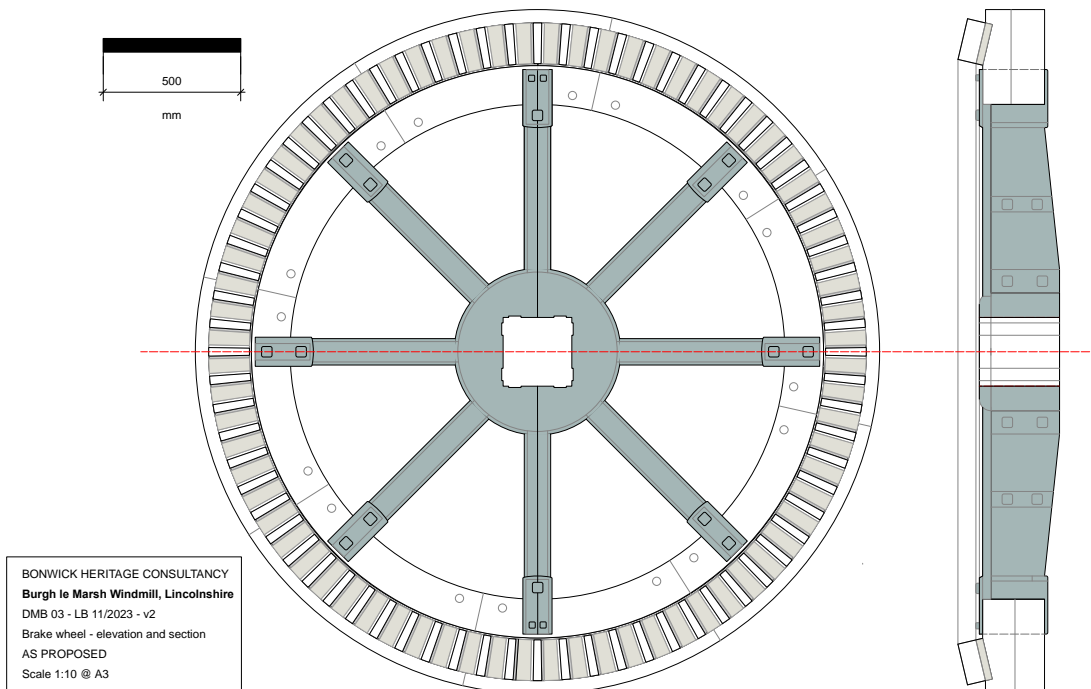
Certain components of Burgh Mill are particularly refined in terms of their construction. The **brake wheel**, for example, is both substantial and elegant, comprising an eight-armed hub cast in halves carrying a hardwood ring which is fitted with sectional iron teeth. The segmental wooden ring forms the braking surface; it is made in two layers doweled together. The overall diameter of the wheel is 2.49m (8ft 2in).

The brake wheel was severely damaged in the tailwinding episode of February 2020 (see Section 7 below).

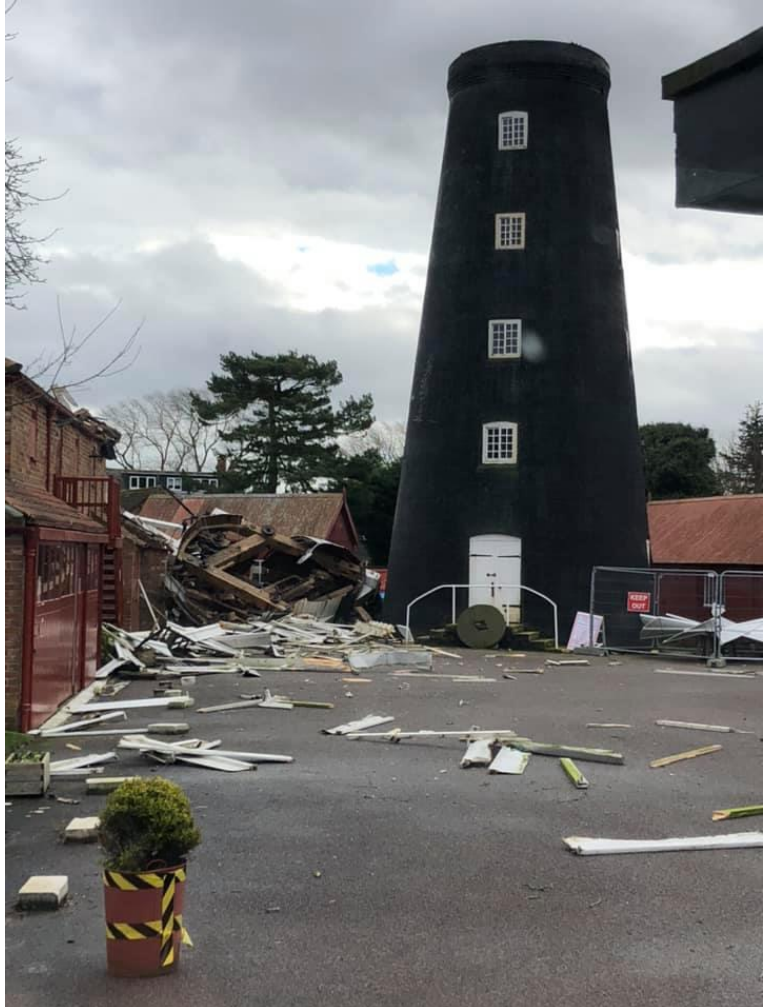
A ‘tailwinding’ situation is a windmill’s worst nightmare. Windmills are designed to withstand winds of considerable strength, but only if these strike the front face of the sail assembly. If the wind veers around and strikes the sails from the rear, the cap will become unbalanced and – as was the case at Burgh le Marsh – the cap and sails may become completely detached from the brick tower.

The tailwinding situation occurred because the eight-bladed fantail, which is designed to automatically keep the sails facing the oncoming wind, was out of action and had been lowered to ground level. During Storm Ciara, the southerly wind struck the cap of the mill from the rear, causing the five sails to rotate backwards against the brake. The strength of the wind forced the shades in the sails to close against the striking gear, increasing the sail area and enabling the sails to rotate faster.

The pressure of the wind on the rear face of the sails forced them forwards, out of the cap, causing the tail journal of the windshaft to attempt to rise out of its bearing. The guide sheaves or centring wheels, attached to the lower face of the cap frame, were initially prevented from rising by the overhang of the teeth on the inside of the curb. Eventually the guide sheaves failed, allowing the tail end of the cap to lift with the windshaft.

The strength of the wind finally overbalanced the rotating sails, drawing the windshaft forwards and outwards. The rotating sails smashed themselves to pieces as they fell on neighbouring buildings, breaking all five arms off the sail cross as they did so and scattering their shades across the yard.

The cap frame and roof followed the brake wheel and windshaft to the ground, landing upside down on top of the remains of the sails and cross. The cast iron arms and wooden rim of the brake wheel were shattered as they parted company with the windshaft.

Figure 6: The decapitated windmill in February 2020, showing debris from the shattered cap and sails strewn across the yard.

Traditional millwrighting techniques, like those used during the original construction of the mill in the 19th century, can be used once again to reconstruct the shattered upper parts of the windmill.

Although all of the large components have been damaged beyond repair, a detailed analysis of their remains has allowed accurate design drawings of each part to be made. This analysis has been aided by numerous photographs of the windmill taken during its working days, and others taken during the process of restoration in 2013, which show exactly how each of the wooden and metal elements fitted together.

Some of the smaller metal gear wheels, brackets, fixings and fittings from the cap and sails survive intact and are capable of being re-used. When the cap and sails are reconstructed, elements of the original fabric will be incorporated wherever it is considered possible and safe to do so.

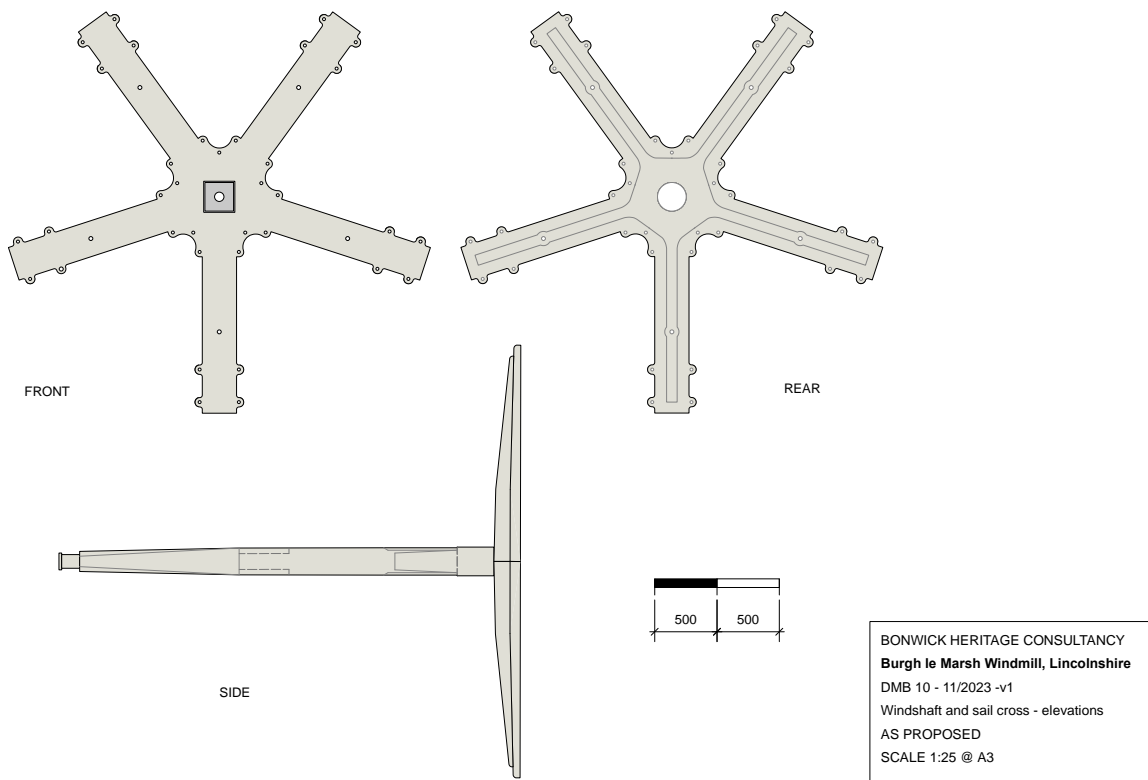
Figure 7: Reconstruction drawing of the five-armed sail cross and windshaft. These large cast iron components have been damaged beyond repair and accurate replacements will be required.

The first stage of the process of making new cast iron components will involve the manufacture of full size wooden patterns. Some of these, such as the pattern for the five-armed sail cross, will be very large indeed (Figure 7).

A sand mould will be created using the patterns, and molten iron poured in to create metal components of the correct size and shape (Figures 8-11). Once cooled, the castings will be fettled to remove excess material and their working surfaces will be accurately machined to enable them to rotate or pivot smoothly.
