REPORT NO. P2023-137 FINAL 01

STRUCTURAL SURVEY REPORT

UNITS A, B, C & D: 314 SPRING LANE, LAMBLEY, NOTTINGHAMSHIRE, NG3 5RQ

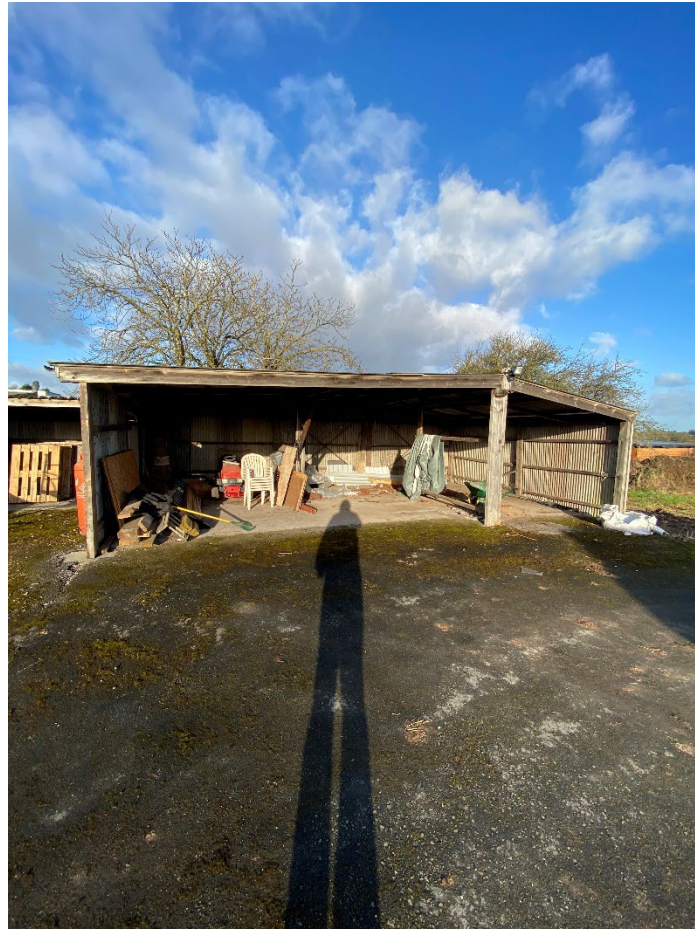
Photograph No. 1

- 3.1.1. This building is a load bearing timber structure formed with primary timber posts and primary timber roof beams [ref: photo 01]. The primary timber roof beams support timber purlins which in-turn carry corrugated cement roofing sheets which are likely to contain asbestos. The rear and side elevations are enclosed with vertically spanning corrugated cement sheets restrained by timber cladding rails and timber eaves beams [ref: photo 02].

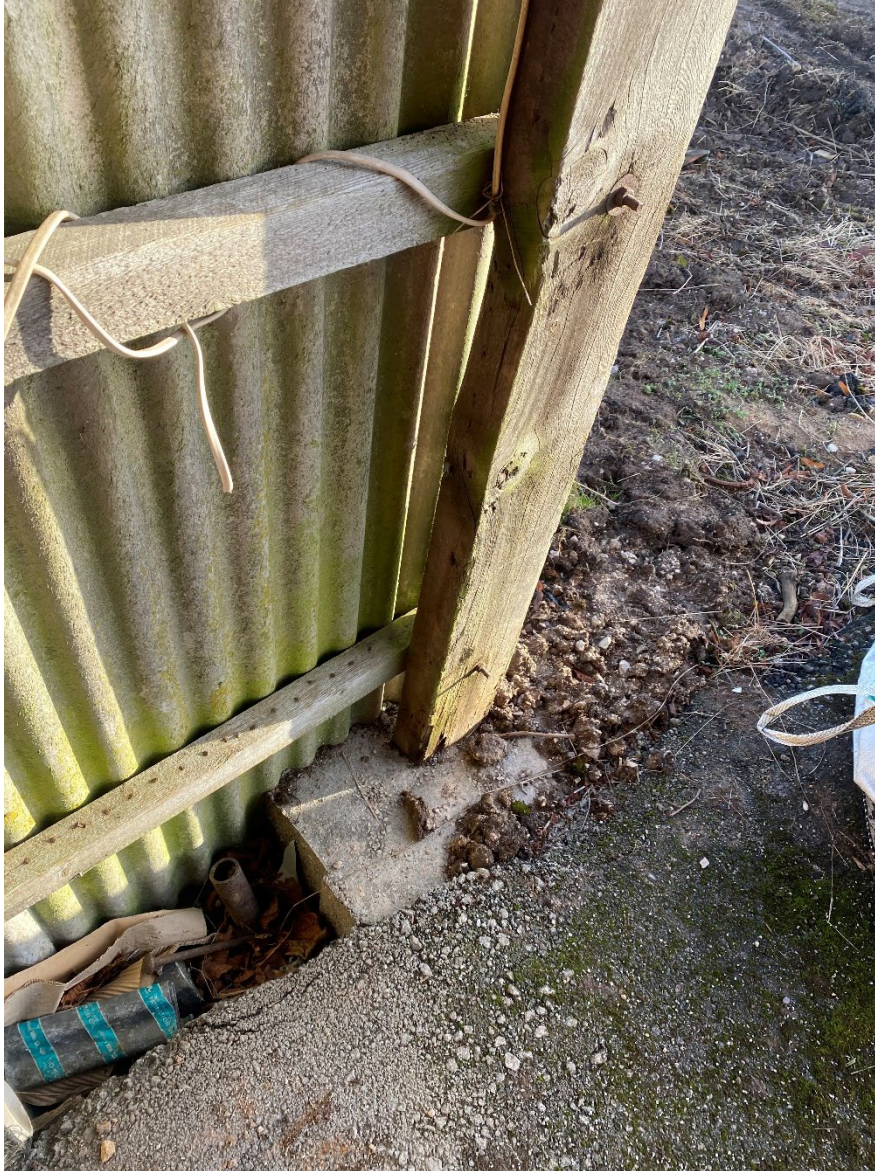
Photograph No. 3

- 3.1.2. We organised for two of the 9 primary timber post bases to be exposed to determine if foundations were present and to check the condition of the bottom of the timber posts. The primary timber posts are supported on concrete pad footings visible beneath the yard slab and asphalt surface finish [ref: photo's 03 & 04]. The base of the primary timber posts are in satisfactory condition and free from wet or dry rot. The ground floor is a concrete "yard" slab in fair condition.

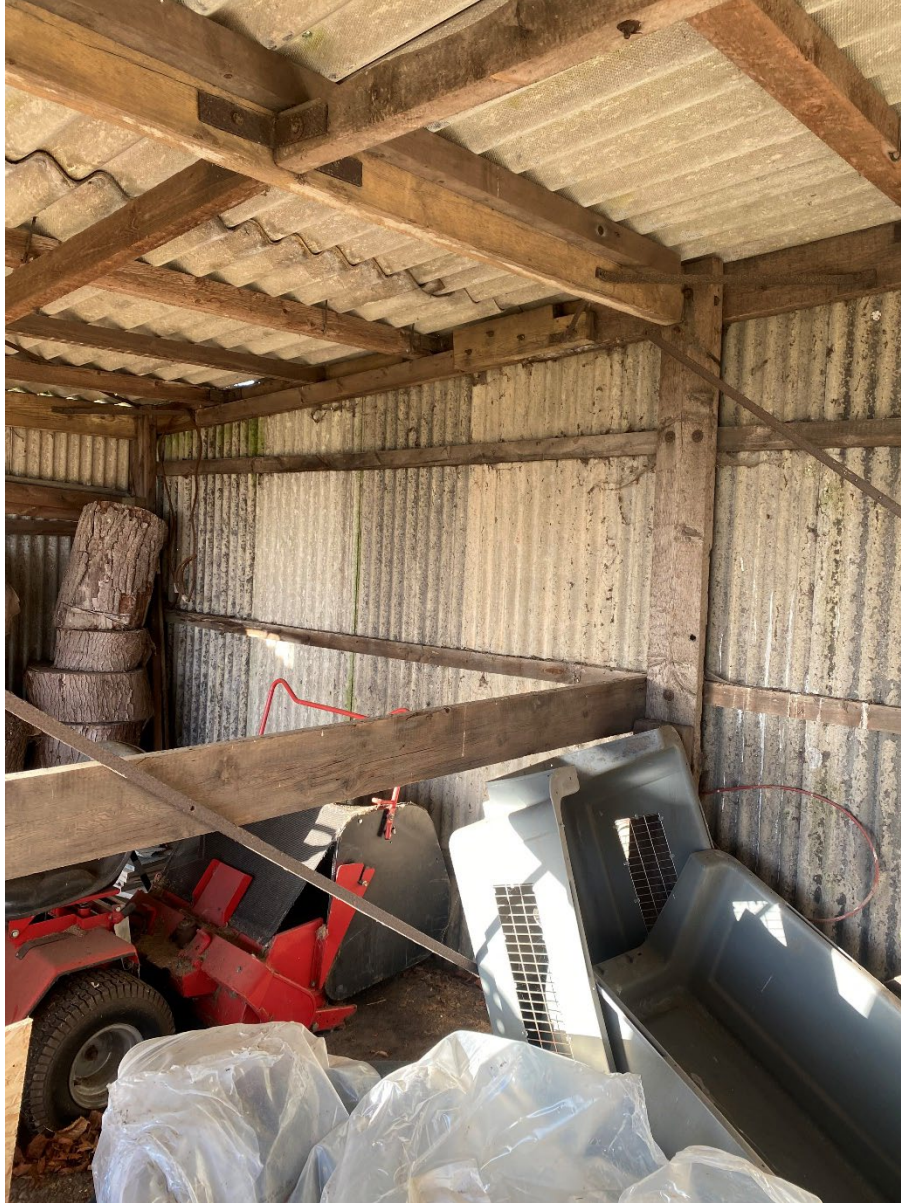
Photograph No. 5

- 3.1.3. The building is stabilised in each direction with vertical cross bracing.
- 3.1.4. The external load bearing timber frame walls are vertical and the timber posts and beams well framed together with bolts and steel cleats [ref: photo 05].

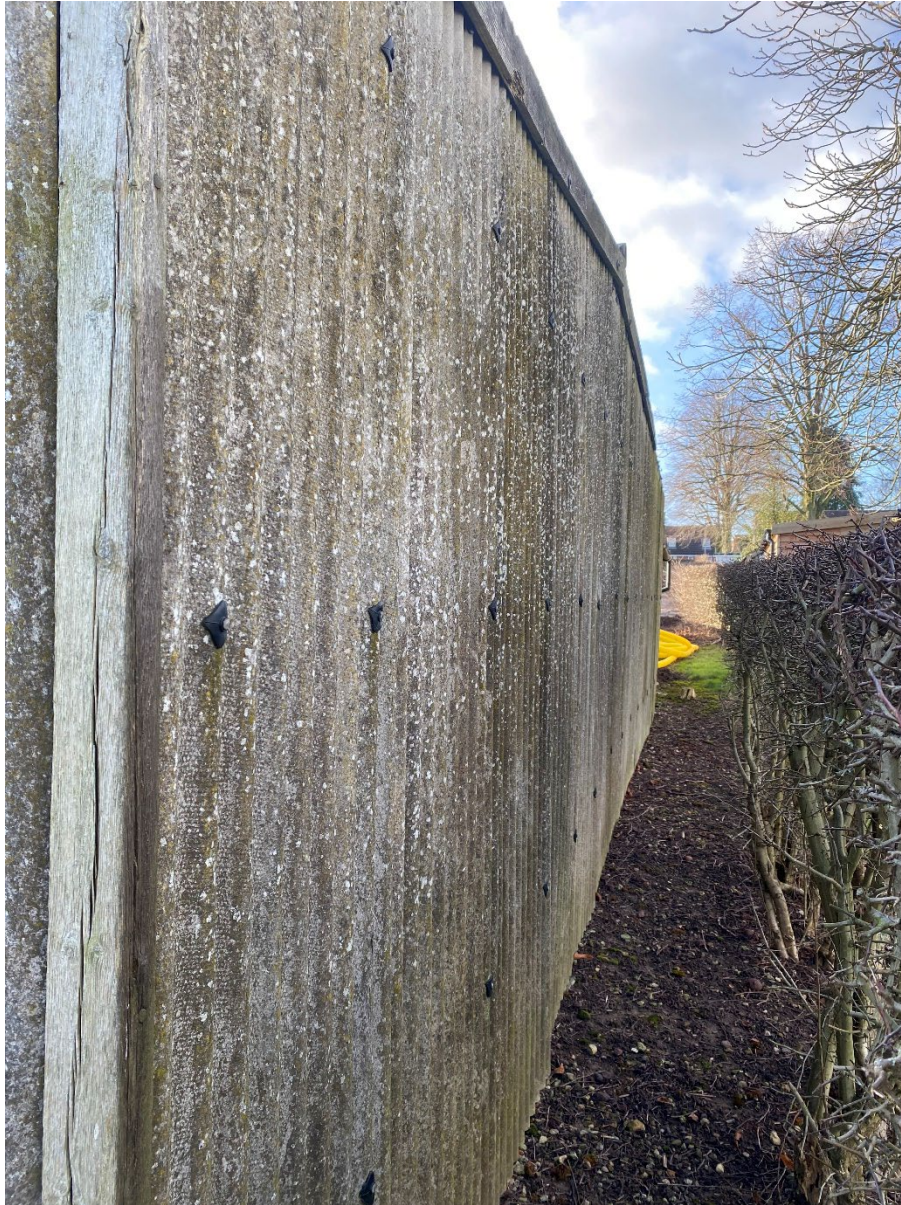
Photograph No. 6

- 3.1.5. The ridge line and cladding appear straight and true with no signs of distress or roof slope sagging [ref: photo 06].

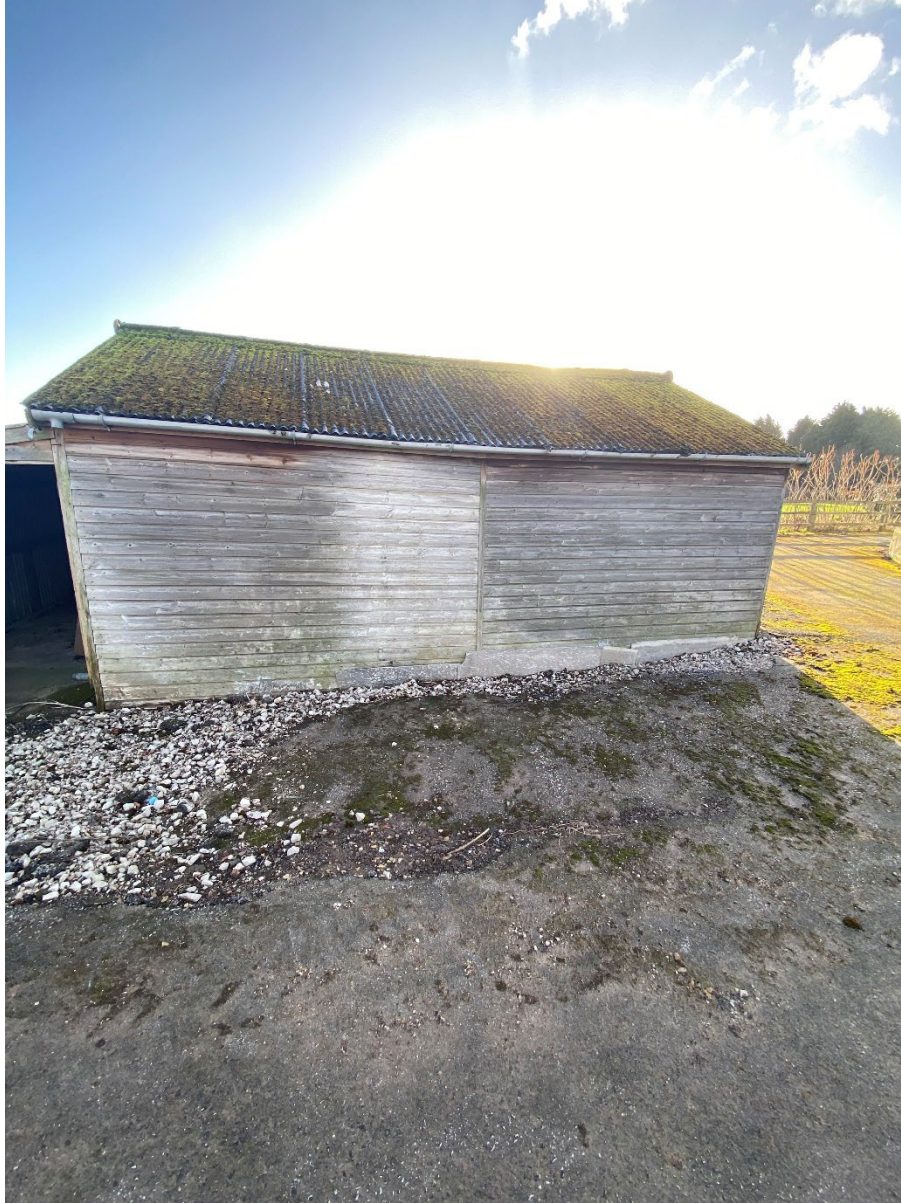
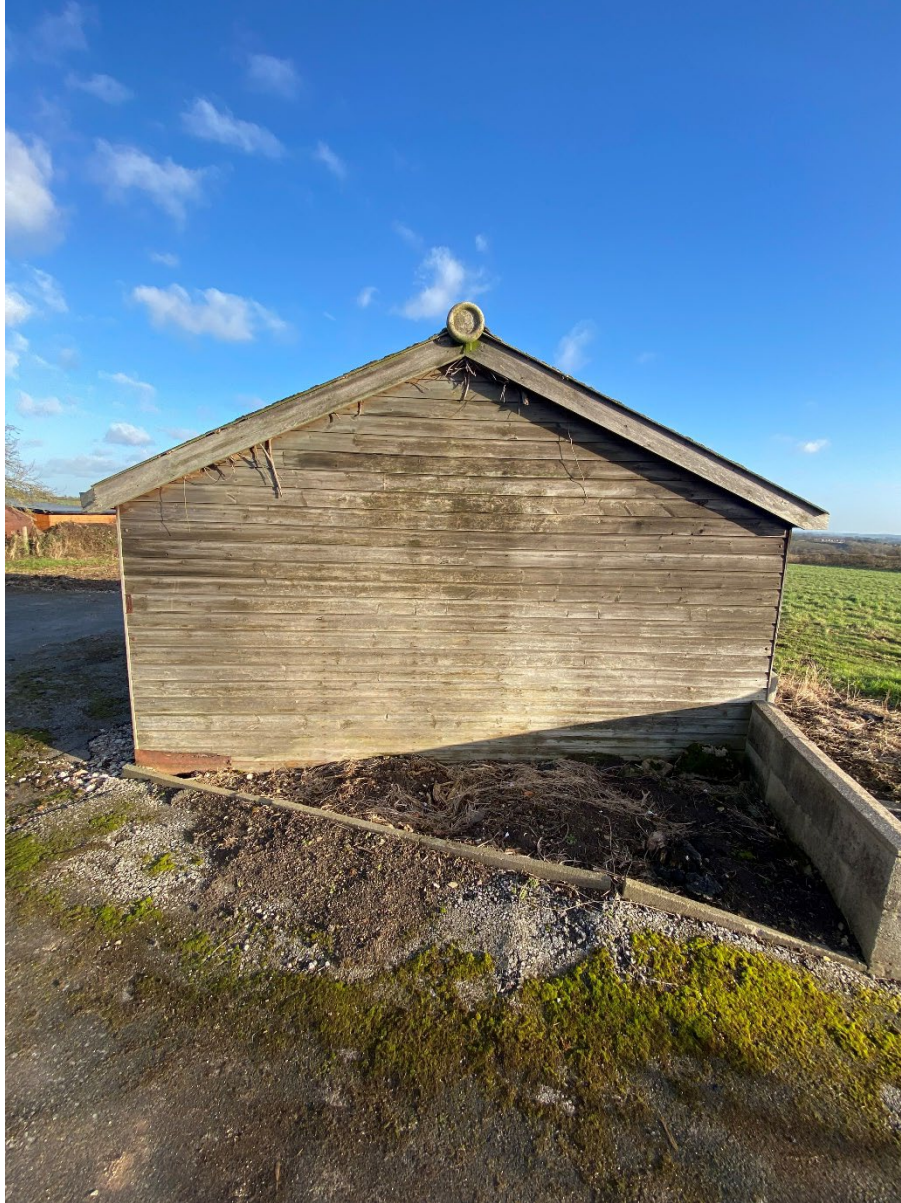
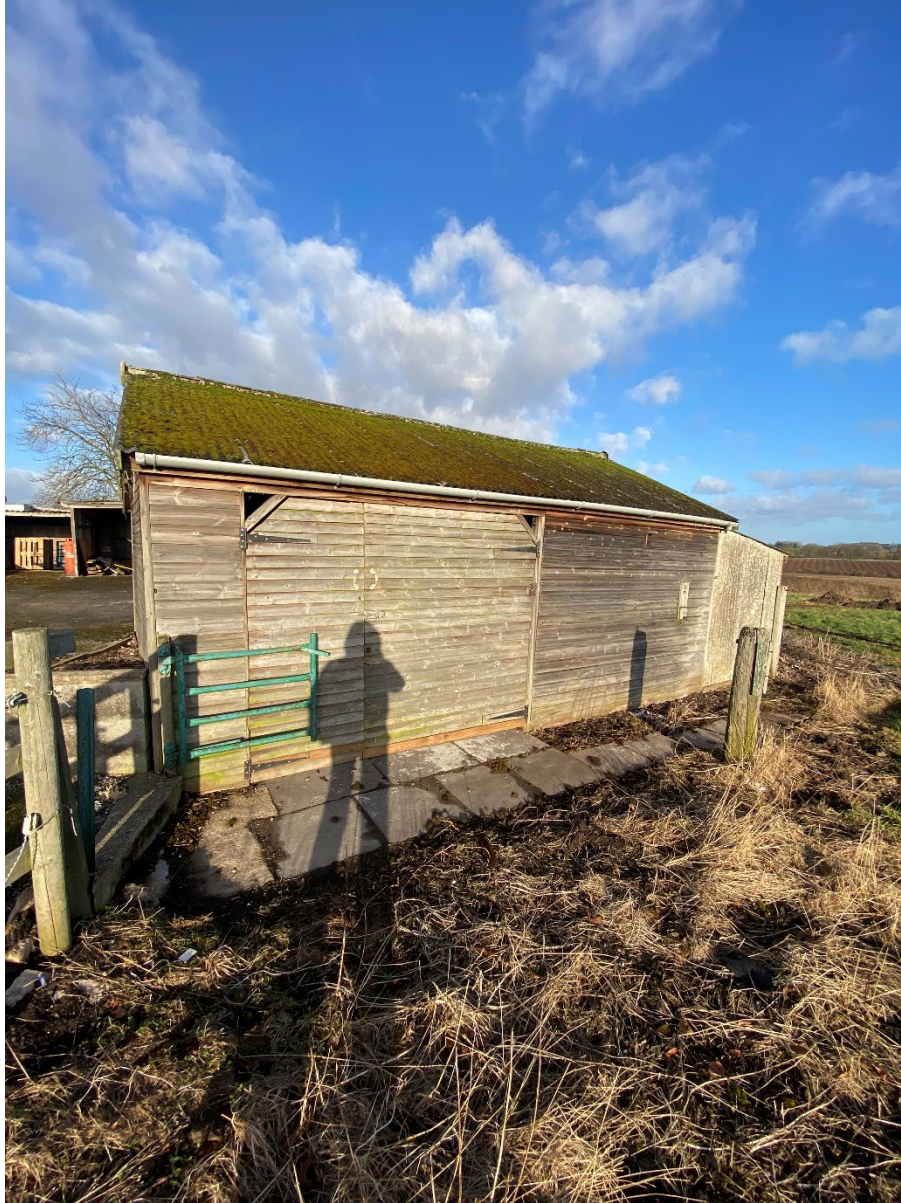
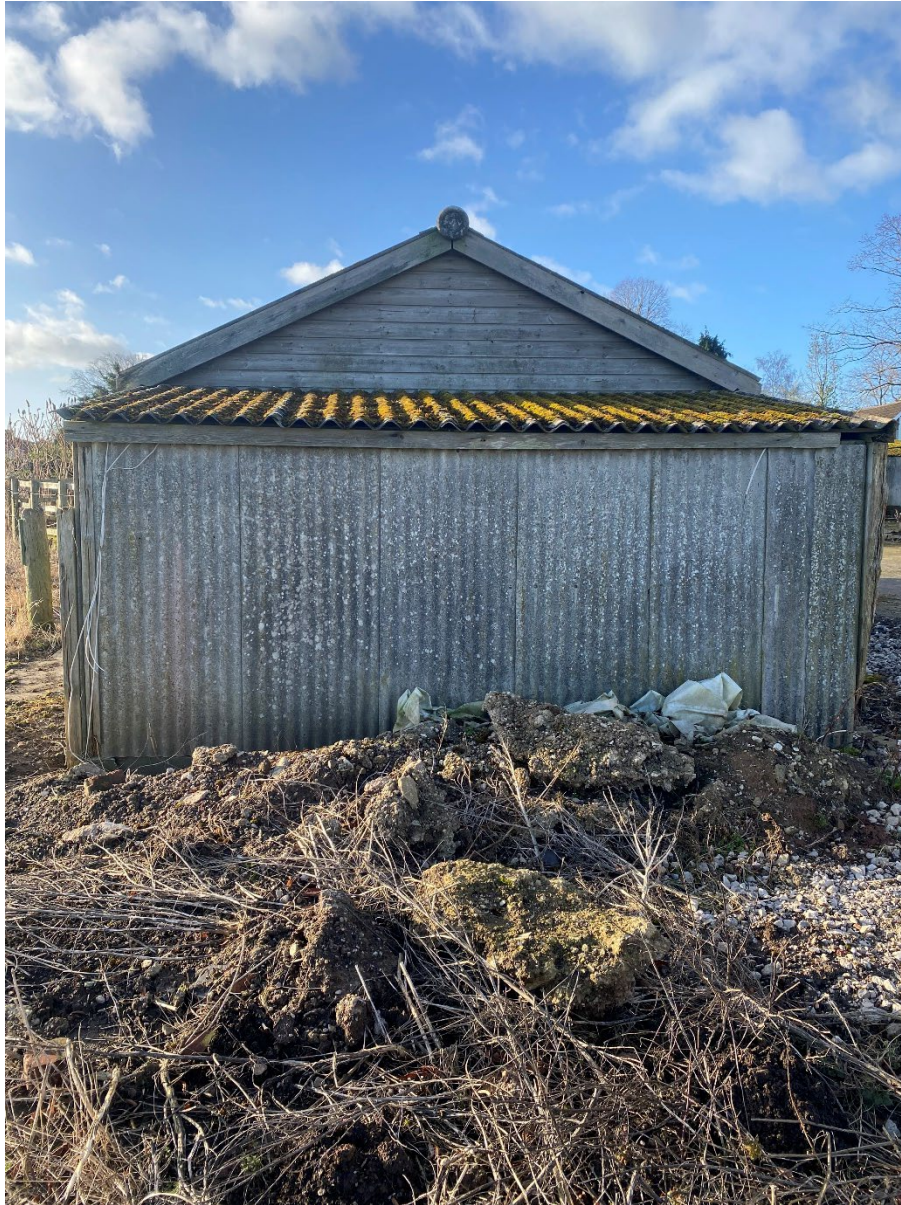
- 3.2.1. This building is a small load bearing timber frame structure [ref: photo's 07, 08, 09 & 10].
- 3.2.2. The walls are load bearing studs lined with OSB sheathing internally [ref: photo 11]. The roof is supported with intermediate roof trusses which support timber purlins which in-turn carry corrugated cement roof sheets [ref: photo 12].
- 3.2.3. The ground floor is a concrete slab in good condition and the external load bearing timber walls are supported by a concrete edge thickening.

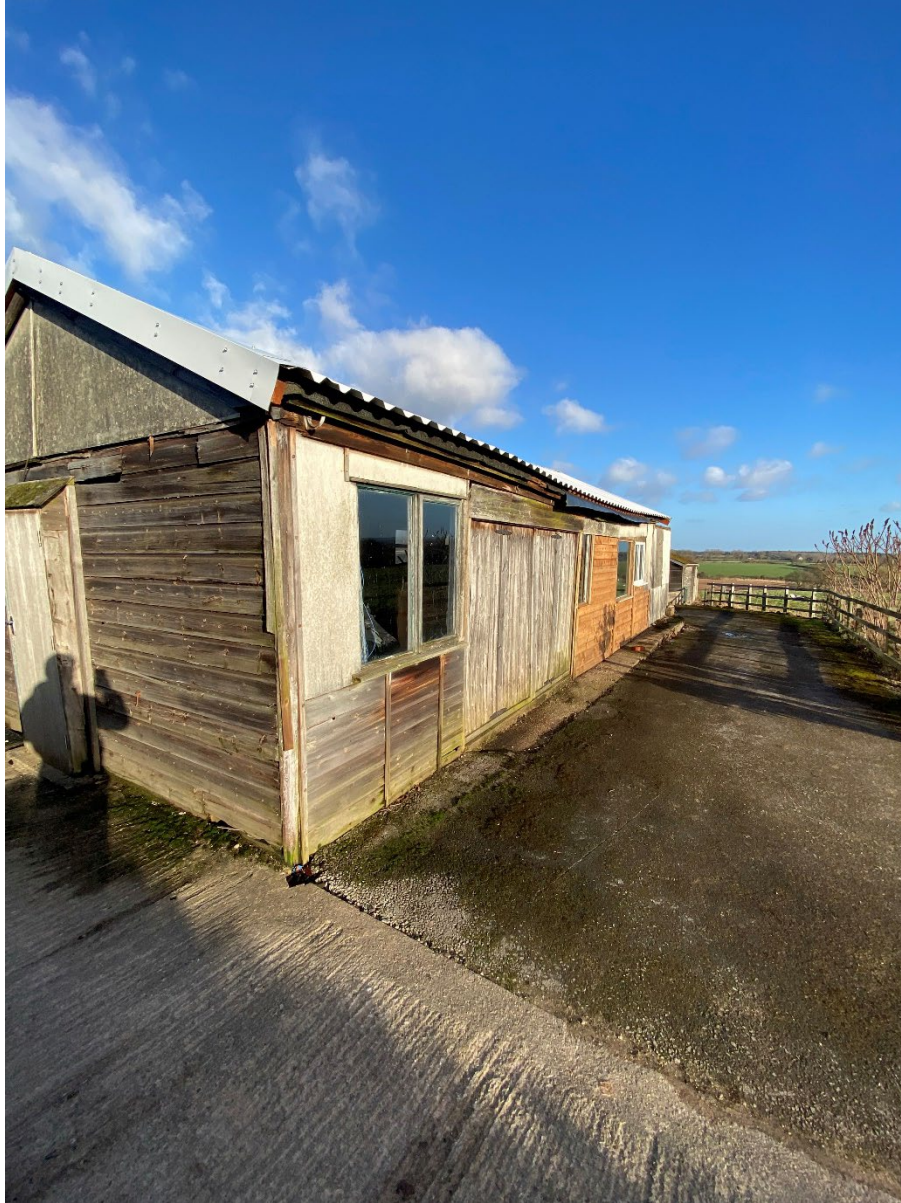
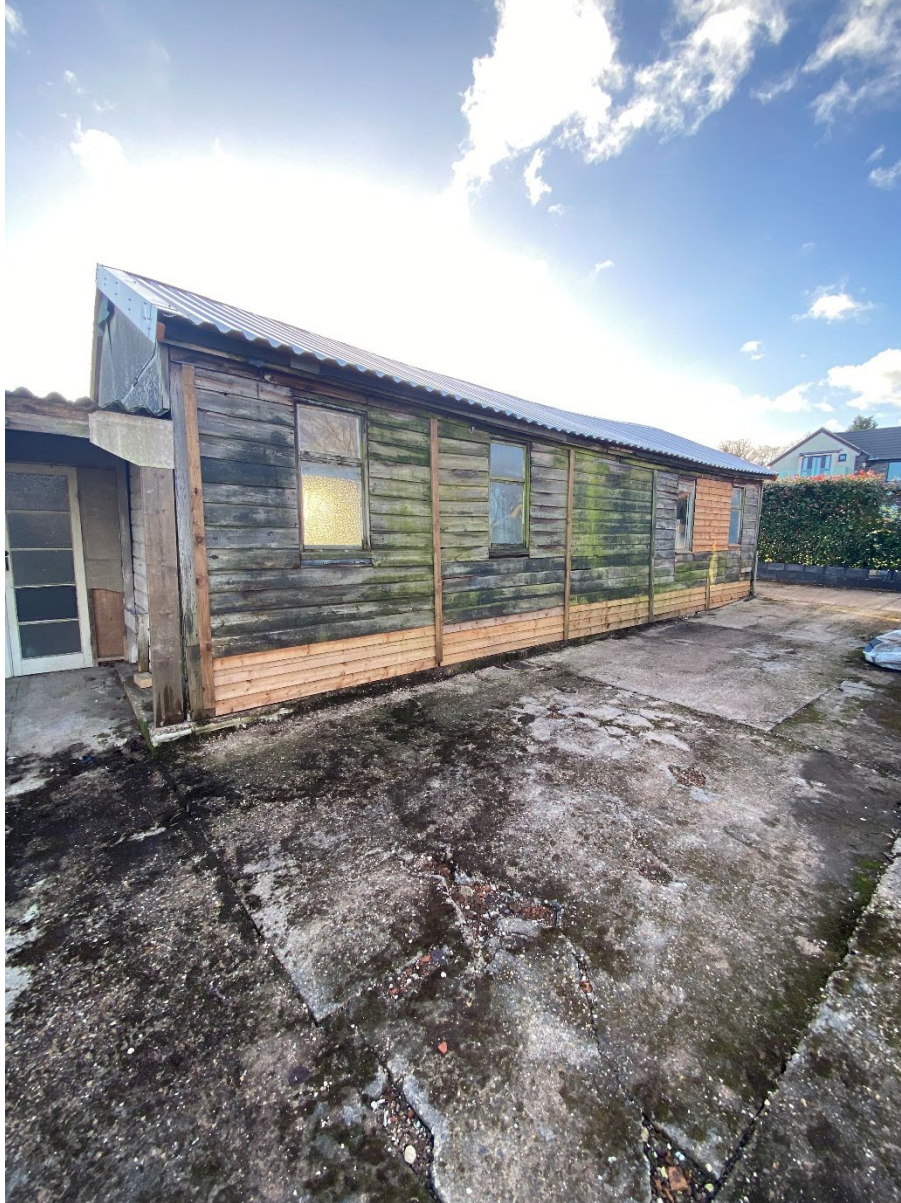
- 3.3.1. This building is a single storey load bearing timber frame structure. The external walls are generally clad with horizontally spanning close board timber cladding with portions of cement board which we presume are repairs [ref: photo's 13 & 14].
- 3.3.2. The roof structure is formed with four regularly spaced timber king post trusses spanning between timber posts embedded within the external walls [ref: photo 15]. Timber purlins span between the timber trusses which in-turn support cut timber rafters. The roof finish is profiled metal sheeting.
- 3.3.3. The load bearing posts within the external walls are supported directly off the existing raft slab foundation [ref: photo's 16 & 17] and braced laterally with knee braces [ref: photo 18].
- 3.3.4. The ground floor slab is the concrete raft slab and therefore considered robust as a floor slab [ref: photo 19].

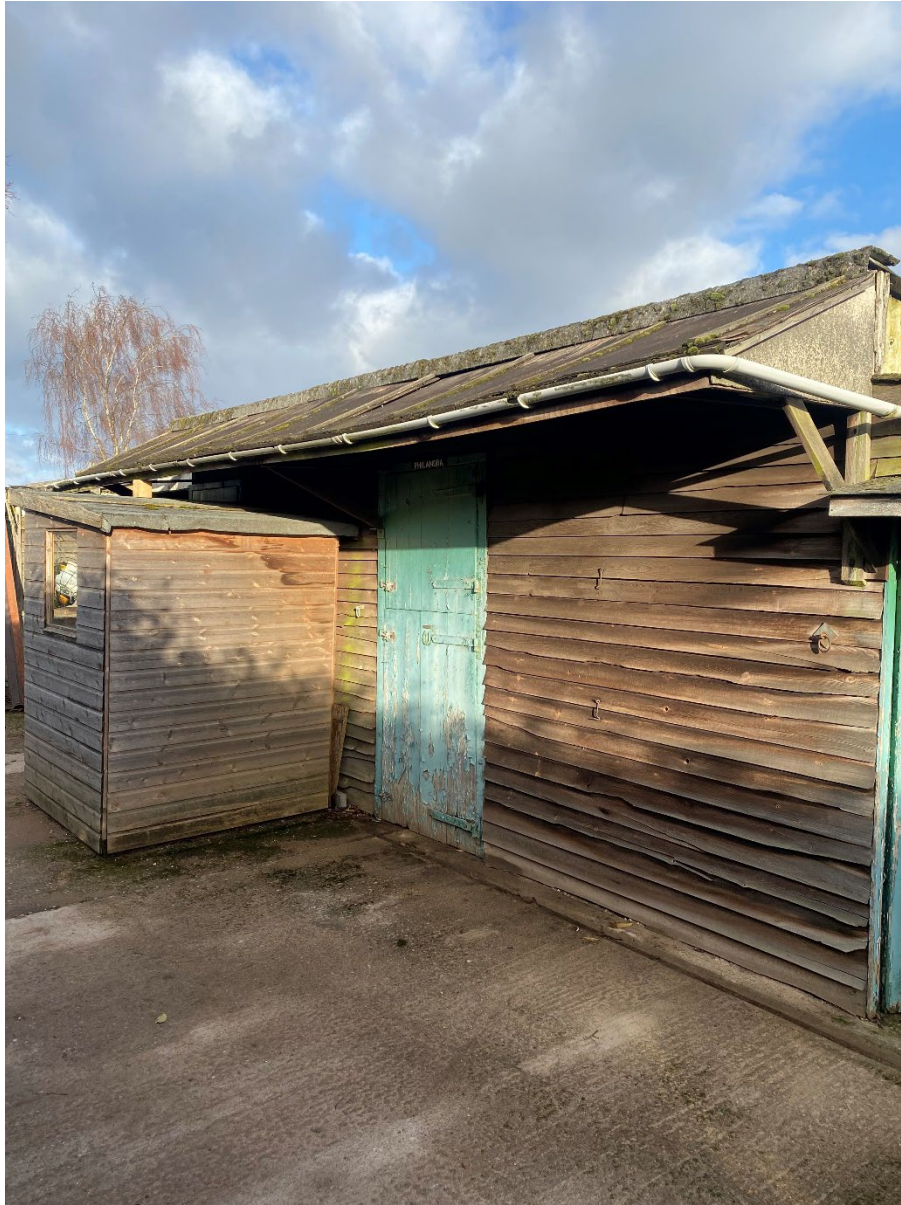
Photograph No. 20

- 3.4.1. This building is a single storey load bearing timber frame structure. The front portion of the building is clad with horizontally spanning close board timber [ref: photo 20].
- 3.4.2. The rear portion of the building is clad with cement boards [ref: photo 21].
- 3.4.3. Internally, the walls are formed with load bearing timber studs and primary timber posts and roof beams. Purlins span between external walls and internal roof beams which in-turn support corrugated cement roof sheets [ref: photo 22].
- 3.4.4. The ground floor is a concrete raft slab [ref: photo 23].
