# Tree Condition Survey 21 Tyne Road, BS7 8EE

*A tree condition survey concentrating on the Horse Chestnut (*Aesculus hippocastanum*) tree at 21 Tyne Road, Bristol, BS7 8EE.*

**Joe Weaver**

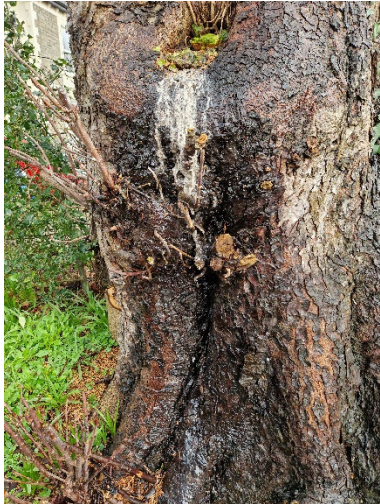
Pic 1. Exudate flowing from internal cavity

Photographic evidence of fungal growth, exudate (colour and flow) and crown health should be collected and logged chronologically for the next 2 years to establish a clearer picture of this trees health.

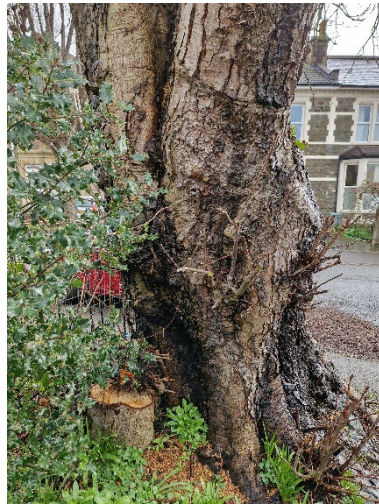
There are fungal fruiting bodies at the base of the tree, possibly saprophytic, that should be included in any future surveys.

Pic 2. Base of tree from driveway

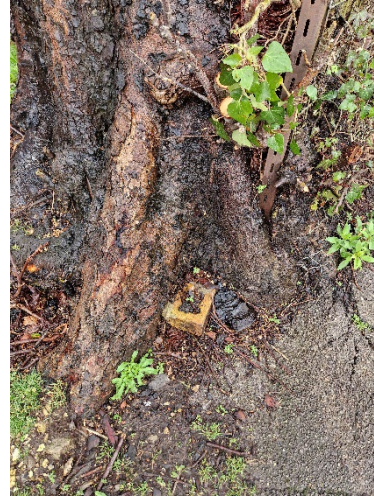
Pic 3. Engulfed brick and old fence

In order to try to give the remaining stem the best chance to survive I would recommend removing the fence as much as possible including the build up of debris behind it. Any epicormic growth should also be removed with clean cuts at the collar of each epicormic stem.

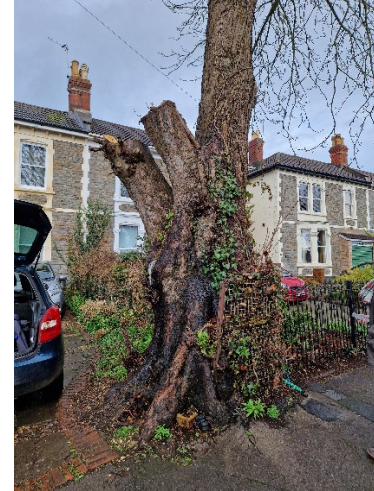
Further monitoring over the next five years is strongly advised. Previous surgery should be tidied up to reduce the build up of debris in the cavity at approximately 2m height.

Pic 4. Previous surgery cuts and healthy stem from road
