— HEBDEN —  
ARBORICULTURE

# Quantified Tree Risk Assessment- St. Peter's Hospice, Brentry, Bristol

A report detailing the findings of a Quantified Tree Risk Assessment on selected trees in and around the grounds of St. Peter's Hospice, Brentry, Bristol.

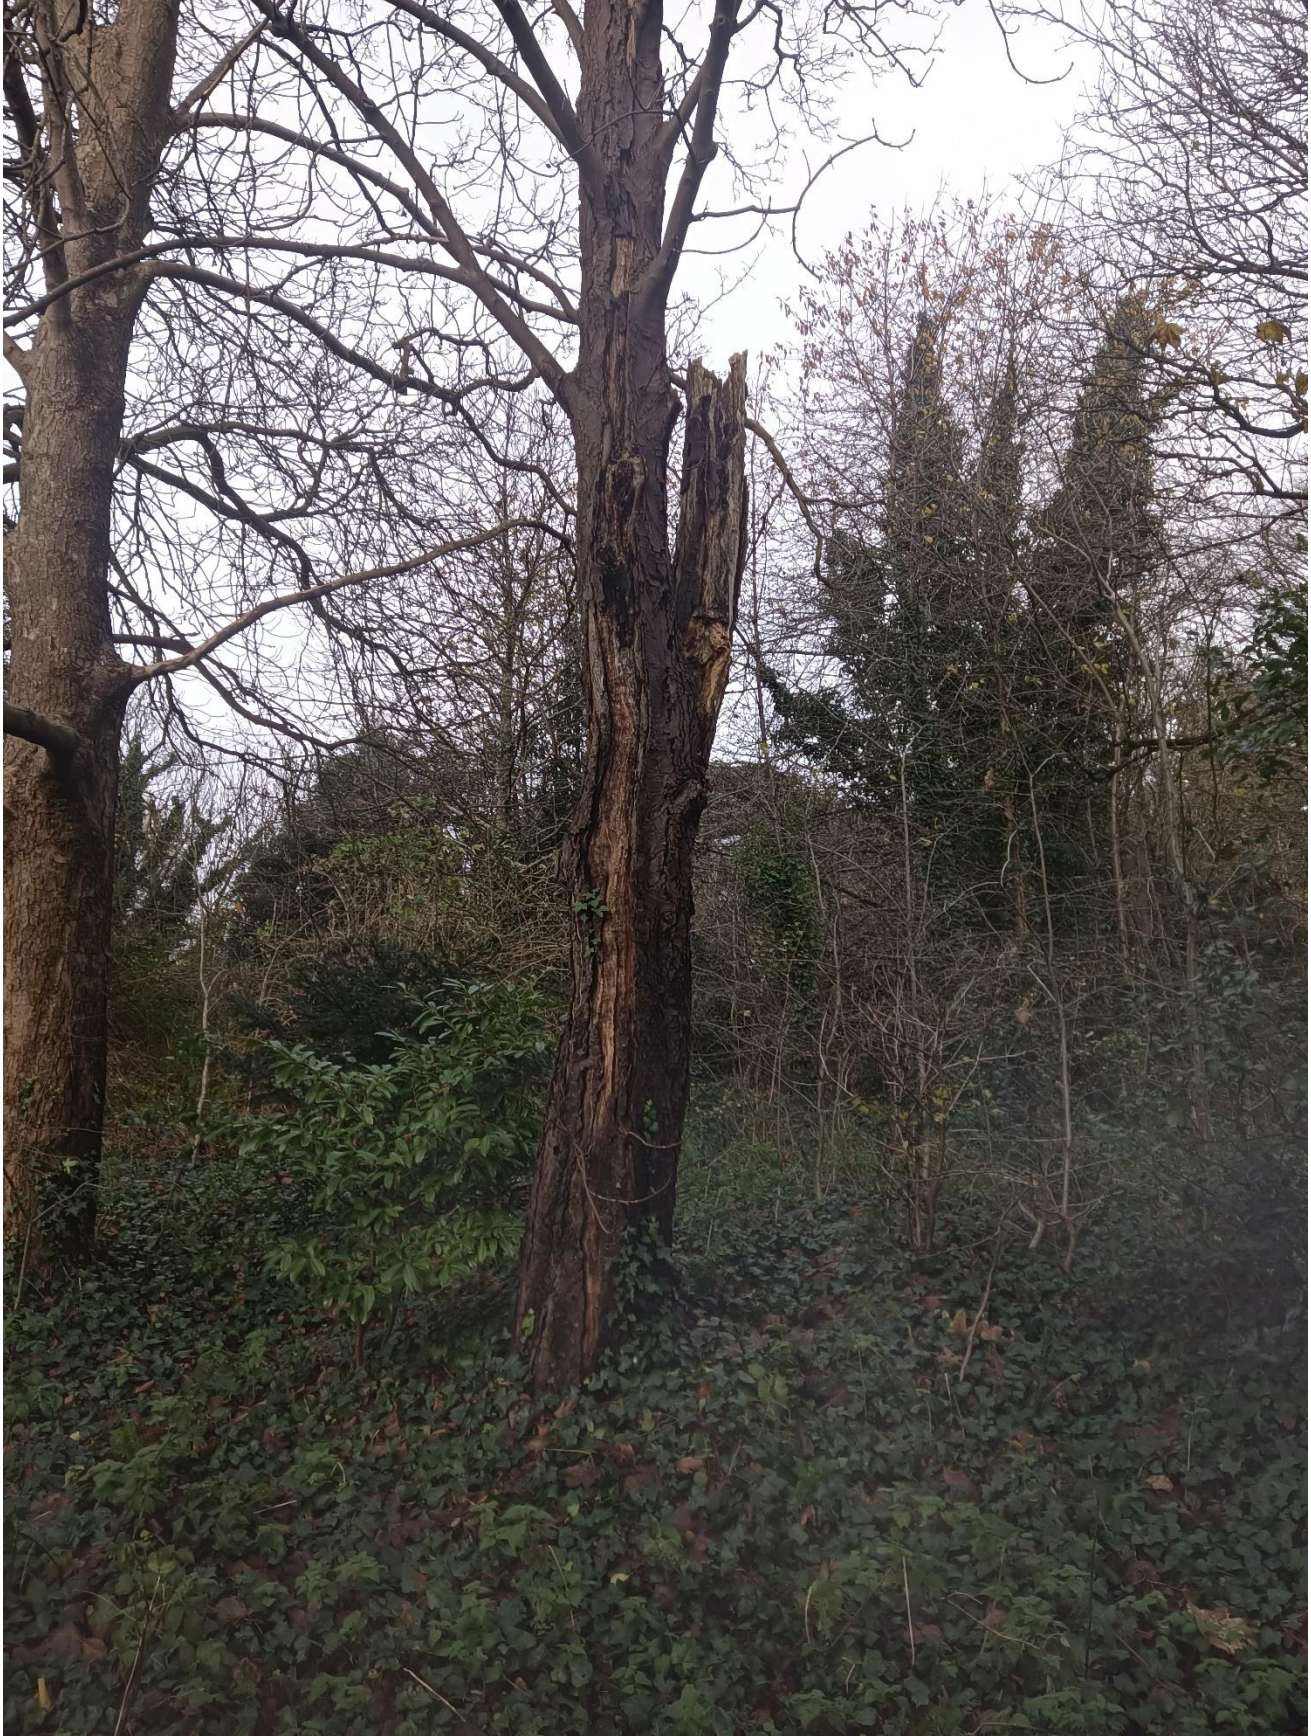
There were only 2 trees that presented an unacceptable risk according to the QTRA method. Both of these were Horse chestnut trees in G21 with advanced signs of decay. One is a whole tree at risk of falling onto the popular footpath in the paddock area and the other has a large decayed limb overhanging the same footpath.

The second assessment was made of the other horse chestnut (see Figure 1 in Appendices) with decay at the base failing onto a pedestrian using the footpath. The pedestrian usage of the footpath was judged to be 2 – 7 per hour which placed it in target group “3”. The size range used was “1” as the diameter of the tree was greater than 460mm. The probability of failure in the coming year was 1/1000 – 1/10,000 which put it in range “4”. **These parameters gave a Risk of Harm (RoH) of 1/400,000 and so is unacceptable and requires management.**

#### 4.1.1 Figure 1 – Horse Chest to fell in G21

As mentioned above there are only two works that are required to mitigate an unacceptable risk. This is the removal of the decayed limb and the felling of one of the Horse chestnuts in G21. As well as this there is the removal of the deadwood across various areas of the site and the removal of the dead Larch in G2, this is to mitigate future risks before they become unacceptable.

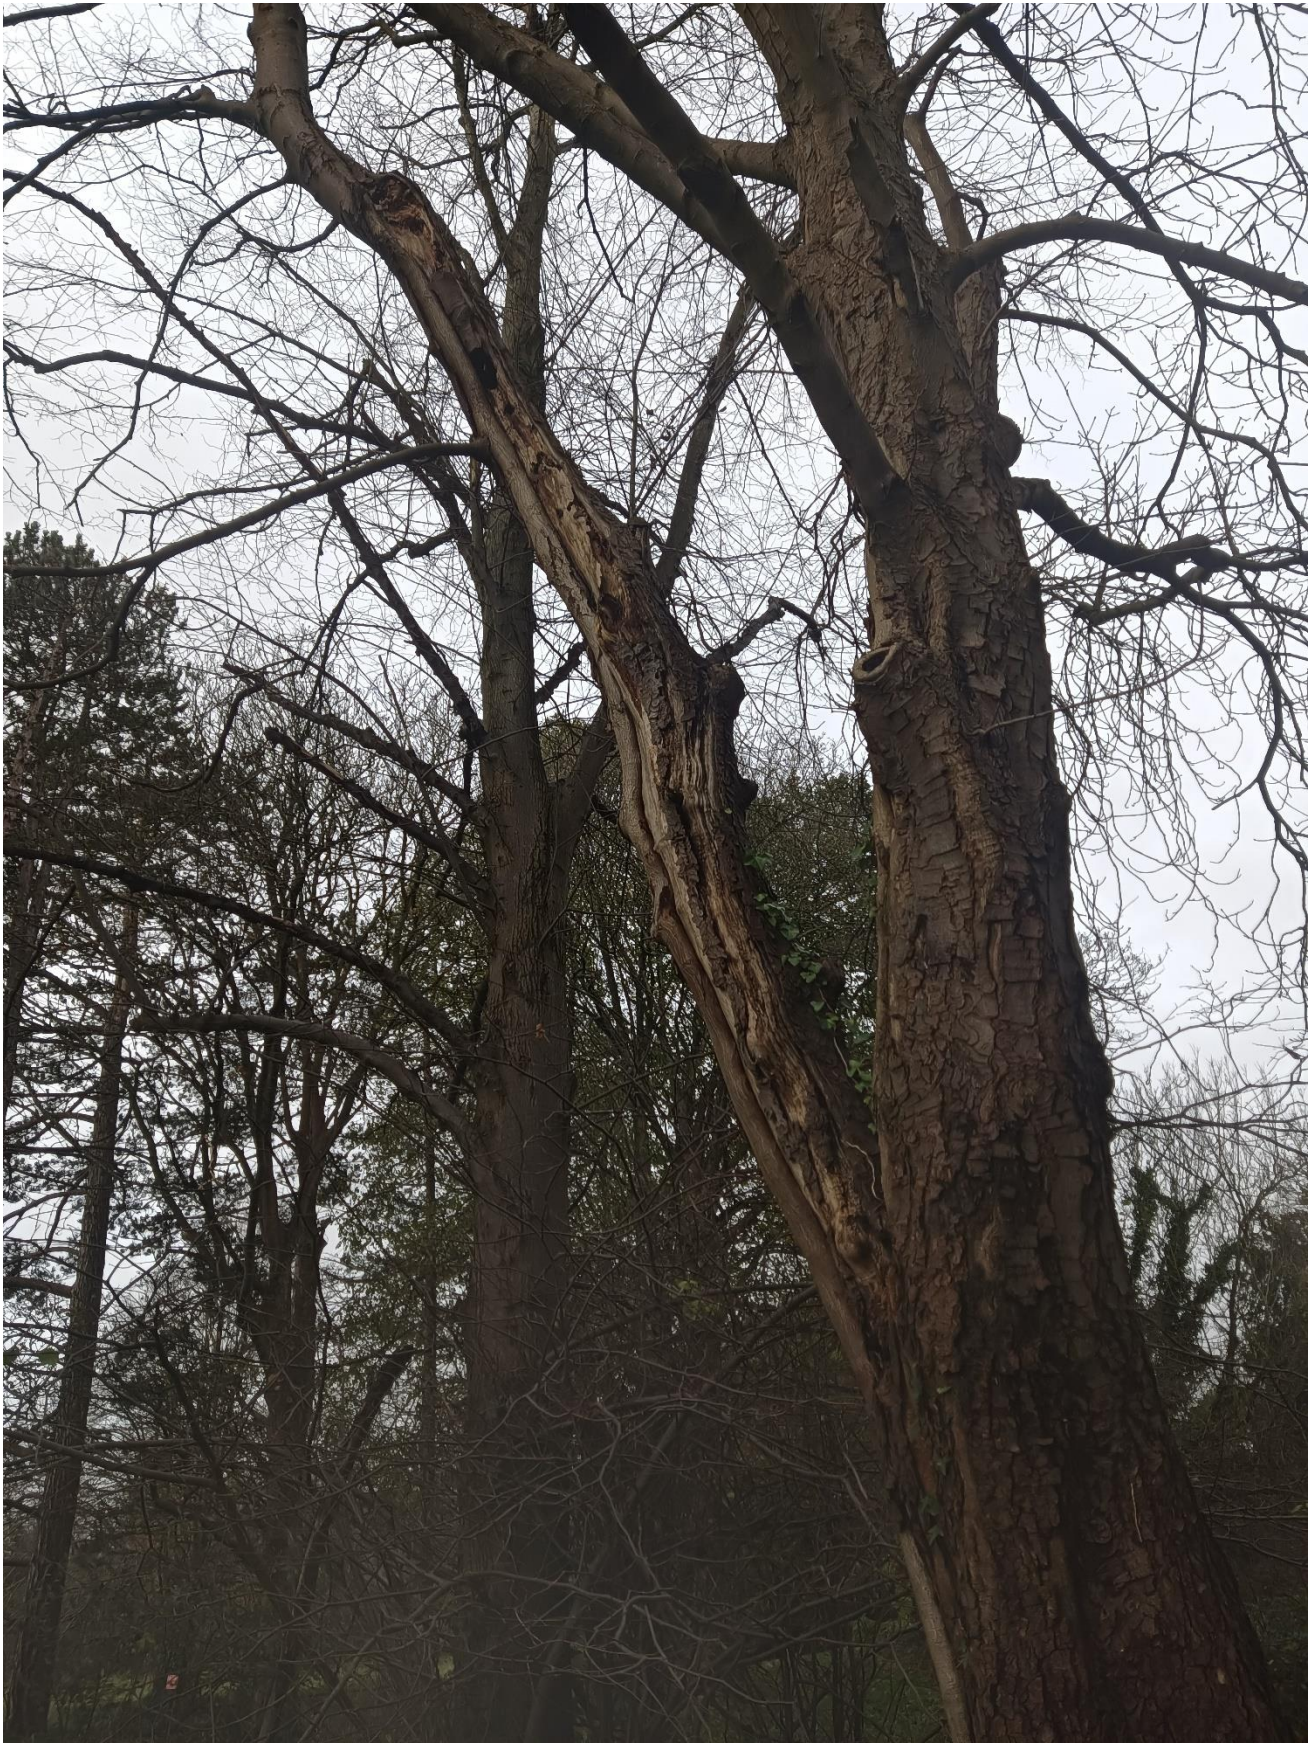
Two separate assessments were made here. The first was made of the decayed branch (see Figure 2 in Appendices) failing on to a pedestrian using the footpath. The pedestrian usage of the footpath was judged to be 2 – 7 per hour which placed it in target group “3”. The size range used was “2” as the diameter of the 1<sup>st</sup> order branch was 260 – 450mm. The probability of failure in the coming year was 1/100,000 – 1/1,000,000 which put it in range “3”. **These parameters gave a Risk of Harm (RoH) of 1/100,000 and so is unacceptable and requires management.**

4.1.2 Figure 2 – Horse Chestnut branch to remove in G21

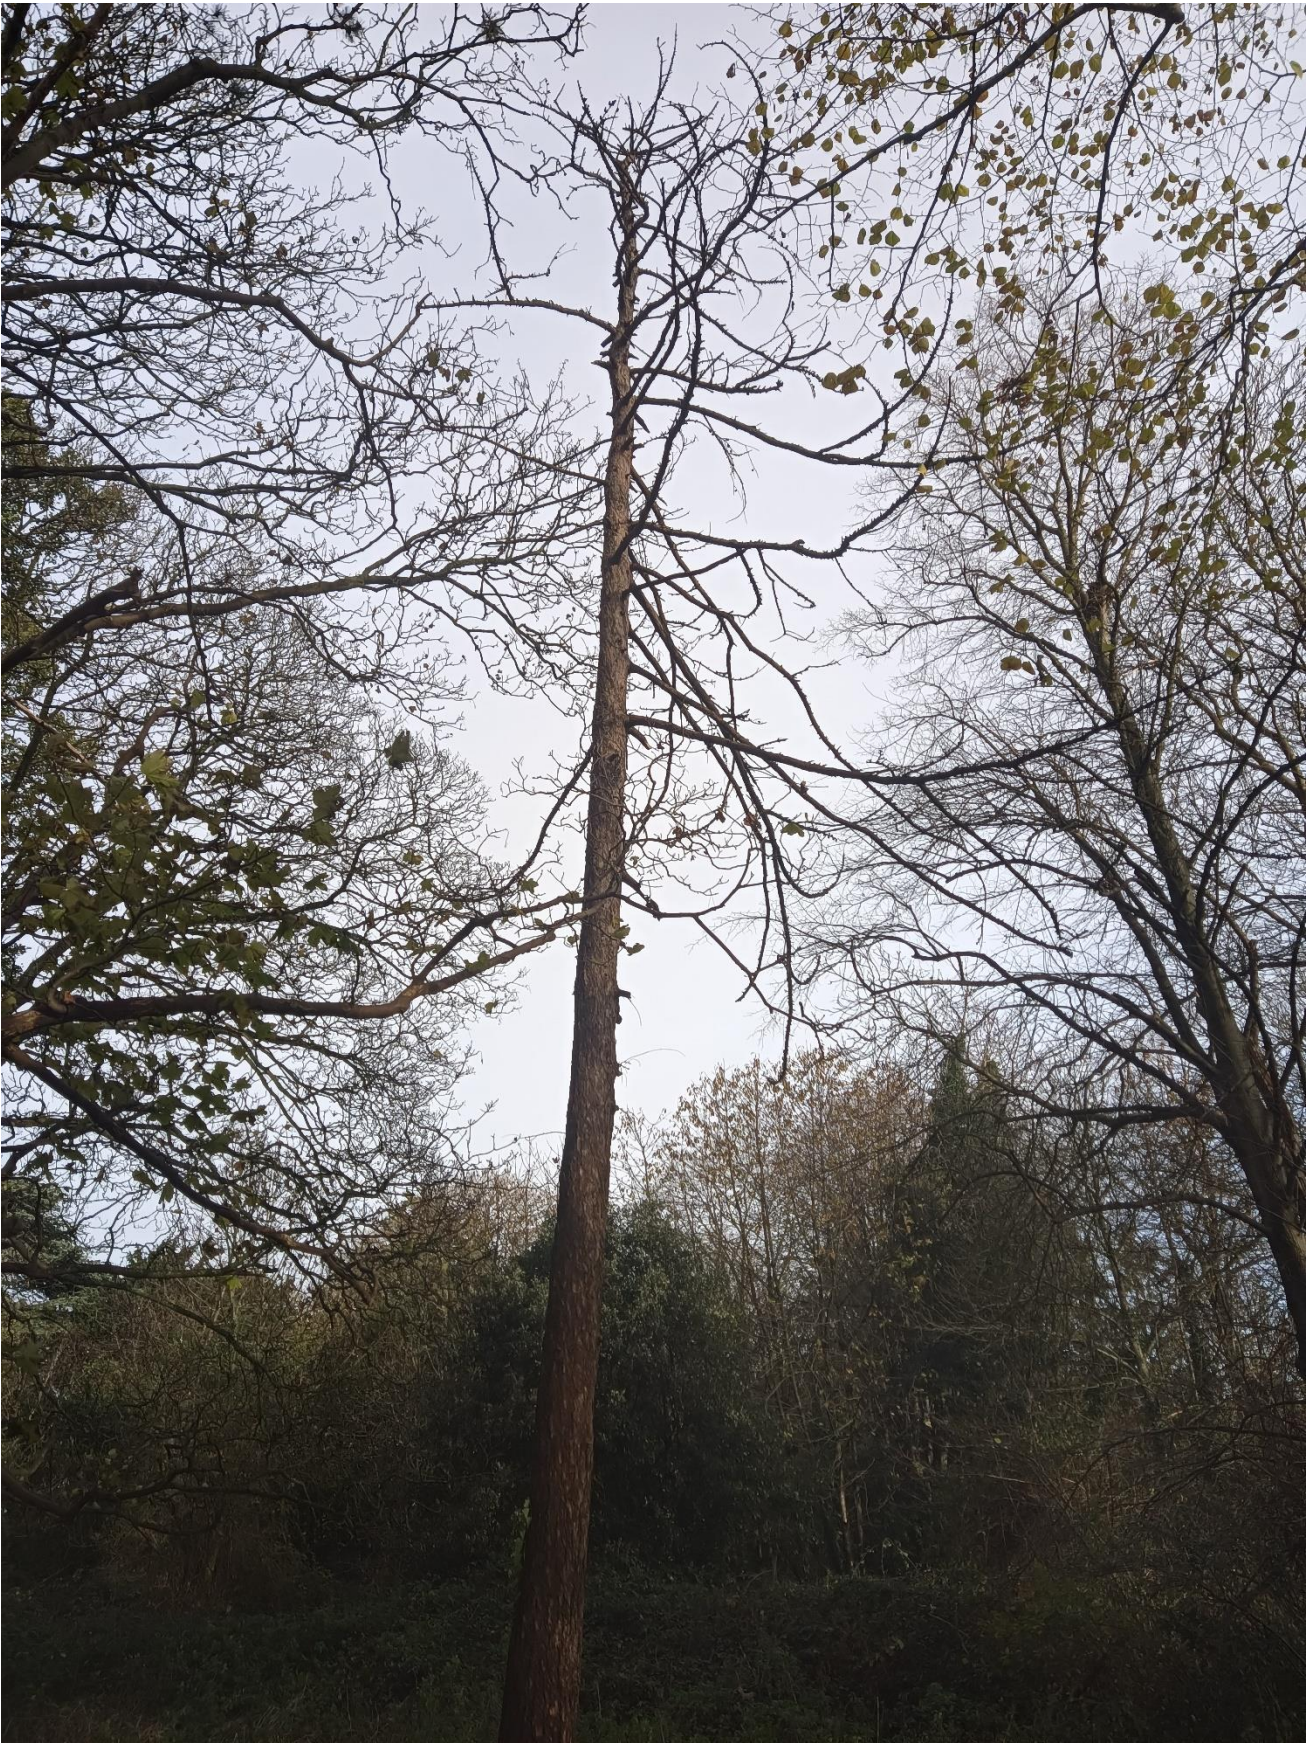
4.1.3 Figure 3 – Dead Larch in G22 to fell

G7 Mixed species		-Remove both pollarded willow and contorted willow	
G11 Mixed species		-Lift pine to 2m -Remove small rowan	
G12 Mixed species		-Lift Hornbeam to 2m	
G13 Mixed species		Remove 2 lowest limbs from cherry over footpath	
G14 Mixed species		Remove Leyland cypresses and consider replanting with broadleaf species	
G21 Mixed species	-Remove decayed limb on Horse chestnut (see Figure 2 in Appendices) -Remove decayed Horse chestnut (see Figure 1 in Appendices)	Remove Deadwood 50mm in diameter and larger	
G22 Mixed species		-Remove Deadwood 50mm in diameter and larger -Remove dead Larch (see Figure 3 in Appendices) -Remove hanging branch (See Figure 4 in Appendices)

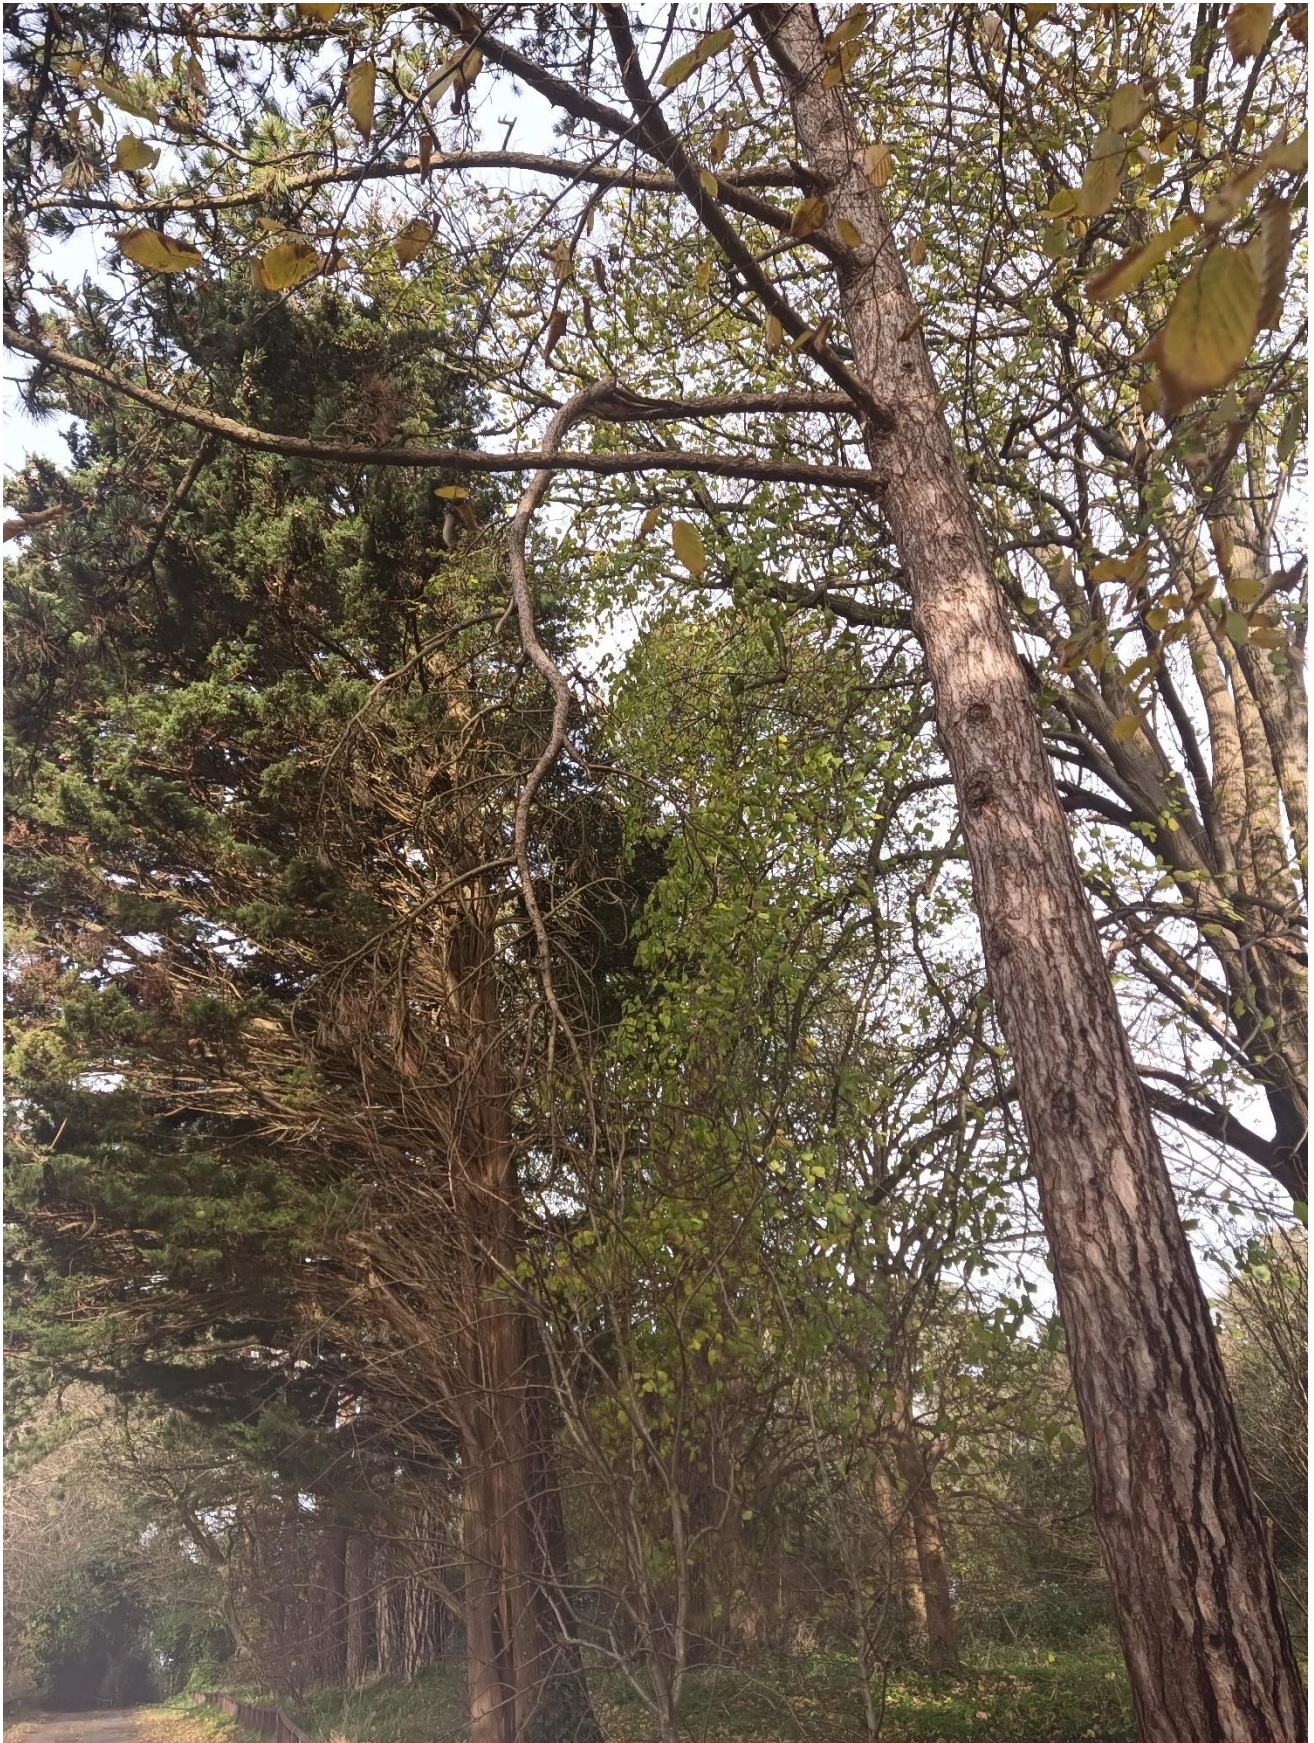
4.1.4 Figure 4 – Hanging Branch on Pine in G22

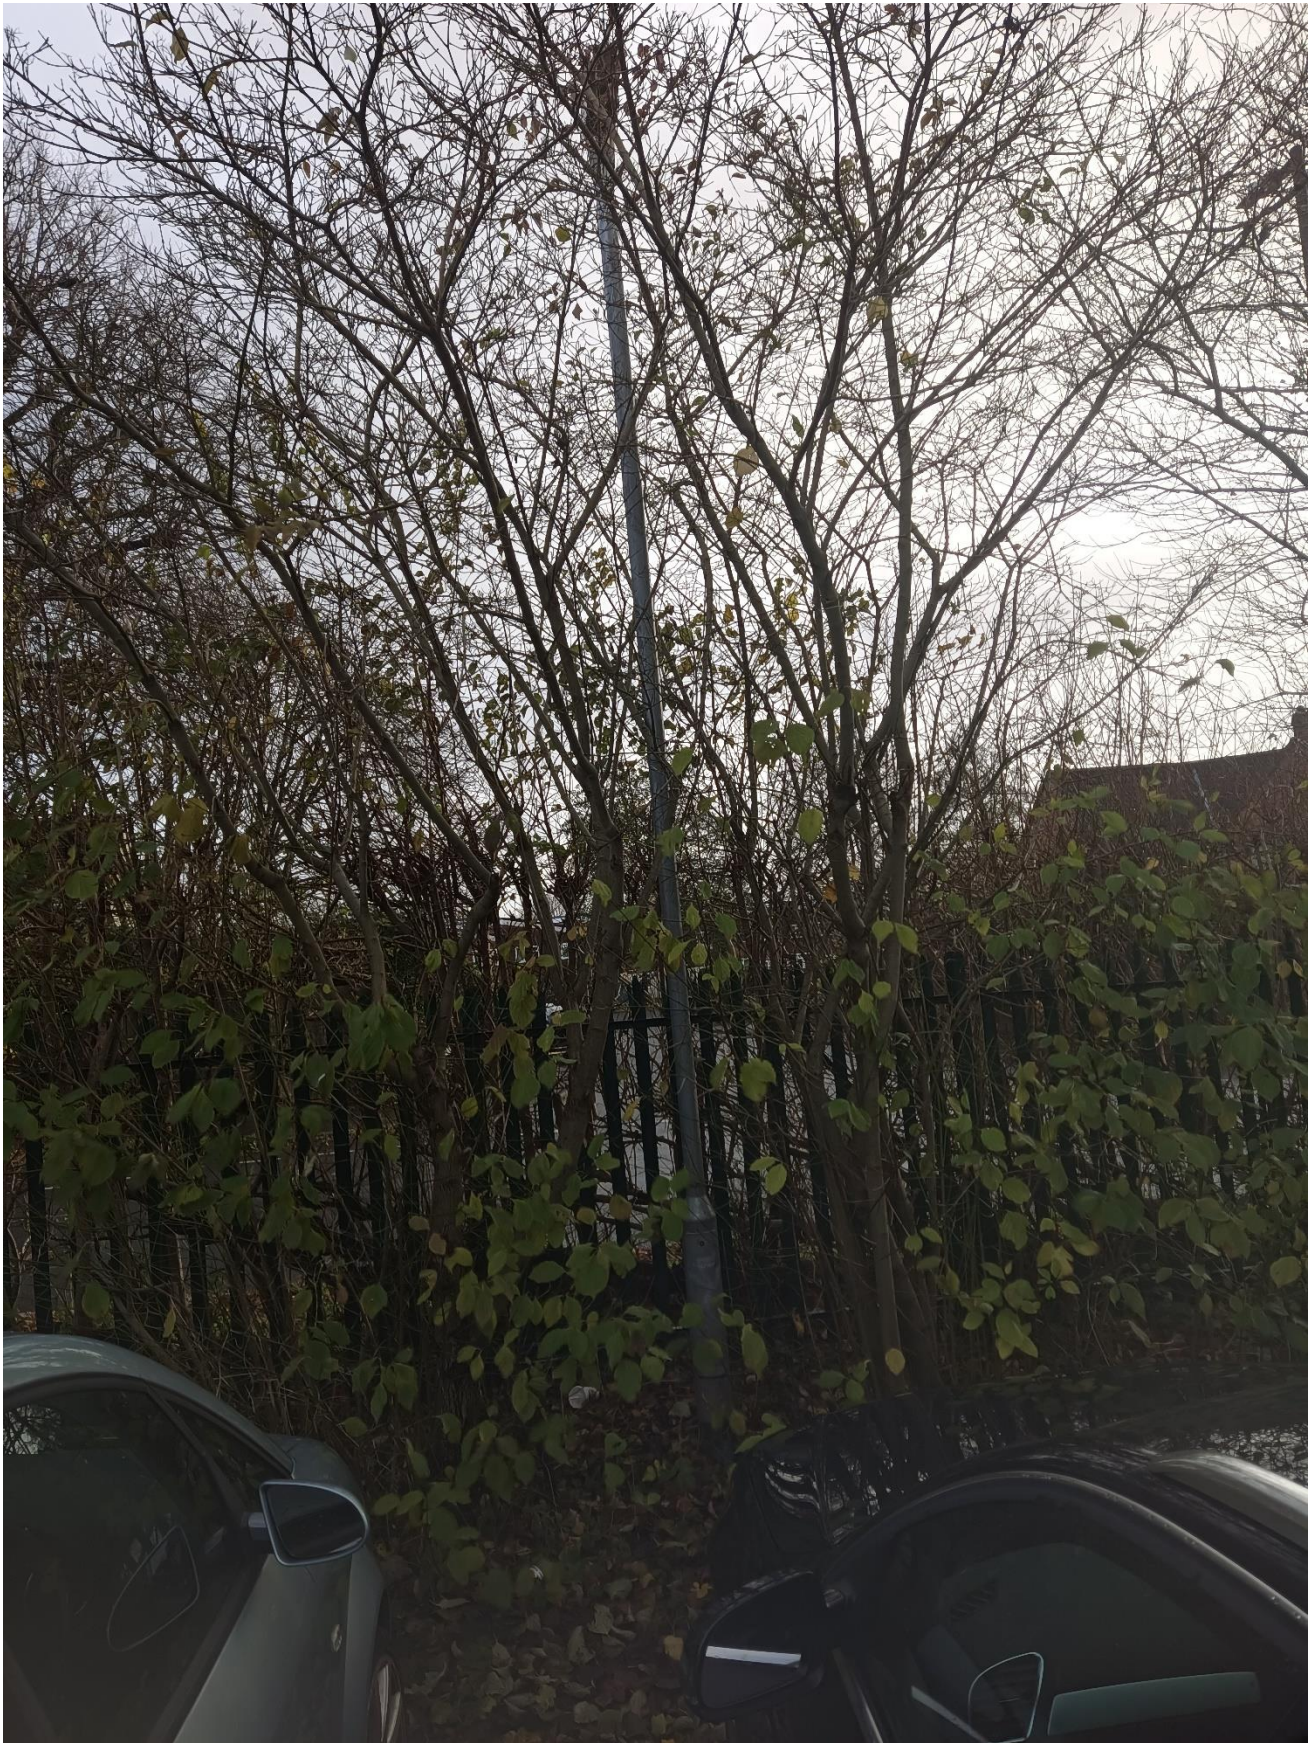
G5 was a large group of small trees and shrubs that are young to semi mature in age. They are growing on both sides of the main carpark entrance and along the edges of the carpark. It also includes the fan palms in the island directly in front of the main pedestrian entrance. The trees in this group are all very small and so present low risk of harm generally speaking. The Leyland cypress in the group has been planted beneath a light and is obscuring it. The cherries in the group on the western side of the car park both have cankers at their bases. There is also a large Dogwood that is obscuring a light.

4.1.5 Figure 5 – Dogwood Obscuring light in G5 to coppice

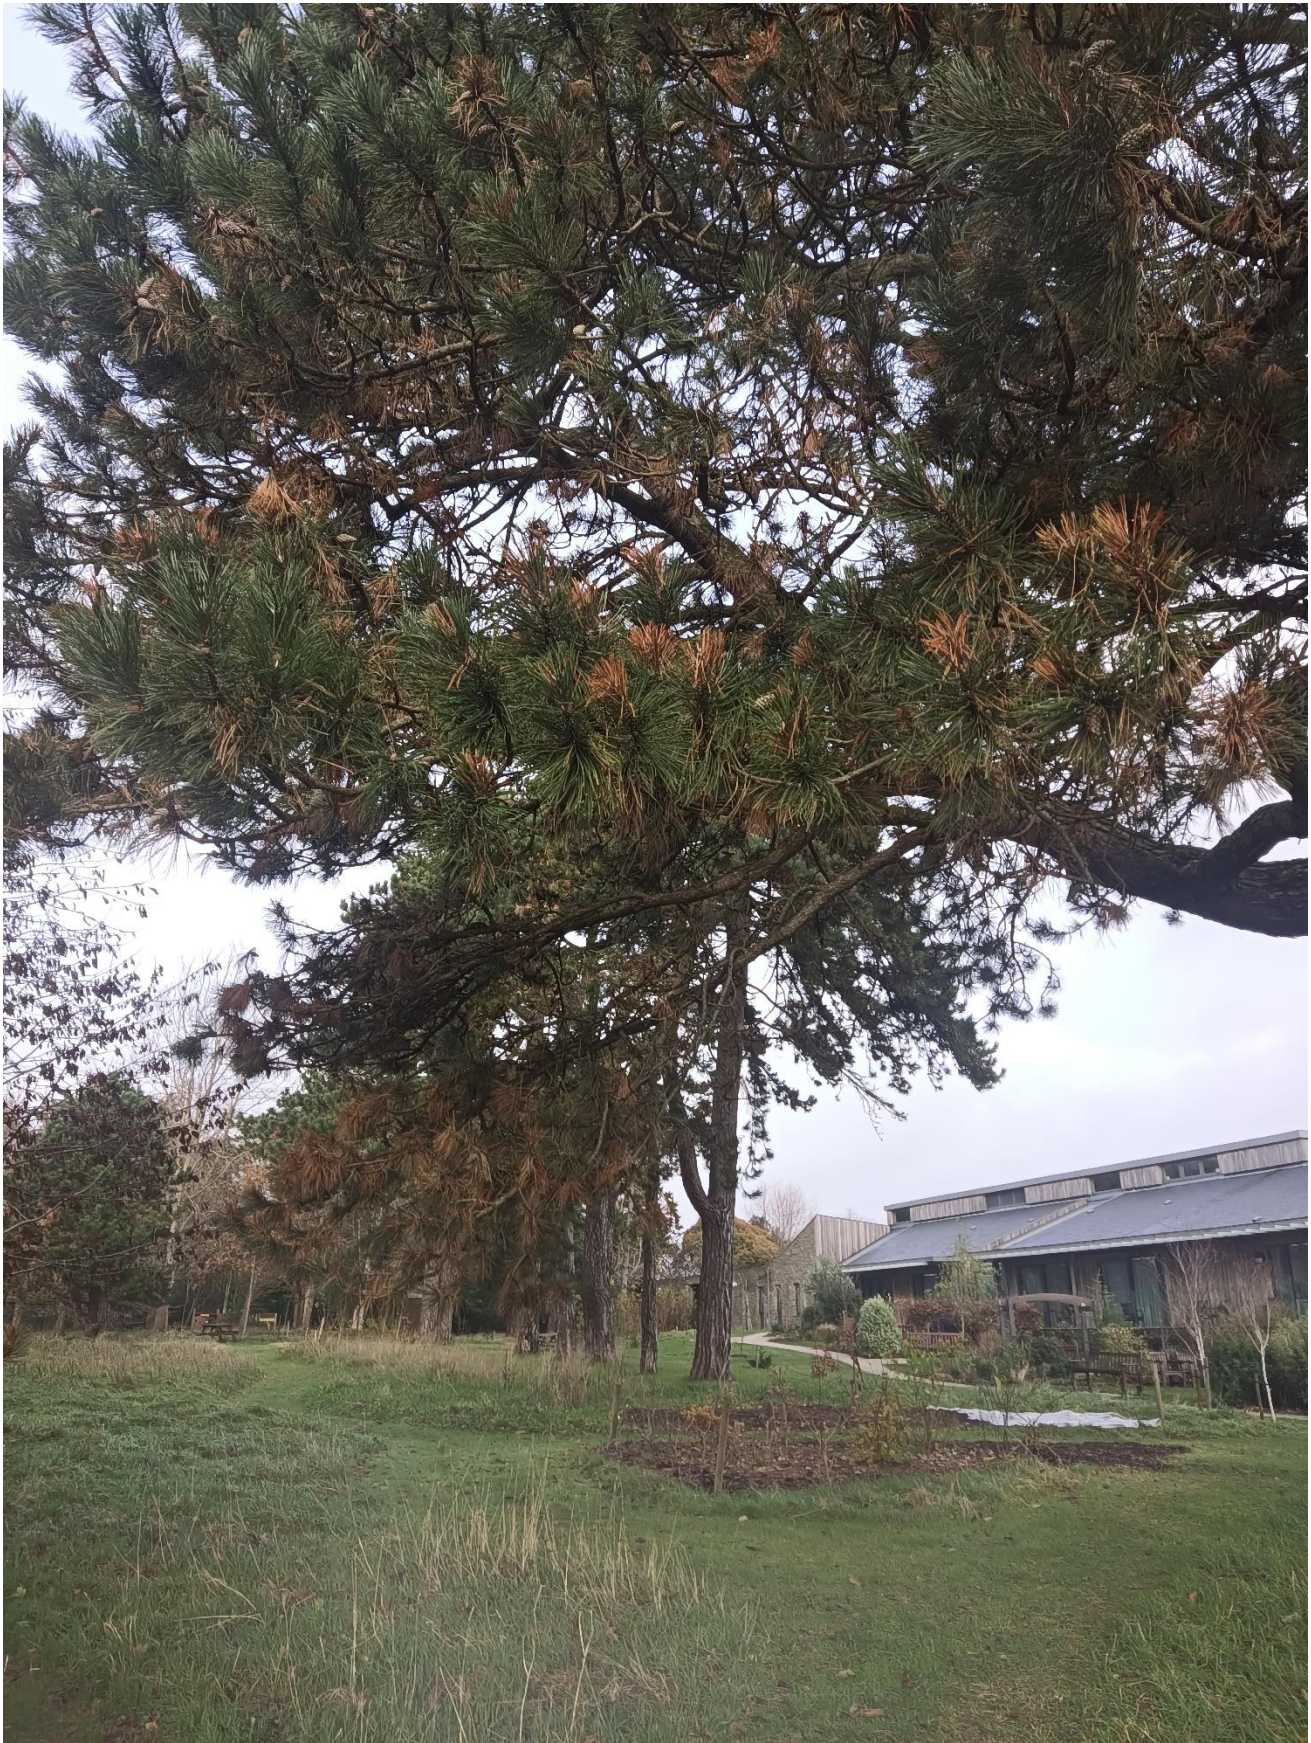
4.1.6 Figure 6 – Reddening needles on Pine in G10
