Report on St. Andrew's Church,  
Bishopstone,  
East Sussex.

By Chris & Rachel Butler

August 2023

- 1.2 Chris Butler Archaeological Services Ltd was commissioned by the PCC of Bishopstone Church to undertake an analysis of the west wall of the north aisle and the north wall of the tower, with a view to establishing dating and phasing, in connection with a potential planning application for a new toilet extension.

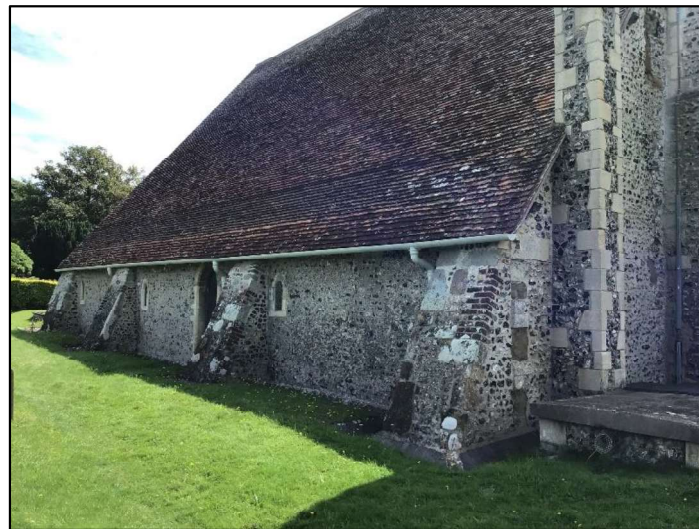
- 2.1 The north aisle was added in the 12<sup>th</sup> century (c1175) and is accessed from the nave through two arches pierced through the north wall of the nave<sup>6</sup>. There were originally six windows in the north and west walls of the north aisle, and Figg records that they were all blocked before 1849<sup>7</sup> at which time five were re-opened (Fig. 3) and provided with internal splays. The buttresses are shown in the 1849 plan (Fig. 2) so must have been present by this date but are likely to be of 18<sup>th</sup> or early 19<sup>th</sup> century date.

Fig. 3: The north aisle (note blocked window to left of western buttress)

- 2.2 The west end of the north aisle is used as a vestry with a wooden half height partition and door separating it from the remainder of the north aisle. This probably accounts for the western window in the north wall remaining blocked. The separate vestry existed in 1849, although Figg's plan suggests it was slightly smaller than the current vestry.

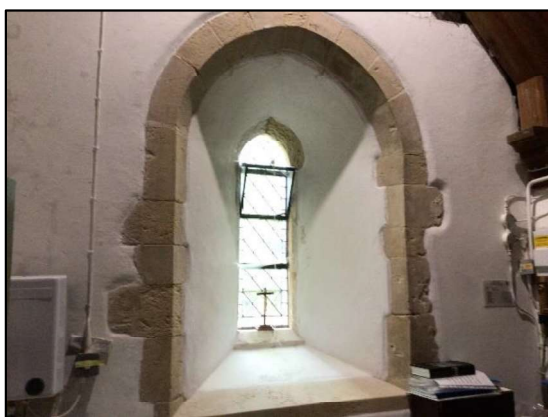
Fig. 4: Window in west wall of aisle interior

- 2.3** The window in the west wall of the north aisle has clearly been replaced after 1849, and it is possible that the wall was thickened on the interior at the same time to accommodate the wide splayed design (Fig. 4), although it is of similar thickness to the north wall. Externally the stonework forming the window surround is unworn, and relatively fresh looking, consistent with a 19<sup>th</sup> century date (Fig. 5 & Fig. 7 (D)). The upper part of the wall inside is much thinner, and probably the original wall (Fig. 6). The interior of the lower west wall is covered in plaster and the upper part is whitewashed so it was not possible to investigate this wall any further from the inside. It should be noted that the east wall of the aisle, which also had its window replaced after 1849, is noticeably thinner than both west and north walls.

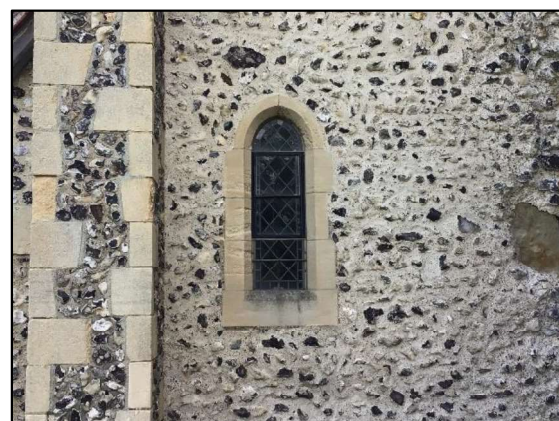
Fig 5: Window exterior west wall of aisle

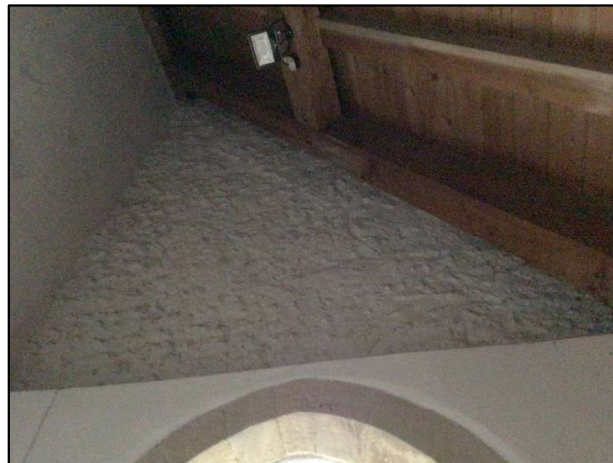
Fig. 6: Upper part of internal west wall of aisle

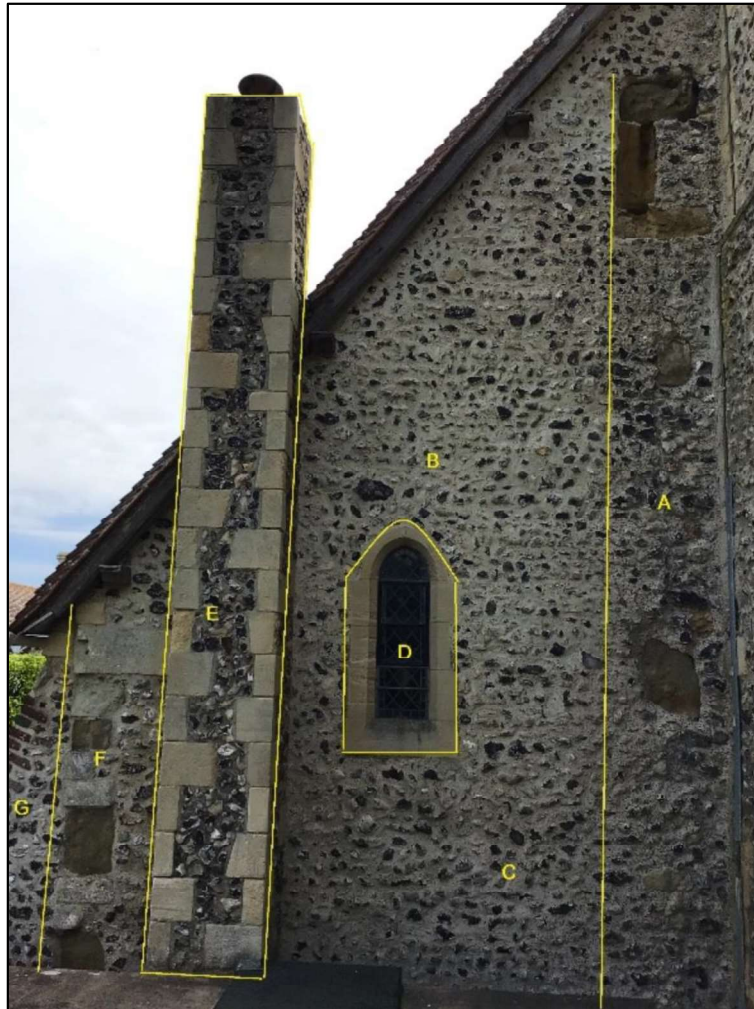
Fig. 7: West wall of aisle exterior

- 2.4** On the exterior of the west wall of the aisle the different phases of construction and alteration can be seen. The earliest evidence is the northwest corner quoin of the Saxon nave; a number of large stone pieces making up the long and short work of the quoin are exposed (Fig. 7 (A)). The flint wall between the quoin and tower wall is irregularly coursed, typical of early flint rubble wall construction. Part of the quoin has been covered with a flint facing in a lime mortar using predominantly knapped flint pieces, something that began in the later 13<sup>th</sup> or 14<sup>th</sup> century<sup>8</sup>.

- 2.5** Between the quoin and the chimney the wall is formed of regular flint courses (Fig. 7 (B)). The presence of some knapped flint and a fresh unworn lime mortar, suggests that this part of the wall has been re-faced, in part or completely, in the 19<sup>th</sup> century, probably at the same time the window was replaced. The evidence confirms that this window was replaced and was not a new insertion. The core of the original 12<sup>th</sup> century wall is likely to survive behind this re-facing. The flint coursing in the lower part of the wall (Fig. 7 (C)) is more irregular, although the mortar is the same as in the wall above, and may be the original 12<sup>th</sup> century wall repointed.

- 2.6** The chimney (Fig. 7 E)) does not appear on the 1849 plan, so seems likely to have been added in the later 19<sup>th</sup> or more likely in the 20<sup>th</sup> century when the boiler room was added.

- 2.7** The northwest corner of the north aisle (Fig. 7 (F)) has a stonework quoin consistent with the 12<sup>th</sup> century date of the aisle, and possibly re-using stonework from the original Saxon structure. The exposed flint wall between the quoin and chimney is formed of irregular flint courses and is similar to that along the north wall of the aisle, again consistent with its 12<sup>th</sup> century date. The buttress against the north wall at the west end (Fig. 7 (G)) is formed of different materials, including stone, flint and bricks and is probably of 18<sup>th</sup> or early 19<sup>th</sup> century date.

- 4.1** The west wall of the north aisle is essentially of 12<sup>th</sup> century date and incorporates the surviving northwest quoin of the Saxon nave. A chimney has been added in the 20<sup>th</sup> century, and the window was re-modelled in the 19<sup>th</sup> century, being enlarged and with a new surround. At the same time it appears the lower part of the wall was thickened internally, probably to take the enlarged internal splay. The external face of the wall also appears to have been re-faced at this time, although the lower part of the wall appears original.

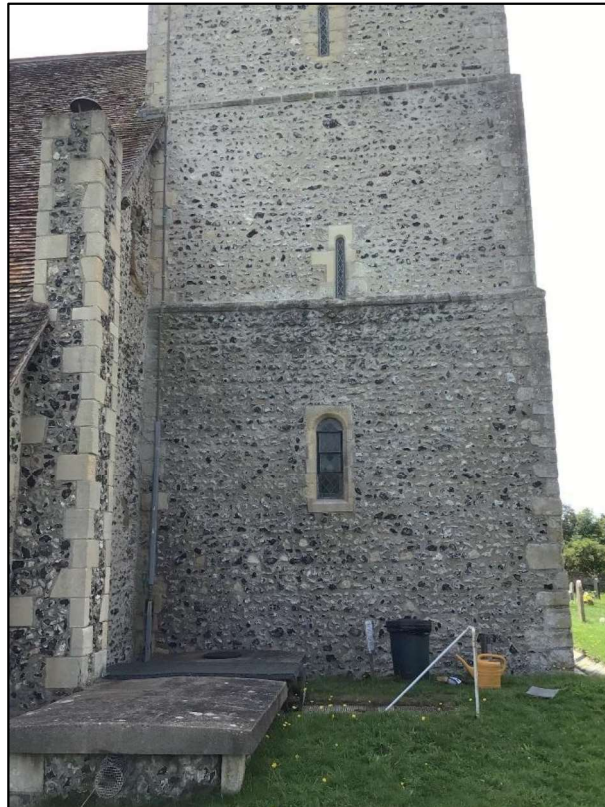
Fig. 8: North wall of tower

- 3.2 The exterior of the north wall of the tower (Fig. 8) appears to be original, although it may have been repointed with new mortar in the 19<sup>th</sup> century. There is a suggestion that originally the external walls may have been covered with coat of plaster which was removed in the 19<sup>th</sup> century<sup>10</sup>. The window in the lower stage is 19<sup>th</sup> century, those in the upper stages are original, although with some recent stonework replacement/repairs.

- 4.2** The exterior of the north wall of the tower appears to be original, although it may have been repointed with new mortar in the 19<sup>th</sup> century when the plaster coating was removed. The window in the lower stage is of 19<sup>th</sup> century date.

- 4.3** A below ground boiler room exists in the external angle between the west wall of the aisle and north wall of the tower (Fig. 8) with steps down. This was inspected and found to be of 20<sup>th</sup> century construction. It is separate from the church structure and has had no impact on either wall or the foundations, although its chimney abuts the west wall.

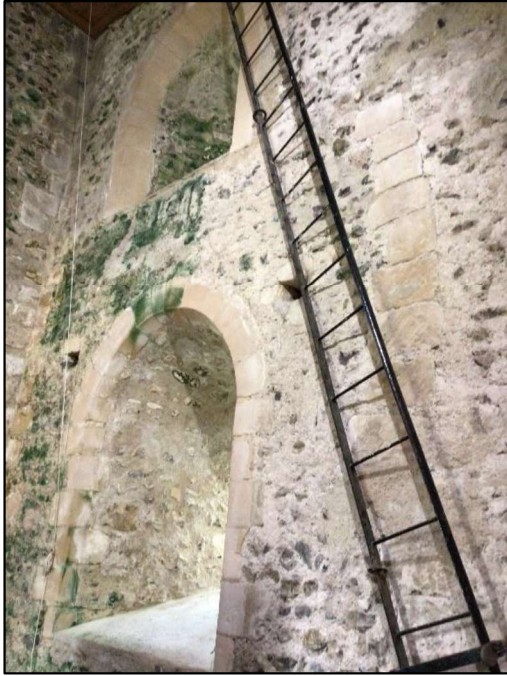
- 3.3 Inside the tower the decayed 19<sup>th</sup> century plaster was removed during the 2006 renovation to expose the north flint wall of the first stage (Fig. 9). An unusual feature was revealed comprising a column of roughly dressed blocks of Caen stone towards the east end of the north and south walls of the tower, rising from the floor to the top of the first stage (Figs. 9 & 10). This feature is only visible internally, and does not extend

through to the exterior face of the walls. It has been suggested that it was intended as a brace inserted during construction of the tower to throw the weight of the tower away from the thinner Saxon walls of the nave<sup>11</sup>.

Fig. 9 North tower wall interior lower stage

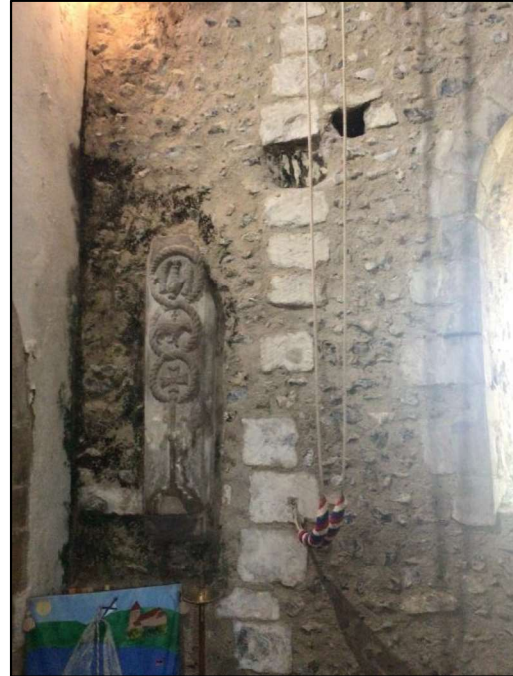
Fig. 10: Tower south wall
