# Rosehill Barn, Longwood, Owslbury, Winchester, SO211JS

Vesper Conservation & Ecology Limited 20/02/2024

Phase 1 & 2 Bat Surveys (PRA, BAS):

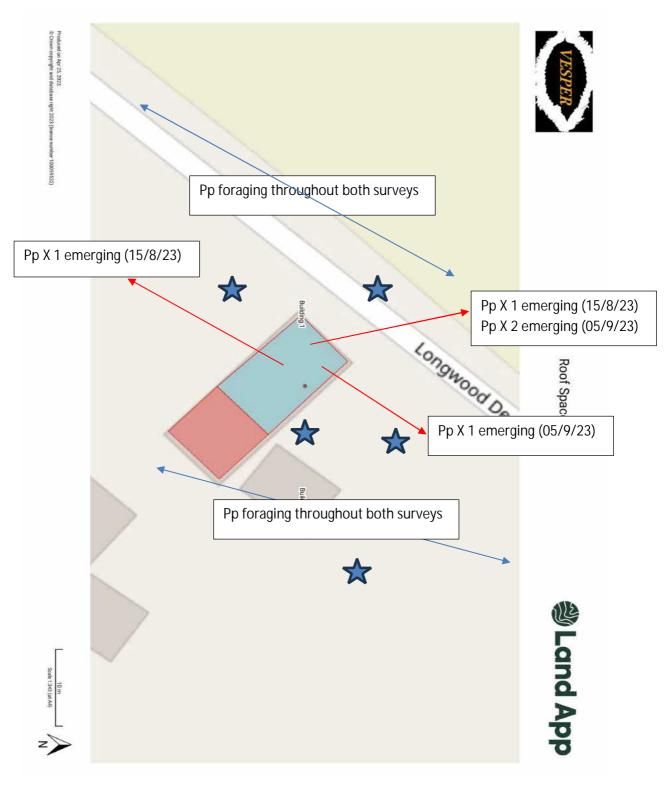
Figure 1: Dusk Surveys summary map (for the activity surveys 15/08/23 and 05/09/23)

- 3.3 Due to the size of the building 1 and its irregular shape three surveyors were used and sited around the house to cover all possible elevations of the building. Building 2 had 2 surveyors to cover all the angles. All the surveyors used Anabat Walkabout bat detectors, EM touch pros or Batlogger to record any hard to identify bats. Night vision aids were used to help identify any difficult to see areas.
- 3.4 During the first dusk survey (15/08/23) 1 species were recorded (Common pipistrelle bats). 2 x Common Pipistrelles seen emerging from the building, One from near the apex of the northwestern elevation, one from under the ridge on the southwestern elevation of building 1. (See Figure 1) (Peter Allan, Rob West, Jake Cousins, Des Purdy, Richard Codlin)

- 3.5 During the second dusk survey (05/09/23) 2 Species of bat were recorded (Common and Soprano Pipistrelle bats). 1 x Common pipistrelle bat was seen emerging from under the lead flashing near the ridge on the northeastern elevation. 2 x Common pipistrelle bats were seen to emerge form near the apex on the northwestern elevation of building 1. (See Figure 1) (Rob West, Peter Allan, Des Purdy, Jake Cousins, Richard Codlin.)

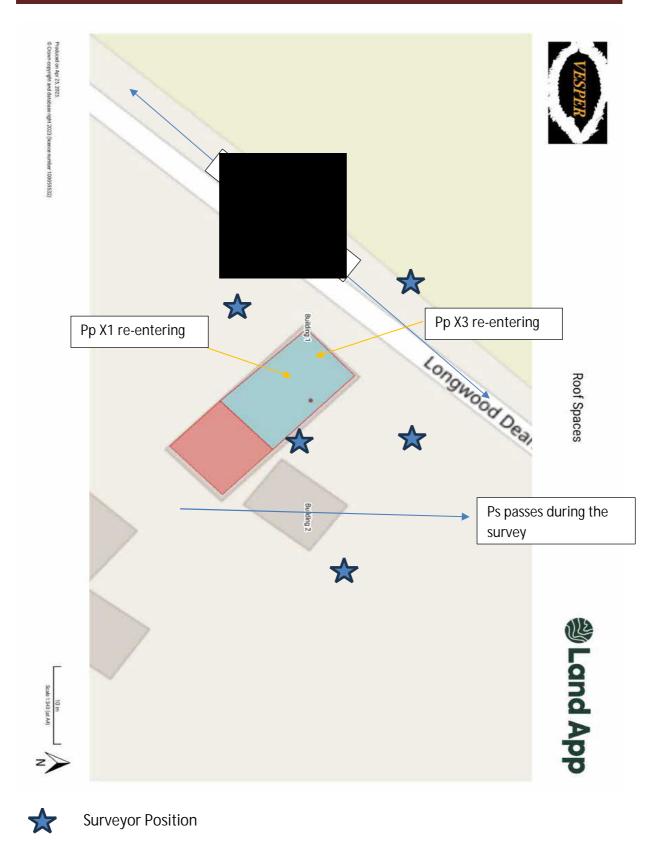
Figure 2: Dawn Survey summary map (for the activity survey 18/07/23)

- 3.6 During the dawn survey (18/07/23) 2 species were recorded (Common and Soprano pipistrelle bats). 1 x Common pipistrelle was seen to re-enter under lead flashing next to the chimney on the southwest elevation, 3 x Common pipistrelle bats were seen to re-enter near the apex on the northwestern elevation of building 1. (See figure 2). (Rob West, Peter Allan, Des Purdy, Jake Cousins, Richard Codlin.)

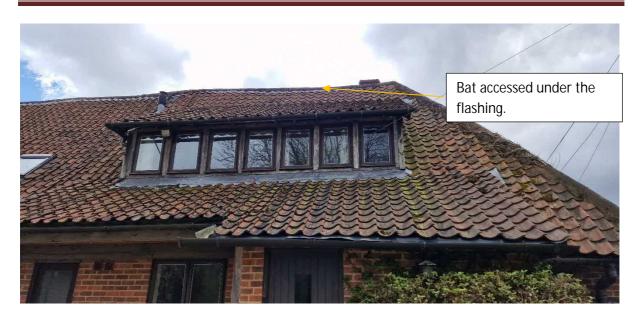
- 2.6 There is a double dorma window on the north-eastern elevation this has pan tile roof and the cheeks are clad in wooden weather boarding this weather boarding is warped and could allow ingress into the building.

Picture 1: Looking at the front of building 1 showing the dorma window

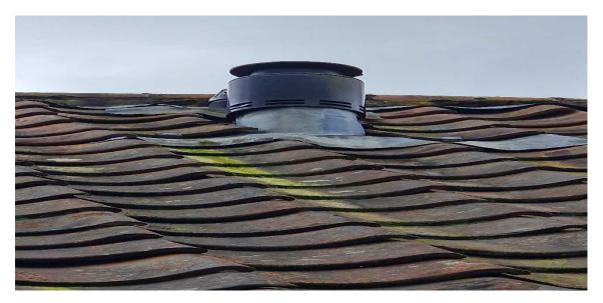
- 2.5 The main roof of building 1 is covered with pan tiles, there are numerous gaps along the eaves and there are missing and lifted tiles on all elevations that could allow ingress into the building. The ridge is constructed from the same materials as the roof and there are gaps which could allow ingress into the building.

Picture 2: Showing the gaps under the tiles on the front elevation of building 1

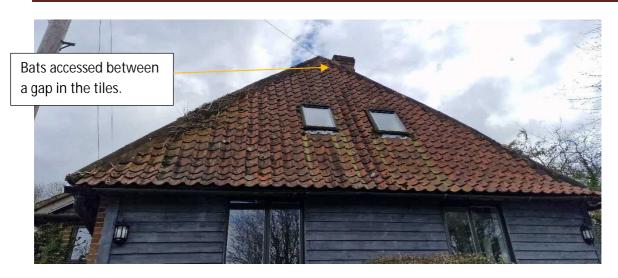
- 2.7 The north-western elevation has hipped roof and the ridge tiles on the hip are tight fitting with no gaps or holes that would allow ingress, there are two velux type of windows which are tight fitting with no obvious gaps or holes that would allow ingress.

Picture 3: Showing the north-western elevation. (Building 1)

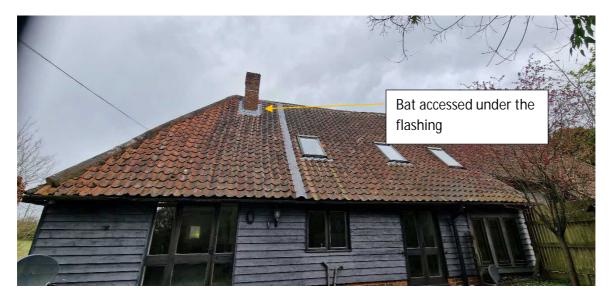
- 2.8 The south-western elevation has three velux style windows which are tight fitting with no obvious gaps or holes. The roof tiles seem tighter on this elevation but there are a few gaps that could allow ingress. There is a chimney on this elevation with lead flashing around it, there are gaps around the flashing.

Picture 4: Showing the south western elevation of building 1.

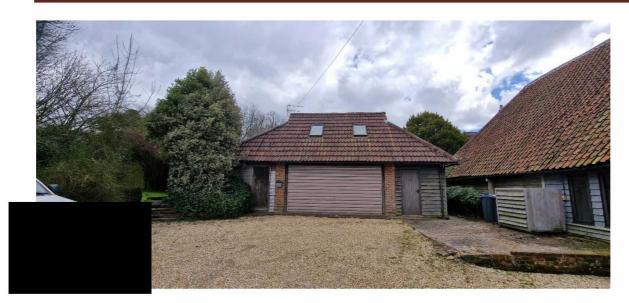
- 2.12 The roof is covered with the same tiles as the building 1, but the tiles are tighter fitting with some holes and gaps that would allow ingress into the building.

Picture 5: Showing the western elevation of building 2

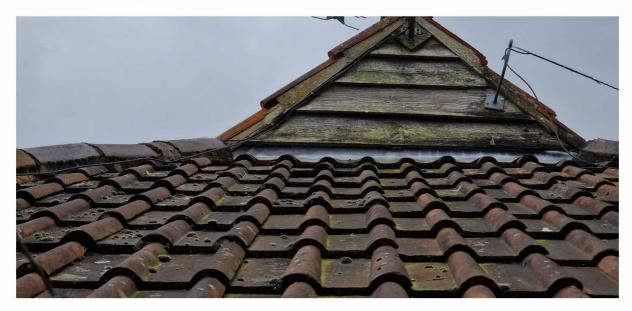
- 2.13 The building has two small apexes which have wooden weather boarding, this weather boarding has a few gaps. The tile verges on the apexes are in the main tight fitting, there is some missing cement from the northern elevation.
- 2.14 Both the buildings have gaps and holes that would allow ingress into the buildings, so they have potential for bats to be roosting with in the fabric of the buildings.

**Picture 6:** showing the weather boarding and the missing cement on the tile verge (building 2)

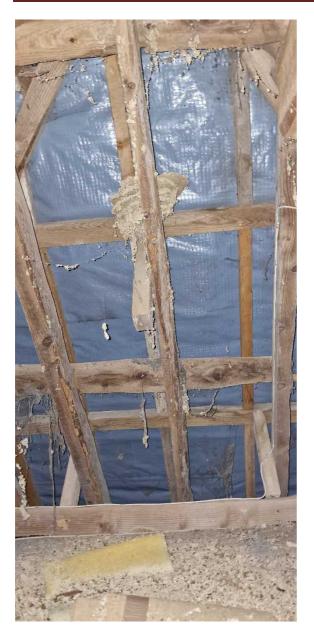
- 2.16 Roof space 1 has a plastic membrane backing the tiles, this roof was redone in the 1980s.
- 2.17 This roof space has thick cob webbing through out there are signs of rodent and wasp activity in the roof. No physical evidence of bats was recorded.

Picture 7: Showing the roof membrane in roof void 1

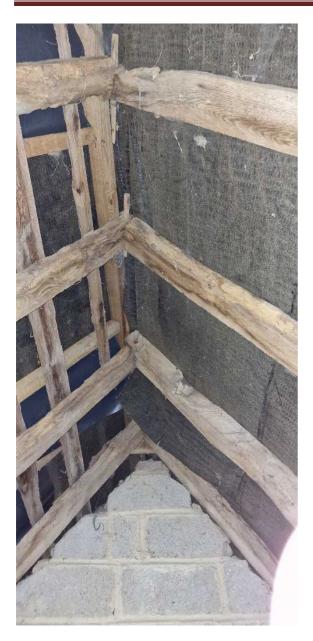
- 2.19 Roof space 2 had easy access, this part of the roof was not redone at the same time as the other roof, there is a felt membrane that backs the tiles.

Picture 8: Showing the roof membrane in roof void 2
