Tree Code: Sgl/013649

Common Name: Lime spp

Site: St Johns Avenue, Harlow

St Johns Avenue Harlow Resistograph readings

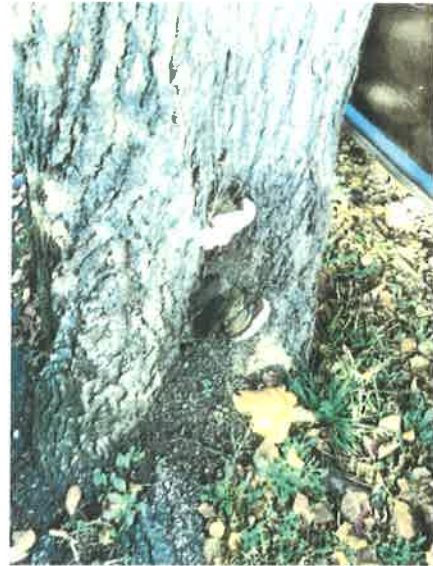
Condition: Poor

Conditions: Crown - Branch Decay
Crown - Fungus
Crown - Low branches
Crown - Lapsed Pollard
Crown - Major Deadwood >5cm
diam/1m length
Crown - Minor Deadwood <>5cm
diam/1m length
Crown - Pollard
Crown - Previous crown reduction
Roots - Fungus
Trunk - Epicomics/suckers

Comments: Overall vitality is poor, defoliation and decay within canopy. Ganoderma located at base of trunk and within crown. Sound tested to reveal extensive hollowing within the main stem and internal decay. Further testing decay detection testing recommended to investigate structural integrity and condition.

Recommendations: Fell Tree to Ground Level

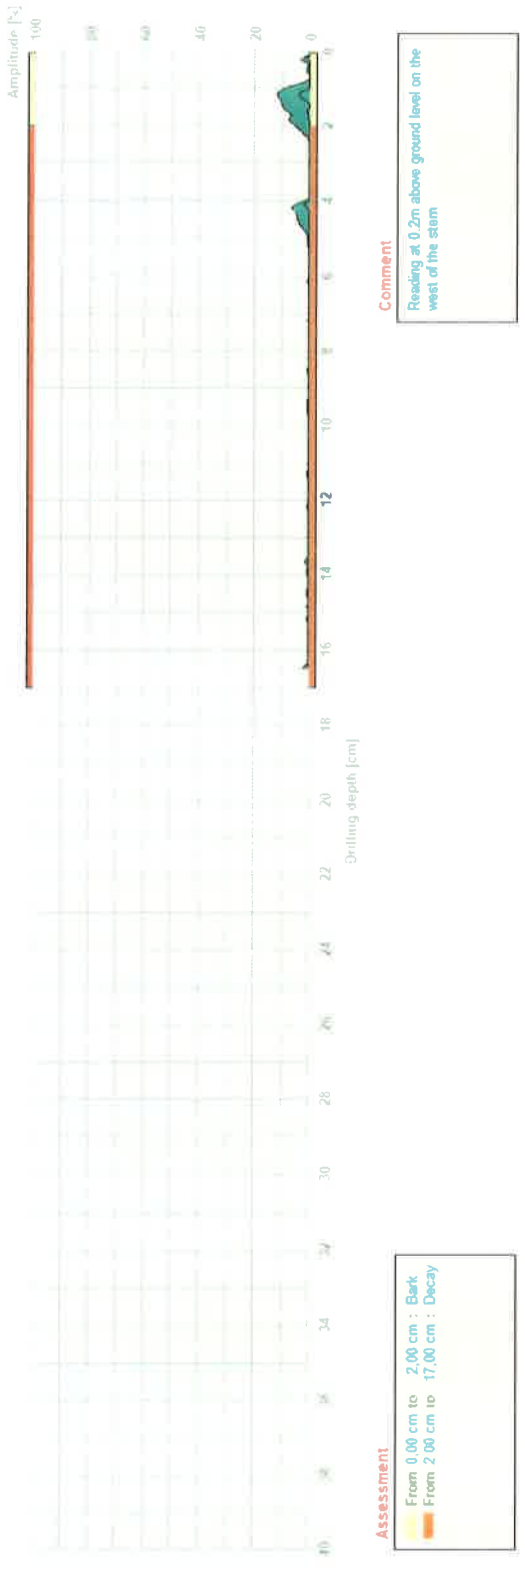
Readings 1 and 2 (Figures 1 and 2) were taken into the west of the main stem adjacent to the footway and evidence little residual wood fibres, with decay throughout. The measurements were ended prematurely based on the little resistance offered against the drill, as evidenced by little to no amplitude in the measurements, suggesting intensely decayed internal fibres.

Figure 2 Resistograph readings taken at 0.2m above ground level on the north of the stem.

Given the position of this tree adjacent to the footway and carriageway along St Johns Avenue, the proximity to resident car parking and private residential properties, as well as overhead cabling, it is recommended that this tree is felled and replanted.

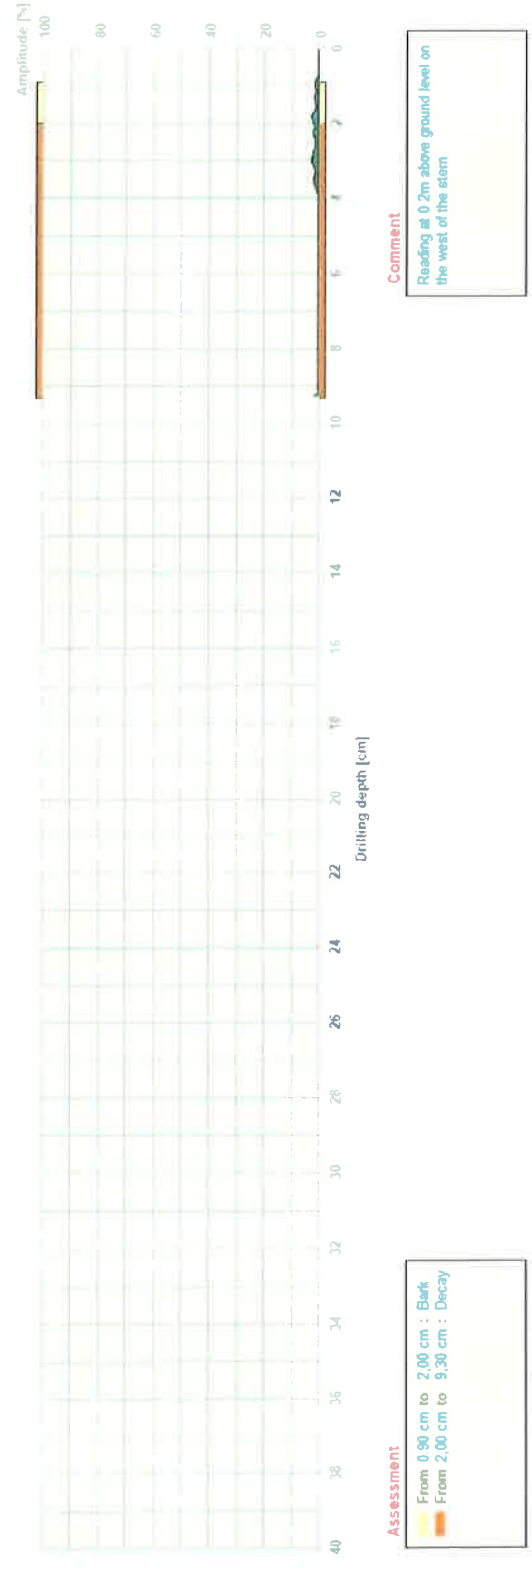
Figure 1 Resistograph readings taken at 0.2m above ground level on the northwest of the stem.
