Forester and Arborist Services Ltd

Inspection of trees on Benefice Land

Record of Remedial Work Proposed and Completed

Inspection date 11.07.2022

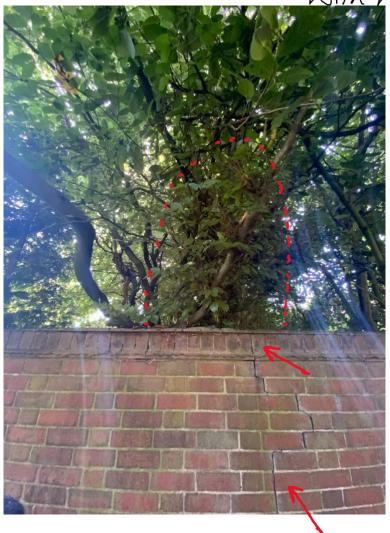
Tree No.	Species	Growth stage	Condition	Date inspected	Action required	Priority level	Date completed
G1	Laurel and beech	Early mature	Growing on neighbouring property Root: not visible from property boundary. Stem: multiple stems. No. Of stems in contact with the boundary wall, which has caused significant displacement and damage to the brickwork Crown: No recent breakouts or dieback. Risk Assessment: number of stems are growing into the boundary wall and are causing damage to the brickwork, which will result in failure of the wall n the near future.	ZA 11.07.2022	Contact the neighbouring property to oraganise the removal of the stems causing damage to the wall. Make good to wall to avoid further damage Inspect within 5years or following named storms Refer to photo detail.	3

GI-Remove Stevis in Contact With Wall
