Subject: Pendley Farm, Tring. Plots 1-4 Garden validation

Our ref: L-22473-2.4.2-24-232-KRP

This letter reports the results of a verification inspection of remedial activities with regards soil contamination in gardens areas of Plots 1 through to 4 inclusive, of the above development.

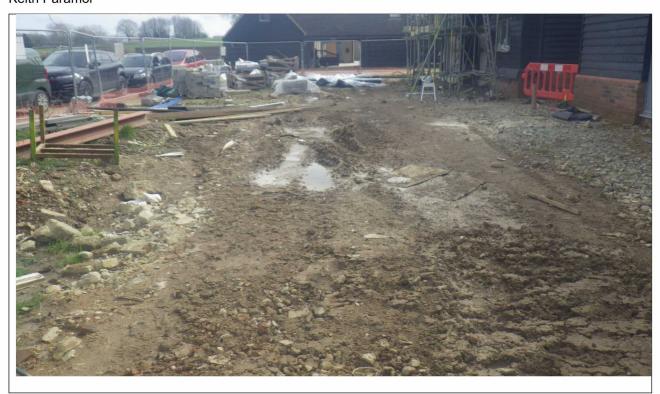
General view east of buildings

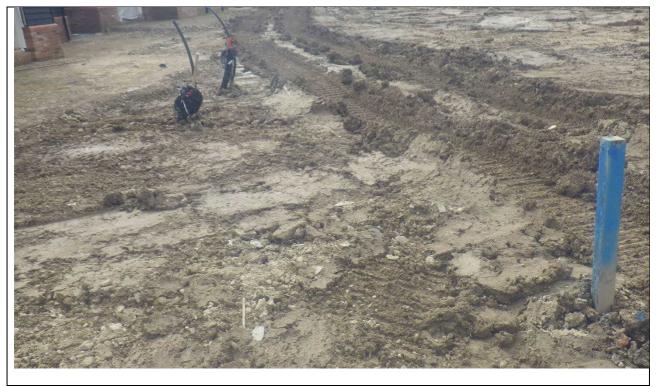
General view north of buildings

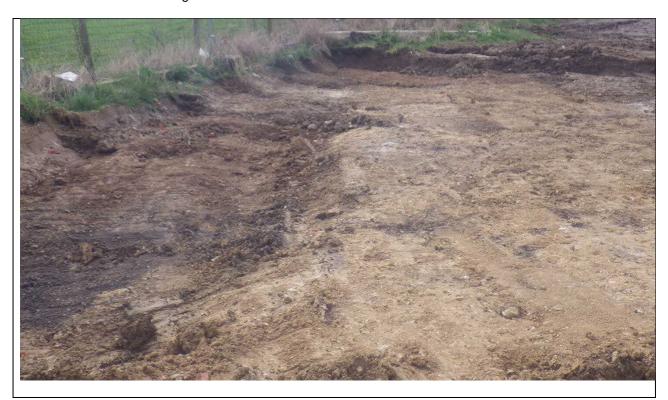
Reduced level dig Plot 1

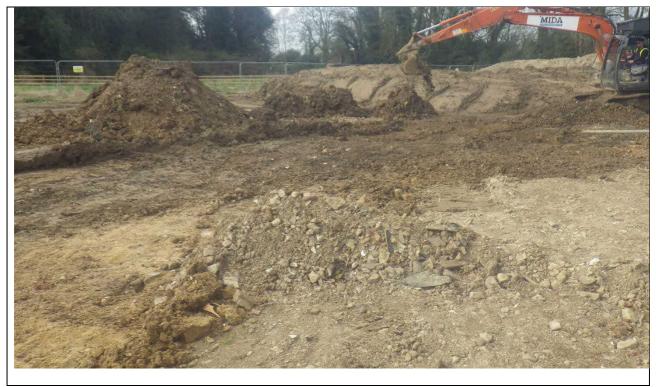
Reduced level dig Plot 1-2 looking west

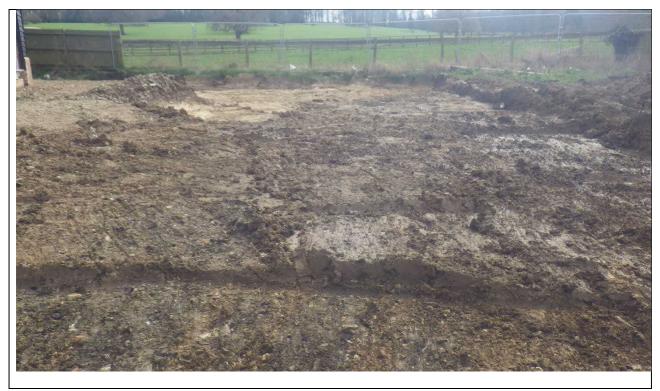
Reduced dig plot 1 garden looking south

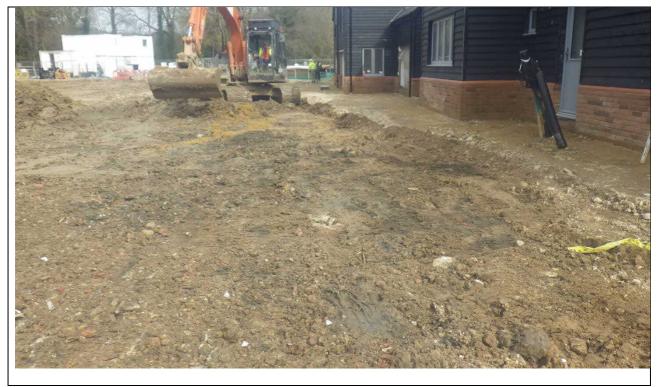
Reduced dig Plots 3 and 4 gardens

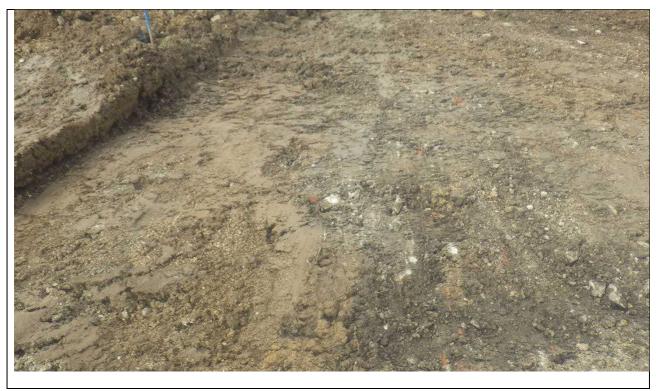
Reduced dig formation

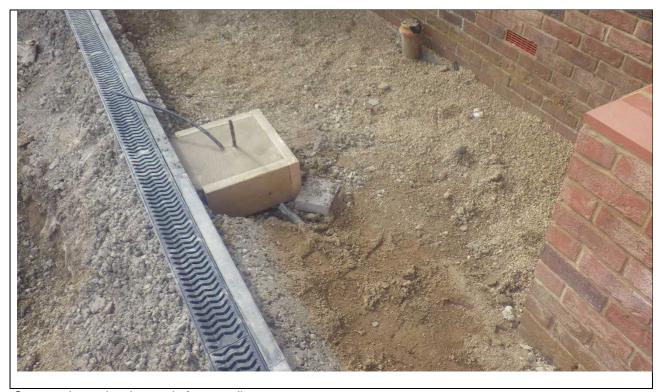
Courtyard area border ready for topsoil

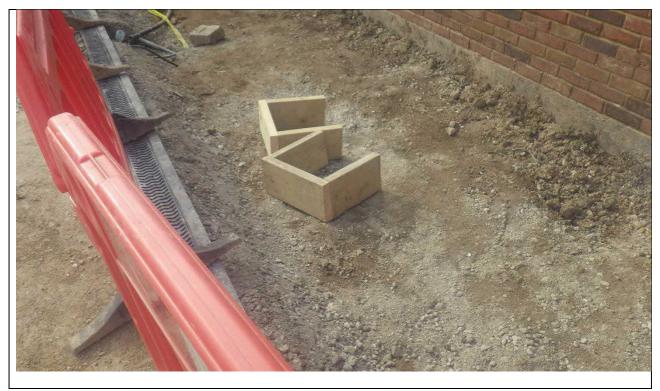
Courtyard area border ready for topsoil
