**Phase 4 Verification Report**  
for  
**The Proposed Development of 4  
No. Detached Dwellings**  
on the site of  
**Former Builders Yard, Cropwell  
Road, Langar, Nottinghamshire  
NG13 9HD**

**Date: February 2024**

Reference: 3606A P4 G S Dev Services – Langar

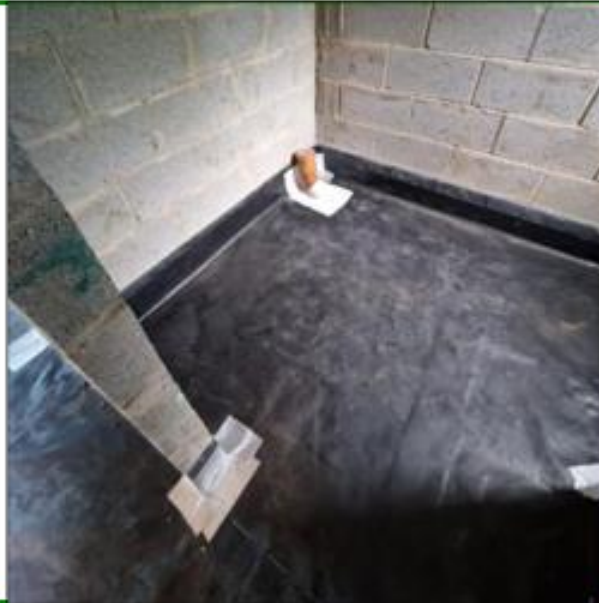
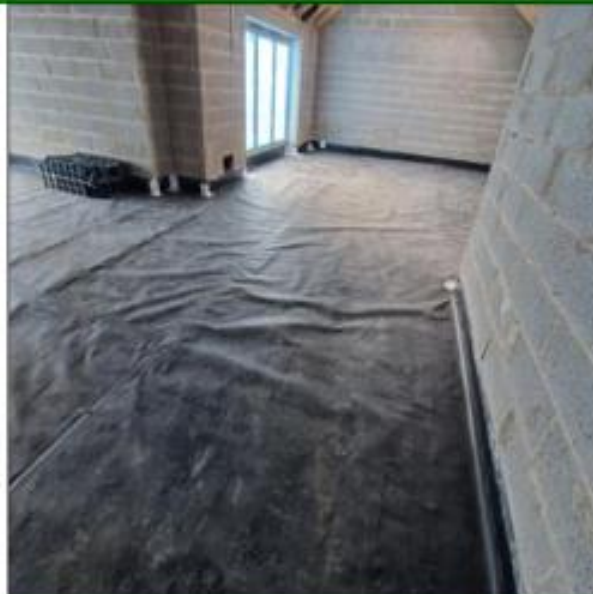
#### Plot 1

Castledine initially attended site on the 25<sup>th</sup> July 2023 in order to inspect Plot 1; however, due to a number membrane repairs required within Plot 1, the membrane was unable to be passed. After a meeting with Dampotec, (the membrane installer for the development) on the 1<sup>st</sup> August 2023 and following recommendations from Castledine in order to remediate the situation, the membrane in Plot 1 was then re-examined following repairs and passed on the same date.

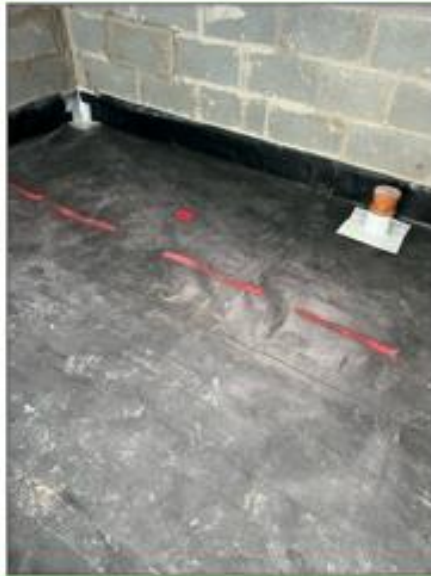
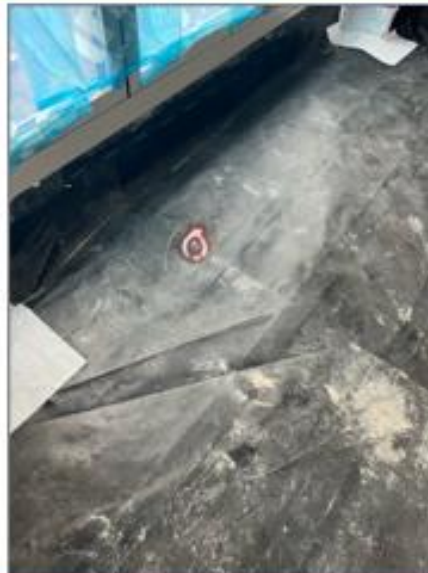
An inspection for Plot 2 was first conducted on the 17<sup>th</sup> August 2023; however, the plots were deemed to be incomplete and following recommendations from Castledine, a number of repairs were also required. These were completed and a second inspection was completed on the 4<sup>th</sup> September 2023, after which the membrane was deemed to have passed.

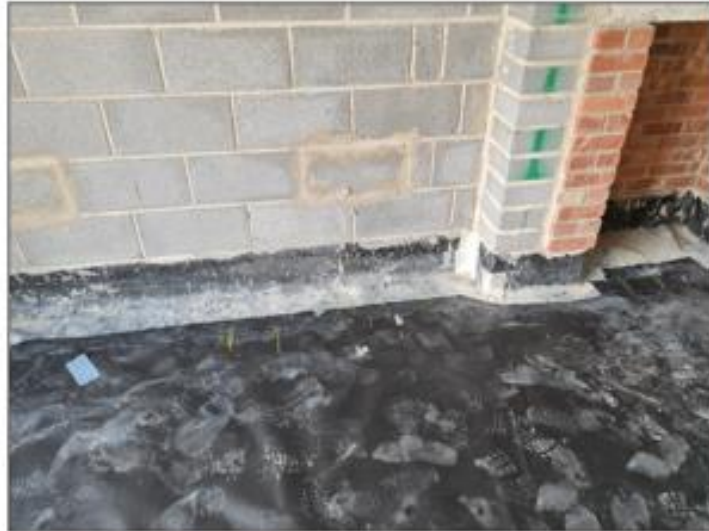
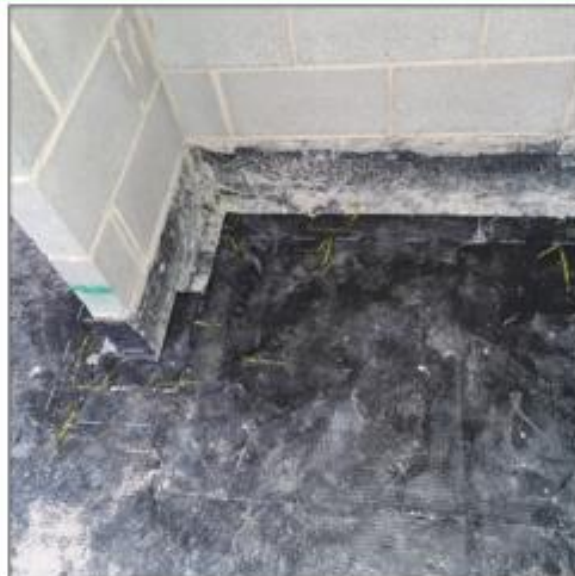
Plot 3 was initially inspected on the 20<sup>th</sup> November 2023; however, a number of repairs to the membrane was considered necessary. Castledine reattended site on the 22<sup>nd</sup> November, at which time repairs were still ongoing. Castledine remained onsite while final repairs were undertaken and the membrane was inspected and deemed to have passed on the same date.

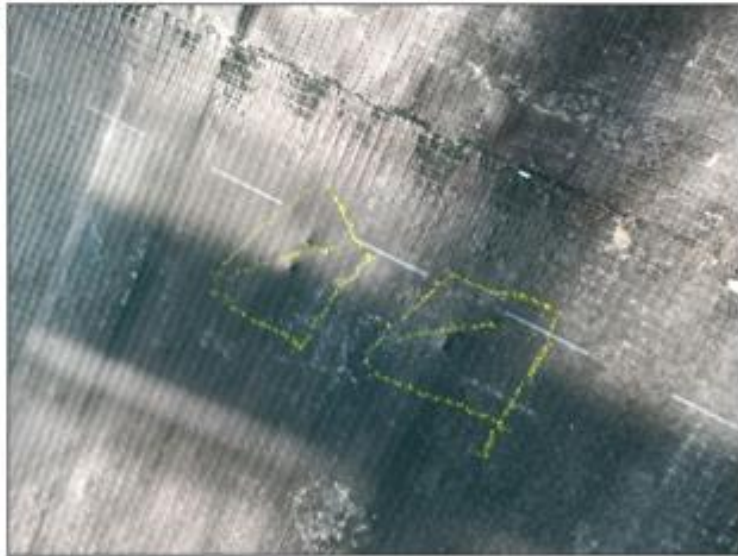
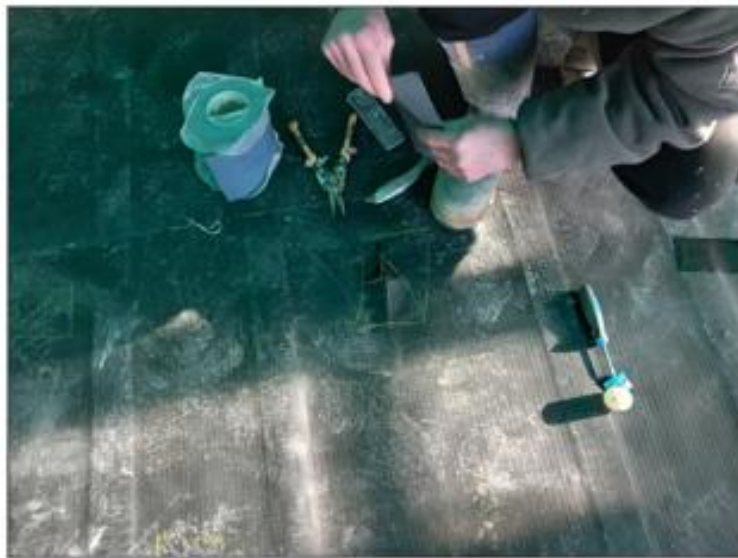
Plot 4 was inspected on the 1<sup>st</sup> February 2024. Whilst repairs were required following an initial inspection, repairs were deemed to be necessary. Castledine remained onsite until repairs were completed, after which the membrane was passed.
