11-17 Wade Street, Bristol

Discharge of Planning Condition 10 (LPA Ref: 21/01065/P and
Appeal Ref APP/Z0116/W/21/3282706)
Pre-Commencement Highway Condition Survey

March 2024

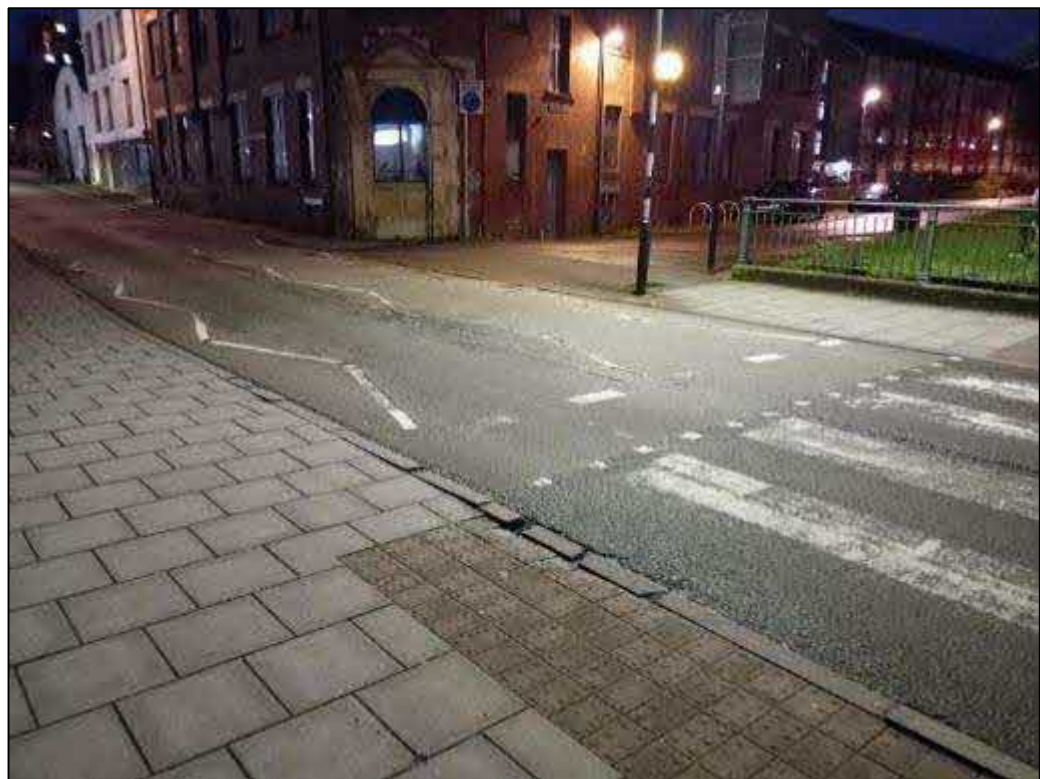
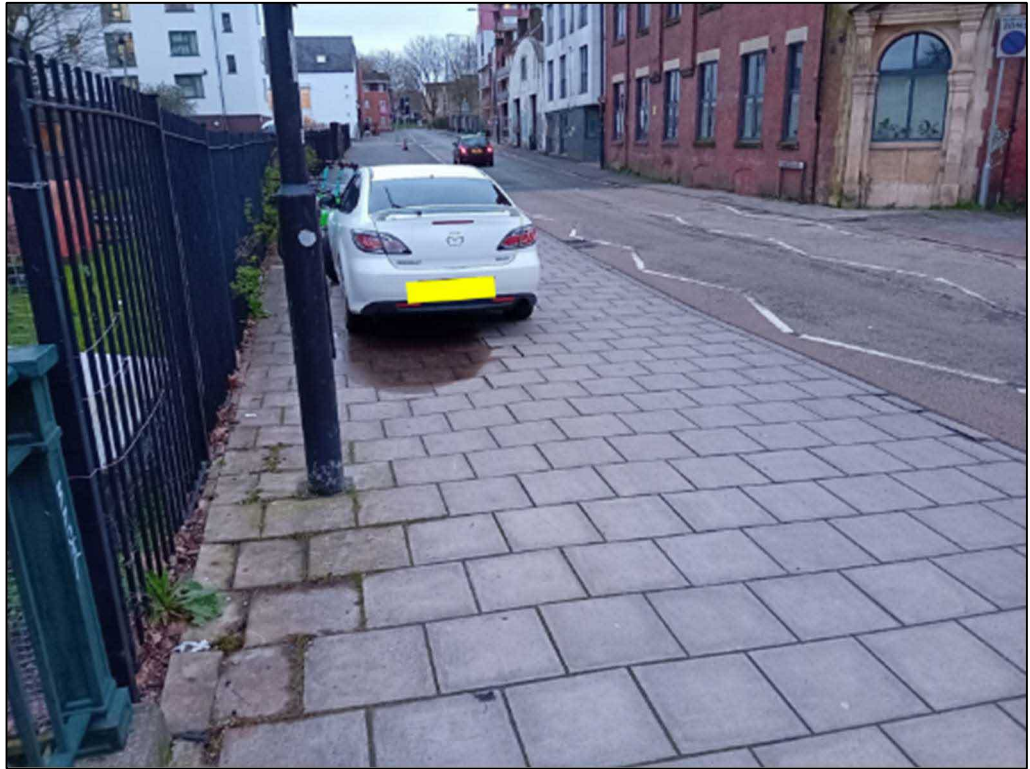
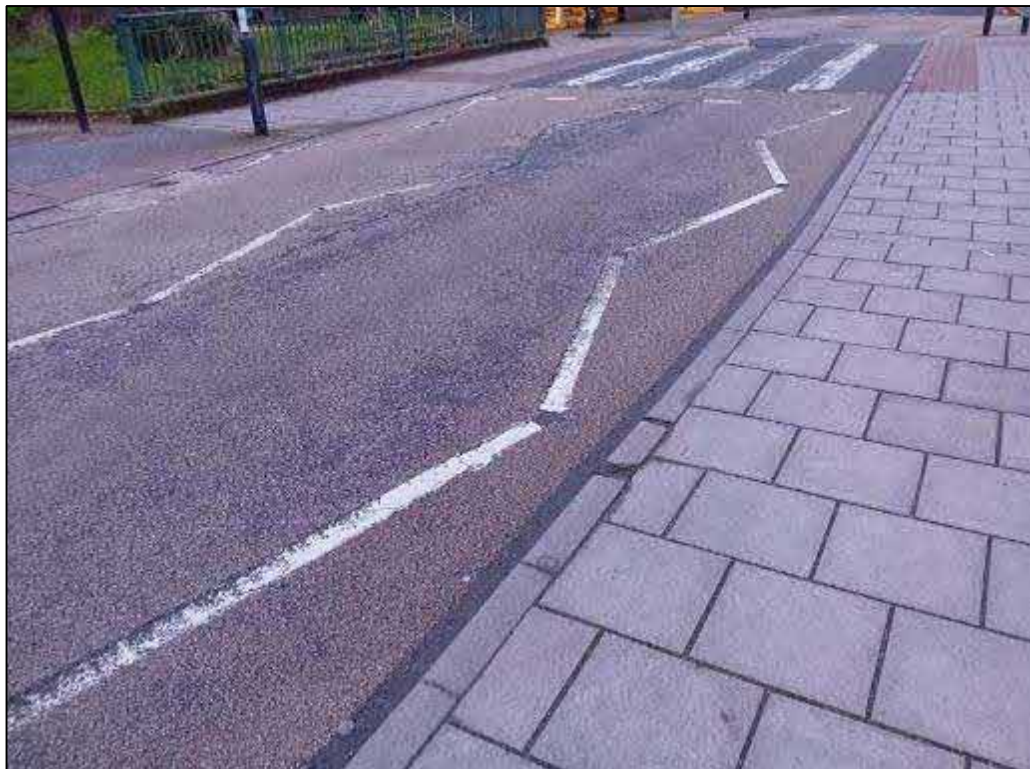
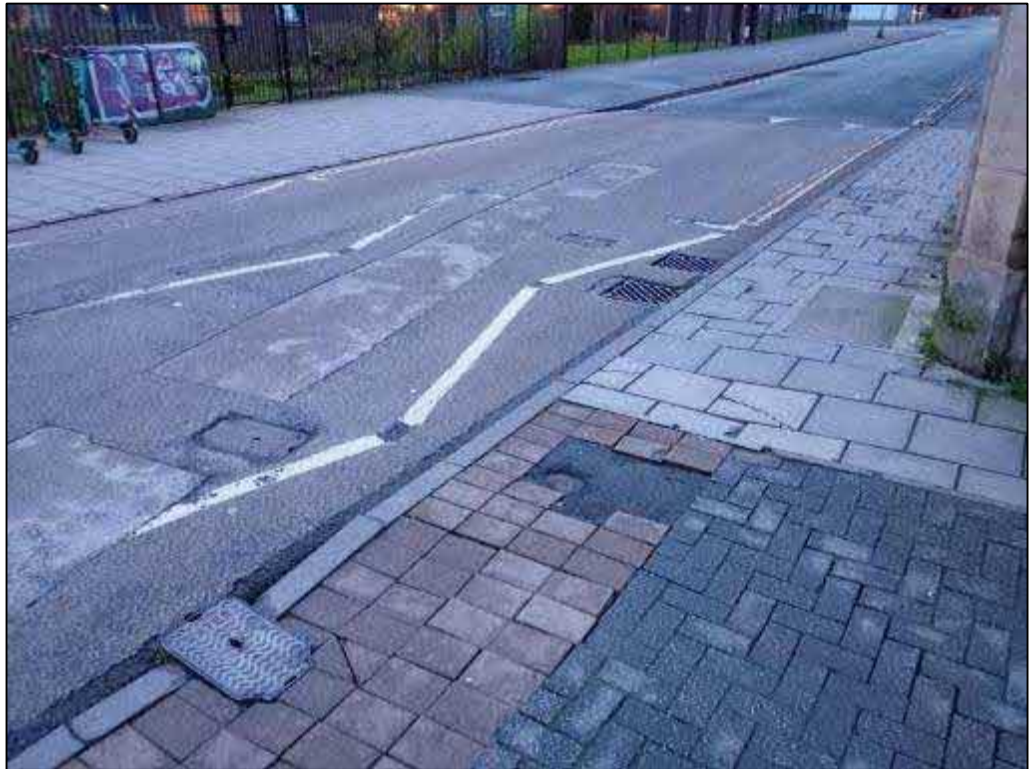
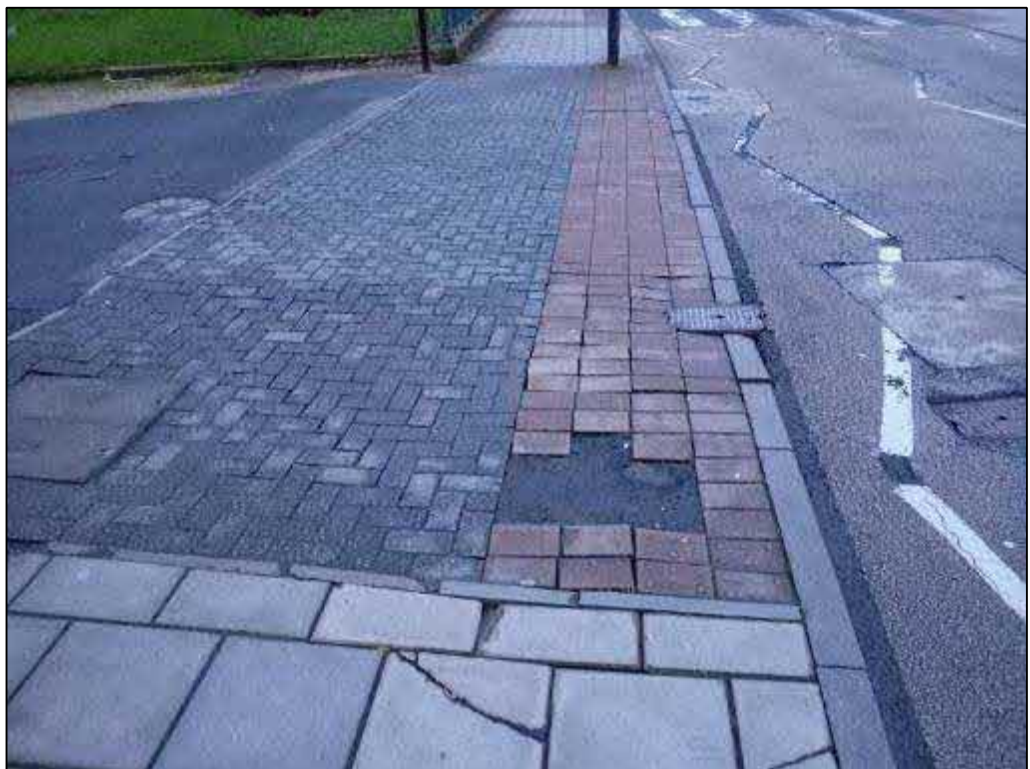
- i. On Wade Street, within the vicinity of the junction with River Street (Photographs 1 to 5), the following defects were observed:
 - There is vegetation growing between some of the paving slabs in the footway along the northern side of Wade Street.
 - The paving slabs in the footway along the southern side of Wade Street are damaged and cracked. Some brick paving slabs are missing from the footway crossover at the junction with River Street (Photograph 5).
 - There is damage to the kerbs along both sides of the carriageway and some kerbs are dislodged from original alignment.
 - The carriageway surfacing has deteriorated in several locations and features patched repairs.
 - There is damage to the carriageway surfacing surrounding the service covers and drains.
 - The white zig zag and zebra crossing road markings, are worn and faded.

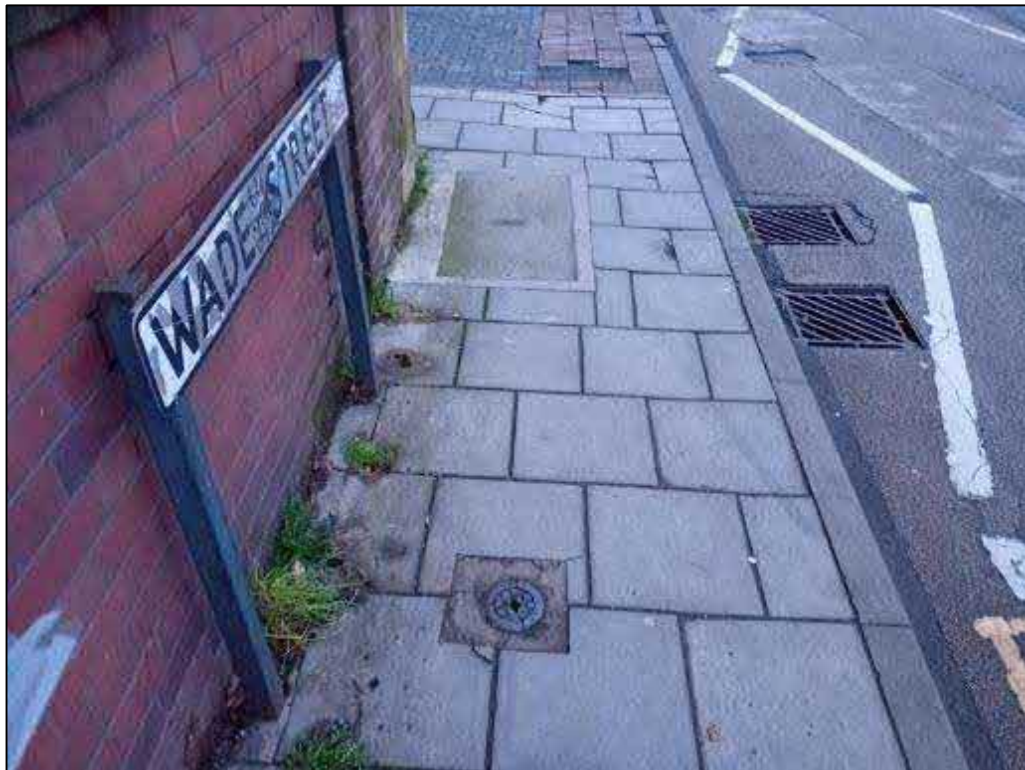
Photograph 6

- The Wade Street Road sign is damaged (photograph 6).
 - There is damage to the kerbs along both sides of the carriageway, including the heritage iron edging kerbs. Some kerbs are dislodged from original alignment.

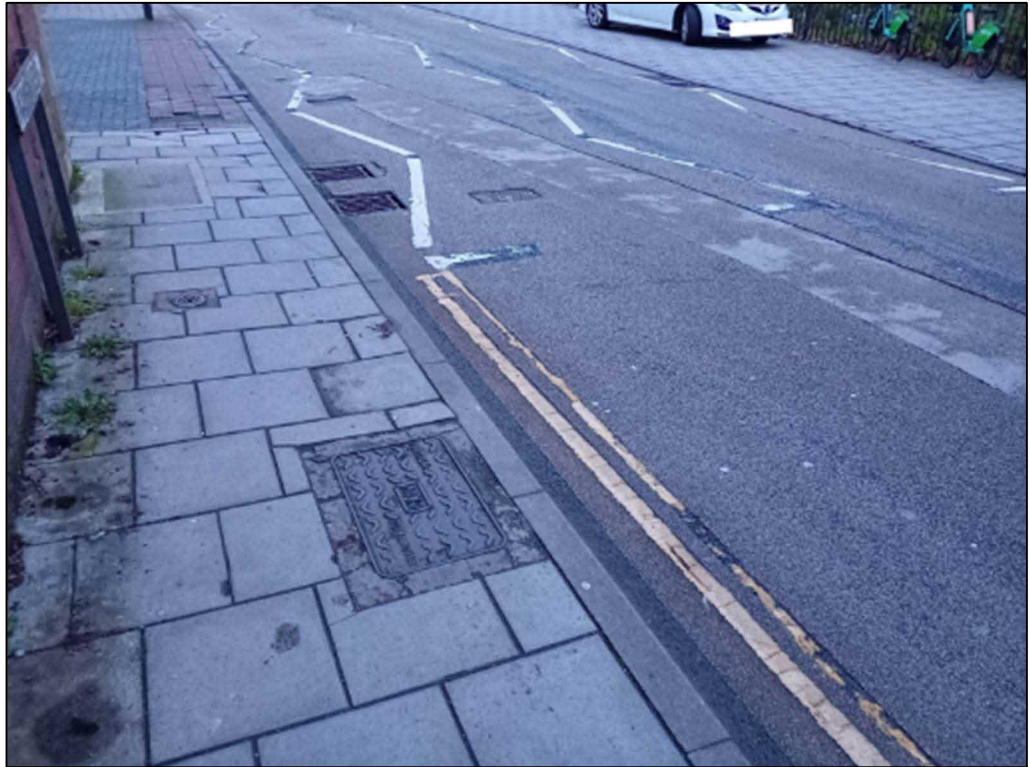
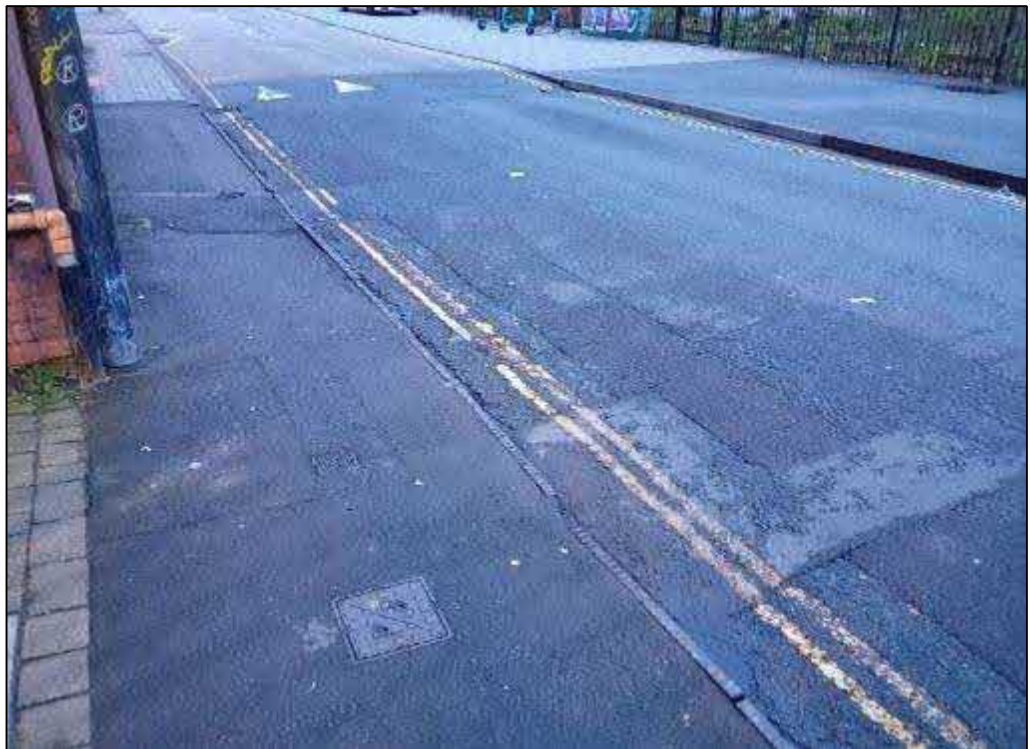
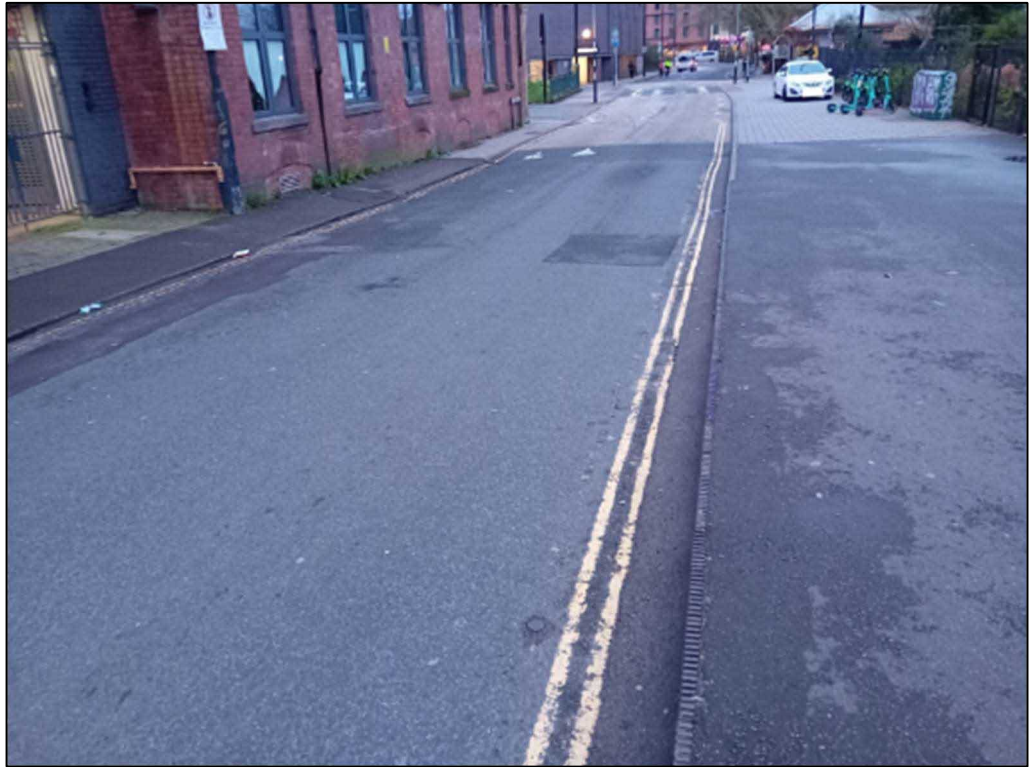
- ii. On Wade Street, to the east of the junction with River Street (Photographs 6 to 10) the following defects were observed:
- The paving slabs in the footway along the southern side of Wade Street are damaged and cracked.

- There is vegetation growing in the gaps between the paving slabs.
 - The footway surfacing on both sides of Wade Street has deteriorated. The surfacing along the southern side of Wade Street features cracking and multiple cracked repairs.

- The carriageway surfacing has deteriorated in several locations and features patched repairs.
 - There are gaps in the carriageway surfacing along the southern side of Wade Street adjacent to the footway (Photograph 10).

- The white zig zag and dragon tooth road markings yellow TRO road markings are worn and faded.
 - There is damage to the carriageway surfacing surrounding the service covers and drains.

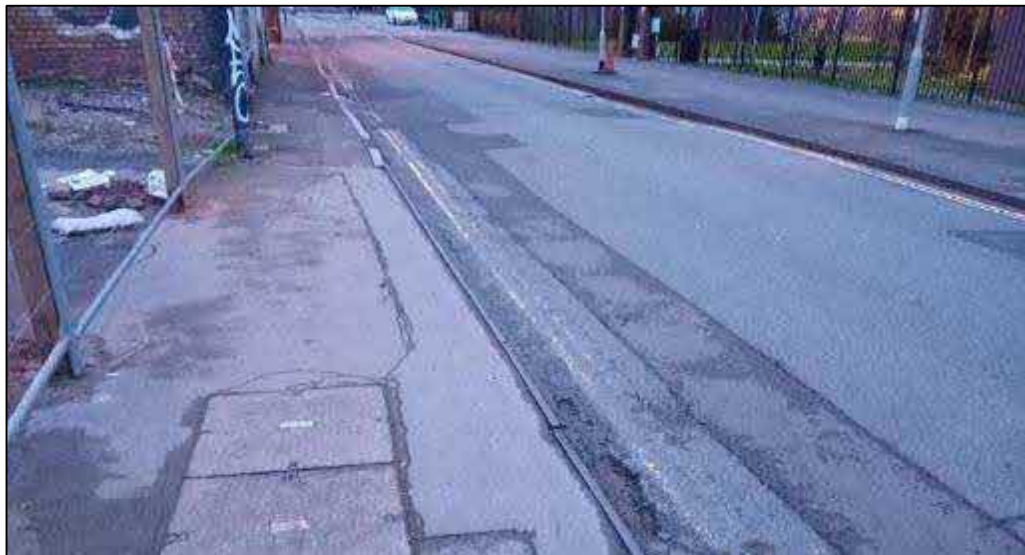
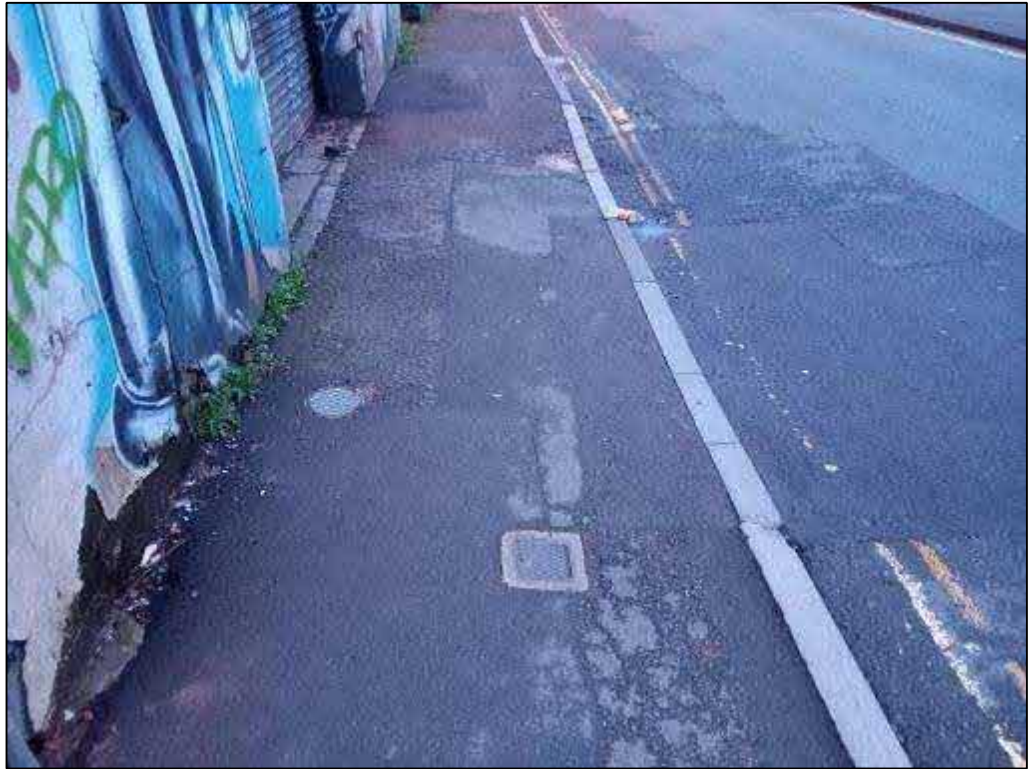
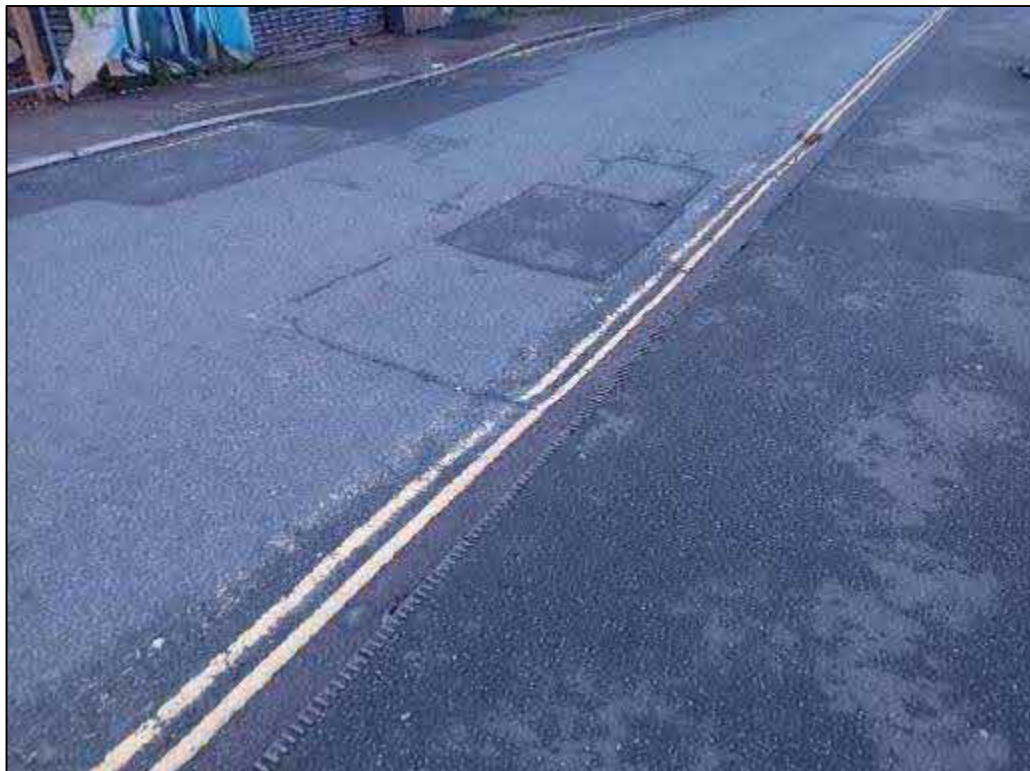
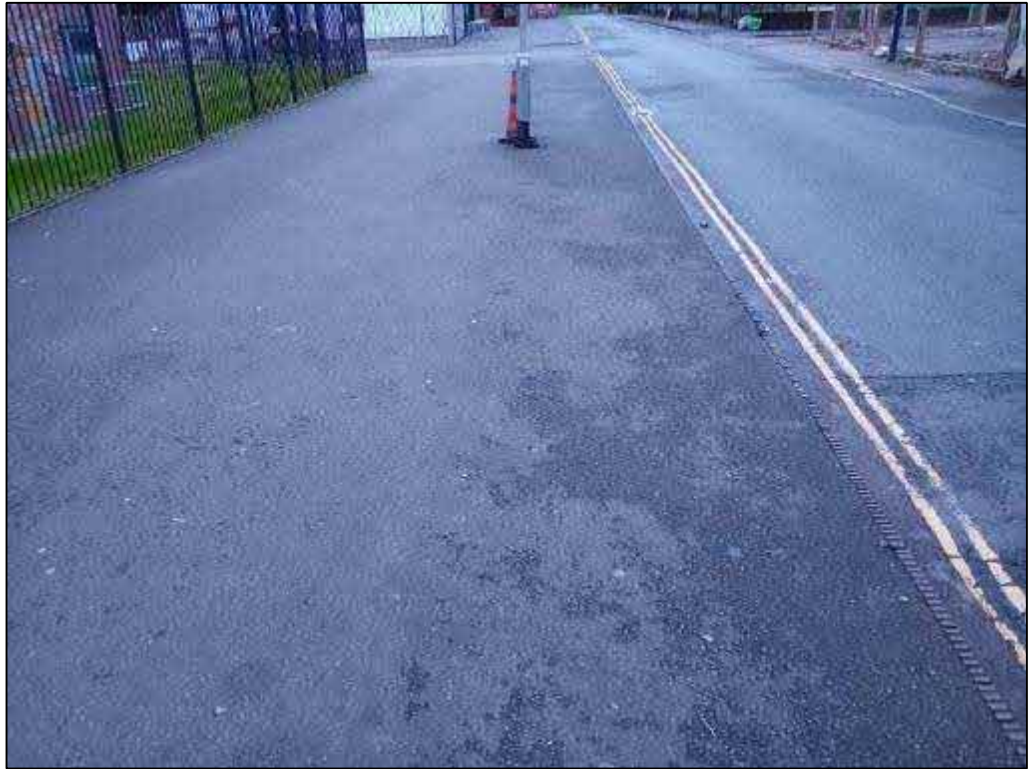
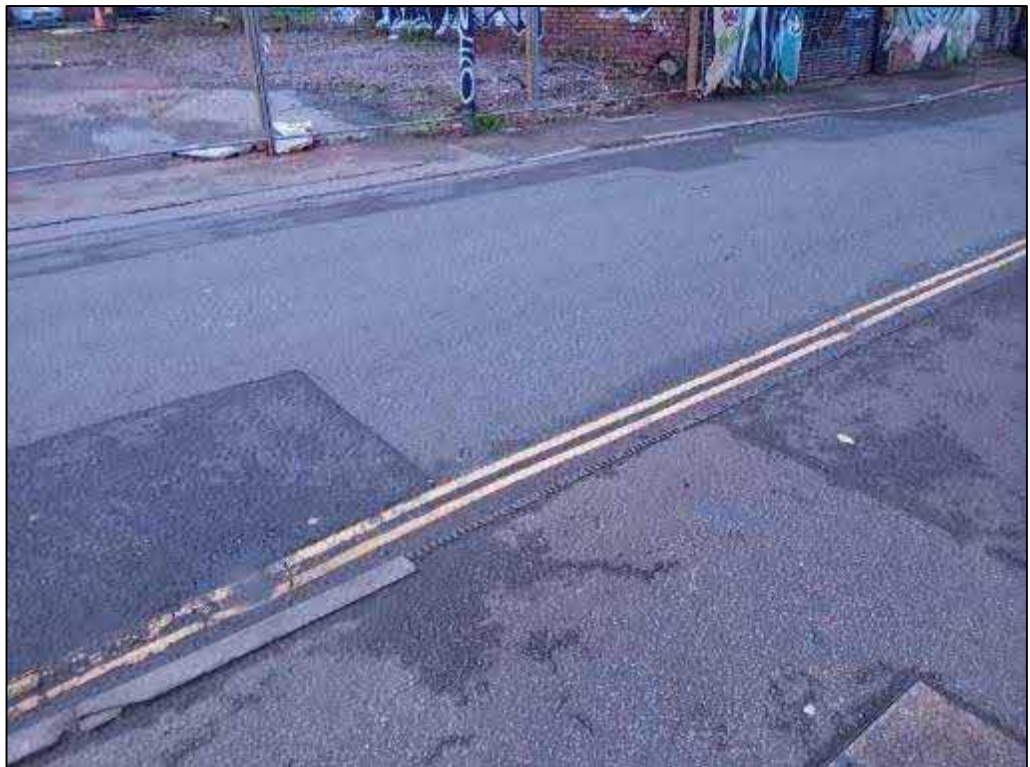
- iii. On Wade Street, to the west of the junction with Little George Street and Great George Street (Photographs 11 to 15) the following defects were observed:
- The footway surfacing on both sides of Wade Street has deteriorated. The surfacing along the southern side of Wade Street features cracking and multiple cracked repairs.
 - There is damage to the kerbs along both sides of the carriageway, including the heritage iron edging kerbs. Some kerbs are dislodged from original alignment.
 - The carriageway surfacing has deteriorated in several locations and features patched repairs.
 - There are gaps in the carriageway surfacing along the southern side of Wade Street adjacent to the footway (Photograph 11).
 - There is damage to the carriageway surfacing surrounding the service covers.
 - The yellow TRO road markings are worn and faded.

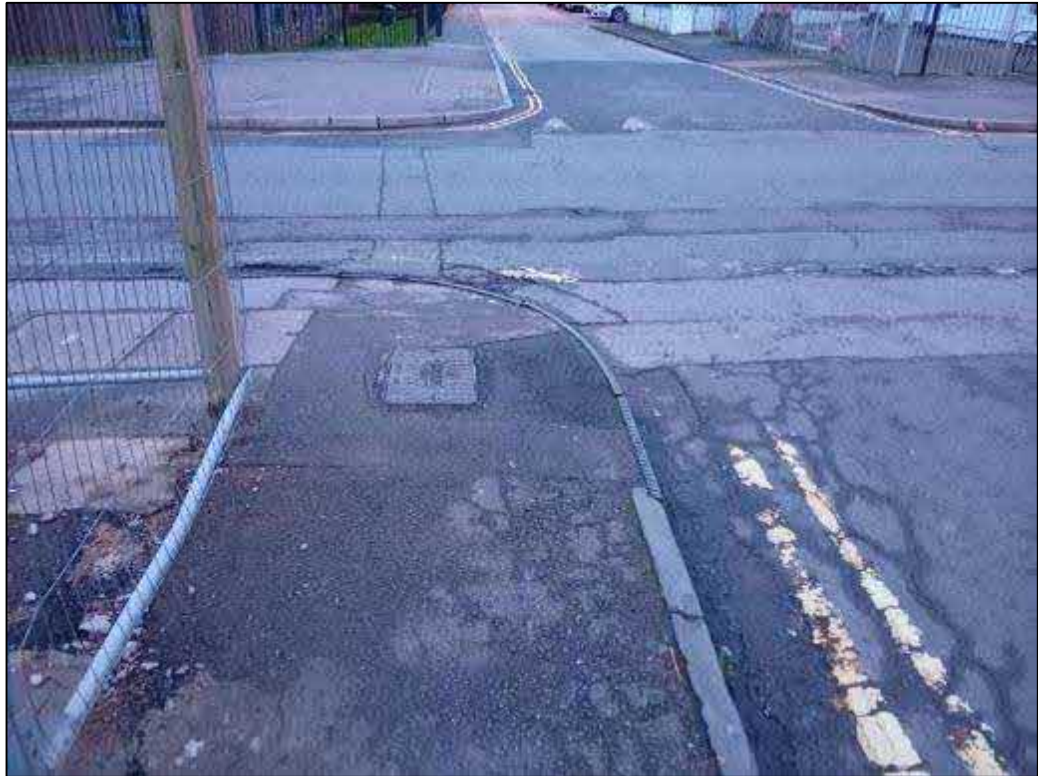
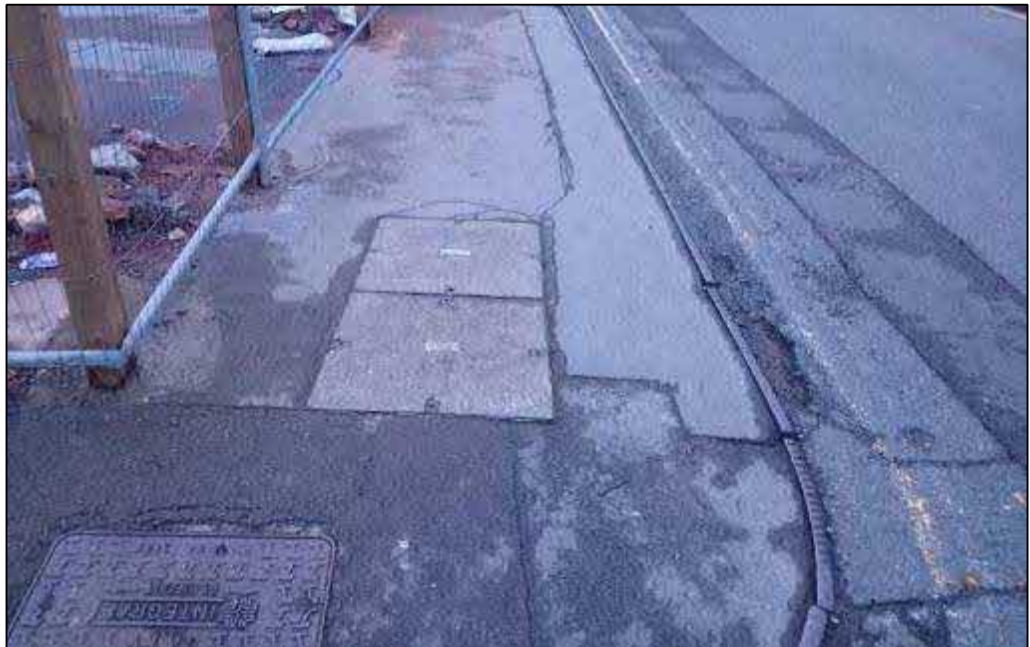
- There are gaps in the carriageway surfacing along the southern side of Wade Street where it connects to the western side of Great George Street, adjacent to the footway (Photograph 16 and 17).

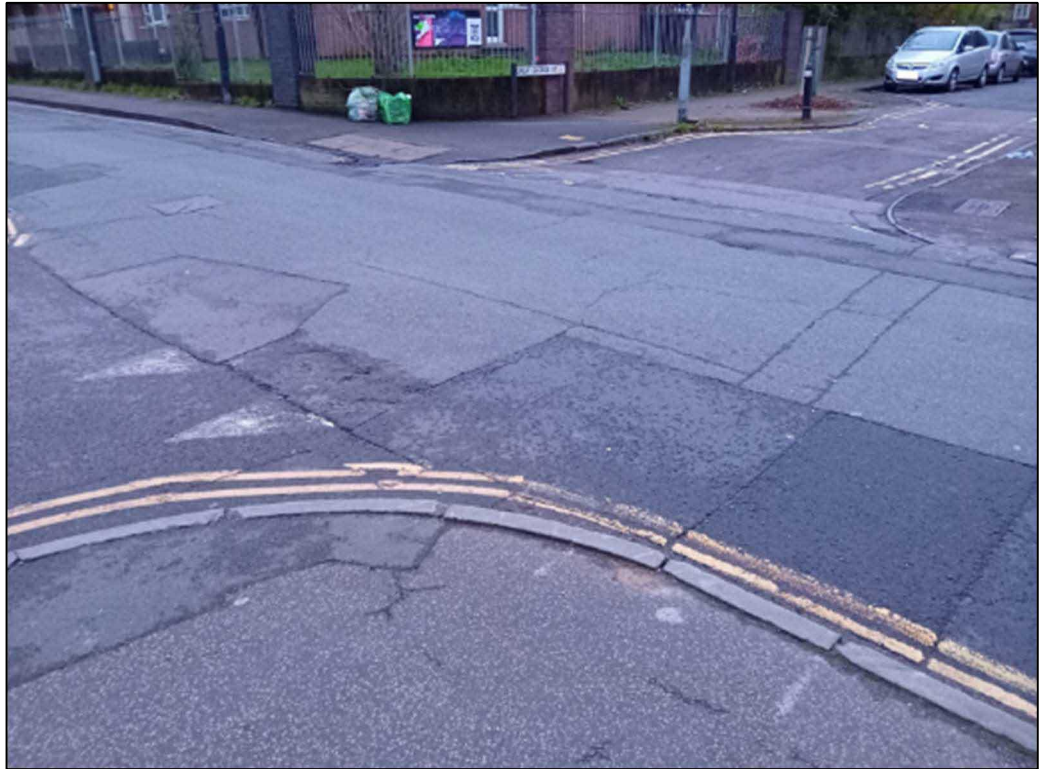
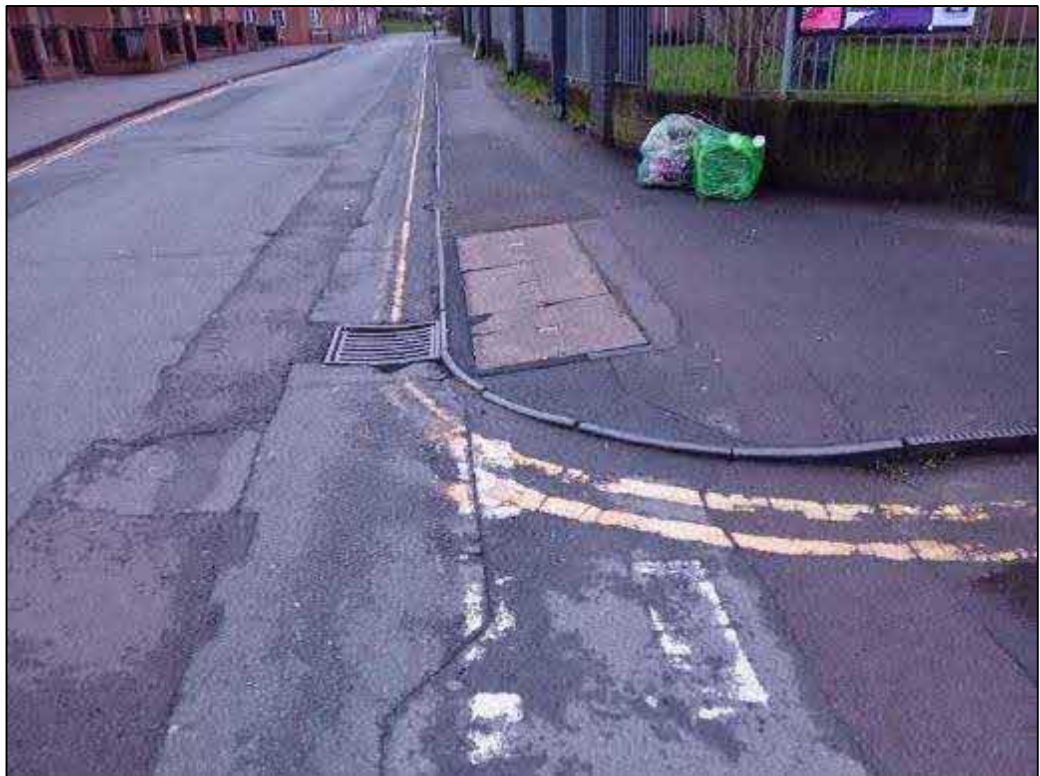
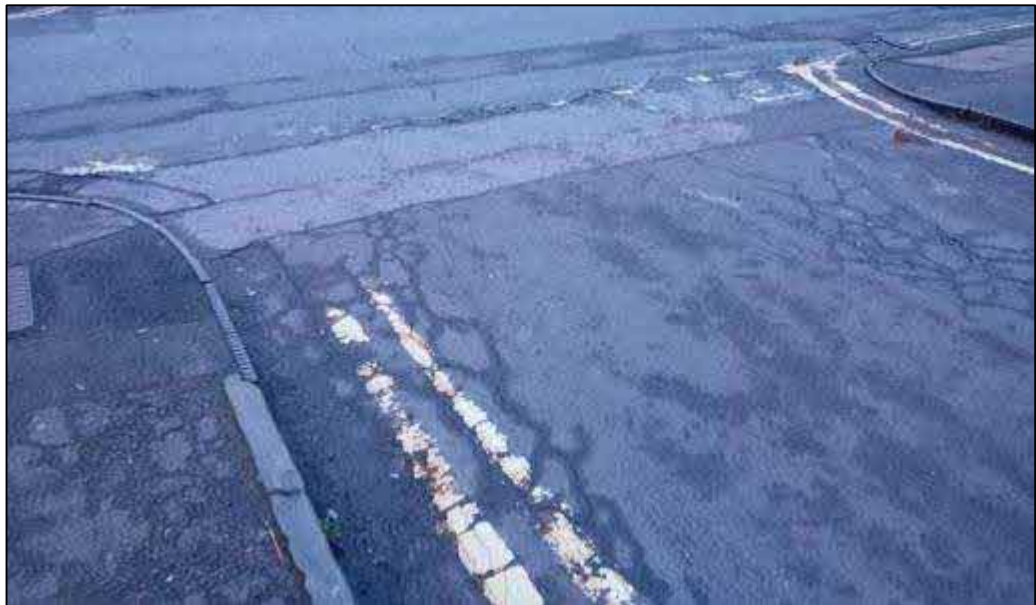
- iv. At the crossroad junction connecting Wade Street to Little George Street and Great George Street (Photographs 16 to 21) the following defects were observed:

- The footway surfacing on all junction radii has deteriorated and features cracking and multiple cracked repairs.
 - There is damage to the kerbs along all junction radii, including the heritage iron edging kerbs. Some kerbs are dislodged from original alignment.

- The tactile paving slabs on the western side of Little George Street are damaged and cracked (Photograph 20).
 - The carriageway surfacing has deteriorated in several locations and features patched repairs.

- There is damage to the carriageway surfacing surrounding the service covers.
 - The white zig zag and dragon tooth road markings yellow TRO road markings are worn and faded.

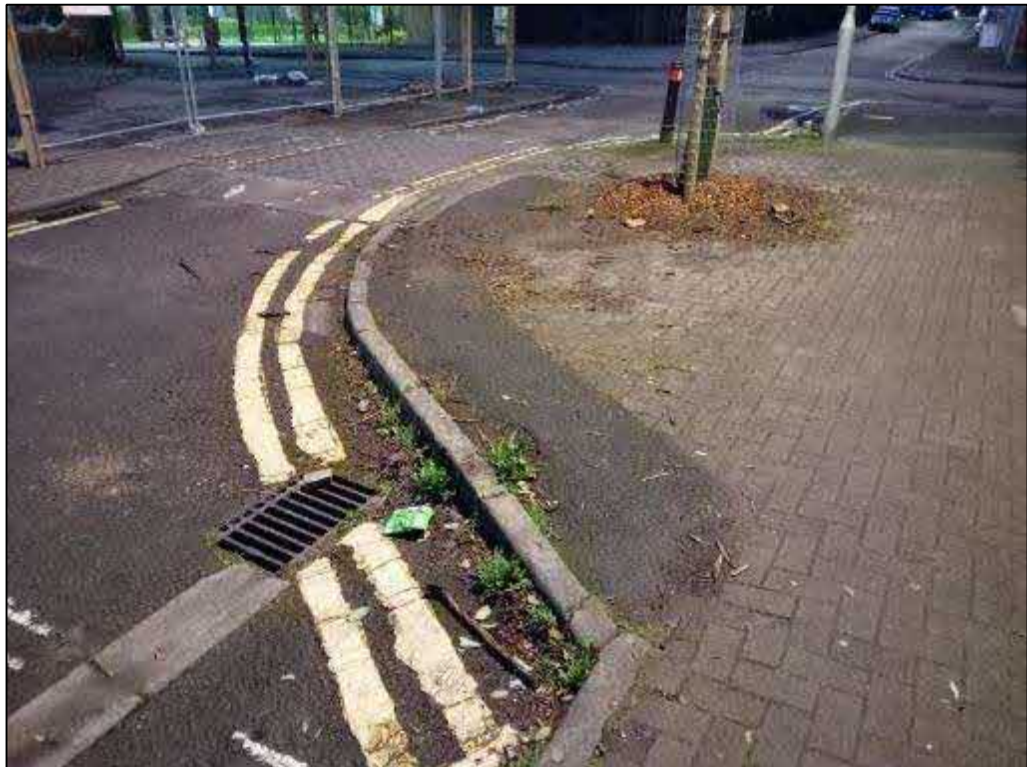
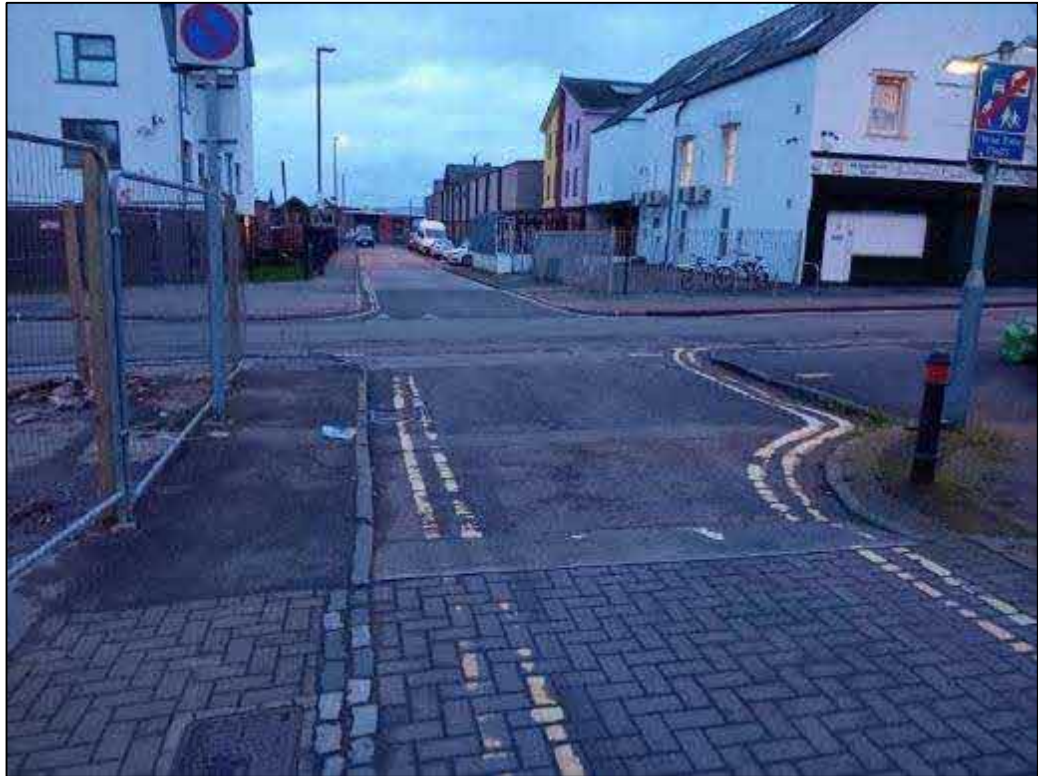
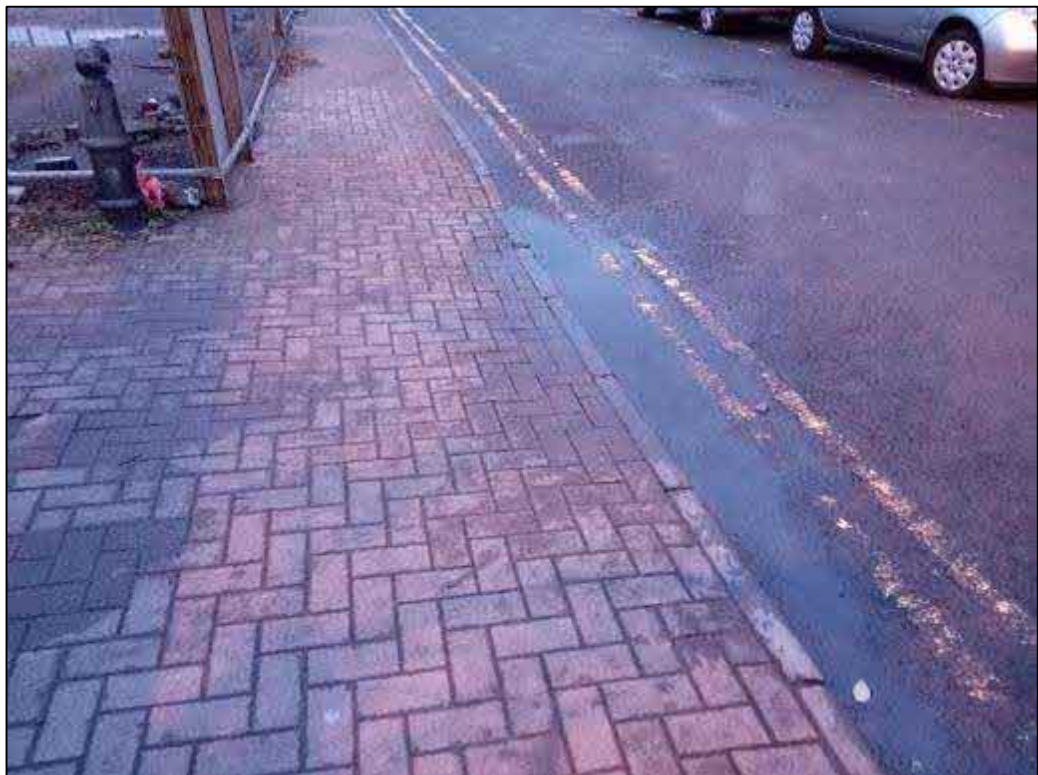
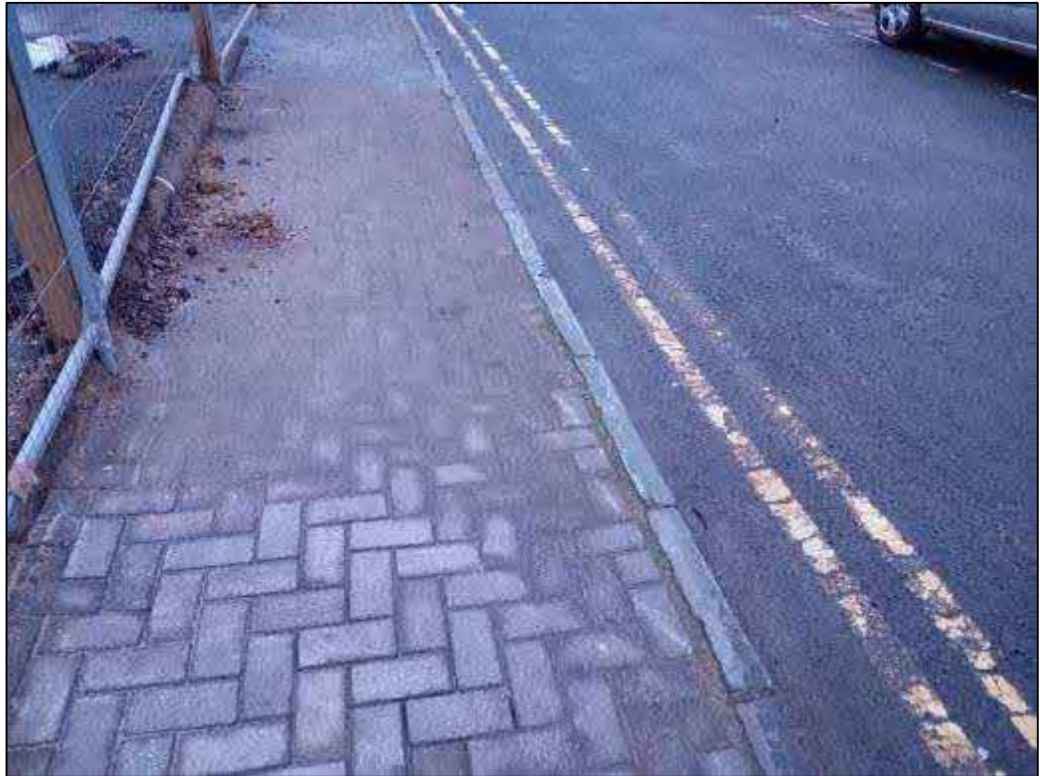
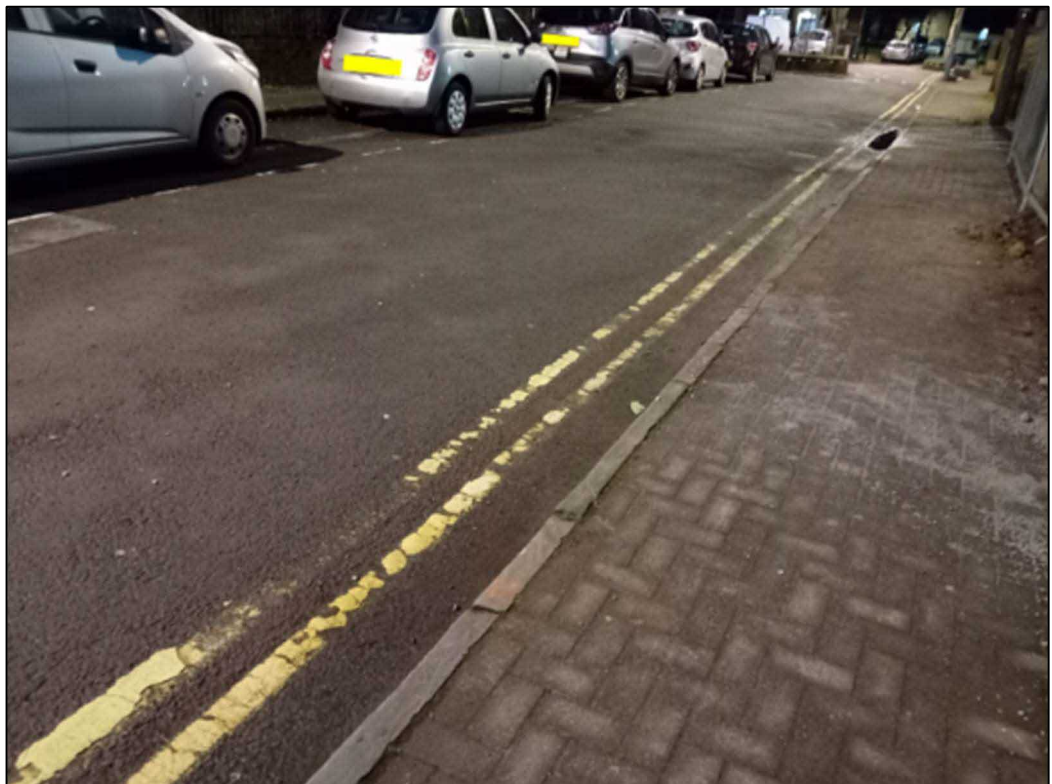
- v. On Great George Street, to the south of the junction with Wade Street (Photographs 22 to 26) the following defects were observed:
- The brick paving and surfacing within the footway on both sides of Great George Street is damaged, and features a large, patched repair on the eastern side (photograph 22).
 - There is damage to the kerbs on both sides of the carriageway, some kerbs are dislodged from original alignment.
 - There is vegetation growing in gaps surrounding the kerbs.
 - The carriageway surfacing has deteriorated in several locations and features patched repairs.
 - There is damage to the surfacing surrounding the service covers and drains.
 - The yellow TRO road markings and white parking cage markings are worn and faded.
