11-17 Wade Street, Bristol

Discharge of Planning Condition 10 (LPA Ref: 21/01065/P and
Appeal Ref APP/Z0116/W/21/3282706)
Pre-Commencement Highway Condition Survey

March 2024

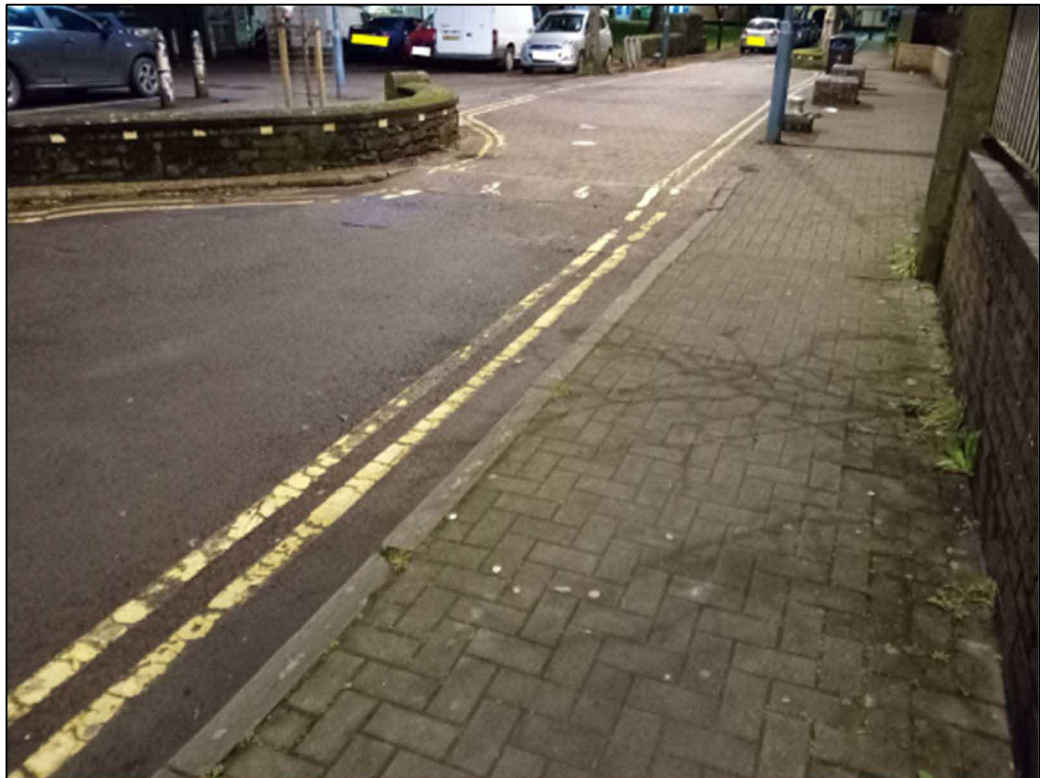
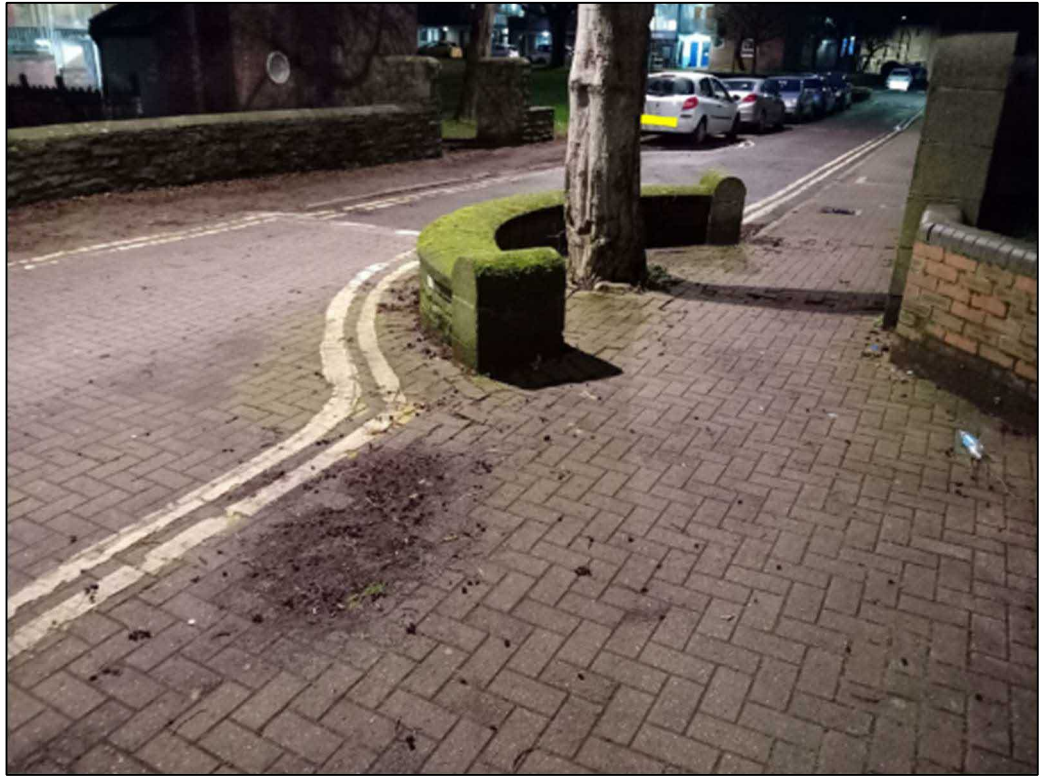
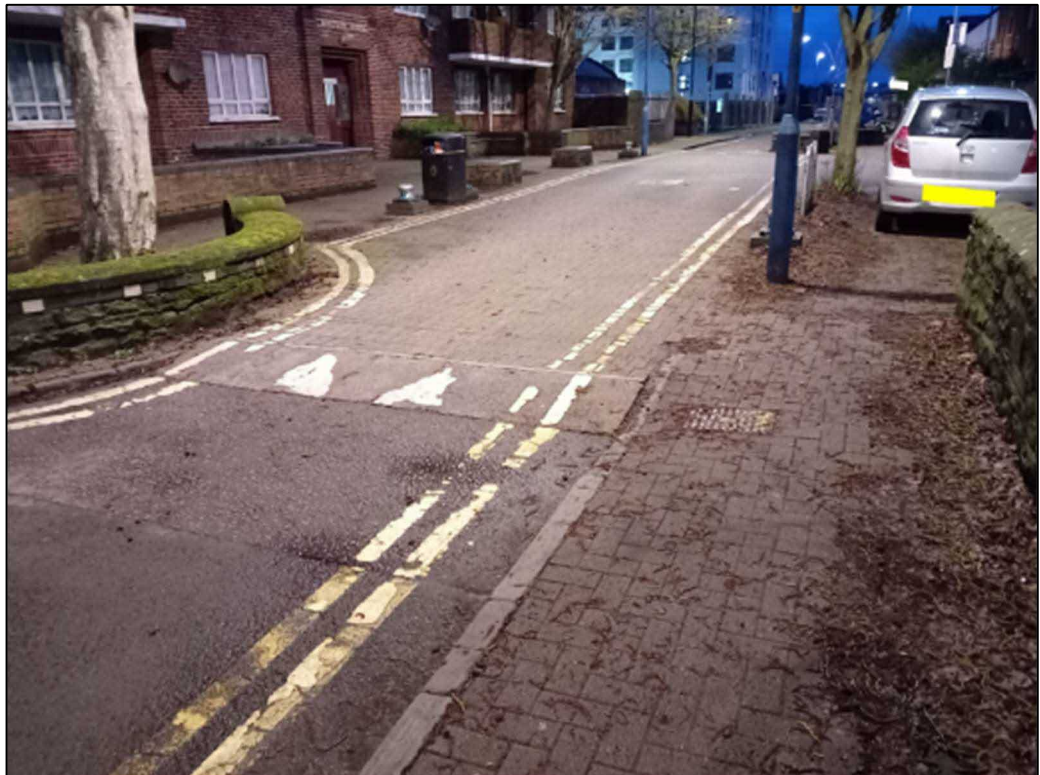
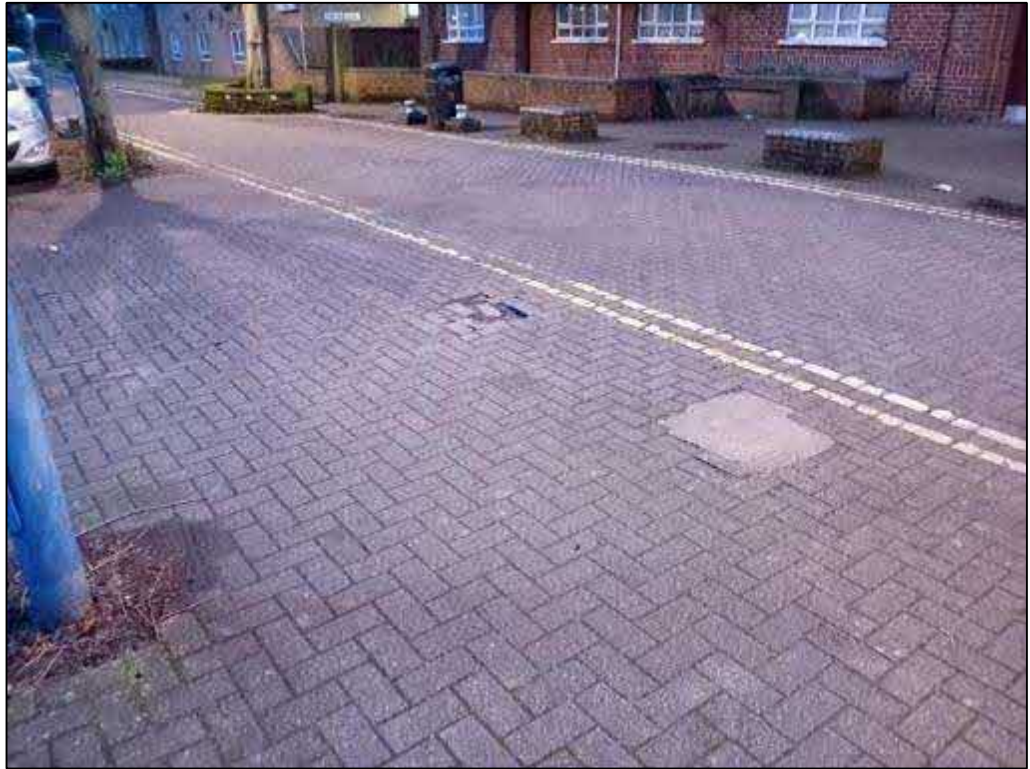
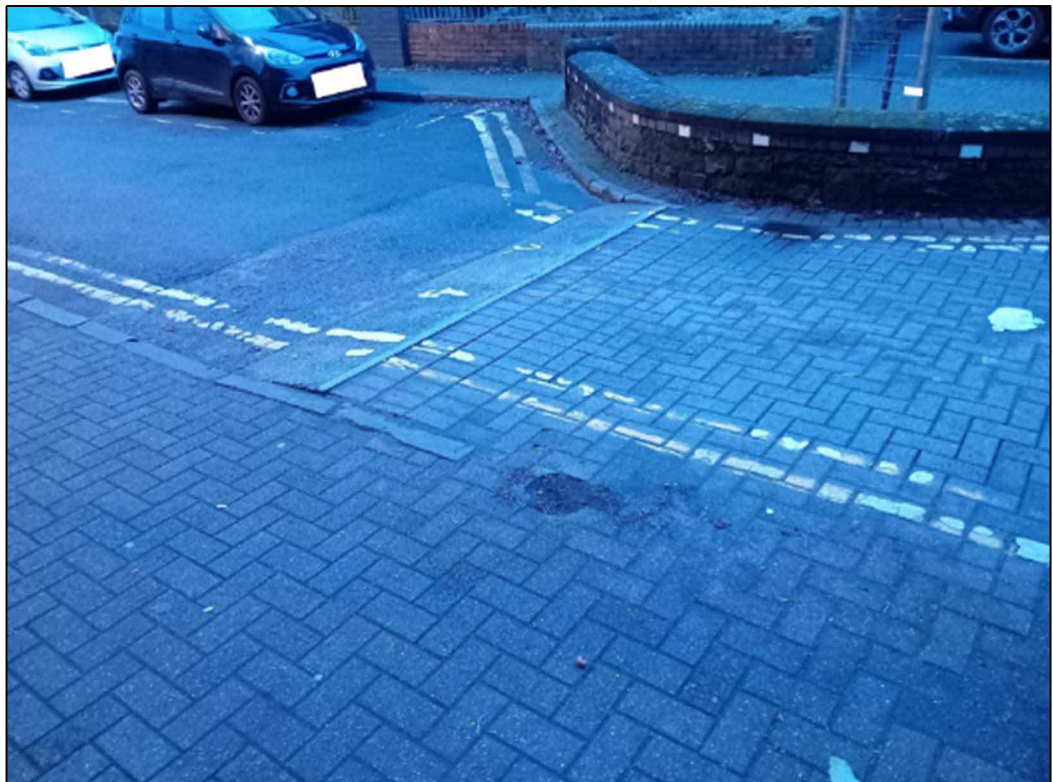
- vi. On Great George Street, within the vicinity of Whitson House (Photographs 27 to 31) the following defects were observed:
- The brick paving and surfacing within the footway on both sides of Great George Street is damaged and features patched repairs.
 - There is vegetation growing in the gaps at the back of the footway along the western side of Great George Street.
 - The roots of a tree within the western side of Great George Street are causing damage to the brick paving in the footway (Photograph 28).
 - There is damage to the kerbs on both sides of the carriageway, some kerbs are dislodged from original alignment.
 - The carriageway surfacing has deteriorated in several locations and features patched repairs.
 - The yellow TRO road markings and white parking cage and dragons tooth markings are worn and faded.

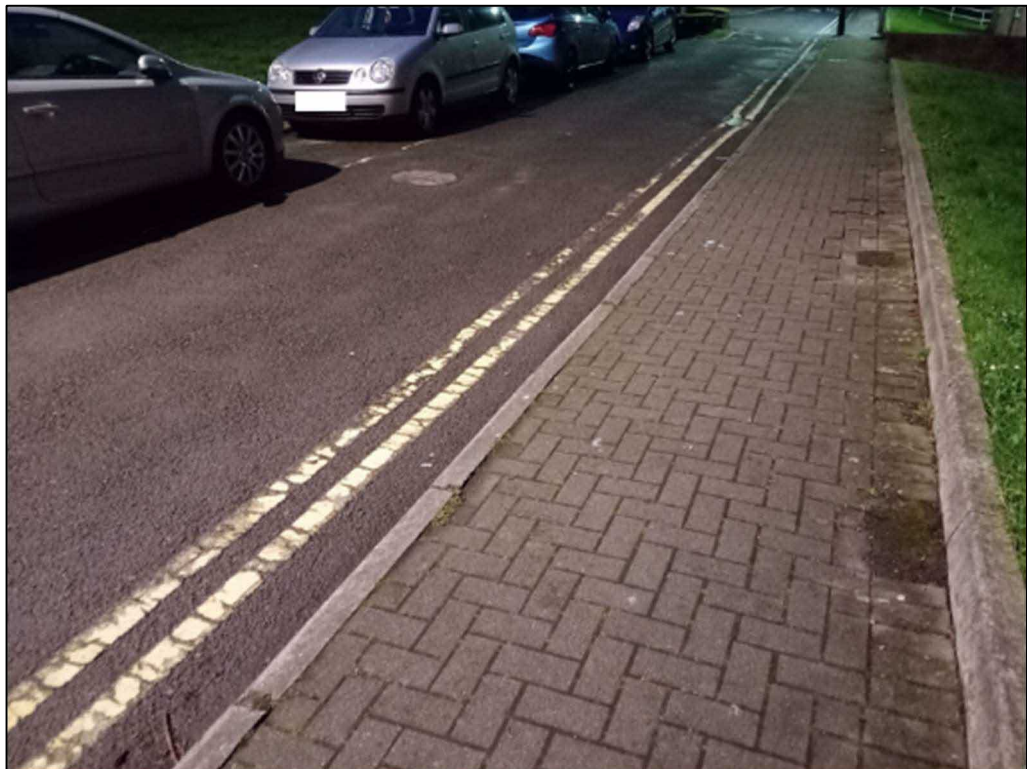
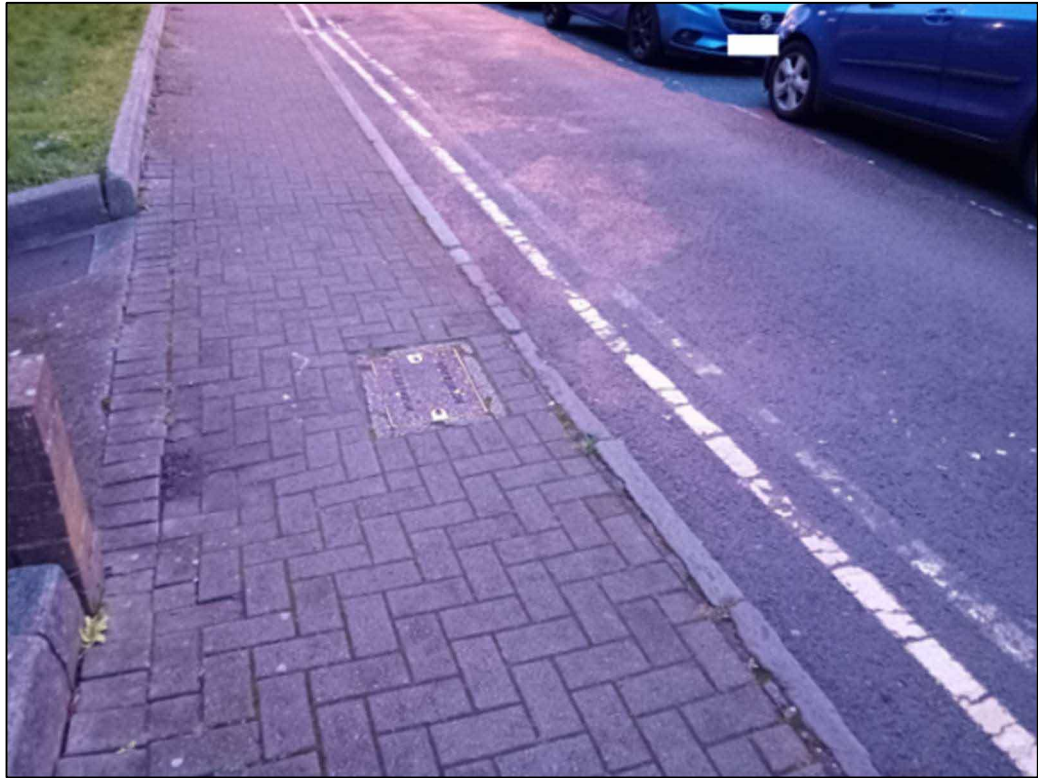
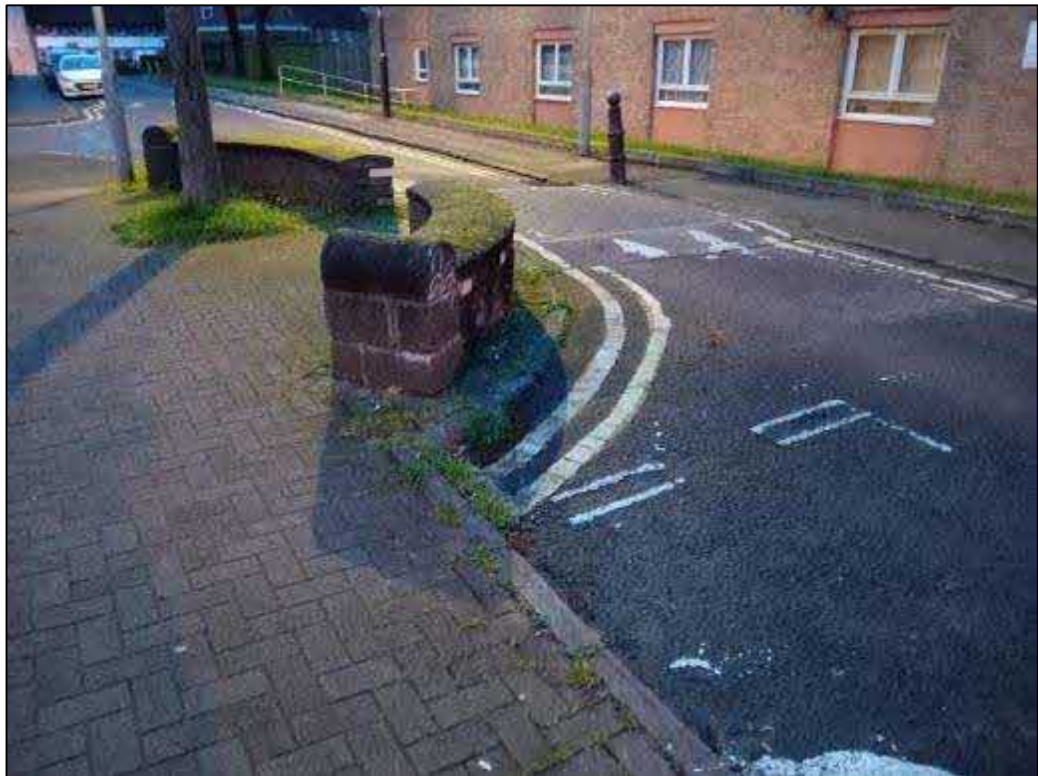
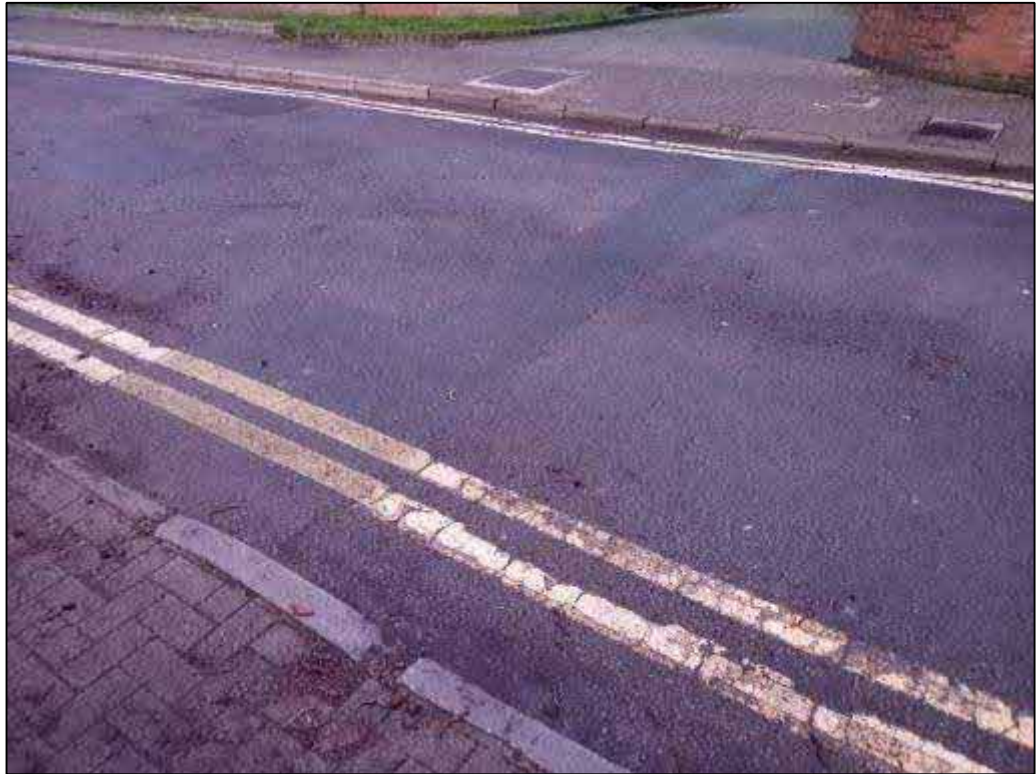
vii. Along Great George Street, to the north of the junction with Great Anne Street Photographs 32 to 35) the following defects were observed:

- The yellow TRO road markings and white parking cage markings are worn and faded.
- The brick paving and surfacing within the footway on both sides of Great George Street is damaged and features patched repairs.
- There is vegetation growing in gaps surrounding the kerbs.
- There is damage to the kerbs on both sides of the carriageway, some kerbs are dislodged from original alignment.
- The carriageway surfacing has deteriorated in several locations and features patched repairs.
- There is damage to the surfacing surrounding the service covers in the footways and carriageway.
- The yellow TRO road markings and white parking cage and dragons tooth markings are worn and faded.

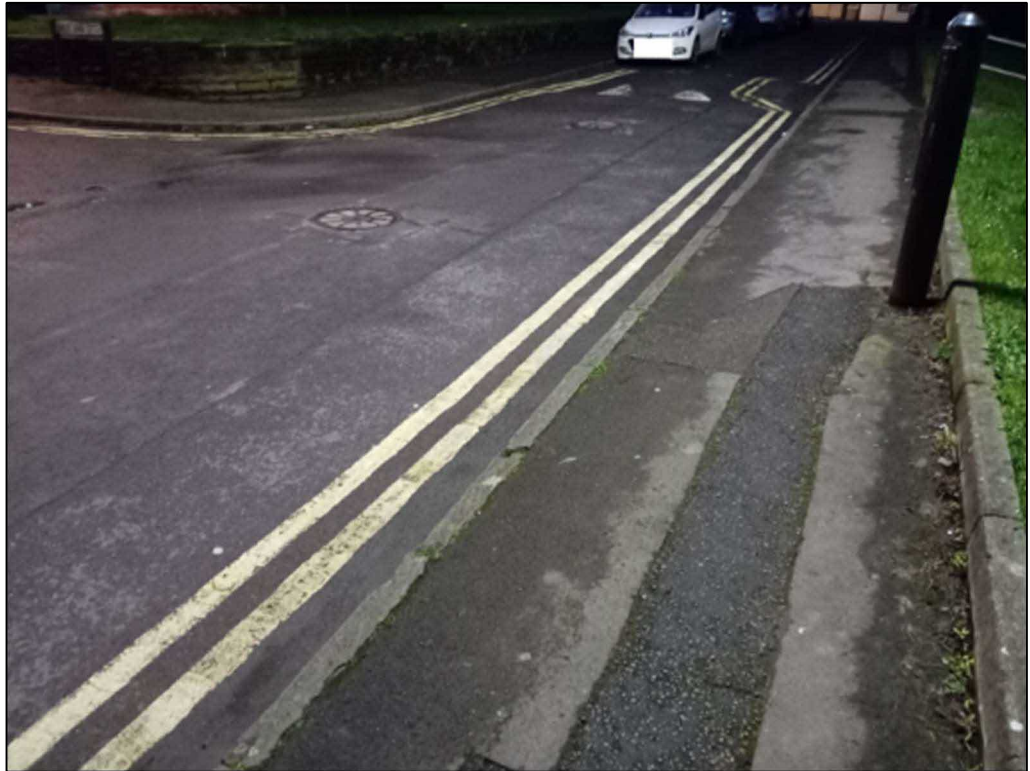
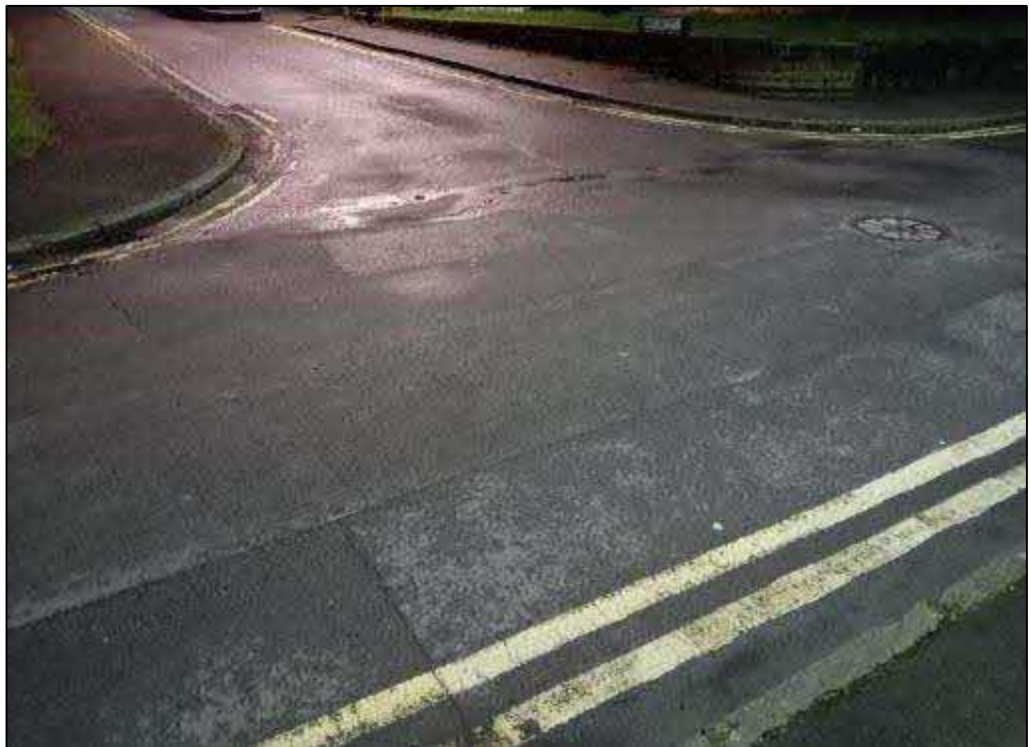
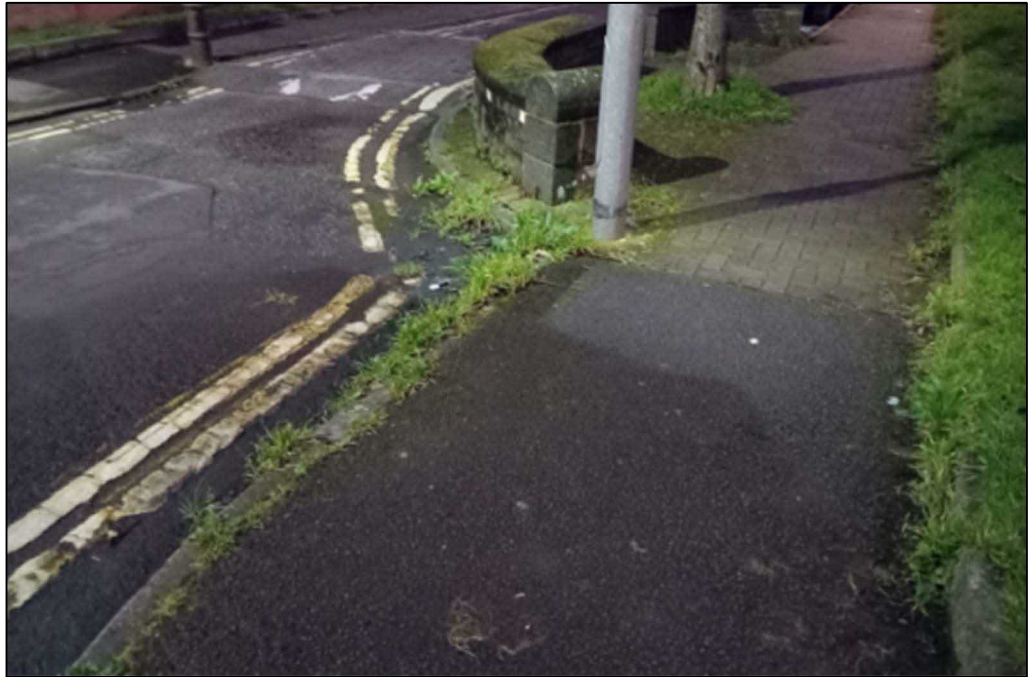
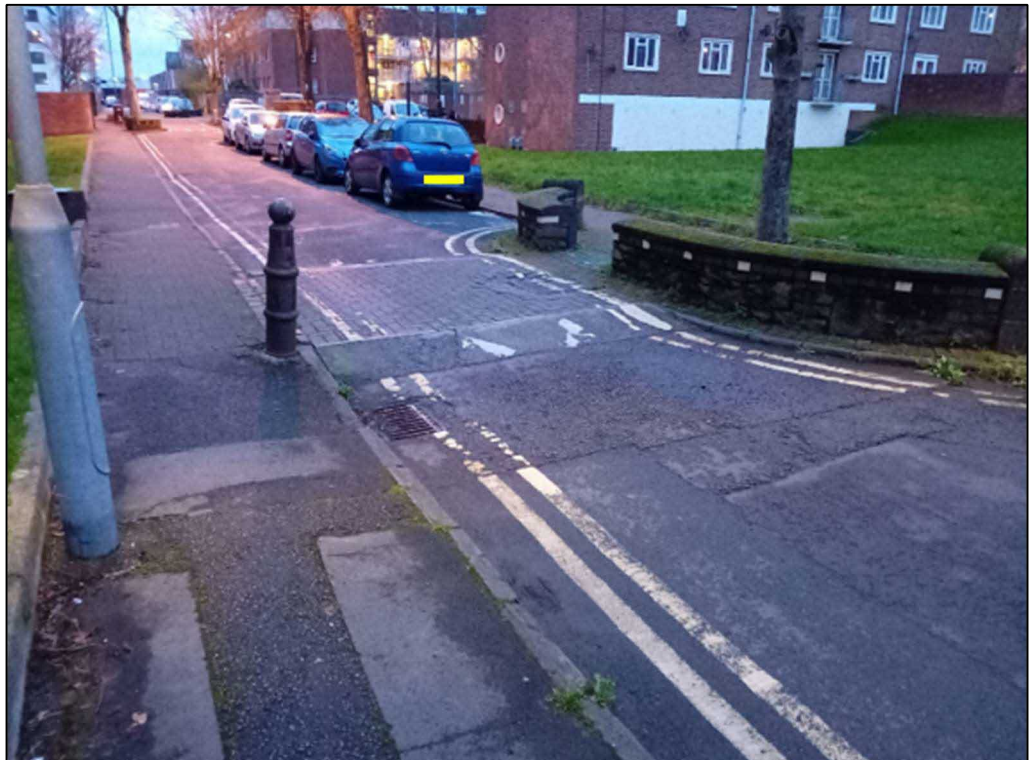
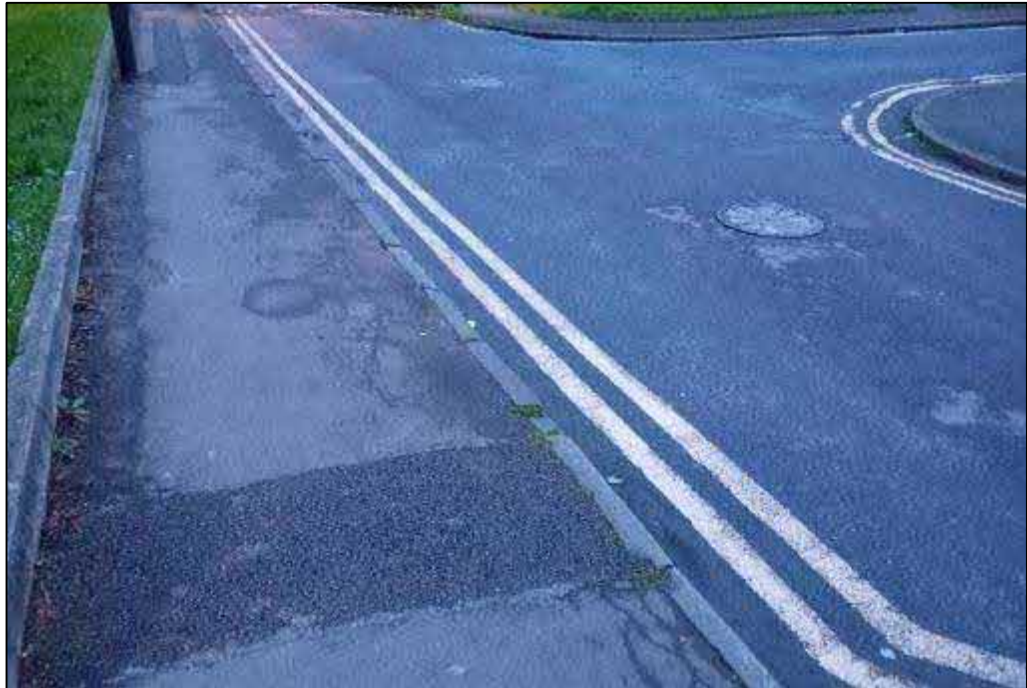
- viii. Along Great George Street, within the vicinity of the junction with Great Ann Street (Photographs 36 to 40) the following defects were observed:
- The surfacing within the footway on both sides of Great George Street is damaged and features patched repairs.
 - There is vegetation growing in gaps surrounding the kerbs on both sides of the carriageway.
 - There is damage to the kerbs on both sides of the carriageway, some kerbs are dislodged from original alignment.
 - The carriageway surfacing has deteriorated in several locations and features patched repairs.
 - There is damage to the surfacing surrounding the service covers in the carriageway.
 - The yellow TRO road markings and white parking cage and dragons tooth markings are worn and faded.

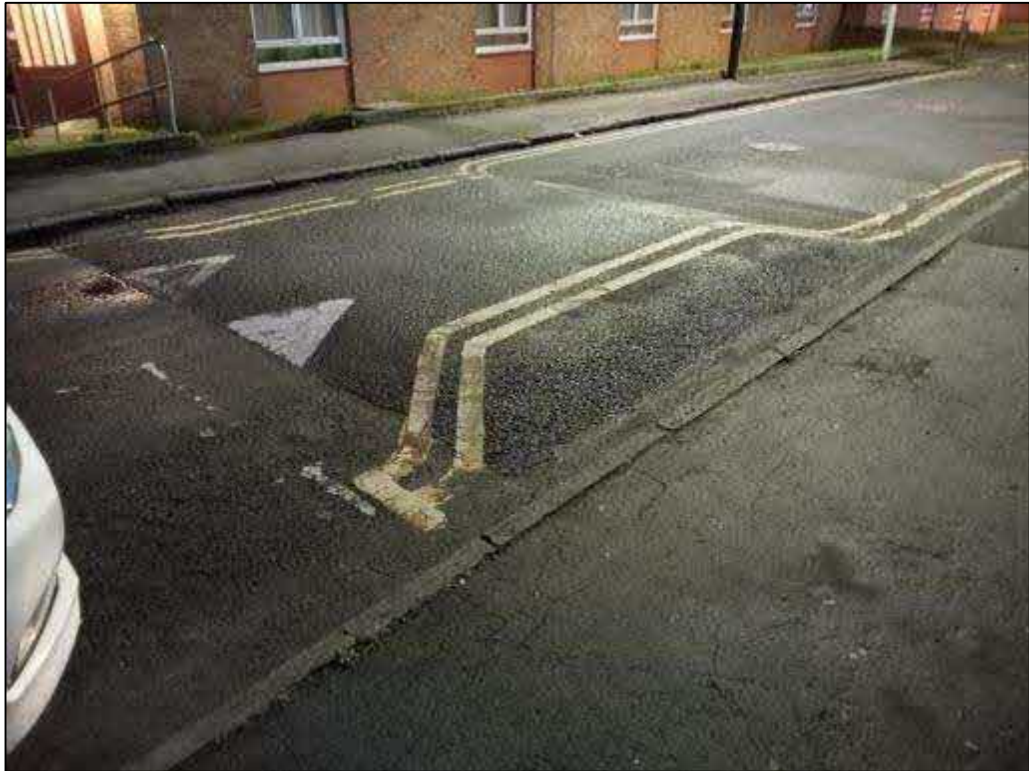
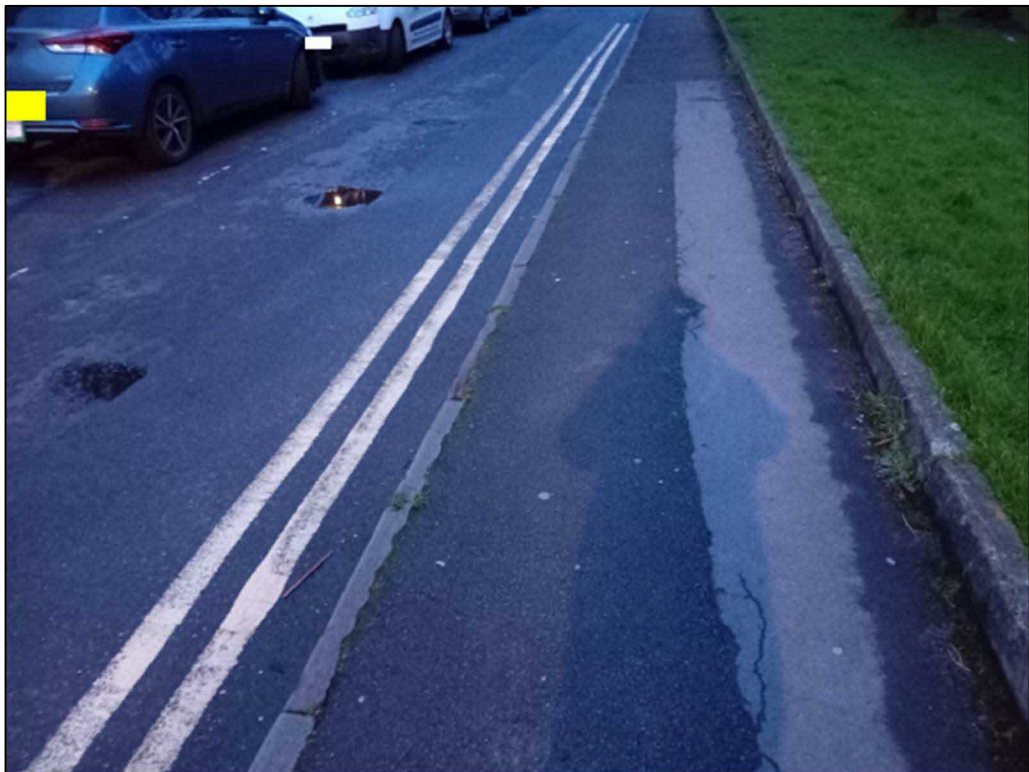
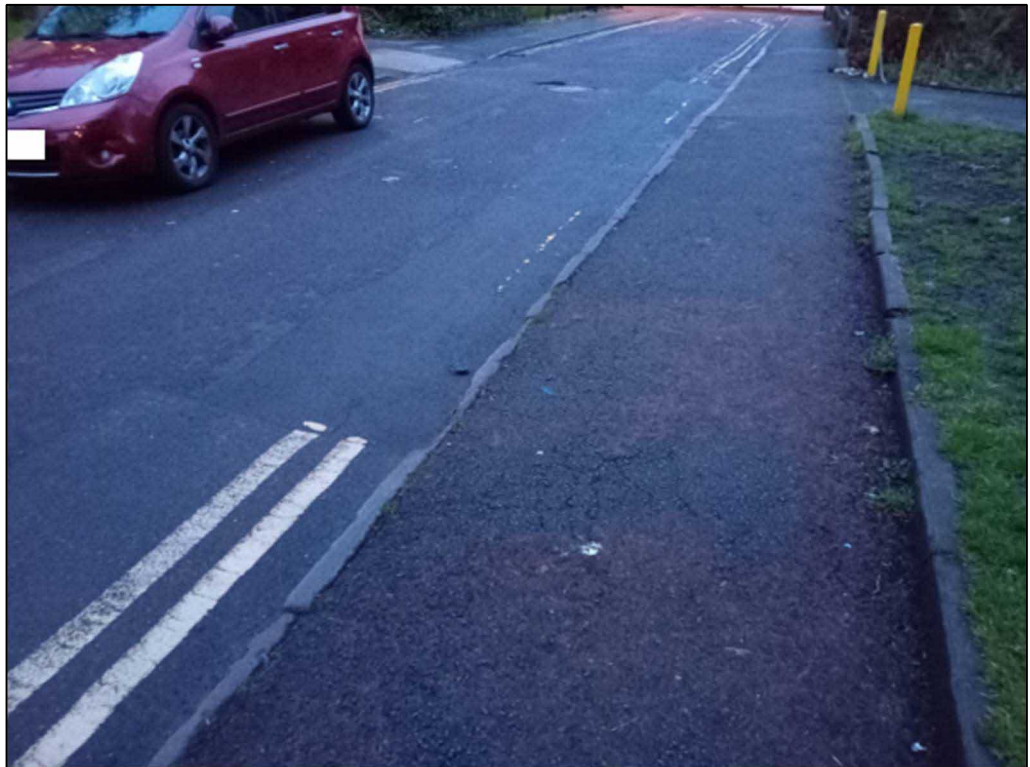
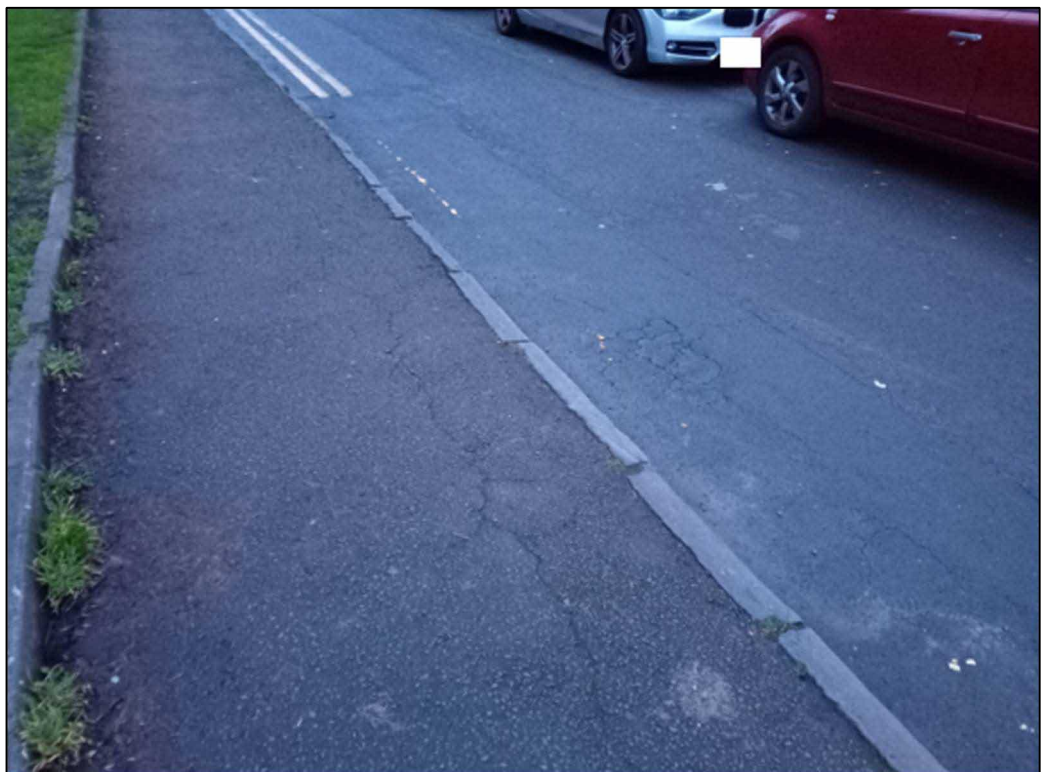
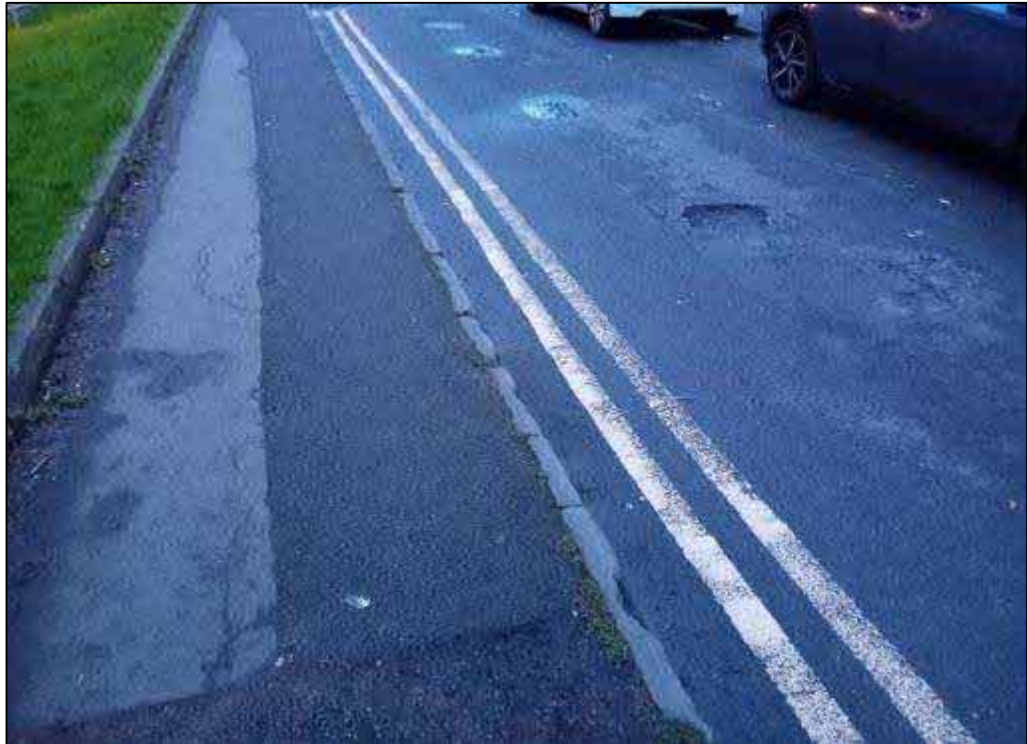
- ix. Along Great George Street, to the south of the junction with Great Ann Street (Photographs 41 to 45) the following defects were observed:
- The surfacing within the footway on both sides of Great George Street is damaged and features patched repairs.
 - There is vegetation growing in gaps surrounding the kerbs on both sides of the carriageway, and in gaps at the back of the footway.
 - There is damage to the kerbs on both sides of the carriageway, some kerbs are dislodged from original alignment.
 - The carriageway surfacing has deteriorated in several locations and features patched repairs.
 - The yellow TRO road markings and white parking cage and dragons tooth markings are worn and faded.

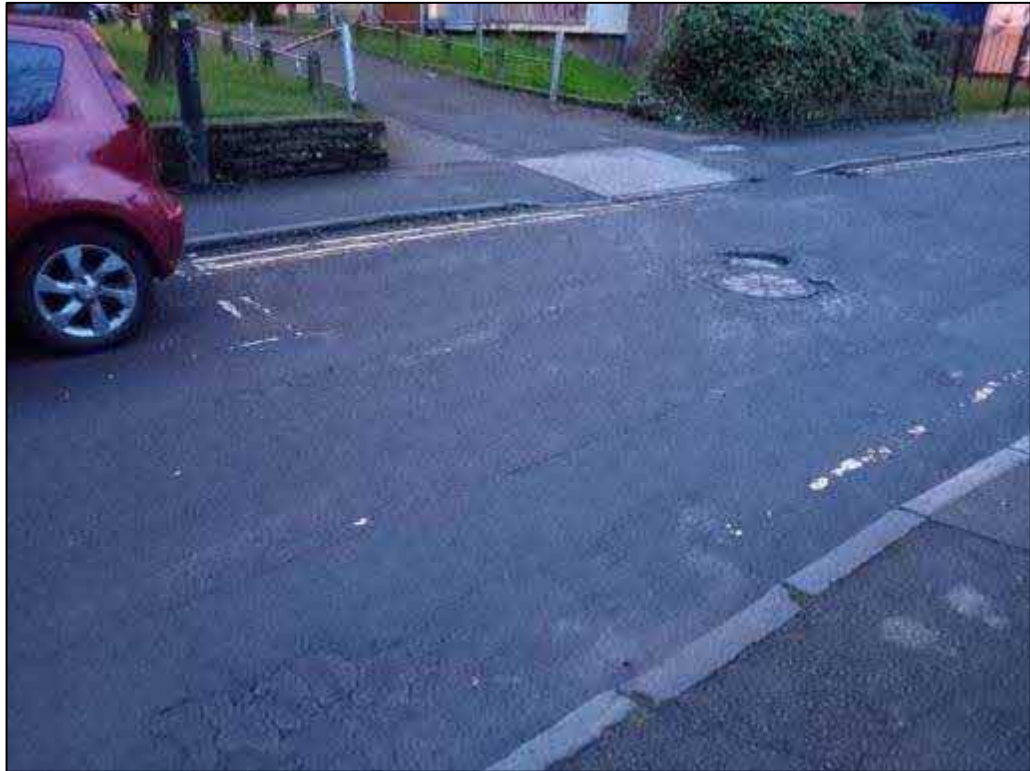
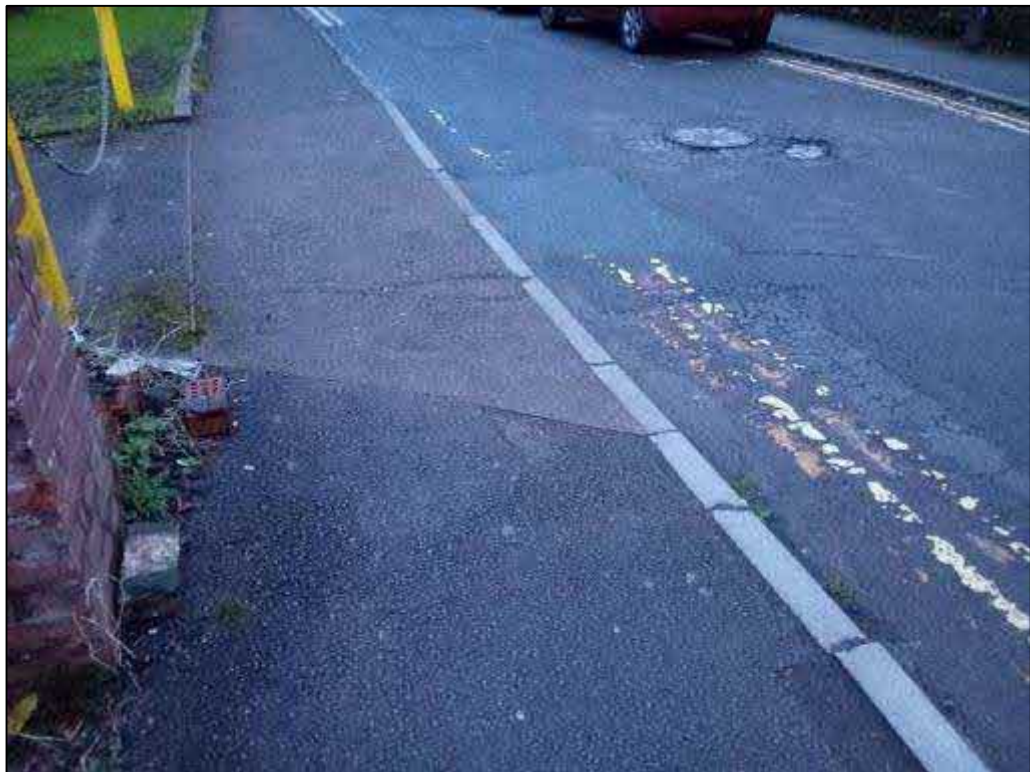
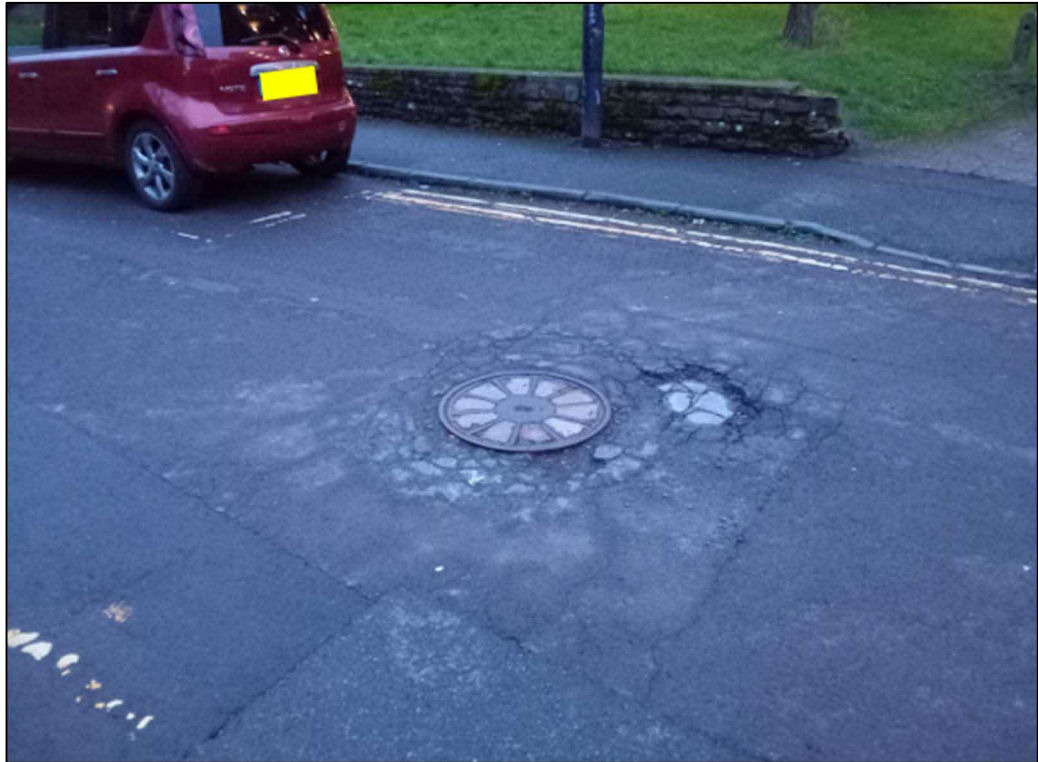
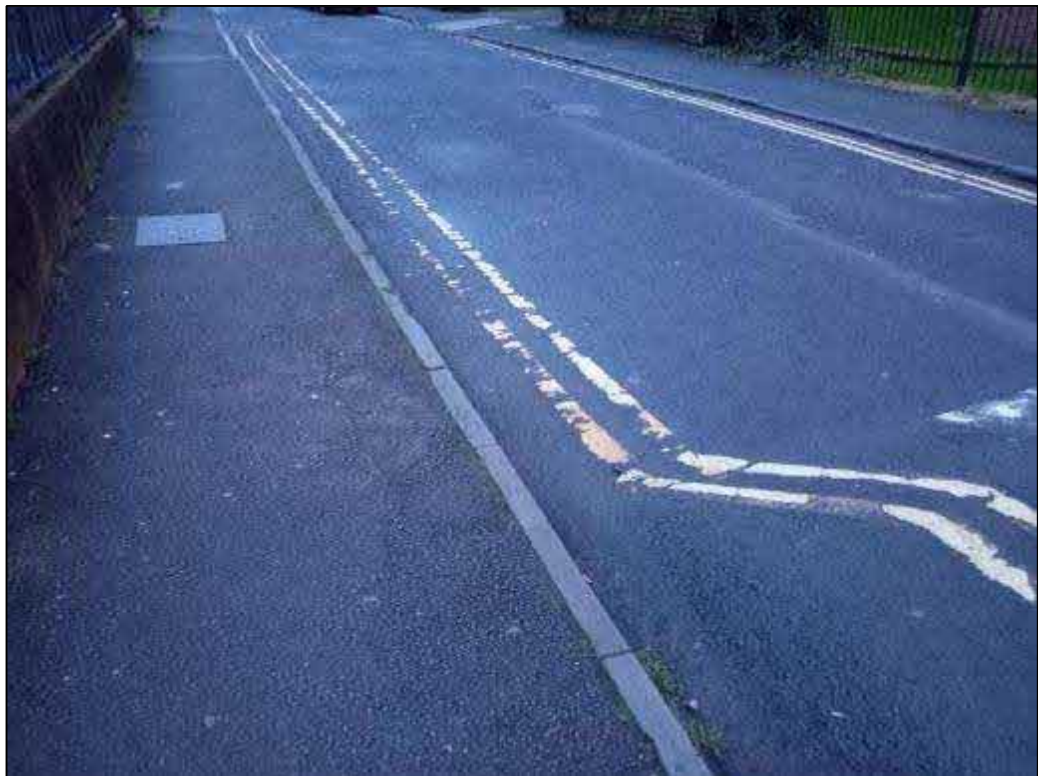
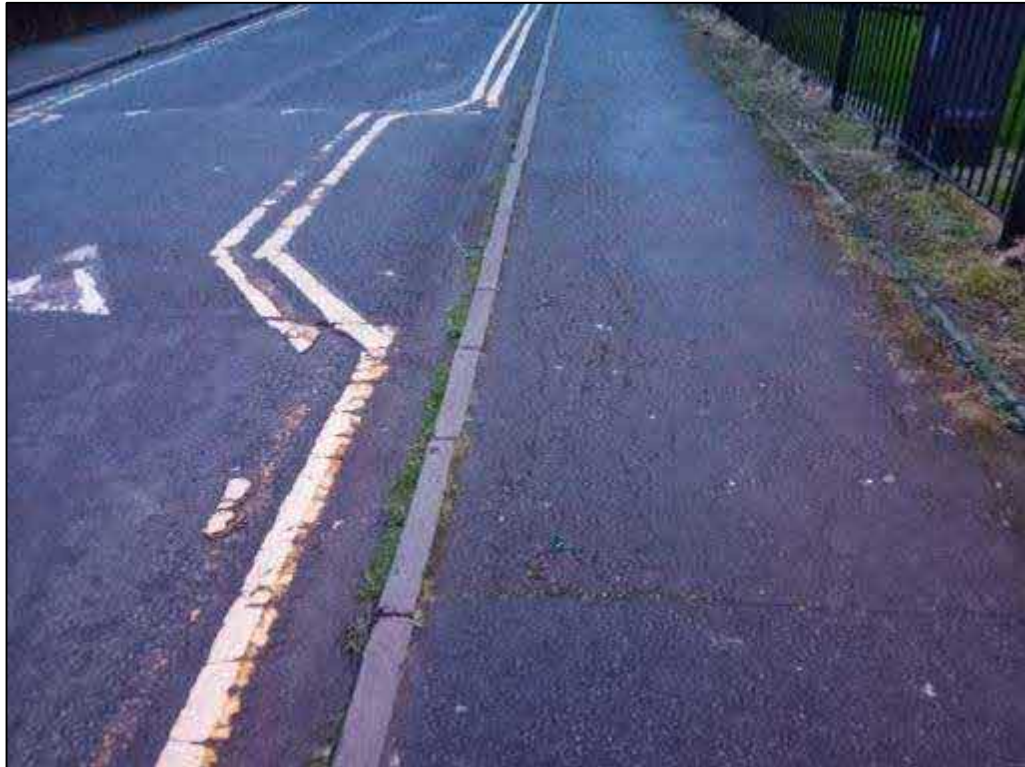
- x. Along Great George Street, to the north of the junction with New Street (Photographs 46 to 50) the following defects were observed:
- The carriageway surfacing has deteriorated and features multiple patched repairs.
 - The surfacing within the footway on both sides of Great George Street is damaged and features patched repairs.
 - There is vegetation growing in gaps surrounding the kerbs on both sides of the carriageway, and in gaps at the back of the footway.
 - There is damage to the kerbs on both sides of the carriageway, some kerbs are dislodged from original alignment.
 - The carriageway surfacing has deteriorated in several locations and features patched repairs.
 - There is damage to the surfacing surrounding the service covers in the footway and the carriageway.
 - The yellow TRO road markings and white parking cage and dragons tooth markings are worn and faded.
