11-17 Wade Street, Bristol

Discharge of Planning Condition 10 (LPA Ref: 21/01065/P and
Appeal Ref APP/Z0116/W/21/3282706)
Pre-Commencement Highway Condition Survey

March 2024

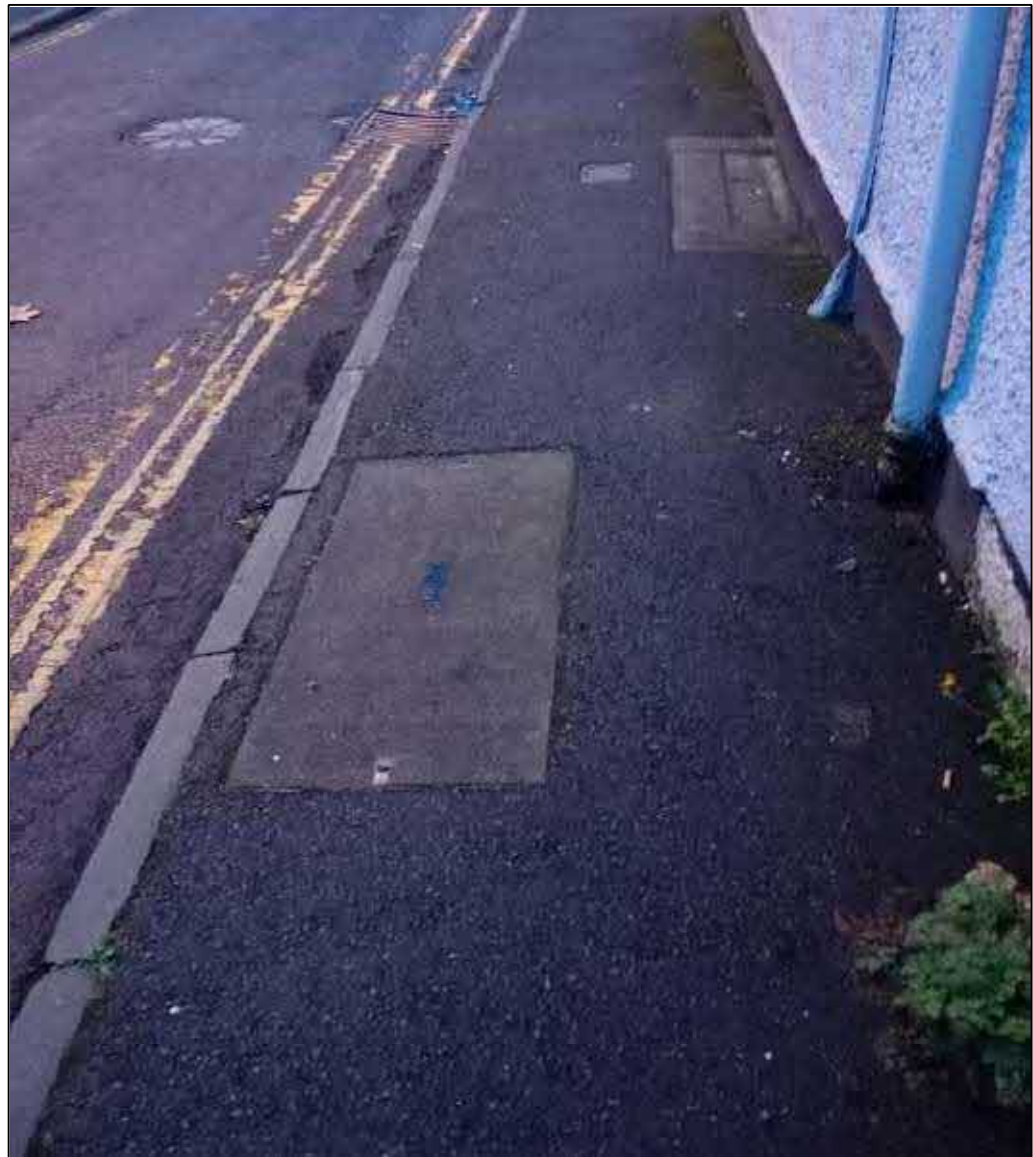
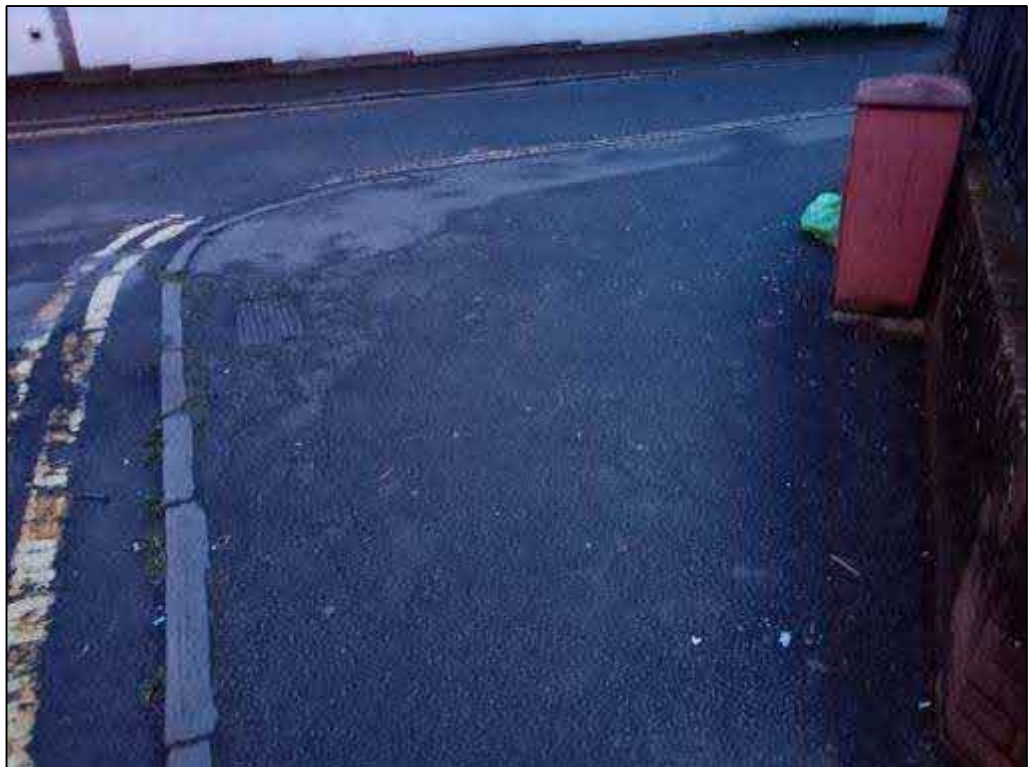
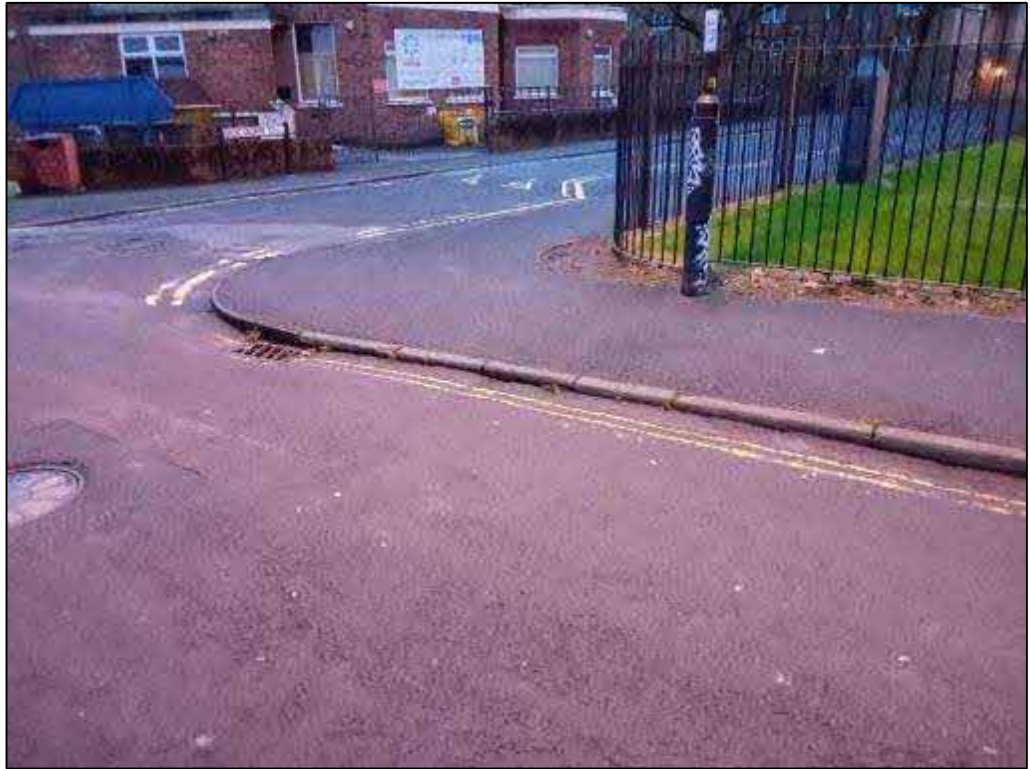
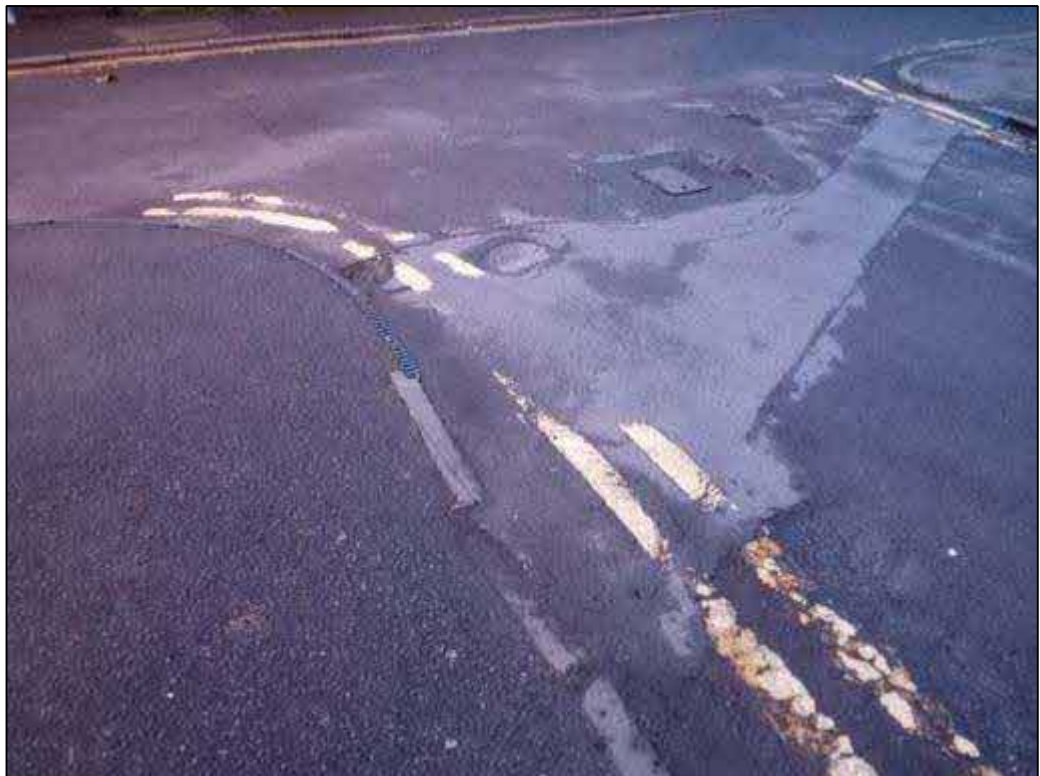
- xi. At the junction of Great George Street and New Street (Photographs 51 to 55) the following defects were observed:
- The carriageway surfacing has deteriorated and features multiple patched repairs.

- The surfacing within the footway on both sides of Great George Street and New Street is damaged and features patched repairs.
 - There is vegetation growing in gaps surrounding the kerbs on both sides of the carriageway, and in gaps at the back of the footway.

- There is damage to the kerbs on both sides of the carriageway, including the heritage iron edging kerbs. Some kerbs are dislodged from original alignment.

- There is damage to the surfacing surrounding the service covers in the footway and the carriageway.
 - The yellow TRO road markings are worn and faded.

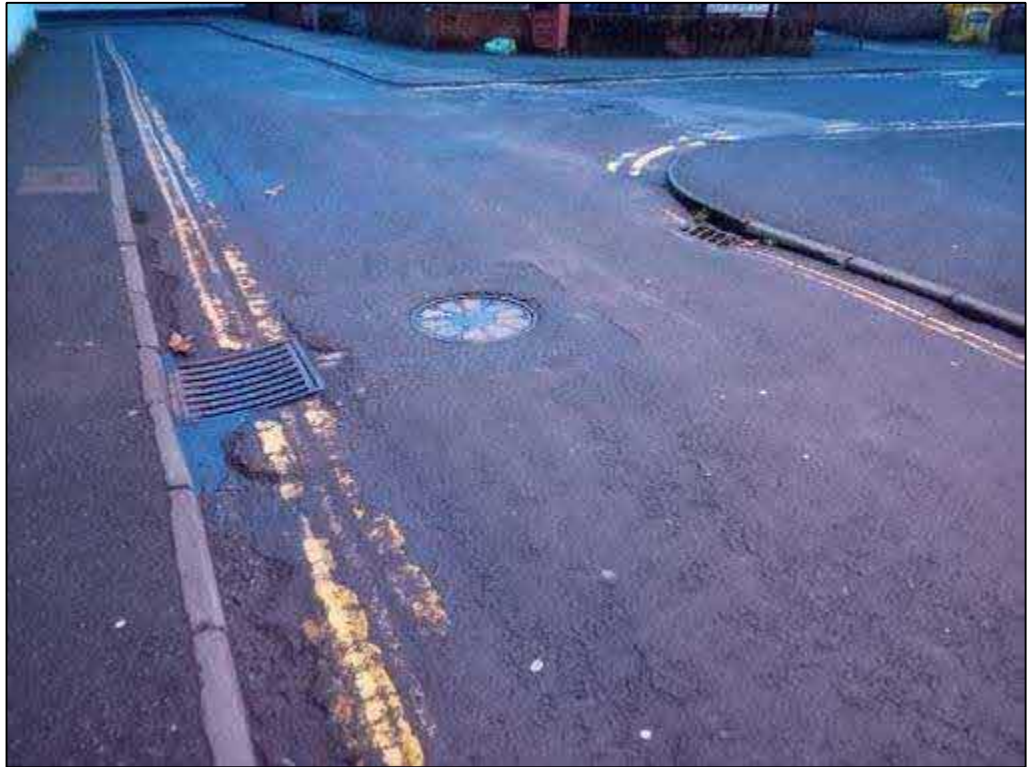
Photograph 52

- The carriageway surfacing has deteriorated in several locations and features patched repairs.
 - The carriageway surfacing is missing along the southern side of New Street, and a large gap has formed (photograph 52).

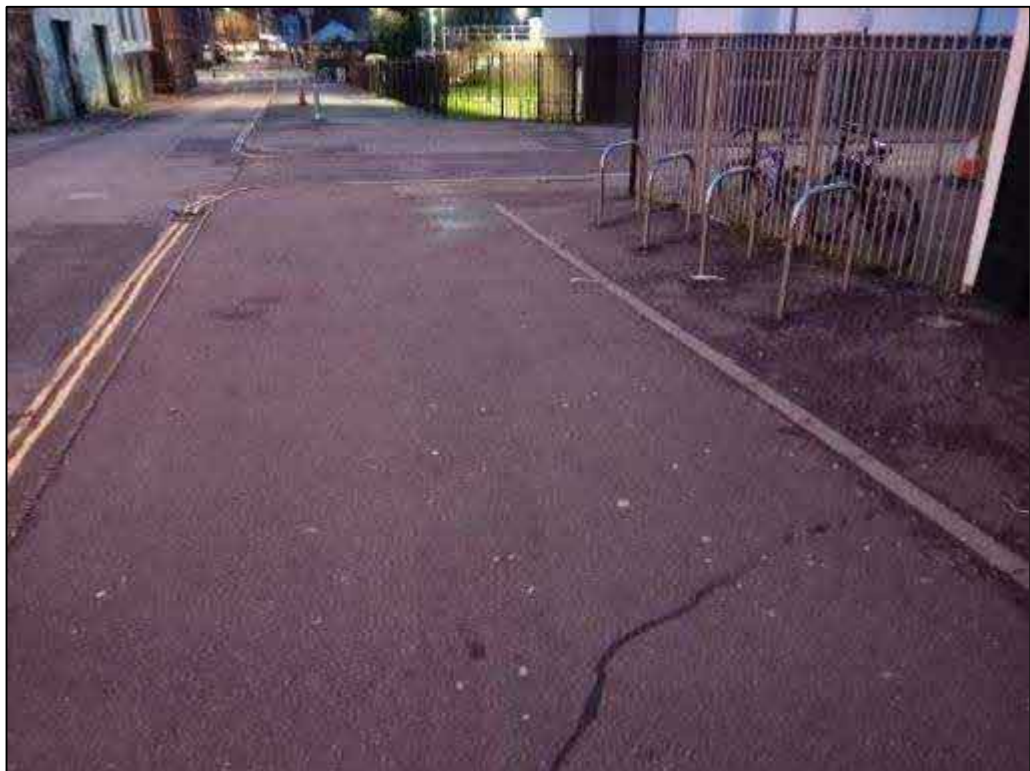
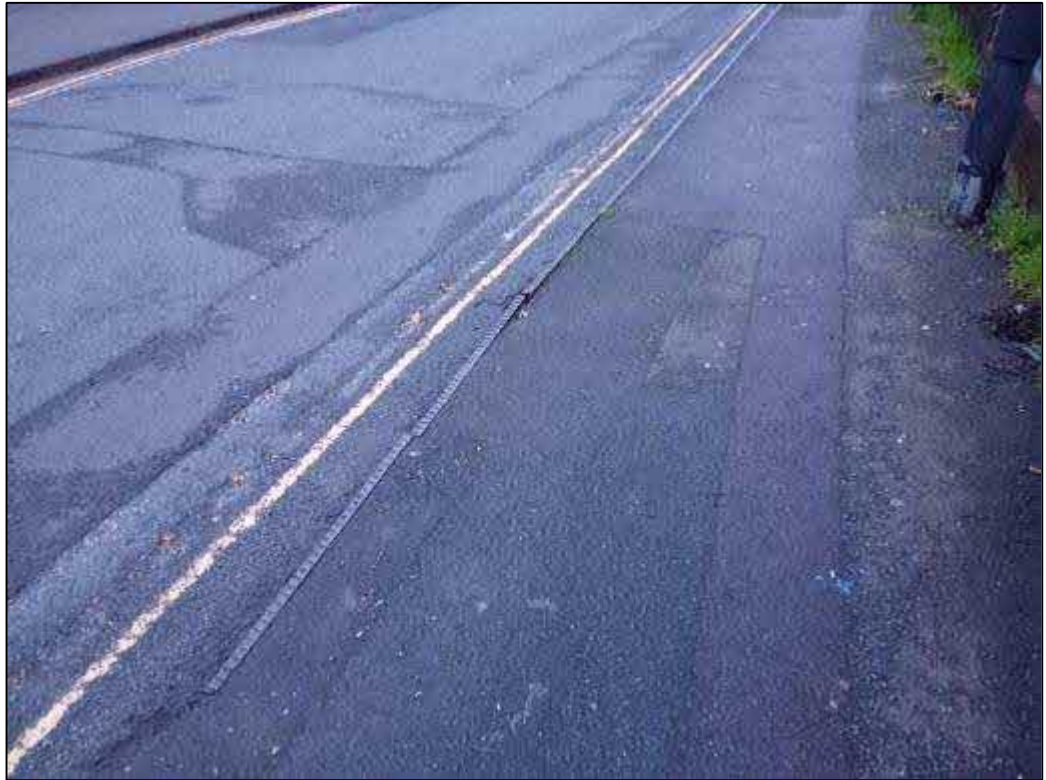
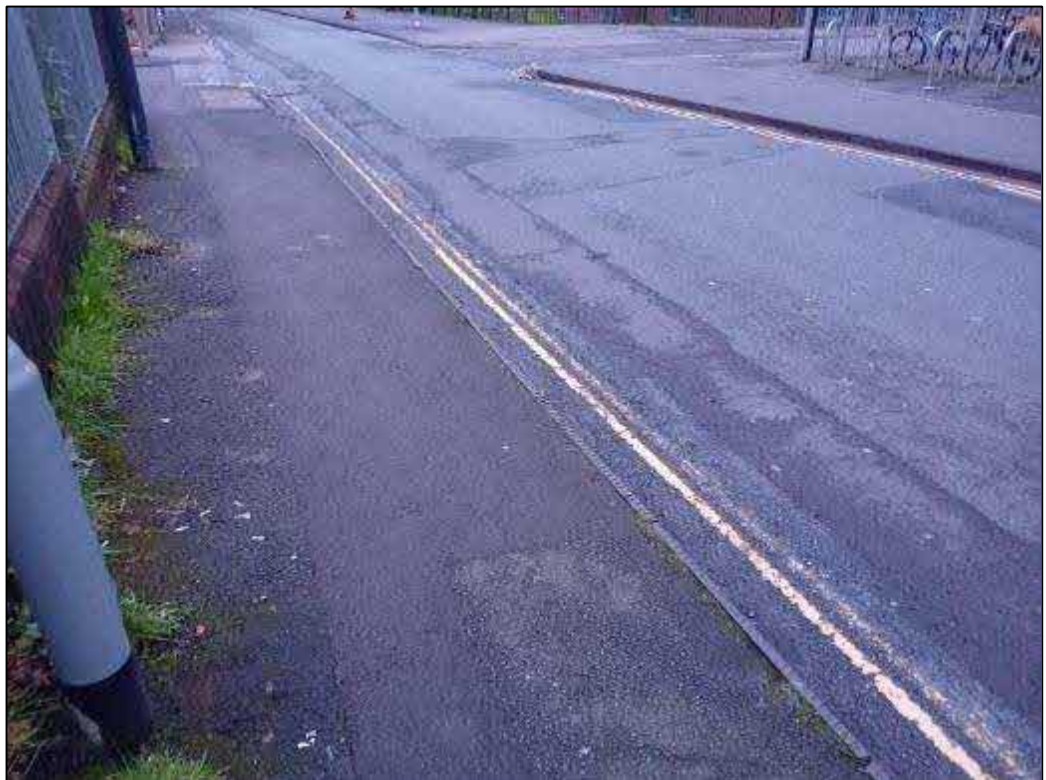
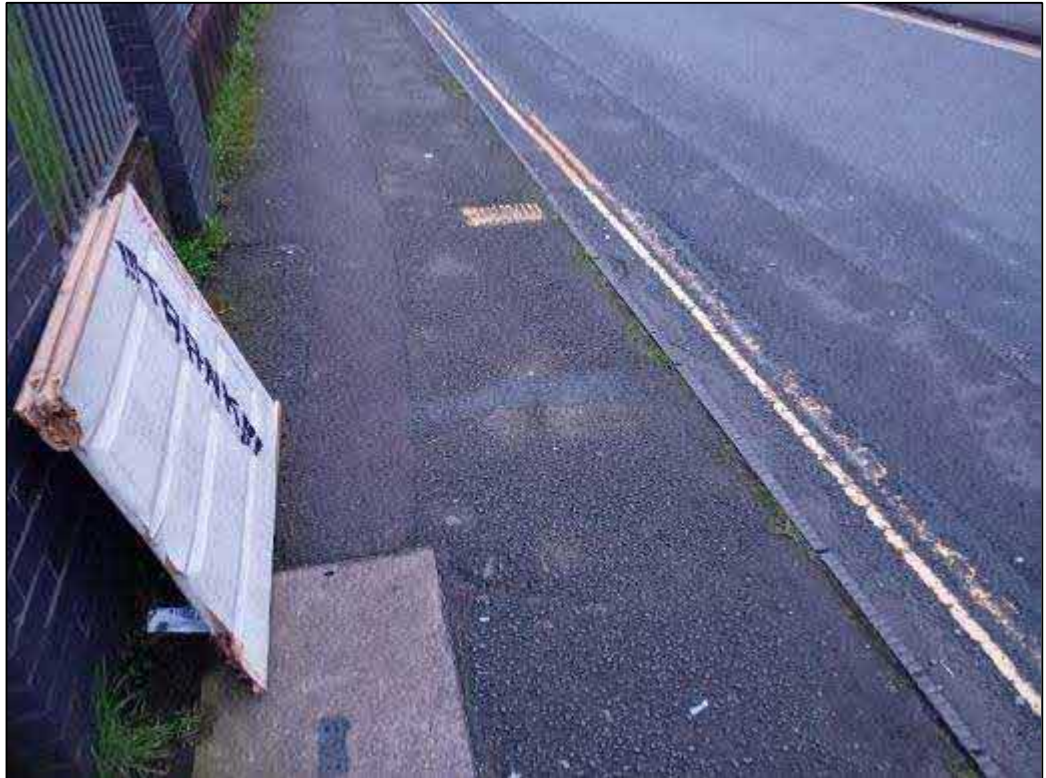
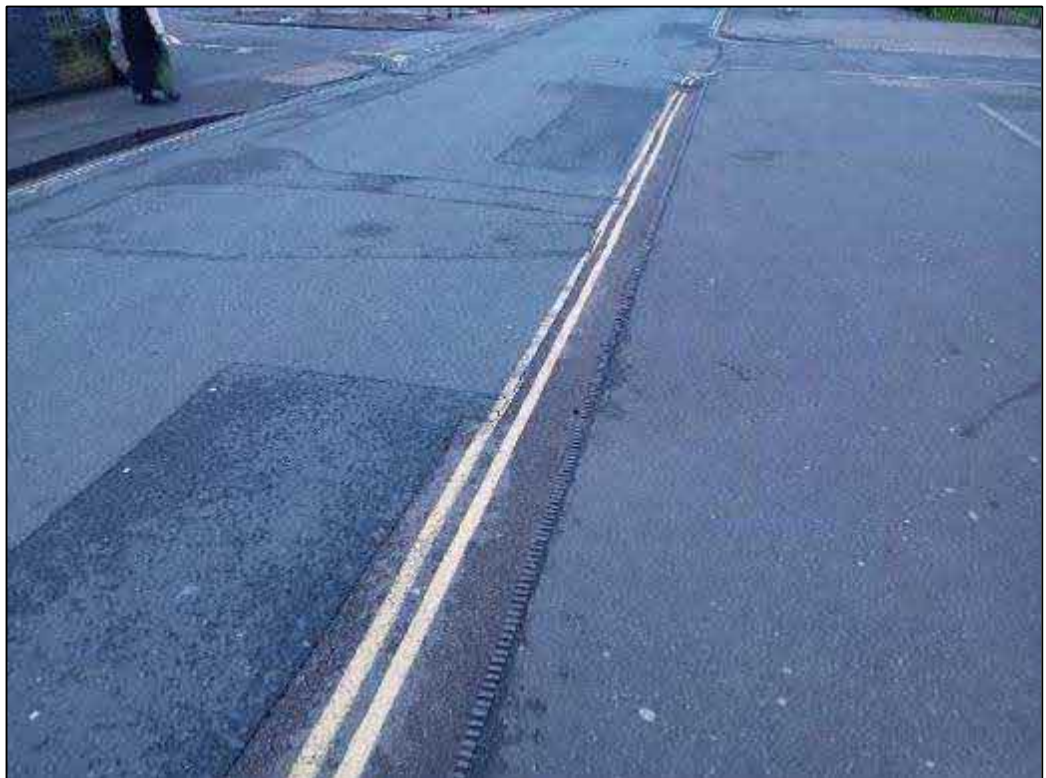
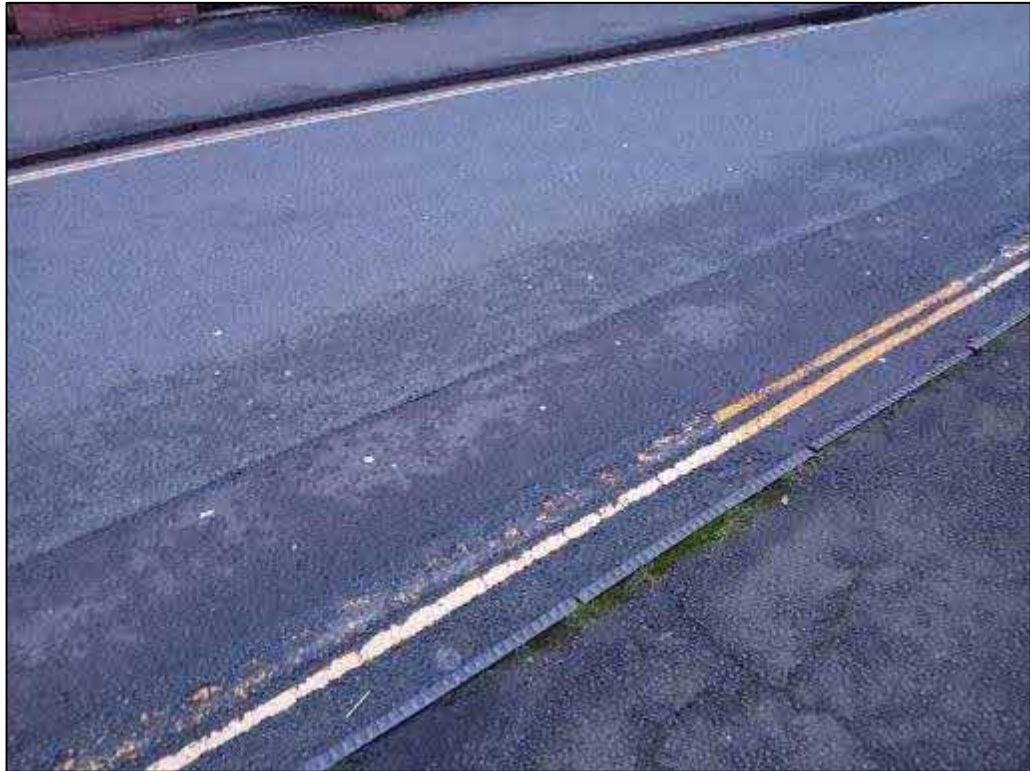
xii. Along Wade Street, to the east of the junction with Great George Street (Photographs 56 to 61) the following defects were observed:

- The carriageway surfacing has deteriorated and features multiple patched repairs.
- The surfacing within the footway on both sides of Wade Street is damaged and features patched repairs.
- There is vegetation growing in gaps surrounding the kerbs on both sides of the carriageway, and in gaps at the back of the footway.
- There is damage to the kerbs on both sides of the carriageway, including the heritage iron edging kerbs. Some kerbs are dislodged from original alignment.
- The carriageway surfacing has deteriorated in several locations and features patched repairs.
- There is damage to the surfacing surrounding the service covers in the footway.
- The yellow TRO road markings are worn and faded.

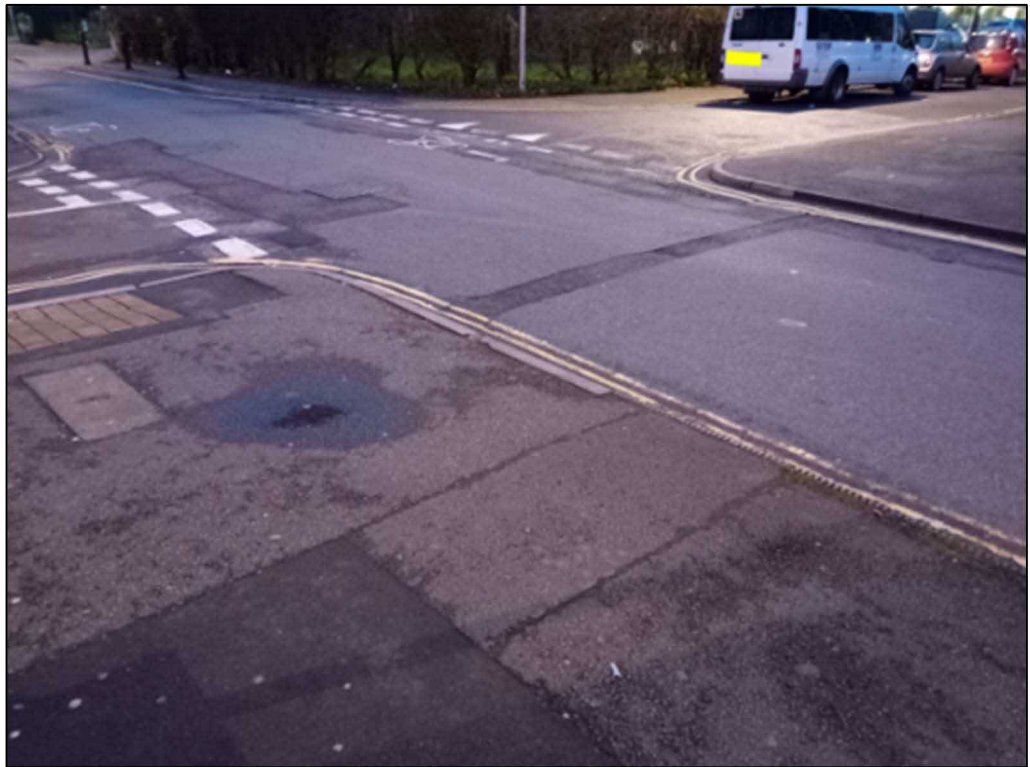
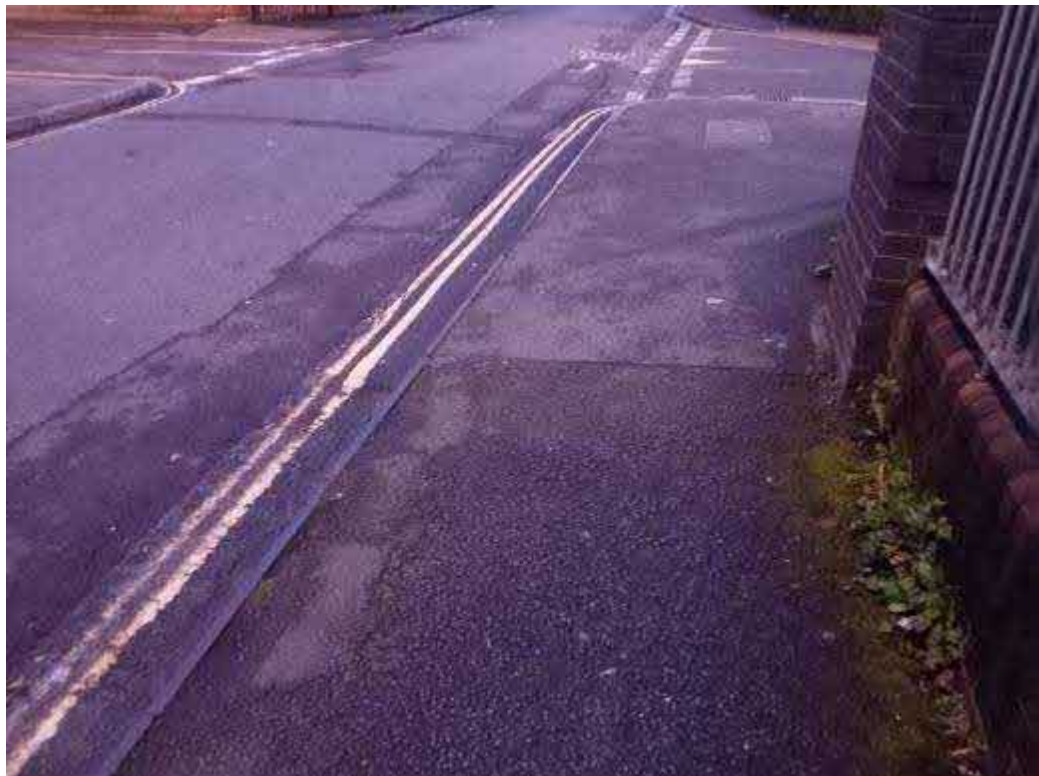
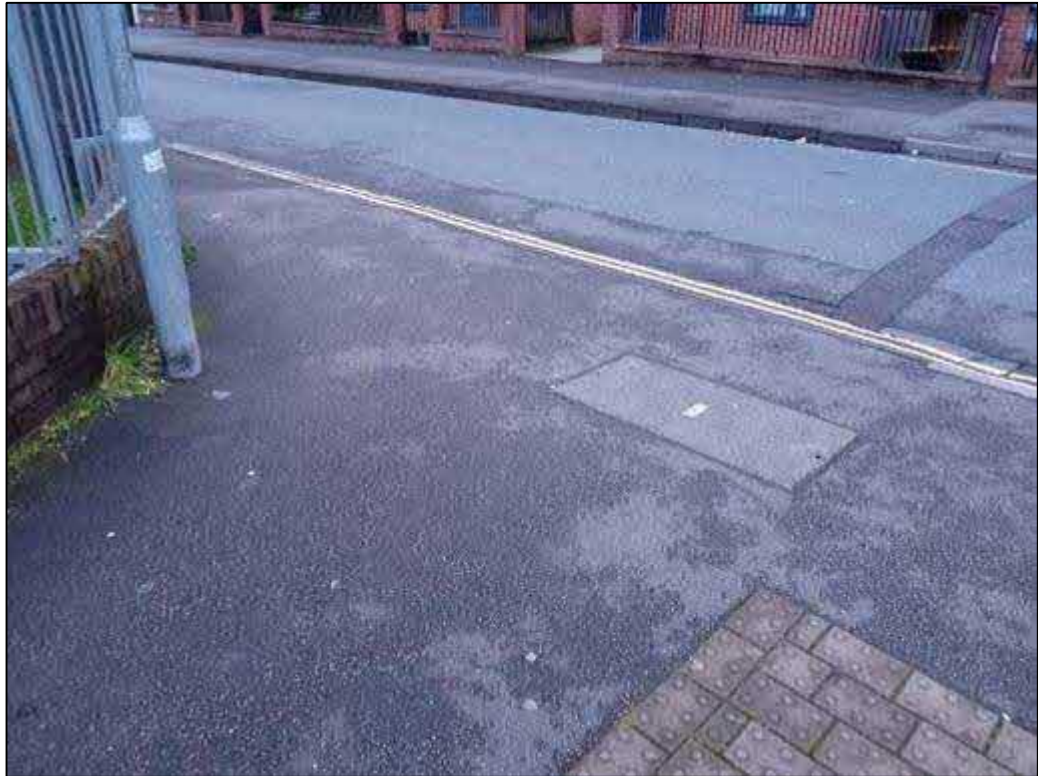
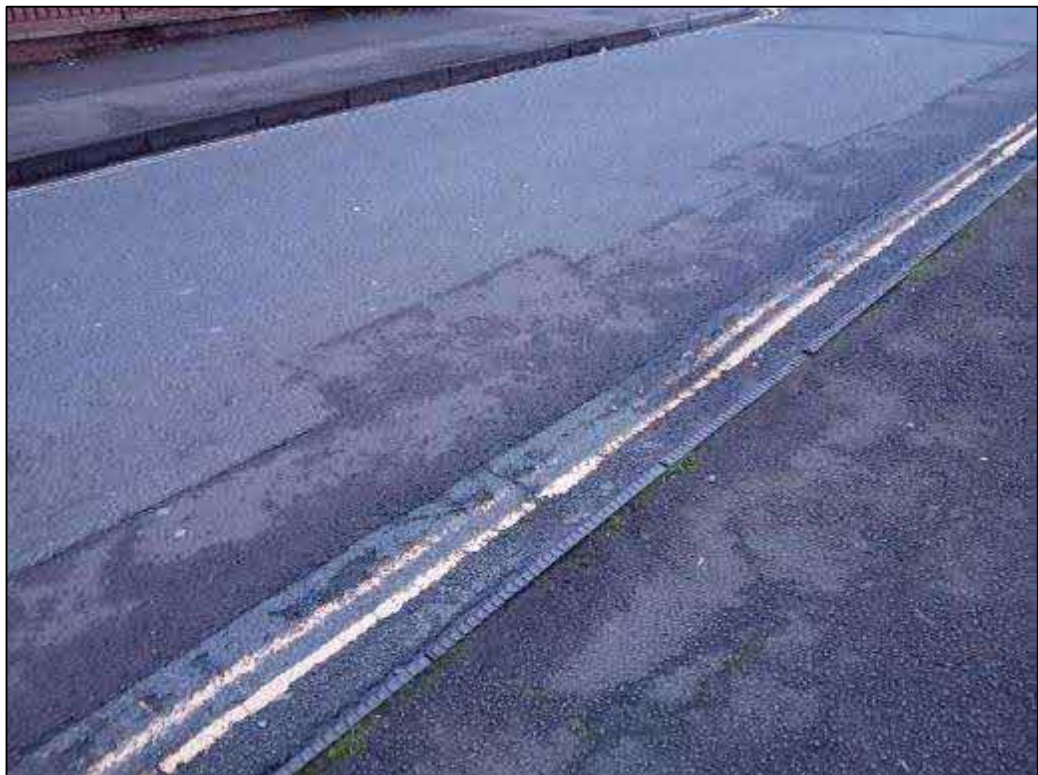
- xiii. Along Great George Street, to the west of the junction with Little Ann Street and Great Ann Street (Photographs 62 to 65) the following defects were observed:
- The carriageway surfacing has deteriorated and features multiple patched repairs.
 - The surfacing within the footway on both sides of Great George Street is damaged and features patched repairs.
 - There is vegetation growing in gaps surrounding the kerbs on both sides of the carriageway, and in gaps at the back of the footway.
 - There is damage to the kerbs on both sides of the carriageway, including the heritage iron edging kerbs. Some kerbs are dislodged from original alignment.
 - The carriageway surfacing has deteriorated in several locations and features patched repairs.
 - There is damage to the surfacing surrounding the service covers in the footway.
 - The yellow TRO road markings are worn and faded.
