BELGRAVE ROAD  
OLDHAM

SHALLOW MINING  
SITE INVESTIGATION WORKS

**Job Number:** LKC 23 1553  
**Date:** February 2024  
**Client:** First Choice Homes Oldham

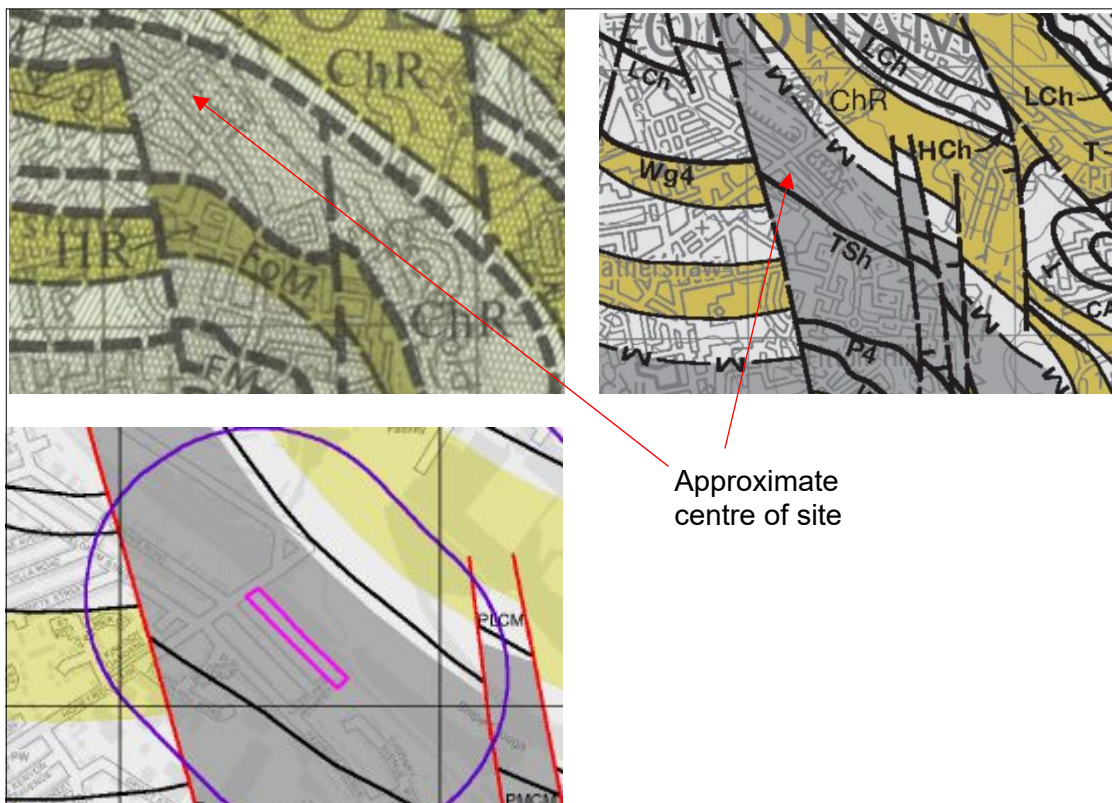
Plate 2-1: Extracts from geological mapping. Top left: 1975 1:50,000 sheet mapping, top right: 2010 1:50,000 sheet mapping (left) and bottom left: 2004 1:10,000 digital mapping. Not to scale.

Extracts from geological mapping are shown on Plate 2-1. These show the differences in geological mapping between 1975 and 2010 mapping.

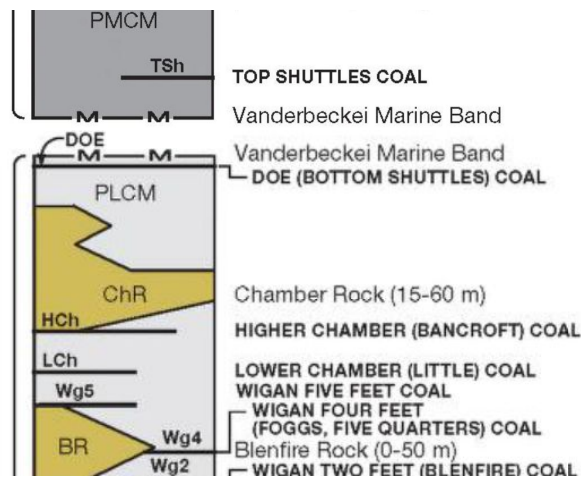
Plate 2-2 Extract of the generalized vertical section from Sheet 85 (dated 2010). Not to scale.

Based on the mapped subcrop location of the Doe coal seam and assumed dips of 5° to 11° south it is likely that the Doe coal seam is present between 10.9m and 24.3m below rock head below the site.

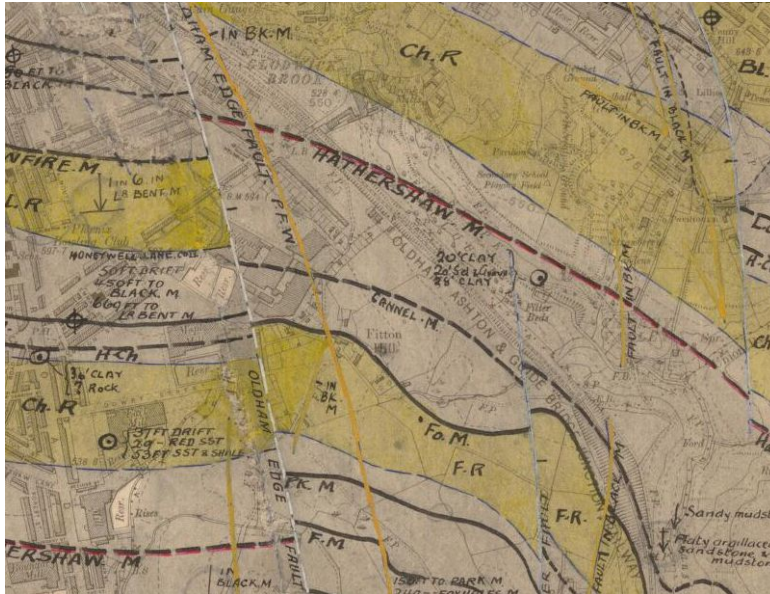
Plate 2-5: Extract from Lancashire Sheet 97SW Solid and Drift, 1924 edition, 1:10,560 scale.

Lancashire Sheet 97SW Solid and Drift, 1924 edition has been reviewed and identifies the Hathershaw Mine (also named as the Doe and Bottom Shuttles) subcropping in the north of the site. This contradicts the more recent editions of geological mapping; however, is in line with the Coal Authority data (see Section 2.1.2).

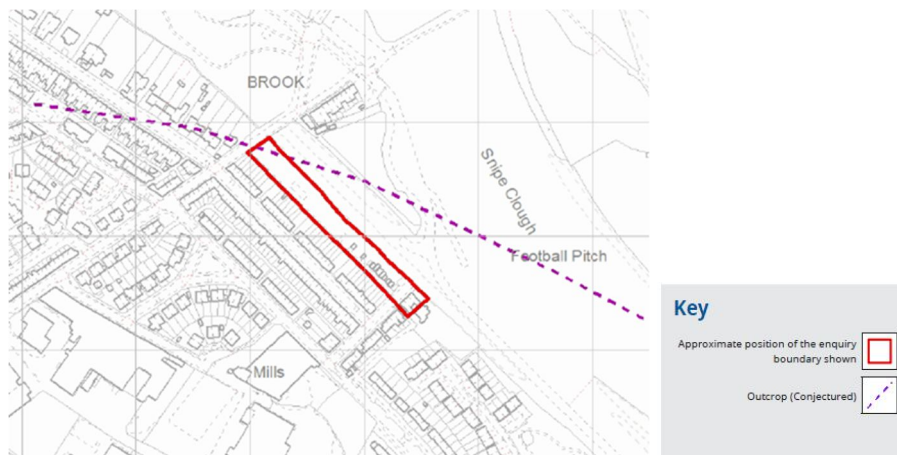
Plate 2-3: Extract from Coal Authority Consultants Coal Mining Report.

The location of the coal seam the Coal Authority Consultants Coal Mining Report corresponds to the Hathershaw Mine identified on Lancashire Sheet 97SW Solid and Drift, 1924 edition, 1:10,560 scale.

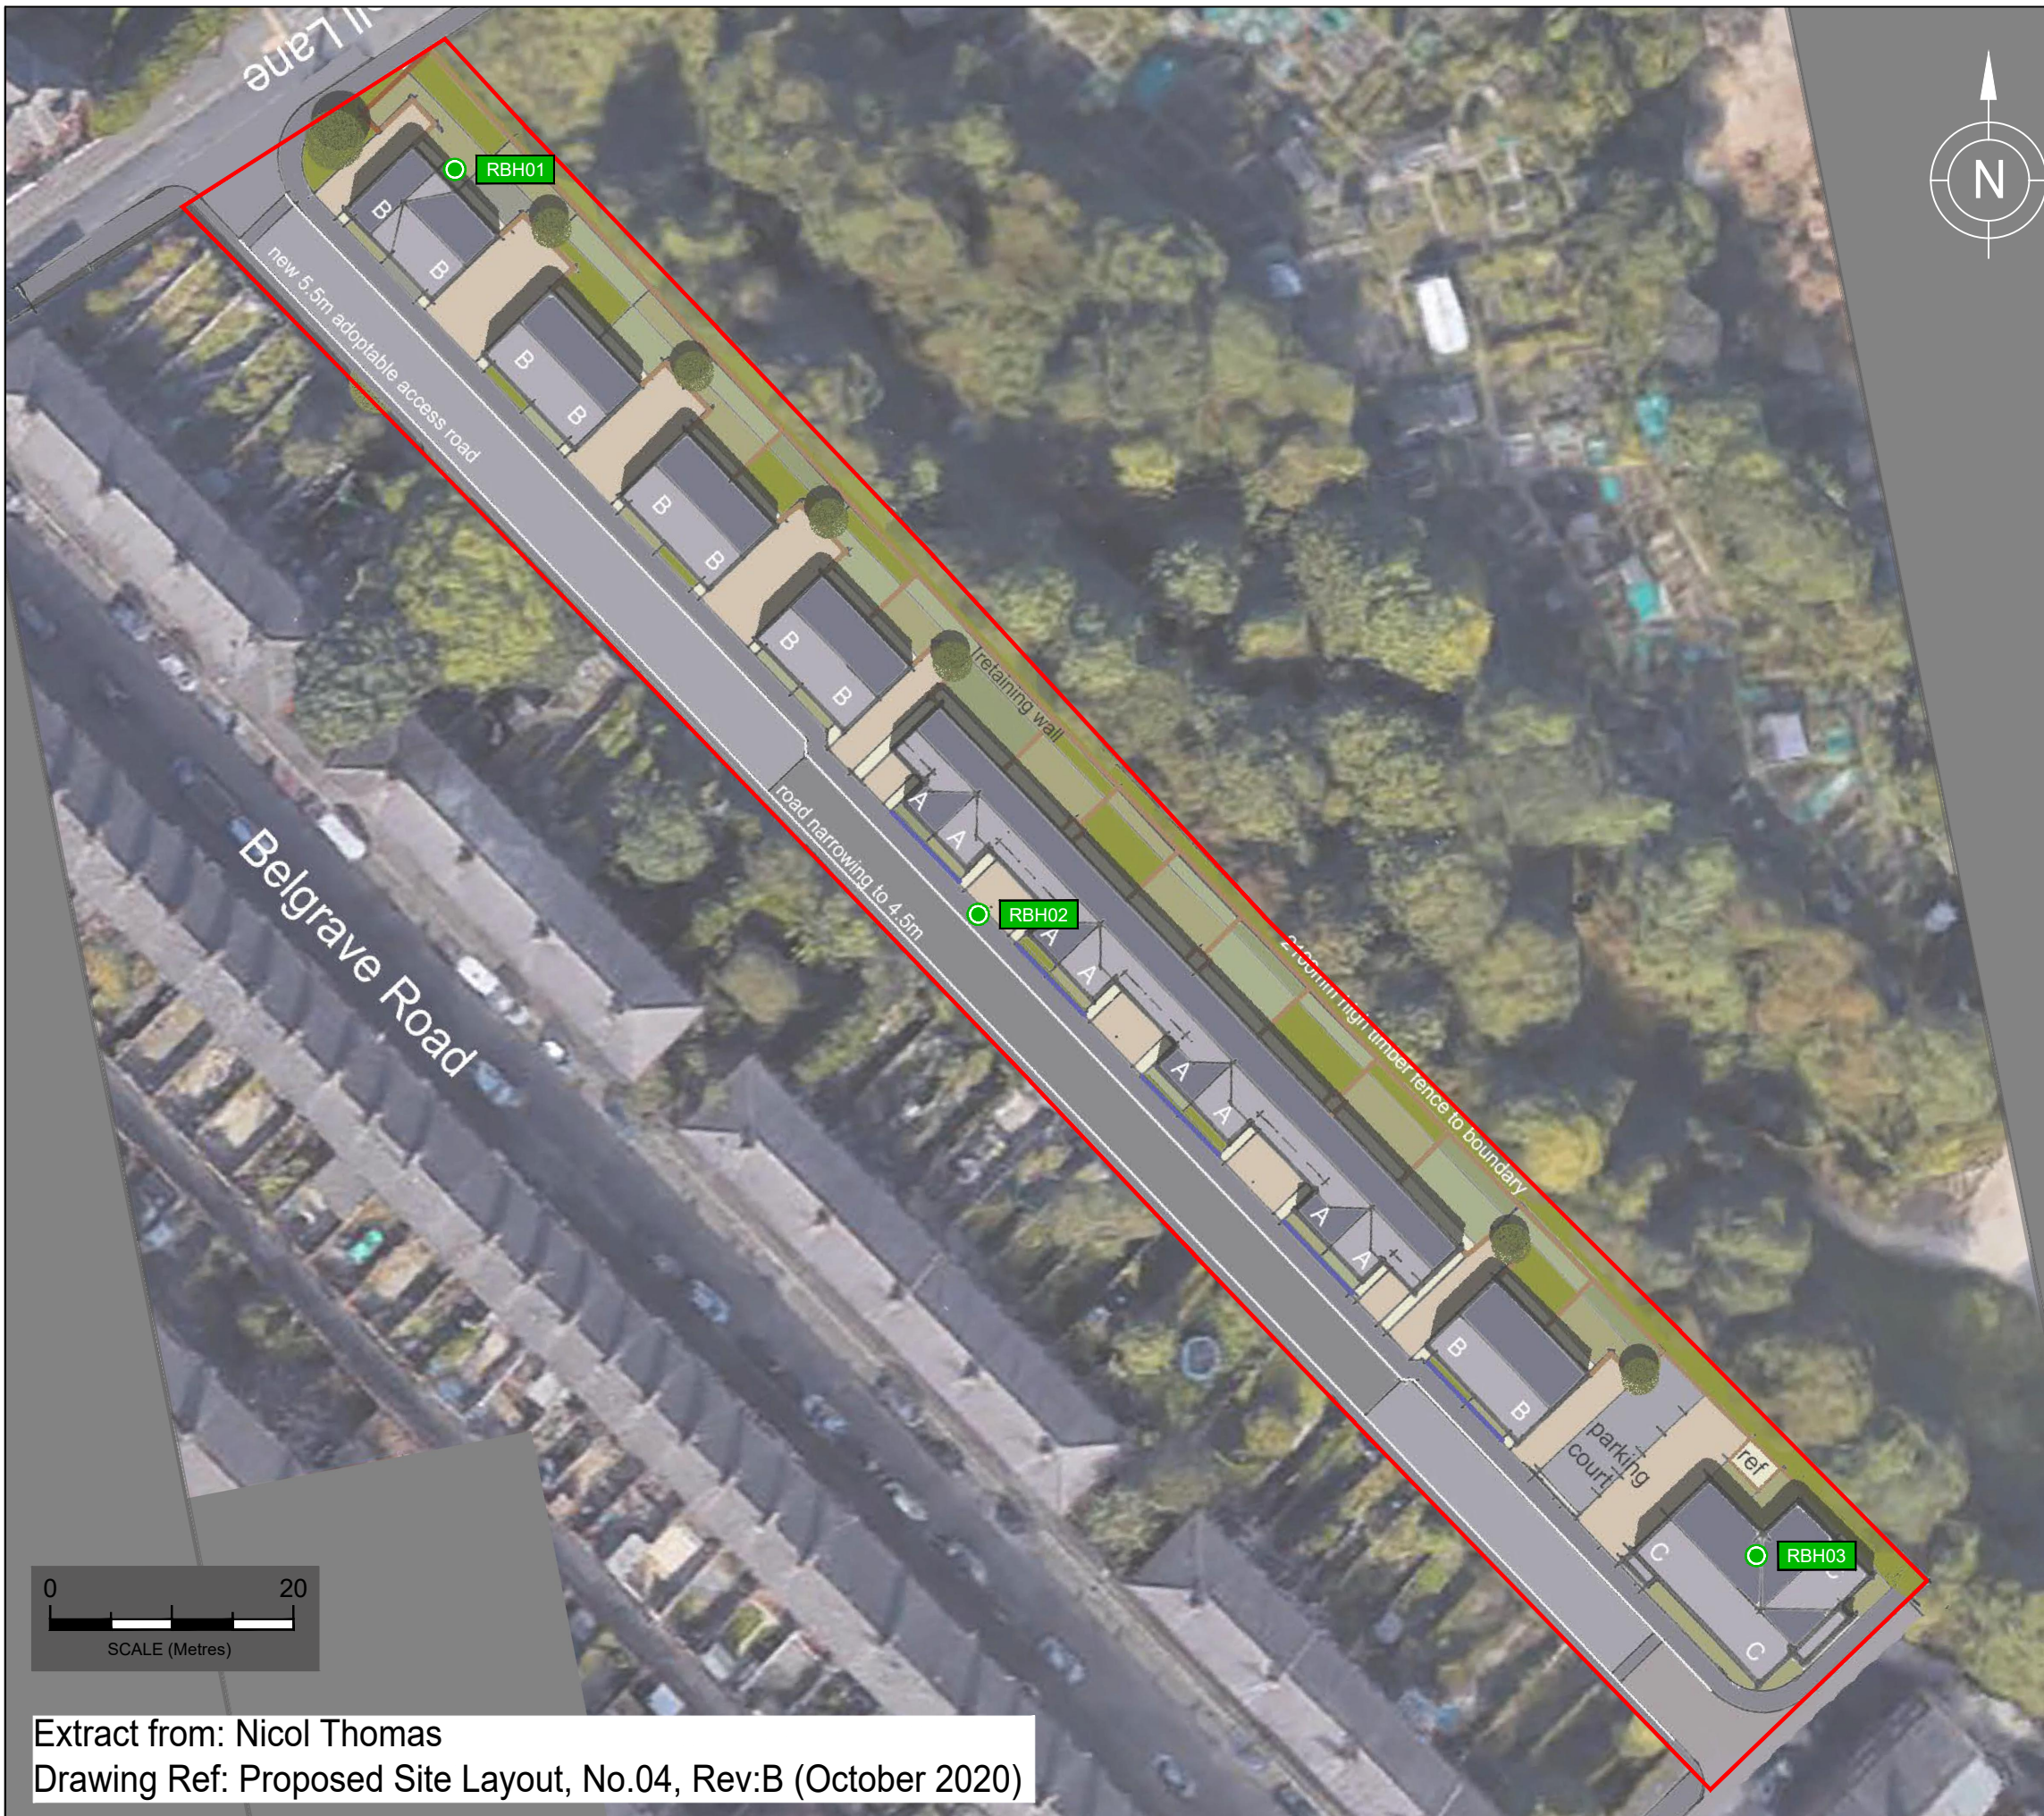
Title: **Site Investigation Location Plan**

The rotary borehole logs are provided in Appendix B. The investigation locations are shown on Figure 3.

- Competent drilling / possible weathered light brown mudstone was recorded from below 28.00mbgl in RH1, 25.00mbgl in RH2 and 25.00mbgl in RH3.
- All boreholes terminated in the above strata at 40.00mbgl.
- No evidence of coal or workings was recorded in any of the locations.

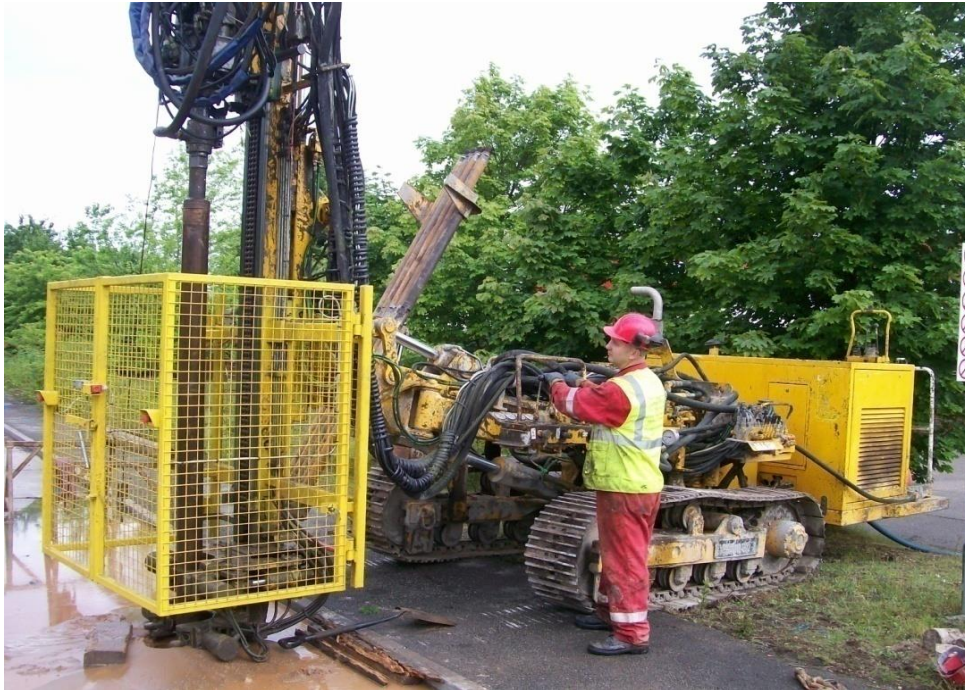
BH Dia: 100mm		Total Depth: 40.0m		Cased		BH No: RH1						
Site:		Belgrave Rd Oldham		Sampling and insitu testing								
Depths (m)		Description of Strata		Key	Depth From/To	75 mm	75 mm	75 mm	75 mm	75 mm	75 mm	N Value
From	To											
GL	2.8m	Colliery Waste Mainly Ash & Clinker										0

2.8m	28.0m	Interbedded Light brown clay + Fine sands										0
28.0m	40.0m	competent drilling poss weathered light brown mudstone										0
												0
												0
												0
												0
												0
												0
												0
												0
												0
												0
												0
												0
												0
												0
												0
												0
												0
												0
<b>Key</b> S-SPT C-CPT U-Undisturbed D-Disturbed NR - No recovery W- Water UB - Bulk U100 B- Bulk <u>Water Entries</u>				Details of standing times, Hand excavations etc.		DEPTHS				TIMES		
						From	To	From	To			
<b>Installation details of</b> <b>Monitoring wells</b> <b>50mm plain pipe</b> <b>50mm slotted pipe</b> <b>Bentonite seal</b> <b>Gravel fill</b>						DEPTHS						
								From	To
