J ROBERTS DESIGN LTD
STRUCTURAL AND CIVIL ENGINEERING CONSULTANTS

Ref – JR/4097

5 Bradleys Lane, Hoveringham, Nottingham, NG14 JG - Structural Inspection

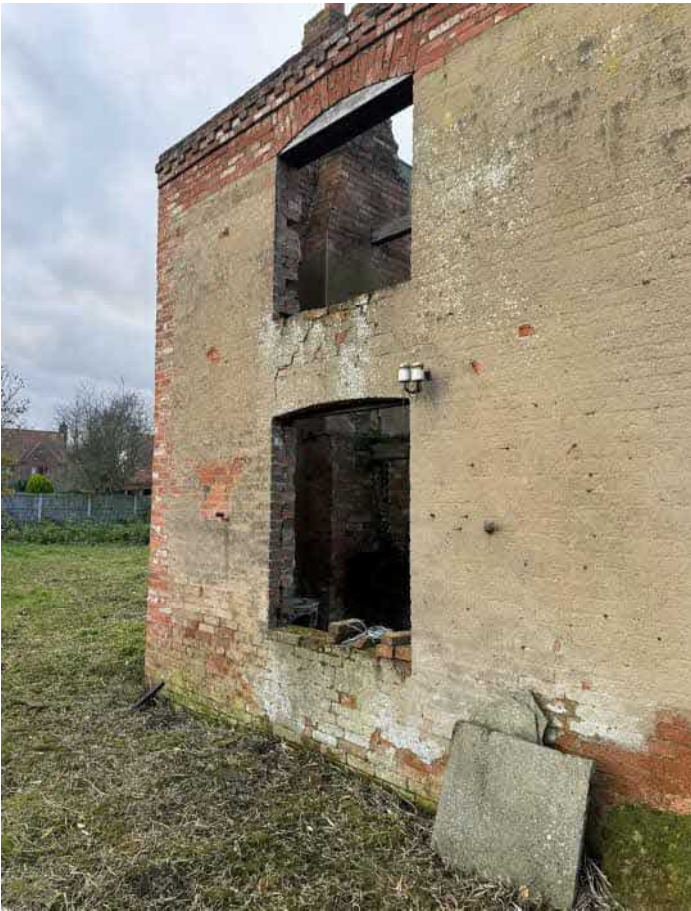
5. On the original front elevation diagonal cracks and vertical slippage of the brick arches were observed above the ground floor window heads. The remainder of the property appears to have had new proprietary steel lintels installed as part of the extension works.

The masonry fracturing and slippage of soldier coursing observed in the front wall is considered to be associated with an absence of lintel support to the outer face of brickwork, potential timber decay of the inner timber lintel and lack of a floor or roof structure providing lateral stability to the wall. We recommend the timber lintels are replaced with steel lintels, and the masonry above the window heads either repaired by crack stitching or the solid brick masonry is rebuilt locally.

FRONT ELEVATION - STEPPED FRACTURES ABOVE GROUND FLOOR WINDOW

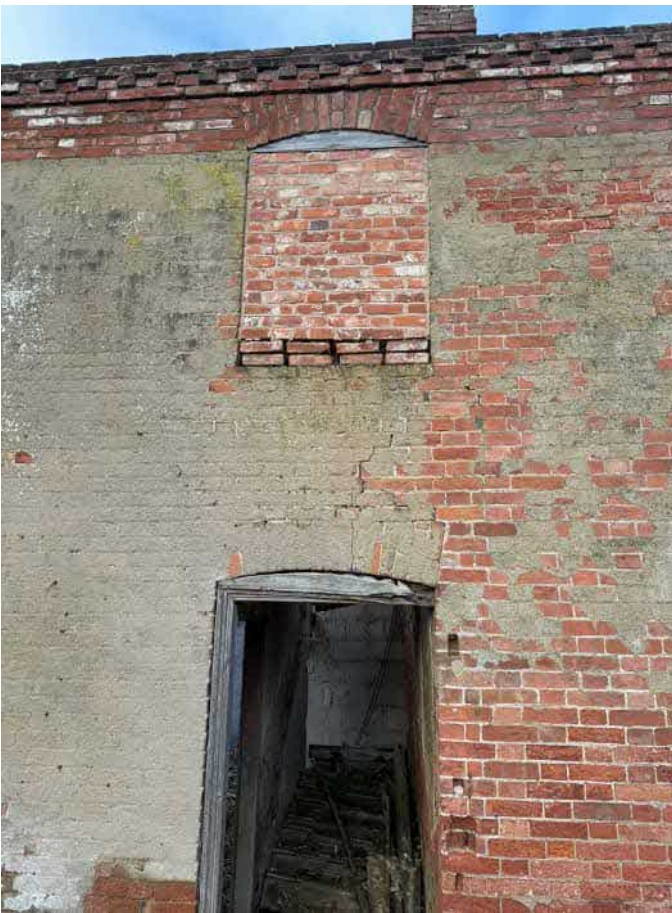
FRONT ELEVATION - STEPPED FRACTURES ABOVE GROUND FLOOR WINDOW

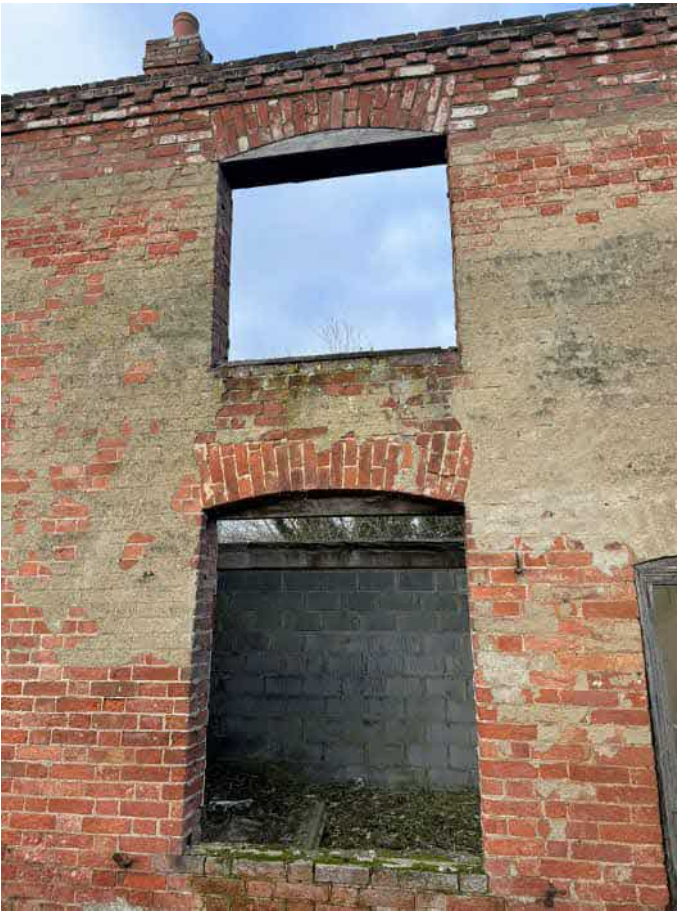
FRONT ELEVATION - STEPPED FRACTURES ABOVE GROUND FLOOR WINDOW

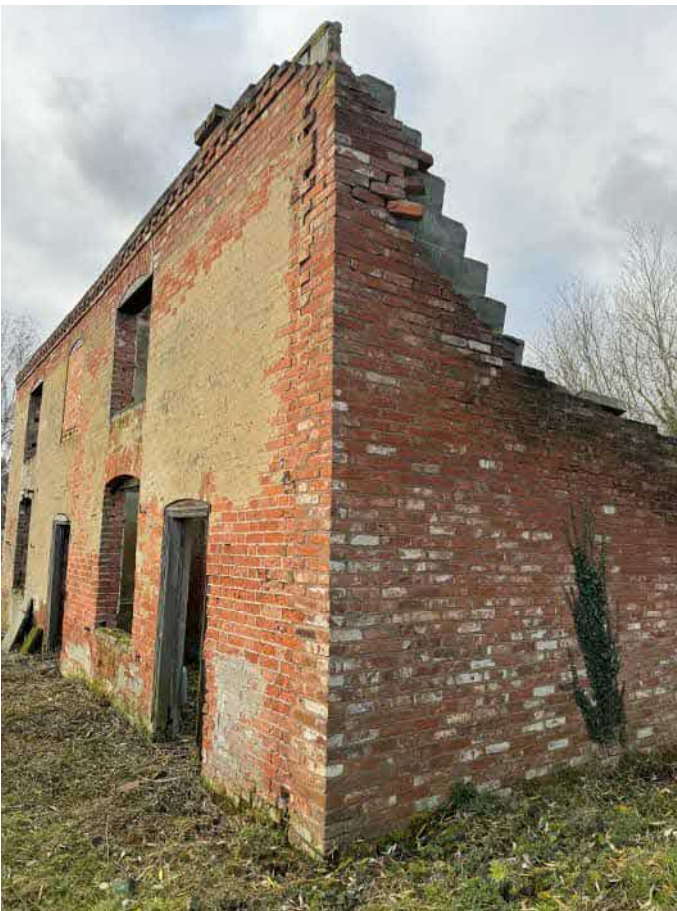
6. Continuing to the north east corner of the gable wall it appears that a section of wall had collapsed resulting in lateral movement of circa 200mm in the masonry and rotation of the masonry at the corner. Loose bricks are still present within the outerleaf of masonry. Internally cracking within the bedjoints are visible reflecting the movement observed. The corner is also noted to be an interface between the solid brick masonry and new cavity construction. The outerbrickwork has been toothed in around the corners, however the blockwork abuts the vertical face of the brickwork on the inner leaf. It is not known if masonry ties are present to the inner leaf of masonry.

FRONT / RIGHT HAND SIDE ELEVATION – STRUCTURAL DEFECTS TO BUILDING CORNER

The defects to the north gable will require the partial demolition of the defective areas of masonry and effective re-building of the corner up to the proposed gable wall level. The inner leaf of blockwork will need to be effectively tied into the solid brickwork at the corner with remedial ties where new or crack stitching around the internal corner of the wall where the blockwork is to remain in place.

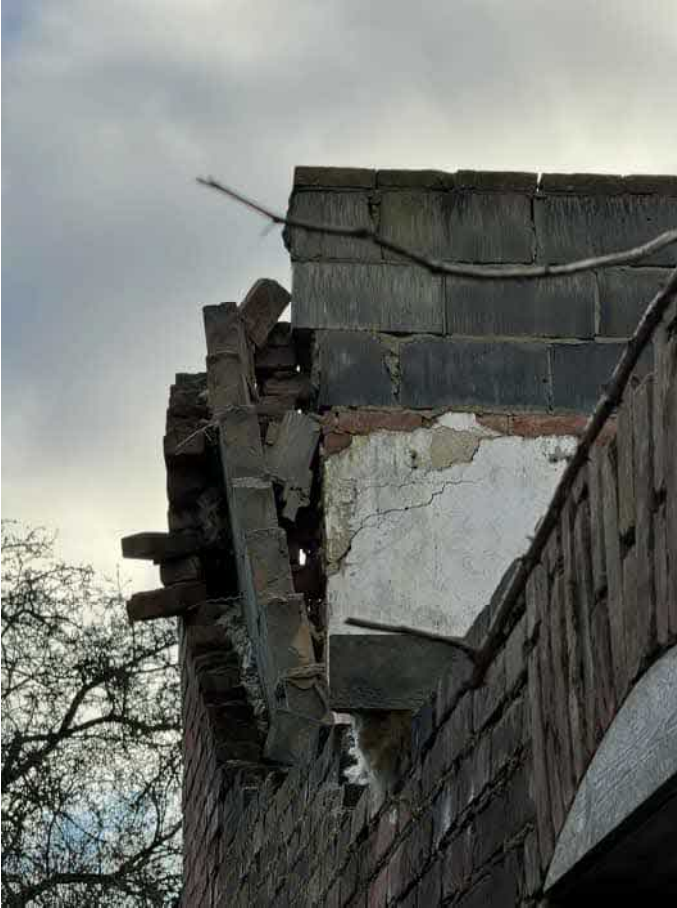
RIGHT HAND SIDE GABLE – STRUCTURAL DEFECTS

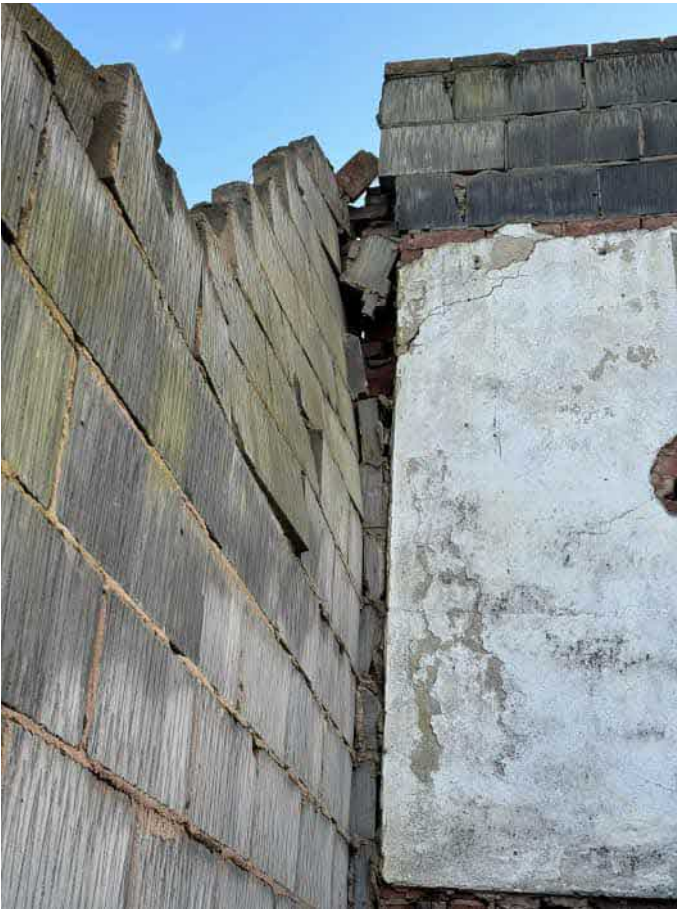
RIGHT HAND SIDE GABLE – STRUCTURAL DEFECTS FROM THE INSIDE

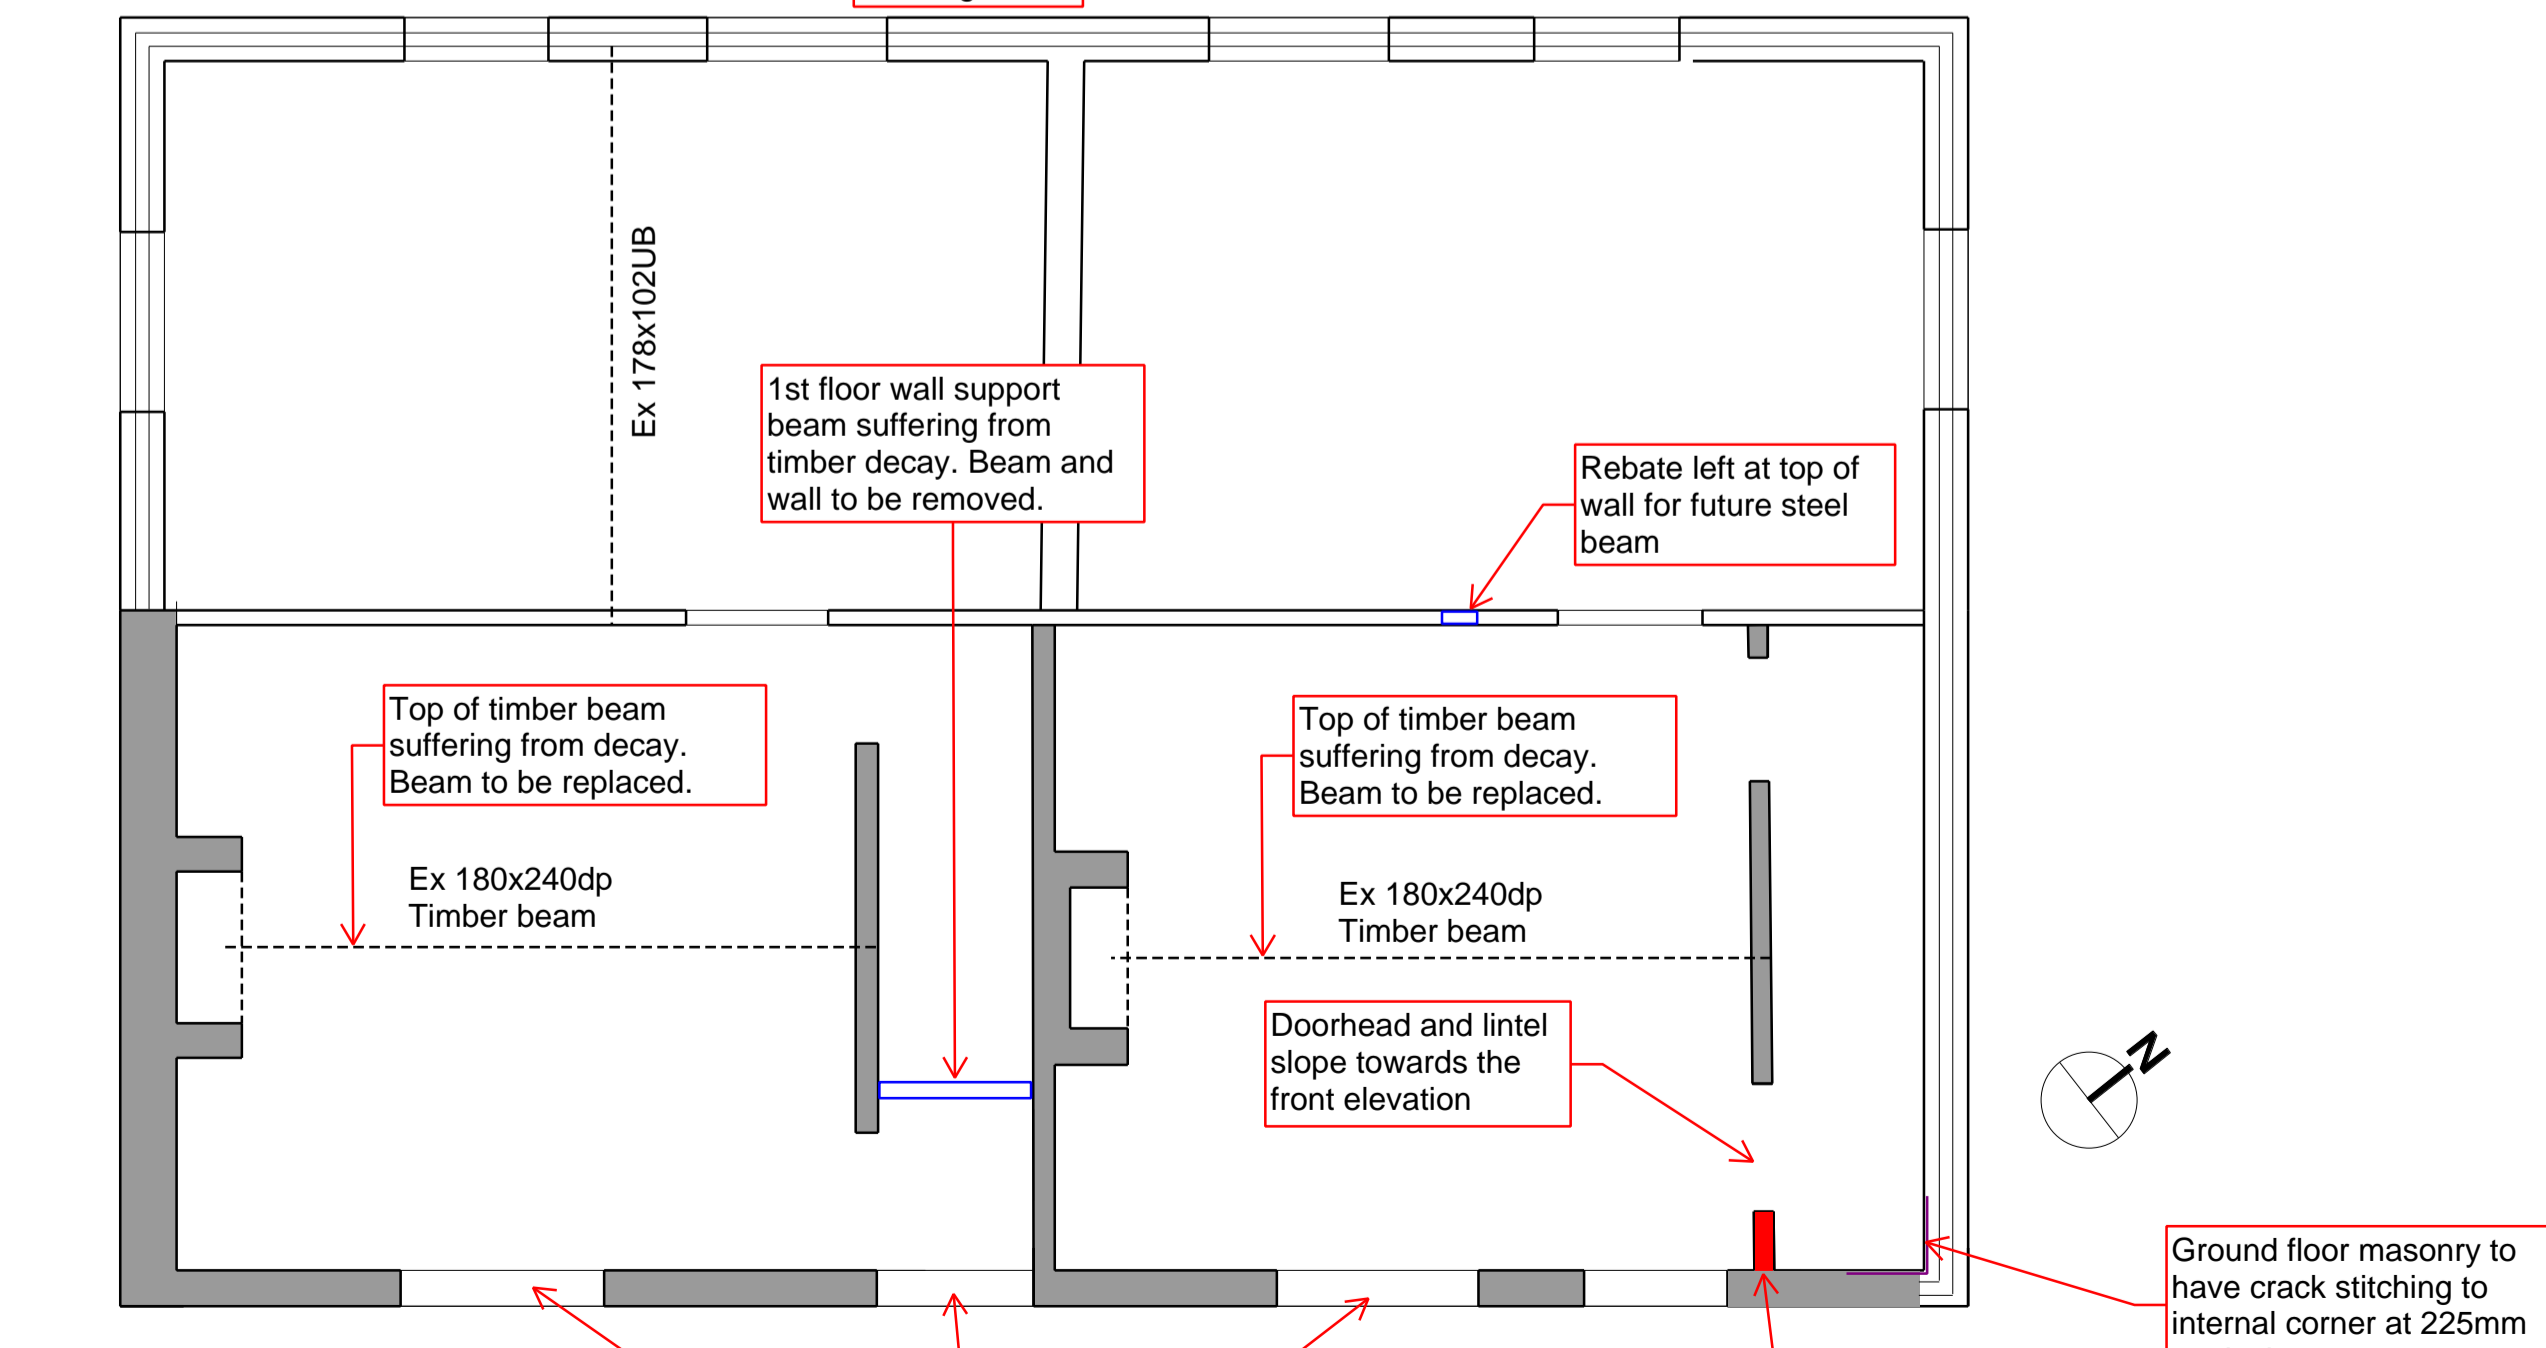
2 Existing Plan
Scale: 1:50

Pier settlement by 150mm

Install new steel lintels
