OLD MANSE AT PILMUIR, HADDINGTON, EAST LOTHIAN | WINDOW SURVEY

MARCH 2024

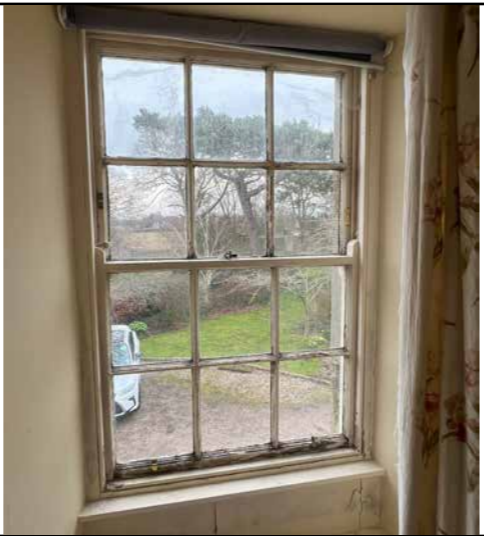
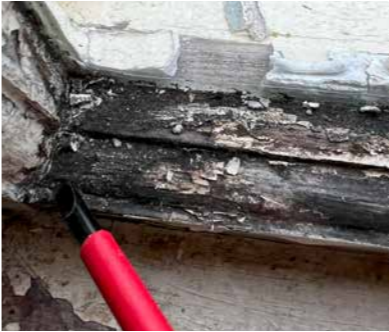
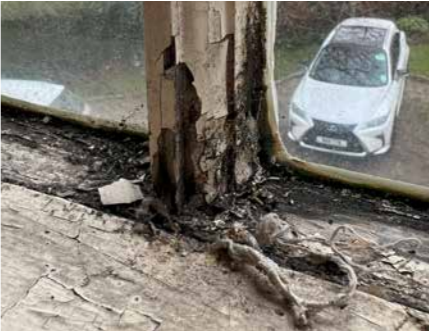
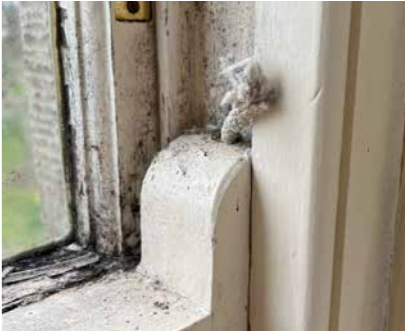
Code	Photo	Notes
W01

<p>W - 1000mm, H - 1500, 6 over 6 - 50/50 split.</p> <p>Rotten base rail, mid rail putty removed and water ingress non weighted and ropes cut and non operable. Non original glass.</p>

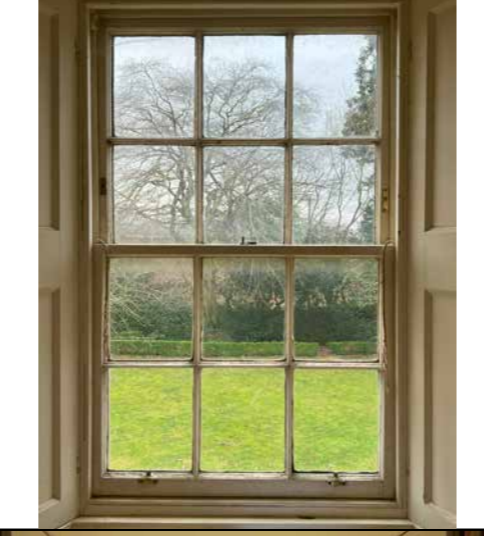
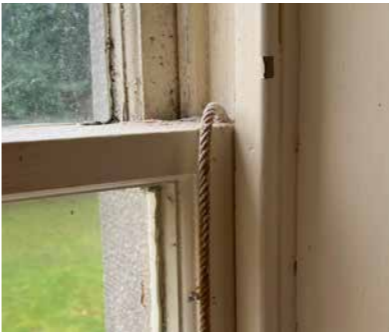
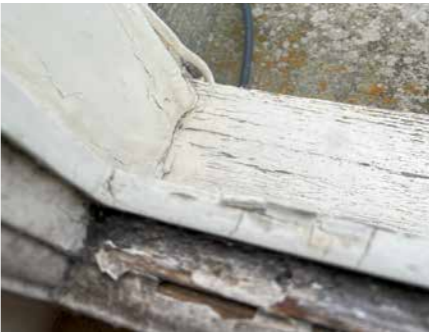
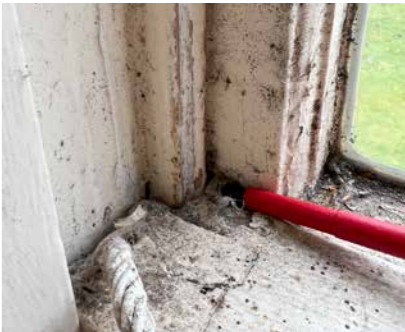
W02

<p>W - 1000mm, H - 1500mm, 6 over 6 - 50/50 split.</p> <p>Areas of rot in base rail and mid rail and cills. Outer frame rotted. Cut ropes. Putty flaked. Non original ironmongery. Non original glass</p>

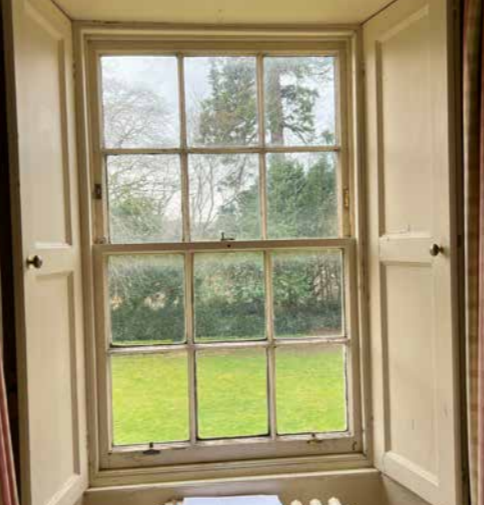
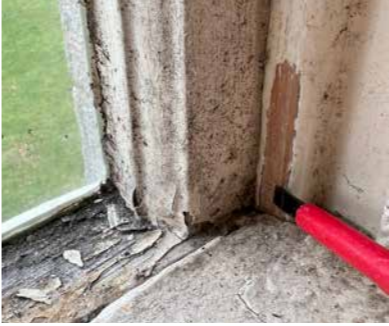
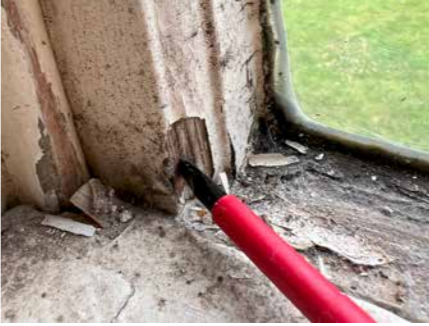
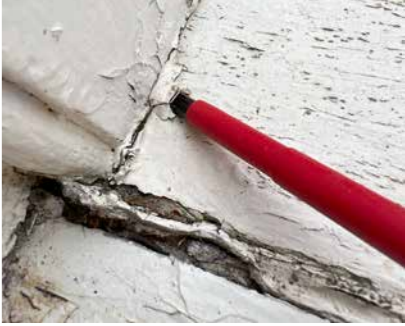
W03

<p>W - 1000, H - 1500, 6 over 6 - 50/50 split.</p> <p>Areas of rot in base rail, mid rail, cills and outer frame. Rotted runners. Non original ironmongery. Non original glass. Weaken and non operable ropes.</p>

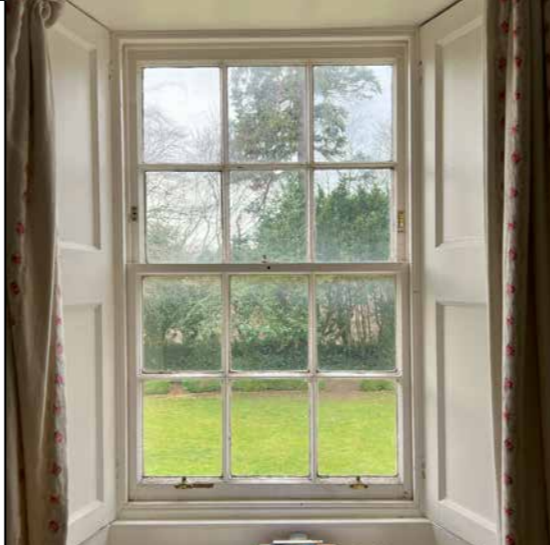
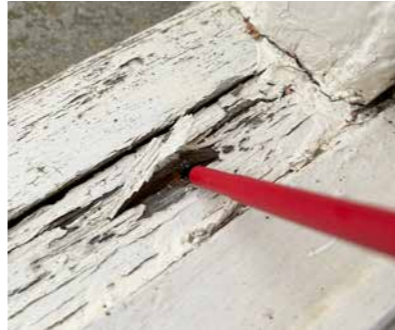
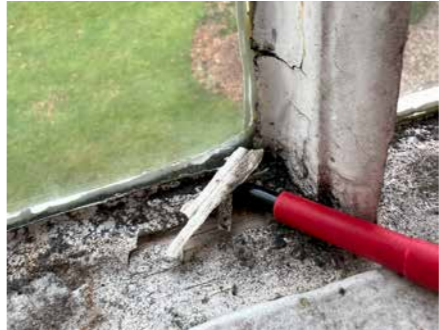
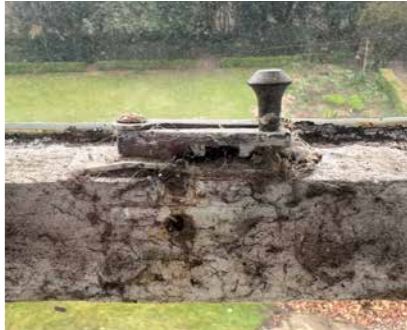
W04

<p>W - 1000, H - 1500, 6 over 6 - 50/50 split</p> <p>Base and mid rail rot. Cill and outer frame rot. non original ironmongery. non original glass. rope and weight working.</p>

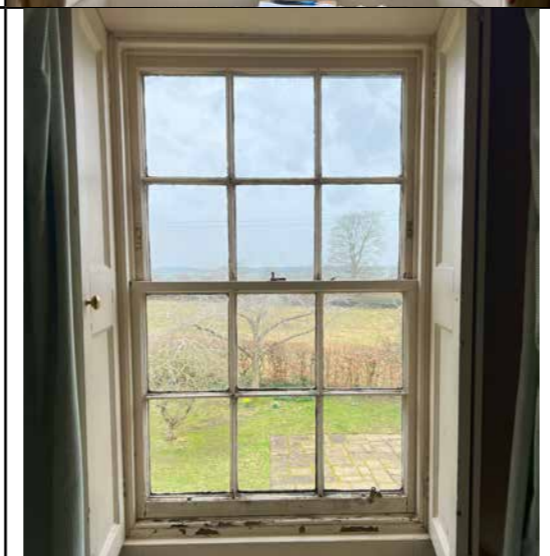
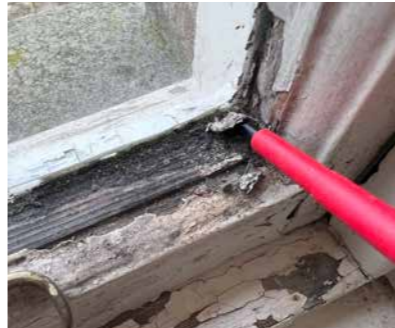
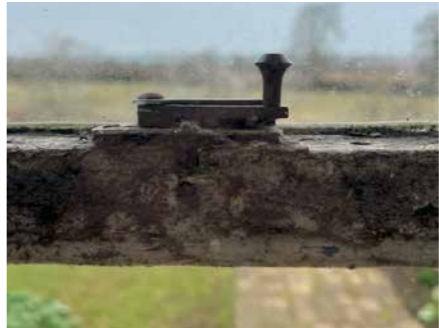
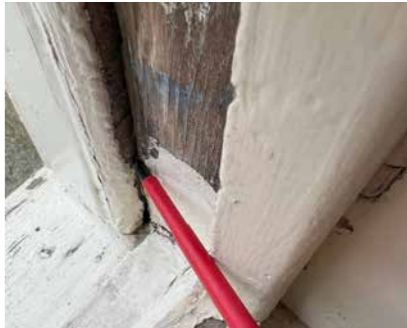
W05

<p>W - 1000, H - 1500, 6 over 6 - 50/50 split</p> <p>Base and mid rail areas of rot. Cills and outer frame areas of rot and frame opening up. Ropes and weights intact. Non original glass and ironmongery.</p>

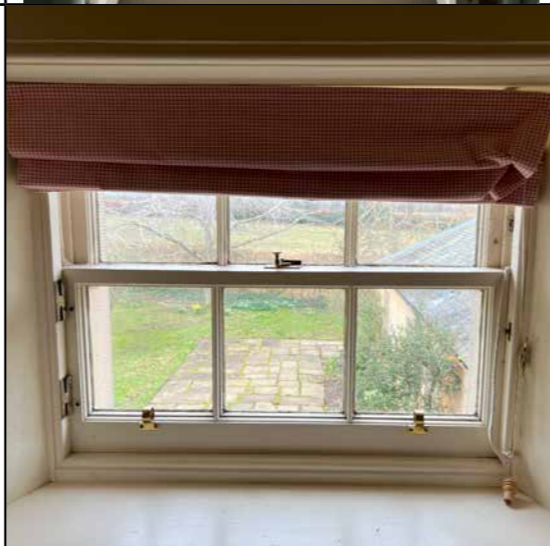
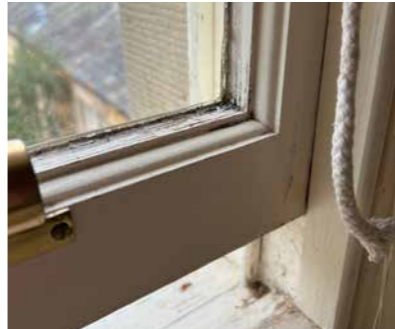
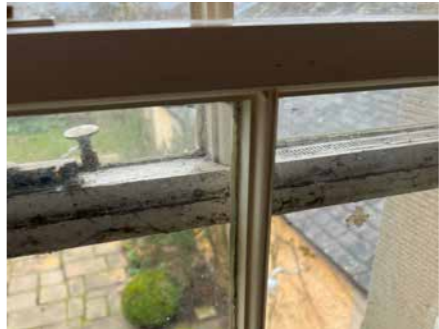
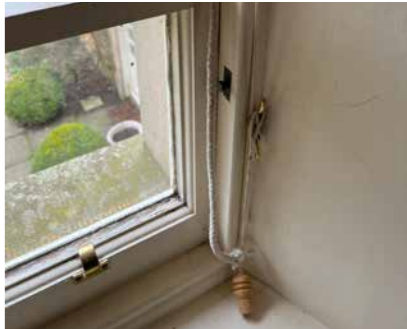
W06

<p>W - 880, H - 710, 3 over 3 - 50/50 split</p> <p>Sashes in good condition, non original windows. Both ropes broken. Areas of rot in cills and external base rail.</p>

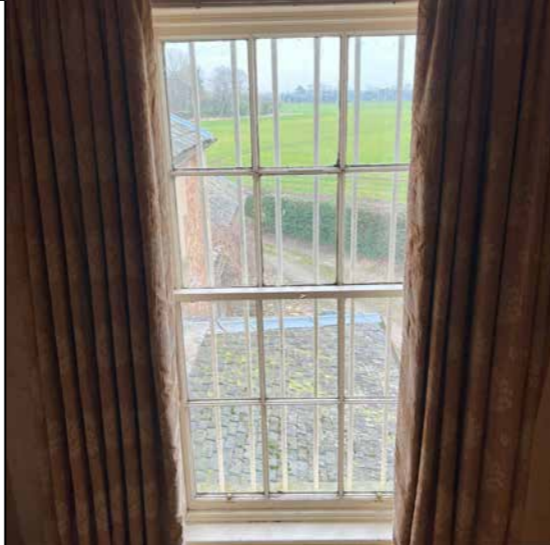
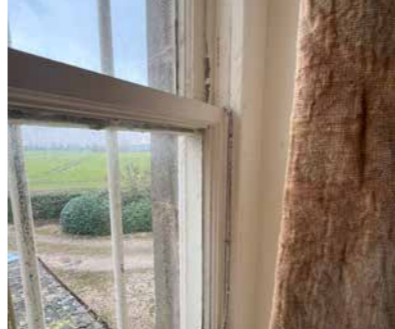
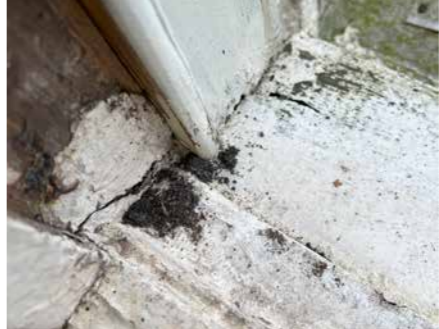
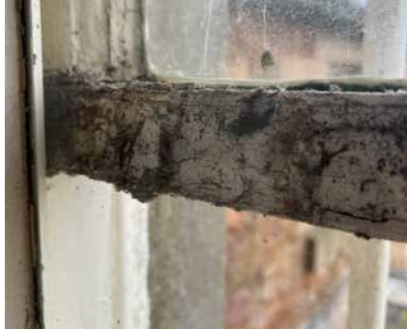
W10

<p>W - 1210, H - 2050, 6 over 6 - 50/50 split.</p> <p>Base and mid rail rot. Cills and outer base frame - signs of rot. Non original glass. Ropes cut to weights.</p>

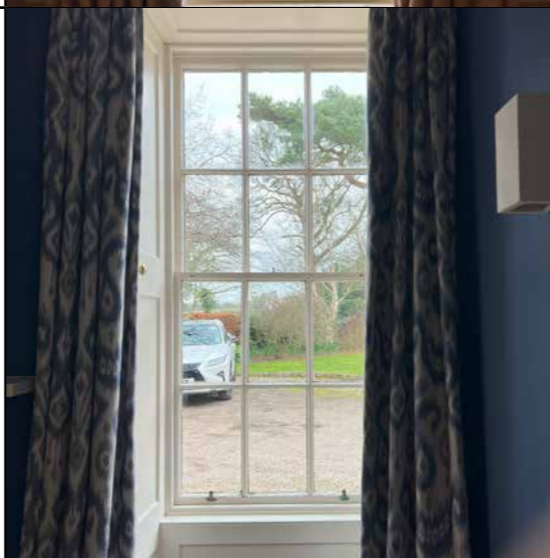
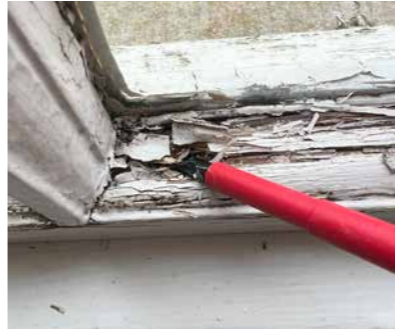
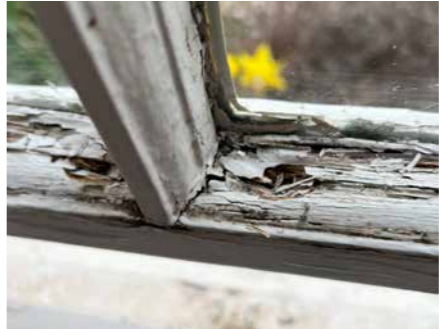
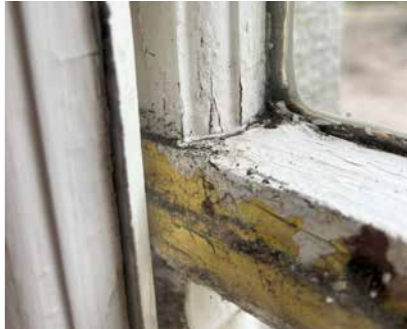
W11

<p>W - 1000, H - 2000, 6 over 6 - 50/50 split.</p> <p>Base and mid rail rotten. Open frame and rot to outer frame and cills. Non original glass. Ropes and weights intact.</p>

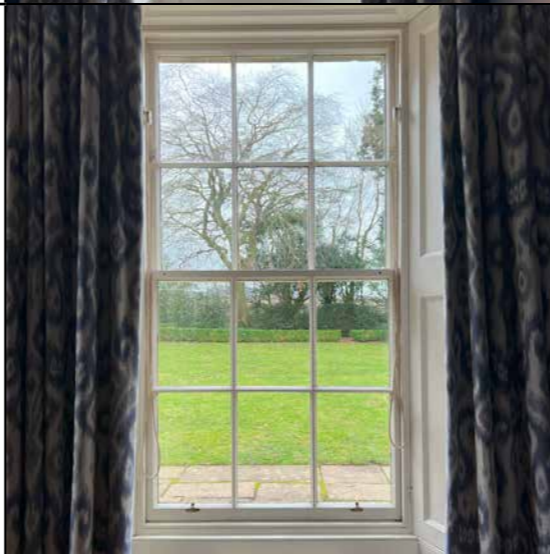
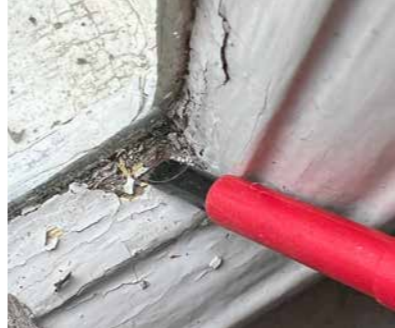
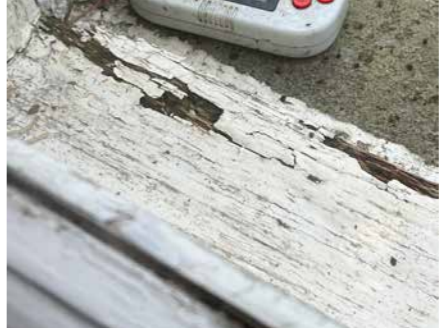
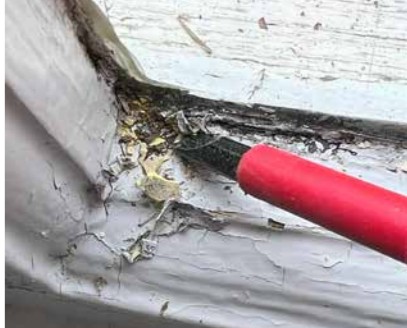
W12

<p>W - 1000, H - 2050, 6 over 6 - 50/50 split.</p> <p>Window painted shut. Base rail rotten. Cills rotten. Non original glass. Base of outer frame rotten. Non original ironmongery. Ropes and weights intact.</p>

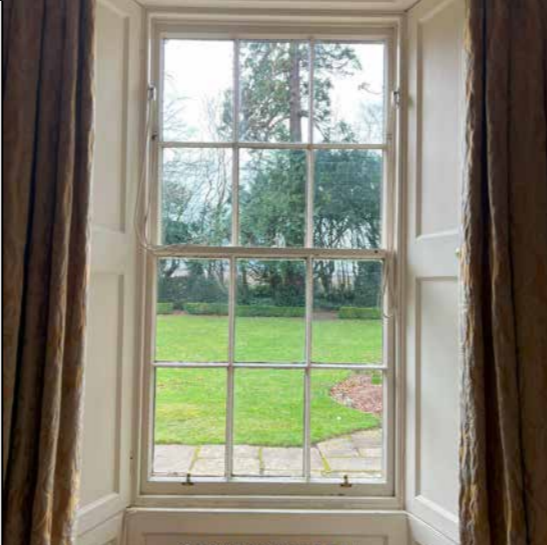
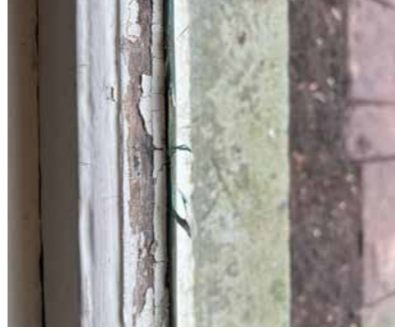
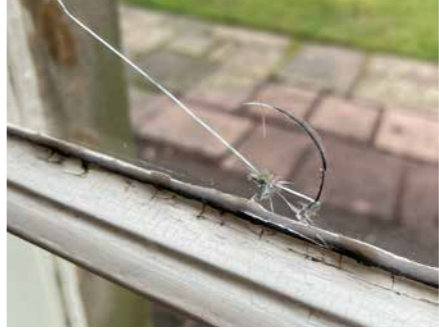
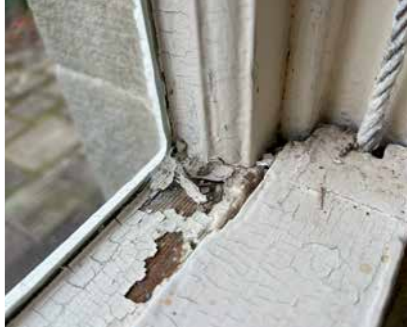
W13

<p>W - 1200, H - 2050, 6 over 6 - 50/50 split.</p> <p>Windows painted shut. Areas of broken glass. Signs of rot to base and mid rail. Non original glass. Ropes and weights intact.</p>

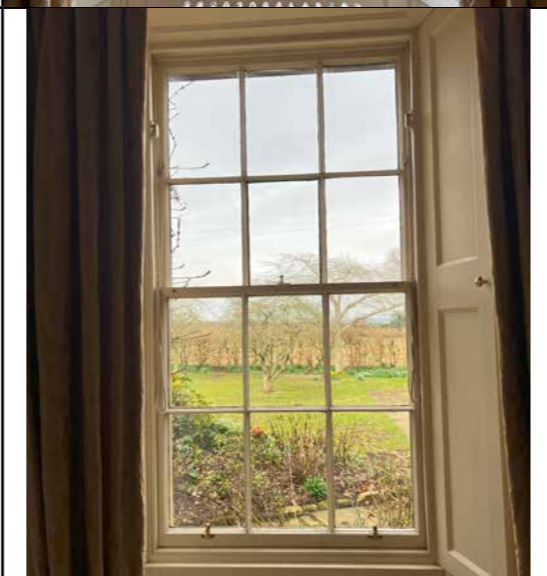
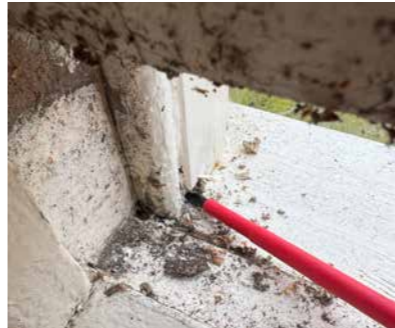
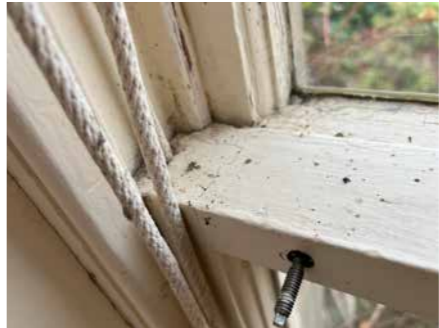
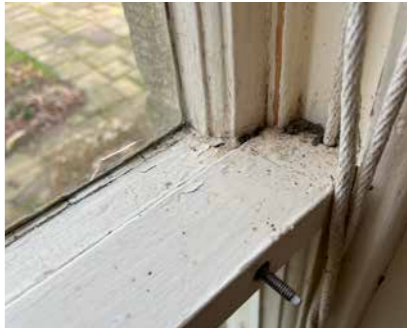
W14

<p>W - 1200, H - 2050, 6 over 6 - 50/50 split.</p> <p>Window sashes in BETTER condition. Small area of rot to base of bottom sash. Signs of rot to base of outer frame and cill junction. Non original glass. Ropes and weights intact.</p>

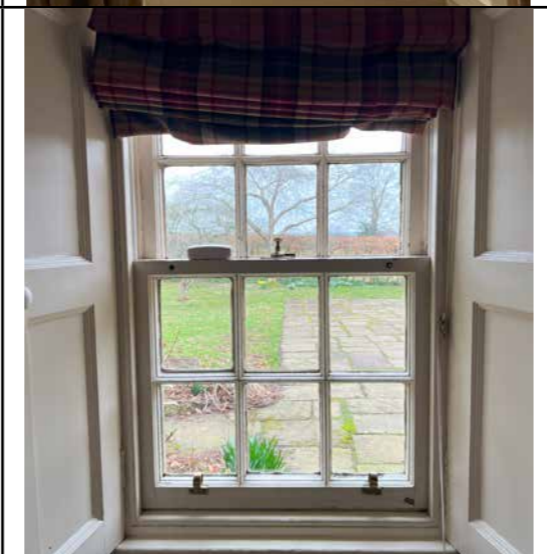
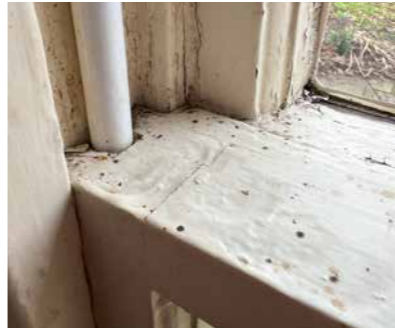
W15

<p>W - 700, H - 1000, 6 over 6 - 50/50 split.</p> <p>Painted shut. No runners, ropes or weights. Non original glass or ironmongery.</p>

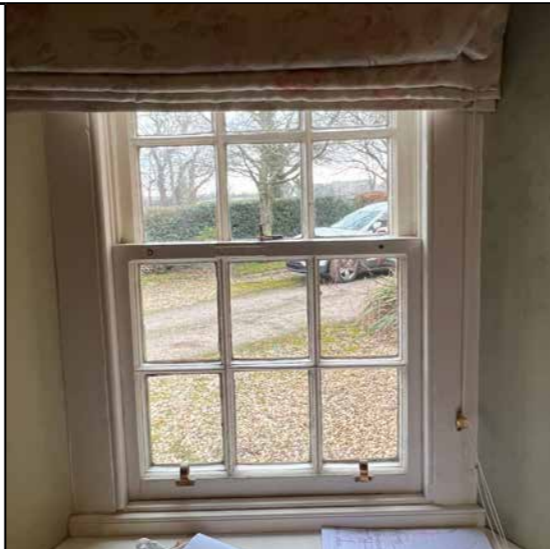
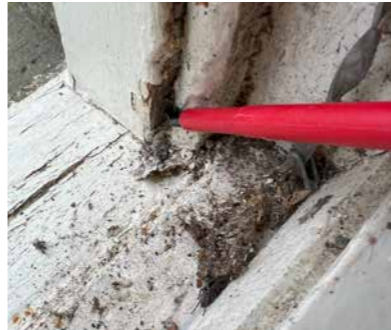
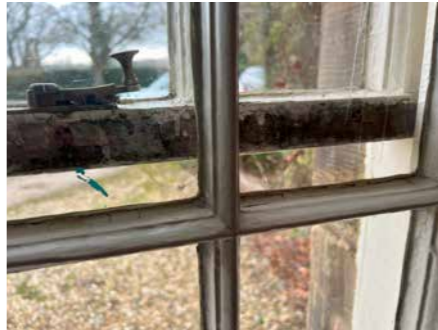
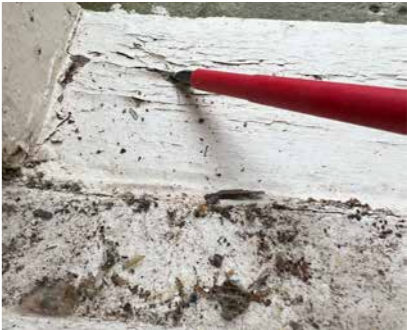
<p>W16</p>

<p>W - 710, H - 1000, 6 over 6 - 50/50 split.</p> <p>No runners. Signs of rot on mid rail of sash. Signs of rot to base of outer frame, runners and cill. Non original glass.</p>

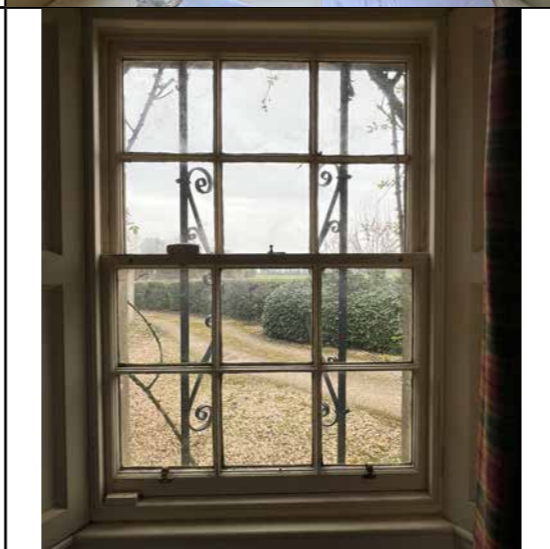
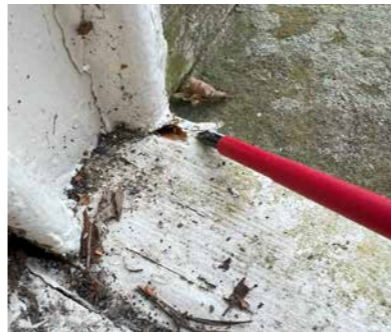
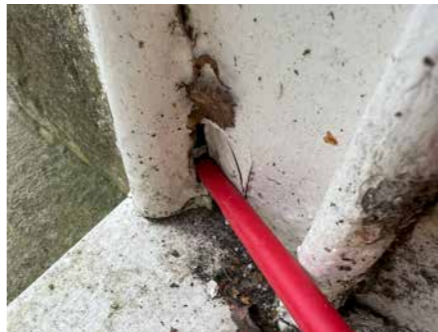
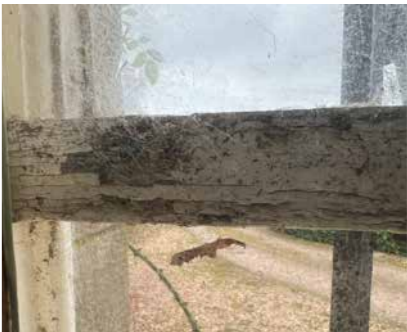
<p>W17</p>

<p>W - 1000, H - 1330, 6 over 6 - 50/50 split.</p> <p>Areas of rot in mid rail of shash. Outer cill rotten and of frame and runners.</p>
