OLD MANSE AT PILMUIR, HADDINGTON, EAST LoTHIAN | WINDOW SURVEY

MARCH 2024

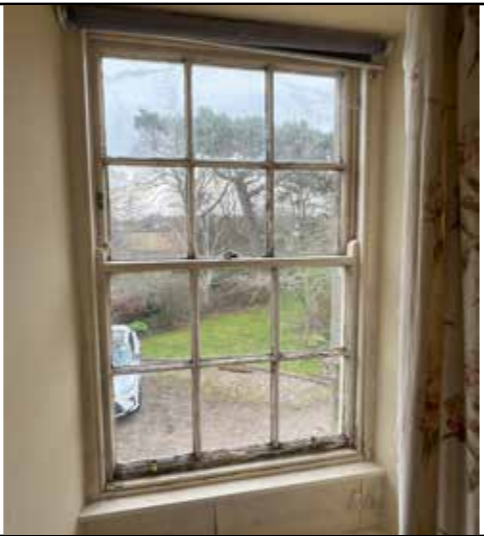
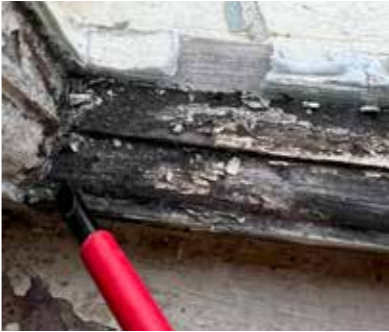
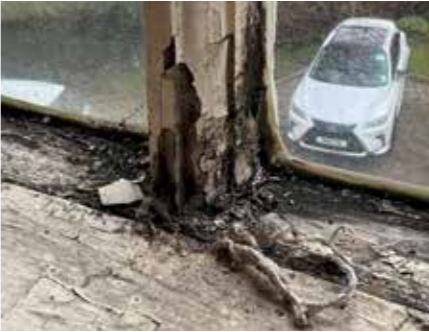
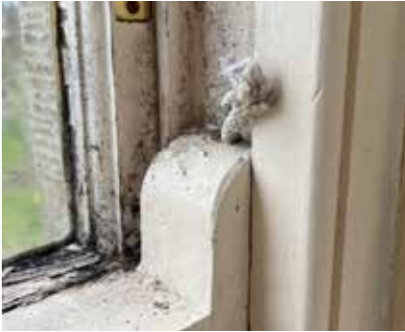
Code	Photo	Notes
W01

<p>W - 1000mm, H - 1500, 6 over 6 - 50/50 split.</p> <p>Rotten base rail, mid rail putty removed and water ingress non weighted and ropes cut and non operable. Non original glass.</p>

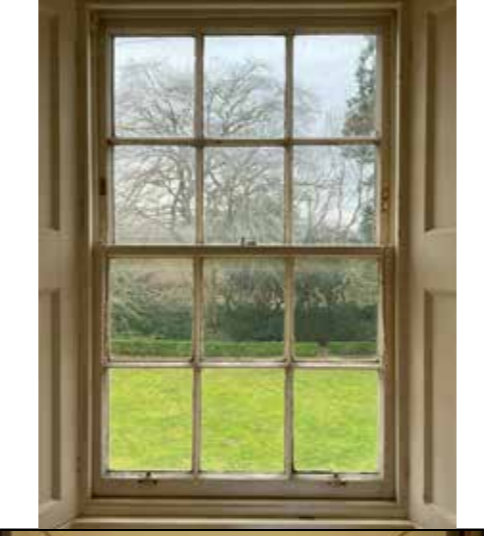
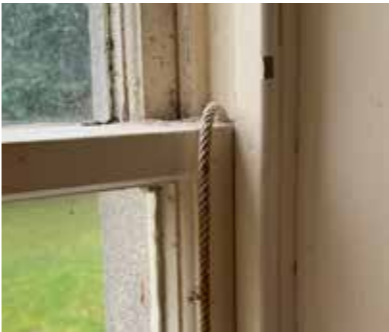
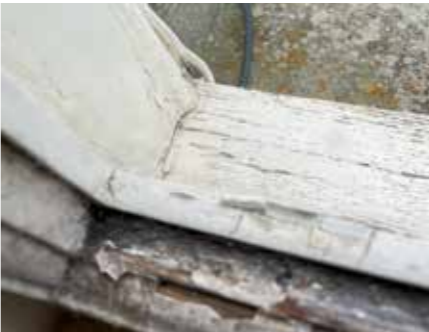
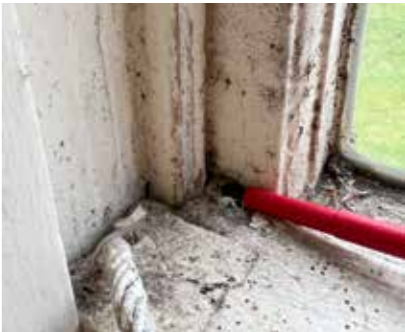
W02

<p>W - 1000mm, H - 1500mm, 6 over 6 - 50/50 split.</p> <p>Areas of rot in base rail and mid rail and cills. Outer frame rotted. Cut ropes. Putty flaked. Non original ironmongery. Non original glass</p>

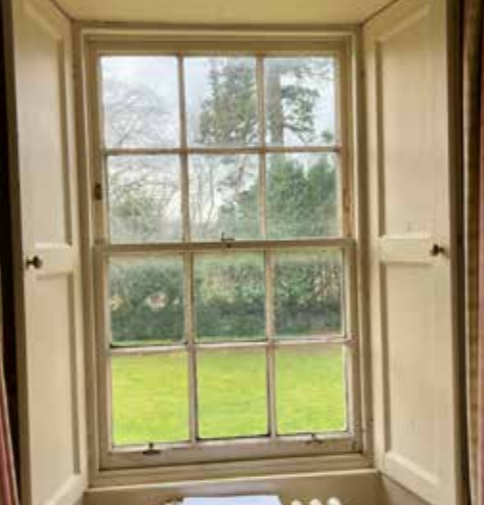
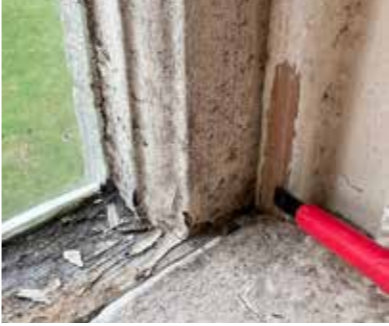
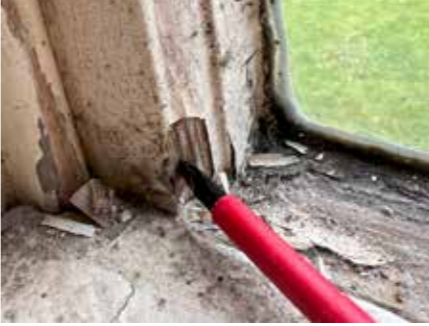
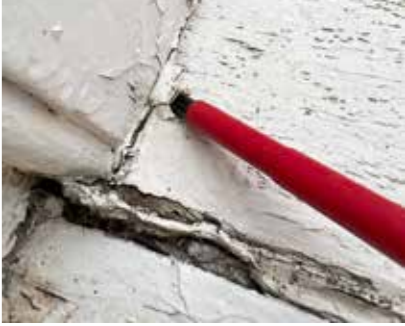
W03

<p>W - 1000, H - 1500, 6 over 6 - 50/50 split.</p> <p>Areas of rot in base rail, mid rail, cills and outer frame. Rotted runners. Non original ironmongery. Non original glass. Weaken and non operable ropes.</p>

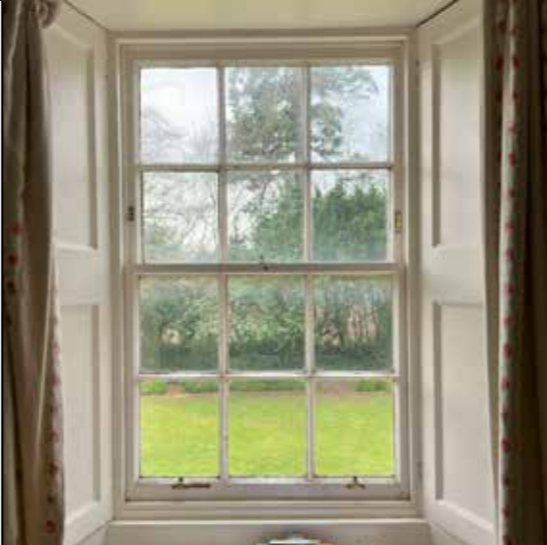
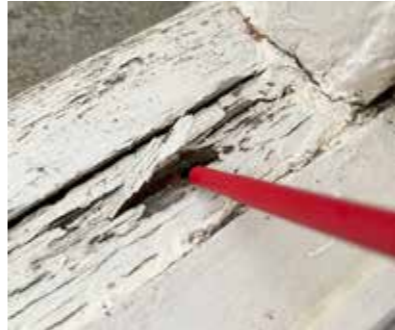
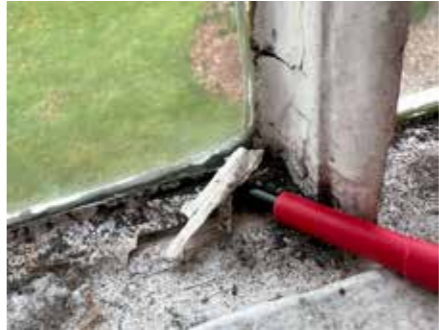
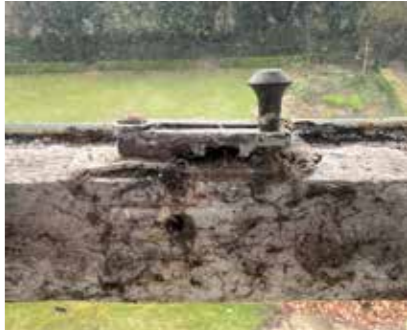
W04

<p>W - 1000, H - 1500, 6 over 6 - 50/50 split</p> <p>Base and mid rail rot. Cill and outer frame rot. non original ironmongery. non original glass. rope and weight working.</p>

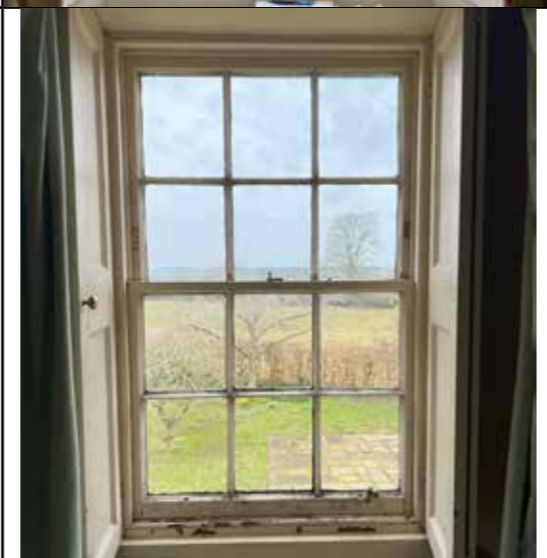
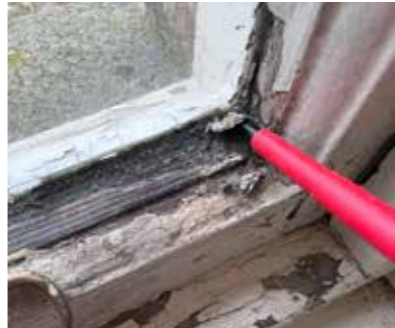
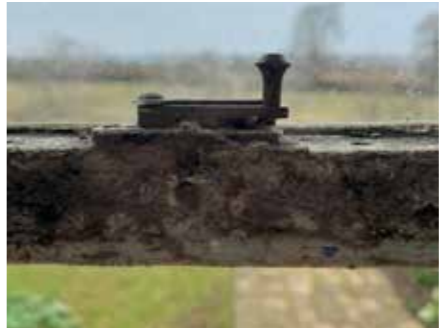
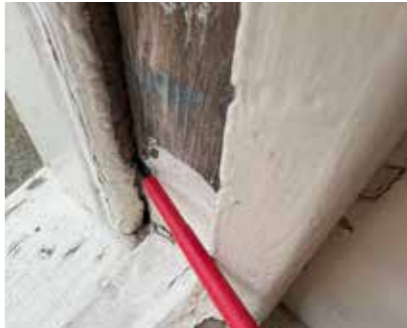
W05

<p>W - 1000, H - 1500, 6 over 6 - 50/50 split</p> <p>Base and mid rail areas of rot. Cills and outer frame areas of rot and frame opening up. Ropes and weights intact. Non original glass and ironmongery.</p>

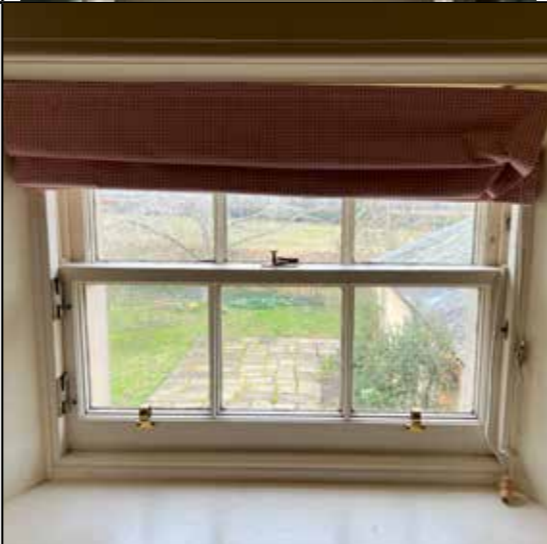
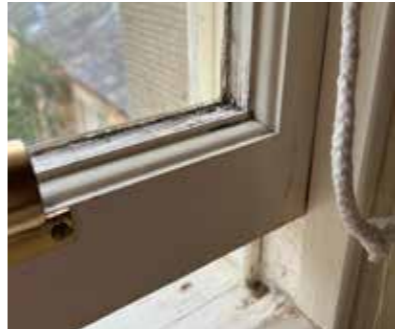
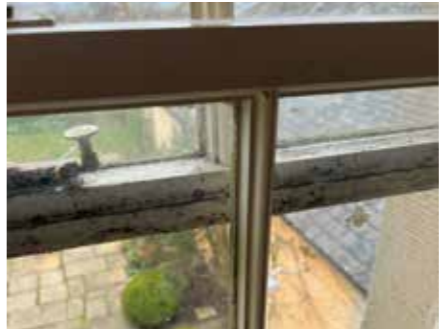
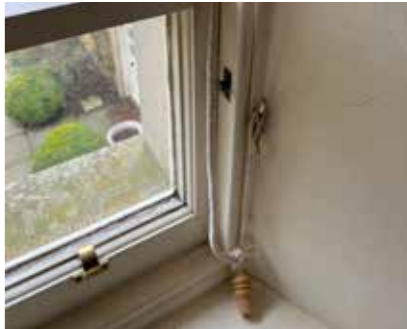
W06

<p>W - 880, H - 710, 3 over 3 - 50/50 split</p> <p>Sashes in good condition, non original windows. Both ropes broken. Areas of rot in cills and external base rail.</p>

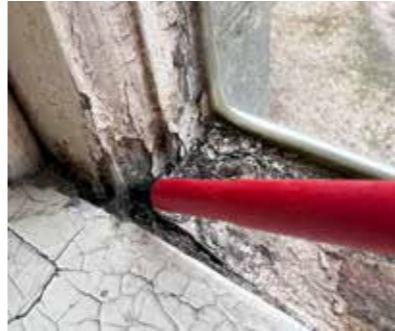
W07	 	<p>W - 880, H - 710, 3 over 3 - 50/50 split.</p> <p>Sashes in good condition, non original windows. Both ropes broken. Areas of rot in cills and base of outer frame.</p>      
W08	 	<p>W - 950, H - 1500, 6 over 6 - 50/50 split.</p> <p>Areas of rot to base and mid rails. Rotten cill and base of outer frame. Non original glass and ironmongery. Ropes and weights in working order.</p>

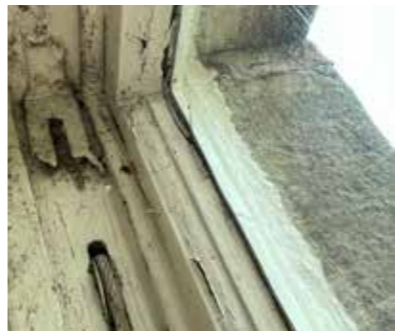
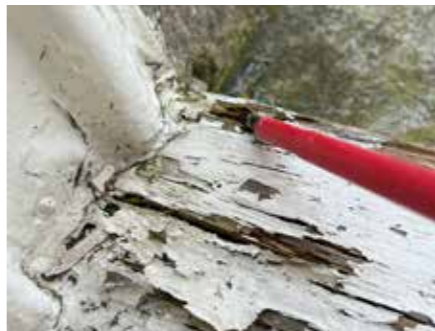
W09	 	<p>W - 950, H - 710, 1 over 1 - 50/50 split.</p> <p>Rot to mid and head rails. Cills rotten. Outer frame, base rail and head have signs of rot. Non original window. Ropes and weights in working order.</p>

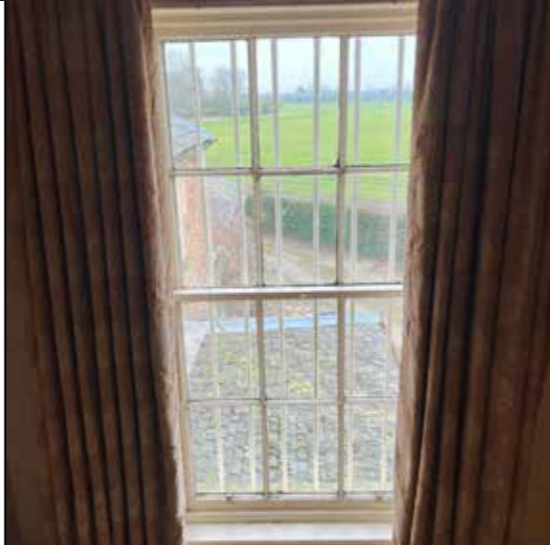
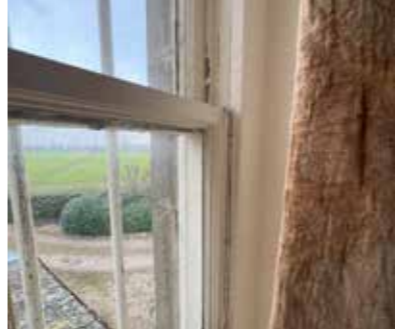
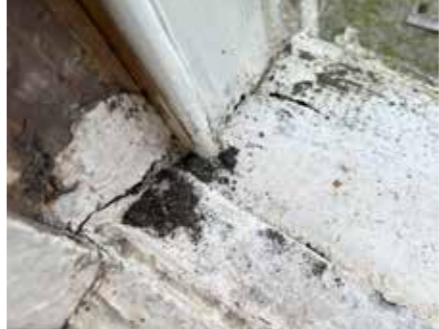
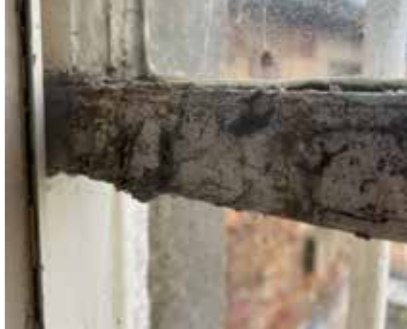
W10

<p>W - 1210, H - 2050, 6 over 6 - 50/50 split.</p> <p>Base and mid rail rot. Cills and outer base frame - signs of rot. Non original glass. Ropes cut to weights.</p>

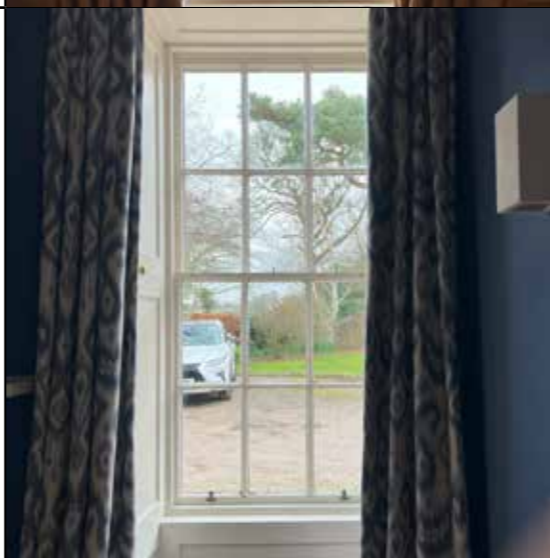
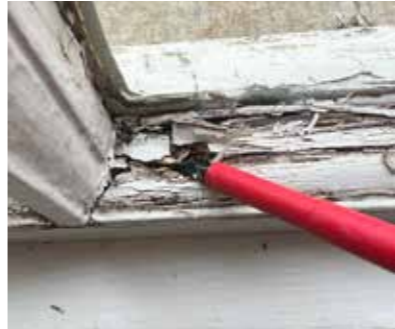
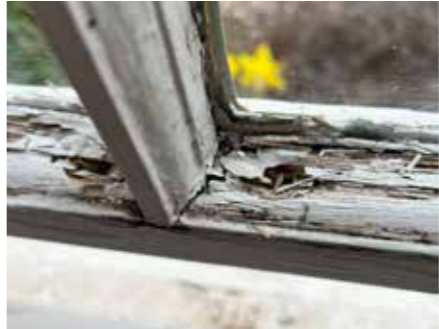
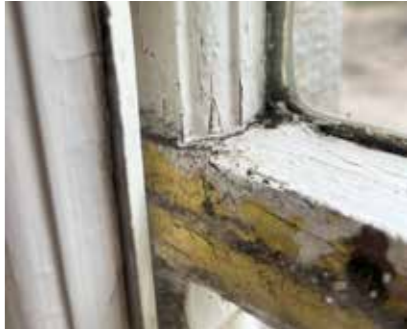
W11

<p>W - 1000, H - 2000, 6 over 6 - 50/50 split.</p> <p>Base and mid rail rotten. Open frame and rot to outer frame and cills. Non original glass. Ropes and weights intact.</p>

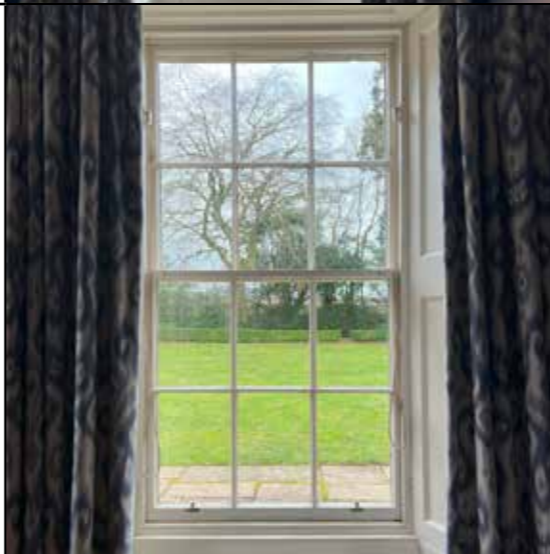
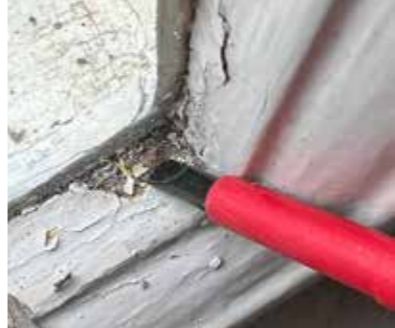
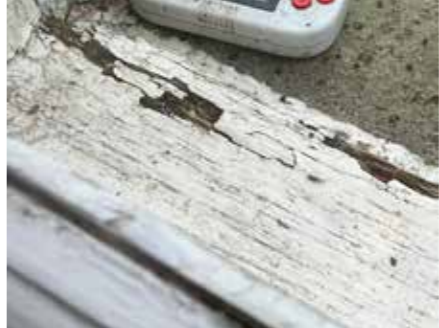
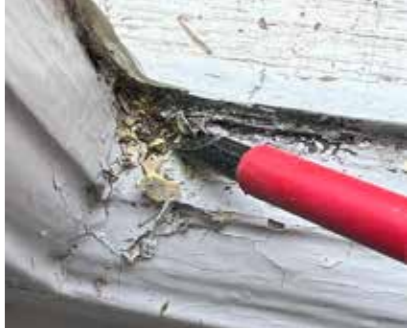
W12

<p>W - 1000, H - 2050, 6 over 6 - 50/50 split.</p> <p>Window painted shut. Base rail rotten. Cills rotten. Non original glass. Base of outer frame rotten. Non original ironmongery. Ropes and weights intact.</p>

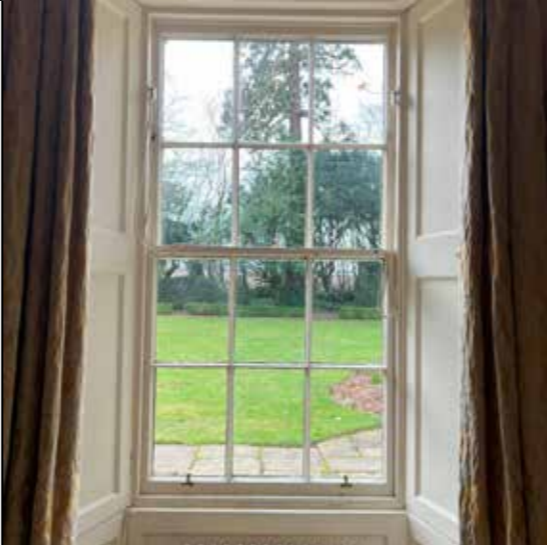
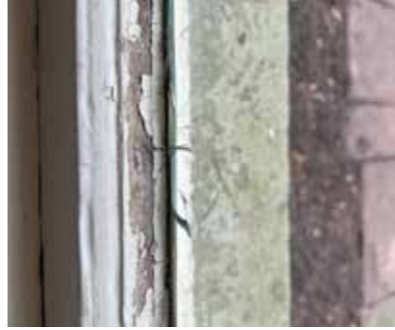
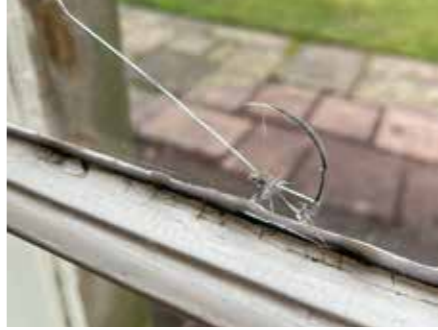
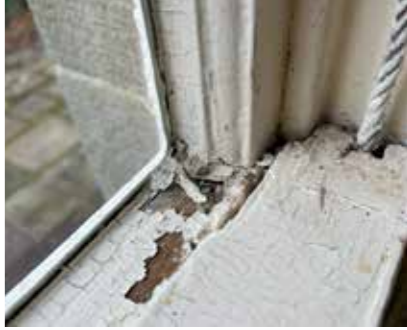
W13

<p>W - 1200, H - 2050, 6 over 6 - 50/50 split.</p> <p>Windows painted shut. Areas of broken glass. Signs of rot to base and mid rail. Non original glass. Ropes and weights intact.</p>

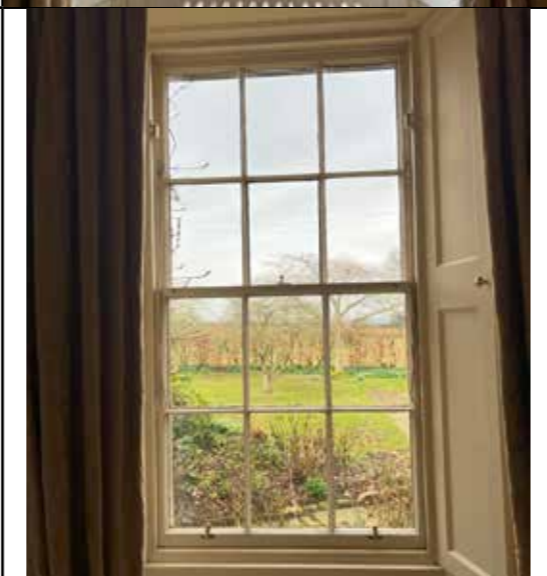
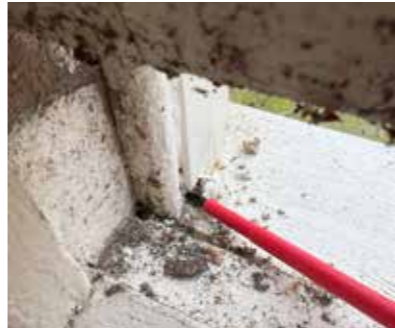
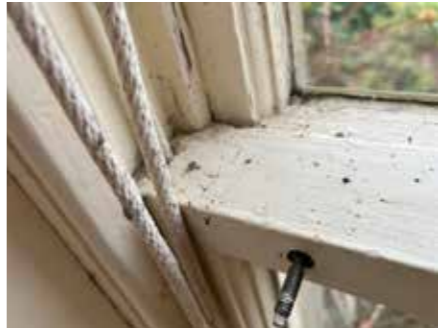
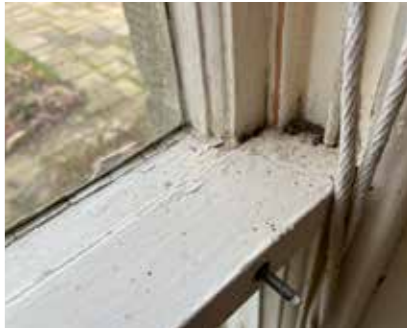
W14

<p>W - 1200, H - 2050, 6 over 6 - 50/50 split.</p> <p>Window sashes in BETTER condition. Small area of rot to base of bottom sash. Signs of rot to base of outer frame and cill junction. Non original glass. Ropes and weights intact.</p>

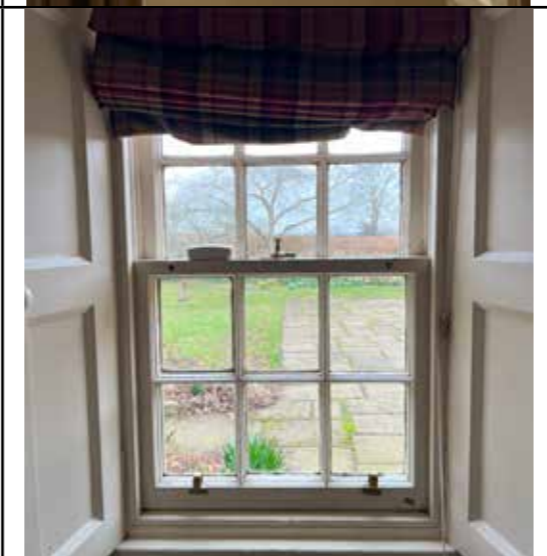
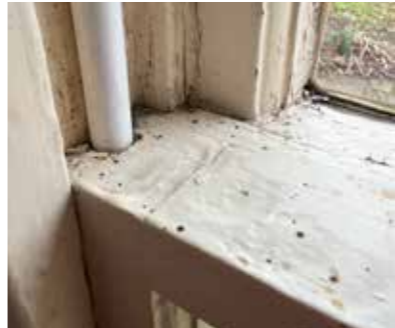
W15

<p>W - 700, H - 1000, 6 over 6 - 50/50 split.</p> <p>Painted shut. No runners, ropes or weights. Non original glass or ironmongery.</p>

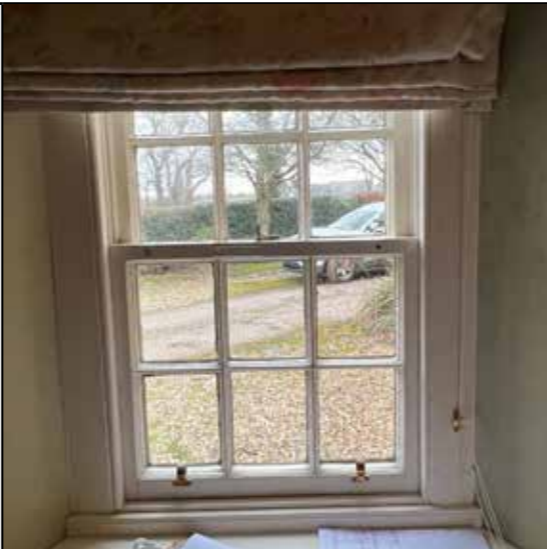
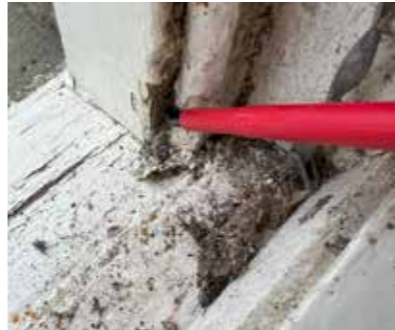
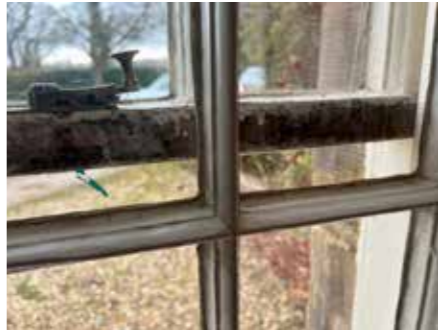
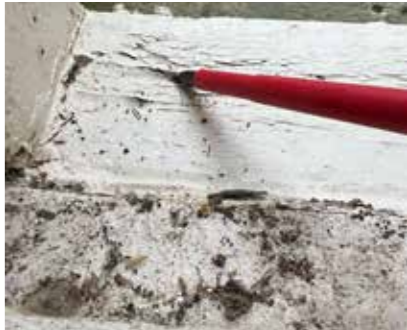
W16

<p>W - 710, H - 1000, 6 over 6 - 50/50 split.</p> <p>No runners. Signs of rot on mid rail of sash. Signs of rot to base of outer frame, runners and cill. Non original glass.</p>

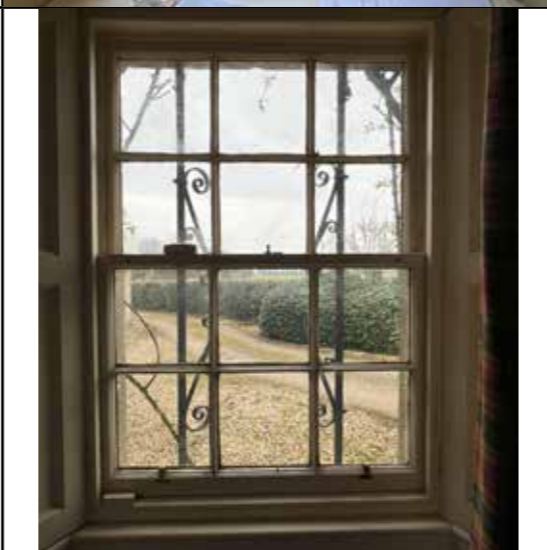
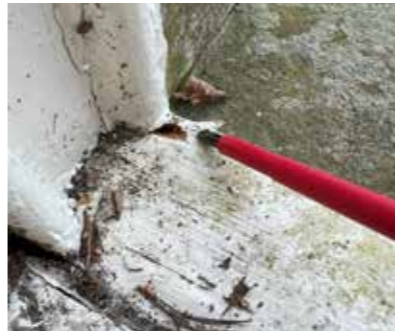
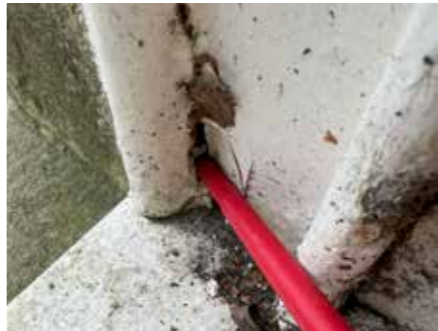
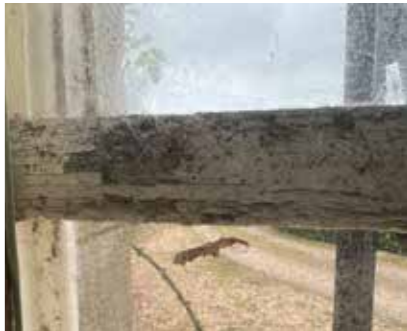
W17

<p>W - 1000, H - 1330, 6 over 6 - 50/50 split.</p> <p>Areas of rot in mid rail of shash. Outer cill rotten and of frame and runners.</p>

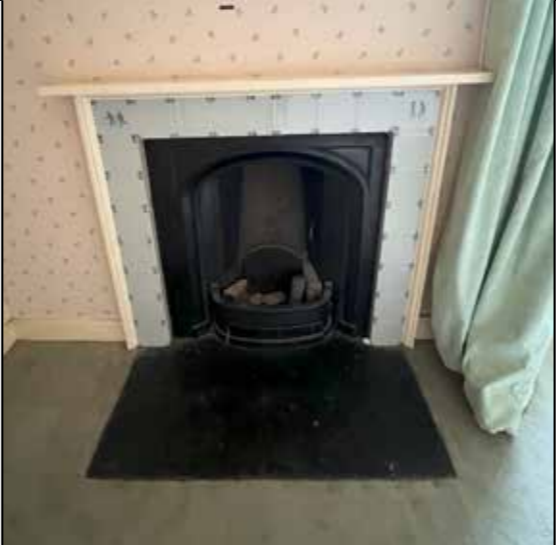
F01

A photograph of a fireplace with a black metal insert. The surround is made of light-colored wood. The wall is covered in patterned wallpaper, and a green curtain is visible on the right side.	Non original wooden insert. Non original tiles. Non original wooden surround.
F02

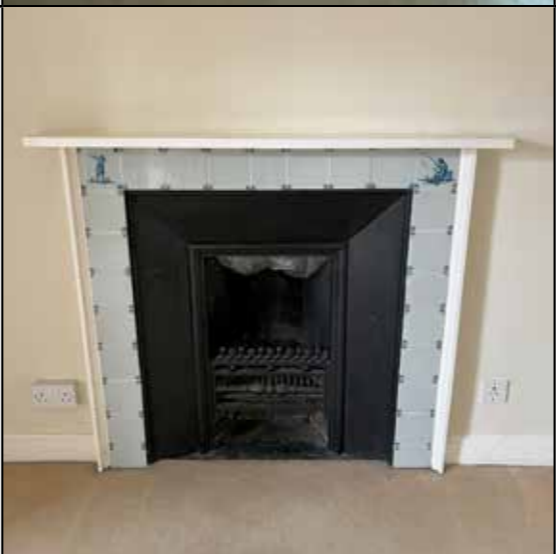
A photograph of a fireplace with a black metal insert. The surround is made of light-colored wood. The wall is plain white, and there are electrical outlets on either side of the fireplace.	Non original wooden insert. Non original tiles. Non original wooden surround.
F03	  A photograph of a fireplace with a black metal insert. The surround is made of light-colored wood. The wall is covered in patterned wallpaper, and a blue carpet is visible in the foreground.	Non original wooden insert. Non original tiles. Non original wooden surround.
