The Old Forge  
Mendlesham Road  
Brockford  
Stowmarket  
IP14 5NU

Proposed Repairs to Brick Plinth  
V0.1

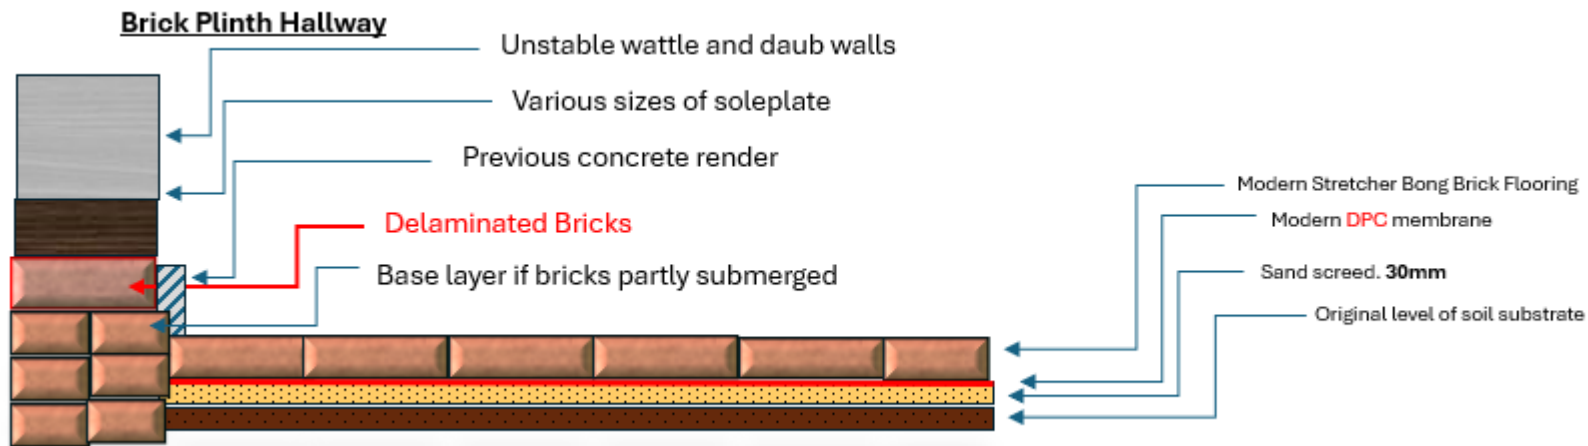
*Firstly, after advice was given to remove the concrete from the internal elevations of the plinth, it appears that the plinth has been damaged by the concrete render, and many of the bricks are delaminated due to water damage. Many of these will likely need to be carefully removed and replaced. The plinth is a mix of modern brickwork in places with some historic brickwork, although now severely damaged. It seems likely that much of the brick plinth will need to be repaired. There is also some unusual air bricks on one elevation, which will need further consideration, as discussed.*

To maintain the stability of sections of soleplate and to reduce impacts to the unstable wattle and daub walls above, it is proposed to completely replace the top layer of bricks in each section with handmade Bulmer bricks (2.5 inches) as per the red line below. The plan is to carefully chisel out and remove 3 bricks at a time and replace and point with lime mortar along the length of the plinth. The bricks at the lower level will be repointed in situ. The plinth will then be rendered with Lime which will protect the bricks from any damage as the area is subject to heavy use.
