STRUCTURAL REPORT - PLANNING

BARN AT MEADOWSIDE, TRESMERE,

DOCUMENT No. AO246-W-0001-A

CLIENT: MRS R.M DANIEL

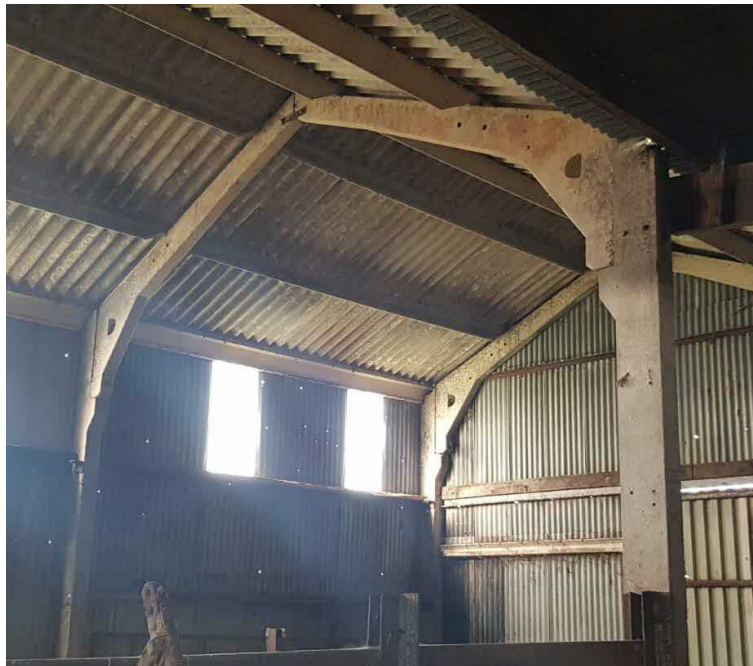
Above: Pre cast concrete portal frames

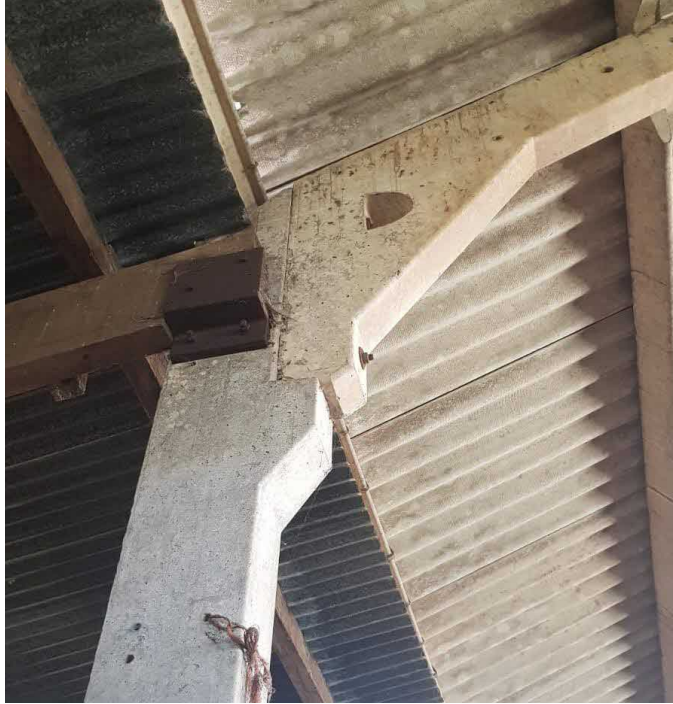
Above: Typical moment connection at the eaves of the pre cast concrete frames

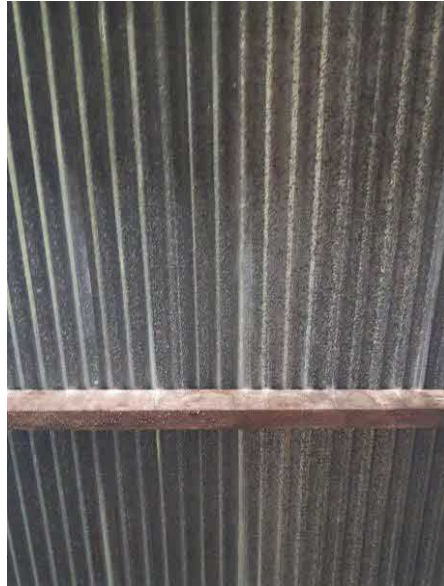
The roof of the lean too section is clad in metal corrugated sheeting. This sheeting requires localised repairs but is in good condition. The repairs are localised and expected as part of the routine maintenance associated with a building of this nature.

Above: Metal corrugated roof cladding, lean too roof

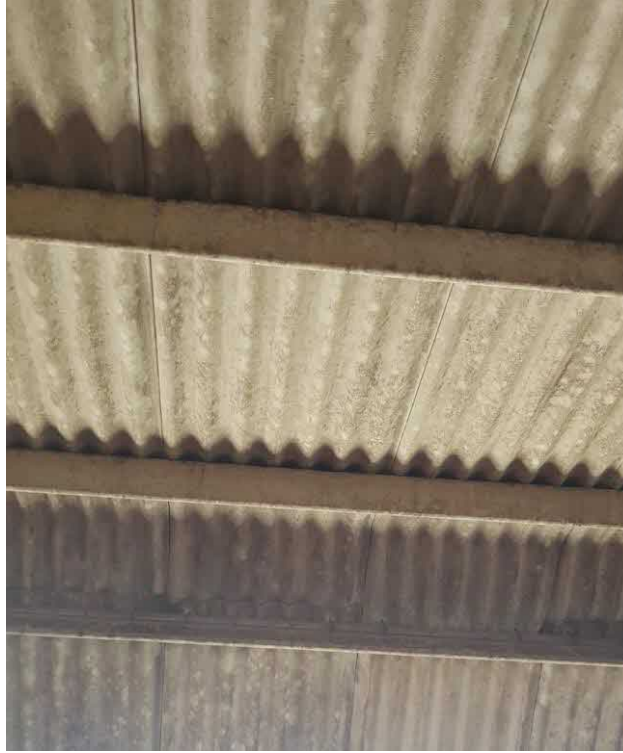
The roof of the concrete framed section is clad in a cement based corrugated sheeting. This sheeting is in good condition and can remain as part of the converted scheme.

Above: Roof cladding to concrete framed section

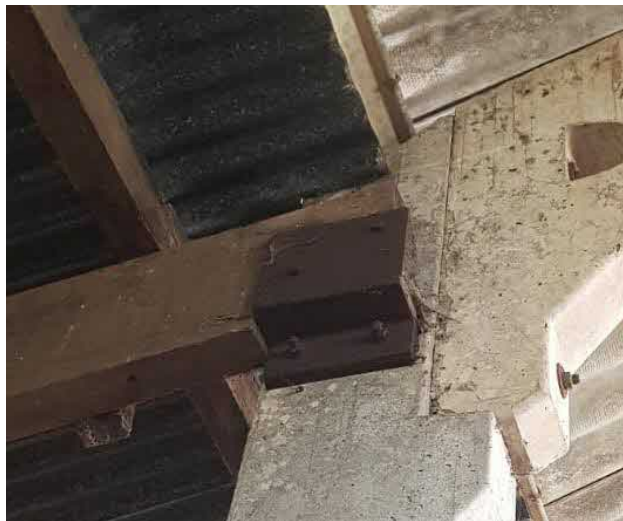
The timber purlins and principal timber rafters of the lean too section are in good condition. The principal rafters bear directly on timber posts and have a cleated connection to the pre cast concrete frames.

Above: Cleated connection support to principal timber rafter

These cleated connections require wire brushing down and a suitable paint application applied but are suitable to remain as part of the converted scheme. The principal rafters appear adequately sized to support a typical converted roof and the timber posts (200mm diameter) are adequate to support the associated increase in vertical loads.

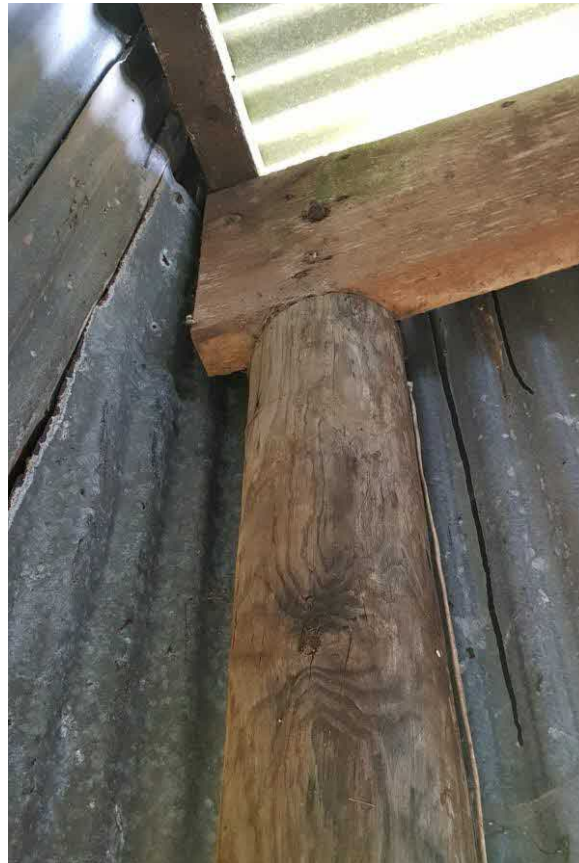
Above: Timber post with direct bearing over to principal timber rafter

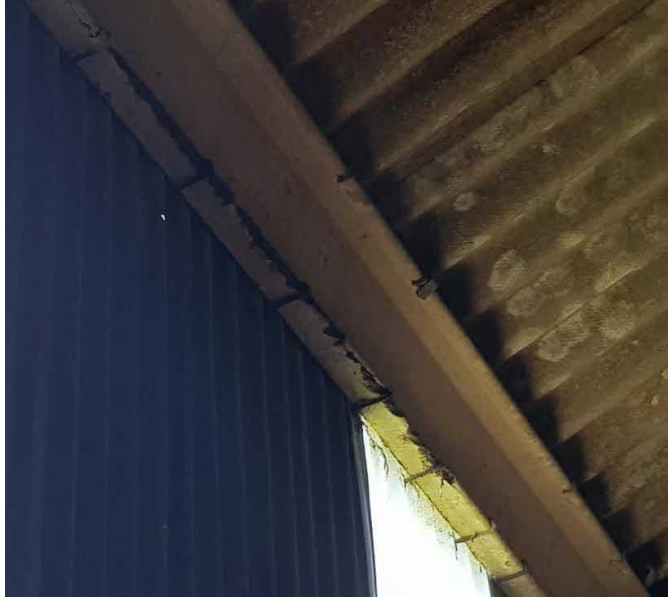
The frames are braced at the eaves by pre cast beams forming the gutter and eaves beams. Some evidence of minor concrete spalling was noted, however this can be treated with a simple cleaning of the reinforcement and grout repair.

Above: Spalling to underside of gutter / eaves beam
