Phase 1 Land Contamination

Risk Assessment

Proposed Residential

No.1 High Street, Leiston,

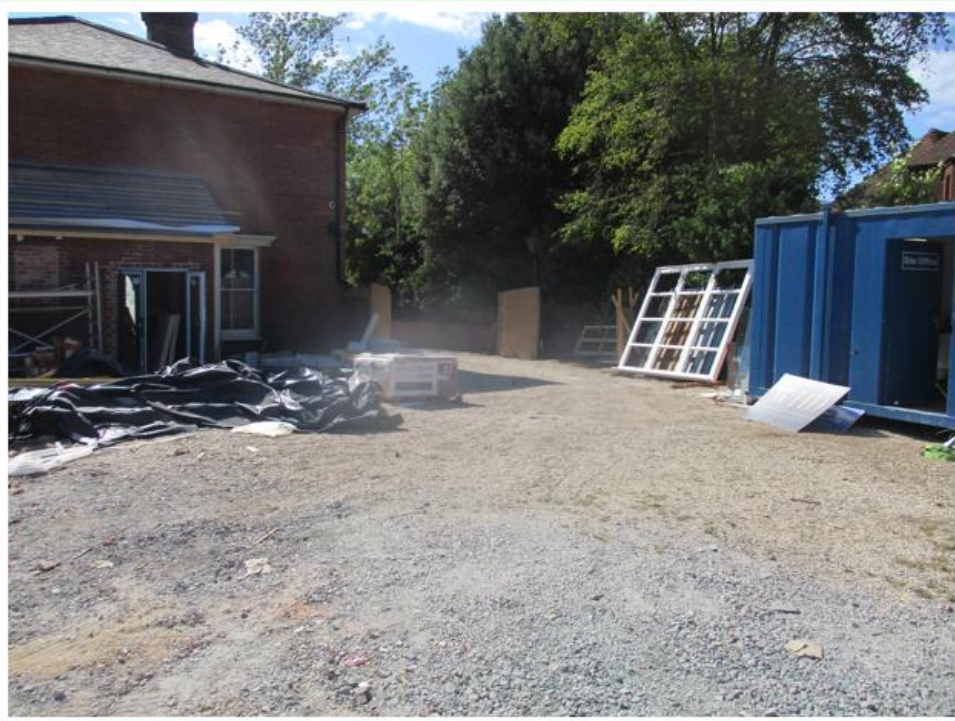
Photo No.1: Facing south from the southern boundary of site showing site access leading north off Valley Road

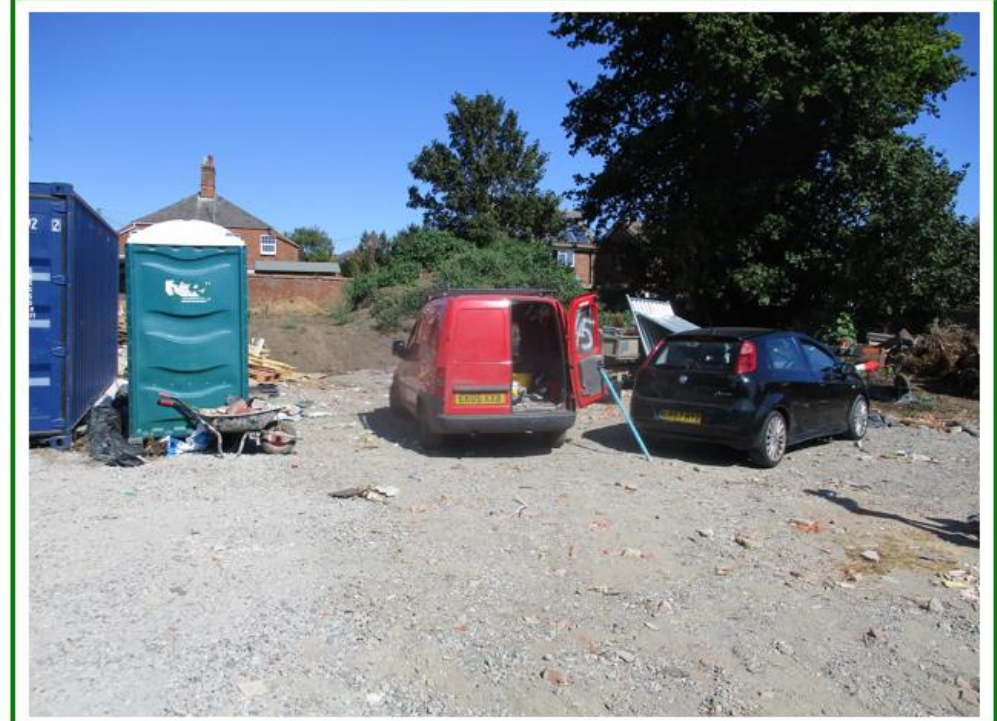
Photo No.2: Facing north from the southern site boundary showing parking and staging area for site works

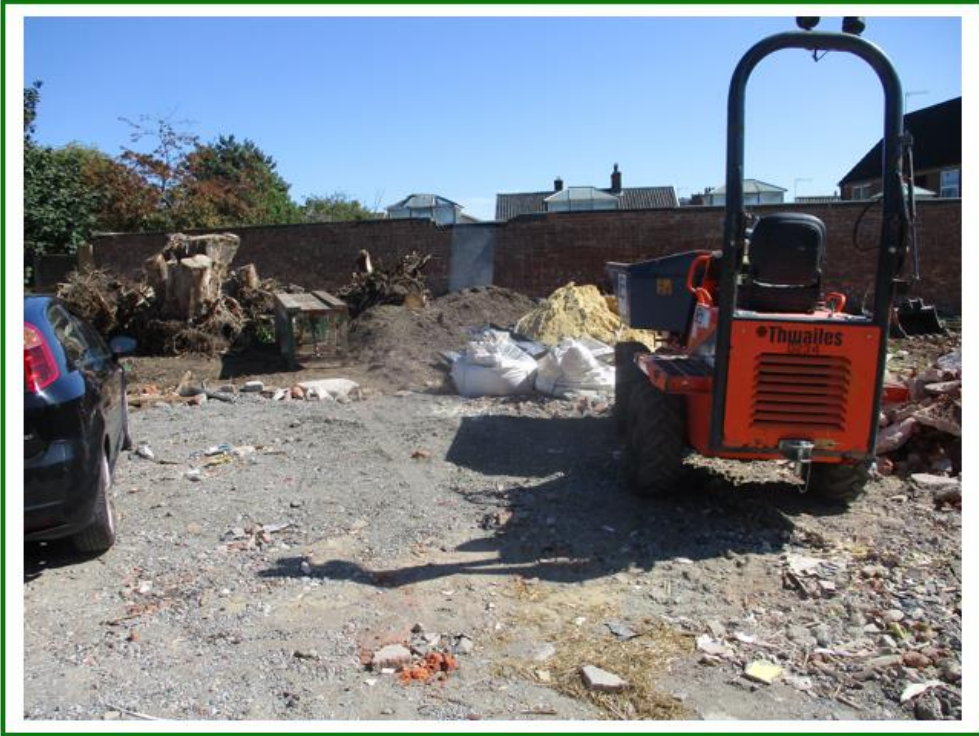
Photo No.3: Facing east from the parking area towards adj. onsite former clubhouse building and storage area on site

It is recommended that the remaining clubhouse structure on site be subject to an asbestos survey and subsequent removal (if required) by appropriately qualified personnel, prior to any demolition or redevelopment occurring in order to ensure site works do not cause future contamination of the site.

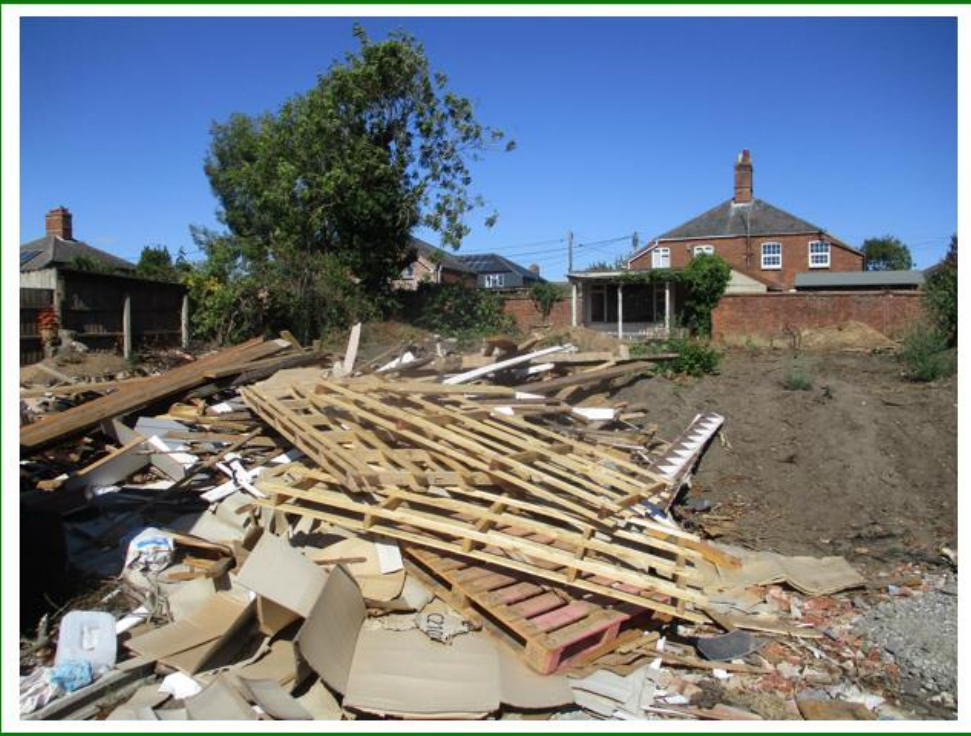
Photo No.4: Facing slightly NW showing timber and refuse heap located centrally on site

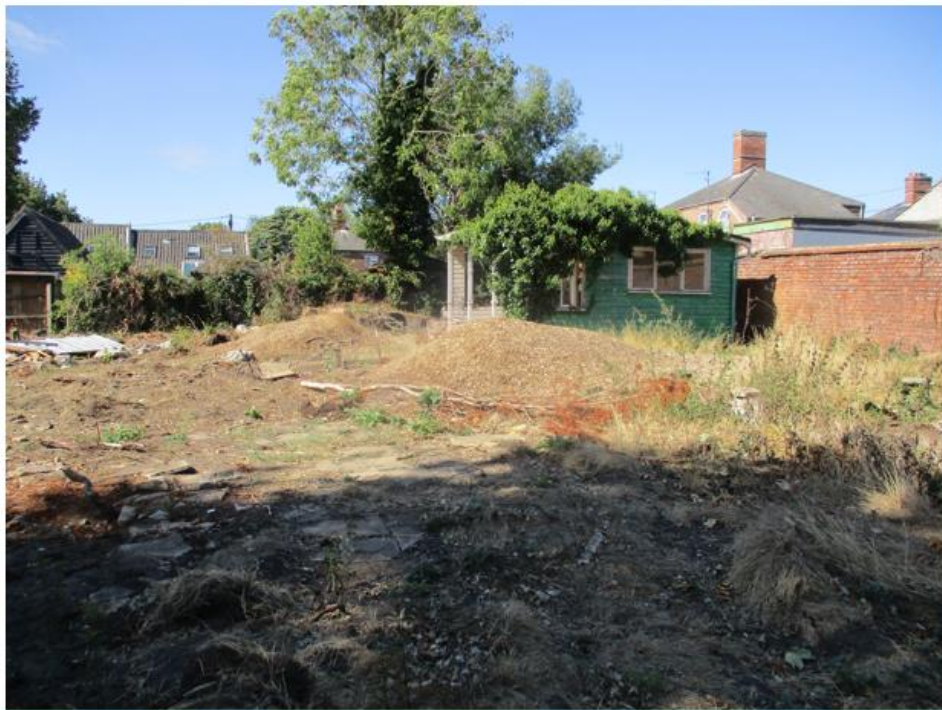
Photo No.5: Facing west from the NE corner of site showing former garden area and summerhouse in northern extent of site

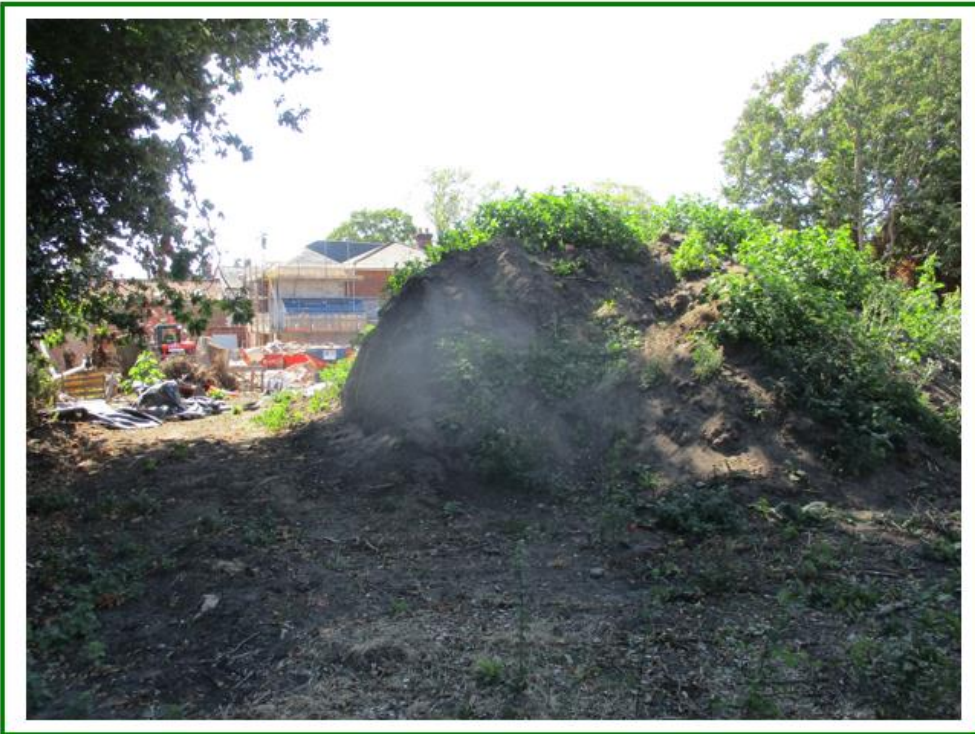
Photo No.7: Facing south from the far northern boundary of site showing topsoil heap located in the NE extent of site

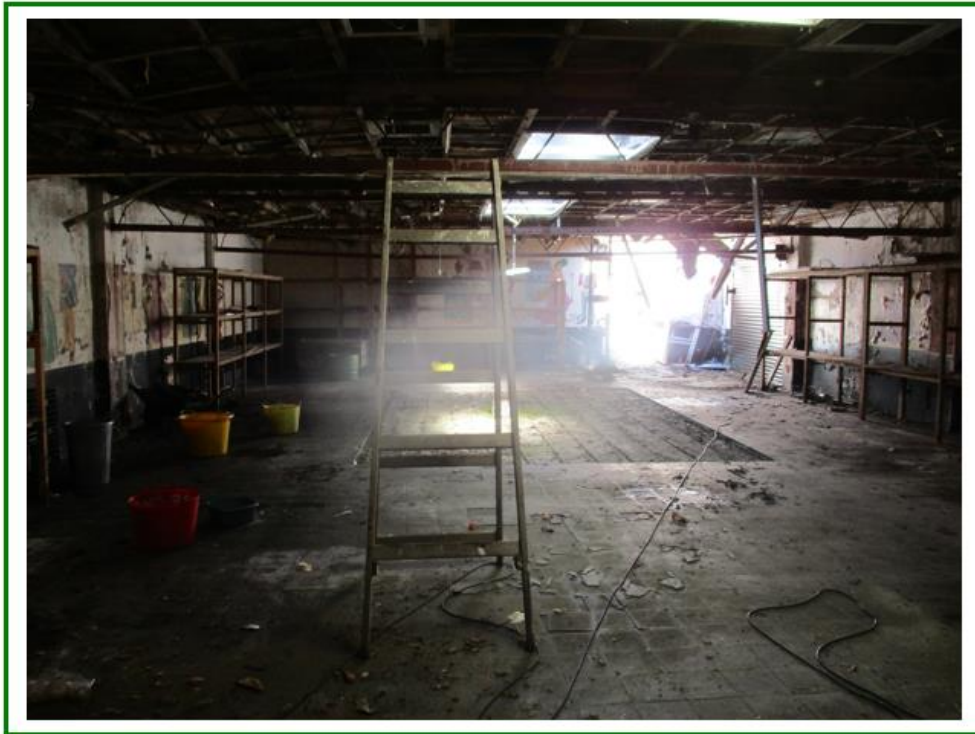
storage such as furniture, bikes and household items; and a rear, larger room comprising a former dancehall. The ceiling and roofing in this rear room were noted to be in a poor state of repair, with areas of the roof being open to the elements. Evidence noted beneath the former dancefloor indicating a concrete base to run through the entirety of the building. This building is proposed to be demolished to provide a more suitable access route into site than the present gravelled track.

Photo No.8: Facing north in adj. onsite former clubhouse showing dilapidated state of building (dancefloor area)

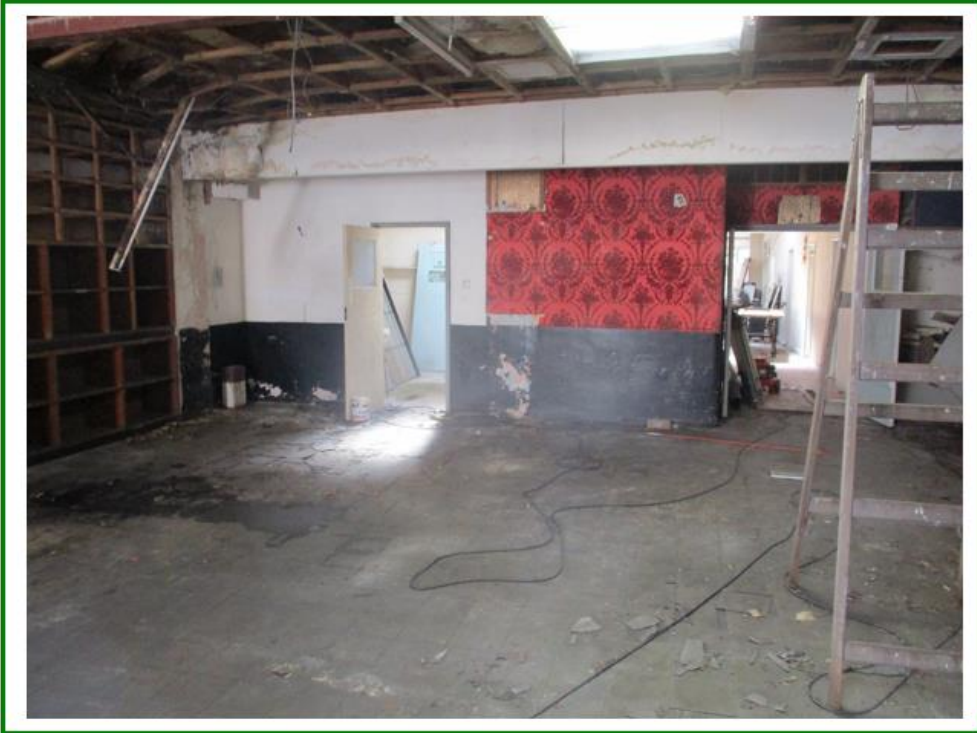
Photo No.9: Facing south from inside the dancefloor room of the adjacent structure with front (southern) rooms in background

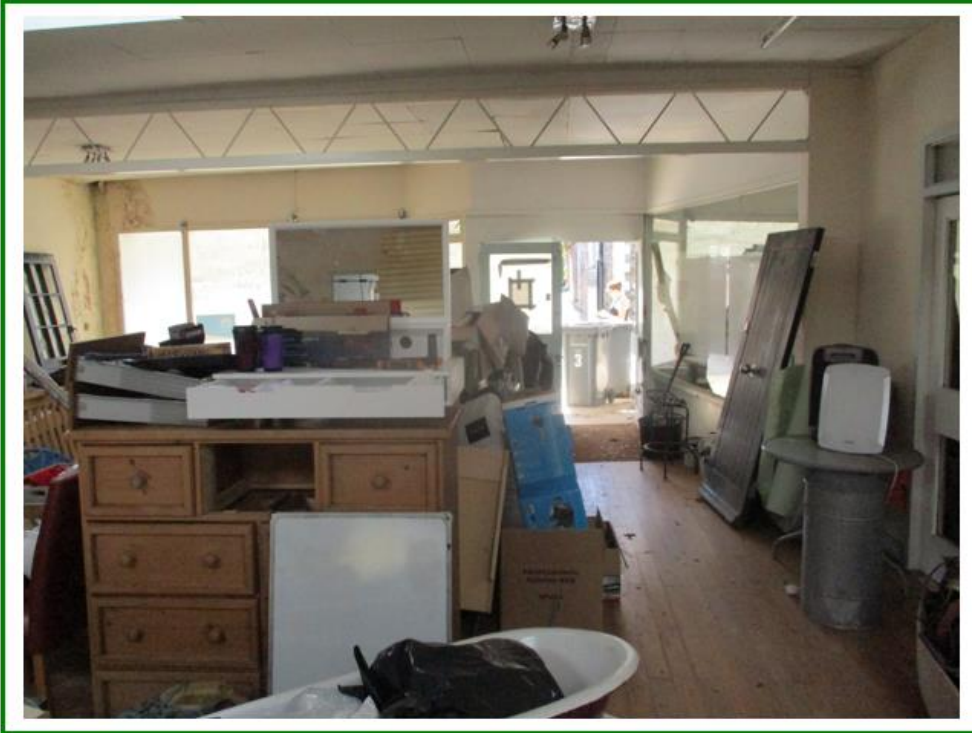
Photo No.10: Facing south in the front (southern) rooms of the former clubhouse toward Valley Rd and showing storage
