## **L.Smith Tree Surgery**

### **Visual Tree Assessment**

**Site Address:** Wildwood, Reading Road North, Fleet, Hampshire, GU51 4AQ

**Tree Name:** *Fagus sylvatica* (Common Beech)

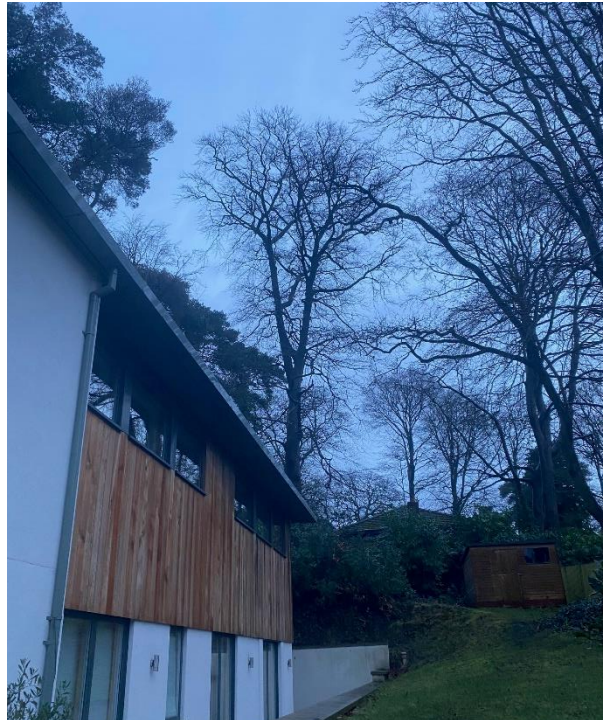
*Ref: 1* Photograph of T1, with tree owners house in the foreground.

4. T1 is single stem at ground level, leading to twin stem at approx. 10m. As visible at from Ref 1.
5. We observed the fruiting bodies of '*Kretchmaria deusta*', in three locations, at ground level on the northwest side between two buttress roots, in the basal cavity and in the vertical wound of the main stem.

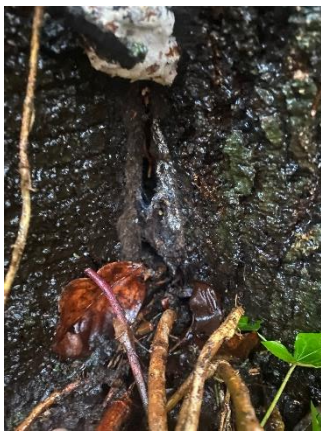
Ref: 4 Photograph of fruiting body one.

10. In our opinion, we believe that the likely cause of the wound on the lower stem, is the result of historical bonfire damage, leading to the dieback of the cambium and subsequent decay of the lower portion of the stem, which has likely lead to ingress of *K.deusta*. which can now be seen fruiting in two separate locations.
11. *K.deusta* is a fungal disease, of the lower stem, commonly found in Common Beech, in the lower stem. The fungi leads to a soft rot leading to brittle fracture of the main stem.
12. The decay was measured as high as we could manage up the stem, to a height of 2-2.5m with an acoustic test.
13. Given the extent of the decay, indicated by the basal cavity, the extent of wounding on the mainstem, coupled with the associated hall marks of *K.deusta*, and full canopy, this will lead to our recommendation to fell the tree.

14. Given the extent of the decay, the presence of *K.deusta*, exposed location in high risk residential area, and tree owners obligation under the Occupiers Liability Act 1957 & 1987, our only recommendation is to fell the tree to ground level. However, the tree could be retained as a standing monolith, of 4m, and be retained for habitat at the discretion of the client/council.

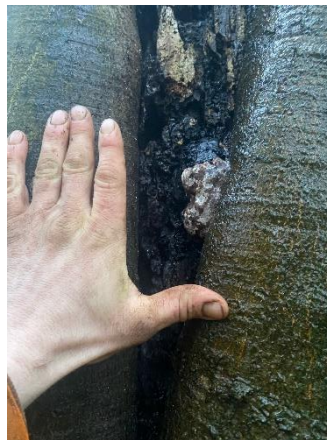
Ref: 3 Fruiting body two.

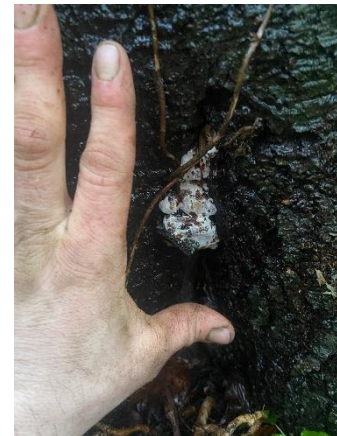
Ref: 2 Photograph of fruiting body three.

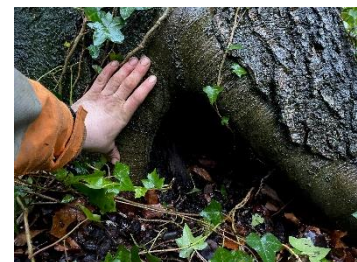
6. T1 has decay at the base of the tree on the West side, between the buttress roots. The decay extends into the centre of the stem, leading to a cavity which extends up into the lower stem, which an acoustic test indicates reaching 1.7m above ground level.

Ref: 5 Photograph of the basal cavity.

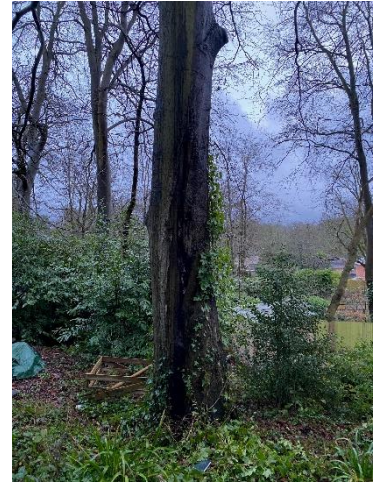
7. We observed dieback of the cambium, with reactive growth callusing the wound on the Northwest side, the dieback of the cambium has led to the decay of the central stem. An acoustic test indicates the decay is prevalent around the wound and across stem.
8. Bulging visible on the East of the stem, at same height of the wounding.
9. Full health crown was visible from ground level; however, the tree was inspected during February 2024, during dormancy.

Ref: 6 Photograph of the west side of stem, detailing cambium dieback.
