Frontier NW LTD  
Unit 191a Mersey wharf Business Park  
Bromborough  
Wirral  
CH62 4SF  
07710492365  
info@frontiernw.co.uk  
<https://frontiernw.co.uk/>  
Date 02/01/2024

## Window Survey

Site address: 139 Holgate Road, York, YO24 4DF

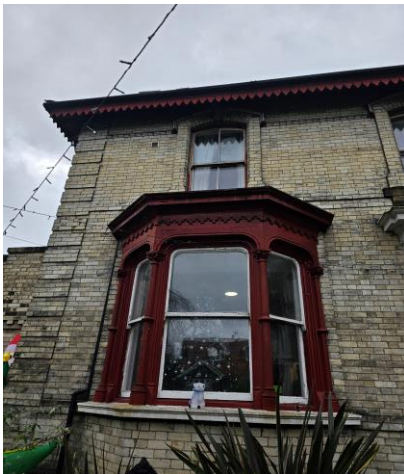
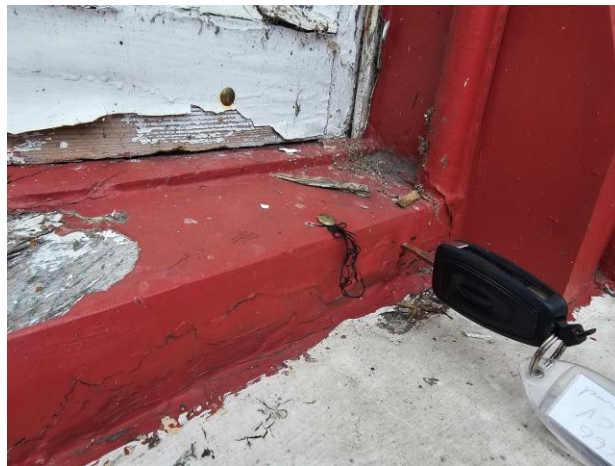
**Window Location:** Front elevation, ground floor left hand bay.

**Window type:** 3no. traditional box sash windows with weights and cords forming bay, top sash's fixed bottom sliding but not operational.

**Frame condition:** Main frame decorations expired, multiple areas of rot to lower sections, splicing and decoration works required.

**Sash's & glazing:** Decorations expired, glazing putty also failed, this has caused water to sit within rebate causing multiple rot in corners and mortice and tenon joints to fail. Replacement advised.

**Internal:** ironmongery and fittings expired; windows not operational.

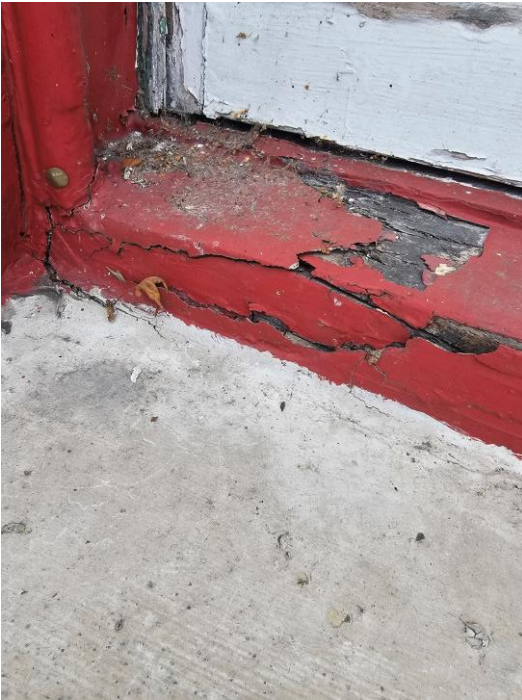
**Window Location:** Front elevation, ground floor right hand bay. (Same condition as left hand bay)

**Window type:** 3no. traditional box sash windows with weights and cords forming bay, top sash's fixed bottom sliding but not operational.

**Frame condition:** Main frame decorations expired, multiple areas of rot to lower sections, splicing and decoration works required.

**Sash's & glazing:** Decorations expired, glazing putty also failed, this has caused water to sit within rebate causing multiple rot in corners and mortice and tenon joints to fail, replacement advised.

**Internal:** ironmongery and fittings expired, windows not operational.

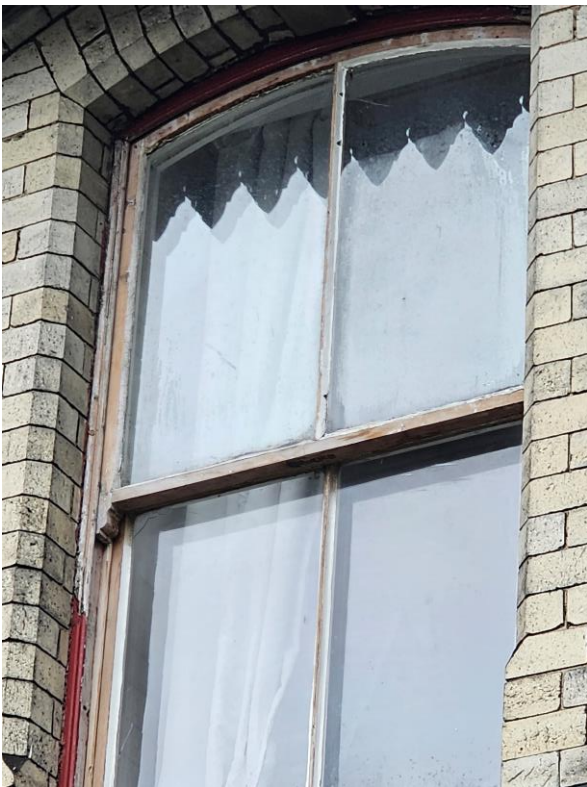
**Window Location:** Front elevation, 1st floor left hand window

**Window type:** 1 no. traditional box sash windows with weights and cords not operational.

**Frame condition:** Main frame decorations expired, large areas of bare timber exposed to weather, areas of rot to lower sections, splicing and decoration works required.

**Sash's & glazing:** Decorations expired, glazing putty expired causing mortice and tenon joints to fail on bottom sash, replacement advised.

**Internal:** ironmongery and fittings expired, Poly carb sheet screwed internally trapping moisture windows not operational.

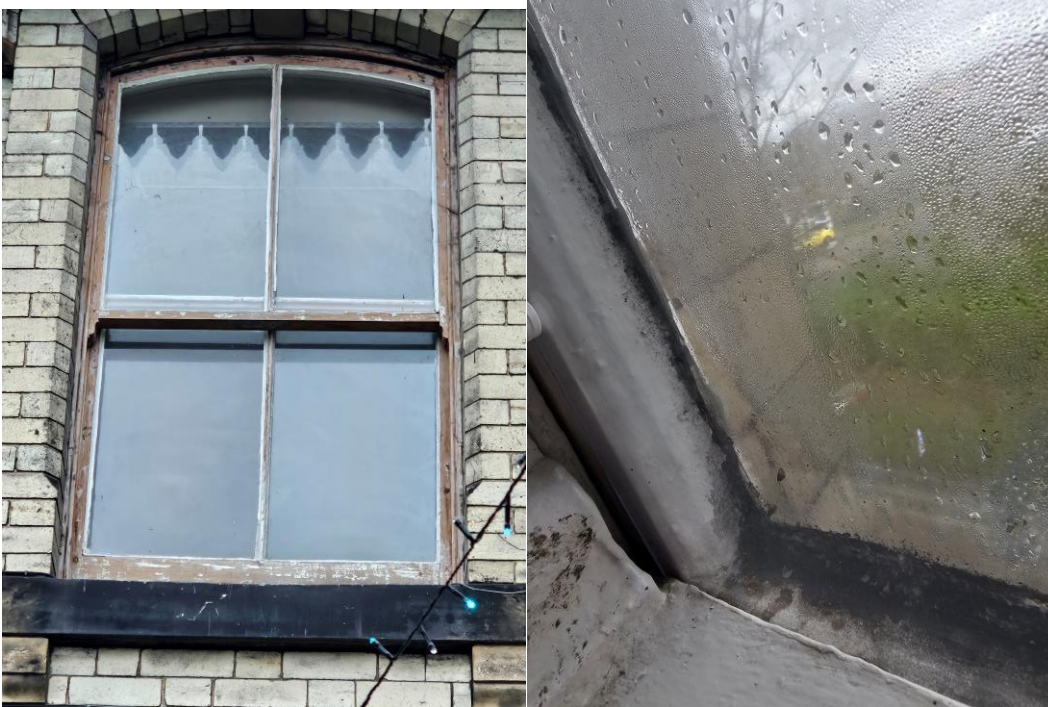
**Window Location:** Front elevation, 1st floor center window above front door.

**Window type:** 1 no. traditional box sash windows with weights and cords, operational but needs easing.

**Frame condition:** Main frame decorations expired, large areas of bare timber exposed to weather, areas of rot to lower sections and cill's splicing required and decorations.

**Sash's & glazing:** Decorations expired, glazing putty expired, sash's do open but need easing.

**Internal:** ironmongery and fittings expired; Poly carb sheet screwed internally trapping moisture in window.

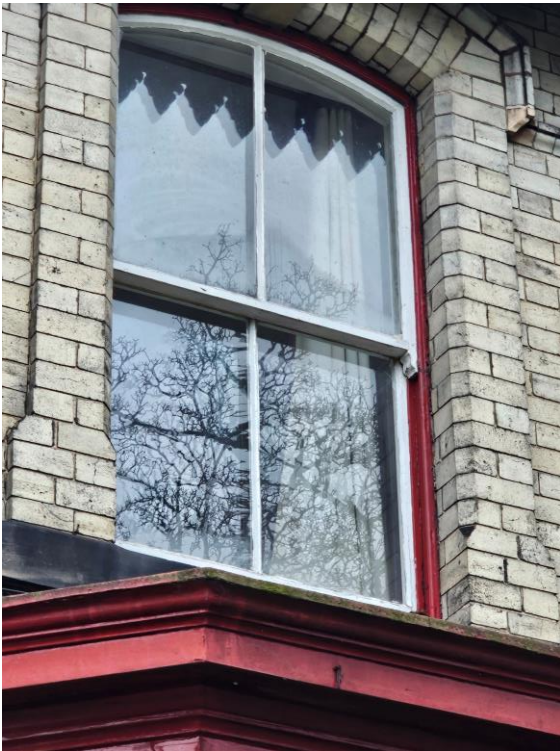
**Window Location:** Front elevation, 1st floor Right hand window.

**Window type:** 1 no. traditional box sash windows with weights and cords, operational but need's easing.

**Frame condition:** Main frame decorations expired, areas of rot to lower sections and cill's splicing required and decorations.

**Sash's & glazing:** Decorations expired, glazing putty expired, Bottom rail of lower sash failed, replacement required.

**Internal:** ironmongery and fittings expired, window not operational.

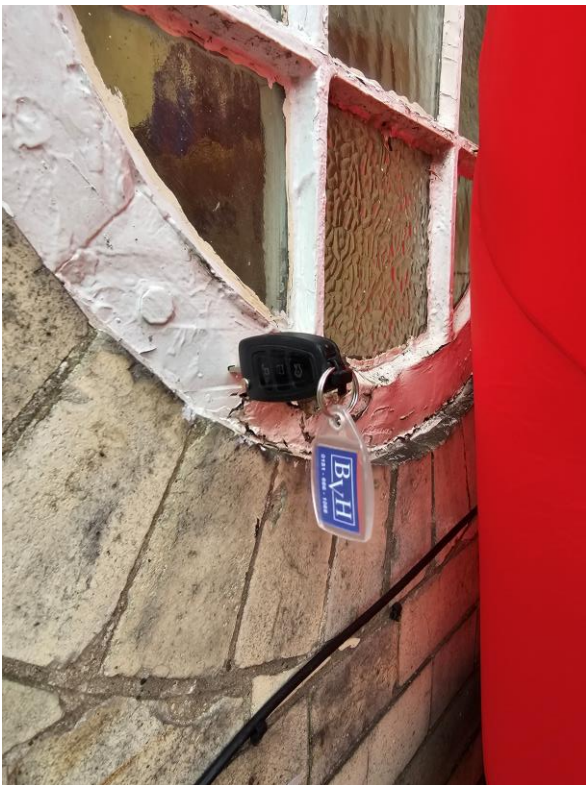
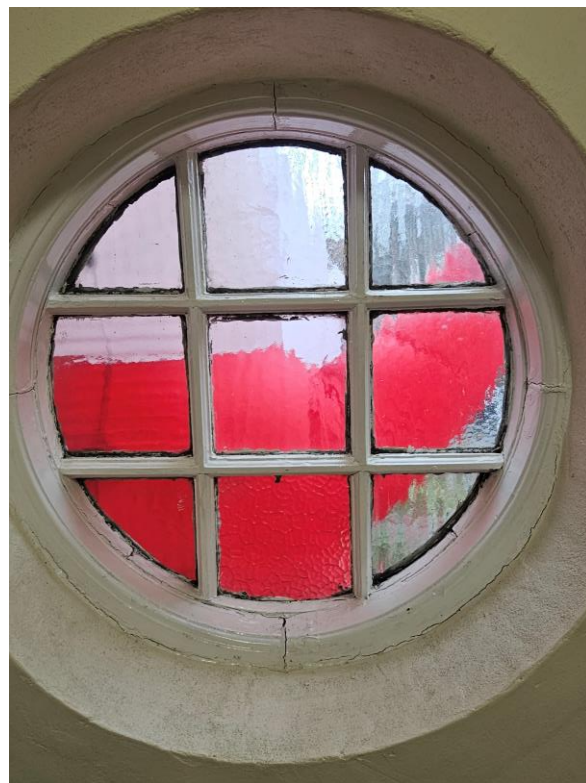
**Window Location:** GF, circular window.

**Window type:** 1 no. fixed circular window with glazing bars.

**Frame condition:** Main frame decorations expired, majority of timber rotten new window needed.

**Sash's & glazing:** As above.

**Internal:** As above
