REPORT OF A $< 25,000\text{m}^3$ RESERVOIR
RAINFORD RESERVOIR

October 2017

REPORT OF A RESERVOIR OF CAPACITY LESS THAN 25,000m³

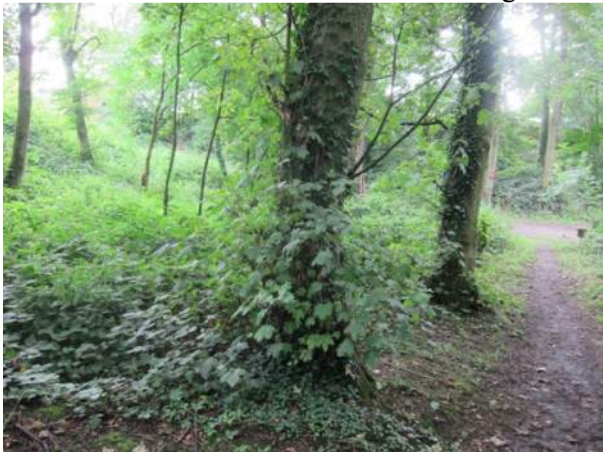
9 – Embankment face to left with footpath from right abutment and car park in distance. Valve chamber is within trees

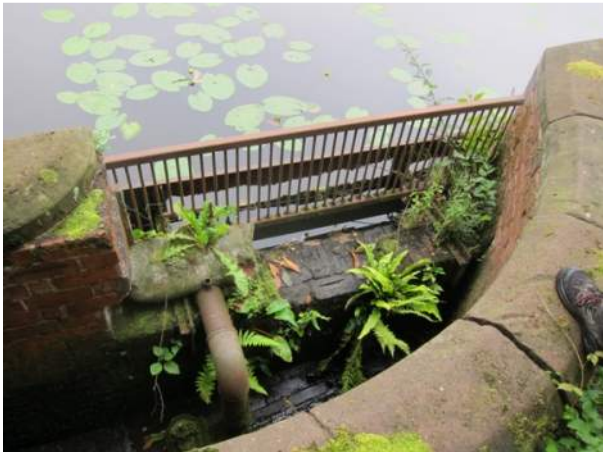
While there was no debris collected on the screens protecting the overflow, there is growth of vegetation within the screen partially obscuring the screen. There was also a temporary siphon pipe and sandbags securing this pipe, both of which obscure the overflow and will significantly limit discharge. **I recommend that screens should be cleared frequently, at least once per week, depending on weather and water levels. The screens should be inspected during or soon after heavy rainfall events or strong winds that could cause branches to fall into the reservoir.** While it is normally best practice not to provide full screens over overflow inlets, the arrangement at this overflow allows flow below the screen bypassing the screen and is a reasonable design. Without the screen, the pipes are liable to block downstream on a regular basis. The existing screen is in very poor condition and may fail if it deteriorates further, or if there is a large debris build up, for example during a storm event. **I recommend the screen is replaced in full with a new screen of similar or other appropriate design.**

The brick overflow structure to the left bank has some damage (missing bricks) and no protection to the overflow sill. It appears that the weir was lowered at some point and the lower brickwork left exposed. It is likely that the jointing between the bricks will become damaged and eroded over time. **I recommend that overflow brickwork damage is repaired and a protective mortar applied to the overflow sill.**

15 – Overflow B – inlet screen, siphon and weir

5. That the left bank overflow intake screen is replaced retaining the current ability to have an underflow bypass. The top of the screen should provide a suitable freeboard to the embankment crest. That the left bank overflow brickwork damage is repaired and the upper surface of the weir is protected with a suitable protective mortar;

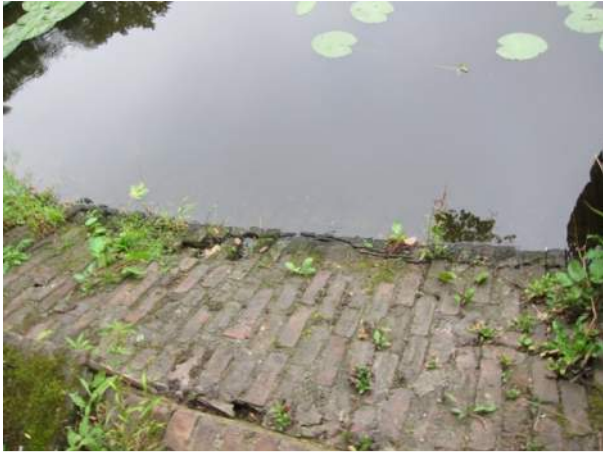
There is cracking across the upstream brickwork slope protection to the left bank just upstream of the dam. This appears to follow the line of the overflow pipe. It is likely that there has either been settlement of the pipe or washout of the pipe bedding or backfill into the pipe causing settlement of the ground above and cracking of the masonry. The cracking could lead to failure of the slope wave protection. It is in the embankment return to the left abutment that is partially protected from wave action by the overflow structure. The movement appears to be long standing and there does not appear to be recent movement. **I recommend the crack is monitored and included on a regular maintenance monitoring schedule. If further movement occurs the masonry should be removed, the backfill reinstated, and the wave protection reinstated. The recommended CCTV pipe inspection should be reviewed to determine if there is loss of material into the pipe in this area and if there is then the pipework should be repaired.**

17 – Crack in brick wave protection downstream of overflow B, which is to the immediate right.

4. That the crack over the left overflow pipe through the wave protection brickwork is monitored and included on regular maintenance monitoring schedule. If further movement occurs the masonry should be removed, the backfill reinstated and the wave protection reinstated. The recommended CCTV pipe inspection should be reviewed to determine if there is loss of external material into the pipe in this area and if there is then the pipework should be repaired or replaced;
5. I recommend that a gauge board is fitted to the side of the left bank overflow and that water levels are recorded no less than weekly. The two overflow levels, the crest level and the upstream and downstream embankment toe levels should also be measured for use in comparison against this recorded water level;

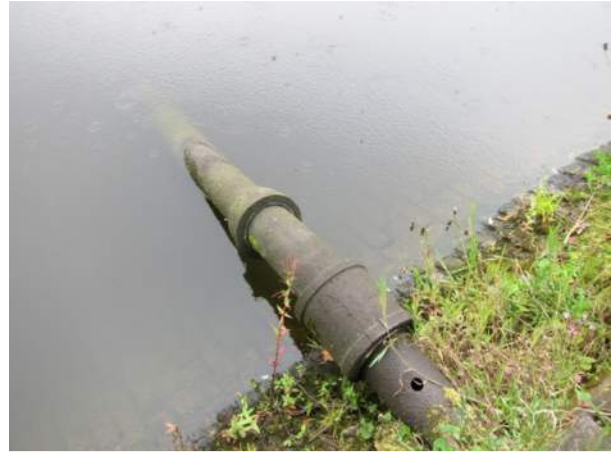
The outlet, the original reservoir drawoff, pipework consists of the two siphons that pass over/through the crest; neither of which are in a serviceable condition. One of these, it is unknown which, is likely to have originally been an inlet pipe back from the sand processing plant.

18 – Siphon 6”

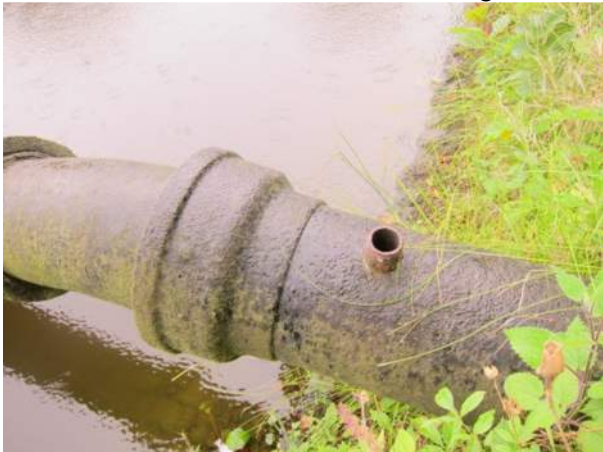
19 – Siphon 8”

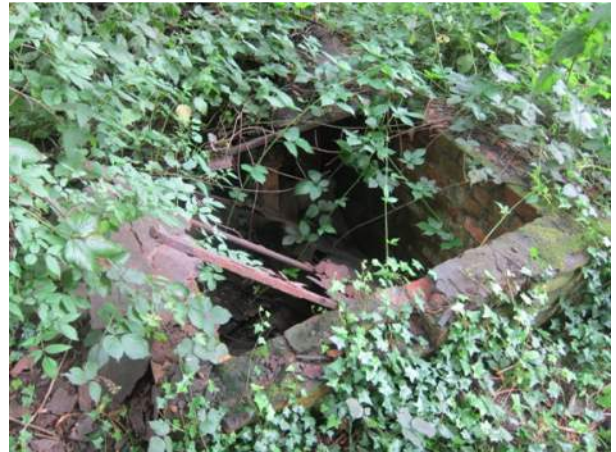
The valve chamber below the reservoir is in a very poor condition. The cover is highly corroded and collapsed. The chamber is partially hidden in undergrowth. This chamber forms a significant hazard to the general public and grounds maintenance operatives. **I recommend that the chamber should be fully exposed and that the existing arrangement should be recorded on a drawing and reviewed to confirm that there are no other features within the chamber that are necessary to the safety of the dam. If the chamber is found to serve no other functional purpose, as I expect, I recommend that this chamber is removed, the valvework removed and disposed of, and the ground reinstated to make the area safe. In the short term a barrier should be erected around the chamber to warn persons of the hazard.**

20 – Drawoff siphon valve chamber overgrown

6. Significant infestations by burrowing animals close to the dam embankments should be dealt with when necessary;
7. If the redundant valve chamber is found to serve no other functional purpose, or is not to be re-purposed for use in another measure above, I recommend this chamber is removed, the valvework removed and safely and disposed of and the ground reinstated to make the area safe. In the short term a barrier should be erected around the chamber to warn persons of the hazard;

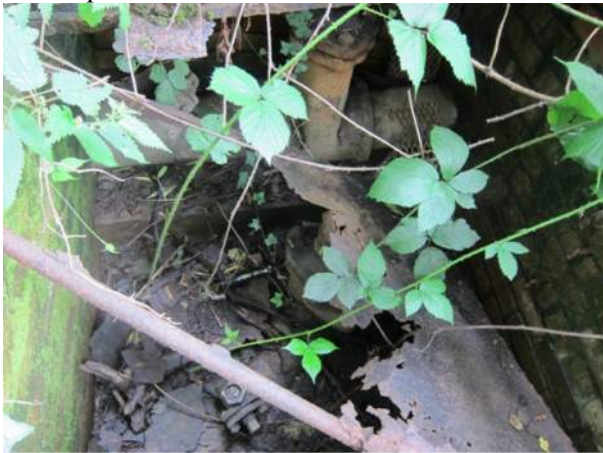
There is a chamber to the downstream foot of the embankment with two pipes and a diagonal cross connection. These appear to be extensions to the two siphon pipes although this was not confirmed. The cover has corroded and disintegrated. This now forms a dangerous void partially hidden in the undergrowth that could cause injury to persons falling into the hidden void.

The direction of these pipes beyond this chamber is not clear and no further features were identified. These inlet and outlet pipes are in an inoperable condition and are unlikely to be in a condition that could be brought back into use.

Following inspection of the downstream valve chamber I do not consider that the two siphons could be easily brought back into service. The dimensions, arrangement, internal condition, location down the downstream face, intake details and control valvework are all unknown and would be difficult to safely determine. The pipework could be used as a conduit and lined with a new flexible siphon pipe. The pipes will each require the addition of valves downstream of the dam toe, to control the release of water and to permit the initial filling of the length of pipe above the valve and up to the dam crest. Sudden opening of the valve may be capable of starting siphonic flow, but a priming header tank or temporary pumps may be needed. The existing valve chamber could be re-purposed to house the siphon downstream valves. Providing the existing pipes remain in place as a continuous unit from low on the upstream slope to the limits of the downstream slope it should be cost effective to modify and use them for water abstraction by siphon action rather than

21 – Drawoff siphon chamber internals

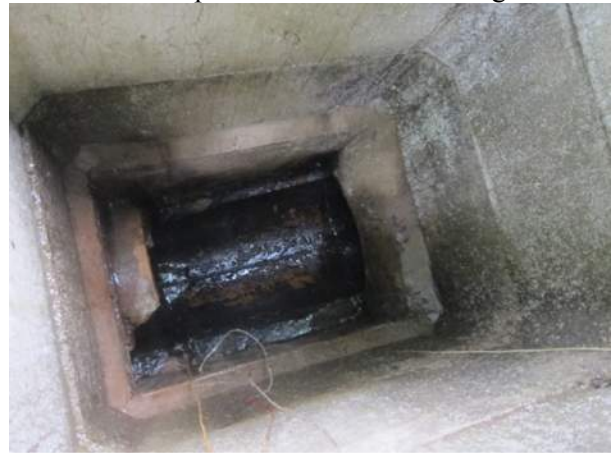
22 – MH1 no flow from overflow B

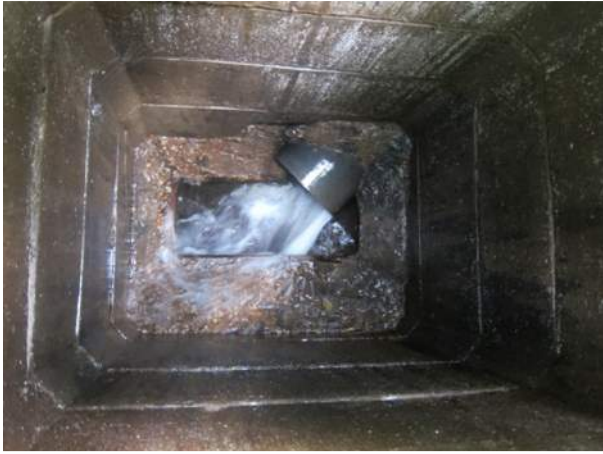
22 – MH2 overflow A flowing and entering existing pipe from overflow B

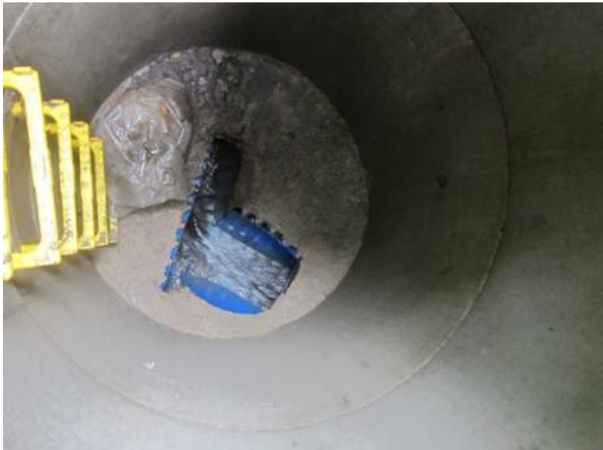
24 – MH4 new manhole, mitred bend liable to catch debris but currently appears clear, flow enters from right

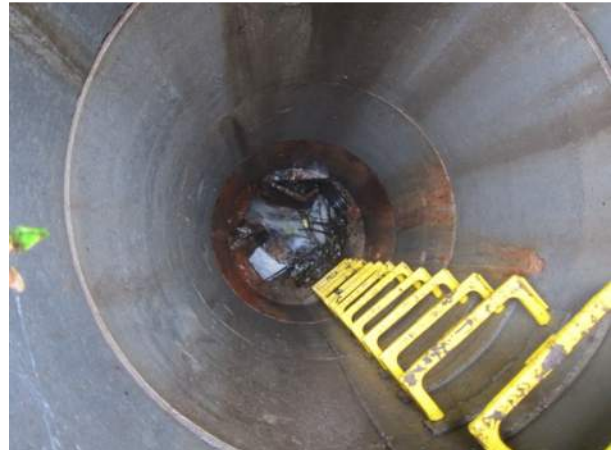
25 – MH5 new manhole immediately upstream of road crossing, flow enters from upper left

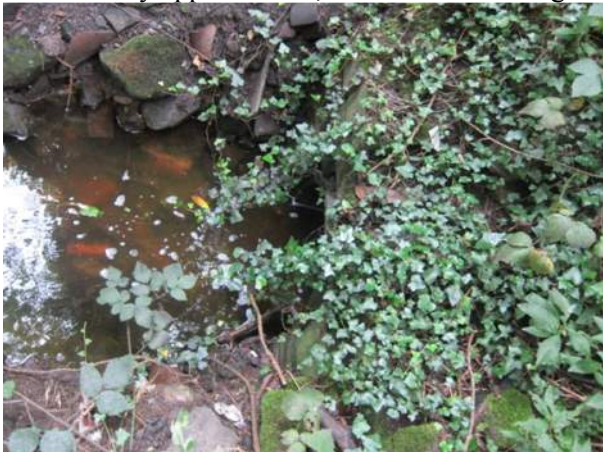
The outfall from the overflow pipe downstream of the public road has a small stone or brick headwall to support the embankment faces above and to either side. To the right of the pipe outfall there is dry stone/brick protection of the embankment face beneath the outfall of another, smaller, pipe that is probably the discharge from the road drains. **I recommend discussion with the highways authority to determine responsibility for maintenance of the culvert crossing the highway and support of the embankment faces.** While I expect maintenance of this area is the responsibility of the highway authority, this is not clear at present. During high flows and with the small size of the headwall structure and lack of extensive face protection, erosion could occur in this location leading to failure of the road edge. The extent of flow and its ability to cause erosion issues is as evidenced at the next downstream hydraulic structure.

26 – Discharge headwall downstream of road
