# Hutton + Rostron Environmental Investigations Limited

## Grandpont House, Oxford: Roof drainage investigation

Site note 3 for December 2023-January 2024, job no. 160-42

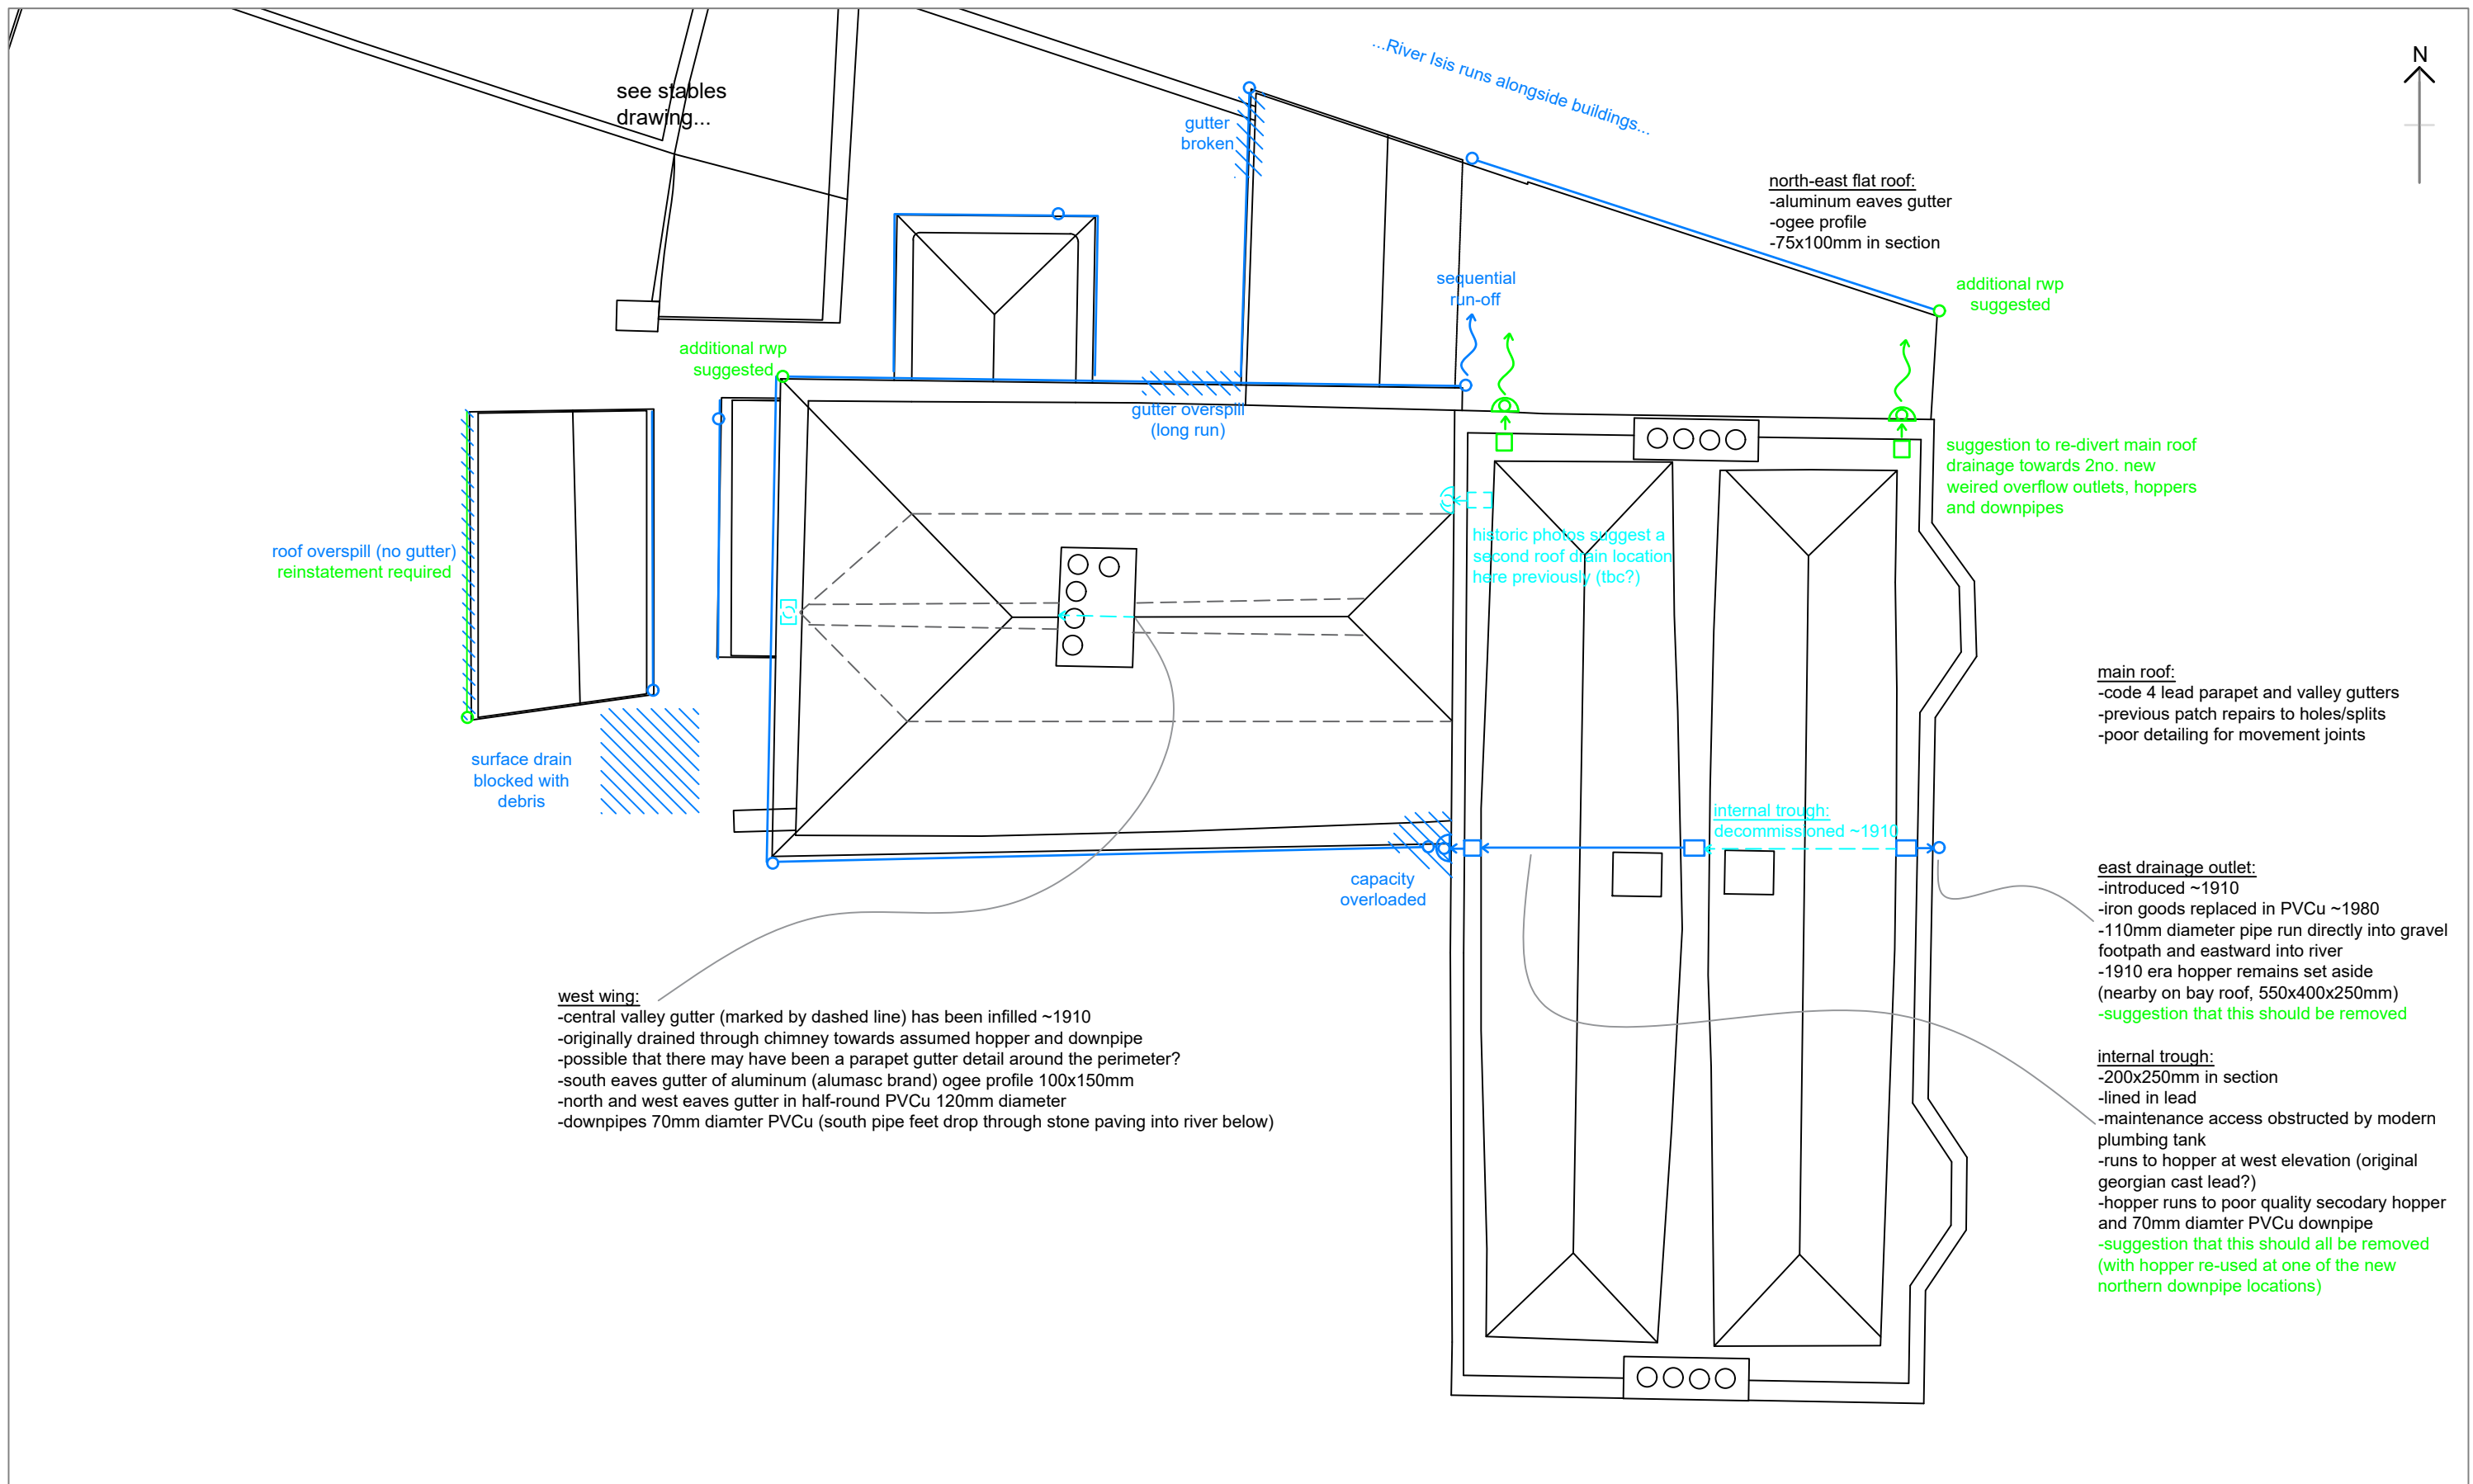
**Grandpont House, Main House - Roof**  
Roof drainage investigation  
December 2023 - January 2024

surface drain blocked with debris

main roof:  
-code 4 lead parapet and valley gutters  
-previous patch repairs to holes/splits  
-poor detailing for movement joints

capacity overloaded

east drainage outlet:  
-introduced ~1910  
-iron goods replaced in PVCu ~1980  
-110mm diameter pipe run directly into gravel footpath and eastward into river  
-1910 era hopper remains set aside (nearby on bay roof, 550x400x250mm)  
-suggestion that this should be removed

west wing:  
-central valley gutter (marked by dashed line) has been infilled ~1910  
-originally drained through chimney towards assumed hopper and downpipe  
-possible that there may have been a parapet gutter detail around the perimeter?  
-south eaves gutter of aluminum (alumasc brand) ogee profile 100x150mm  
-north and west eaves gutter in half-round PVCu 120mm diameter  
-downpipes 70mm diameter PVCu (south pipe feet drop through stone paving into river below)

internal trough:  
-200x250mm in section  
-lined in lead  
-maintenance access obstructed by modern plumbing tank  
-runs to hopper at west elevation (original georgian cast lead?)  
-hopper runs to poor quality secondary hopper and 70mm diameter PVCu downpipe  
-suggestion that this should all be removed (with hopper re-used at one of the new northern downpipe locations)

additional rwp suggested

suggestion to re-divert main roof drainage towards 2no. new weired overflow outlets, hoppers and downpipes

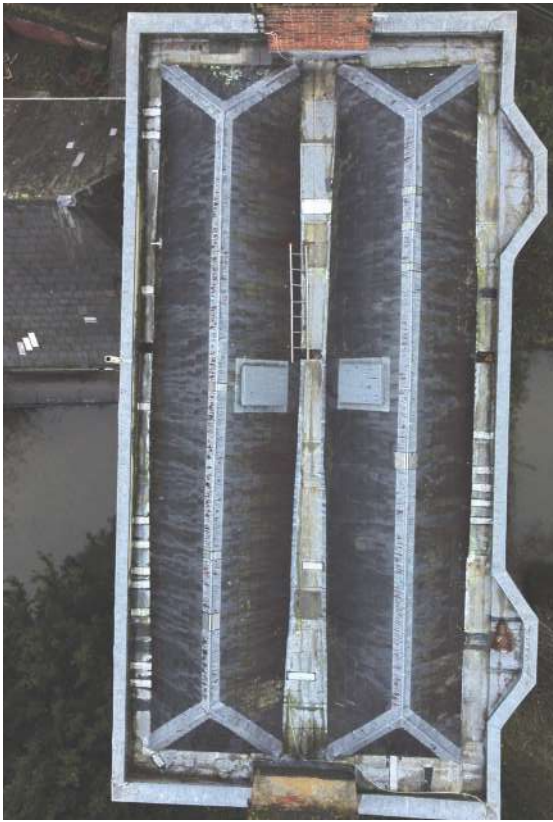
**Fig 1:**

Main House, main roof

Showing general view with north orientated at head of image

The parapet and valley gutters originally drained to the west via two internal troughs

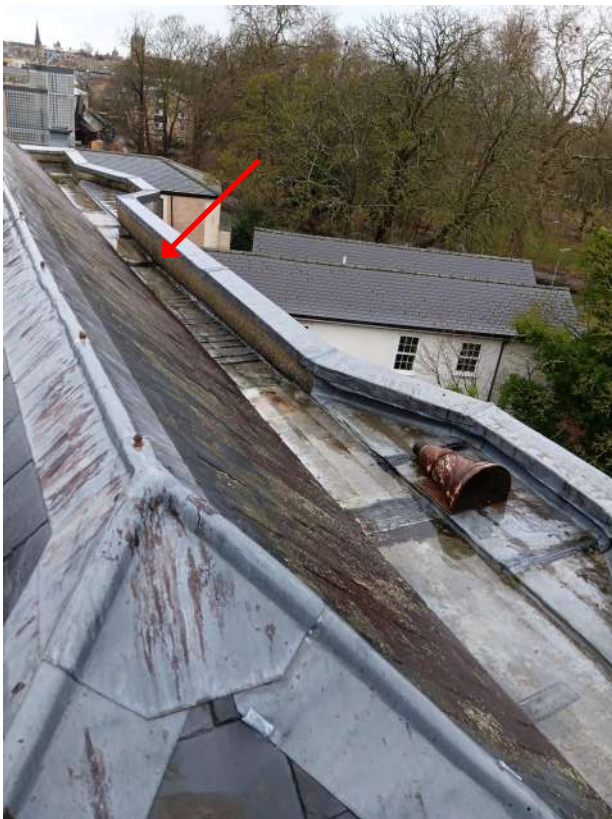
**Fig 2:**

Main House, main roof

Showing east gutter

Outlet position marked (arrow)

1910 era hopper has been set aside on the roof (rhs)

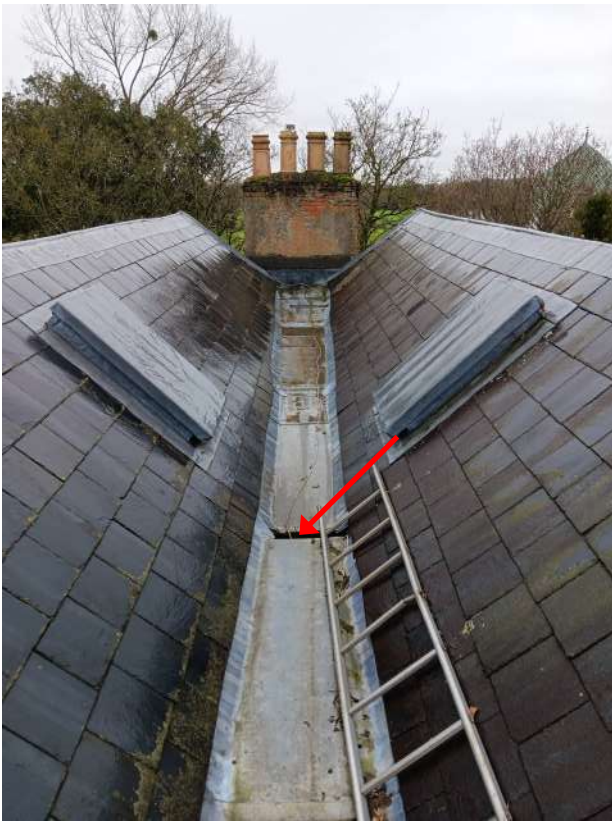
**Fig 3:**

Main House, main roof

Showing central valley gutter

Position of outlet to internal trough  
marked by arrow

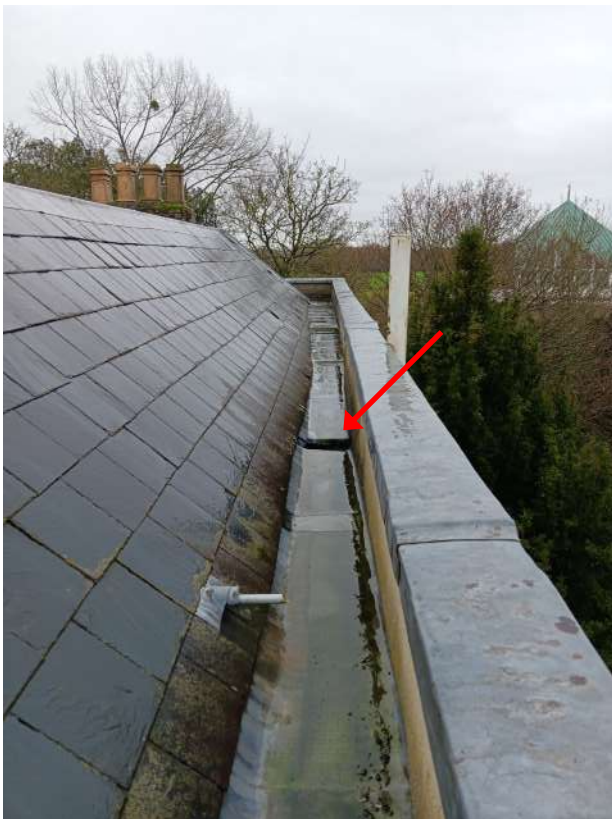
**Fig 4:**

Main House, main roof

Showing west parapet gutter

Position of outlet (for both the parapet  
gutter and internal trough) is marked by  
arrow

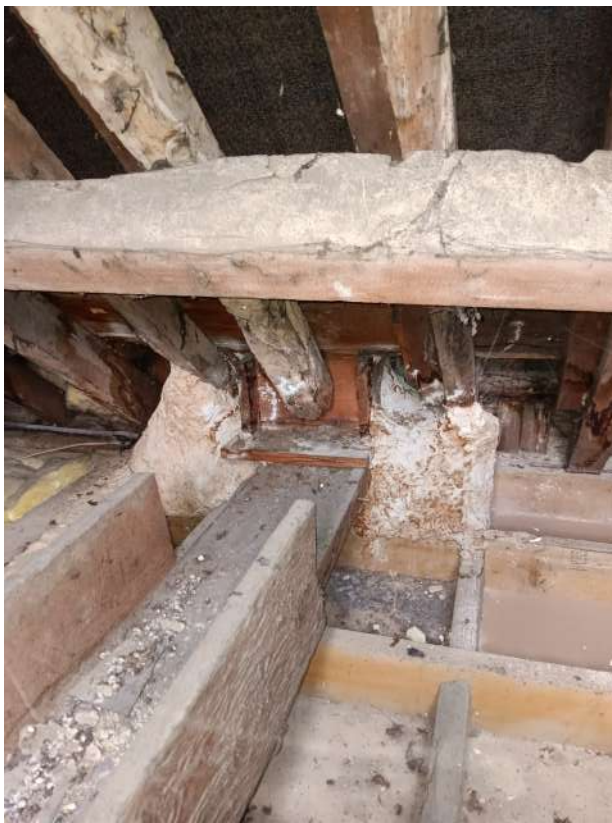
**Fig 5:**

Main House, main roof

Showing example of internal drainage trough. In this particular area, the trough has been decommissioned during the 1910 works with water diverted to the east elevation (see fig 6 below)

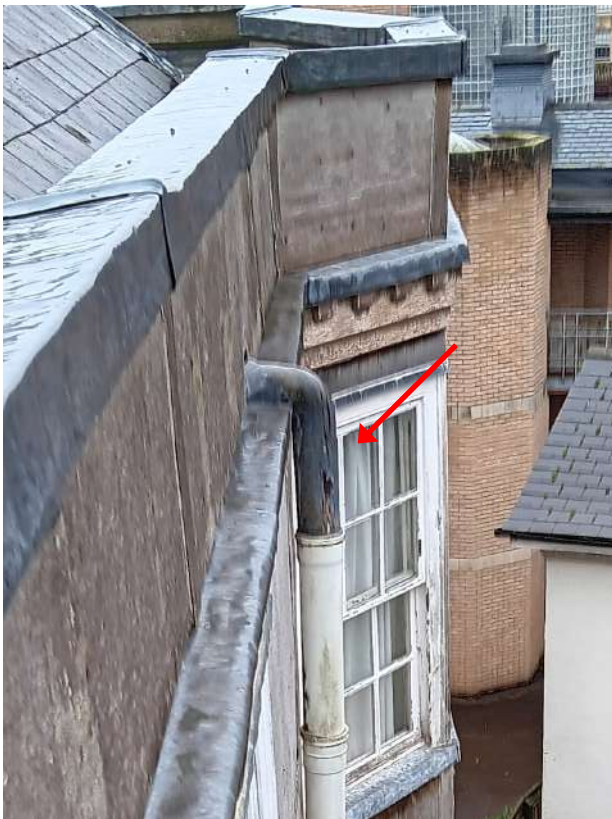
**Fig 6:**

Main House, main roof

Showing east parapet outlet; this was a non-original drainage position

When first installed in ~1910, there was an iron hopper here (currently set-aside on the roof)

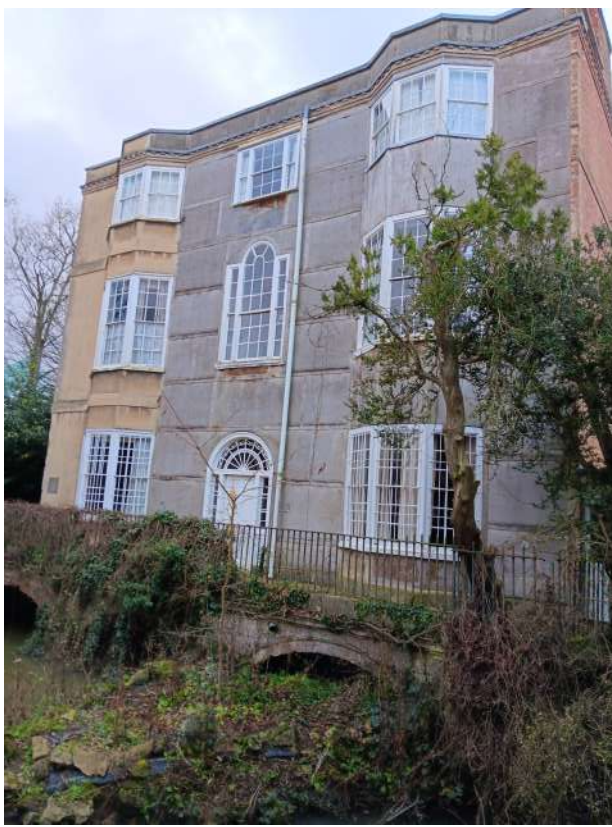
**Fig 7:**

Main House, main roof

Showing east drainpipe

Aesthetically, this spoils the architecture of the principal façade

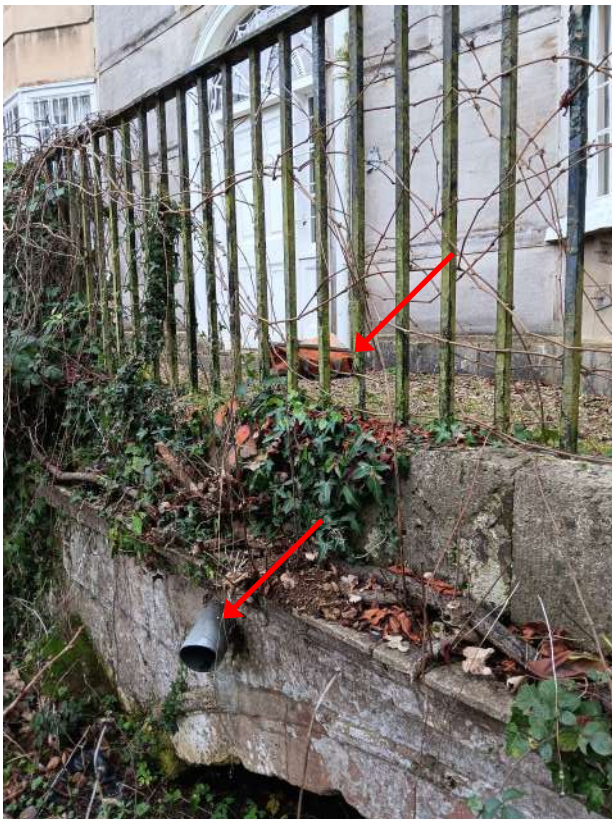
**Fig 8:**

Main House, main roof

Showing east drainpipe run below gravel path and onto spit of land beside river

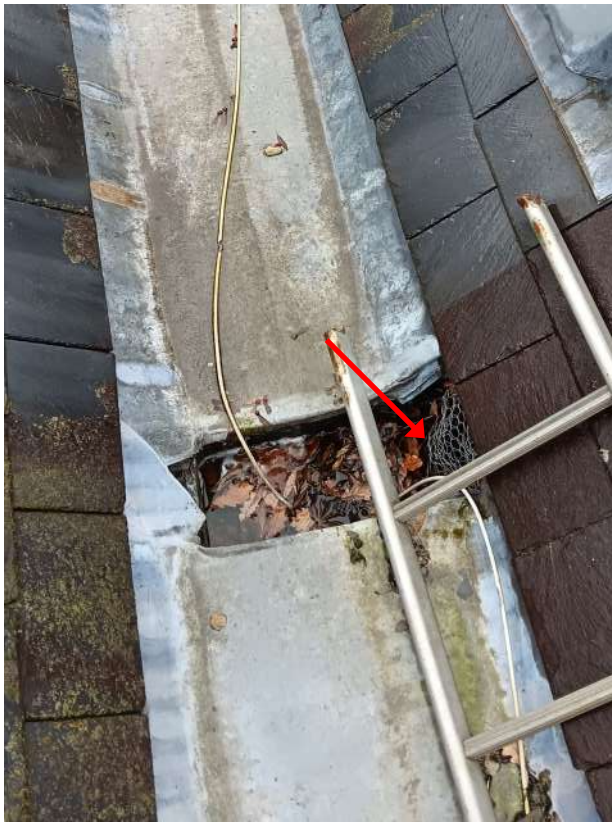
**Fig 9:**

Main House, main roof

Showing outlet for central valley gutter

This was partially blocked by tree matter; in the past this has led to water flooding the interiors

Note mesh restricting bird access

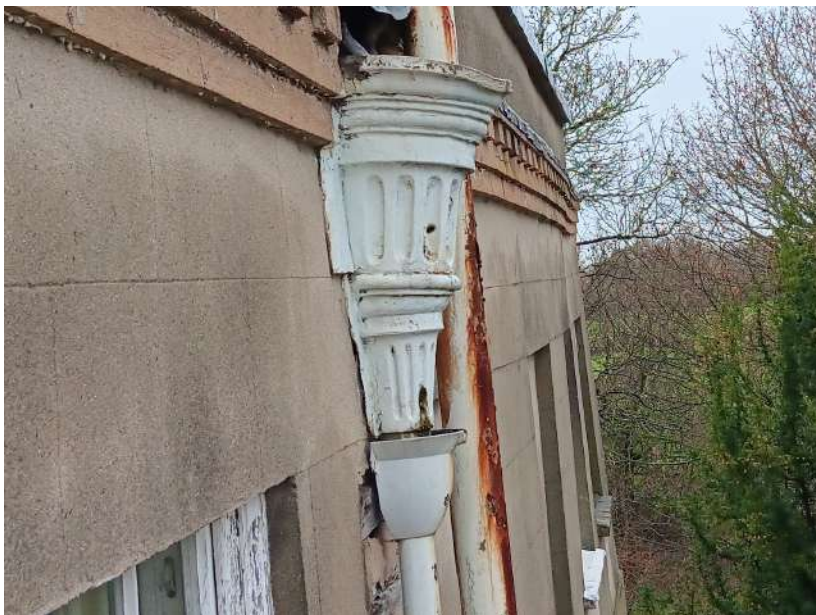
**Fig 10:**

Main House, main roof

Showing drainage outlet to west façade

The historic hopper (Georgian cast lead?) appeared in reasonable condition although some stains in the paintwork suggested the metal may be deteriorating

Note rather crude detail where secondary hopper is provided. Also note modern downpipe which seemed under-size

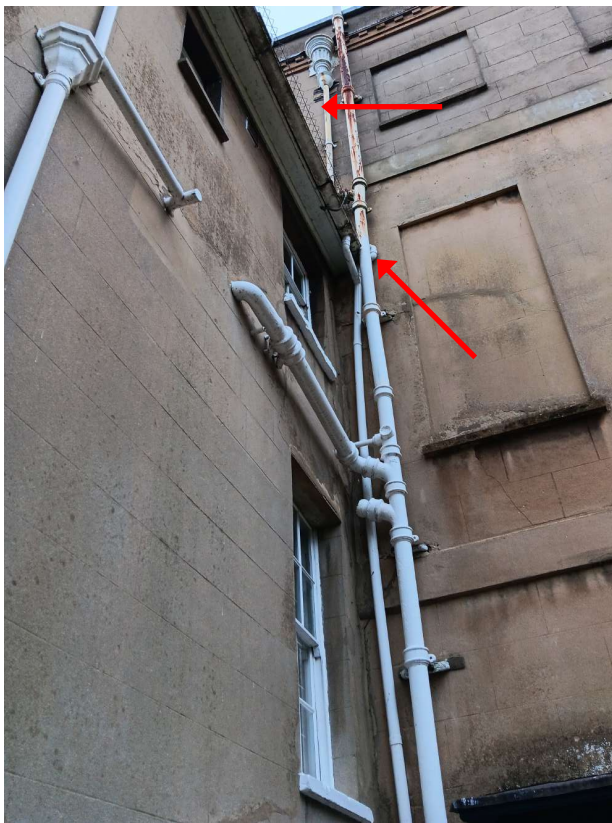
**Fig 11:**

Main House, main roof

Showing west rainwater downpipe in small diameter goods with various complex bends

Fixings into the masonry were scant and crude

Note cast iron soil stack alongside has become detached from its fixings to the wall

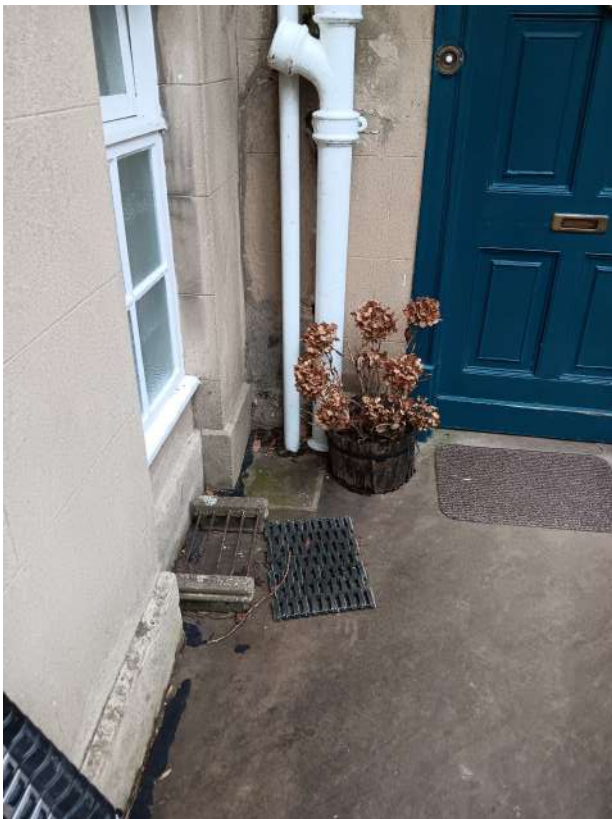
**Fig 12:**

Main House, main roof

Showing west rainwater downpipe penetrating the stone entrance slab (presumably dropping directly into the River running below)

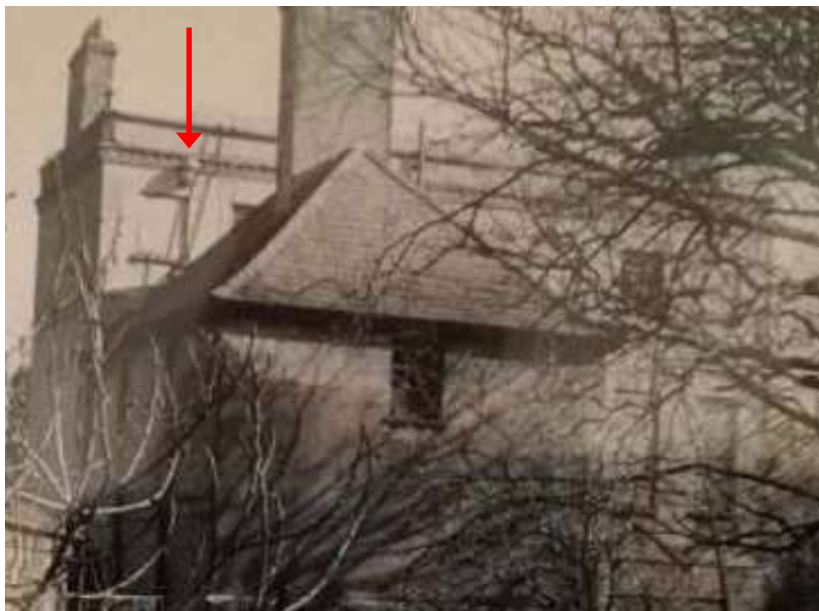
**Fig 13:**

Main House, main roof

Showing historic image from DIA heritage statement; this appears to show another hopper location at the west elevation (tbc)

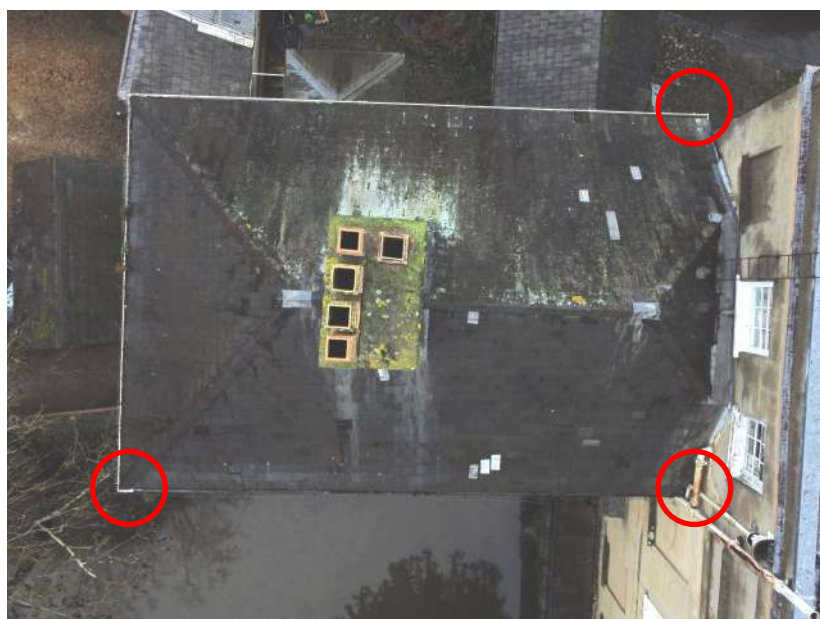
**Fig 14:**

Main House, west wing

Showing general view with north orientated at head of image

Downpipe locations serving eaves gutter are marked

Note the roof shape has been changed circa 1910 from the original central valley gutter

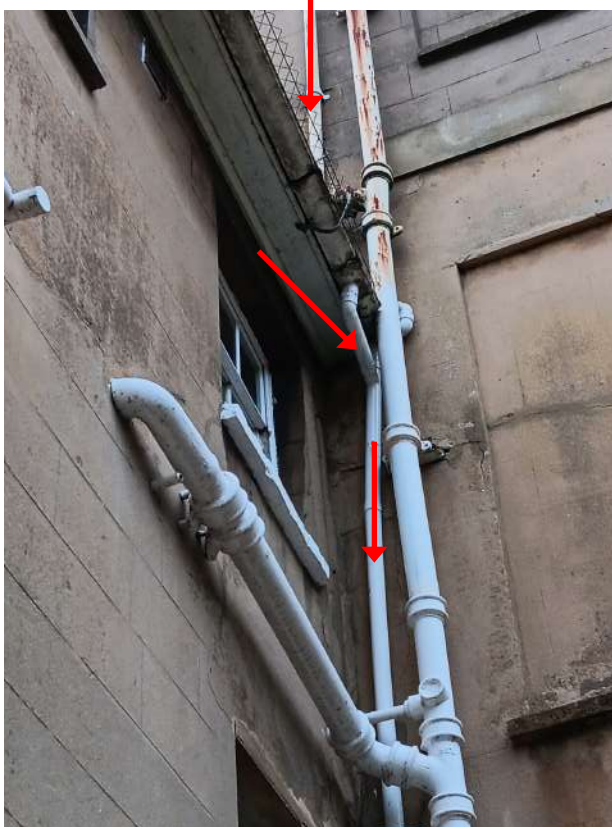
**Fig 15:**

Main House, west wing

Showing south-east drainpipe

Note the main roof drainpipe also teed-into this pipe which seemed to be overloaded as a result

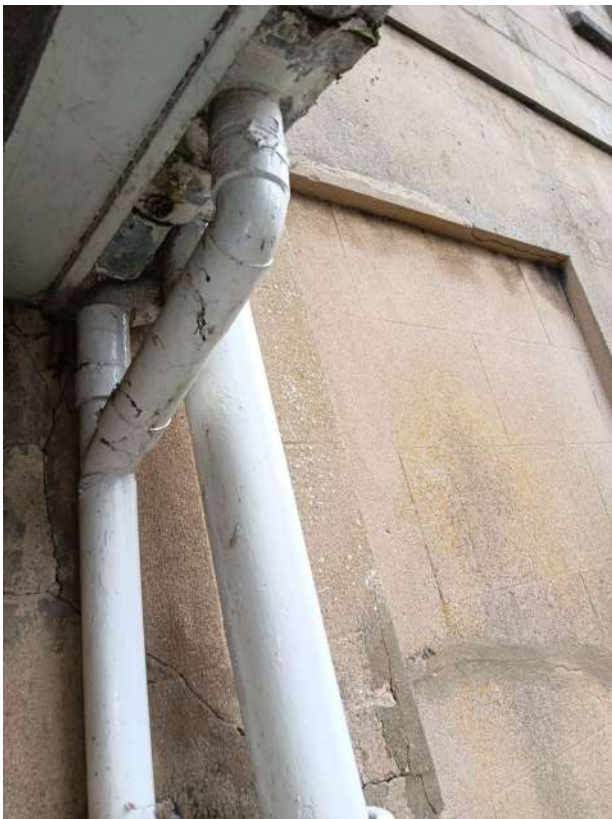
**Fig 16:**

Main House, west wing

Showing south-east drainpipe which was of remarkably small diameter for the size of roof area drained

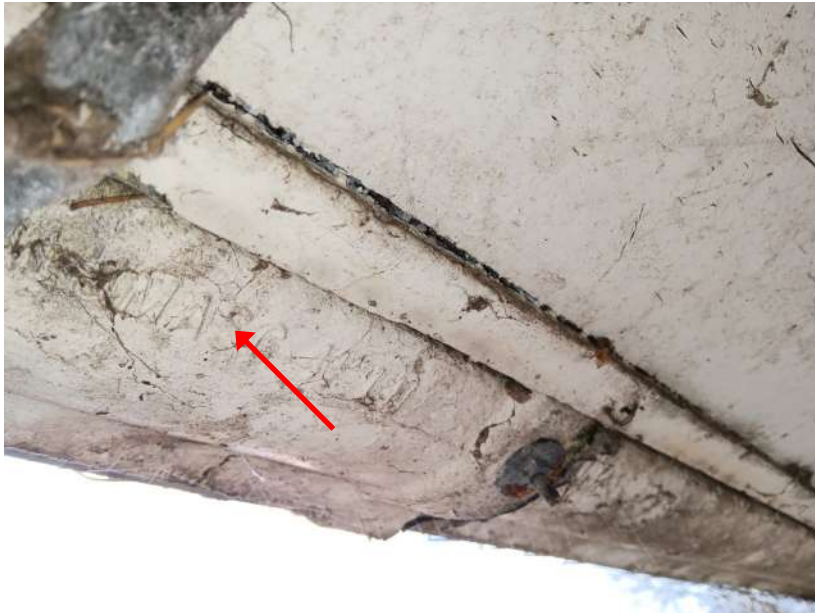
**Fig 17:**

Main House, west wing

Showing south gutter where 'Alumasc' branding was evident

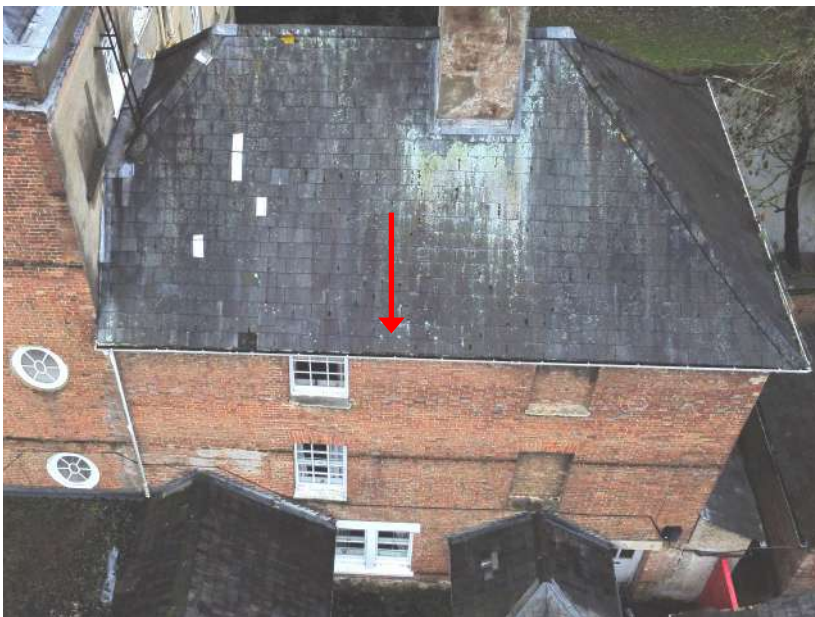
**Fig 18:**

Main House, west wing

Showing north gutter draining sequentially onto flat roof below

The gutter was in a very long run and appeared to overflow at the location marked due to lack of appropriate falls and undersize goods

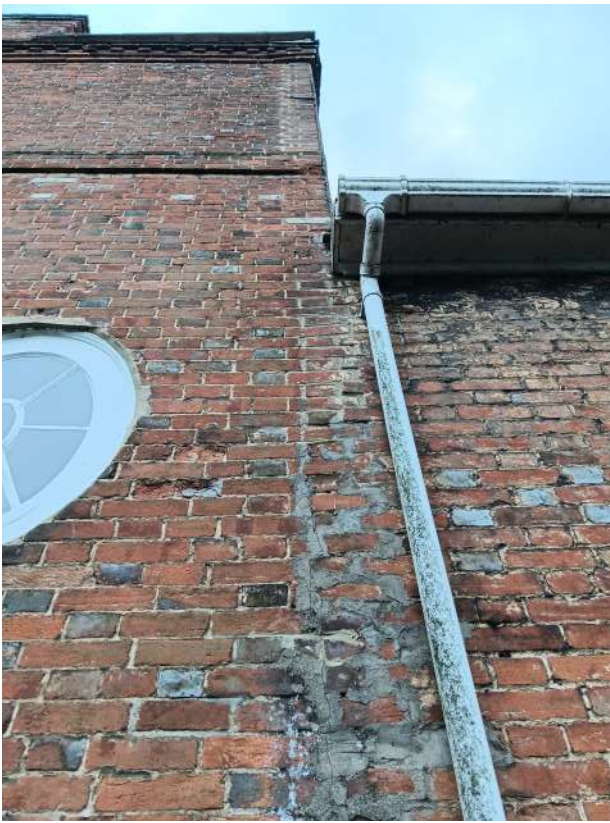
**Fig 19:**

Main House, west wing

Showing north gutter draining sequentially onto flat roof below

Note ogee profile PVCu guttering

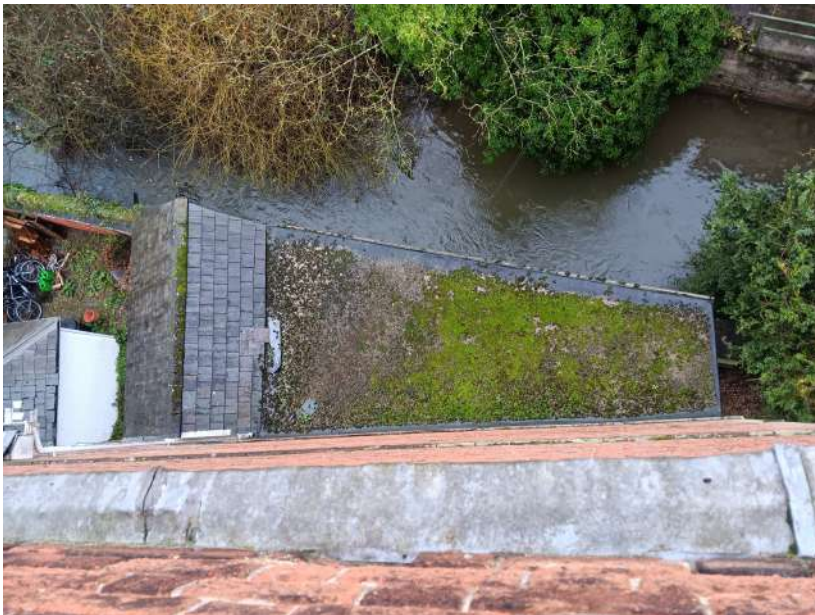
**Fig 20:**

Main House, secondary roofs

Showing north-east flat roof

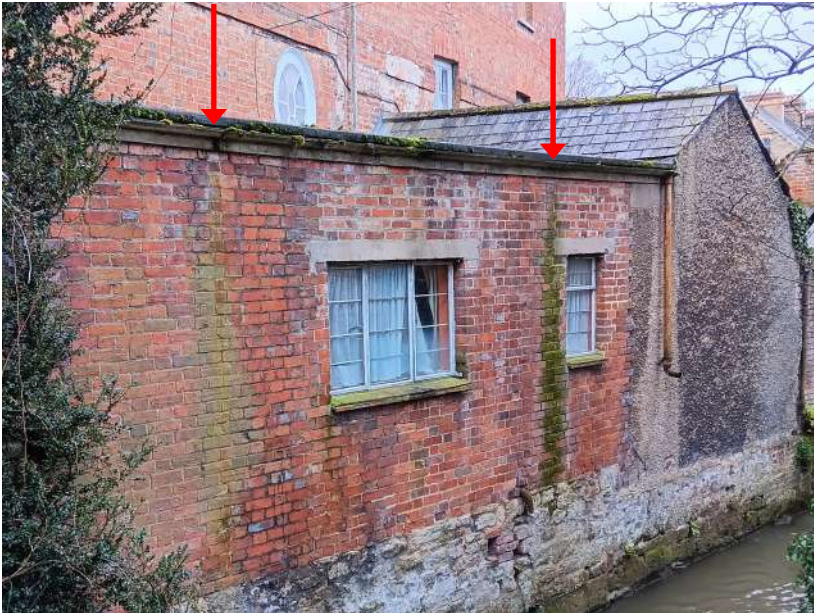
**Fig 21:**

Main House, secondary roofs

Showing north-east flat roof

Note evidence of various leaks in the gutter (at joints)

Note downpipe discharges into river

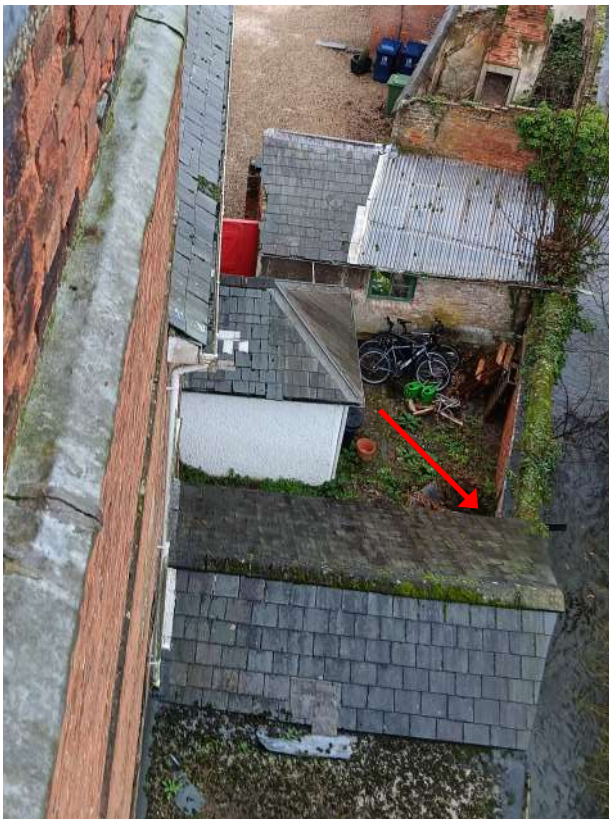
**Fig 22:**

Main House, secondary roofs

Showing various pitched roofs draining to eaves gutters

A broken section of eaves gutter is marked by an arrow

Also note at upper LHS of image where it appears that the north gutter of the west wing is blocked with debris such that water is backing-up within the gutter

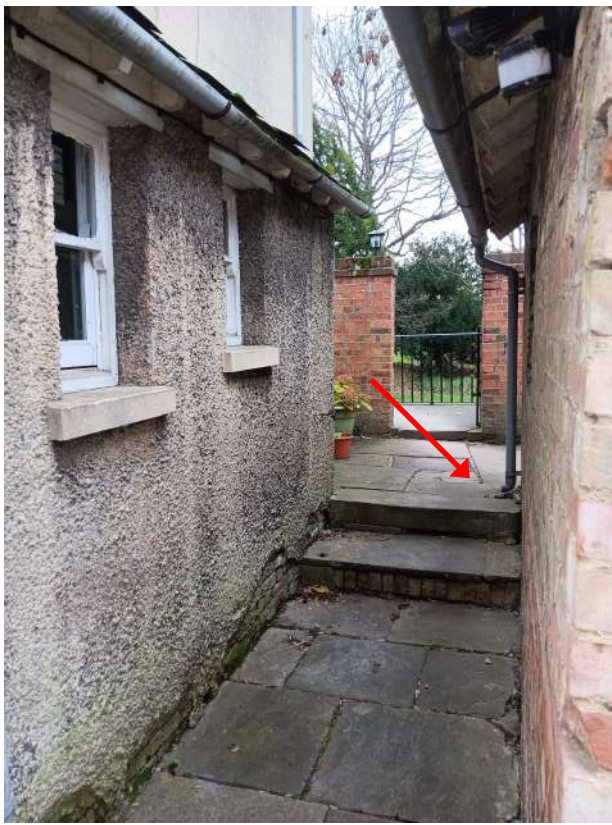
**Fig 23:**

Main House, secondary roofs

Showing storage rooms/sheds at west side of west wing

Overhanging eaves drained to plastic eaves gutters

Note downpipe marked by arrow was intended to run along a surface drainage channel (towards the river) but this has become blocked with debris

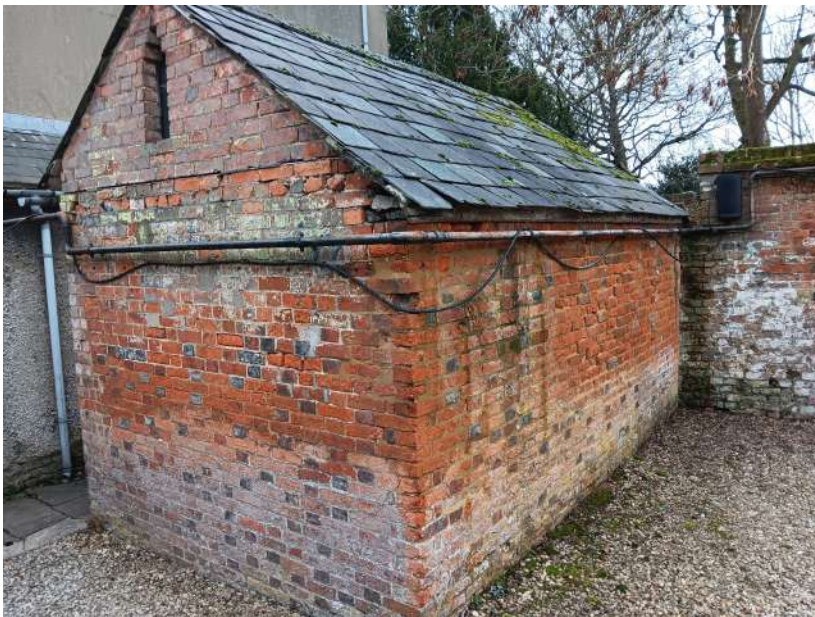
**Fig 24:**

Main House, secondary roofs

Showing storage rooms/sheds at west side of west wing

The gutter has been entirely lost from this location, allowing water to drain into the wall

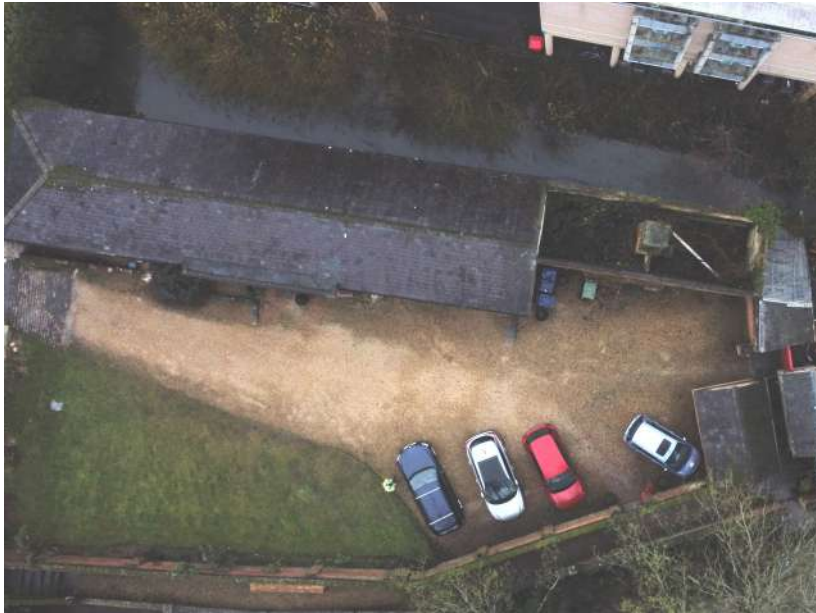
**Fig 25:**

Stables

Showing general view with north orientated at head of image

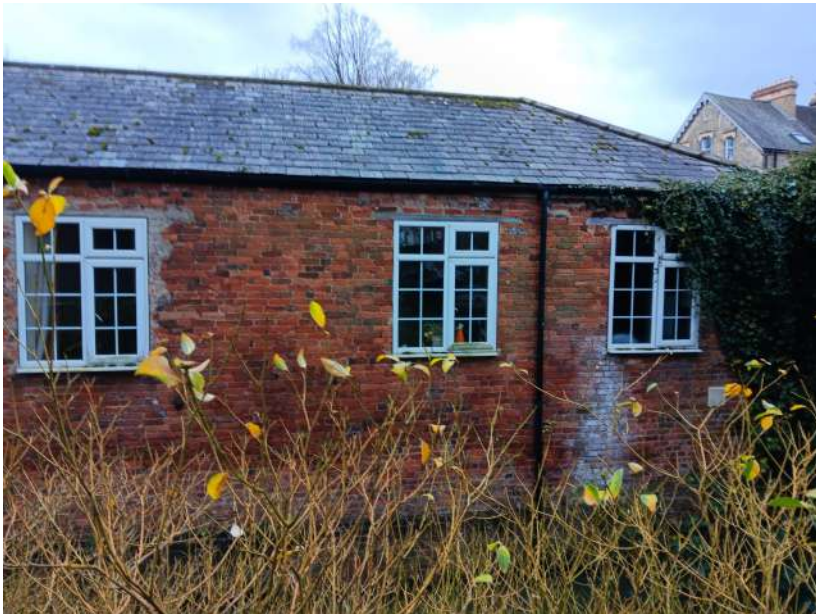
**Fig 26:**

Stables, north pitch

Showing eaves gutter and downpipe draining into river

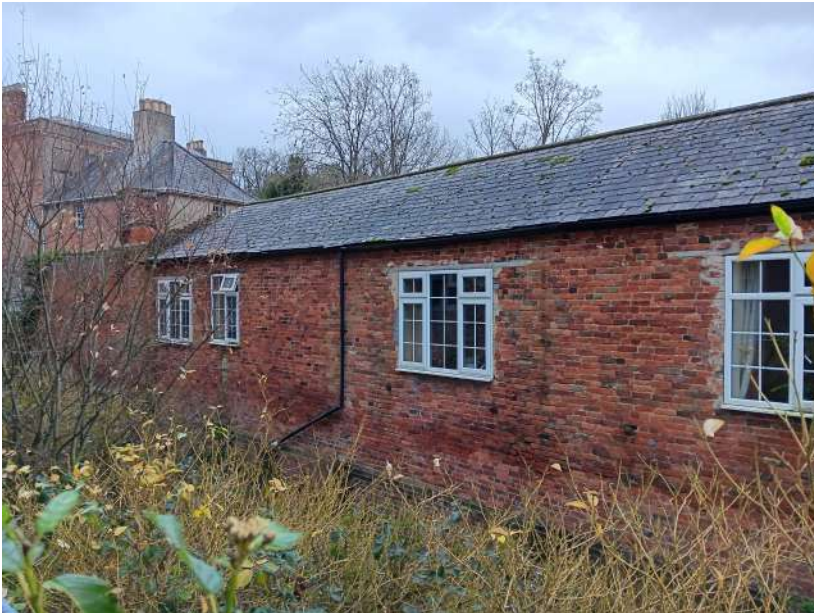
**Fig 27:**

Stables, north pitch

Showing eaves gutter and downpipe  
draining into river

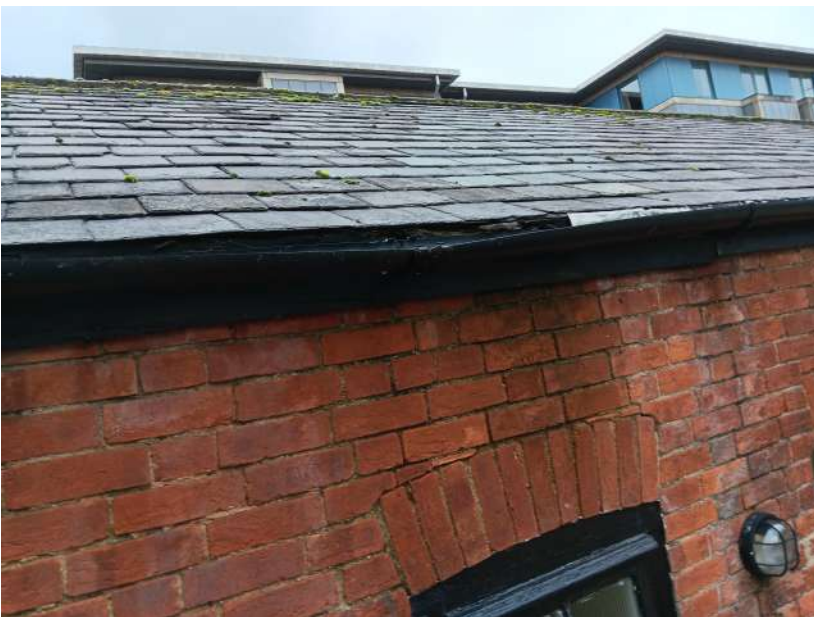
**Fig 28:**

Stables, south pitch

Showing slate overhang insufficient to  
reach gutter (leading to water running  
down brick face)

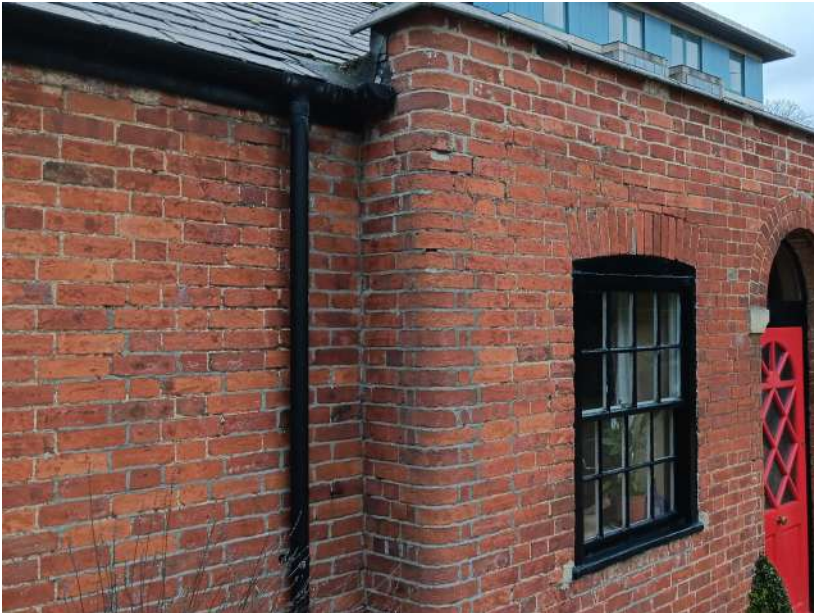
**Fig 29:**

Stables, south pitch

Showing eaves gutter and downpipe also carrying water draining from small parapet gutter/flat roof

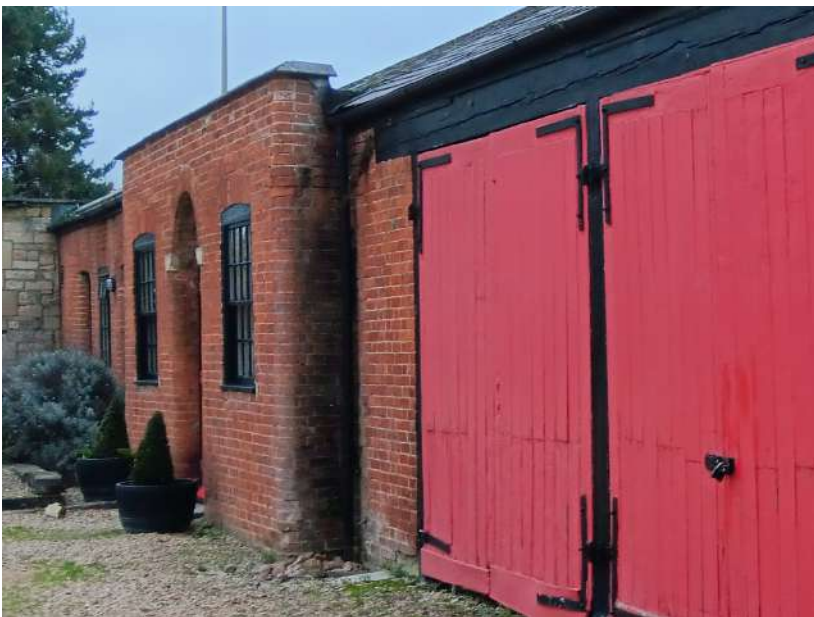
**Fig 30:**

Stables, south pitch

Showing eaves gutter and downpipe also carrying water draining from small parapet gutter/flat roof

A defective flashing, vulnerable drainage detailing and blockage of the system were leading to water saturating the adjacent brickwork
