Hutton + Rostron Environmental Investigations Limited

Grandpont House, Oxford: Roof finishes investigation

Site note 2 for December 2023-January 2024, job no. 160-42

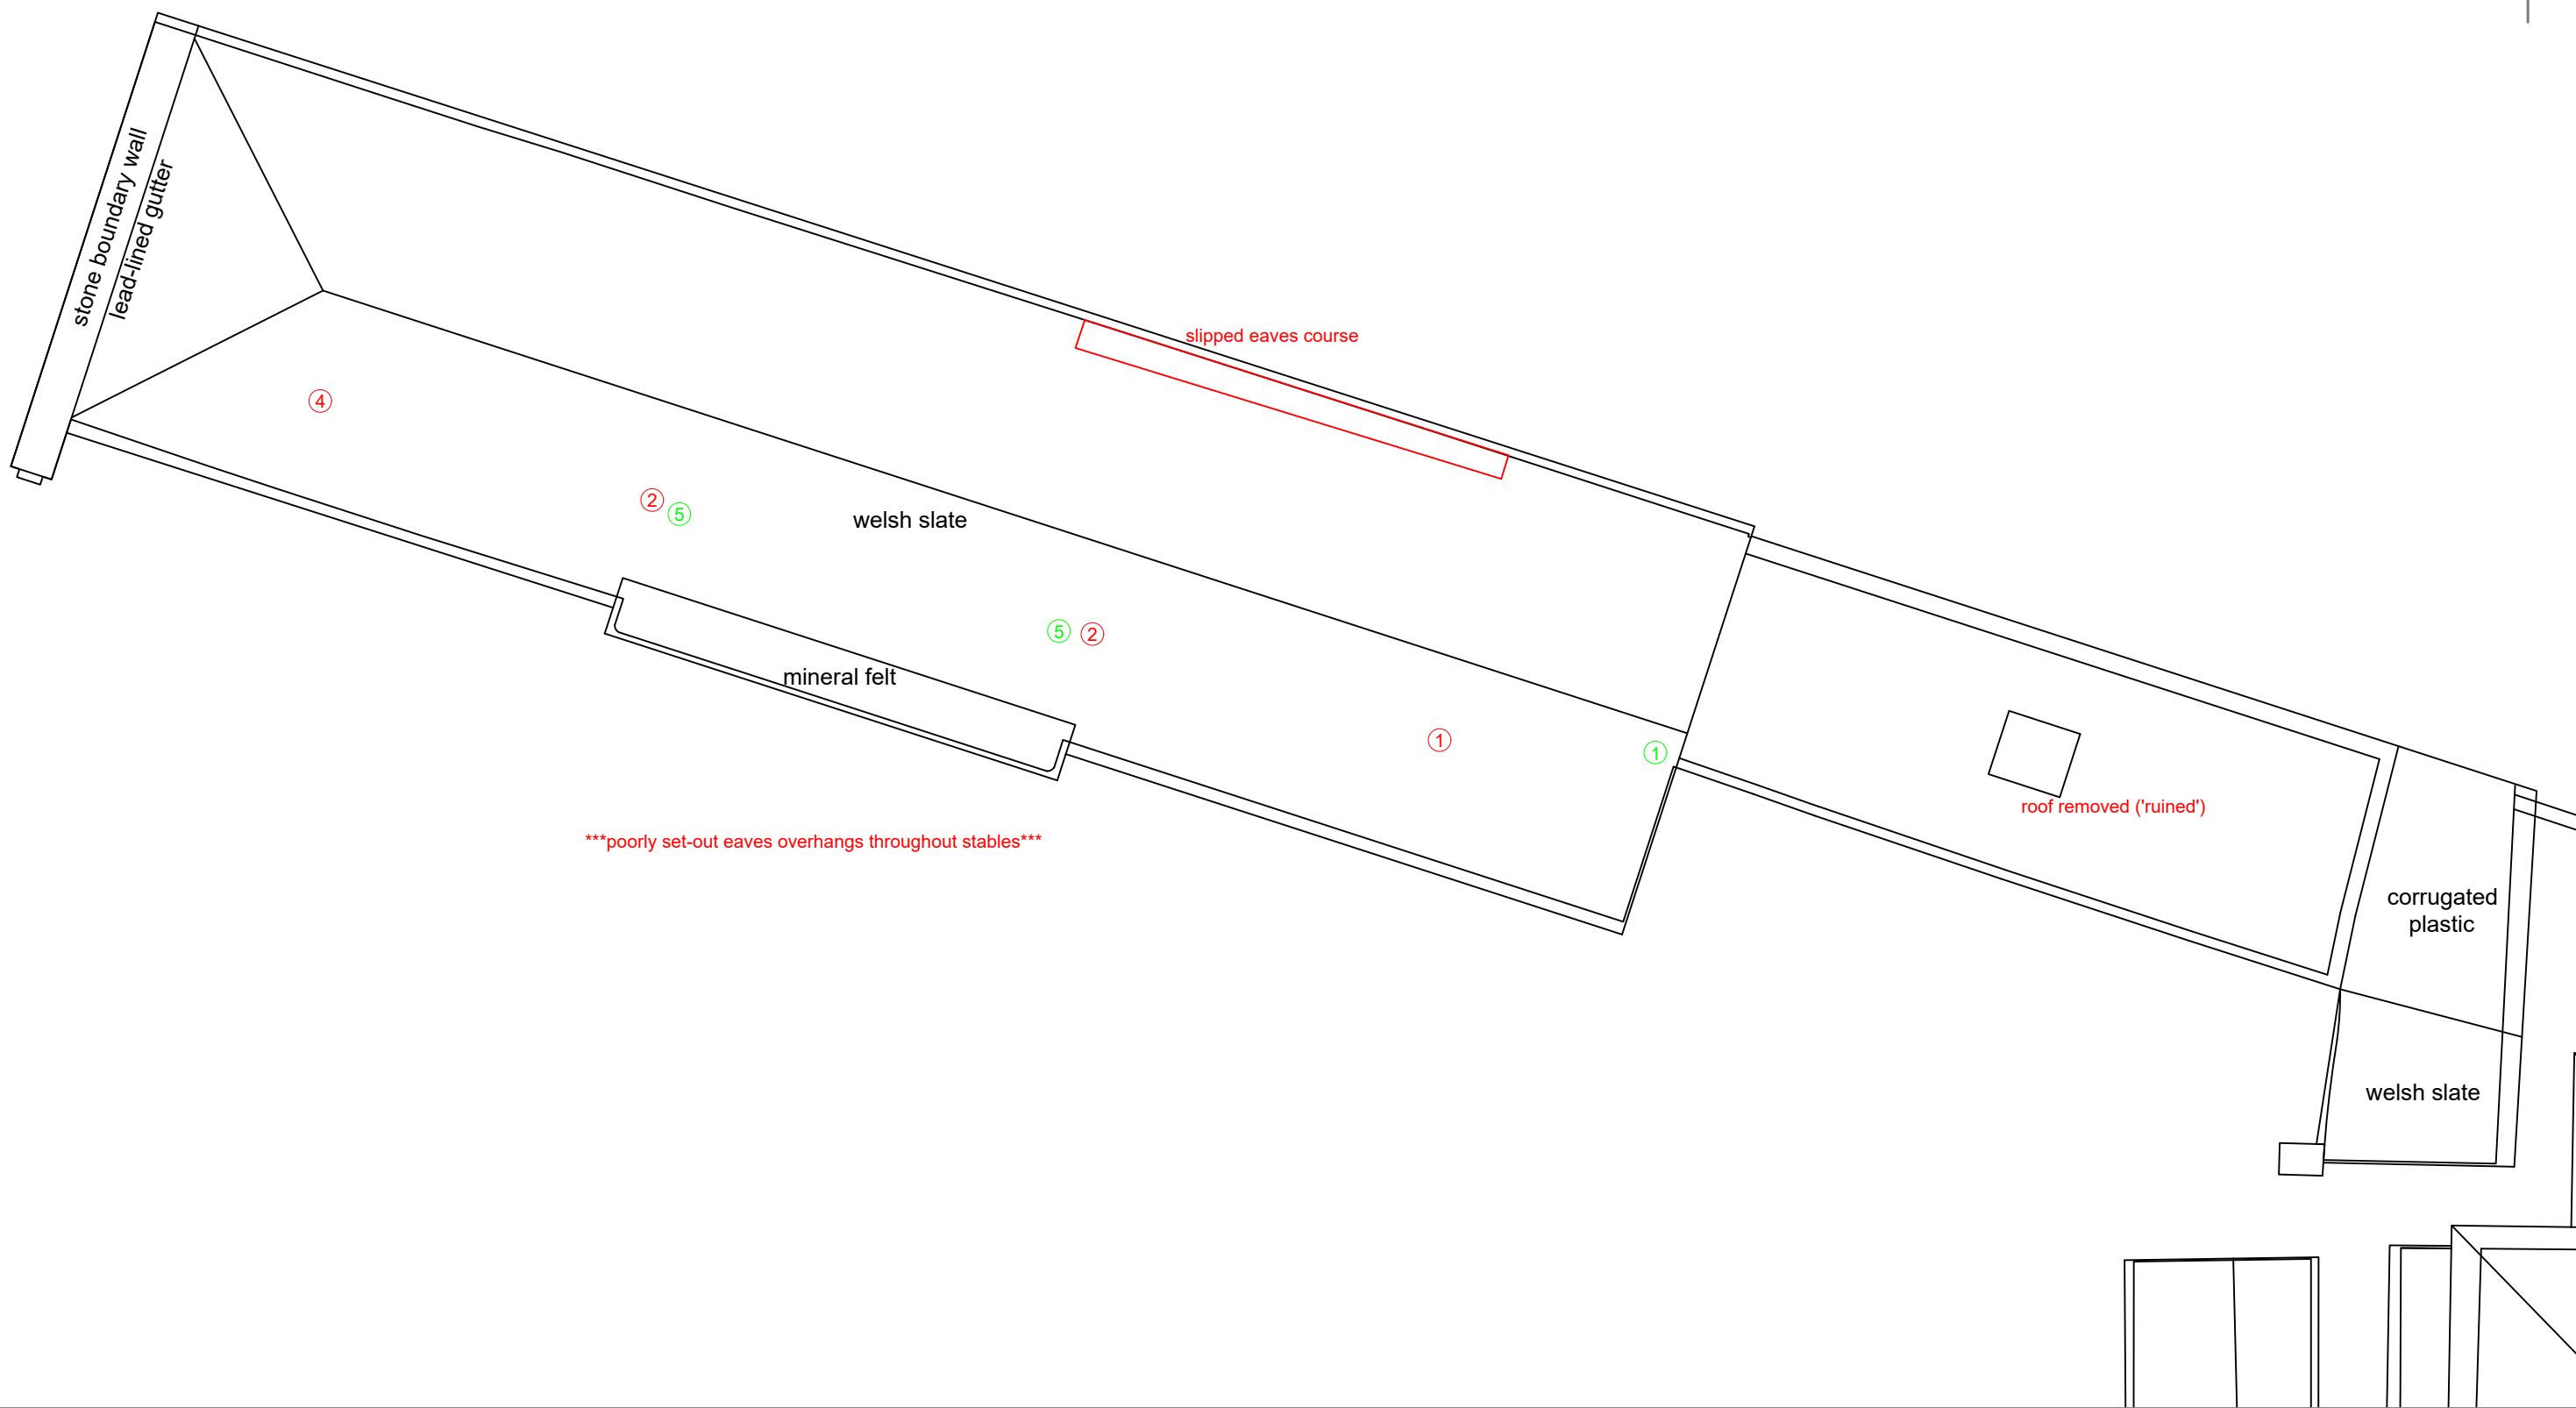
Grandpont House, Stables - Roof
Roof finishes investigation
December 2023 - January 2024

SN2.3.2	Stables Roof finish Condition	<p>At the south pitch, there were at least 9no. broken/slipped slates and 10no. patched slates. In the north pitch, a large proportion of the eaves course seems to be slipping out of position</p> <p>None of the eaves overhangs seemed to have been properly set-out (they often barely projected enough to shed water into the gutter). The roof did not appear to include adequate detailing for insulation or ventilation. The 1F felt underlay did not allow for moisture vapour diffusion</p>	<p><i>Total replacement of roof finishes using Penrhyn slate with lead dressing along with upgrading of build-up detailing is recommended (as per main roof)</i></p> <p><i>New and improved detailing for eaves overhangs will be required. This can be undertaken in conjunction with new detailing for insulation, ventilation and underlayment. For example, linear vent strips along a shadow gap above a new fascia board</i></p>

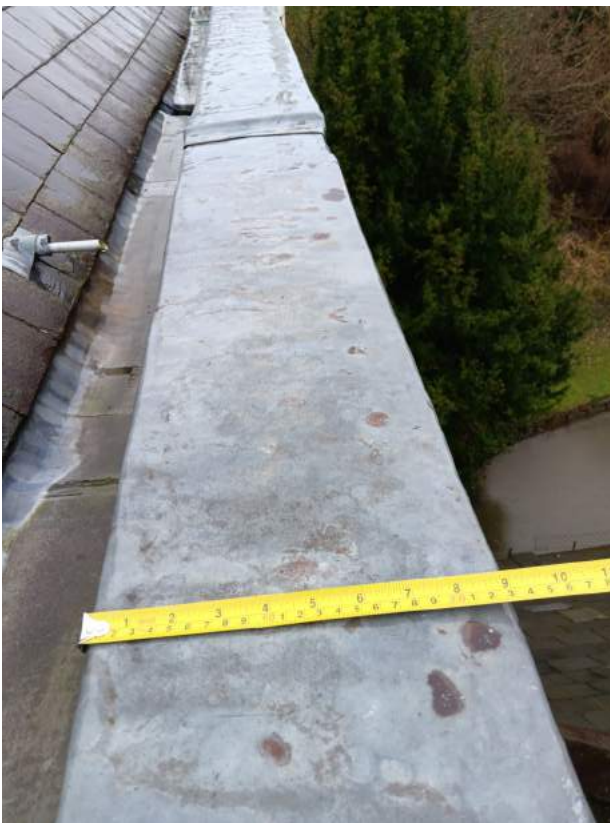
Fig 3:

Main roof; showing measurement of lead flashing upon parapet wallhead

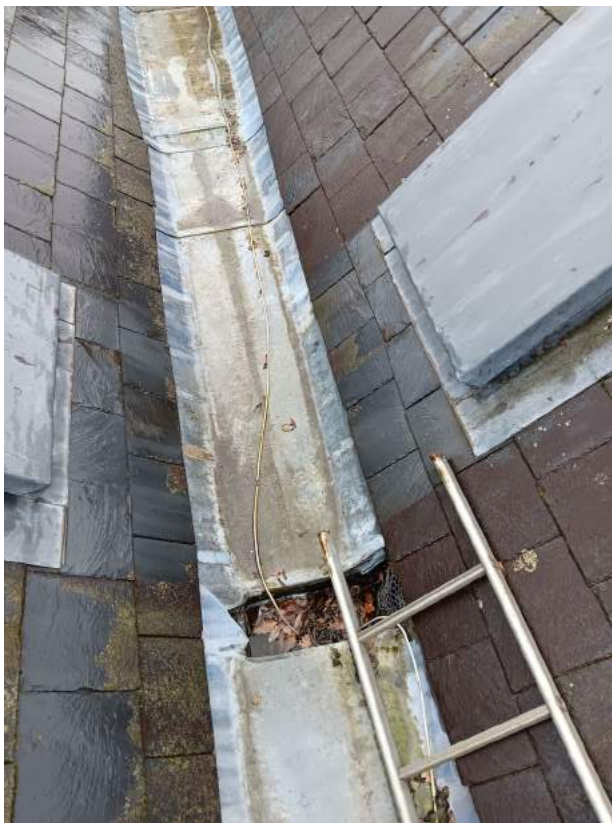
Fig 5:

Main roof; showing central valley and drainage catchpit leading to interiors

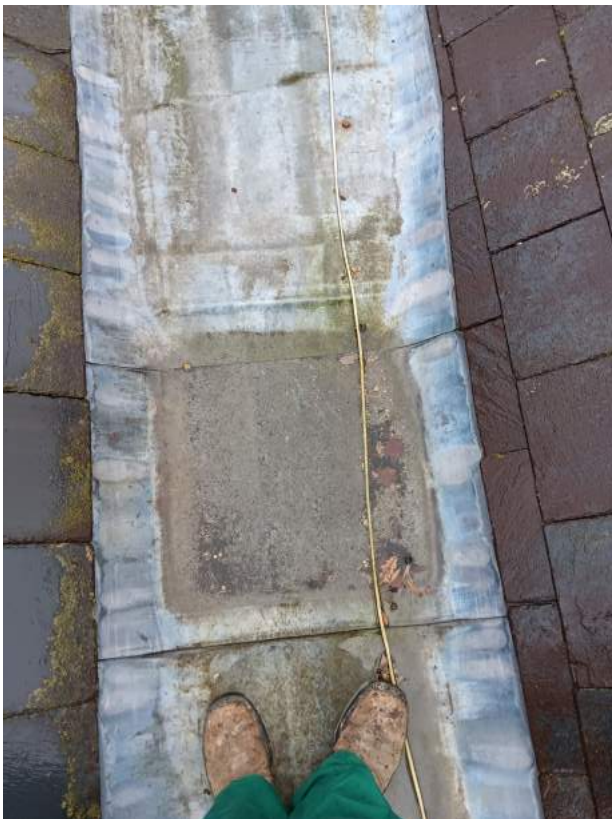
Fig 6:

Main roof; showing wetted joints in gutter lining

Note standing water due to lack of falls

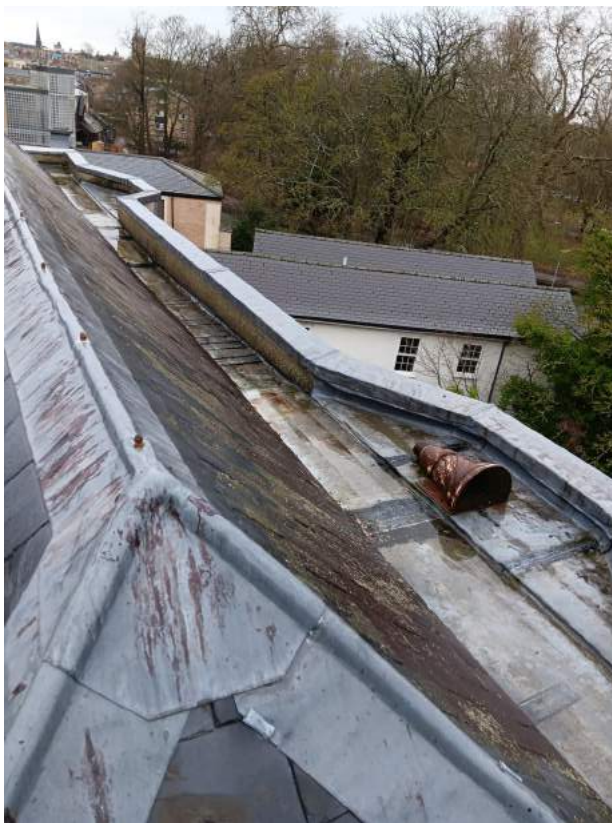
Fig 7:

Main roof; showing east pitch, east gutter and bay windows

Note previous patch repairs to damage in gutter/bay leadwork

Note purple staining at ridge which H+R commonly observe where atmospheric pollution levels have dropped

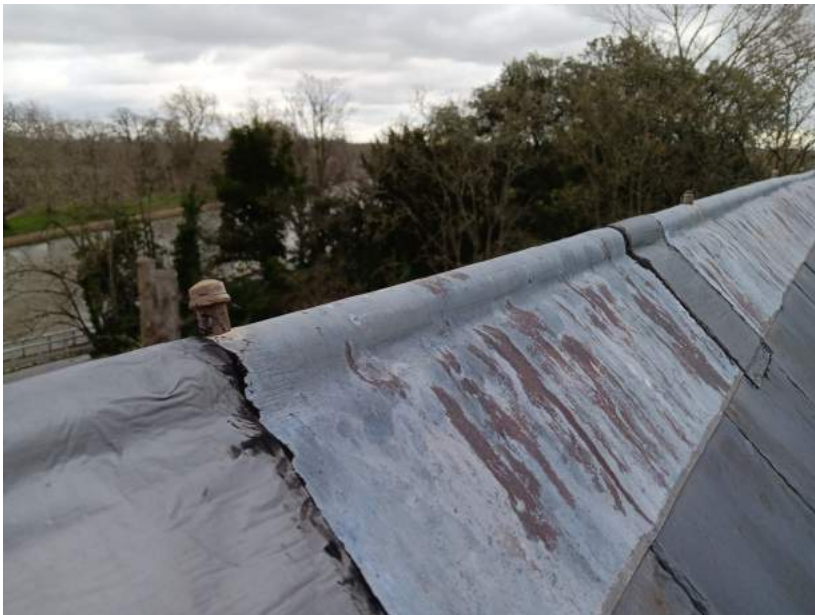
Fig 8:

Main roof; showing various repairs to ridge flashing

Note flashband patches and plastic screw fixings

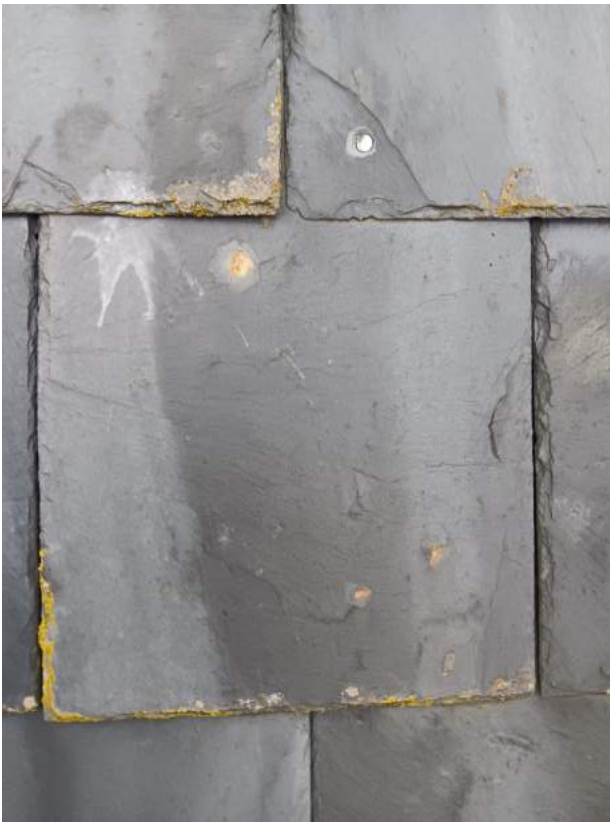
Fig 9:

Main roof; showing corroding pyrite inclusions within Spanish slate

Note slate repaired by nailing directly through (against good practice)

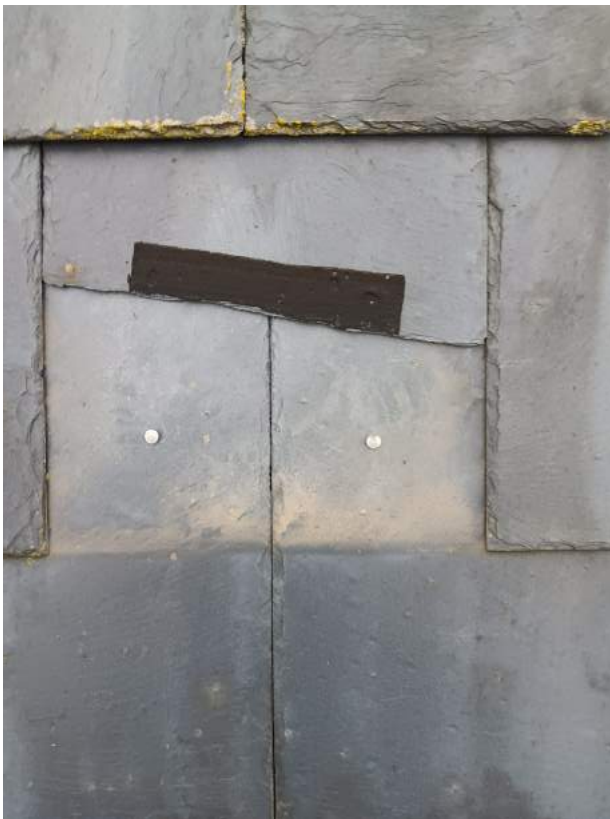
Fig 10:

Main roof; showing failed slate repair (cracked had been taped-together)

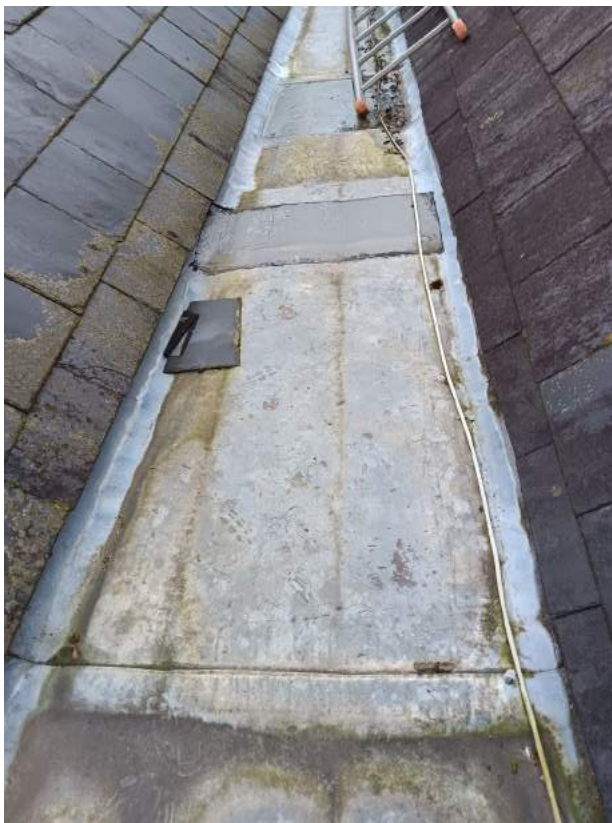
Fig 11:

Main roof; showing flashband patches to stress splits in parapet gutter

Note there are lacking movement joints due to wetting detail

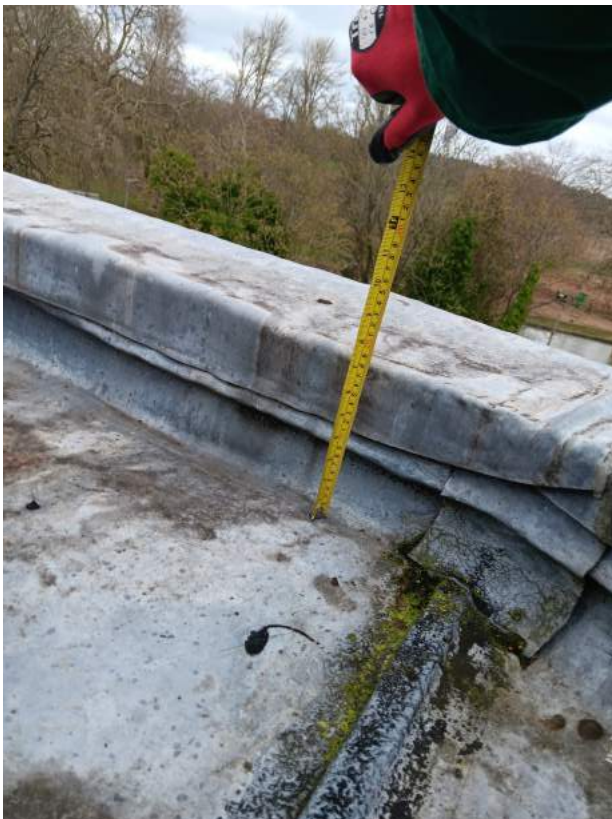
Fig 12:

Main roof; showing constrained parapet height which limited proper step detailing in gutter lining

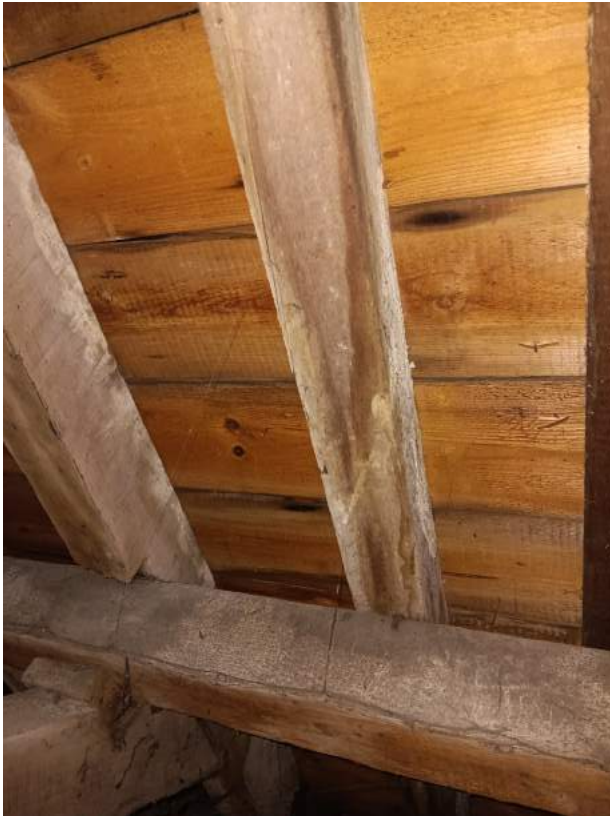
Fig 14:

Main roof, west side; showing sarking boards (which are not present in all pitches)

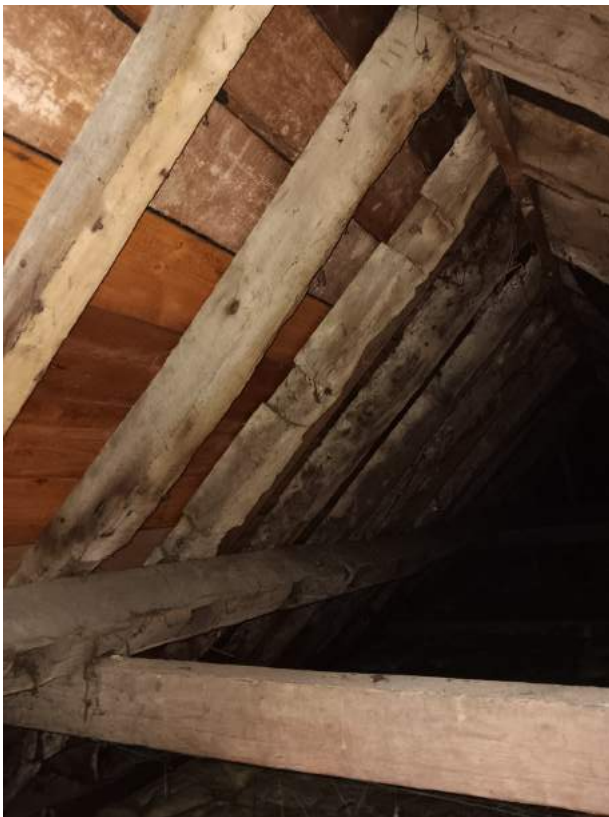
Fig 16:

Main roof, east side; showing sarking boards (which are not present in all pitches)

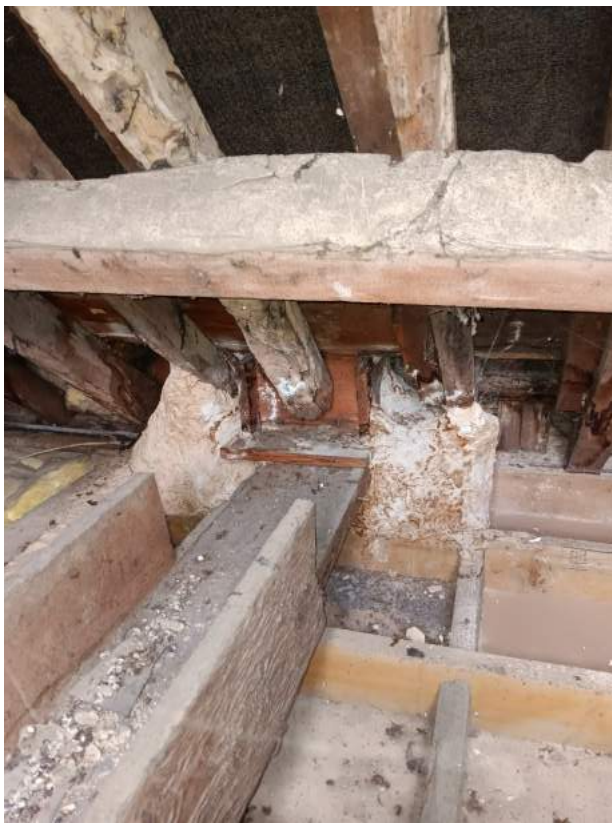
Fig 17:

Main roof, east side; showing internal drainage trough which has been decommissioned in the past

Note large bees nest present in this area

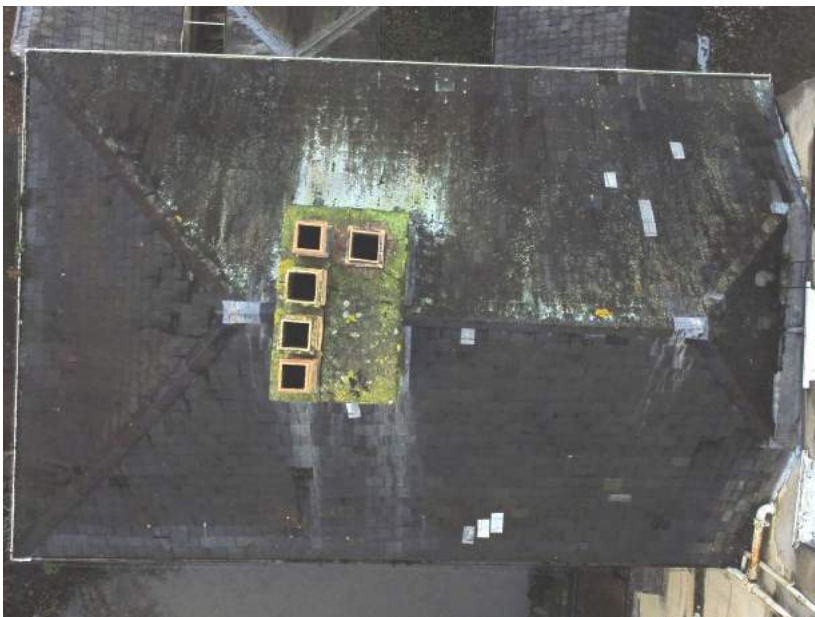
Fig 18:

West wing; showing general view

Note various patch repairs to slates using flashband

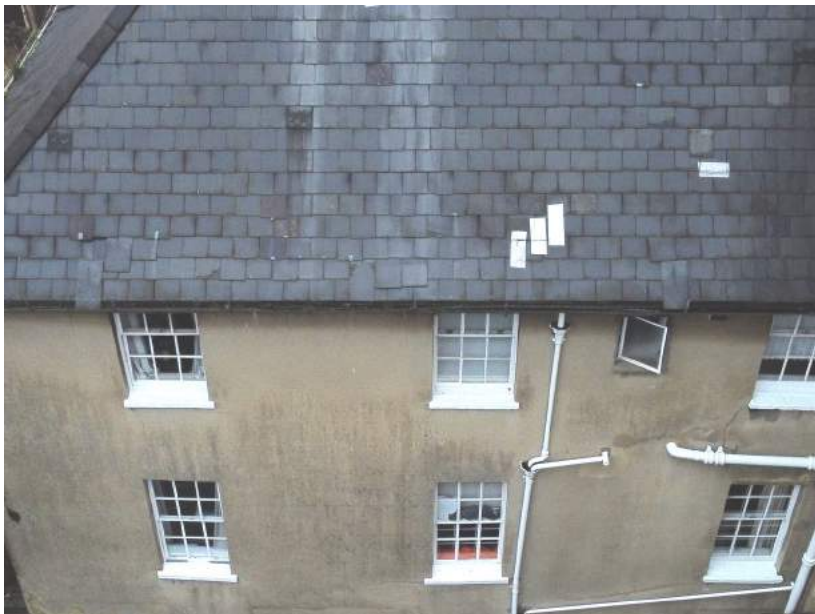
Fig 20:

West wing; showing south pitch

Note various slipped slates resting in gutter/snowguard above entrance walkway (risk of injury to persons by falling material!)

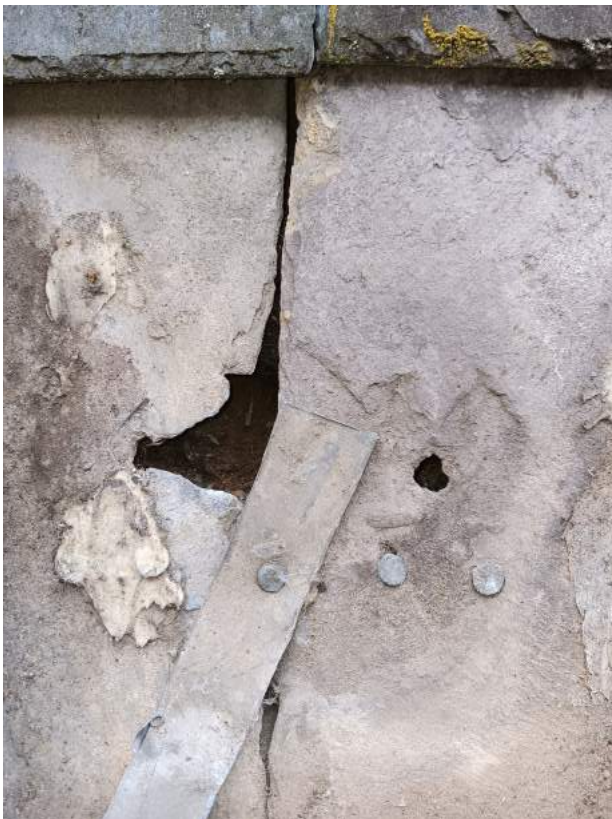
Fig 22:

West wing; showing sample exposure
of slate build-up

Note fibrous matting underlay

Note re-holed slates

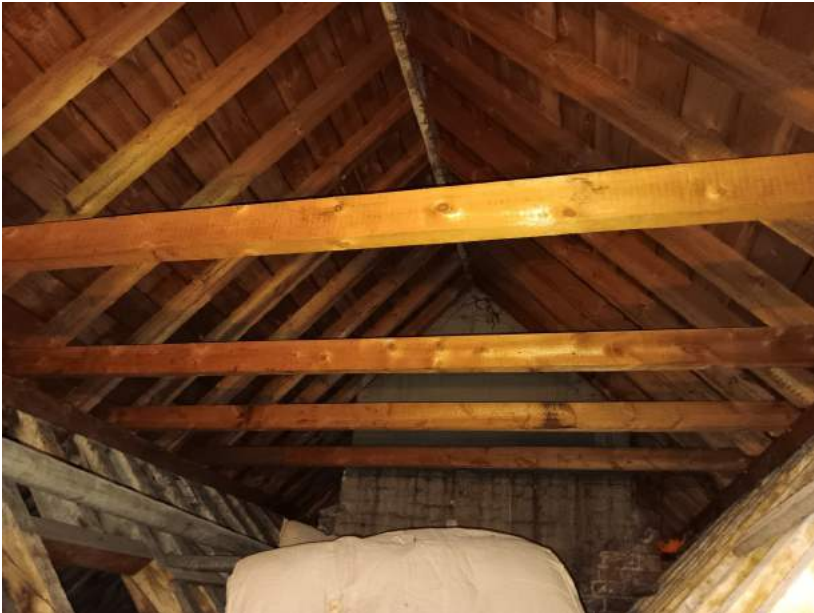
Fig 23:

West wing; showing alteration to internal structure (central valley infilled)

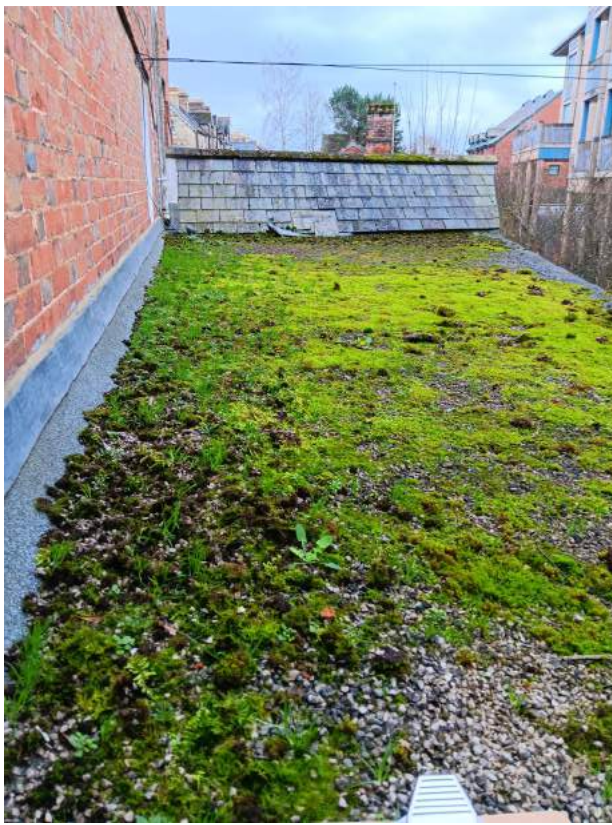
Fig 27:

Secondary roofs along north side;
showing mineral felt flat roof

Note gravel protection layer with
accumulation of moss/debris

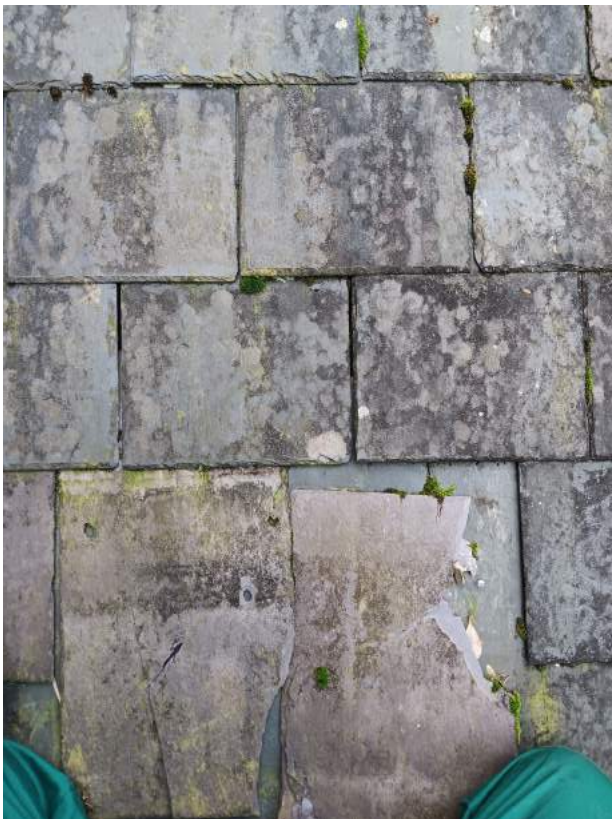
Fig 28:

Secondary roofs along north side;
showing grey slates with localised
breakage

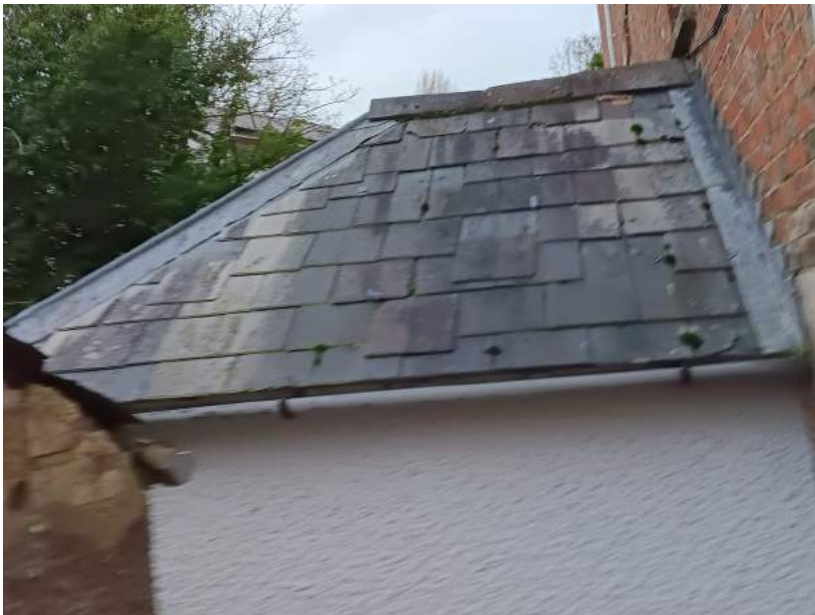
Fig 30:

Secondary roofs along north side;
showing damaged slating

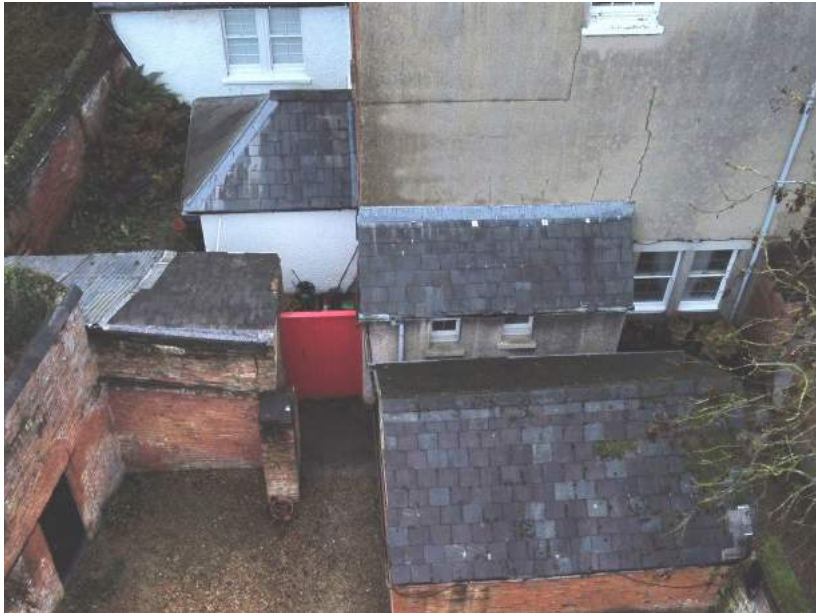
Fig 31:

Secondary roofs along west side;
showing various slipped and repaired
slates

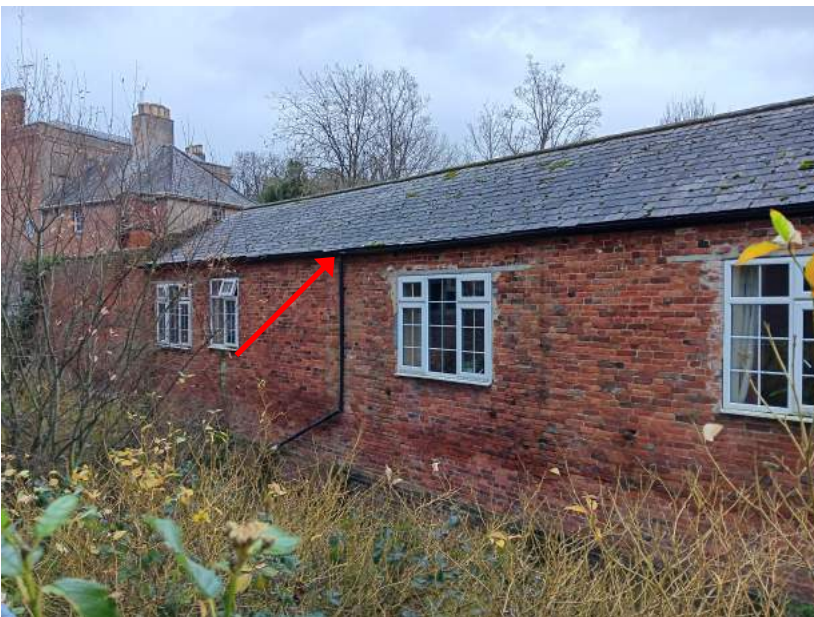
Fig 34:

North pitch; showing east end

Note large area of slipped eaves course

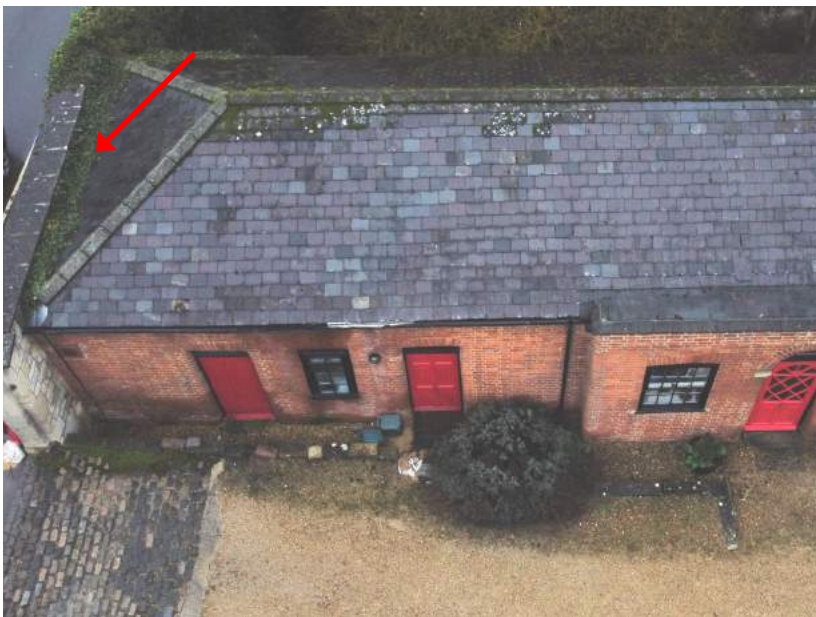
Fig 36:

South pitch; showing west end

Note back-gutter at boundary wall
abutment

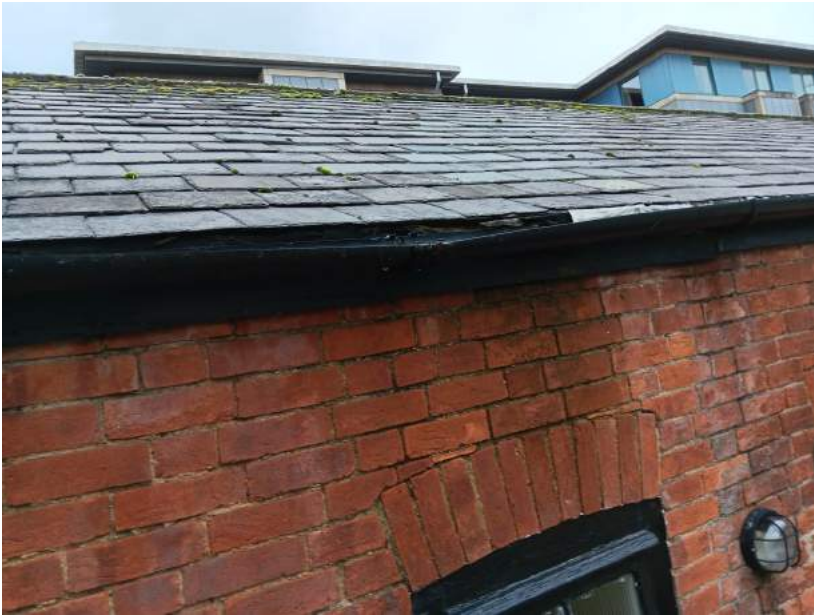
Fig 37:

South pitch; showing lacking eaves overhang projection (causing water to 'miss' the gutter)

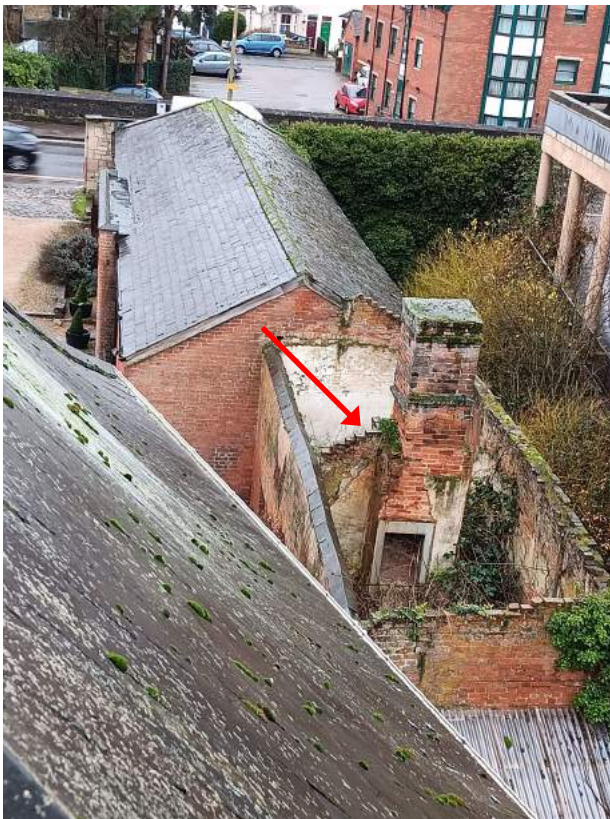
Fig 38:

The 'Cottage'; showing purposeful removal of roof carried out in the past
