Hutton + Rostron Environmental Investigations Limited

Grandpont House, Oxford: Façade investigation

Site note 4 for December 2023-January 2024, job no. 160-42

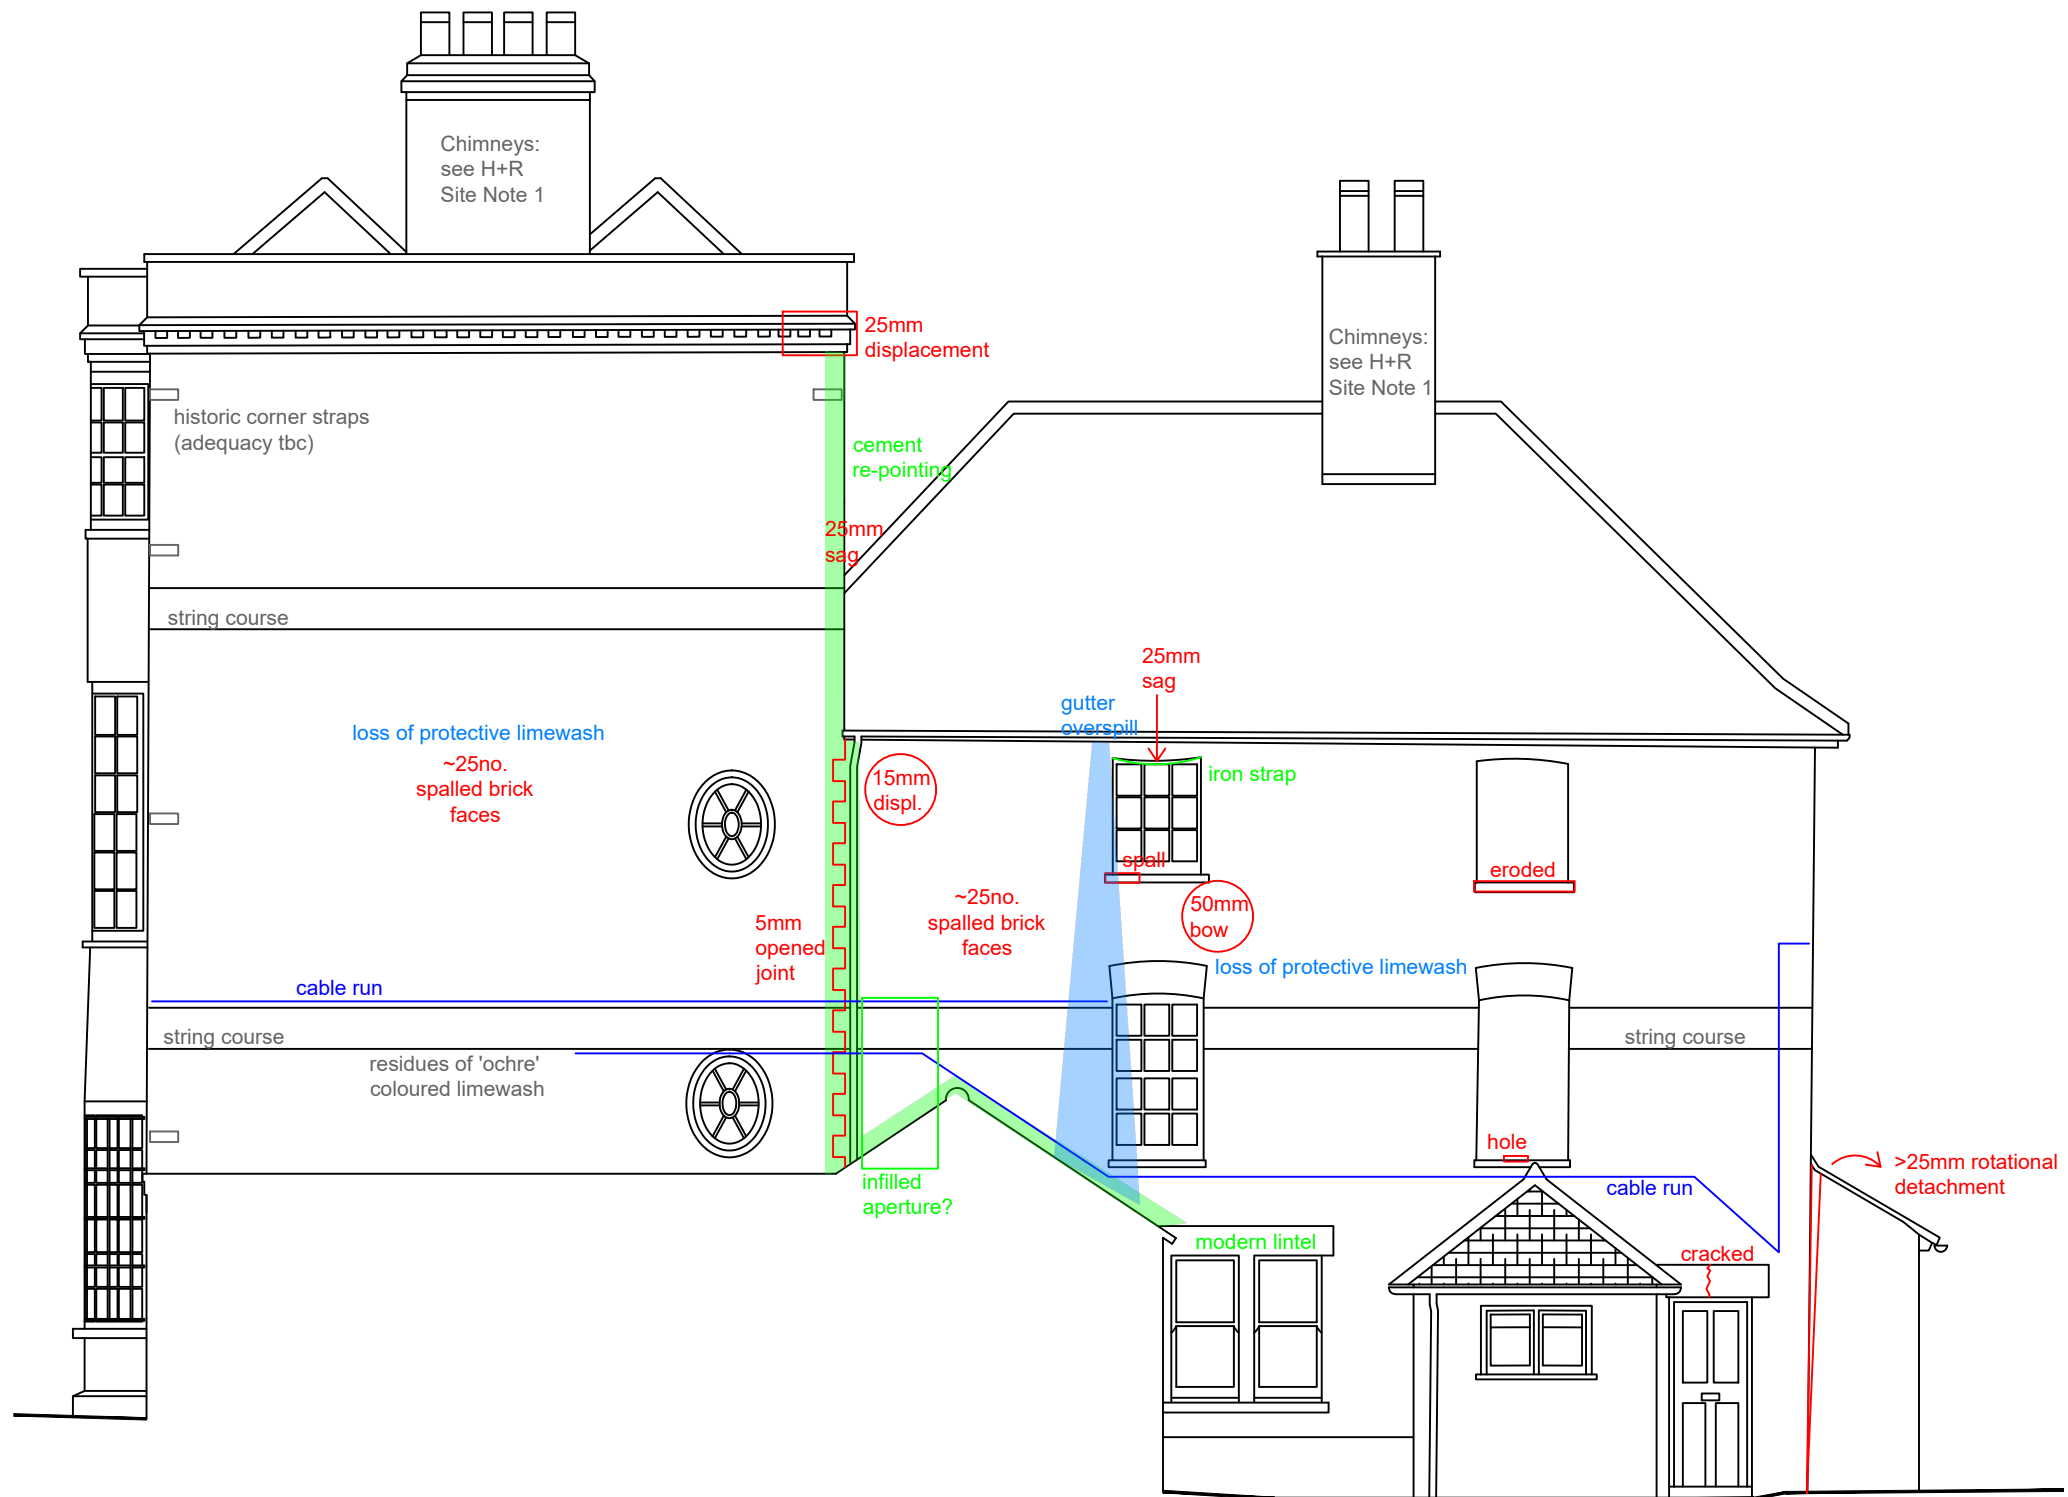
Grandpont House, Main House - North elevation
 Facade investigation
 December 2023 - January 2024

only the cornice and south end of the facade is finished in render (remainder has been clad in temporary plywood)

REFERENCE	ITEM	OBSERVATIONS	RECOMMENDATIONS	CLIENT COMMENTS
SN4.1 MAIN HOUSE FACADES (non-original georgian phase)				
SN4.1.1	Main house North elevation	<p>Soft red clay bricks laid in lime putty mortar. Projecting brick cornice at wallhead and string courses at each (2no.) intermediate floor level serve to encourage surface water to shed off the wall</p> <p>The north elevation of the main house incorporated a four-flue chimney, as described at the south elevation. However, there was significant variation in overall wall thickness from 250-750mm thick. This suggested that parts of this elevation may have incorporated older fabric (from the pre-existing west wing). This was difficult to fully understand because externally there was a vertical crack/construction joint which seemed to divide the main house from the west wing</p> <p>The brickwork showed limited residues of limewash, apparently a yellow/ochre colour which was built-up in many coatings during the early centuries of the building's life but has been left to weather-away in the last century</p> <p>There were ~25no. superficially spalled brick faces which had developed since upkeep of the protective limewash coating lapsed</p> <p>There were a number of fairly small fixings into the brickwork for cable-runs; these were visually poor</p> <p>There has been localised re-pointing using cement which corresponded with areas of previous cracking/erosion around the first-floor oculus window and the vertical construction joint to the west wing. Cracking and in-plane-displacement between 15-25mm has been a recurrent issue at the vertical joint</p> <p>A relatively modern (1930s?) flat roof single story extension has been added along the riverside frontage, albeit with evidence of incorporating various elements of slightly older fabric. This was measured locally as 220mm solid brickwork (single brick thickness) in Flemish bond with concrete lintels and tiled sills externally</p>	<p><i>Allow to renew lead flashing to cornice ledge</i></p> <p><i>Structural Engineer to review. For example, it may or may not be desirable to restrain the vertical cracking by helibars</i></p> <p><i>H+R recommend that the wall is lightly cleaned/brushed-off in preparation for restoring a limewash finish. Given that so little remains of the coating, it was expected that a significant number of coats may need to be applied (say 4-8no. at the discretion of the heritage mason engaged to carry out the building restoration)</i></p> <p><i>Subject to reinstatement of limewash, H+R did not believe it necessary to replace spalled brick faces</i></p> <p><i>In preparation of limewashing, all surface-mounted services should be removed along with any fixings (small holes to be patched/filled in lime putty mortar). On refurbishment, service runs should be rationalised and ideally run internally</i></p> <p><i>Structural Engineer to review. As a minimum, and as mentioned above, allowances should be made for localised patching/filling defects using lime putty mortar prior to limewashing</i></p> <p><i>This structure seemed relatively insubstantial compared to the main house. It may be in particular need of additional insulation internally. Externally, H+R would recommend localised lime putty mortar repairs and a limewash finish in common with the rest of the north elevation</i></p>

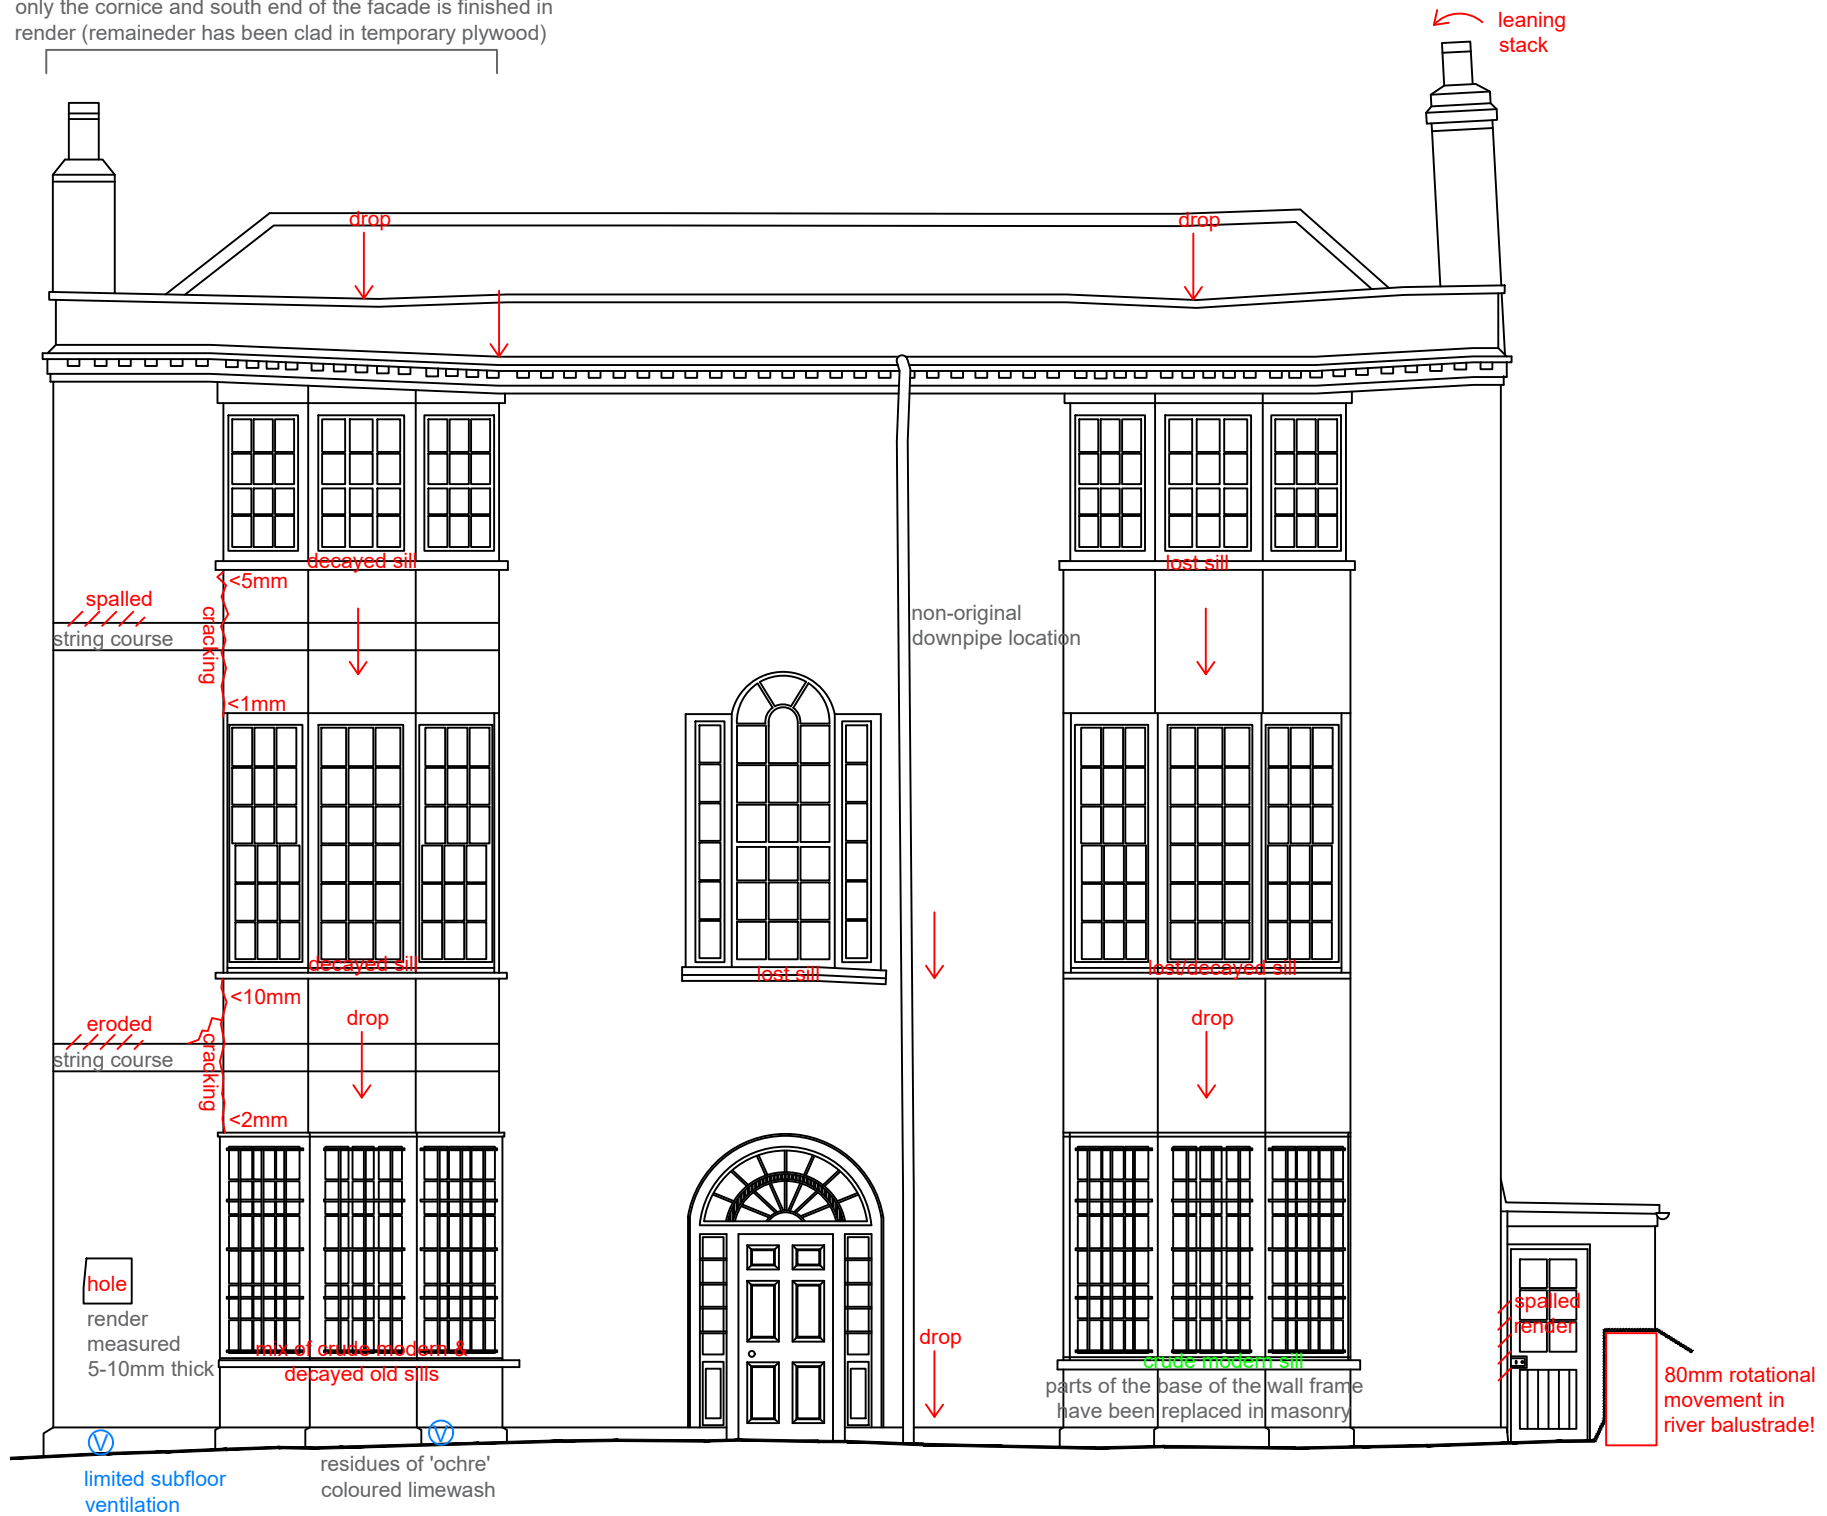
Grandpont House, Main House - East elevation
Facade investigation
December 2023 - January 2024

... river Isis runs below ...
condition of stone bridge unknown!

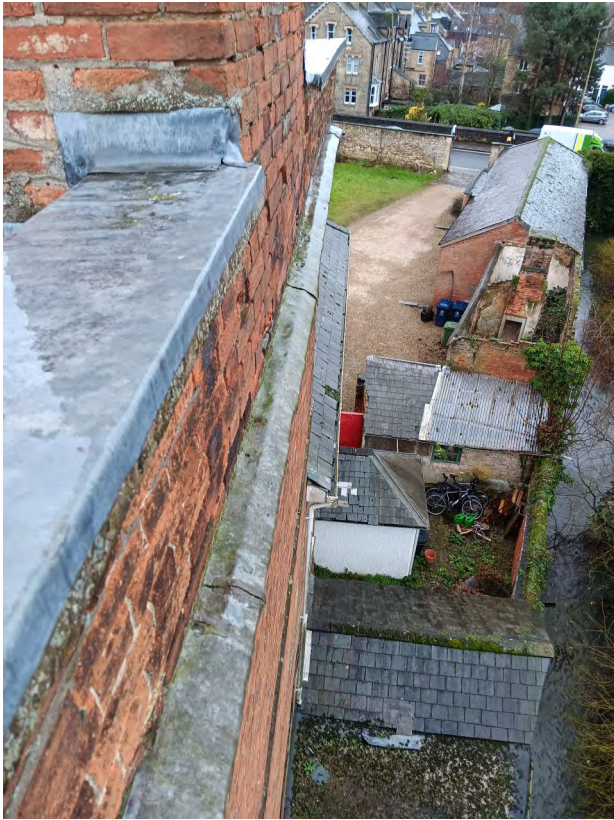
Fig 1/3:

Showing degraded lead flashing on cornice ledge

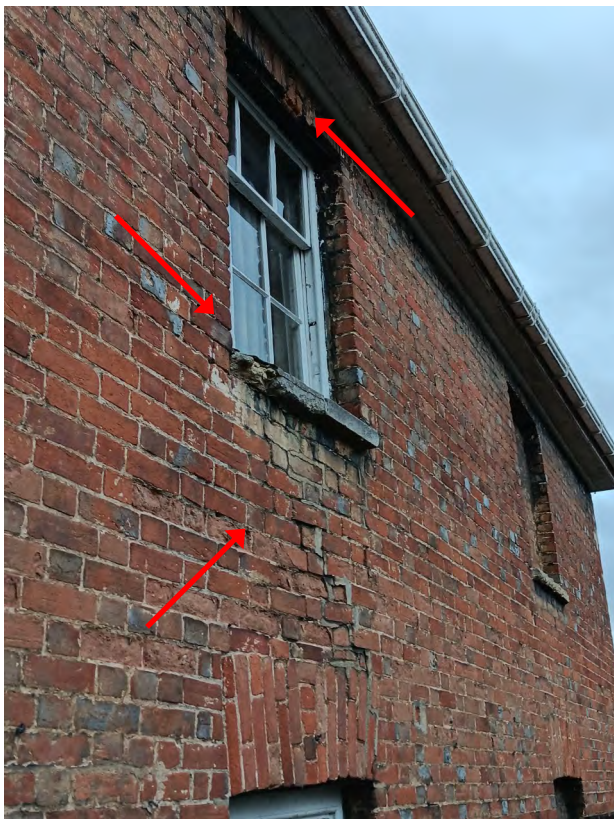
Fig 1/4:

Showing cracking and distortion around second floor window

Also note damaged sill

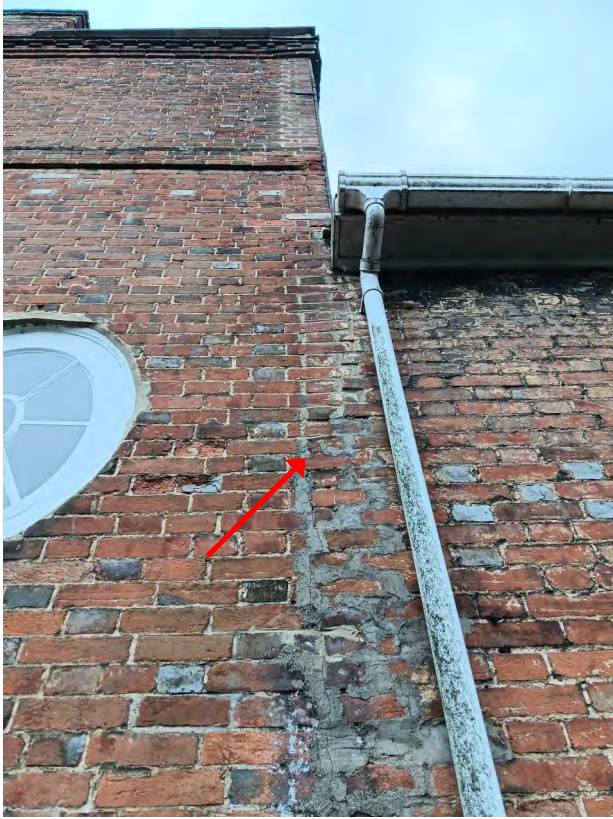
Fig 1/5:

Showing recurrent cracking at joint between main house and west wing (despite previous re-pointing)

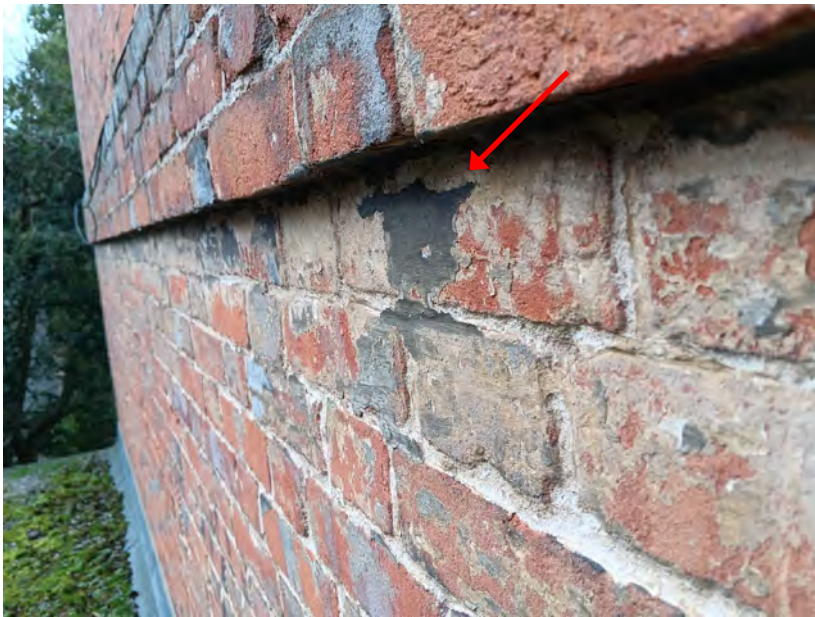
Fig 1/6:

Showing limited residues of 'ochre' limewash in the shelter of the lower string course

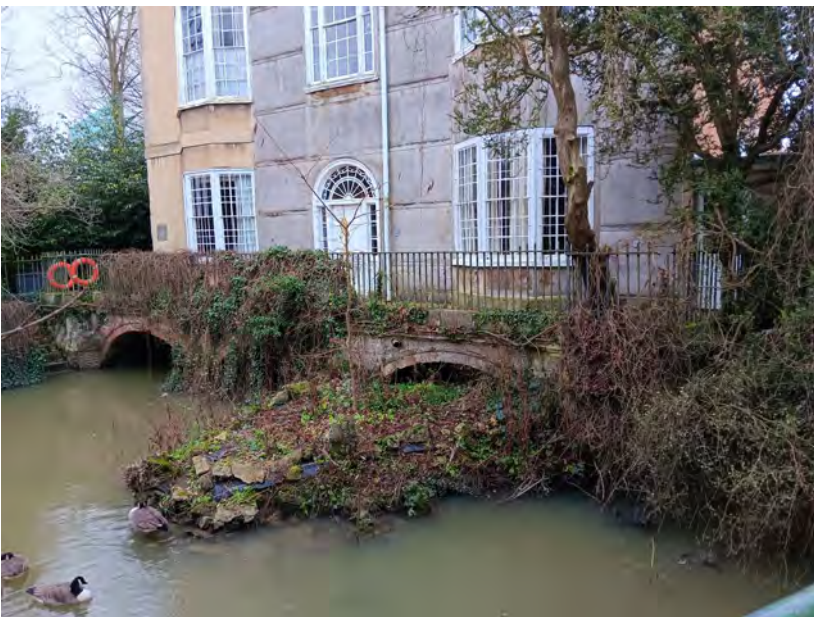
Fig 1/8:

Showing low level view of the stone bridge which serves as the foundation

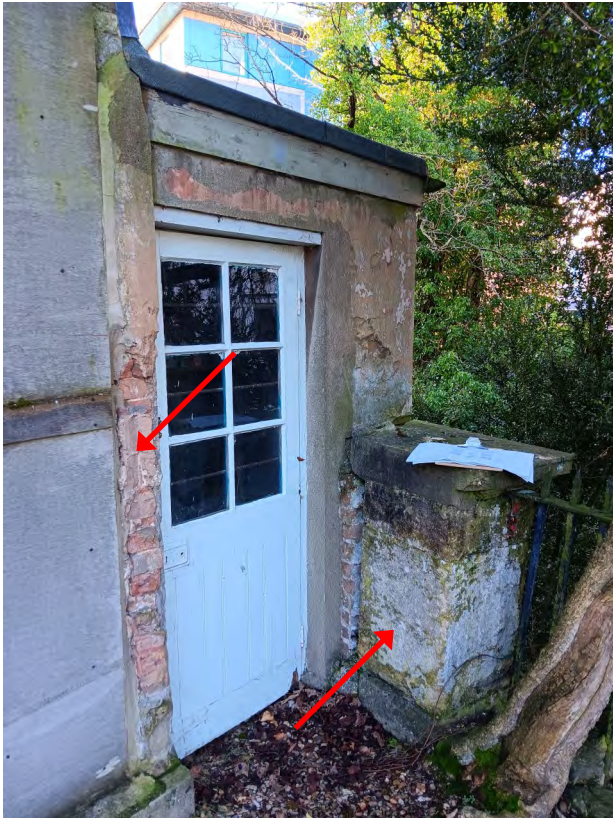
Fig 1/9:

Showing storage shed attached to north side

Note damaged render and distorted stone balustrade pier

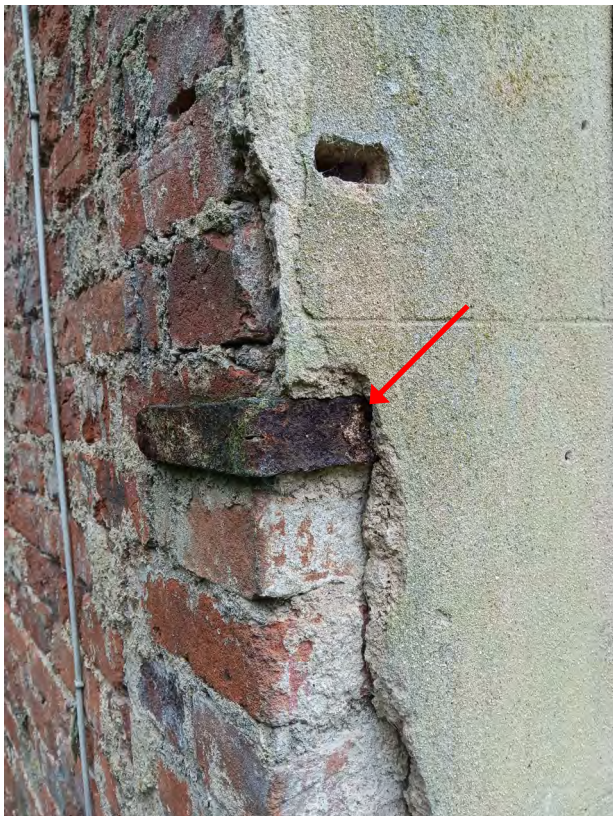
Fig 1/10:

Showing example of metal bracket corner connection between brick and timber frame walls

Also note decorative lined-out effect of render to imitate ashlar stone

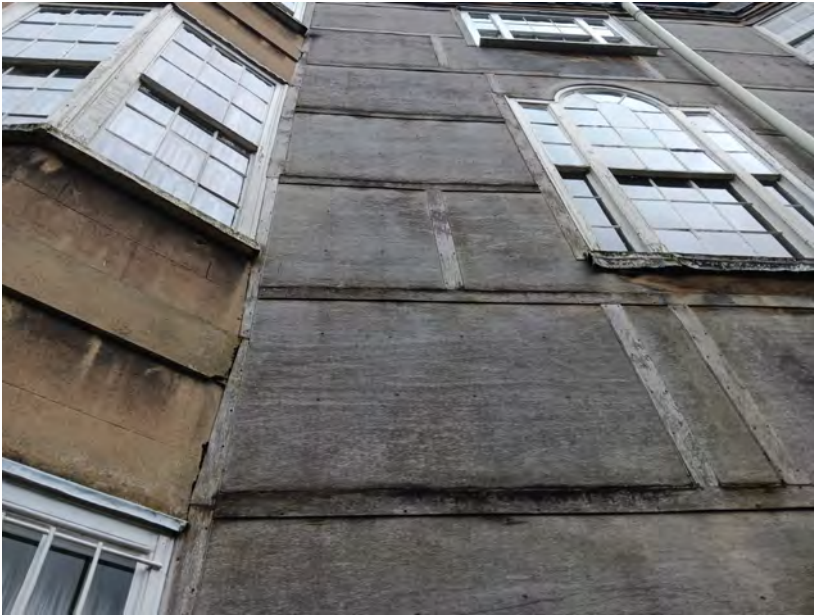
Fig 1/11:

Showing interface between render finish (south) and temporary ply cladding (north)

Also note many of the window sub-sills were missing, decayed or crudely replaced (albeit disguised below lead flashings)

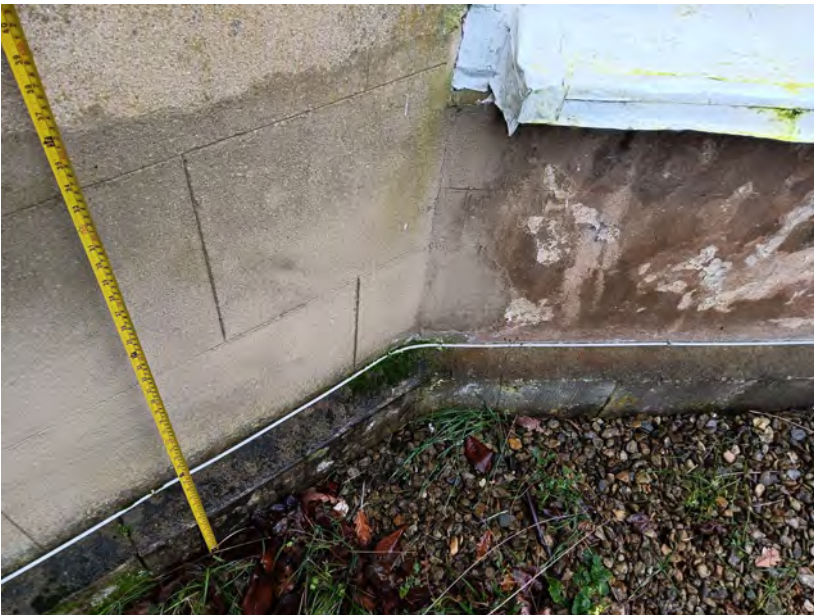
Fig 1/12:

Showing stone plinth with evidence of multiple previous works to replace lower part of framework wall with masonry infill

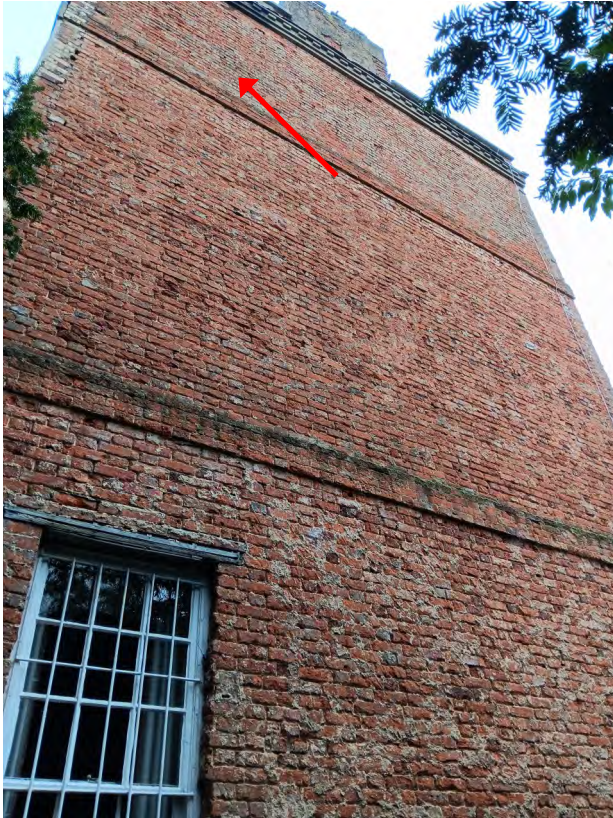
Fig 1/15:

Showing low level view; render has been stripped some time ago with no replacement provided

Note previous repairs to west corner where there has been recurrent cracking

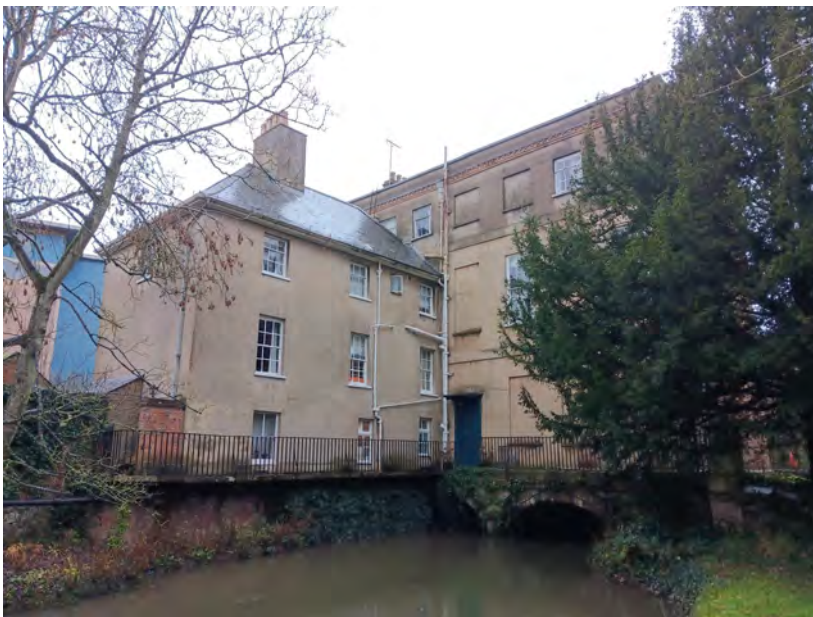
Fig 16:

Note riverbank and bridge supporting base of property (condition TBC)

Note stone 'balcony' serving as entrance to property (set significantly above internal floor level of the west wing which tended to bridge moisture to the interiors)

The waterway would make scaffold installation more complex

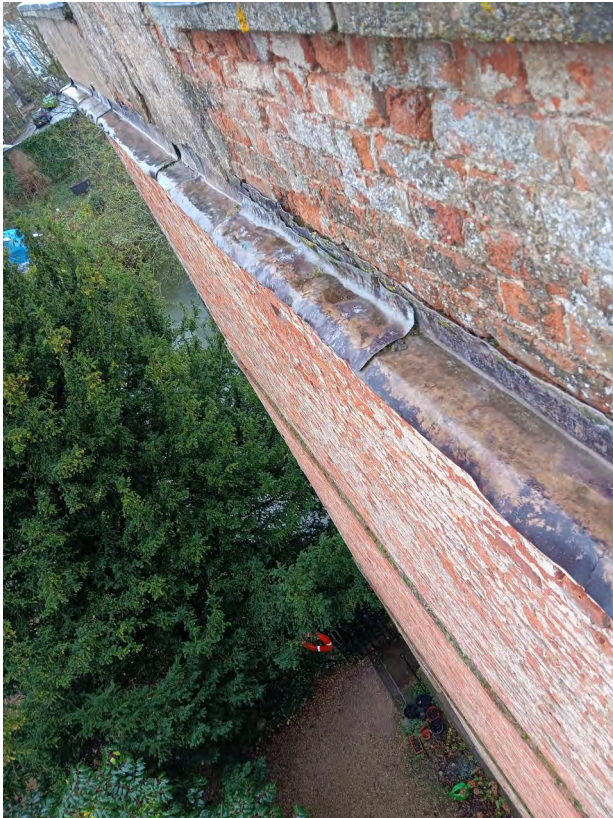
Fig 1/17:

Showing poor condition of cornice flashing

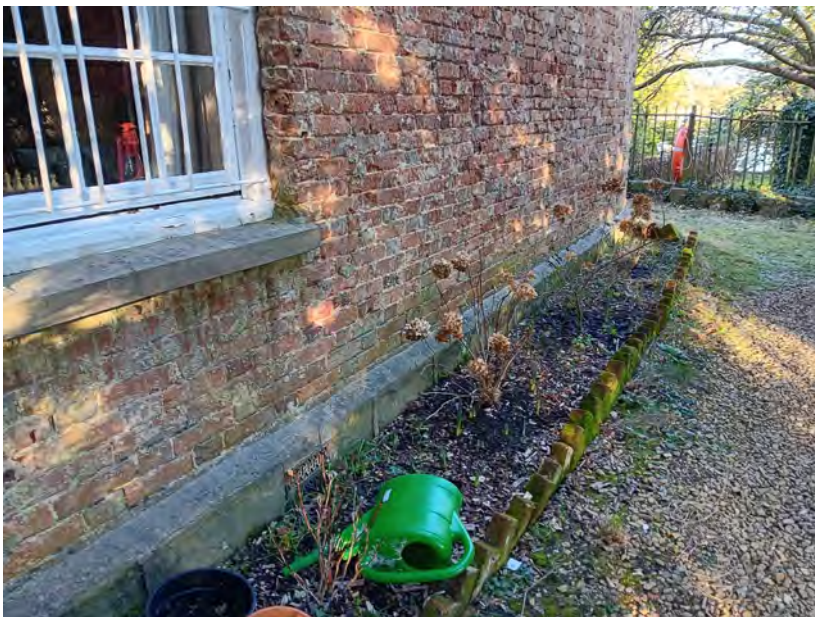
Fig 1/18:

Showing earth heaped-up against the plinth

Also note cracked render sill and rough state of brickwork (following render removal)

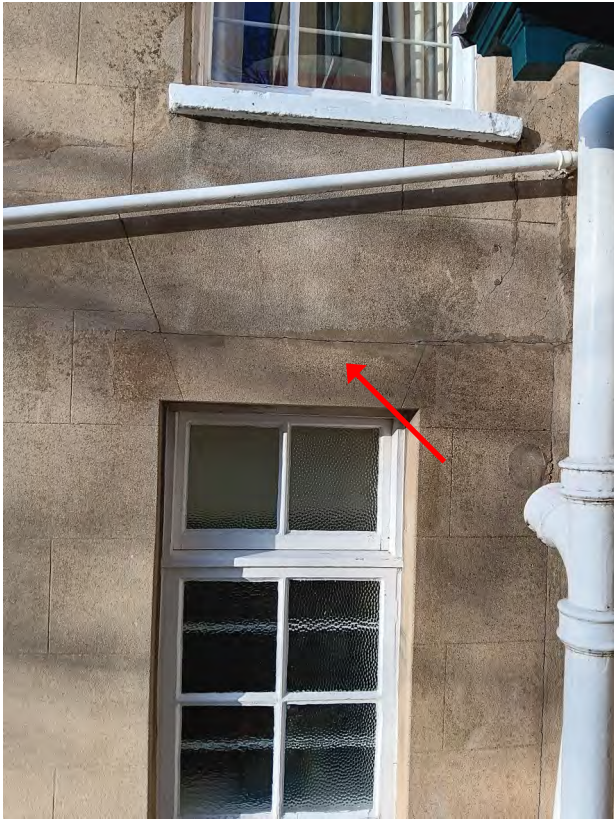
Fig 1/19:

Showing history of cracking and render patchwork

Also note crude service runs (pipework)

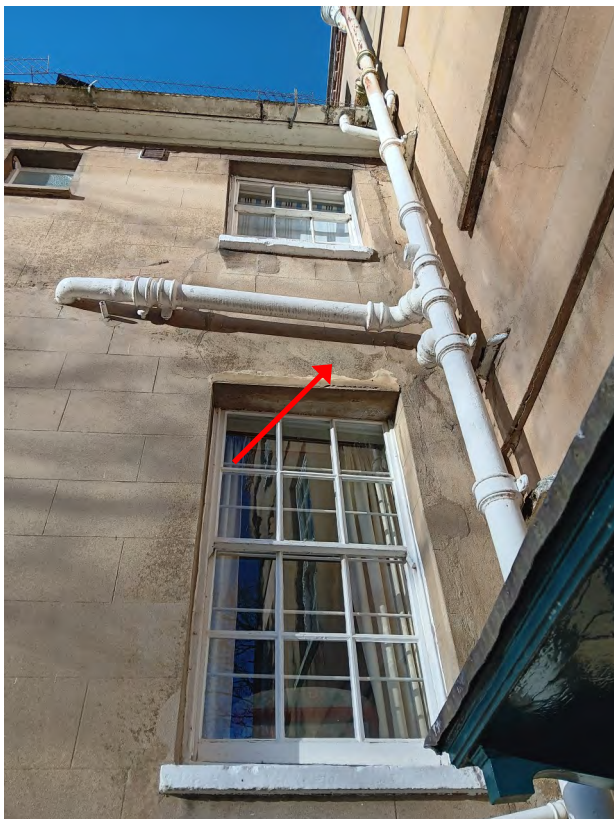
Fig 1/20:

Showing history of cracking and render patchwork

Also note crude service runs (pipework)

The window apertures shown had both distorted by dropping at the east side

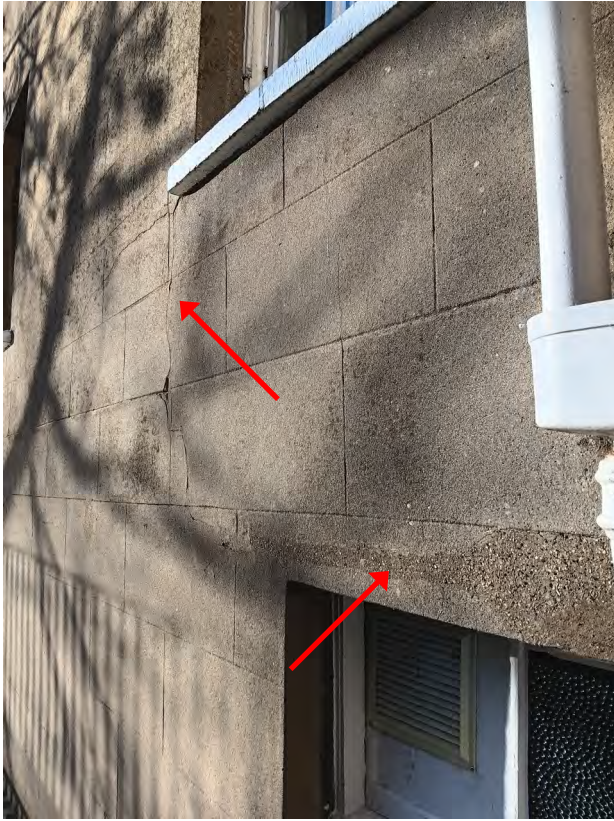
Fig 1/21:

Showing history of cracking and render patchwork

Also note crude service runs (pipework)

The wall had also bowed outwards at the lhs of the image

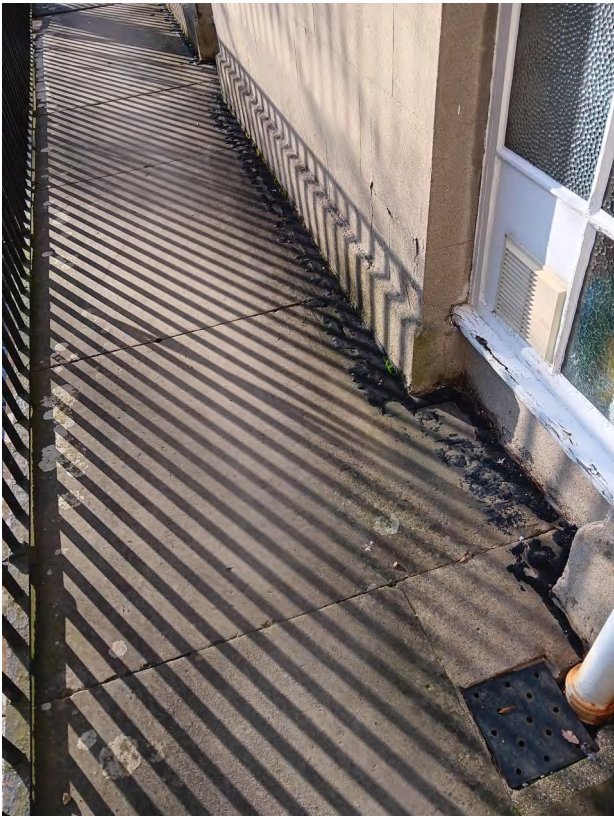
Fig 1/22:

Showing stone paving bridging surface water to the interior

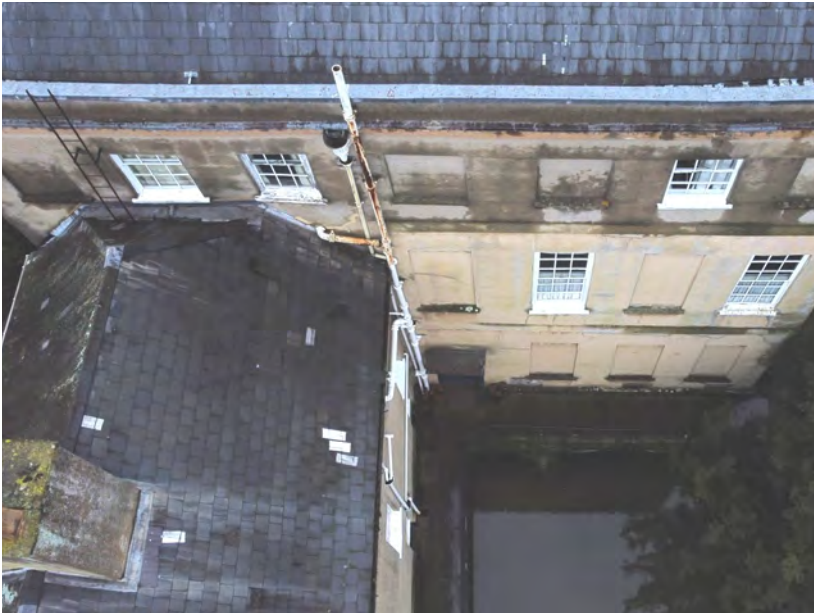
Fig 1/23:

Showing high level view

Note obvious dampness at upper storey due to weathering exposure and use of cement render (which tends to entrap moisture)

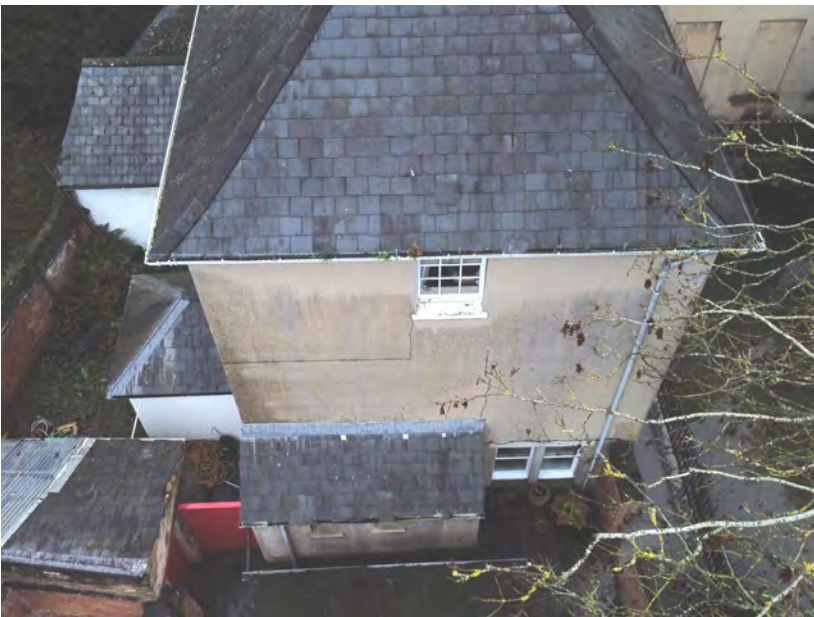
Fig 1/24:

Showing high level view

Note single storey elevation (which has cracked and dropped away from the elevation due to foundation issues)

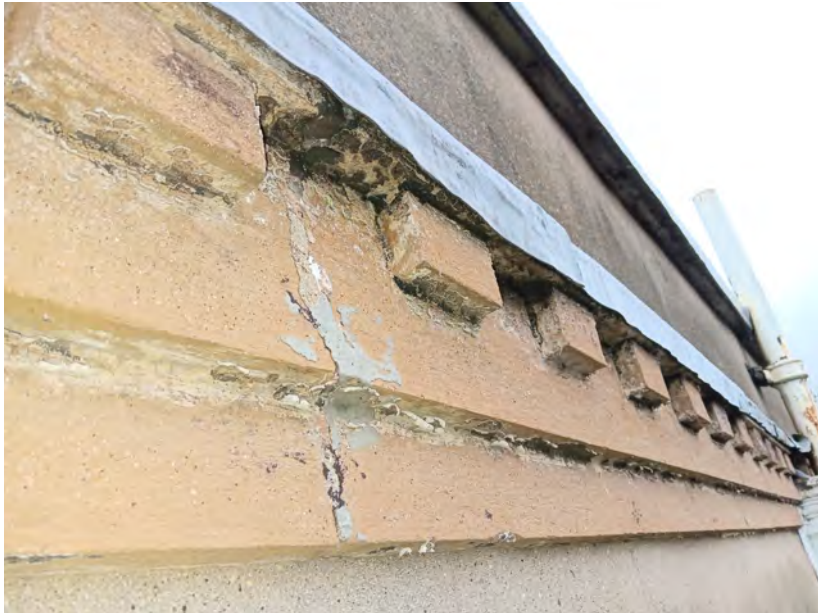
Fig 21/5:

Showing historic cornice with ochre limewash finish and lead flashing

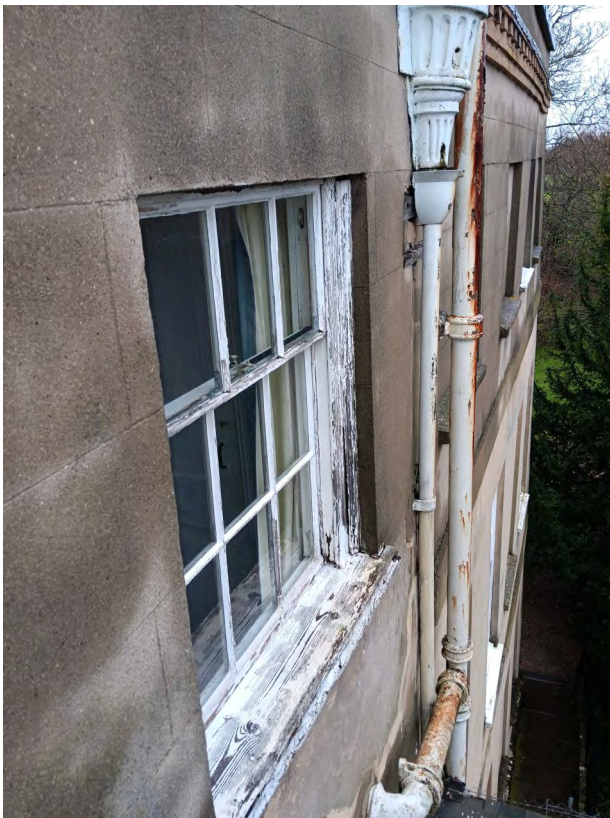
Fig 1/26:

Showing second floor render replaced in cement

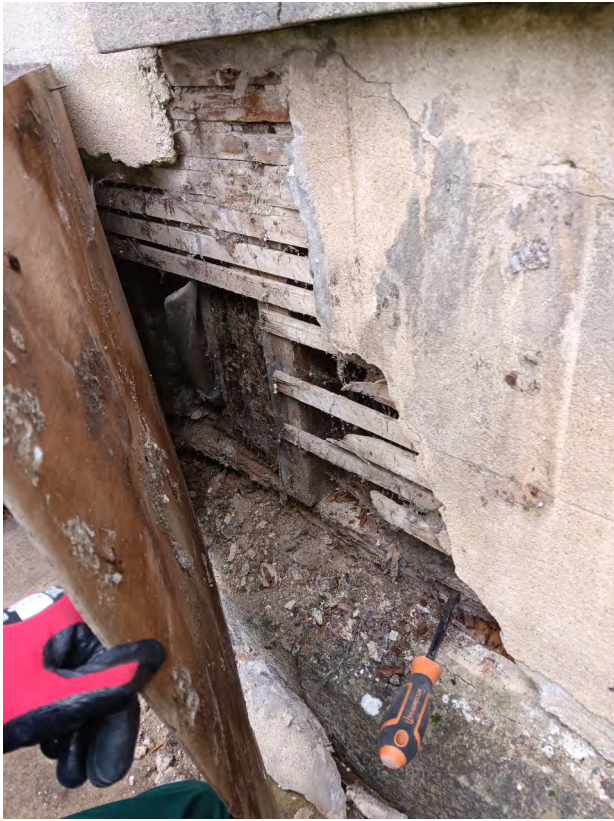
Fig 1/27:

Showing pre-existing exposure of render to reveal frame

The sole plate was clearly decayed at likely to crush (allowing wall to drop)

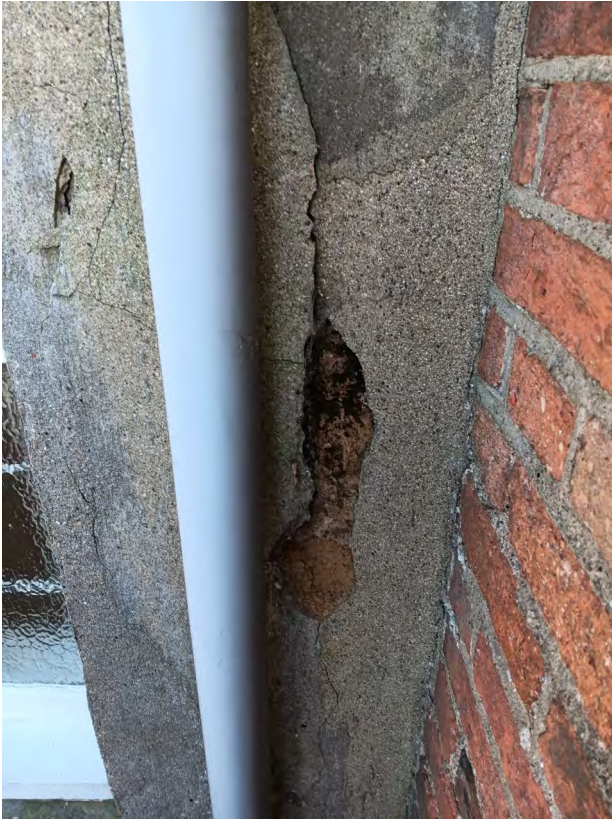
Fig 1/29:

Showing spalled render adjacent to defective roof drain

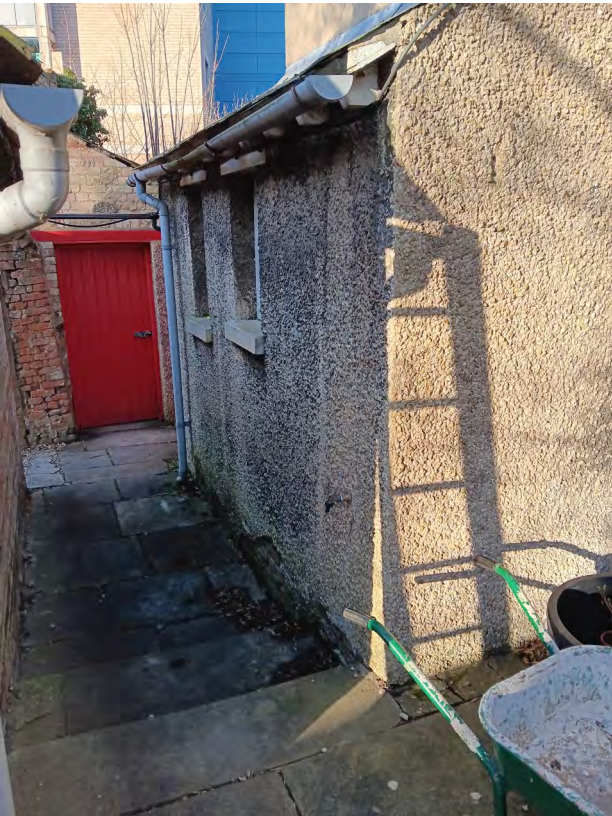
Fig 1/30:

Showing lean-to extension with render failure at landscape junction

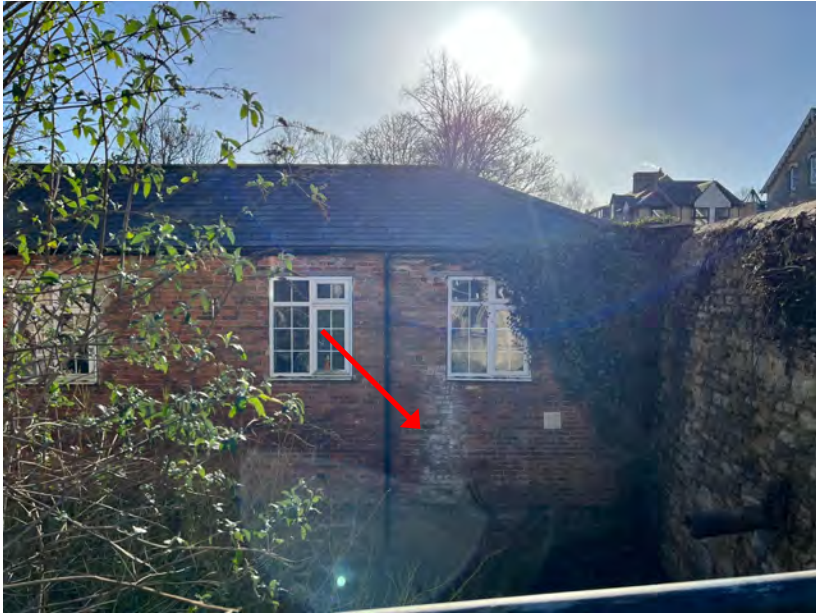
Fig 2/1:

Showing dampness and plant growth below gutter at junction with west boundary wall

Also note salt staining to brickwork

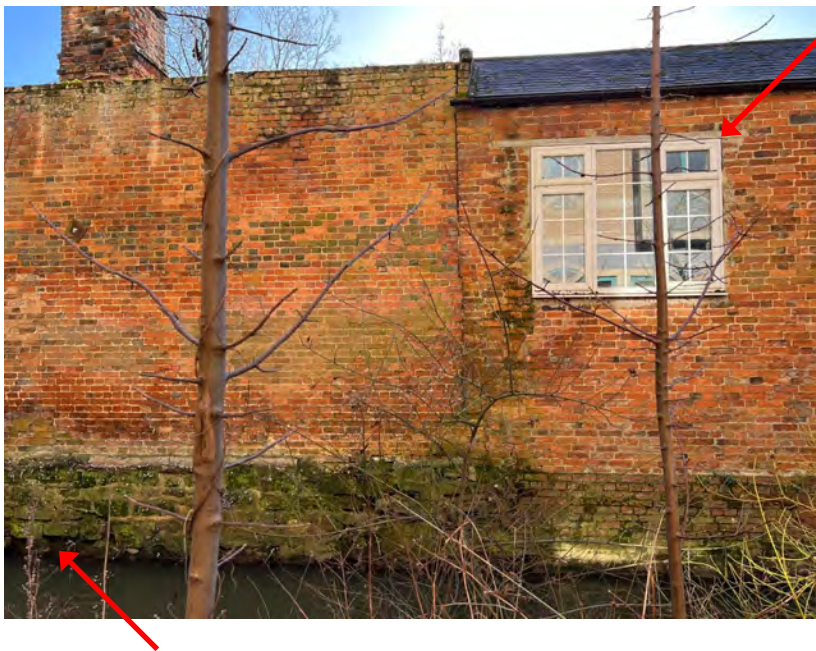
Fig 2/2:

Showing washed-out footings

Also showing fairly crude modern works around window aperture (replacement lintel and repaired reveals)

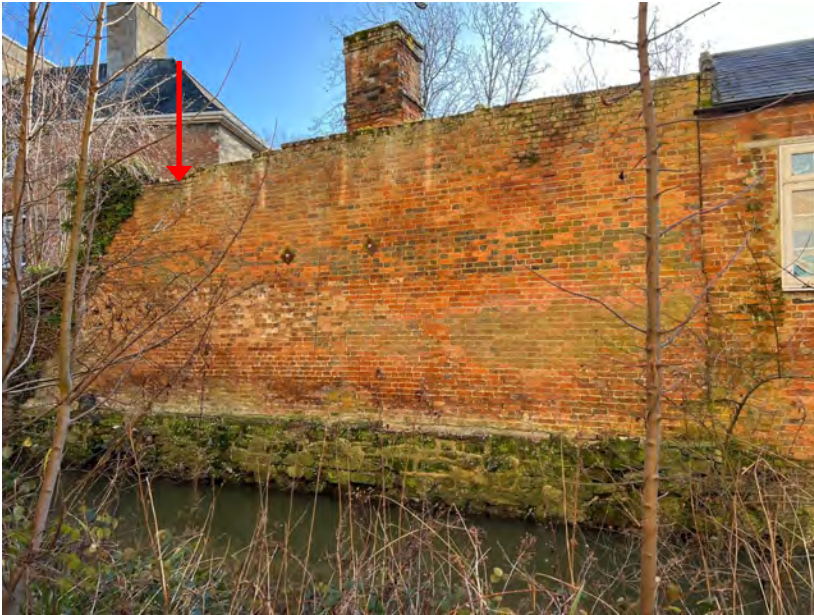
Fig 2/3:

Showing missing fabric from wallhead
(roof purposefully removed)

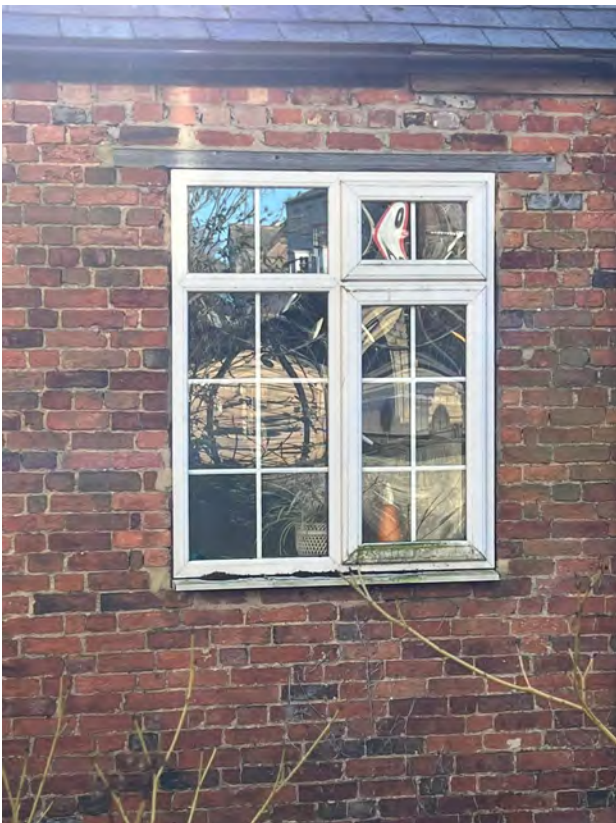
Fig 2/4:

Showing timber lintel exposed to
weathering (against good practice)

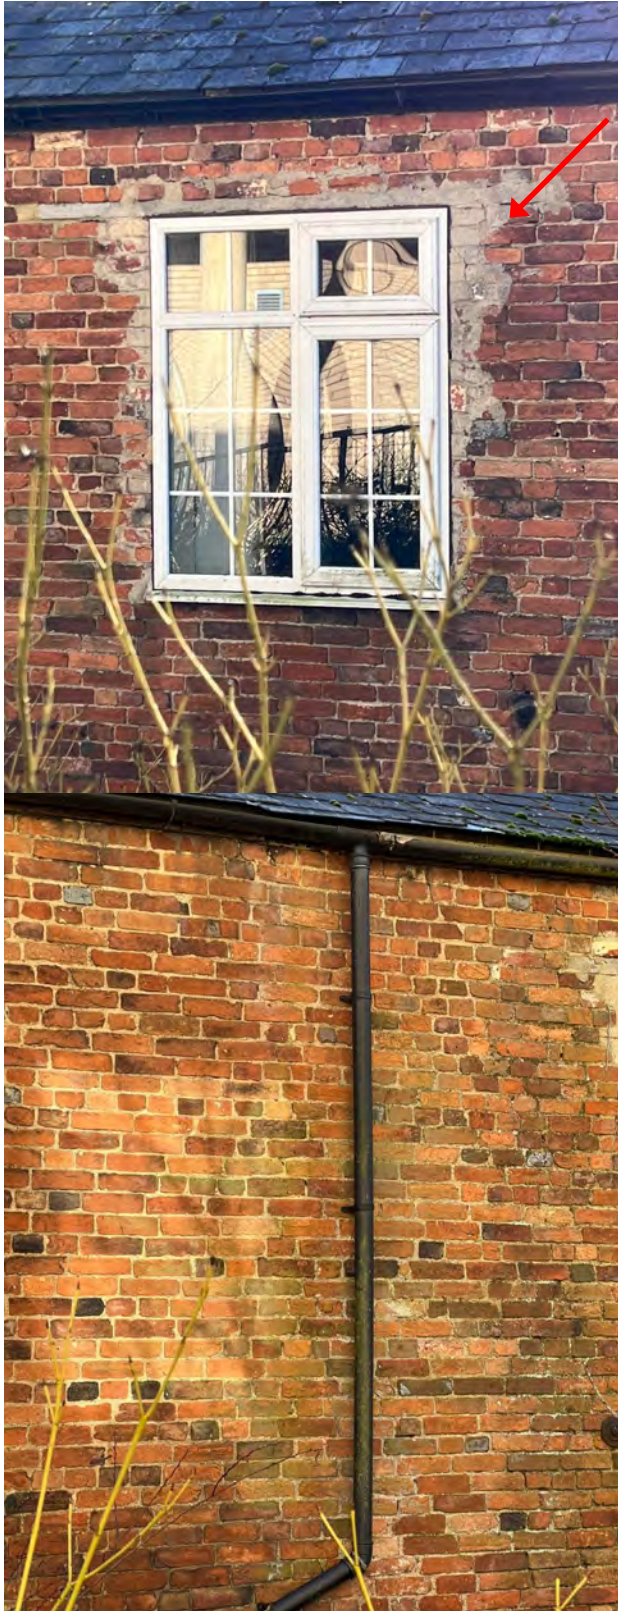
Showing crude modern works around window aperture (replacement lintel and repaired reveals)

Showing poorly bonded brickwork which may suggest bad workmanship and/or crude previous alterations
