Hutton + Rostron Environmental Investigations Limited

Grandpont House, Oxford: Façade investigation

Site note 4 for December 2023-January 2024, job no. 160-42

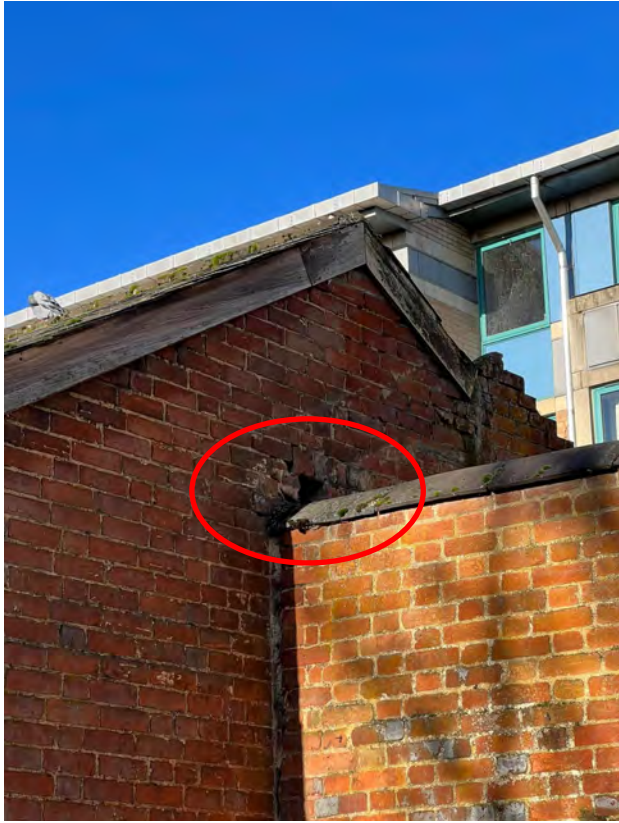
Fig 2/7:

Showing hole in wall at junction with 'ruined' roof over the cottage

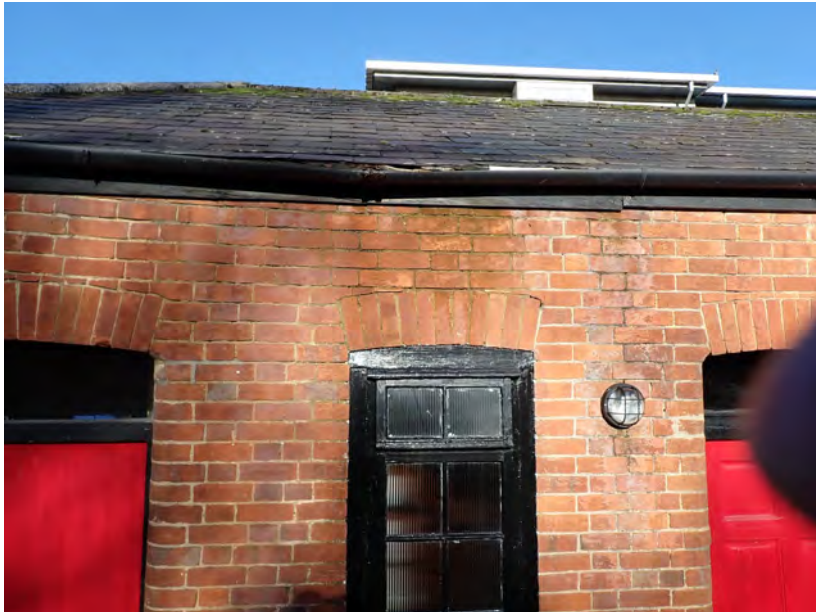
Fig 2/8:

Showing stained brickwork below roof leaks

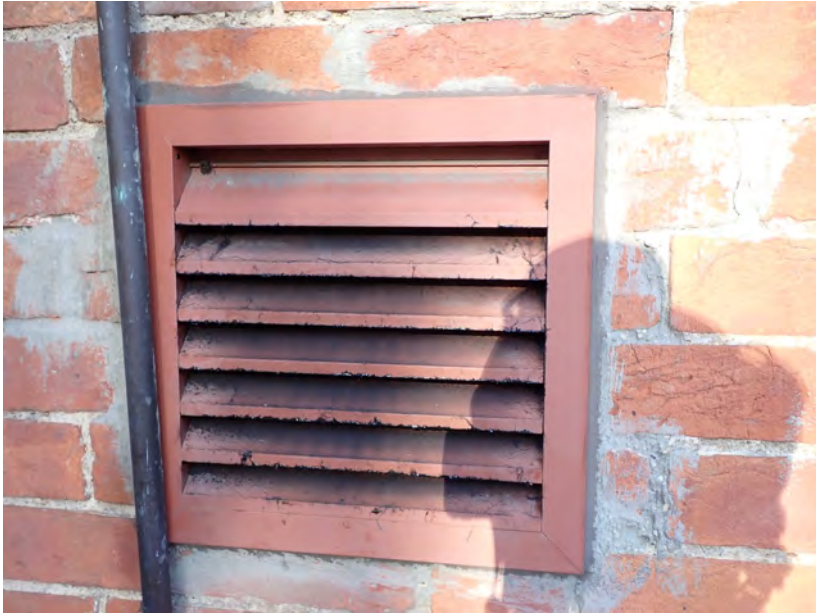
Fig 2/9:

Showing crude work around modern service installation

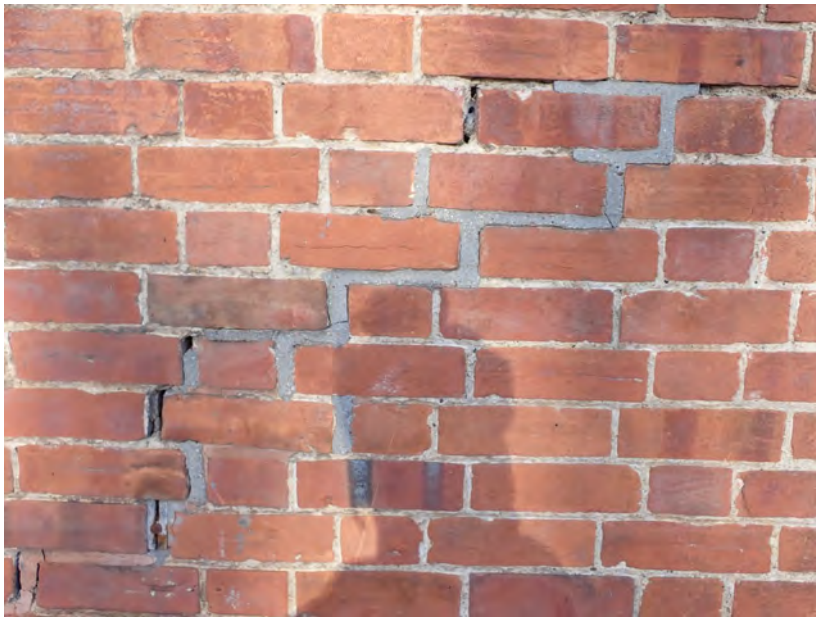
Fig 2/10:

Showing recurrent cracking despite previous pointing repair

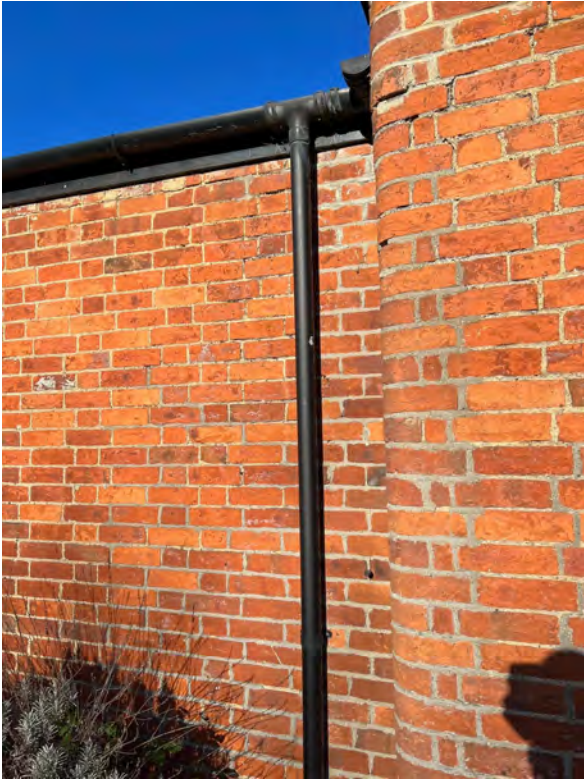
Fig 2/11:

Showing previous patch re-pointing
carried out

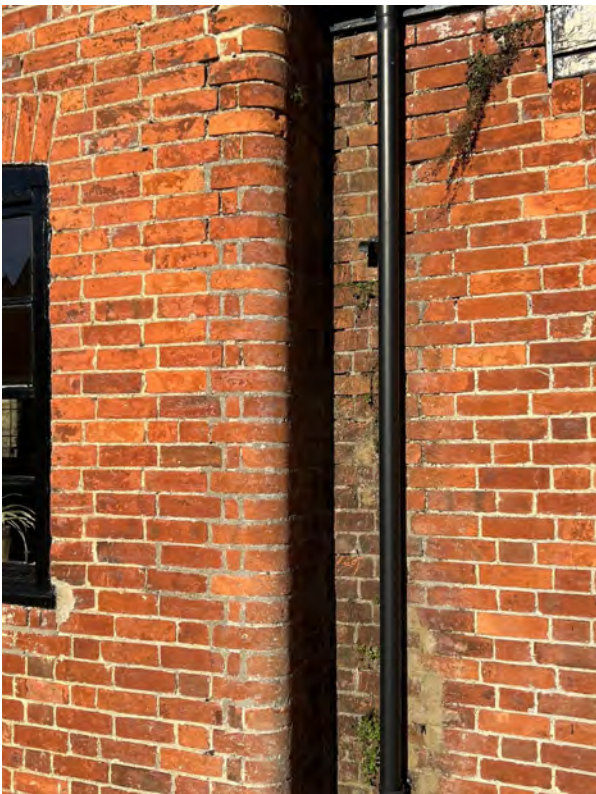
Fig 2/12:

Showing areas of pointing loss around
overspilling roof drainage

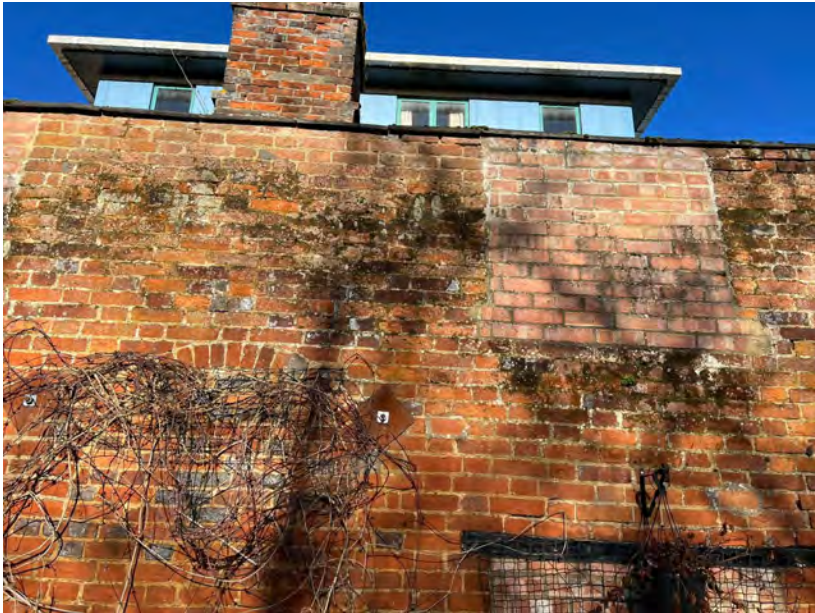
Fig 2/13:

Showing closed window/door apertures in 'The Cottage' where the roof has been purposefully removed in the past

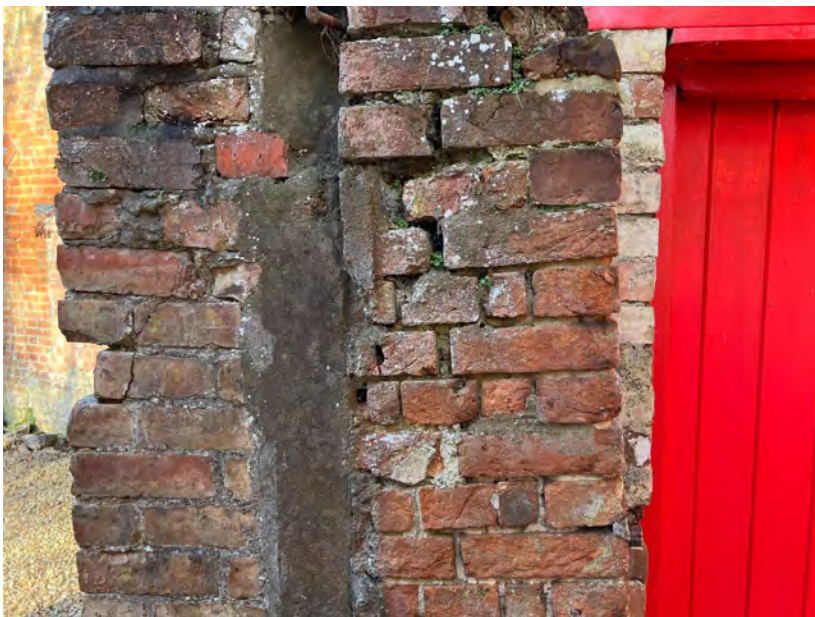
Fig 2/14:

Showing example of crude/scarred brickwork where various outbuildings have been partially demolished/alterd
