# Hutton + Rostron Environmental Investigations Limited

## Grandpont House, Oxford: Window and door unit investigation

Site note 5 for December 2023-January 2024, job no. 160-42

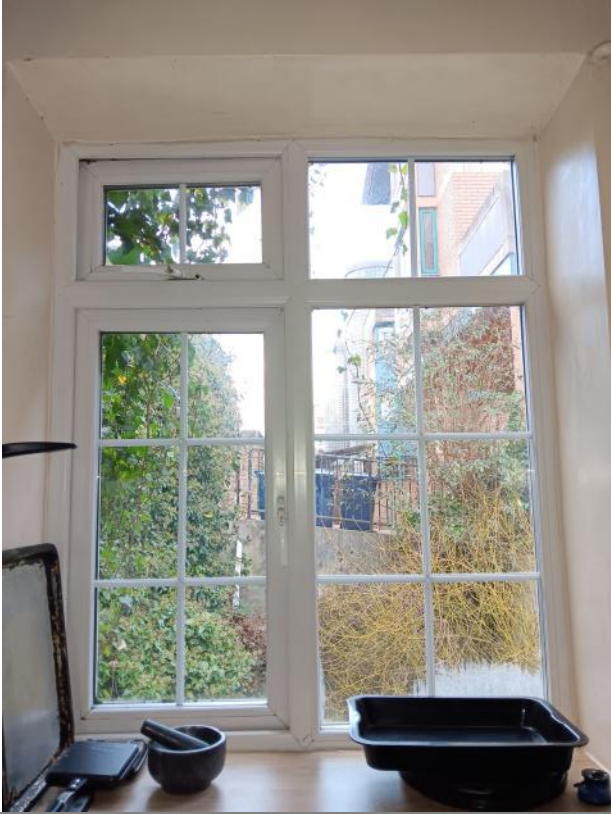
<b>Reference</b>	H+R window 1

<b>Location</b>	Stables North side	
<b>Type</b>	uPVC modern window unit	
<b>Strategy</b>	Justifiable for replacement due to lack of historic value (but fairly easy to repair)	
<b>Item</b>	<b>Works/Observations</b>	<b>Tender</b>
<b>Dimensions</b>	Overall aperture size 1400 x 1200mm	
<b>Operation</b>	Replace faulty hinge mechanisms for 2 no. casements

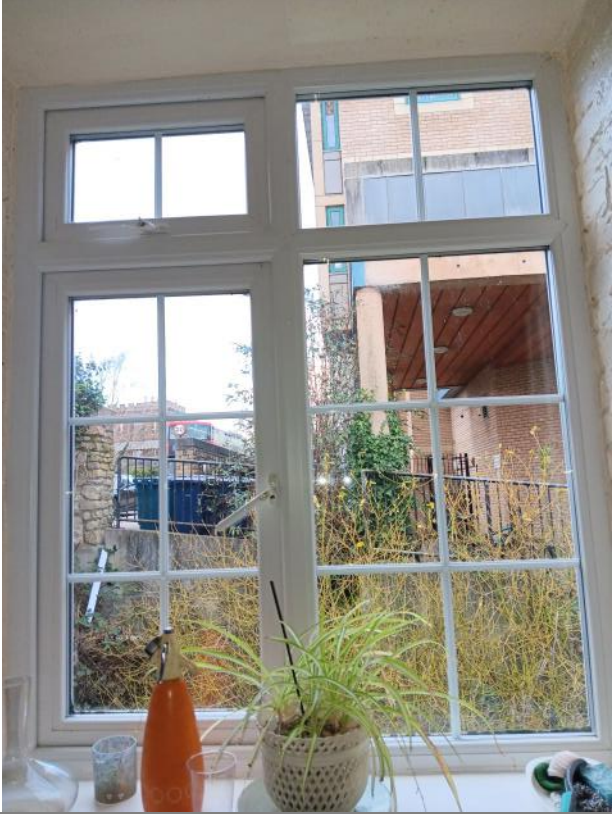
<b>Reference</b>	H+R window 2

<b>Location</b>	Stables North side	
<b>Type</b>	uPVC modern window unit	
<b>Strategy</b>	Justifiable for replacement due to lack of historic value (but remains serviceable)	
<b>Item</b>	<b>Works/Observations</b>	<b>Tender</b>
<b>Dimensions</b>	Overall aperture size 1400 x 1200mm

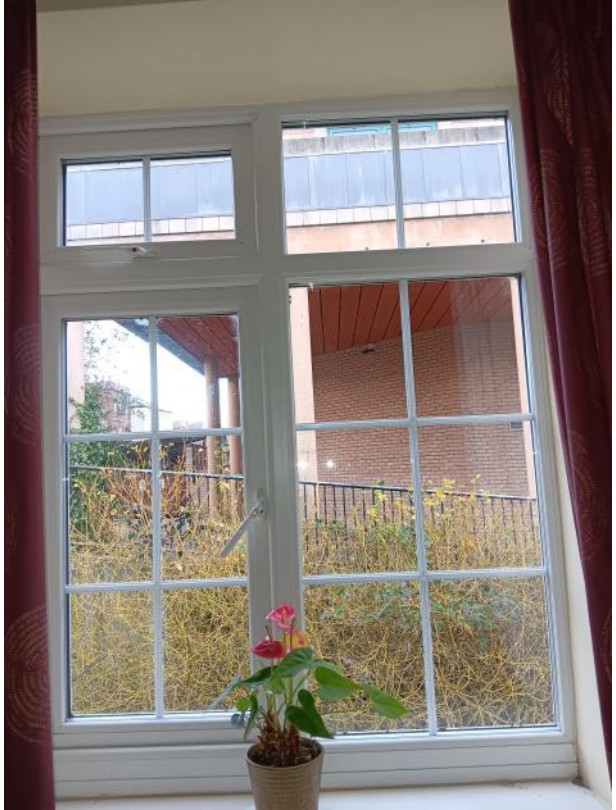
<b>Location</b>	Stables North side	
<b>Type</b>	uPVC modern window unit	
<b>Strategy</b>	Justifiable for replacement due to lack of historic value (but fairly easy to repair)	
<b>Item</b>	<b>Works/Observations</b>	<b>Tender</b>
<b>Dimensions</b>	Overall aperture size 1400 x 1200mm	
<b>Operation</b>	Lubricate or replace stiff handles/locking mechanisms for 2 no. casements

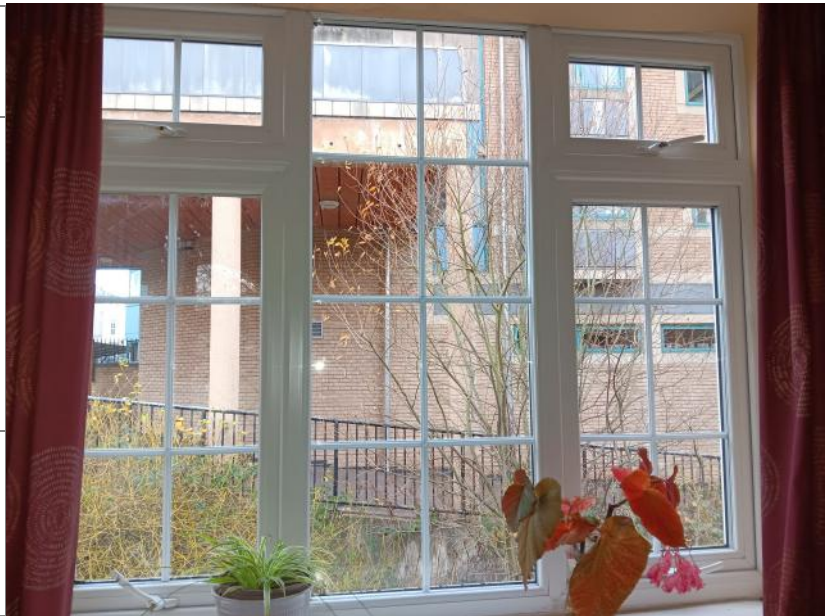
<b>Reference</b>	H+R window 4	
<b>Location</b>	Stables North side	
<b>Type</b>	uPVC modern window unit	
<b>Strategy</b>	Justifiable for replacement due to lack of historic value (but fairly easy to repair)	
<b>Item</b>	<b>Works/Observations</b>	<b>Tender</b>
<b>Dimensions</b>	Overall aperture size 1400 x 1700mm	
<b>Operation</b>	Lubricate or replace stiff handles/locking mechanisms for 2 no. casements

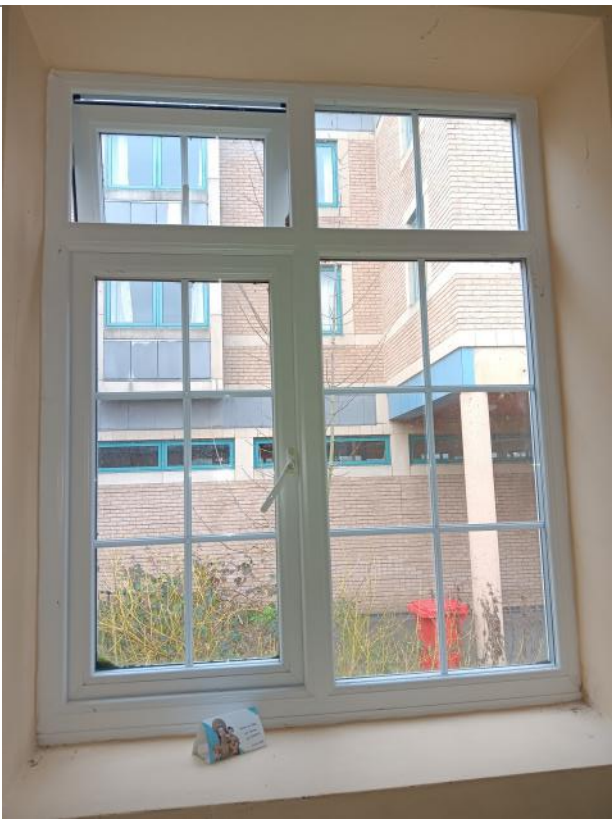
<b>Location</b>	Stables North side	
<b>Type</b>	uPVC modern window unit	
<b>Strategy</b>	Justifiable for replacement due to lack of historic value (but remains serviceable)	
<b>Item</b>	<b>Works/Observations</b>	<b>Tender</b>
<b>Dimensions</b>	Overall aperture size 1400 x 1200mm

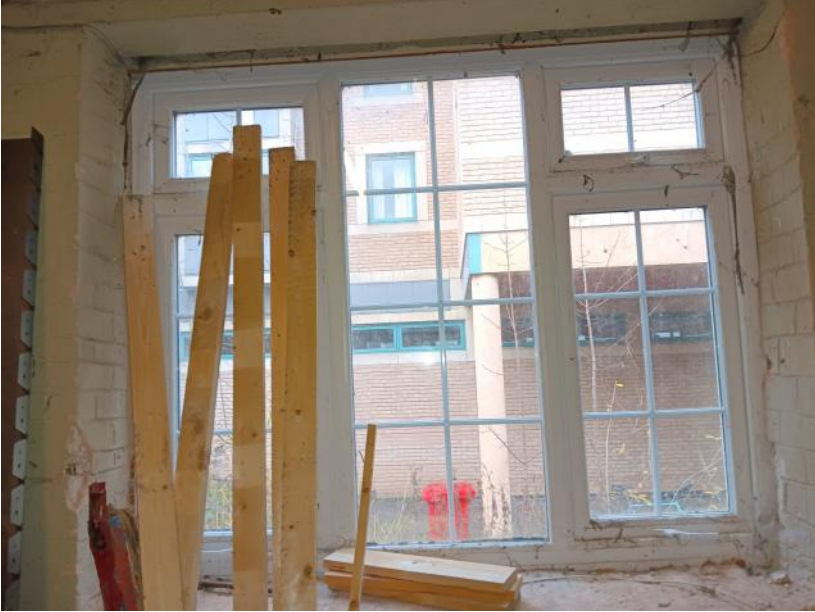
<b>Location</b>	Stables North side	
<b>Type</b>	uPVC modern window unit	
<b>Strategy</b>	Justifiable for replacement due to lack of historic value (but remains serviceable)	
<b>Item</b>	<b>Works/Observations</b>	<b>Tender</b>
<b>Dimensions</b>	Overall aperture size 1400 x 1700mm

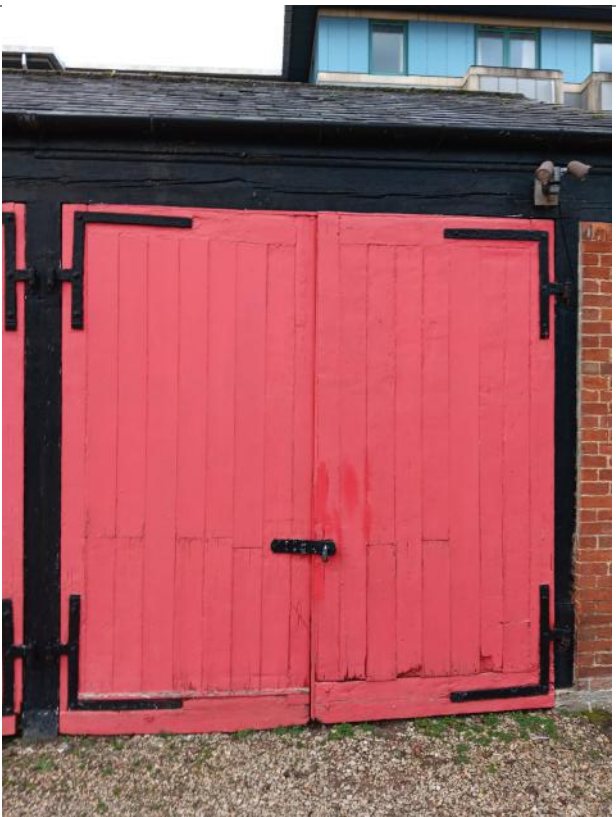
<b>Location</b>	Stables South side	
<b>Type</b>	Carriage house doors, pair of leaves	
<b>Strategy</b>	Doors appeared to be of historic value but require dismantlement and complete overhaul due to history of deterioration and failure of repairs	
<b>Item</b>	<b>Works/Observations</b>	<b>Tender</b>
<b>Dimensions</b>	Each door leaf 2800 X 1400mm	
<b>Decoration</b>	Paintwork largely intact but cracked/breached at joints; allow to prepare and redecorate throughout	
<b>Timber decay</b>	History of repair to lower third of almost all boards due to decay (which has recurred); to be re-done  Bottom rails for both doors both decayed; to be replaced  East (rhs) frame decayed; to be replaced  Retrospective boards have been fixed to the internal face (west top rail, east bottom rail); to be removed and defective elements of the original door fabric replaced as needed	
<b>Operation</b>	Iron L strap hinges appear to have sagged over time. The doors no longer close tightly as the meeting stiles overlap at the head. Retrofit bracing to each door (internally) has not arrested sag; doors to be totally dismantled and joints re-set to square (workbench task, not in-situ)

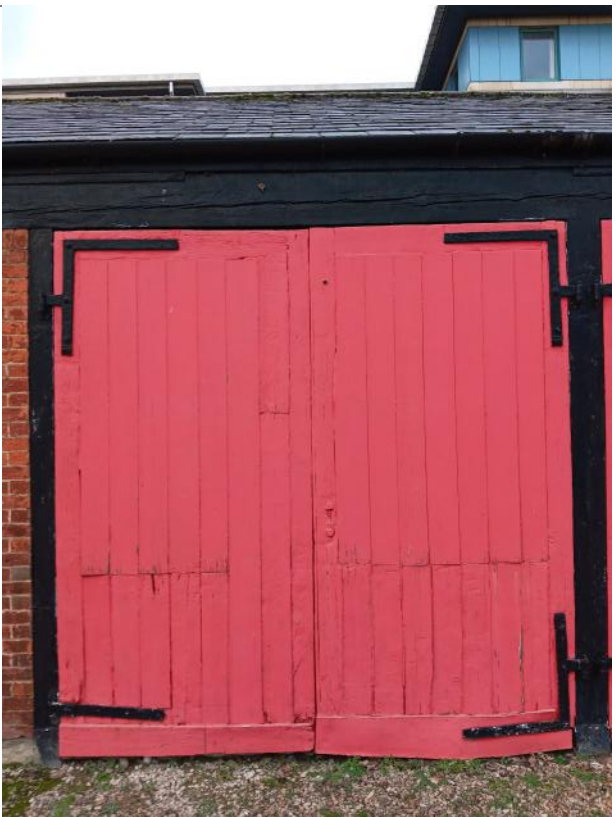
<b>Location</b>	Stables South side	
<b>Type</b>	Carriage house doors, pair of leaves	
<b>Strategy</b>	Doors appeared to be of historic value but require dismantlement and complete overhaul due to history of deterioration and failure of repairs	
<b>Item</b>	<b>Works/Observations</b>	<b>Tender</b>
<b>Dimensions</b>	Each door leaf 2800 X 1400mm	
<b>Decoration</b>	Paintwork largely intact but cracked/breached at joints; allow to prepare and redecorate throughout	
<b>Timber decay</b>	History of repair to lower third of almost all boards due to decay (which has recurred); to be re-done  Bottom rails for both doors both decayed and crudely patched; to be replaced  Additional cost allowances may be needed due to access restriction during survey (stored materials inside)	
<b>Operation</b>	Iron L strap hinges appear to have sagged over time. The doors no longer close tightly as the meeting stiles overlap at the head. Retrofit bracing to each door (internally) has not arrested sag; doors to be totally dismantled and joints re-set to square (workbench task, not in-situ)

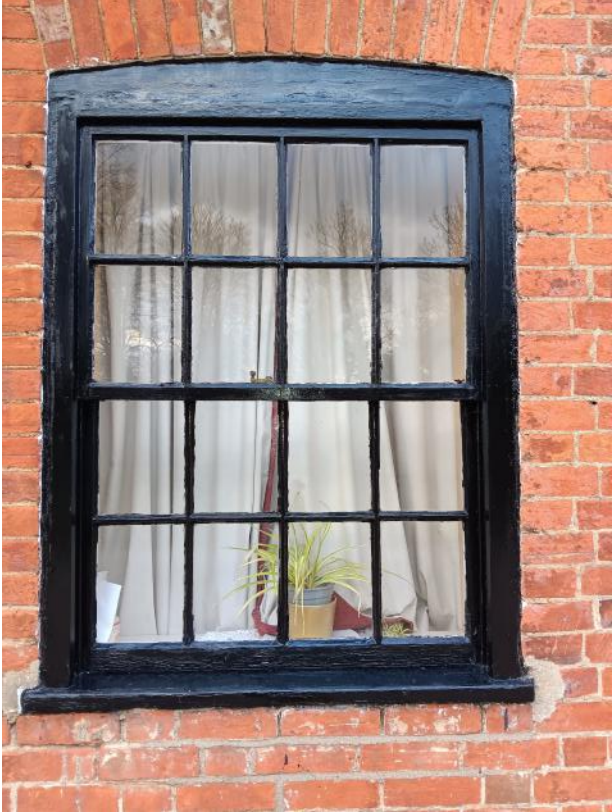
<b>Location</b>	Stables South side	
<b>Type</b>	Softwood sliding sash	
<b>Strategy</b>	Suspected to be of early C20th origin, not especially good construction or condition (potentially justified to replace)	
<b>Item</b>	<b>Works/Observations</b>	<b>Tender</b>
<b>Dimensions</b>	Overall aperture size 1500 x 1100mm	
<b>Decoration</b>	Paintwork largely intact (paint has exacerbated decay, disguised decay and seized operation); allow to prep and redecorate (if window is to be retained)	
<b>Timber decay</b>	Lefthand side pulley lining and adjacent beading partially decayed (painted over); replace these elements (if window is to be retained)	
<b>Operation</b>	Meeting rail faster remains  Both sashes painted shut; ease operation (if window is to be retained)

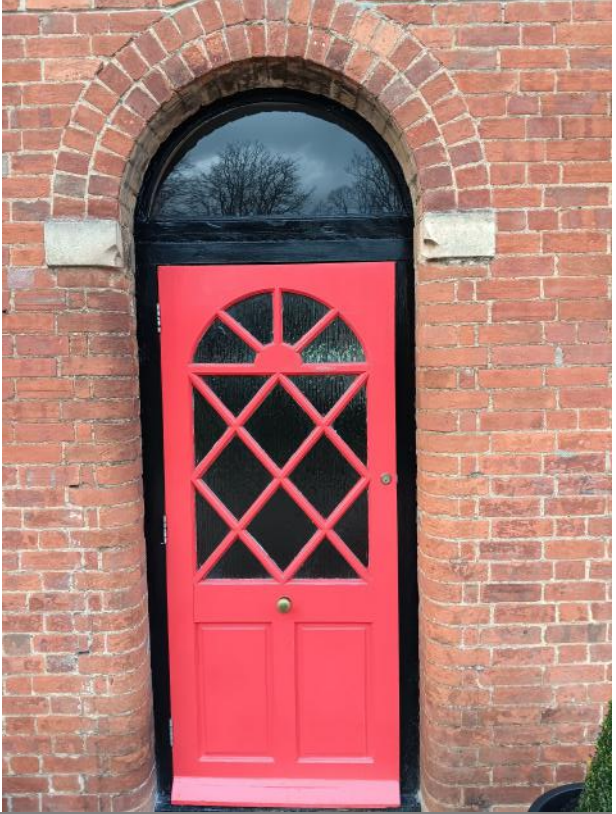
<b>Location</b>	Stables South side	
<b>Type</b>	Modern timber door with obscured glazing, suspected hardwood construction set within slightly older timber frame	
<b>Strategy</b>	Suspected to be of early C20th origin, not especially good construction or condition (potentially justified to replace)	
<b>Item</b>	<b>Works/Observations</b>	<b>Tender</b>
<b>Dimensions</b>	Overall aperture size 2800 x 1100mm	
<b>Decoration</b>	Paintwork largely intact; allow to prep and redecorate (if door is to be retained)	
<b>Timber decay</b>	Underside of sill partially decayed; to be replaced (if door is to be retained)	
<b>Operation</b>	Furniture remains functional

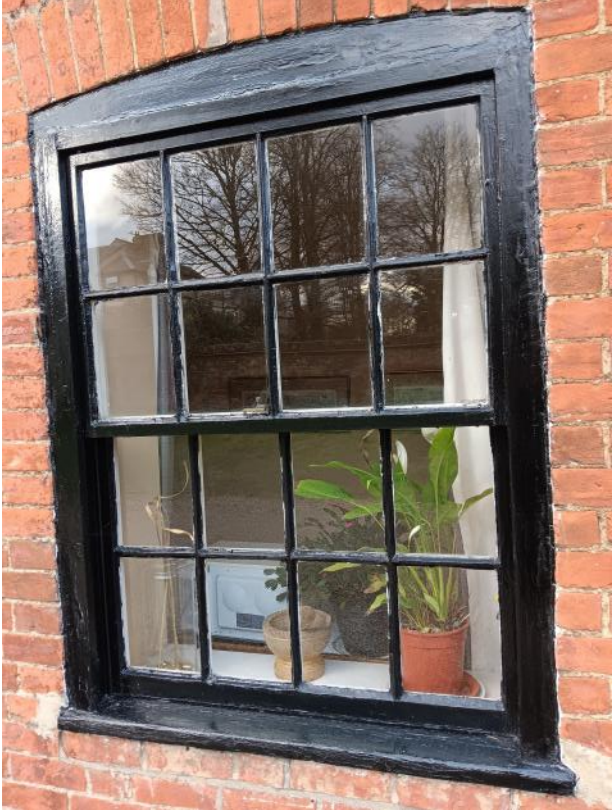
<b>Location</b>	Stables South side	
<b>Type</b>	Softwood sliding sash	
<b>Strategy</b>	Suspected to be of early C20th origin, not especially good construction or condition (potentially justified to replace)	
<b>Item</b>	<b>Works/Observations</b>	<b>Tender</b>
<b>Dimensions</b>	Overall aperture size 1500 x 1100mm	
<b>Decoration</b>	Paintwork largely intact (paint has exacerbated decay, disguised decay and seized operation); allow to prep and redecorate (if window is to be retained)	
<b>Timber decay</b>	Lefthand side pulley lining and outer lining partially decayed (painted over); replace these elements (if window is to be retained)	
<b>Operation</b>	Meeting rail faster remains  Both sashes painted shut; ease operation (if window is to be retained)

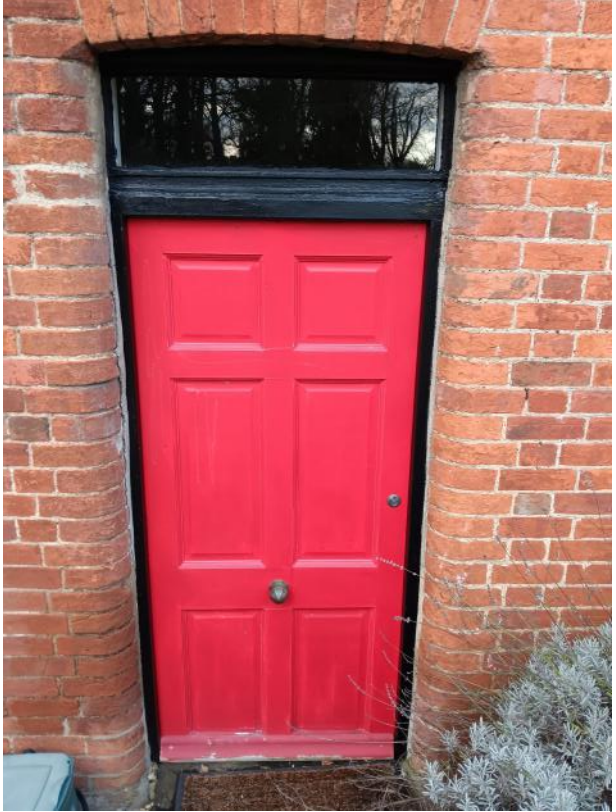
<b>Location</b>	Stables South side	
<b>Type</b>	Modern timber door with obscured glazing, suspected hardwood construction set within slightly older timber frame	
<b>Strategy</b>	Suspected to be of early C20th origin, not especially good construction or condition (potentially justified to replace)	
<b>Item</b>	<b>Works/Observations</b>	<b>Tender</b>
<b>Dimensions</b>	Overall aperture size 2200 x 900mm	
<b>Decoration</b>	Paintwork largely intact; allow to prep and redecorate (if door is to be retained)	
<b>Timber decay</b>	Replacement weatherboard suspected to disguise decay in bottom rail; element to be reviewed and potentially replaced (if door is to be retained)  Decay in threshold may be disguised by modern access ramp addition; element to be reviewed and potentially replaced (if door is to be retained)	
<b>Operation</b>	Furniture remains functional

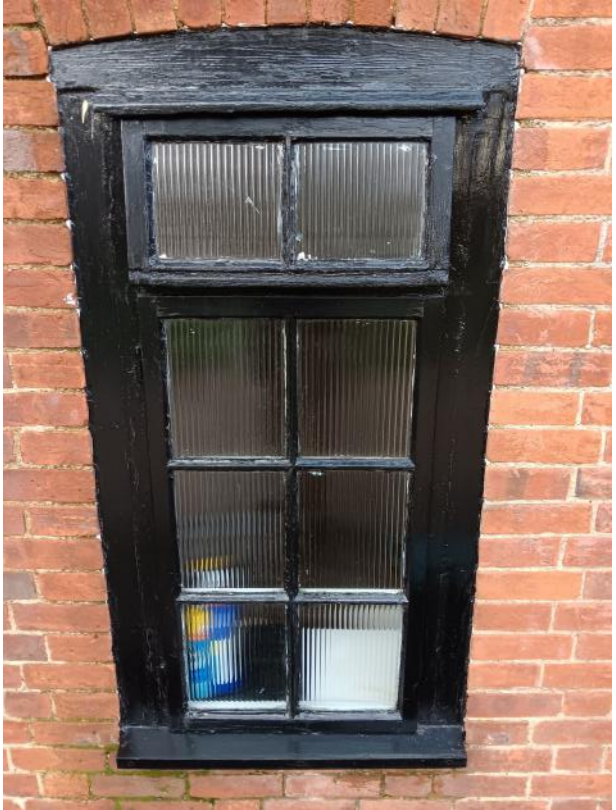
<b>Location</b>	Stables South side	
<b>Type</b>	Softwood frame, obscured glass, top hung casement	
<b>Strategy</b>	Apparently only 30-40yrs old, not especially good construction or condition (potentially justified to replace)	
<b>Item</b>	<b>Works/Observations</b>	<b>Tender</b>
<b>Dimensions</b>	Overall aperture size 1400 x 800mm	
<b>Decoration</b>	Paintwork largely intact (paint has exacerbated decay, disguised decay and seized operation); allow to prep and redecorate (if window is to be retained)	
<b>Timber decay</b>	Weathering fillet lost from lower edge of casement; element to be replaced (if window is to be retained)	
<b>Operation</b>	Unknown if lower part of window is a sized side-hung casement; provisionally allow to ease operation

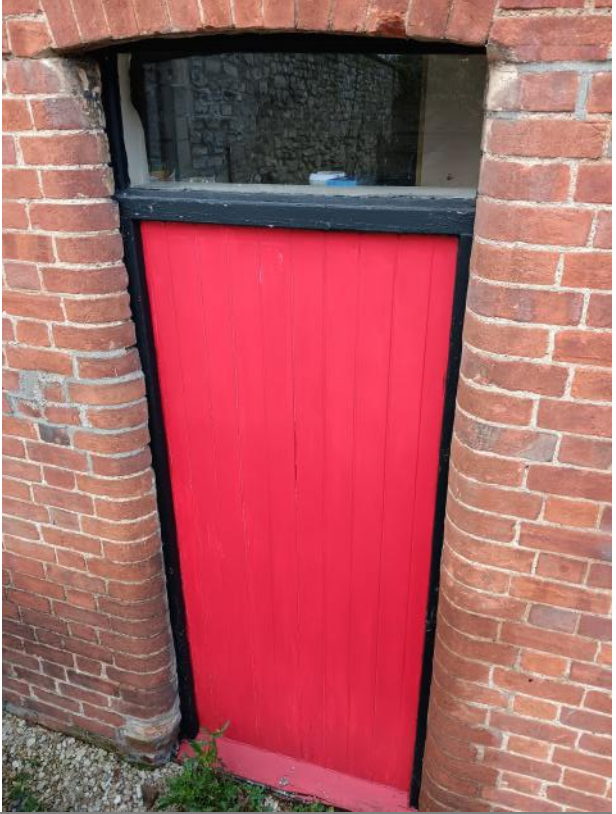
<b>Location</b>	Stables South side	
<b>Type</b>	Modern timber door with obscured glazing, ledged and braced door clad in boarding	
<b>Strategy</b>	Suspected to be of late C20th origin, not especially good construction or condition (potentially justified to replace or infill aperture if doorway no longer needed)	
<b>Item</b>	<b>Works/Observations</b>	<b>Tender</b>
<b>Dimensions</b>	Overall aperture size 2200 x 900mm	
<b>Decoration</b>	Paintwork largely intact; allow to prep and redecorate (if door is to be retained)	
<b>Timber decay</b>	The base of the door and frame were partially decayed, especially the weatherboard, threshold and frame feet; elements to be reviewed and potentially replaced (if door is to be retained)	
<b>Operation</b>	Door has been disused for many years (fitted shelves obstruction internally); operation to be reinstated (if door is to be retained)

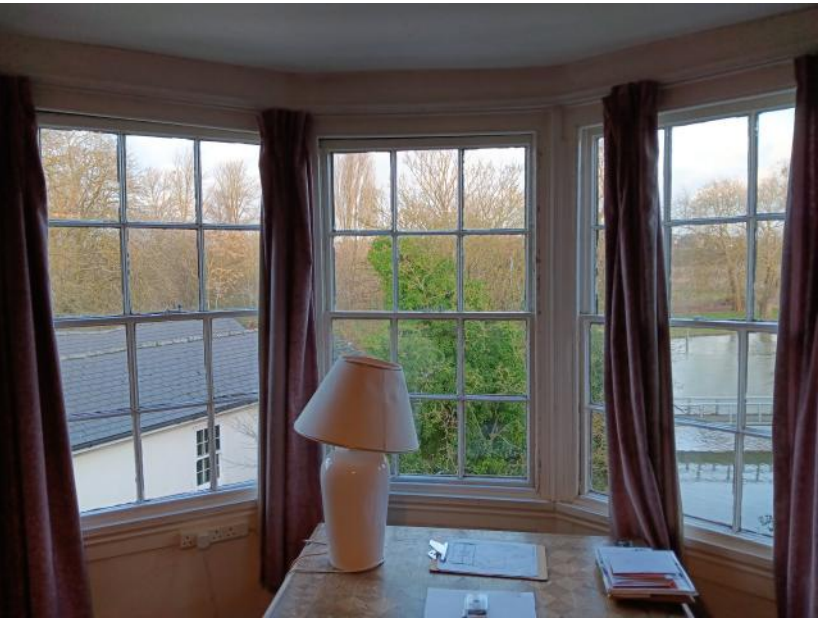
<b>Location</b>	Main House Second floor East side	
<b>Type</b>	3no. sash window units making-up canted bay	
<b>Strategy</b>	Window holds historic value but is in very poor condition; this could justify total re- placement	
<b>Item</b>	<b>Works/Observations</b>	<b>Tender</b>
<b>Dimensions</b>	Each window unit measured 1500 x 1000mm. Overall sash thickness 40mm. Glazing bar profile a slender lambs tongue type design 15mm thick. The glazing bar depth internal was 25mm. The thickness of the glazing and glazing rebate was therefore encompassed within a 15mm zone	
<b>Decoration</b>	Poor state of paintwork and putty  (window replacement recommended)	
<b>Timber decay</b>	The surrounding structure of the bay window (timber frame) has dropped towards the outer edge, as exhibited by the uneven gap at the top of the lefthand window (distortion by at least 20mm); Structural Engineer to comment in terms of whether aperture distortion can be corrected or not  External lead flashings at the sill were heavily corroded and underlying timber sill projection has been lost  Spandrel panel and architrave beneath the window internally appeared to have been lost or crudely replaced in the past; to be restored (only if desirable)  (window replacement recommended)

<b>Operation</b>	The righthand fastener was missing. The centre and lefthand fastener differed in design and were now difficult, if not impossible, to operate due to distortion or lack of fully closing sashes  Only 2 out of the 6 sashes were operable. The other sashes are assumed to have been seized by painting shut  (window replacement recommended)

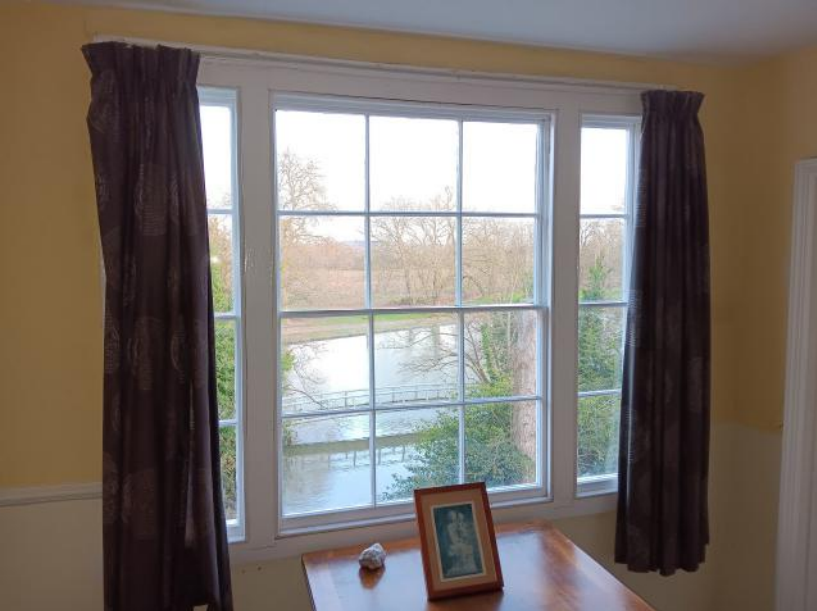
<b>Location</b>	Main House Second floor East side	
<b>Type</b>	3no. sash window units within single aperture (flanking sashes not designed to operate). Modern detailing such as brush strips	
<b>Strategy</b>	Recently replaced, therefore no historic value and potentially justified for replacement if there is a desire to upgrade performance (but currently remains serviceable)	
<b>Item</b>	<b>Works/Observations</b>	<b>Tender</b>
<b>Dimensions</b>	Overall aperture size 1500 x 2000mm  The replacement sashes were of a matching overall thickness to the original windows 15 and 17 nearby, although the glazing bar profile was a slightly different design	
<b>Decoration</b>	Fairly recent paintwork remained in reasonable condition; prep and redecorate (if window is to be retained)	
<b>Timber decay</b>	There were no signs of decay, although water staining suggested driving rain penetration at the lower corners of the posts between sections of the window; external weathering checks and making good required (if window is to be retained)

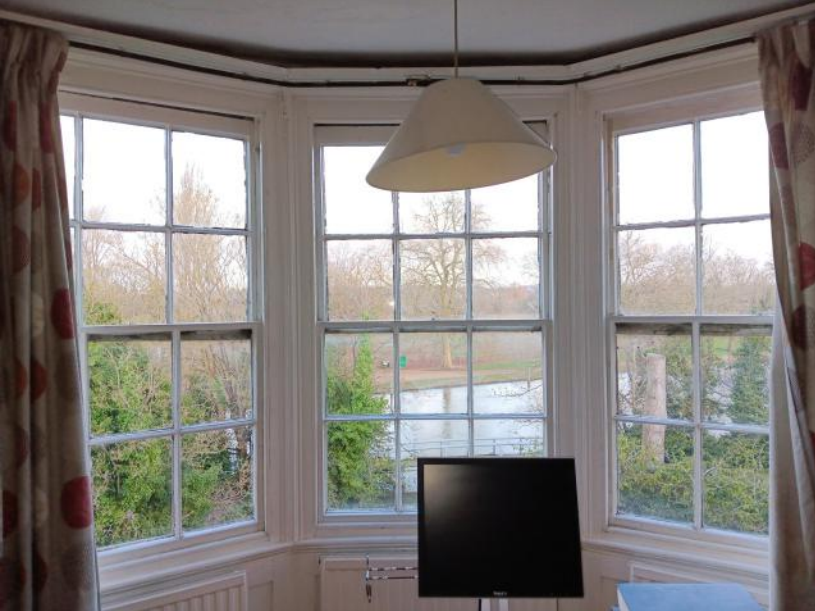
<b>Location</b>	Main House Second floor East side	
<b>Type</b>	3no. sash window units making-up canted bay	
<b>Strategy</b>	Window holds historic value but is in very poor condition; this could justify total re- placement	
<b>Item</b>	<b>Works/Observations</b>	<b>Tender</b>
<b>Dimensions</b>	Each window unit measured 1500 x 1000mm. Overall sash thickness 40mm. Glazing bar profile a slender lambs tongue type design 15mm thick. The glazing bar depth internal was 25mm. The thickness of the glazing and glazing rebate was therefore encompassed within a 15mm zone	
<b>Decoration</b>	Poor state of paintwork and putty  (window replacement recommended)	
<b>Timber decay</b>	The surrounding structure of the bay window (timber frame) has dropped towards the outer edge, as exhibited by the uneven gap at the top of the lefthand window (distortion by at least 40mm); Structural Engineer to comment in terms of whether aperture distortion can be corrected or not  South window top sash: meeting rail decayed at all joists (glazing bars and stiles)  South window bottom sash: decay at lower lhs corner (crude metal bracket added)  North window top sash: heavily decayed meeting rail  Centre window: decayed pulley lining feet (2no.)  External sill partially decayed  (window replacement recommended)

<b>Operation</b>	All furniture damaged/missing  Only 2 out of the 6 sashes were operable. The other sashes are assumed to have been seized by painting shut  (window replacement recommended)

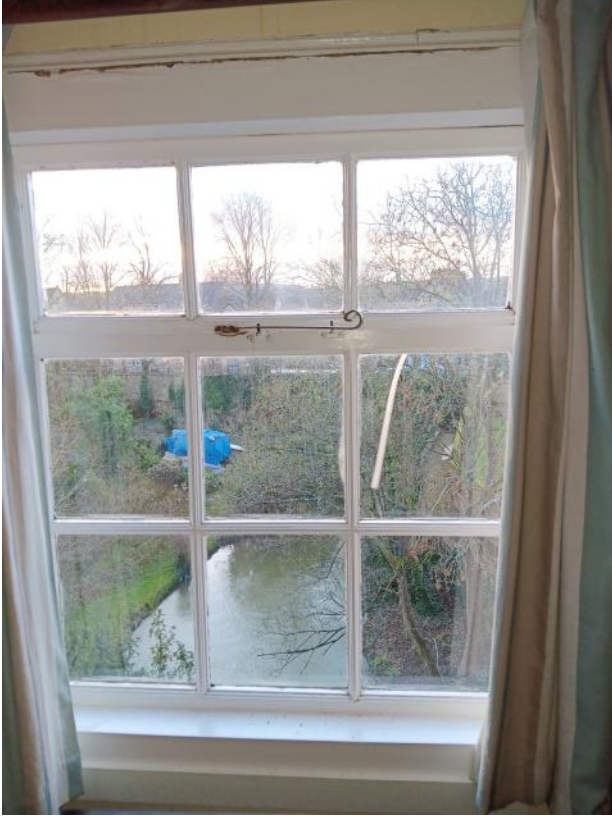
<b>Location</b>	Main House Second floor West side	
<b>Type</b>	Modern frame and casement installed within recent decade. This appeared to be a mismatching design vaguely imitating a 3 over 6 sliding sash but utilising a top hung casement detail). Original detail can be seen at window 19	
<b>Strategy</b>	No historic or material value, poor condition; replacement justified	
<b>Item</b>	<b>Works/Observations</b>	<b>Tender</b>
<b>Dimensions</b>	Overall aperture size 1200 x 1000mm	
<b>Decoration</b>	Poor  (window replacement recommended)	
<b>Timber decay</b>	The lower righthand corner of the casement heavily decayed  (window replacement recommended)	
<b>Operation</b>	Casement could not be fully closed. It was stuck in the ajar position and a plastic draught strip has fallen out at this location  (window replacement recommended)

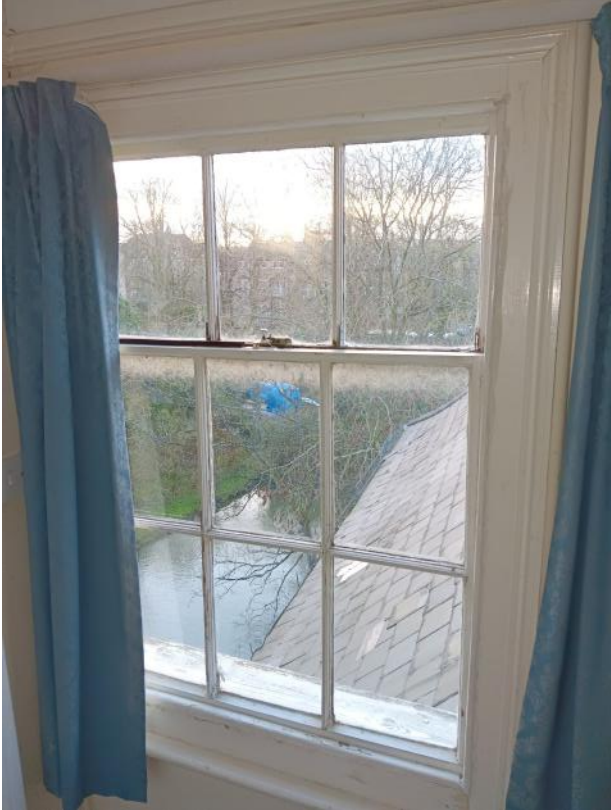
<b>Location</b>	Main House Second floor West side	
<b>Type</b>	Softwood sliding sash, single glazing	
<b>Strategy</b>	Historic but not original (Edwardian?) and poor condition; potentially justifies replacement	
<b>Item</b>	<b>Works/Observations</b>	<b>Tender</b>
<b>Dimensions</b>	Overall aperture size 1300 x 900mm  The glazing bar thickness in comparison to window 17 was slightly thicker (20mm) and was therefore suspected to be a non-original replacement	
<b>Decoration</b>	Poor  (window replacement recommended)	
<b>Timber decay</b>	Top sash meeting rail: heavily decayed with crude metal bracket repair  External timber sill and lower frame corners previously heavily decayed, crudely patched with a board fixed over within recent decades  (window replacement recommended)	
<b>Operation</b>	The bottom sash was difficult to operate due to a missing pulley at the lefthand side  (window replacement recommended)

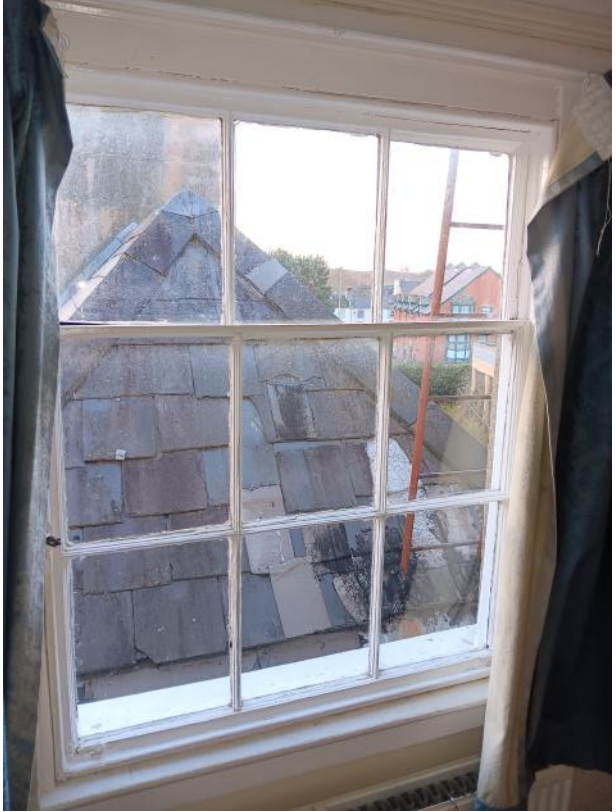
<b>Location</b>	Main House Second floor West side	
<b>Type</b>	Softwood, single glazing. Imitation sash adapted as side-hung casement for roof access	
<b>Strategy</b>	Historic but not original (Edwardian?) and poor con- dition; potentially justifies replacement  Previously would have al- lowed fairly safe roof ac- cess when the west wing had an enclosed central valley  No longer deemed safe as a route to climb onto the upper roof! Especially not- ing that there is a way to safely climb into the en- closed central valley of the main roof via internal hatch- way)	
<b>Item</b>	<b>Works/Observations</b>	<b>Tender</b>
<b>Dimensions</b>	Overall aperture size 1300 x 900mm	
<b>Decoration</b>	Poor  (window replacement recommended)	
<b>Timber decay</b>	The external timber sill was decayed at least at the righthand corner  (window replacement recommended)	
<b>Operation</b>	The bottom casement has dropped over time and no longer fully shuts  The top sash has been painted shut (in a slightly ajar position)  (window replacement recommended)

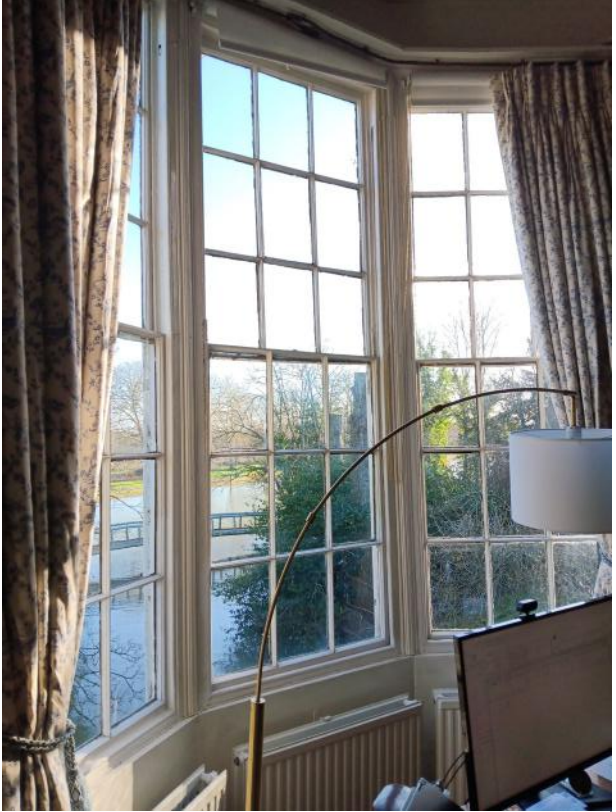
<b>Location</b>	Main House First floor East side	
<b>Type</b>	Triple window forming cant- ed bay window	
<b>Strategy</b>	Historic value and limited extent of damage would potentially justify retention	
<b>Item</b>	<b>Works/Observations</b>	<b>Tender</b>
<b>Dimensions</b>	Each unit measuring 2500 x 900mm  The sashes measured 35mm thick with a 28mm internal moulded glazing bar which very little depth for the single glazing and putty	
<b>Decoration</b>	The condition of external paintwork was poor which would allow water entrapment and the conditions for wet rot decay; prep and re-decorate	
<b>Timber decay</b>	Replace partially decayed external sill (north and centre)  Replace missing external sill (south)  The base of the frame posts showed a history of splice repair and filler repair; provisionally allow to inspect and re-do repairs if necessary	
<b>Operation</b>	All fasteners at the meeting rails were either damaged, missing or inoperable (evidence remains for historic fastener design at north window); all pulls, fasteners and pulleys to be replaced (replicate original fastener design)  5 out of 6 sashes painted-shut; ease operation

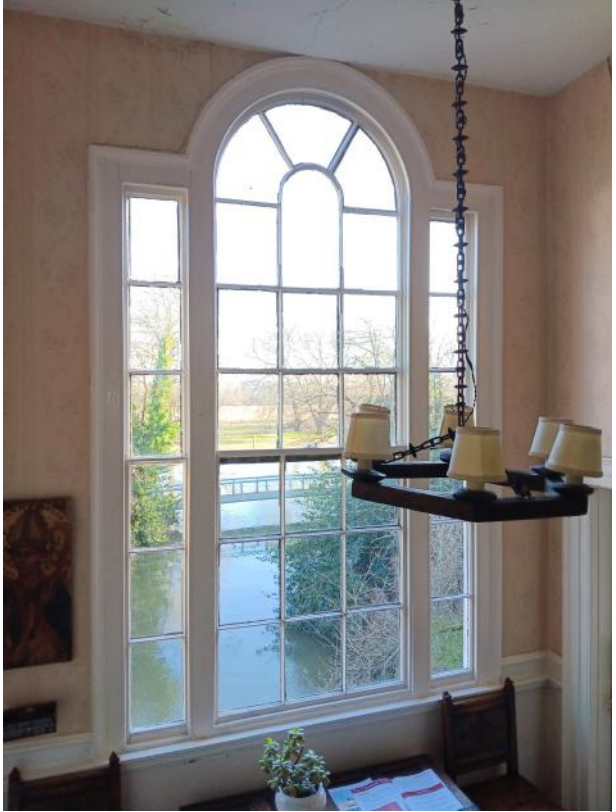
<b>Location</b>	Main House First floor East side	
<b>Type</b>	'Palladian' style sash window comprising 3no. Window units within a single aperture	
<b>Strategy</b>	Historic value and limited extent of damage would potentially justify retention	
<b>Item</b>	<b>Works/Observations</b>	<b>Tender</b>
<b>Dimensions</b>	Overall dimensions 3100 x 2000mm	
<b>Decoration</b>	Dilapidated paint finishes had allowed moss growth which suggested timbers would be damp enough for decay; prep and re-dec	
<b>Timber decay</b>	Replace missing external sill  The base of the frame posts showed a history of splice repair and filler repair; provisionally allow to inspect and re-do repairs if necessary  The centre top sash showed some evidence of decayed/damaged glazing bars on the basis that daylight was visible around the perimeter of some panes; provisionally allow to de-glaze and replace glazing bars

<b>Glazing</b>	1 no. cracked pane was noted at the upper north sash; replace damaged pane	
<b>Operation</b>	All 6no. sashes painted/fixed-shut; ease operation of main 2no. Sashes  Fastener at centre meeting rail non-operational (top sash painted-shut in ajar position); provisionally allow to renew all pulls, fasteners and pulleys

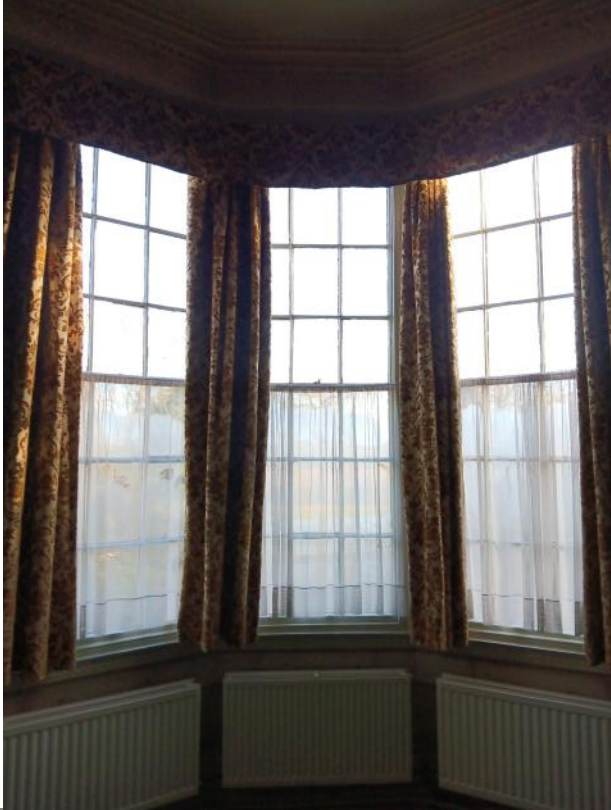
<b>Location</b>	Main House First floor East side	
<b>Type</b>	Triple window forming cant- ed bay window	
<b>Strategy</b>	Historic value and limited extent of damage would potentially justify retention	
<b>Item</b>	<b>Works/Observations</b>	<b>Tender</b>
<b>Dimensions</b>	Each unit measuring 2500 x 900mm  The sashes measured 35mm thick with a 28mm internal moulded glazing bar which very little depth for the single glazing and putty	
<b>Decoration</b>	The condition of external paintwork was poor which would allow water entrap- ment and the conditions for wet rot decay; prep and re-decorate	
<b>Timber decay</b>	Suspected partial decay in all external sills; provisionally allow to replace  The base of the frame posts showed a history of splice repair and filler repair which were suspected to suffer at least some latent decay; provisionally allow to inspect and re-do repairs if necessary

<b>Glazing</b>	1 no. cracked pane identified in the bottom sash of the north window; replace broken pane	
<b>Operation</b>	All fasteners at the meeting rails were either damaged, missing or inoperable; all pulls, fasteners and pulleys to be replaced  5 out of 6 sashes painted-shut (in ajar position); ease operation  Evidence of lost 'meakins-system' operation for top sashes; Architect to consid- er reinstating this to all high-level sash windows

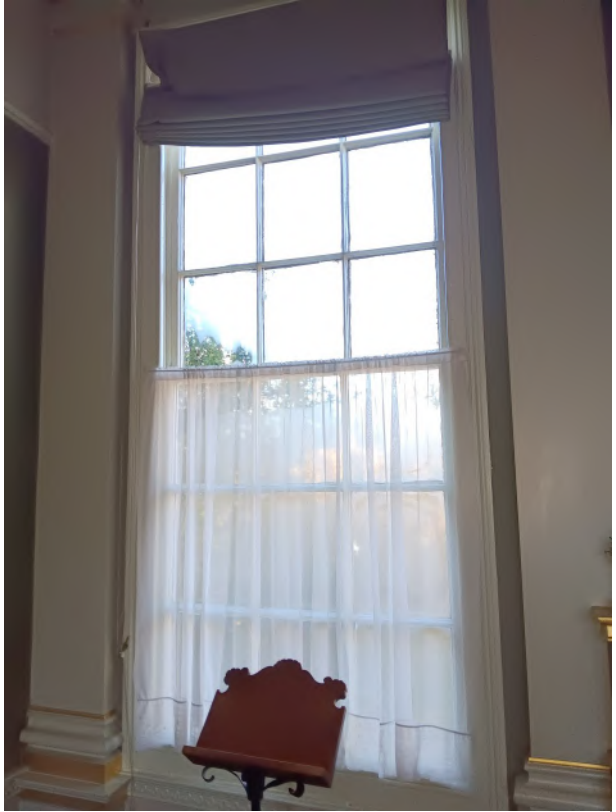
<b>Location</b>	Main House First floor West side	
<b>Type</b>	Sliding sash window	
<b>Strategy</b>	Appeared capable of retention	
<b>Item</b>	<b>Works/Observations</b>	<b>Tender</b>
<b>Dimensions</b>	Overall dimensions 2500 x 1100mm	
<b>Decoration</b>	Reasonable; prep and re-decorate	
<b>Timber decay</b>	No decay identified (external access not available); make a provisional cost allowance for timber repair pending external inspection	
<b>Glazing</b>	1 no. cracked pane in the bottom sash; replace broken pane	
<b>Operation</b>	Both sashes appeared to have been painted shut for many years; ease operation  Fastener remains at meeting rail

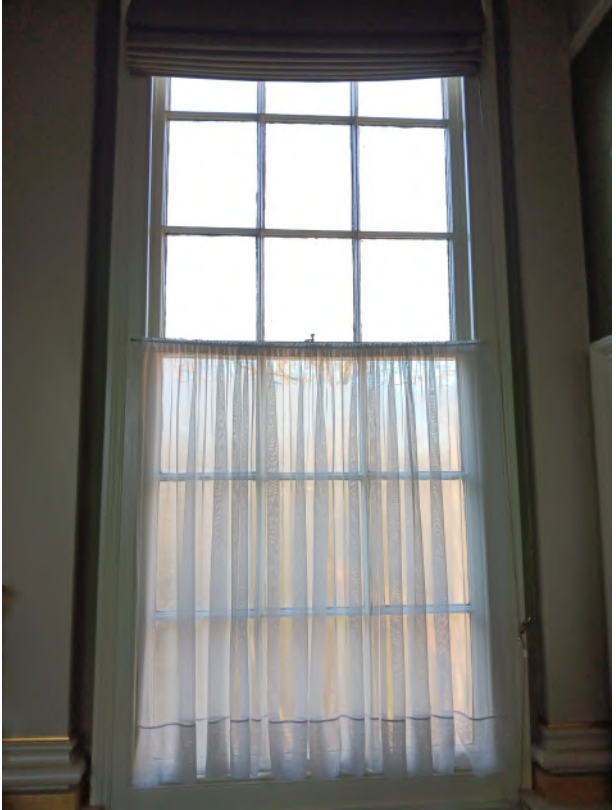
<b>Location</b>	Main House First floor West side	
<b>Type</b>	Sliding sash window, modern replacement beads with brush-strips	
<b>Strategy</b>	Appeared capable of retention	
<b>Item</b>	<b>Works/Observations</b>	<b>Tender</b>
<b>Dimensions</b>	Overall dimensions 2500 x 1100mm	
<b>Decoration</b>	Reasonable; prep and re-decorate	
<b>Timber decay</b>	There was evidence of repair/replacement to the outer linings, both of these had suffered recurrent wet rot decay at the feet of the frame; allow to splice repair	
<b>Operation</b>	Top sash painted shut; ease operation  Fastener remains at meeting rail

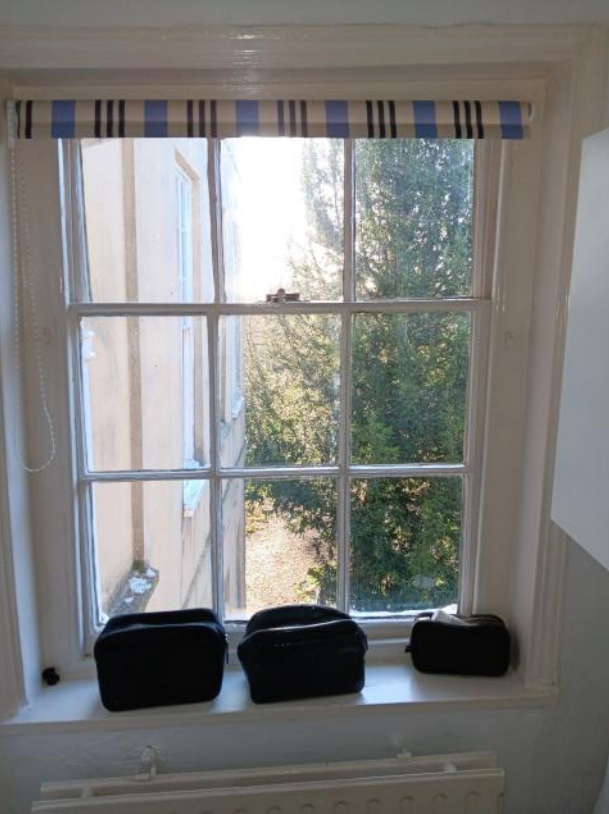
<b>Location</b>	West wing First floor South side	
<b>Type</b>	Sliding sash window	
<b>Strategy</b>	Some historic value and capable of retention if desired	
<b>Item</b>	<b>Works/Observations</b>	<b>Tender</b>
<b>Dimensions</b>	Overall dimensions 1200 x 1100mm	
<b>Decoration</b>	Build-up of paint coats had hindered the operation; prep and re-dec	
<b>Timber decay</b>	There did not seem to be signs of decay in the frame	
<b>Operation</b>	The window aperture was clearly affected by distortion. The surrounding structure seemed to have dropped differentially towards the east side. The top and bottom sashes were both operable, although rather stiff and affected by the distortion of the aperture; easing operation required

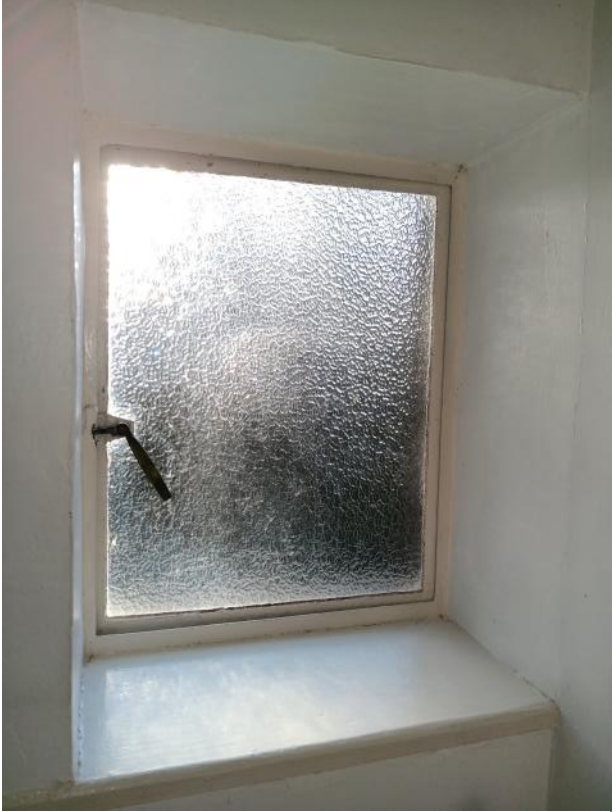
<b>Location</b>	West wing First floor South side	
<b>Type</b>	Fairly modern (mid-20 <sup>th</sup> century) metal framed window, obscured glazing, brass handle	
<b>Strategy</b>	Mid C20th addition (new wall aperture created?)  Could be justified to remove, infill or replace	
<b>Item</b>	<b>Works/Observations</b>	<b>Tender</b>
<b>Dimensions</b>	Overall dimensions 600 x 450mm	
<b>Decoration</b>	Good	
<b>Glazing</b>	Minor crack in upper corner of pane	
<b>Operation</b>	Good

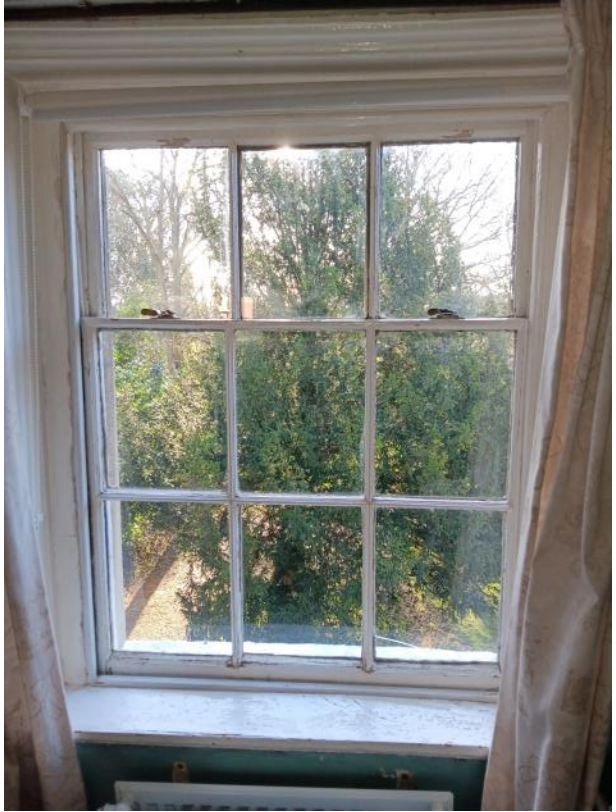
<b>Location</b>	West wing First floor South side	
<b>Type</b>	Sliding sash window	
<b>Strategy</b>	Some historic value and capable of retention if desired	
<b>Item</b>	<b>Works/Observations</b>	<b>Tender</b>
<b>Dimensions</b>	Overall dimensions 1200 x 1100mm	
<b>Decoration</b>	Moderate to poor; prep and re-dec	
<b>Glazing</b>	The glazing has been rather crudely repaired in the bottom sash with a large build-up of putty and with window pane setts into the glazing bar to a variable depth; crude glazing to be replaced  1 no. cracked pane in the bottom sash; to be replaced	
<b>Operation</b>	The window aperture was clearly affected by distortion (sag at soffit). Both sashes were operable, although the top sash tended to drop open and the bottom sash was very stiff. There was a very large amount of play in the top sash as it seemed to be able to drop open diagonally. Cam fasteners were anachronistic  Easing operation required  New pulls, fasteners and pulleys recommended

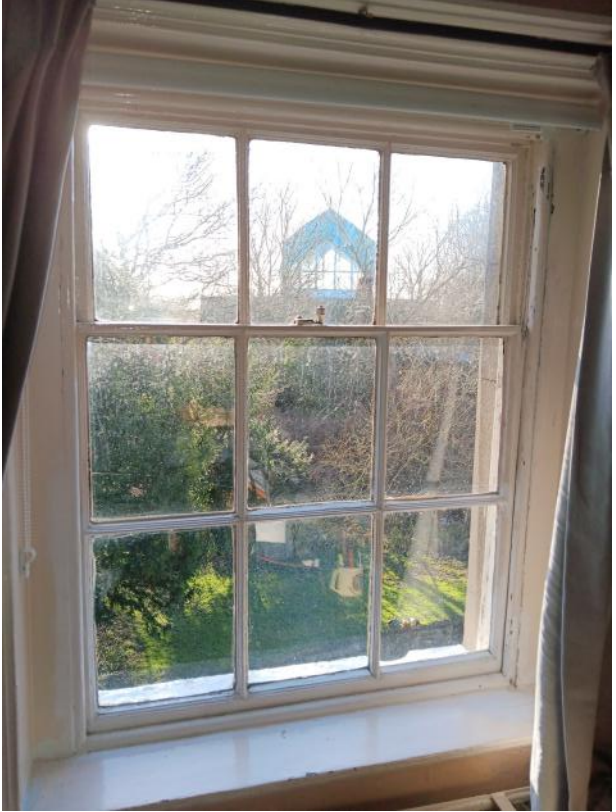
<b>Location</b>	West wing First floor South side	
<b>Type</b>	Sliding sash window	
<b>Strategy</b>	Some historic value and capable of retention if desired	
<b>Item</b>	<b>Works/Observations</b>	<b>Tender</b>
<b>Dimensions</b>	Overall dimensions 1200 x 1100mm  Sash thickness was approximately 35mm	
<b>Decoration</b>	Moderate to poor; prep and re-dec	
<b>Timber decay</b>	History of decay in the lower corner of the frame and sill (disguised by filler and paint); provisionally allow for further filler repair if found necessary	
<b>Operation</b>	Top sash has been painted shut; ease operation  Historic fastener remained operable

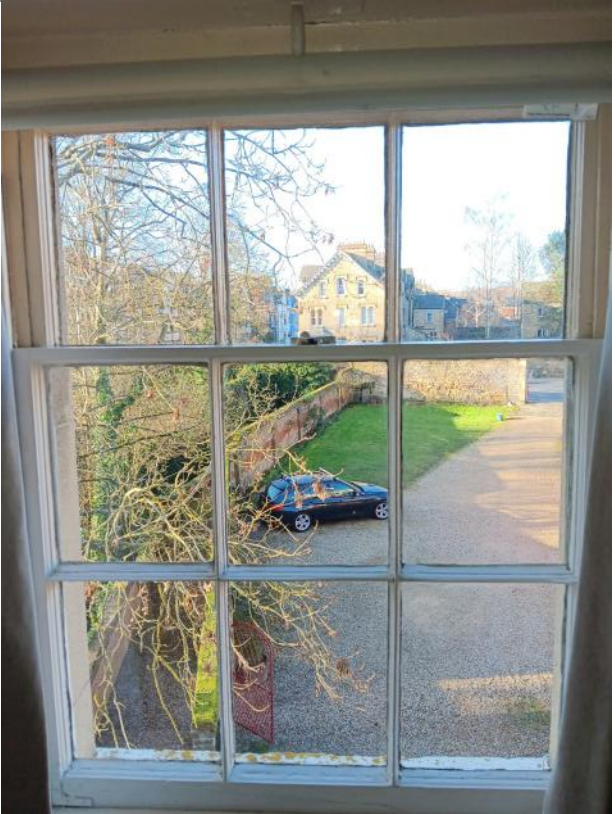
<b>Location</b>	West wing First floor West side	
<b>Type</b>	Sliding sash window	
<b>Strategy</b>	Some historic value and capable of retention if desired	
<b>Item</b>	<b>Works/Observations</b>	<b>Tender</b>
<b>Dimensions</b>	Overall dimensions 1200 x 1100mm	
<b>Decoration</b>	Moderate condition; prep and re-dec	
<b>Timber decay</b>	Bottom sash decayed at lower corners (metal bracket repair); provisionally allow to strengthen this repair as part of reinstating operation	
<b>Operation</b>	Top sash operable but unbalanced; adjust pulley weights  Bottom sash fixed shut (recently?); ease operation  Broken fastener; replace

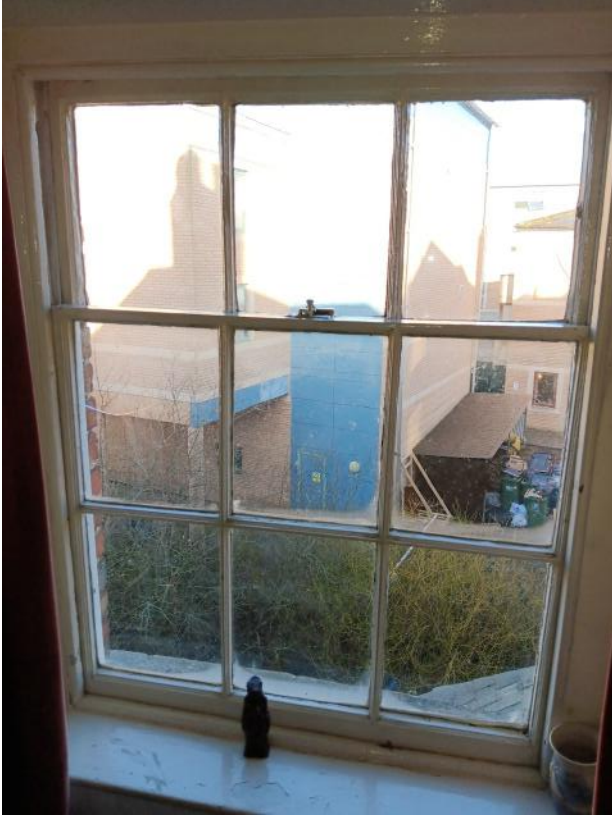
<b>Location</b>	West wing First floor North side	
<b>Type</b>	Sliding sash window	
<b>Strategy</b>	Some historic value and capable of retention if desired	
<b>Item</b>	<b>Works/Observations</b>	<b>Tender</b>
<b>Dimensions</b>	Overall dimensions 1200 x 1100mm	
<b>Decoration</b>	Moderate condition; prep and re-dec	
<b>Glazing</b>	There was 1 no. broken pane within the bottom sash; replace	
<b>Operation</b>	Fastener remained intact and serviceable  Top sash operable but unbalanced; adjust pulley weights  Bottom sash operable but tended to jar due to excessive play; ease operation	
<b>Structure</b>	The external brick arch lintel has sagged above this window frame; Structural Engineer may call for this window unit to be removed in order to strengthen lintel above
