# Hutton + Rostron Environmental Investigations Limited

## Grandpont House, Oxford: Window and door unit investigation

Site note 5 for December 2023-January 2024, job no. 160-42

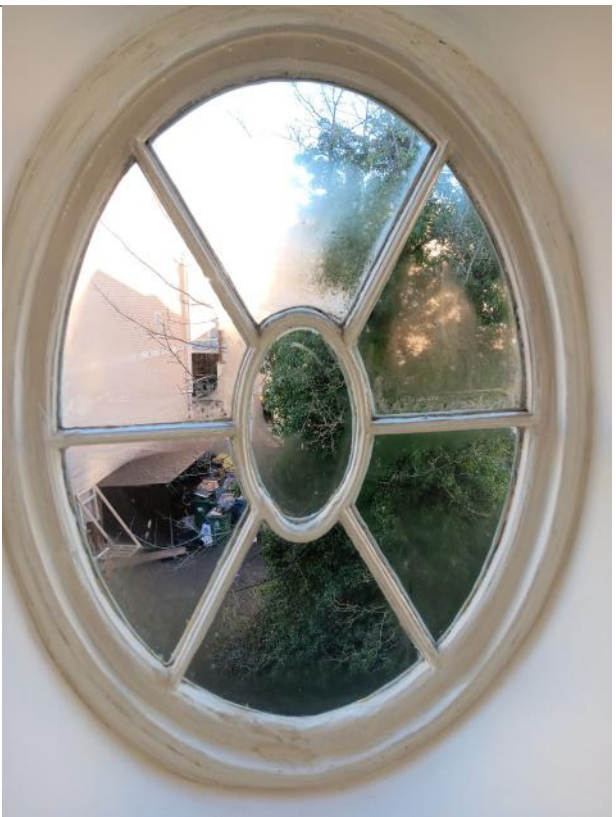
<b>Location</b>	West wing First floor North side	
<b>Type</b>	Oval shaped oculus window	
<b>Strategy</b>	Some historic value and capable of retention if desired	
<b>Item</b>	<b>Works/Observations</b>	<b>Tender</b>
<b>Dimensions</b>	~600mm high	
<b>Decoration</b>	Moderate condition; prep and re-dec	
<b>Timber decay</b>	There was evidence of previous filler repairs to broken/decayed/split sections of the glazing bar in the lower parts of the centre pane and bottom pane although these seemed intact	
<b>Operation</b>	Seemed to be a fixed frame design, although these are sometimes found to be centre pivot tilted on other similar buildings; reinstatement of operation can be considered (if desired)

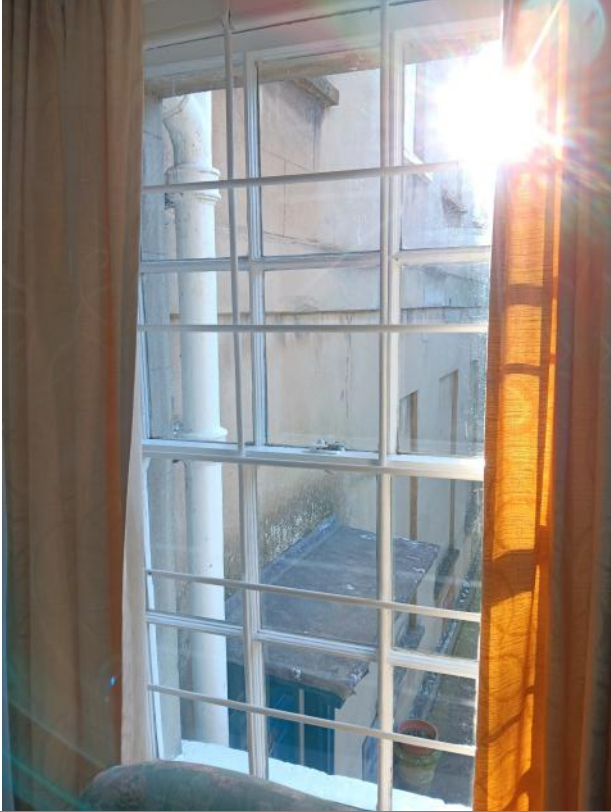
<b>Location</b>	West wing Mezzanine above ground flr South side	
<b>Type</b>	Sliding sash window	
<b>Strategy</b>	Seemingly a later generation of joinery (plain horns at the sash corner joints) . Horns on the bottom sash for example are fairly non-traditional and visually jarring. Non-original security bars had been fitted across the inside of the window  Could justify replacement if desired	
<b>Item</b>	<b>Works/Observations</b>	<b>Tender</b>
<b>Dimensions</b>	Overall dimensions 1600 x 1000mm. Sashes measured 35mm thick	
<b>Decoration</b>	Good  Remove security bars if desired	
<b>Timber decay</b>	No visible decay	
<b>Operation</b>	The meeting rail fastener was broken; replace  The top sash is painted shut; ease operation

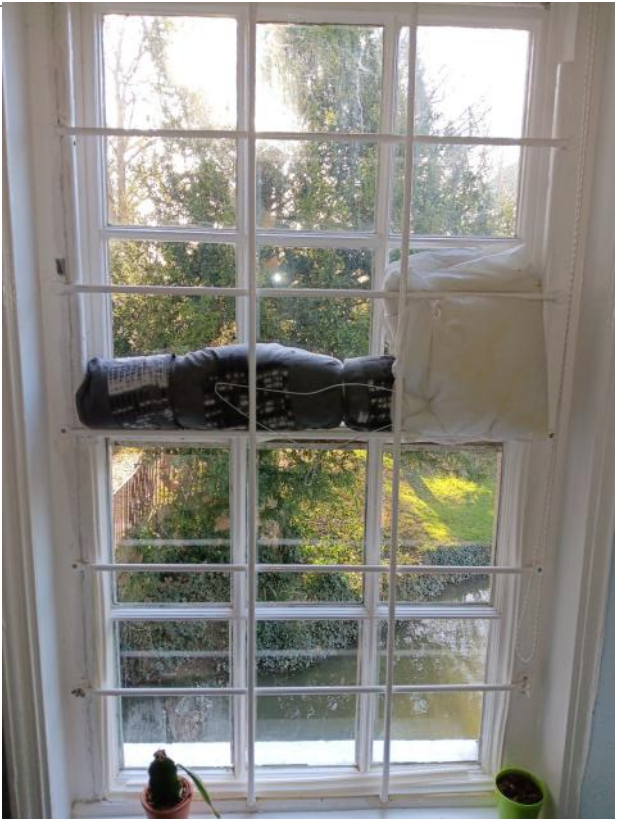
<b>Location</b>	West wing Mezzanine above ground flr South side	
<b>Type</b>	Sliding sash	
<b>Strategy</b>	Apparently a historic window (modern security bars); feasible to retain	
<b>Item</b>	<b>Works/Observations</b>	<b>Tender</b>
<b>Dimensions</b>	Overall dimensions 1600 x 1000mm	
<b>Decoration</b>	Moderate condition; prep and re-dec  Remove security bars if desired	
<b>Timber decay</b>	There was evidence of previous decay and patch repairs to the lower corners of the frame. This has been largely covered by a lead flashing and multiple coats of paint. It was notable that many of the external window sills had been covered in lead flashings which may disguise various defects and decay  Provisionally allow for repair	
<b>Operation</b>	The window seems to have seized in the ajar position with a permanent air flow through the top of the top sash (uncomfortable for occupants during the winter months)  The bottom sash has been sealed shut or seized  The meeting rail fastener was intact

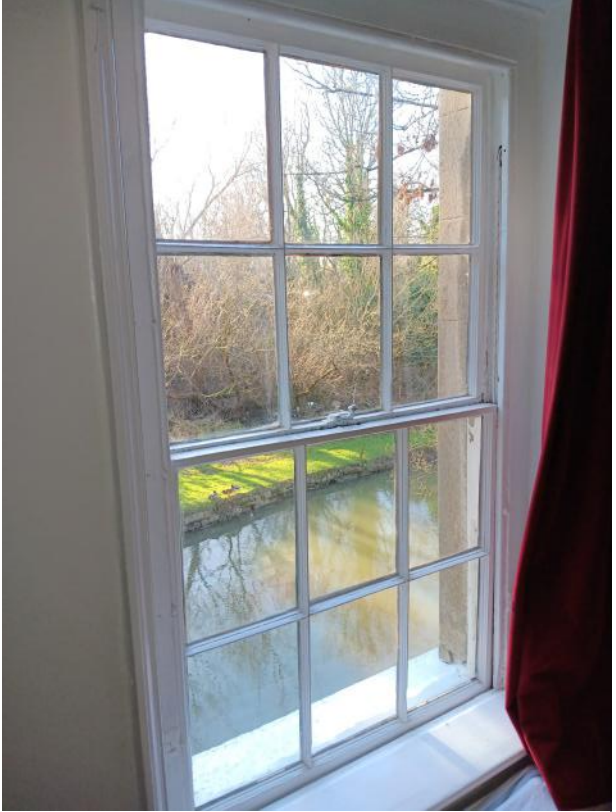
<b>Location</b>	West wing Mezzanine above ground flr South side	
<b>Type</b>	Sliding sash window	
<b>Strategy</b>	Apparently a historic window; feasible to retain	
<b>Item</b>	<b>Works/Observations</b>	<b>Tender</b>
<b>Dimensions</b>	Overall dimensions 1600 x 1000mm	
<b>Decoration</b>	Moderate condition; prep and re-dec	
<b>Timber decay</b>	The sill of the window seems to have been decayed/entirely lost (resulting in the bottom sash dropping lower than intended to the point that the meeting rails barely met); sill to be replaced	
<b>Operation</b>	The top sash was painted shut; ease operation  The bottom sash was operable but subject to significant play; ease operation

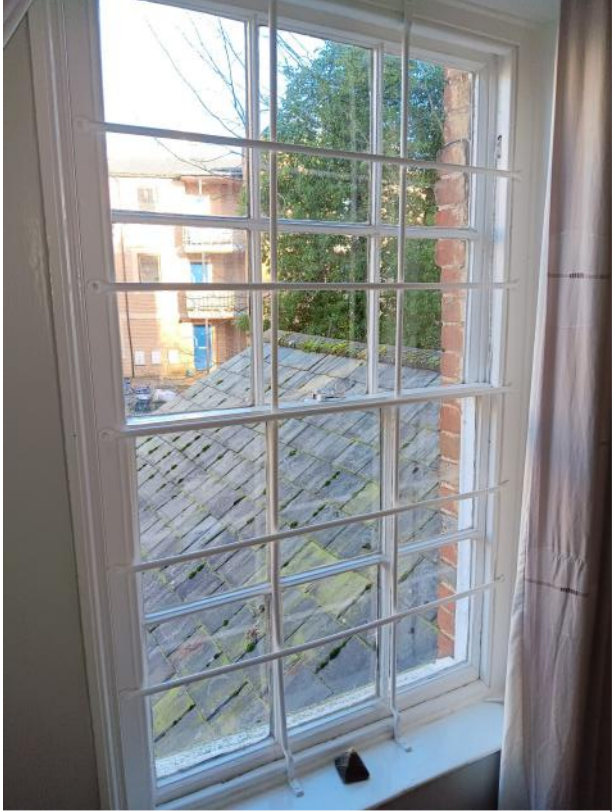
<b>Location</b>	West wing Mezzanine above ground flr North side	
<b>Type</b>	Sliding sash window	
<b>Strategy</b>	Apparently a historic window (modern security bars); feasible to retain	
<b>Item</b>	<b>Works/Observations</b>	<b>Tender</b>
<b>Dimensions</b>	Overall dimensions 1600 x 1000mm Sashes 35mm thick	
<b>Decoration</b>	Moderate condition; prep and re-dec Remove security bars if desired	
<b>Glazing</b>	The top sash showed 1 no. cracked pane; replacement	
<b>Damage</b>	The meeting rail fastener was operable Top sash has been painted shut; ease operation The bottom sash appeared to have been useable recently but was currently seized. The east pulley cord for the bottom sash has snapped; ease operation

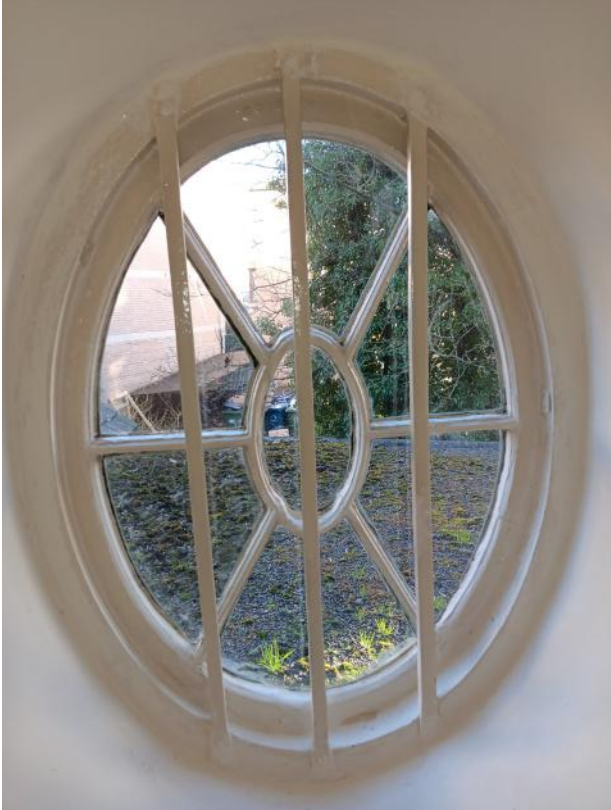
<b>Location</b>	West wing Mezzanine above ground flr North side	
<b>Type</b>	Oval shaped oculus window	
<b>Strategy</b>	Some historic value and capable of retention if desired  Security bars also historic	
<b>Item</b>	<b>Works/Observations</b>	<b>Tender</b>
<b>Dimensions</b>	~600mm high	
<b>Decoration</b>	Moderate condition; prep and re-dec	
<b>Timber decay</b>	There was evidence of previous filler repairs to broken/decayed/split sections of the glazing bar in the lower parts of the centre pane and bottom pane although these seemed intact	
<b>Operation</b>	Seemed to be a fixed frame design, although these are sometimes found to be centre pivot tilted on other similar buildings; reinstatement of operation can be considered (if desired and only if security bars were to be removed)

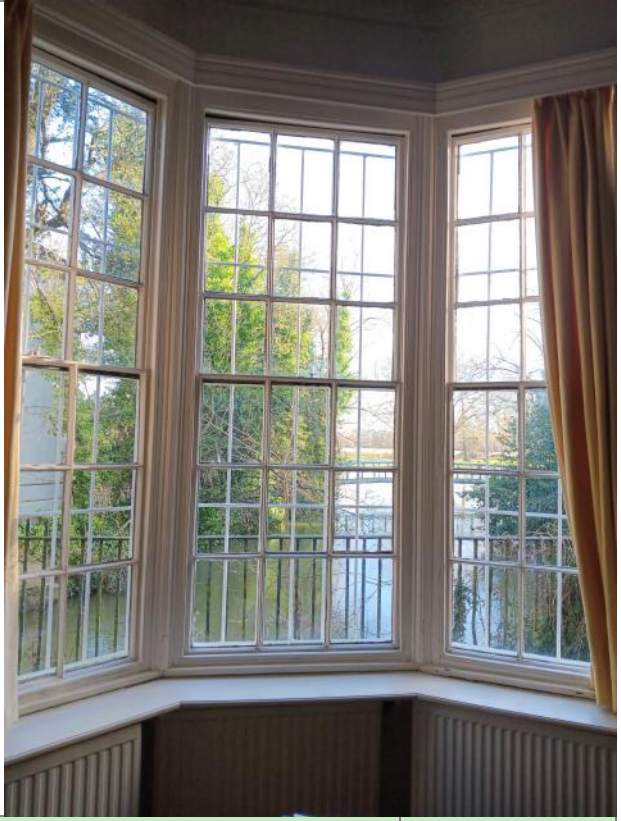
<b>Location</b>	Main House Ground floor East side	
<b>Type</b>	Triple sash window in cant- ed bay format	
<b>Strategy</b>	Historic window joinery, rel- atively recent metal security bars fitted externally; feasi- ble to refurbish	
<b>Item</b>	<b>Works/Observations</b>	<b>Tender</b>
<b>Dimensions</b>	Each window measured 2300 x 1000mm	
<b>Decoration</b>	Moderate condition; prep and re-dec  Remove security bars if desired	
<b>Timber decay</b>	The overall aperture of the window has distorted historically, consistent with the outermost edge of the bay dropping. This had created unequal gaps at the top of the top sashes; Structural Engineer to comment in terms of whether aperture distortion can be corrected or not  As view externally, the sill has been replaced in a very crude combination of softwood packing elements (disguised by the lead flashing); to be replaced

<b>Glazing</b>	There was 1 no. cracked pane in the top sash of the north window and 1 no. cracked or heavily scratched pane in the top sash of the centre window; allow to replace these	
<b>Operation</b>	Of the 6 no. sashes, only the bottom sash in the centre window was operable; operation to be eased  All 3 no. fasteners at the meeting rails were present, although they were in poor condition; all pulls, fasteners and pulleys to be replaced

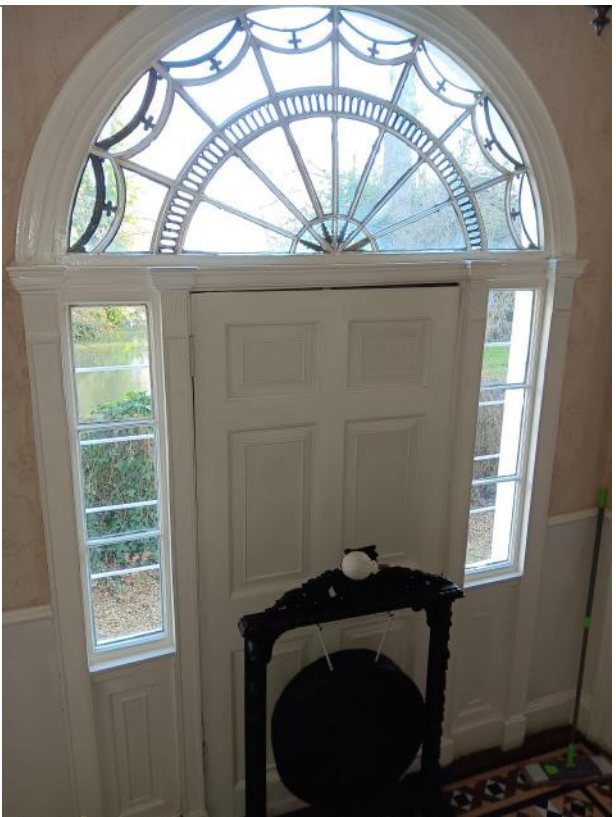
<b>Location</b>	Main House Ground floor East side	
<b>Type</b>	Panelled door, fanlight above, flanking windows and spandrel panels	
<b>Strategy</b>	High historic value (although door leaf itself may not be original), priority to refurbish	
<b>Item</b>	<b>Works/Observations</b>	<b>Tender</b>
<b>Dimensions</b>	Overall aperture size 3000 x 2000mm	
<b>Decoration</b>	Moderate condition; prep and re-dec	
<b>Timber decay</b>	<p>Fanlight remained in fairly good condition but has possibly lost an external cornice/hood feature which ran across the top of the door; Architect to reinstate according to historically appropriate design</p> <p>The aperture seems to have been affected by structural movement in the vicinity (north edge of aperture has dropped relative to the south); Structural Engineer to comment in terms of whether aperture distortion can be corrected or not</p> <p>The lower part of the south spandrel panel was decayed by wet rot. This seems to have been a recurrent issue across the base of the frame and paneling generally, although patch repairs had been conducted over time; provisionally allow for further piece-in/filler repairs</p>

<b>Operation</b>	<p>The door has been sealed shut/disused for many years; ease operation</p> <p>All furniture was missing from the exterior and the internal door lockbox was in a fairly poor state; historically appropriate furniture specified by the Architect to be reinstated</p> <p>The base of the door also had been fitted with a section of trim moulding which may disguise decay or an open gap allowing a draught; if the door is to be reinstated for use, draught stripping can be added</p>

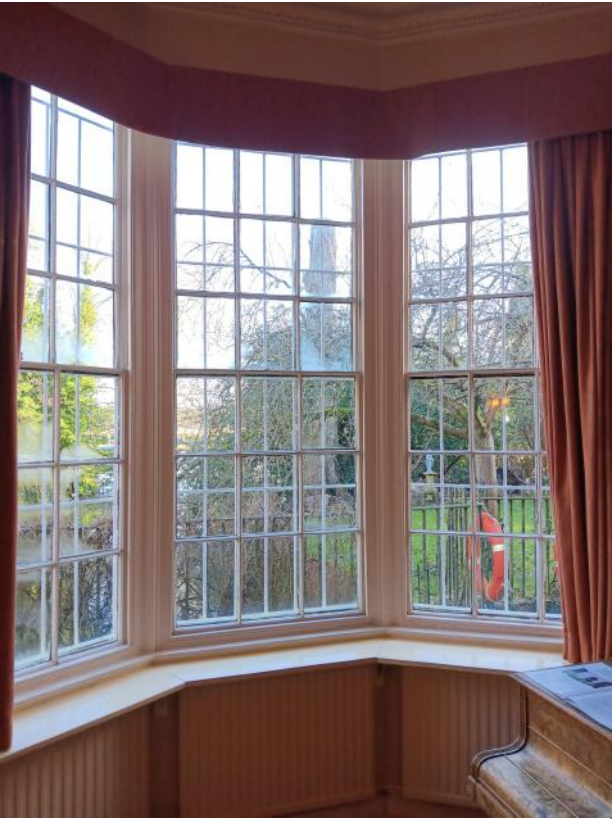
<b>Location</b>	Main House Ground floor East side	
<b>Type</b>	Triple sash window in cant- ed bay format	
<b>Strategy</b>	Historic window joinery, rel- atively recent metal security bars fitted externally; feasi- ble to refurbish	
<b>Item</b>	<b>Works/Observations</b>	<b>Tender</b>
<b>Dimensions</b>	Overall aperture size 3000 x 2000mm	
<b>Decoration</b>	Moderate condition; prep and re-dec  Remove security bars if desired	
<b>Timber decay</b>	Replace all external sills (3no.) due to crude modern works and partial decay  The overall aperture of the window has distorted historically, consistent with the outermost edge of the bay dropping. This had created unequal gaps at the top of the top sashes; Structural Engineer to comment in terms of whether aperture distortion can be corrected or not	
<b>Operation</b>	Of the 6 no. sashes, only the bottom sash in the centre window was operable; ease operation  The meeting rail fasteners were either missing or damaged; all pulls, fasteners and pulleys to be replaced

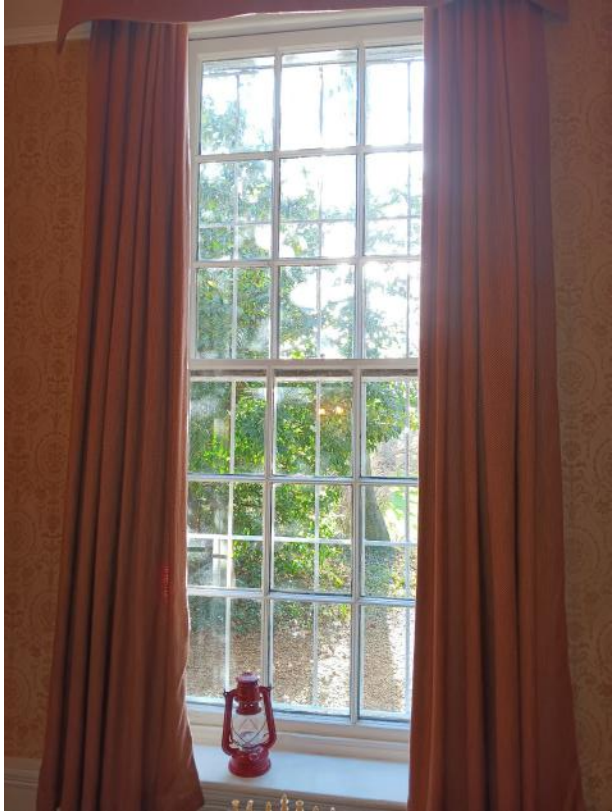
<b>Location</b>	Main House Ground floor South side	
<b>Type</b>	Sliding sash window	
<b>Strategy</b>	Historic window joinery, relatively recent metal security bars fitted externally; feasible to refurbish	
<b>Item</b>	<b>Works/Observations</b>	<b>Tender</b>
<b>Dimensions</b>	Overall dimensions 2200 x 1100mm	
<b>Decoration</b>	Moderate condition; prep and re-dec  Remove security bars if desired	
<b>Timber decay</b>	Heavily decayed sill externally; to be replaced	
<b>Operation</b>	The meeting rail fasteners no longer met correctly at the centre due to decay of sill; see rectification above  The fastener at the meeting rail remained in-situ  The top sash was painted shut and the bottom sash was seized; ease operation

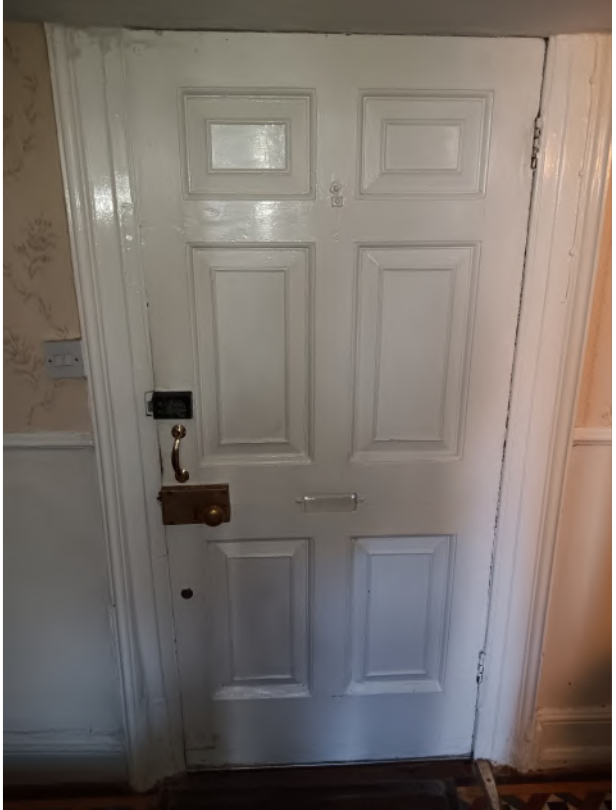
<b>Location</b>	Main House Ground floor West side	
<b>Type</b>	The door was a historic Georgian detail in a 6 panel format with a panelled surround and lead flashed canopy	
<b>Strategy</b>	High historic value, priority to refurbish	
<b>Item</b>	<b>Works/Observations</b>	<b>Tender</b>
<b>Dimensions</b>	The overall aperture size was 2000 x 1200mm	
<b>Decoration</b>	Moderate condition; prep and re-dec	
<b>Timber decay</b>	<p>The base of the frame was decayed up to the height of approximately 100mm at both sides; splice repair required</p> <p>Decay in the base of the frame also reflected the architraves both internally and externally and the adjoining skirting boards; splice repair required</p> <p>The original weatherboard from the bottom of the door has been lost and replaced in a plain square board (it may have originally been moulded); reinstate historically appropriate weatherboard if desired</p> <p>Brass furniture was present in the form of a letterbox, knocker and doorknob; the other more modern elements of furniture could be removed/replaced if desired</p>

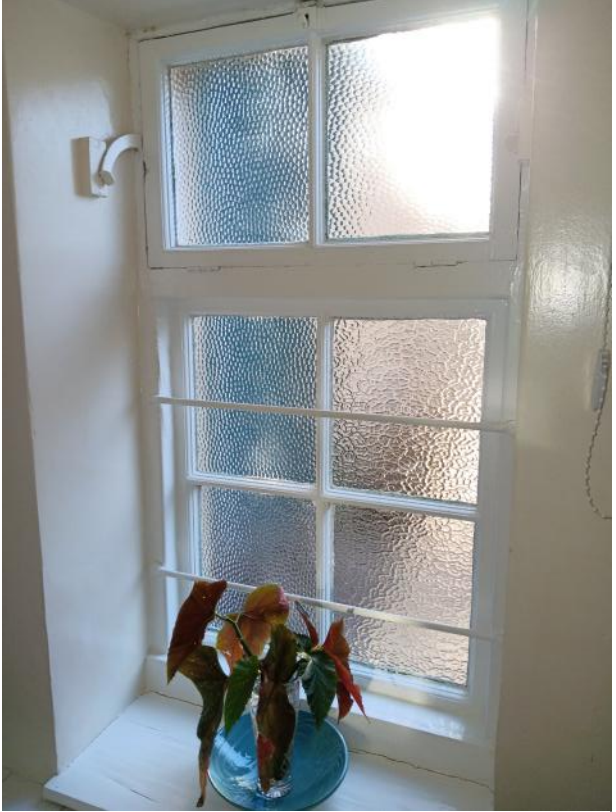
<b>Location</b>	West wing Ground floor South side	
<b>Type</b>	Timber frame window with bottom hung casement  Modern security bars	
<b>Strategy</b>	The window seems to have been much altered on what may have been a sash orig- inally; potentially justified to replace	
<b>Item</b>	<b>Works/Observations</b>	<b>Tender</b>
<b>Dimensions</b>	Overall aperture size 1400 x 750mm	
<b>Decoration</b>	Moderate condition; prep and re-dec  Remove security bars if desired	
<b>Timber decay</b>	Internal window board (modern) has been heavily decayed by fungus; replace with DPM laid at underside  The base of the frame was partially decayed at least at the east side (to rectify this may make it more appropriate to replace the entire window unit)	
<b>Damage</b>	The casement was seized; ease operation

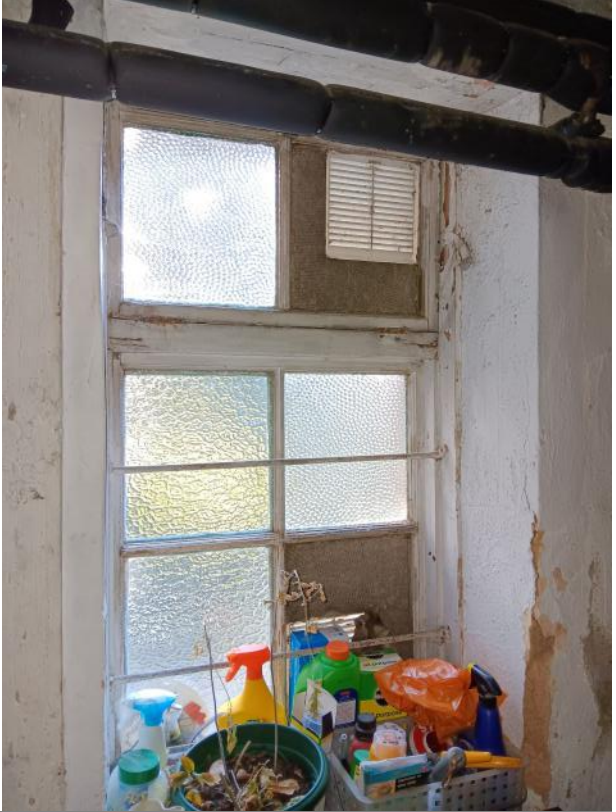
<b>Location</b>	West wing Ground floor South side	
<b>Type</b>	Timber frame window with bottom hung casement  Modern security bars	
<b>Strategy</b>	The window seems to have been much altered on what may have been a sash orig- inally; potentially justified to replace  Fibre-cement panels may contain asbestos!	
<b>Item</b>	<b>Works/Observations</b>	<b>Tender</b>
<b>Dimensions</b>	Overall aperture size 1400 x 750mm	
<b>Decoration</b>	Poor  (window replacement recommended)	
<b>Timber decay</b>	As viewed externally, the base of the frame and sill were decayed across their surfaces  (window replacement recommended)

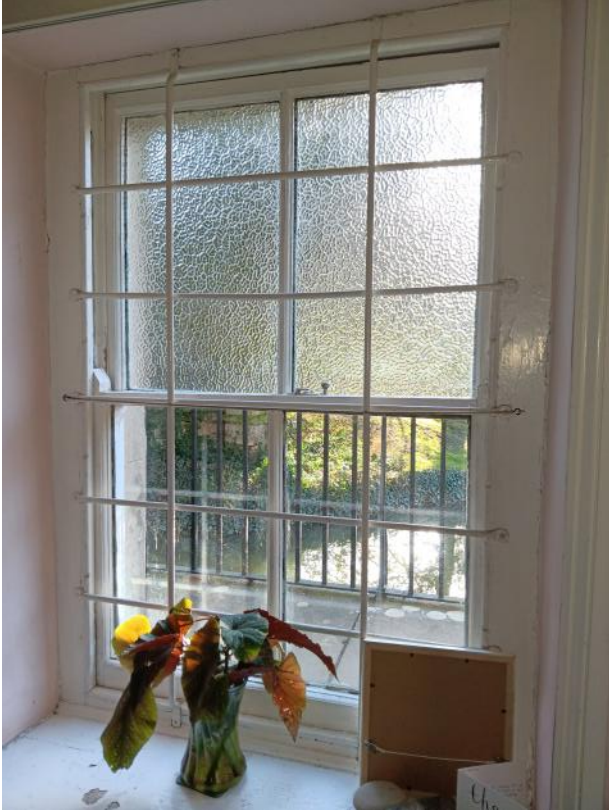
<b>Location</b>	West wing Ground floor South side	
<b>Type</b>	Sliding sash window  Internal security bars had been fitted later  The top sash closing was obscured	
<b>Strategy</b>	The sashes were a later generation of joinery with very thick glazing bars and horned features at the corner joints similar to those seen in the floor above at window 33; potentially justified to replace if desired	
<b>Item</b>	<b>Works/Observations</b>	<b>Tender</b>
<b>Dimensions</b>	Overall dimensions 1400 x 1100mm	
<b>Decoration</b>	Moderate condition; prep and re-dec  Remove security bars if desired	
<b>Structure</b>	There may have been some distortion in the surrounding wall on the basis of unequal joints around the window	
<b>Operation</b>	There seemed to be an issue with the closure of one or both sashes which did not allow the meeting rails to close fully, such that the fastener could not be operated; to be rectified by easing operation  The top sash has been fixed shut by wooden blocks in the lining; allow to ease operation and possibly re-balance/replace pulley cords  The bottom sash was operable, although it seems that the joint with the glazing bar has been broken when this was used to pull the window open; joint repair/strengthening required

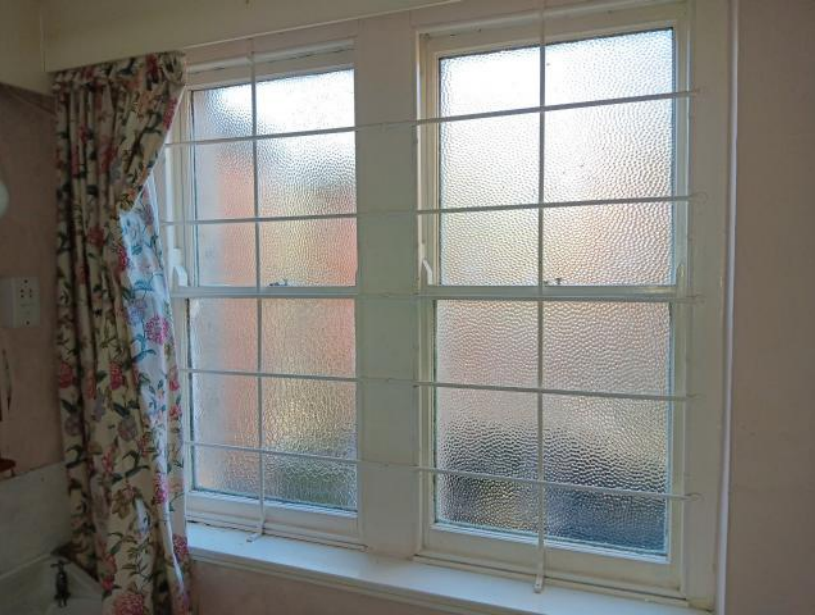
<b>Location</b>	West wing Ground floor West side	
<b>Type</b>	Pair of sliding sash windows  Horns were present at the corners of sashes and obscured glazing was used throughout  Modern internal security bars	
<b>Strategy</b>	This window was of a later generation of joinery similar to that seen in the adjoining window 45; potentially justified to replace if desired	
<b>Item</b>	<b>Works/Observations</b>	<b>Tender</b>
<b>Dimensions</b>	Overall combined aperture size 1500 x 1700mm	
<b>Decoration</b>	Moderate condition; prep and re-dec  Remove security bars if desired	
<b>Timber decay</b>		
<b>Operation</b>	Bottom sashes had been fully fixed shut by screwing blocks into the linings; reinstate operation  Top sashes had dropped-open historically which no longer allowed the meeting rails to close properly (filler has been installed in the gaps along the top of the top sash); reinstate operation and alignment

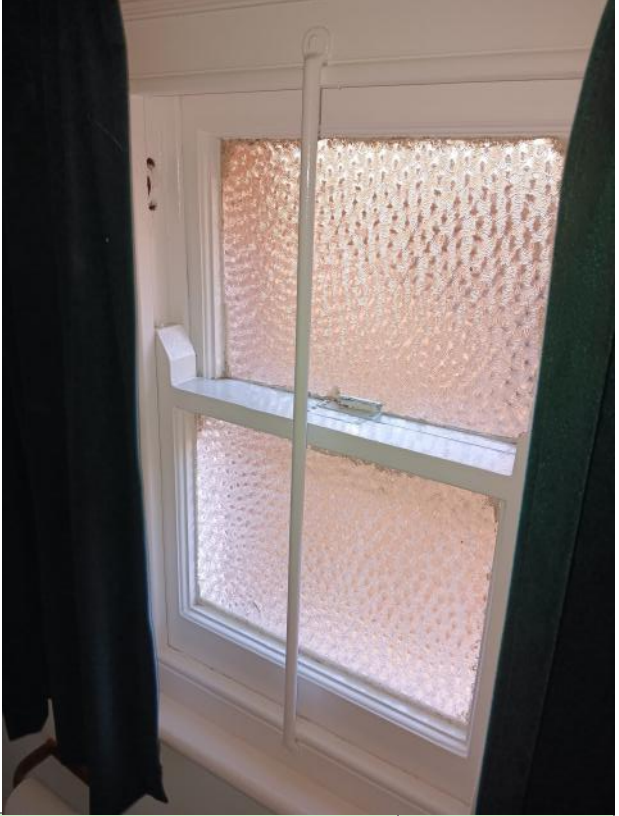
<b>Location</b>	West wing Ground floor West side	
<b>Type</b>	Modern sliding sash with horns at corners and obscured glazing  Internal security bar fitted	
<b>Strategy</b>	Feasible to retain if desired	
<b>Item</b>	<b>Works/Observations</b>	<b>Tender</b>
<b>Dimensions</b>	Overall aperture size 800 x 600mm	
<b>Decoration</b>	Good	
<b>Timber decay</b>	No apparent decay seen at this stage	
<b>Operation</b>	Both sashes had been painted shut, the meeting rail fastener was broken and both pulley cords were missing; ease operation (including opening the linings to attach new pulley cords)

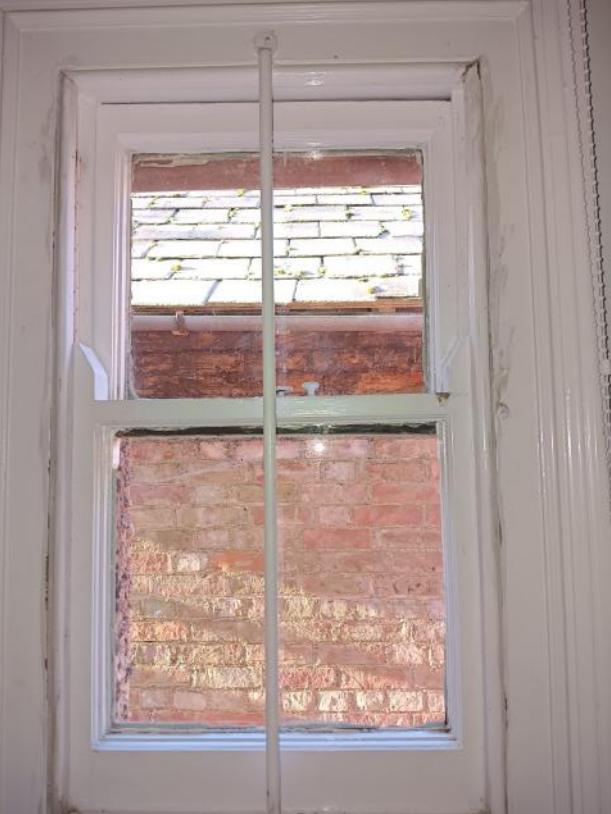
<b>Location</b>	West wing Ground floor West side	
<b>Type</b>	Modern sliding sash with horns at corners and obscured glazing  Internal security bar fitted	
<b>Strategy</b>		
<b>Item</b>	<b>Works/Observations</b>	<b>Tender</b>
<b>Dimensions</b>	Overall aperture size 1000 x 650mm	
<b>Decoration</b>	Good	
<b>Glazing</b>	Pane in bottom sash has cracked; replace if desired	
<b>Operation</b>	Meeting rails no longer meet due to sashes no fully closing. Top sash painted shut, bottom sash stiff but operable; ease operation  Meeting rail fastener remains

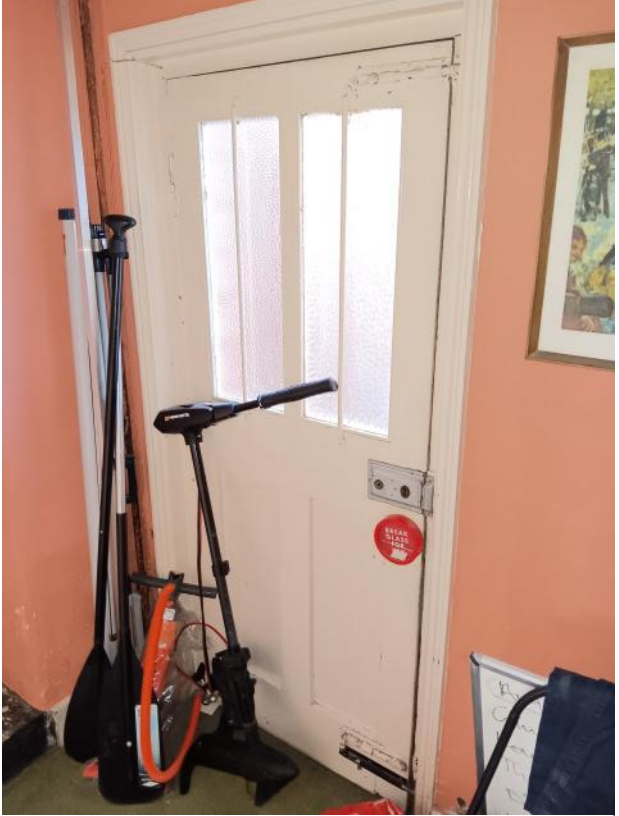
<b>Location</b>	West wing Ground floor North side	
<b>Type</b>	4 panel door  The upper panels were glazed in two types of obscured glass and had internal security bars fitted	
<b>Strategy</b>	Limited age and distortion may justify replacement	
<b>Item</b>	<b>Works/Observations</b>	<b>Tender</b>
<b>Dimensions</b>	Overall aperture size 2100 x 1000mm	
<b>Decoration</b>	Moderate; prep and re-dec (if door is to be retained)	
<b>Timber decay</b>	Splice repair decay at base of door frame (east side)	
<b>Operation</b>	The bottom of the door appeared to have warped and no longer fully closed; alter frame and furniture to suit profile of warped door (if door is to be retained)  Missing doorknob and poor deadbolts (possible danger to fire strategy if door cannot be easily opened!); furniture to be replaced (if door is to be retained)

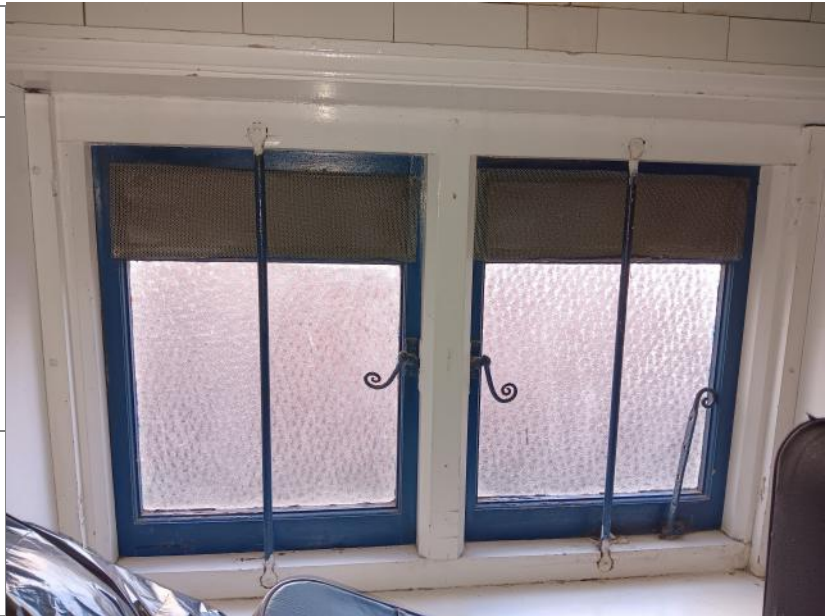
<b>Reference</b>	H+R window 50	
<b>Location</b>	West wing Ground floor North side	
<b>Type</b>	Pair of side hung casements with obscured glazing and monkey tail catches  Internal security bars	
<b>Strategy</b>	Refurbish if desired	
<b>Item</b>	<b>Works/Observations</b>	<b>Tender</b>
<b>Dimensions</b>	Overall aperture size 500 x 1200mm	
<b>Decoration</b>	Moderate; prep and re-dec	
<b>Operation</b>	There were originally monkey tail stays on each window but one of these was missing and the other was slightly broken; stays to be replaced if desired  Both casements were seized shut; ease operation

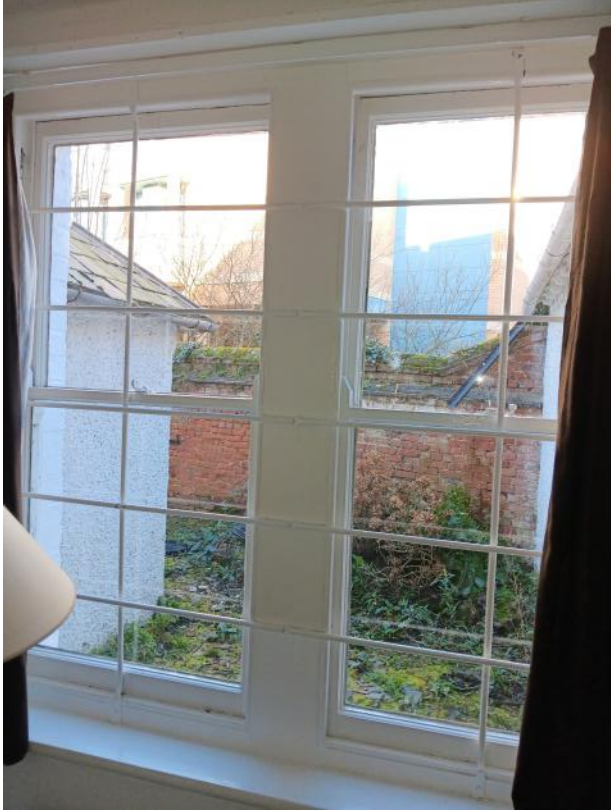
<b>Location</b>	West wing Ground floor North side	
<b>Type</b>	Pair of sliding sash windows  Security bars had been fitted internally	
<b>Strategy</b>	The generation of window joinery appeared fairly modern noted by the horns at the corner joints of the sashes; potentially justified to replace if desired	
<b>Item</b>	<b>Works/Observations</b>	<b>Tender</b>
<b>Dimensions</b>	Overall aperture size 1500 x 1700mm	
<b>Decoration</b>	Moderate condition; prep and re-dec  Remove security bars if desired	
<b>Timber decay</b>	There were no signs of decay at this stage	
<b>Damage</b>	The west window sashes were both seized shut; ease operation  The east window top sash was seized shut but the bottom sash was operable. However, the meeting rails did not close correctly which did not allow their fastener to engage; ease operation and correct alignment

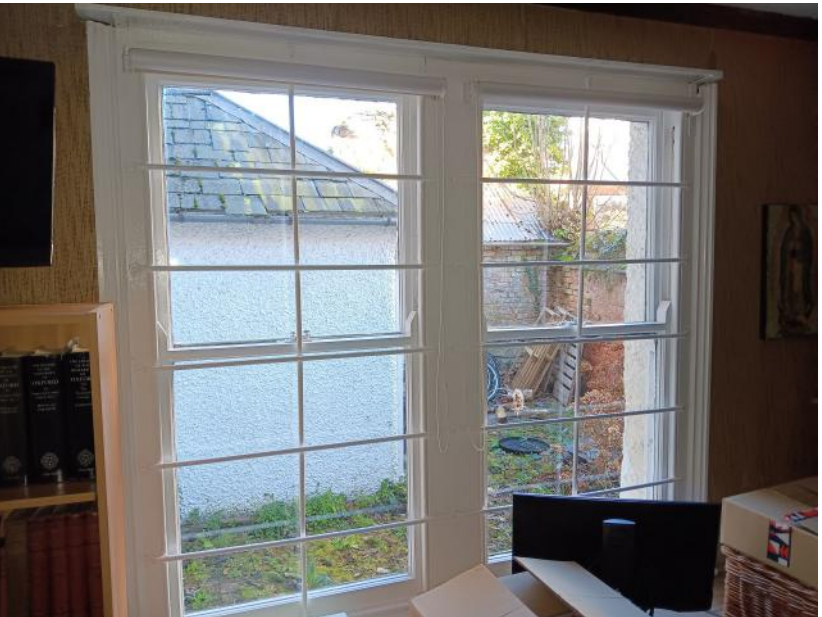
<b>Location</b>	West wing Ground floor North side	
<b>Type</b>	Pair of sash windows  Security bars had been fitted internally	
<b>Strategy</b>	The generation of window joinery appeared fairly modern noted by the horns at the corner joints of the sashes; potentially justified to replace if desired	
<b>Item</b>	<b>Works/Observations</b>	<b>Tender</b>
<b>Dimensions</b>	Overall aperture size 1500 x 1700mm	
<b>Decoration</b>	Moderate condition; prep and re-dec  Remove security bars if desired	
<b>Timber decay</b>	There were no signs of decay at this stage	
<b>Operation</b>	Both top sashes were painted shut; ease operation  Both bottom sashes were stiff but operable; ease operation  The fasteners at the meeting rails were of two different types suggesting previous repairs, they were both functional; replace furniture if desired

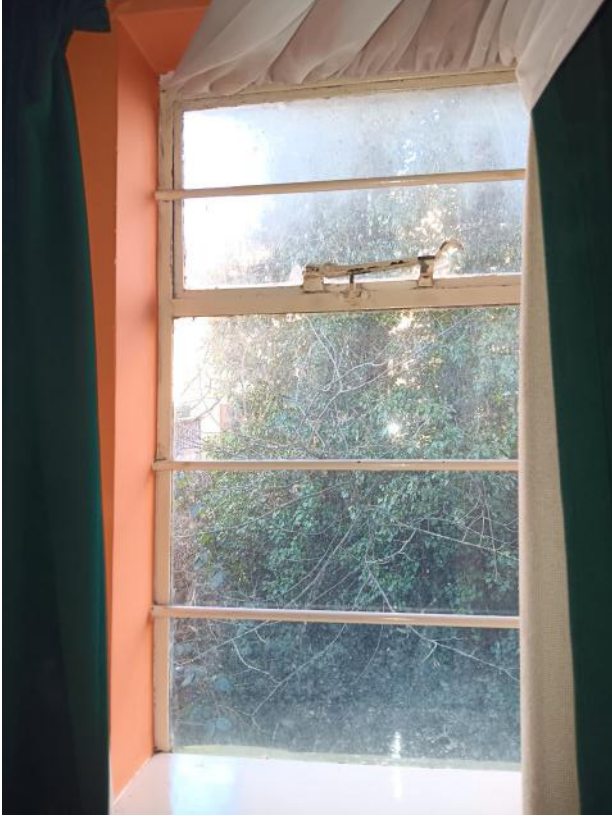
<b>Location</b>	Main House Ground floor North side	
<b>Type</b>	This was a modern early c20th wing of the building. The steel frame and single glazed windows were original to this period. All glazing was provided with security bars at the inner face	
<b>Strategy</b>	Poor thermal performance and limited historic value may justify replacement	
<b>Item</b>	<b>Works/Observations</b>	<b>Tender</b>
<b>Dimensions</b>	Overall aperture size 900 x 600mm	
<b>Decoration</b>	Moderate condition; prep and re-dec	
<b>Operation</b>	The upper pane was top hung casement which was operable
