Hutton + Rostron Environmental Investigations Limited

Grandpont House, Oxford: Chimney investigation

Site note 1 for December 2023-January 2024, job no. 160-42

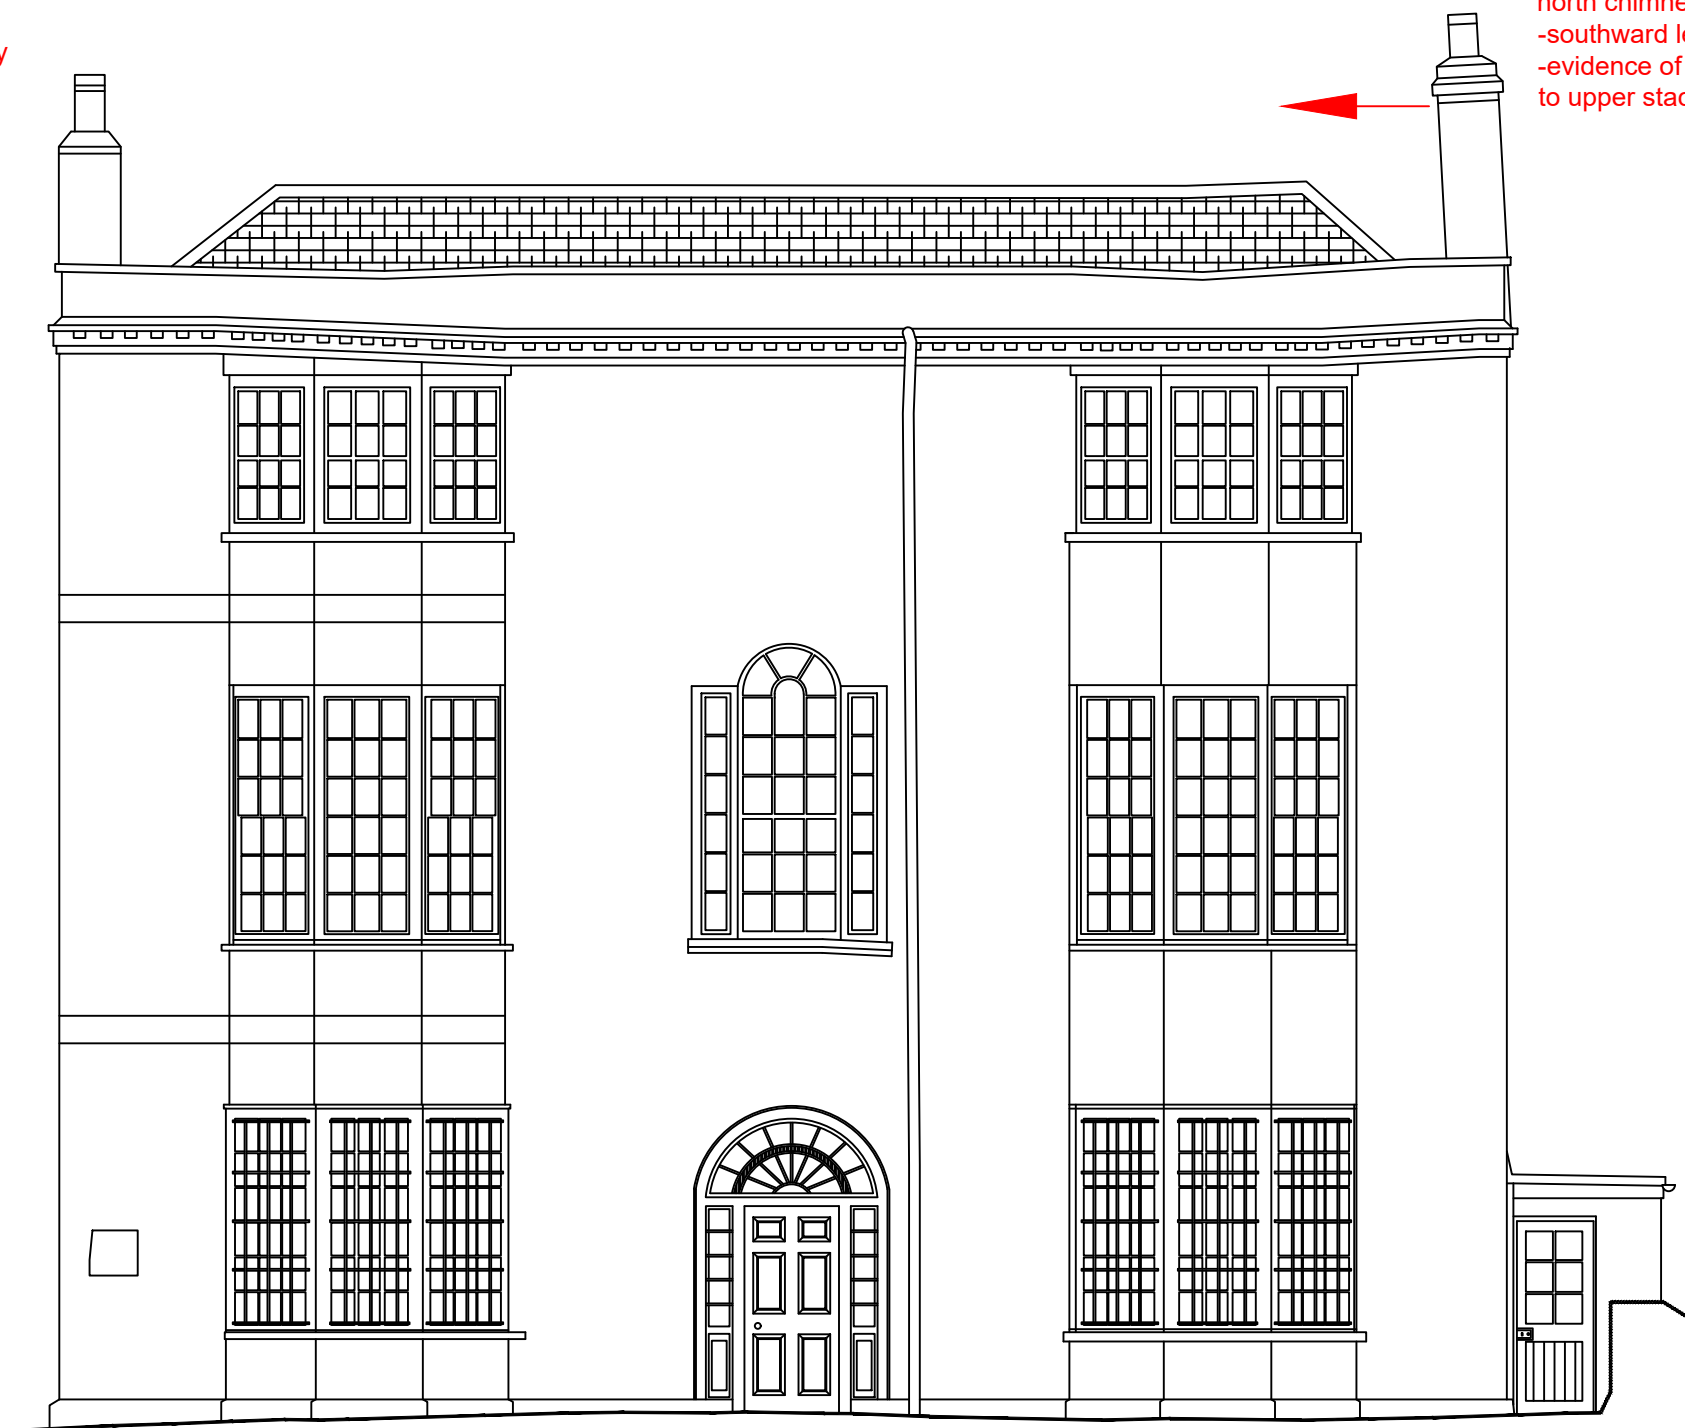
Grandpont House, Main House - East elevation
Chimney investigation
December 2023 - January 2024

north chimney:
-southward lean apparent
-evidence of previous re-build
to upper stack

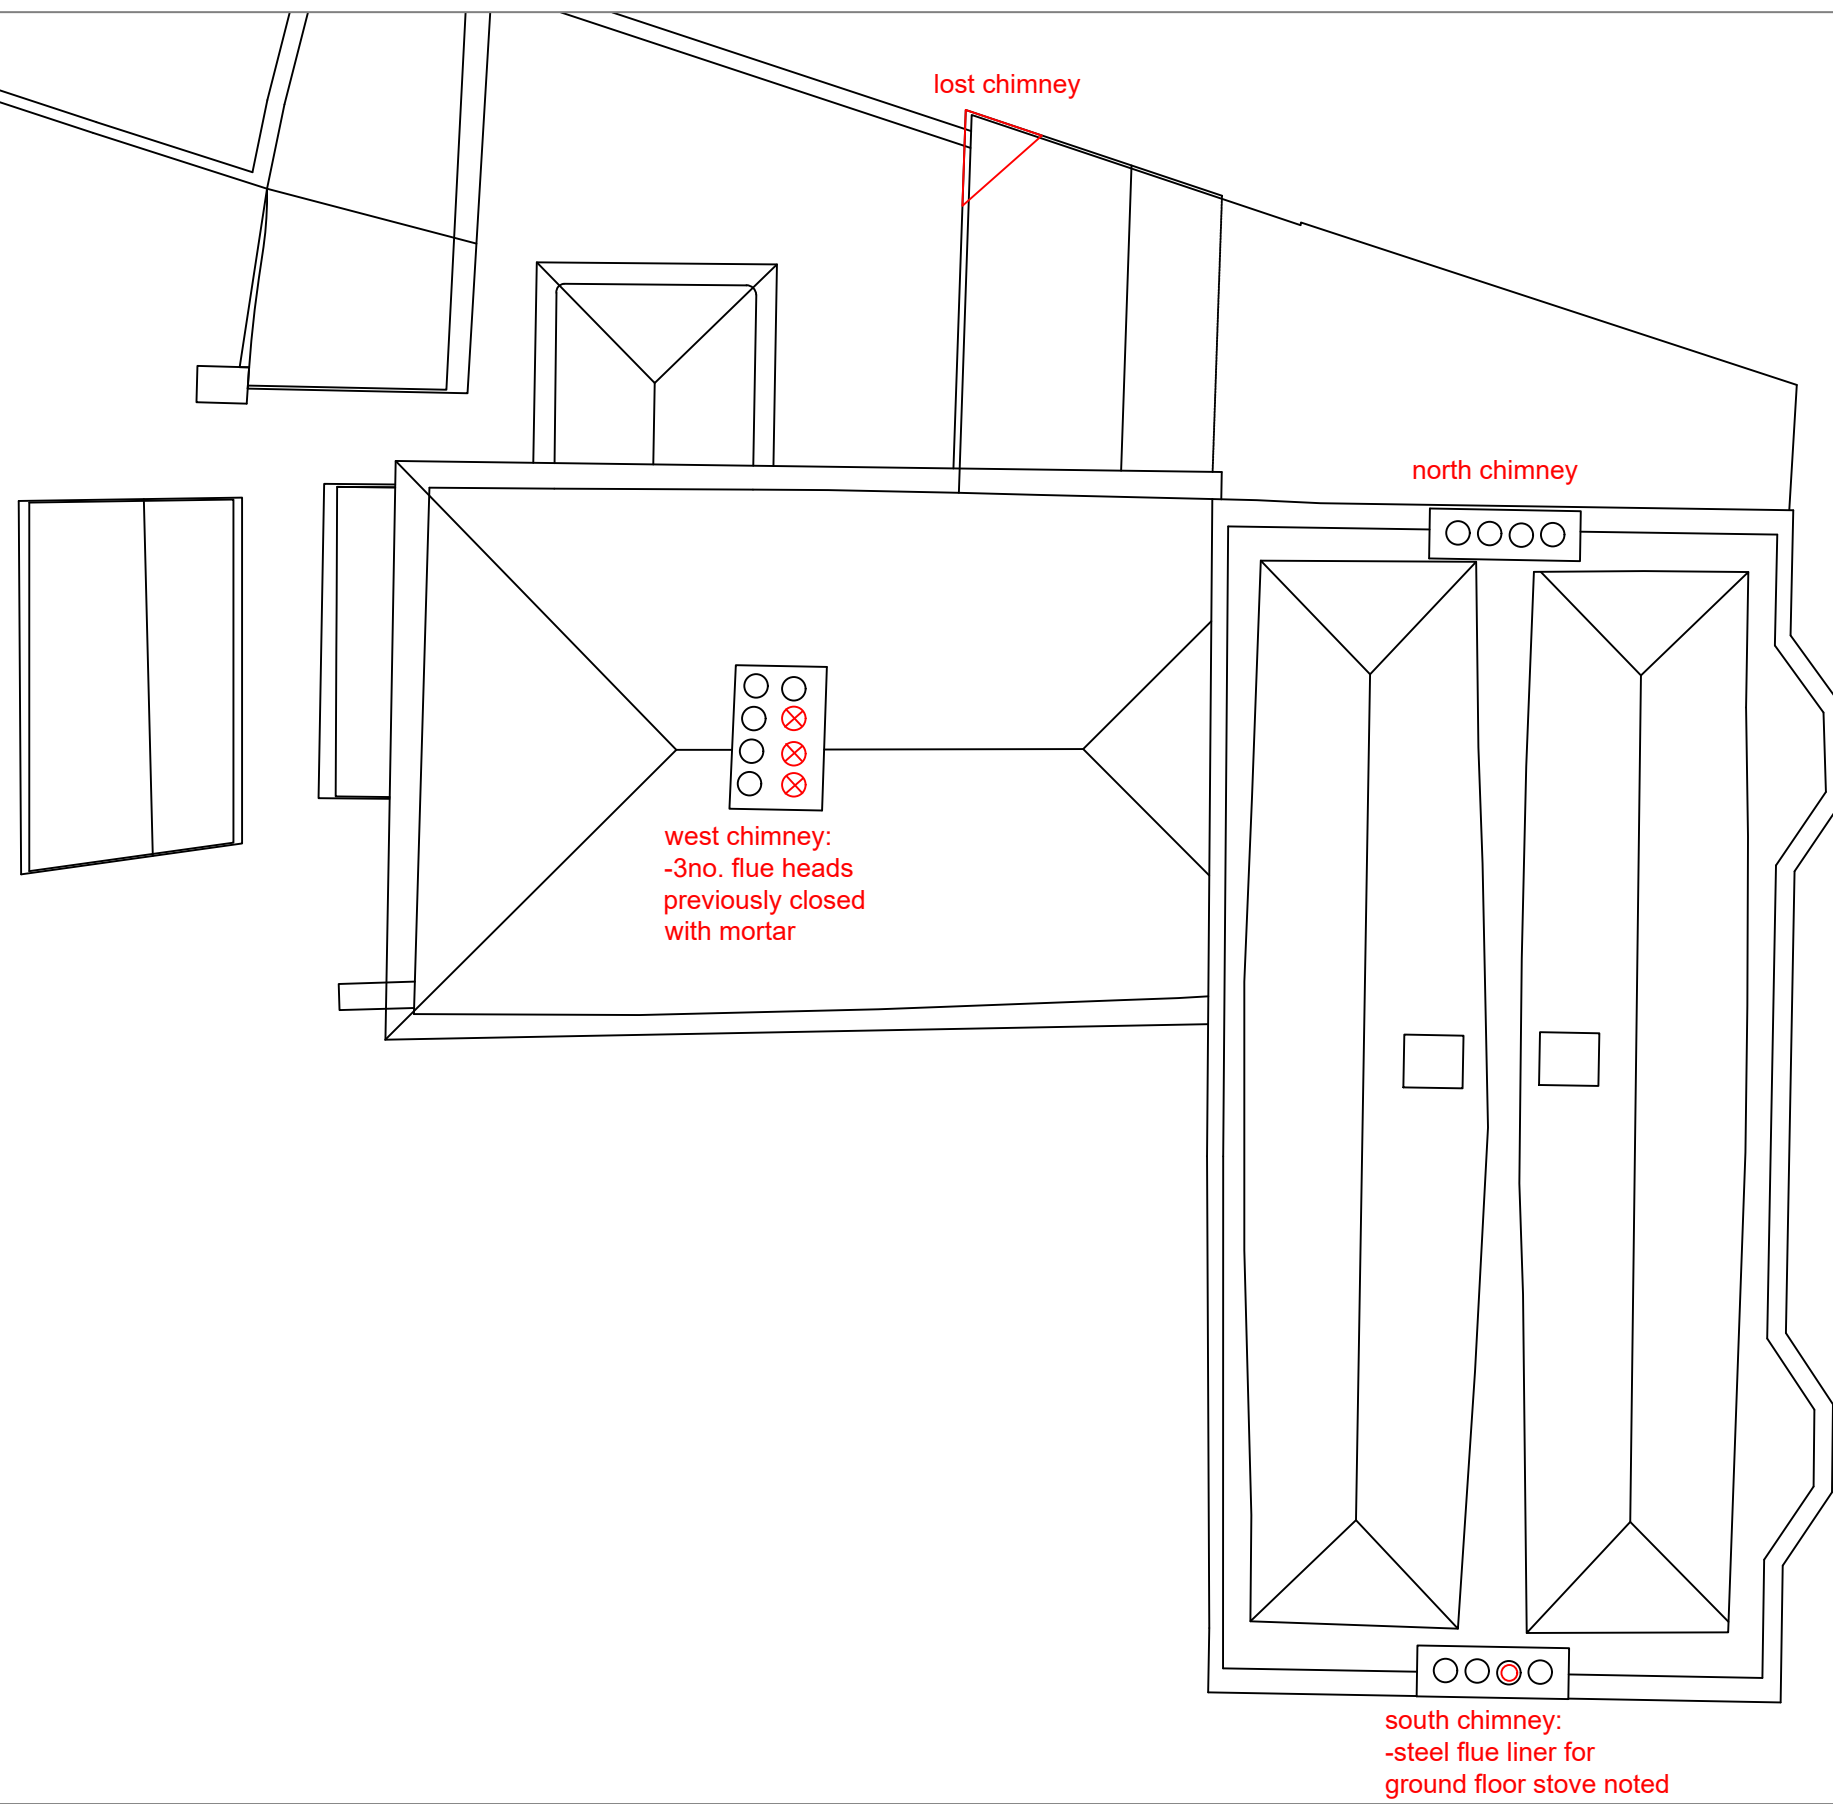
Grandpont House, Main House - Roof
Chimney investigation
December 2023 - January 2024

west chimney:
-3no. flue heads
previously closed
with mortar

south chimney:
-steel flue liner for
ground floor stove noted

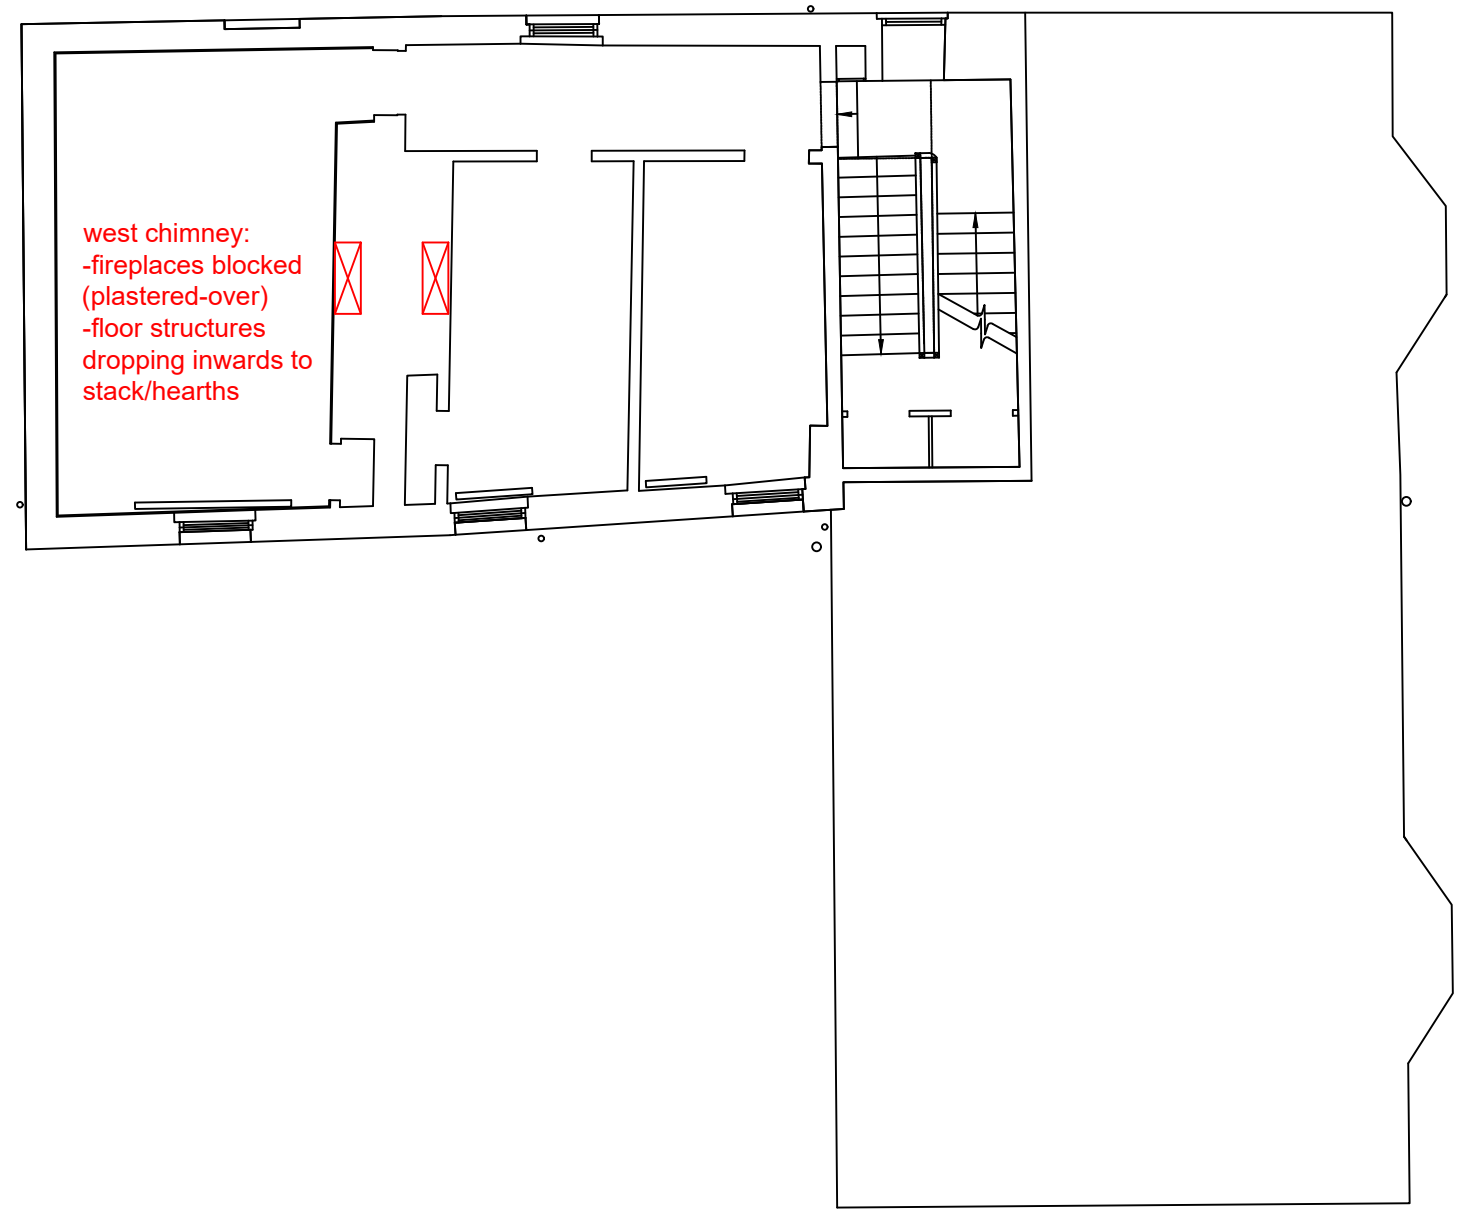
Grandpont House, Main House - Mezzanine above ground
Chimney investigation
December 2023 - January 2024

west chimney:
-fireplaces blocked
(plastered-over)
-floor structures
dropping inwards to
stack/hearths

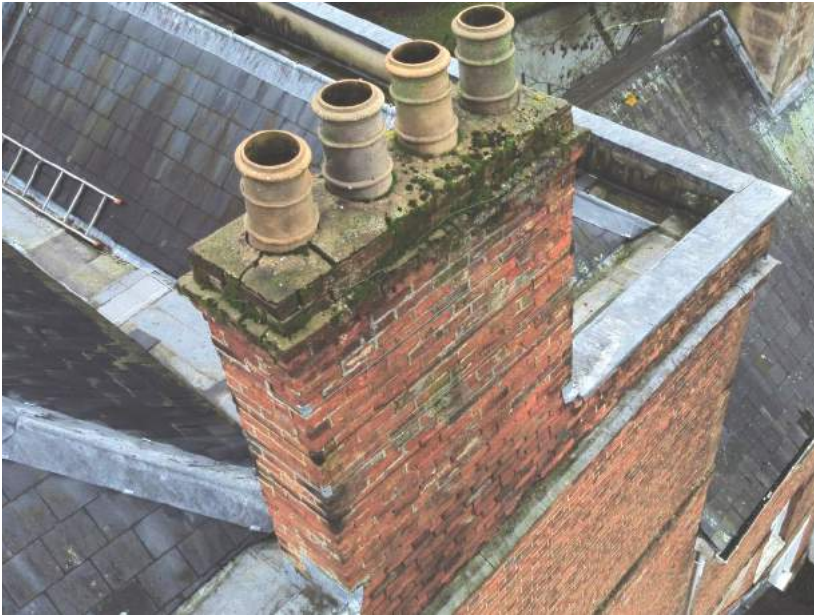
Fig 1:

External stack; showing north and east faces

Note mortar failure and cracked flaunching

Note stack was a non-original re-build

REFERENCE	ITEM	OBSERVATIONS	RECOMMENDATIONS	CLIENT COMMENTS
SN1.1 MAIN HOUSE, NORTH CHIMNEY				
SN1.1.1	Main house North chimney External stack	<p>4no. flues, assumed to have originally served two fireplaces at second floor, one fireplace at first floor and one fireplace at ground floor. Stack measured 2300mm high and 1860x600mm in section</p> <p>Internal fireplaces were lost or dis-used which limited airflow within the flue risers</p> <p>Pots were not fitted with cowls which allowed direct water penetration</p> <p>The brickwork stack above parapet level has been re-built (apparently within the last 150 years). Round yellow clay pots were also non-original. Presumably the re-build was to correct previous material deterioration in the original stack. The pronounced southward lean of the stack was suspected to be a recurrent defect which may have affected the original stack too. Leaning chimneystacks can develop by the effects of rain and flue gasses ('sulphate attack') but in this case it might also relate to movement of the timber frame which supports the north gable brickwork</p> <p>Flaunching mortar and pointing was cement-based. This has cracked and fallen-off in recent decades</p>	<p><i>H+R recommend that this stack is taken-down to parapet level and re-built to match the geometry and appearance of the original south stack (i.e. 1700mm height, limewashed lime render finish, corbeled head, square yellow clay pots)</i></p> <p><i>All dis-used flues should have cowl vents fitted within pots to shed direct water penetration whilst facilitating airflow</i></p> <p><i>A lead DPC/tray could be incorporated when the stack is re-built</i></p>

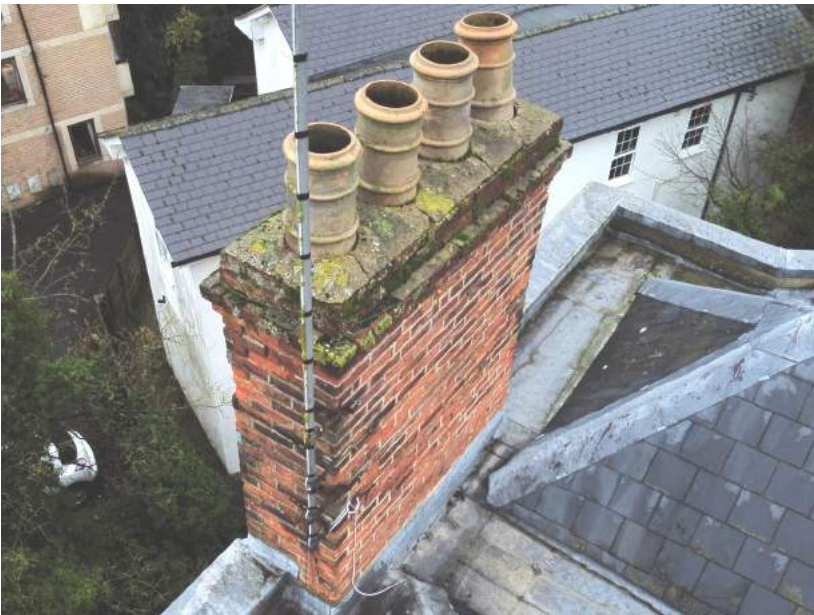
Fig 2:

External stack; showing south and west faces

Note stack has developed a southward lean (presumably a progressive issue given that it has been re-built in the past)

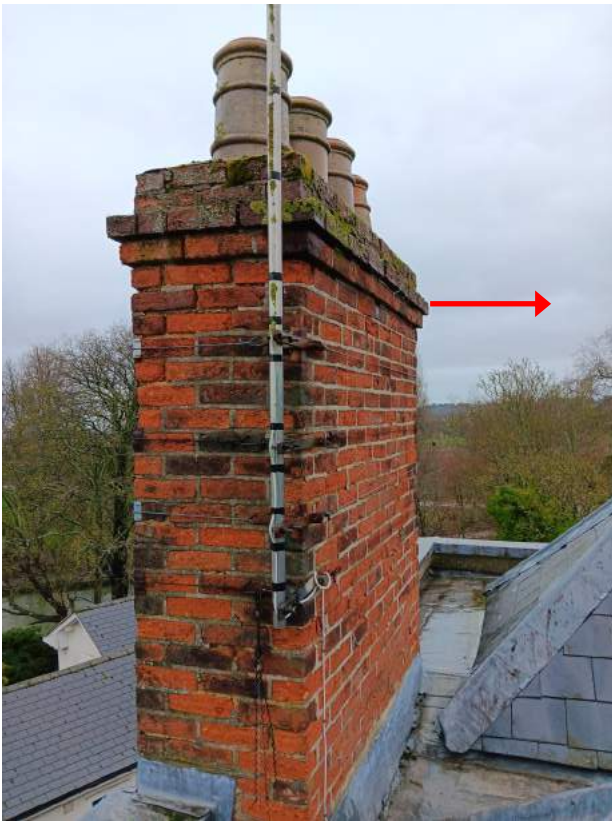
Fig 3:

External stack; showing mortar failure and southward lean

Note TV aerial attached by wire straps

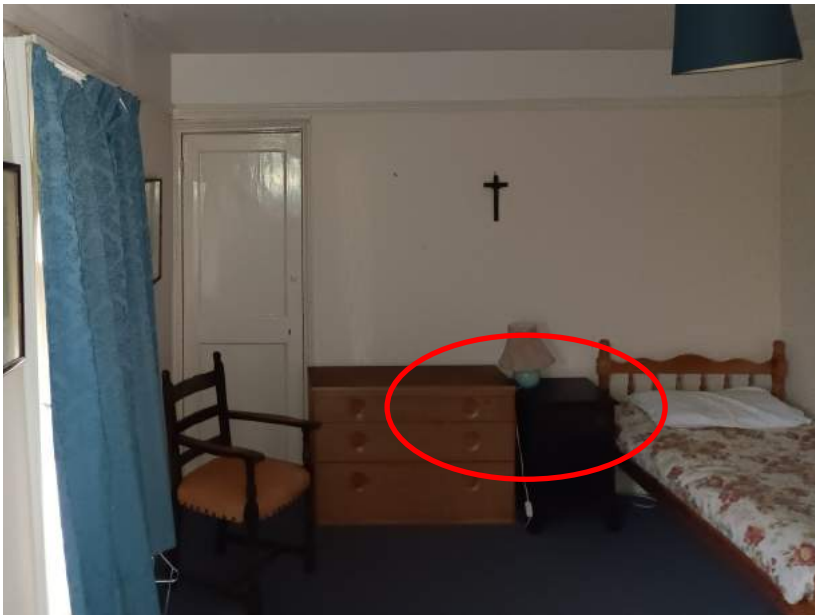
Fig 4:

Second floor; showing lost fireplace vent in north-west room

SN1.1.2	Main house North chimney Second floor	The north-east and north-west bedrooms retained the original chimneybreasts with 'press-cupboards' alongside. However, the fireplace apertures appear to have been blocked and plastered-over	<p><i>Both fireplace apertures should be re-opened and all debris swept-out of the flues</i></p> <p><i>A traditional fireplace surround could be reinstated or an insulated board wall lining installed. In either case, a trickle vent airbrick should be installed to allow airflow to run up the flue (from interior fireplace to exterior pot). The fire officer should review detailing of this; intumescent closures for the vents may be needed</i></p>	
SN1.1.3	Main house North chimney First floor	The chimneybreast, fireplace and decorative surround remained. The flue entrance itself had been closed with a board	<p><i>Board to be removed from the fireplace and all debris swept out of the flue</i></p> <p><i>Assuming that the fireplace will not be used in future as an open fire, a sensitively detailed closure should be provided for the flue entrance. This should include an air vent to allow airflow to run up the flue (from interior fireplace to exterior pot). The fire officer should review detailing of this; intumescent closure for the vent may be needed</i></p>

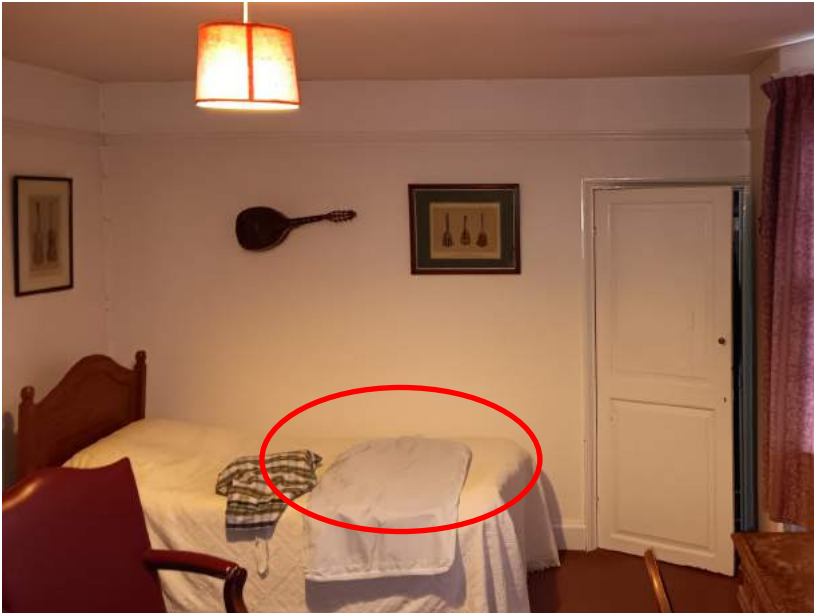
Fig 5:

Second floor; showing lost fireplace vent in north-east room

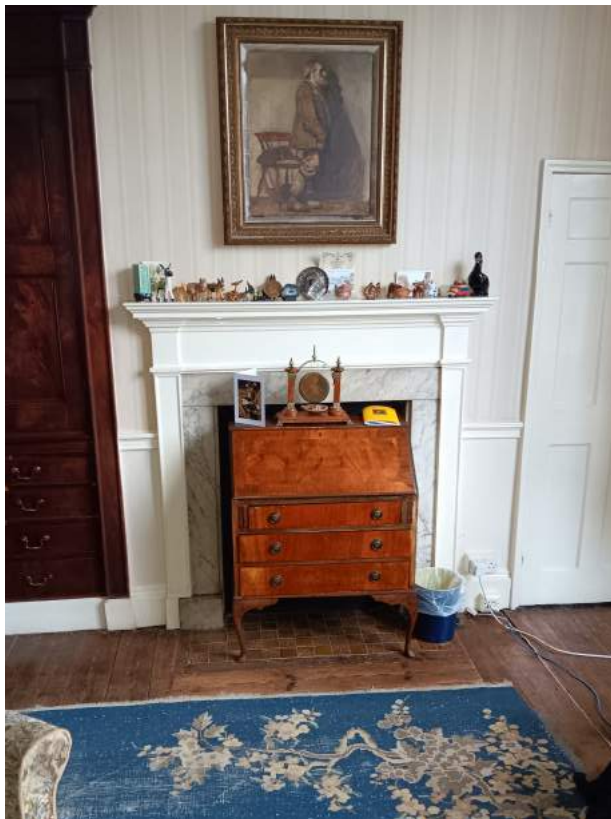
Fig 6:

First floor; showing fireplace (flue entrance closed by board)

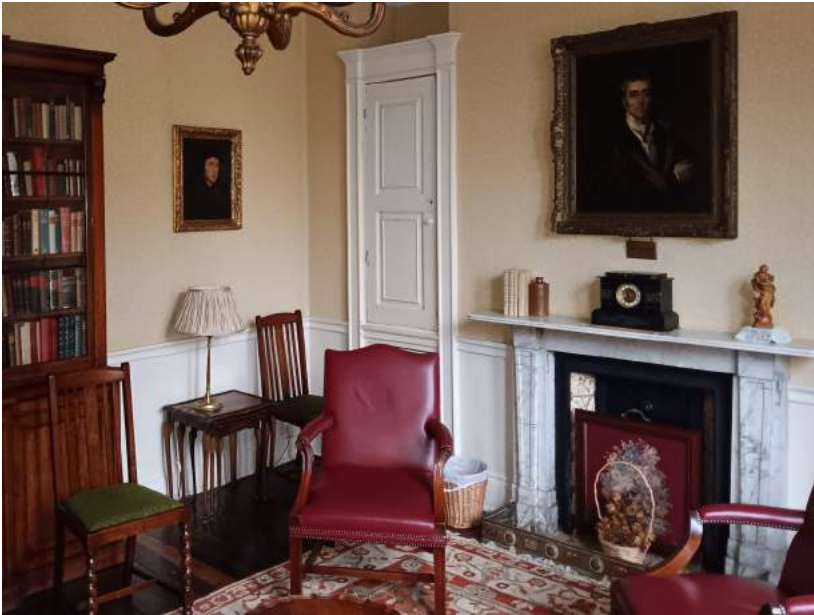
Fig 7:

Ground floor; showing fireplace

Note that the chimneybreast (at all floor levels) was flanked by 'press cupboards'

SN1.1.4	Main house North chimney Ground floor	The chimneybreast, fireplace and decorative surround remained. The flue entrance itself was assumed to have been closed with a board	<p><i>Board to be removed from the fireplace and all debris swept out of the flue</i></p> <p><i>Assuming that the fireplace will not be used in future as an open fire, a sensitively detailed closure should be provided for the flue entrance. This should include an air vent to allow airflow to run up the flue (from interior fireplace to exterior pot). The fire officer should review detailing of this; intumescent closure for the vent may be needed</i></p> <p><i>H+R can provide further advice on the north chimney, if instructed. Any proposals to reinstate operation of chimney systems for combustion should be according to the design of a fire engineer</i></p>

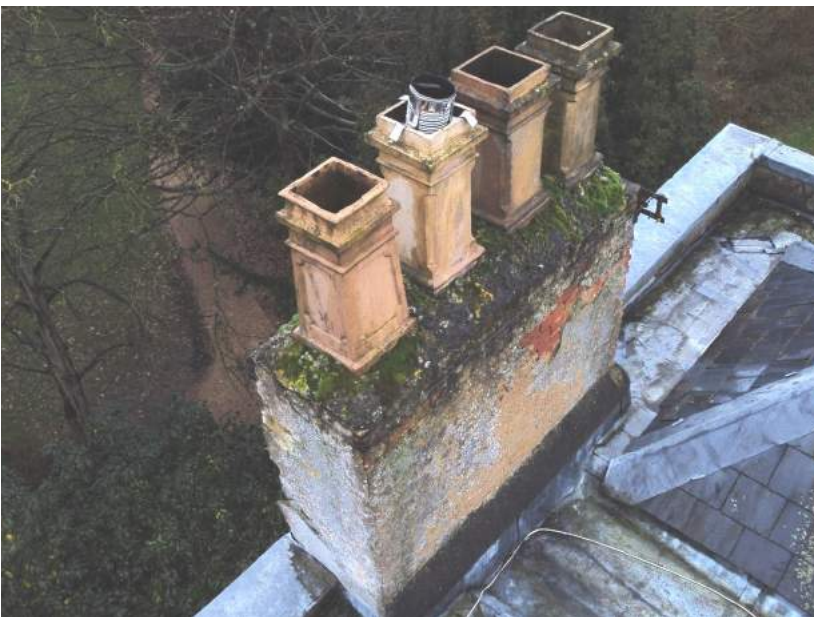
Fig 8:

External stack; showing north and east faces

Note render failure and degraded flaunching

Note stack was original although pots have been altered/replaced over time

Note metal flue liner serving ground floor stove

REFERENCE	ITEM	OBSERVATIONS	RECOMMENDATIONS	CLIENT COMMENTS
SN1.2 MAIN HOUSE, SOUTH CHIMNEY				
SN1.2.1	Main house South chimney External stack	<p>4no. flues, assumed to have originally served two fireplaces at second floor, one fireplace at first floor and one fireplace at ground floor. Stack measured 1700mm high and 1860x600mm in section</p> <p>Internal fireplaces were lost or steel-lined which limited airflow within the brick flue risers</p> <p>Pots were not fitted with cowls which allowed direct water penetration. The steel flue liner (1no.) was also missing a cowl</p> <p>The brickwork stack appeared original. The protective render coating was in a fragmentary state (missing in several patches). The render had likely originally been limewash although this has long since weathered-away. The south gable, within which the chimney was built, has been purposely stripped of the original protective render, leaving it vulnerable to driving rain. An original lead flashing remained at the upper string course projection</p> <p>The yellow clay pots were of two slightly different designs and had been seated at irregular heights (indicating previous replacement/repairs)</p>	<p><i>At this stage, H+R believe that the stack can be retained in-situ, subject to replacement of the original lime render and reinstatement of a limewash finish. The existing pots should also be lifted and re-laid into new lime mortar flashing</i></p> <p><i>All dis-used flues should have cowl vents fitted within pots to shed direct water penetration whilst facilitating airflow</i></p> <p><i>Restoration of the stack and the south gable façade should be co-ordinated (i.e. rendering and limewashing throughout in common materials)</i></p>

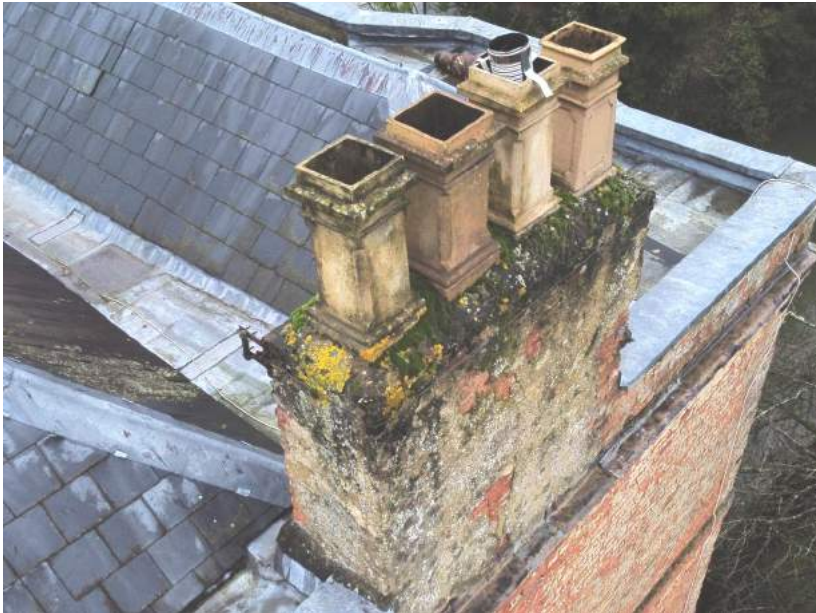
Fig 9:

External stack; showing south and west faces

Note render failure and degraded flaunching

Note redundant TV aerial bracket

Note remainder of south elevation has been stripped of the original protective render (lead flashed cornice/drip remains)

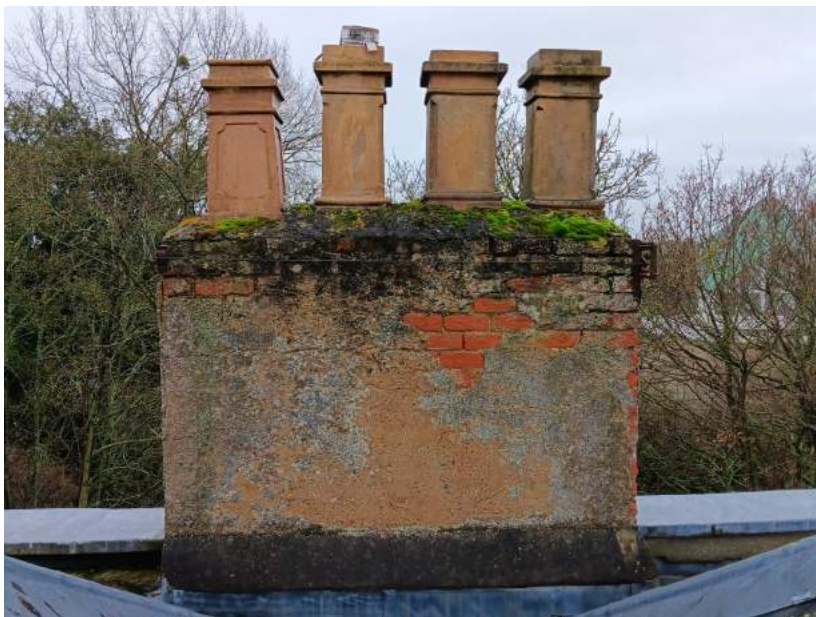
Fig 10:

External stack; showing render failure and irregularly seated chimneypots

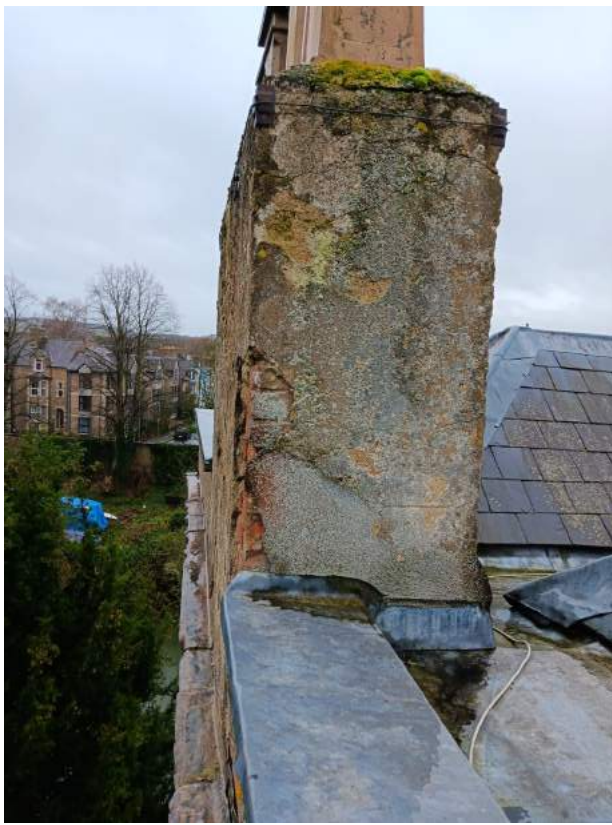
Fig 11:

External stack; showing render failure

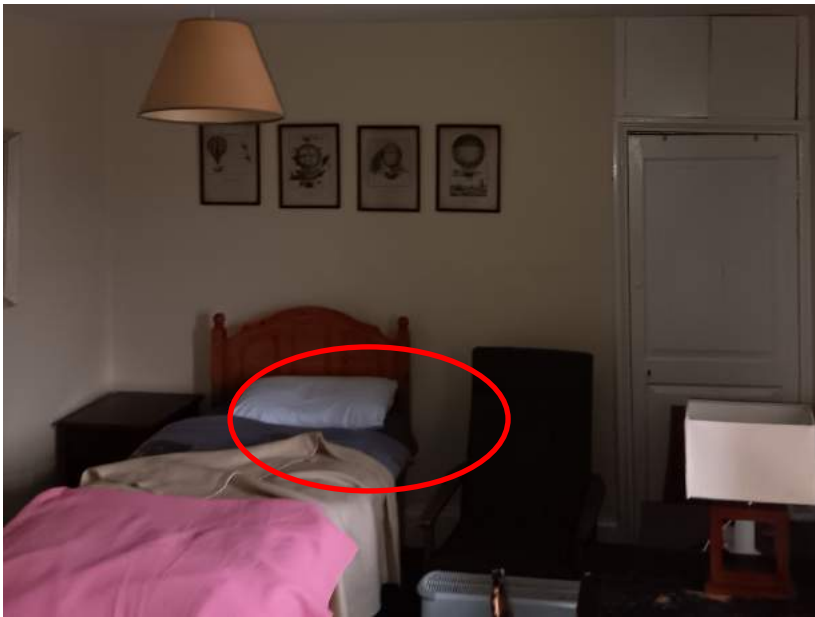
Fig 12:

Second floor; showing lost fireplace vent in south-west room

SN1.2.2	Main house South chimney Second floor	The south-east and south-west bedrooms retained the original chimneybreasts with 'press-cupboards' alongside. However, the fireplace apertures appear to have been blocked and plastered-over	<p><i>Both fireplace apertures should be re-opened and all debris swept-out of the flues</i></p> <p><i>A traditional fireplace surround could be reinstated or an insulated board wall lining installed. In either case, a trickle vent airbrick should be installed to allow airflow to run up the flue (from interior fireplace to exterior pot). The fire officer should review detailing of this; intumescent closures for the vents may be needed</i></p>	
SN1.2.3	Main house South chimney First floor	The original chimneybreasts remained although the fireplace aperture has been blocked and plastered-over	<p><i>The fireplace aperture should be re-opened and all debris swept-out of the flue</i></p> <p><i>A traditional fireplace surround could be reinstated or an insulated board wall lining installed. In either case, a trickle vent airbrick should be installed to allow airflow to run up the flue (from interior fireplace to exterior pot). The fire officer should review detailing of this; intumescent closures for the vents may be needed</i></p>

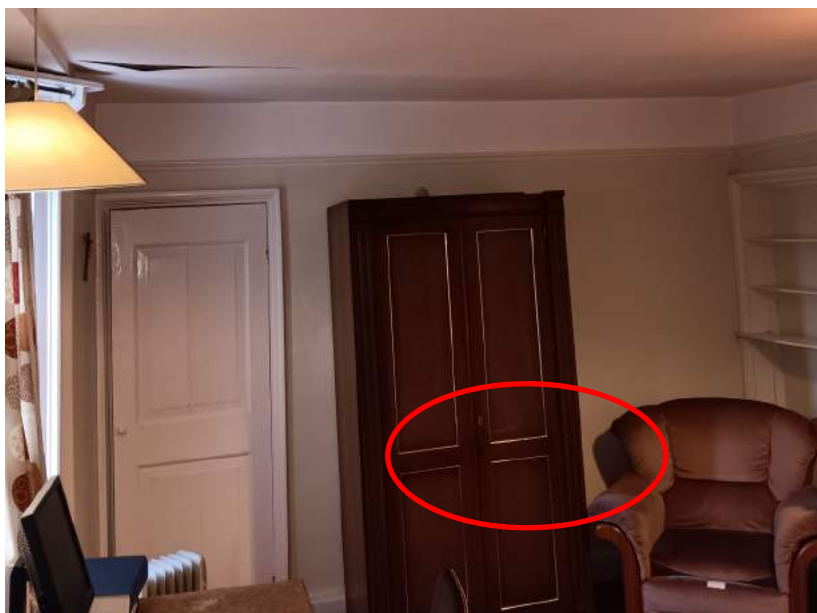
Fig 13:

Second floor; showing lost fireplace vent in south-east room

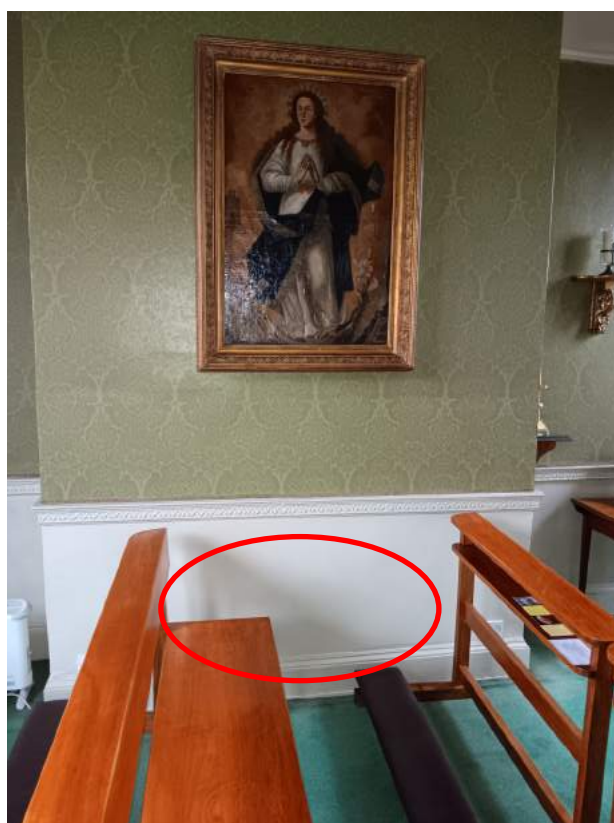
Fig 14:

First floor; showing lost fireplace vent

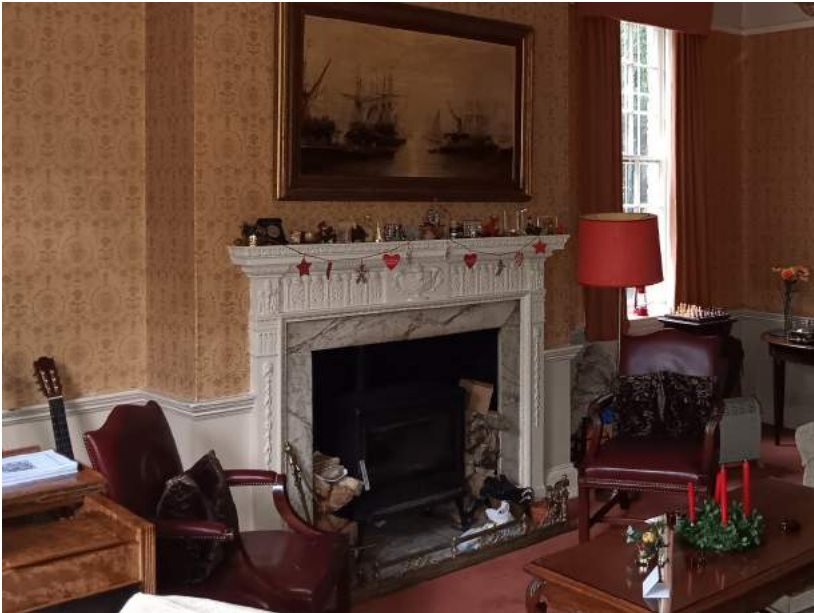
Fig 15:

Ground floor; showing stove appliance installed within fireplace

SN1.2.4	Main house South chimney Ground floor	The chimneybreast, fireplace and decorative surround remained. A modern 'log-burning' stove has been installed within the fireplace aperture and a flexible steel liner run up the brick flue void. H+R suspected that there may be various non-compliant aspects of the stove installation (e.g. lack of cowl and potentially under-size flue diameter)	<p><i>At this stage, H+R would caution against use of the stove</i></p> <p><i>As part of the refurbishment scheme, H+R would suggest that the stove and flue liner should either be removed, replaced or at least overhauled. Caution is required in relation to potential asbestos-containing materials within the stove/liner installation</i></p> <p><i>H+R can provide further advice on the south chimney, if instructed. Any proposals to reinstate operation of chimney systems for combustion should be according to the design of a fire engineer</i></p>

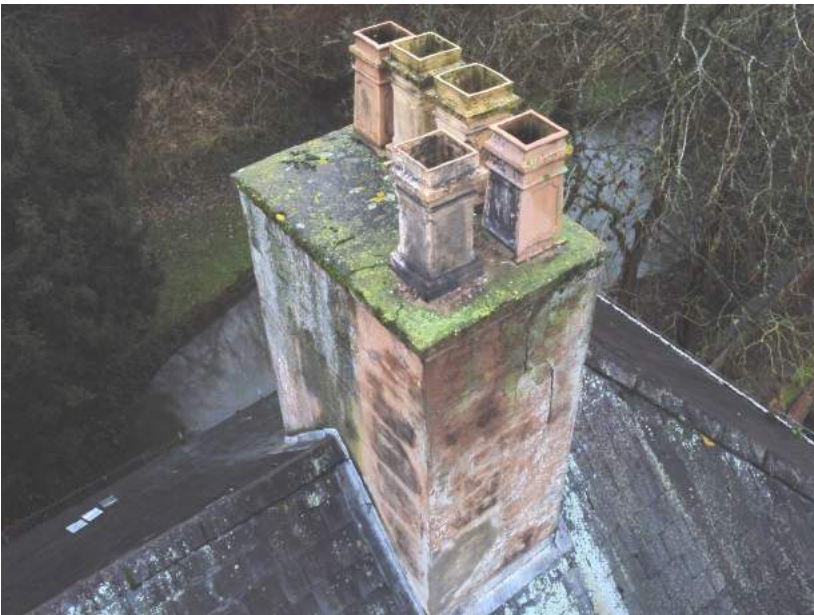
Fig 16:

External stack; showing north and east faces

Note poor state of non-original cement render

Note 3no. missing pots (flues have been capped without ventilation)

Note original corbelled head detail has probably been lost in the past

REFERENCE	ITEM	OBSERVATIONS	RECOMMENDATIONS	CLIENT COMMENTS
SN1.3 MAIN HOUSE, WEST CHIMNEY				
SN1.3.1	Main house West chimney External stack	<p>8no. flues, assumed to have originally served two fireplaces at first floor, two fireplaces at mezzanine level and four fireplaces at ground floor. 3no. flue heads have been closed with a mortar capping</p> <p>Internal fireplaces were almost all lost or steel-lined which limited airflow within the brick flue risers</p> <p>Pots were not fitted with cowls which allowed direct water penetration. Flue gasses being run up brick chimney flues can be an increased risk of cracking and material deterioration</p> <p>The brickwork stack has been re-rendered in the past using cement. The stack has been partly enclosed when the central valley roof has been infilled with a pitched roof (see photos). There was a 'shoulder'/step in the chimney which was now enclosed within the roof void</p> <p>The yellow clay pots were of various slightly different designs and had been seated at irregular heights as part of previous replacement/repairs</p>	<p><i>At this stage, H+R believe that the stack can be retained in-situ, subject to replacing the finish using lime render and limewash. The existing pots should also be lifted and re-laid into new lime mortar flashing (those missing pots and any found to be damaged should be replaced to a matching design)</i></p> <p><i>All dis-used flues should have cowl vents fitted within pots to shed direct water penetration whilst facilitating airflow</i></p> <p><i>There is the option to restore the original central valley gutter roof design (in which case, further re-rendering works would be required to the chimneystack currently enclosed by the modern roof pitch). As mentioned below, in light of structural movement, there is also the theoretical option to totally demolish the west chimney system (subject to LBC)</i></p>

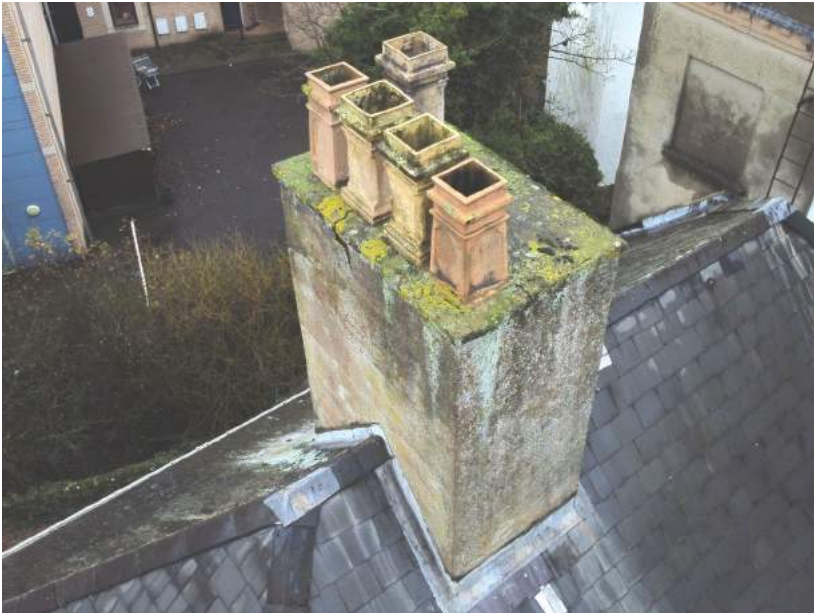
Fig 17:

External stack; showing south and west faces

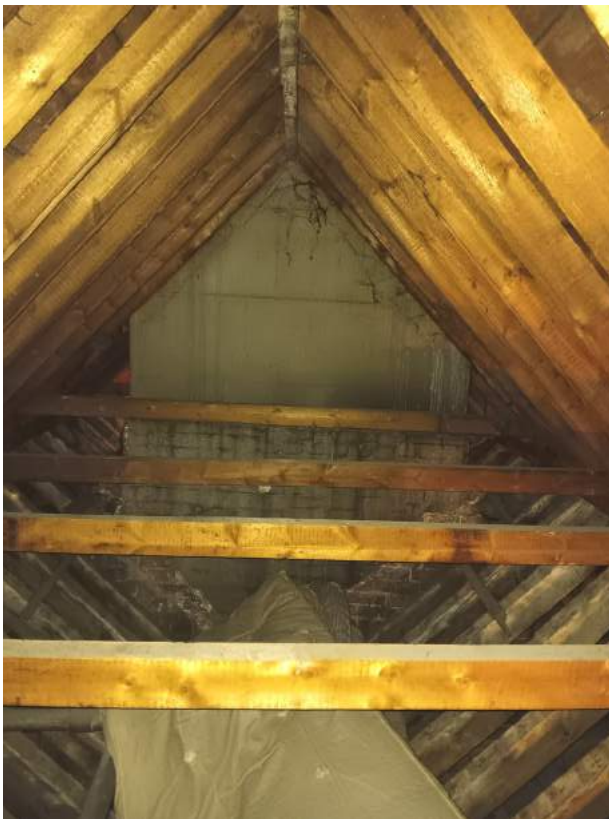
Fig 18:

Roof void; showing original central valley previously enclosed by a larger pitched roof (a large part of the chimneystack has been internalised as a result)

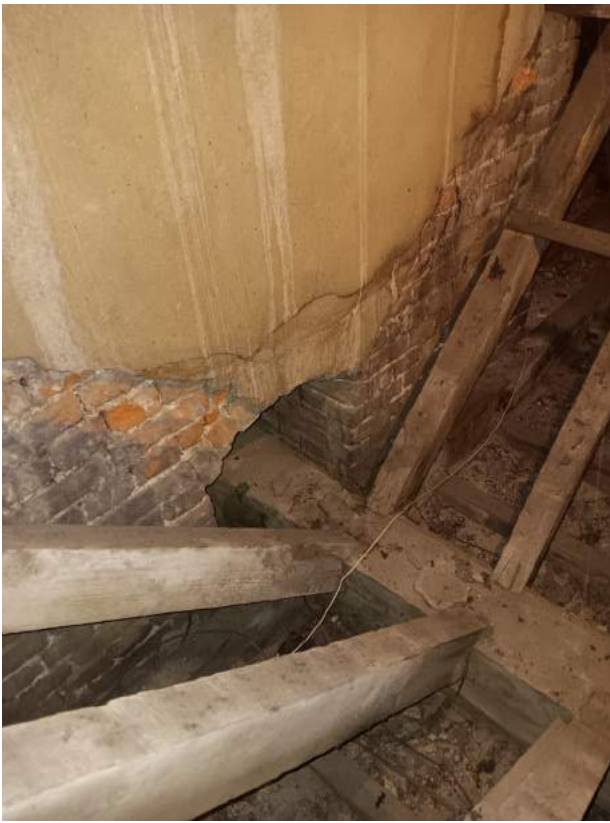
Fig 19:

Roof void; showing original central valley which drained through the chimney stack via a small arched aperture

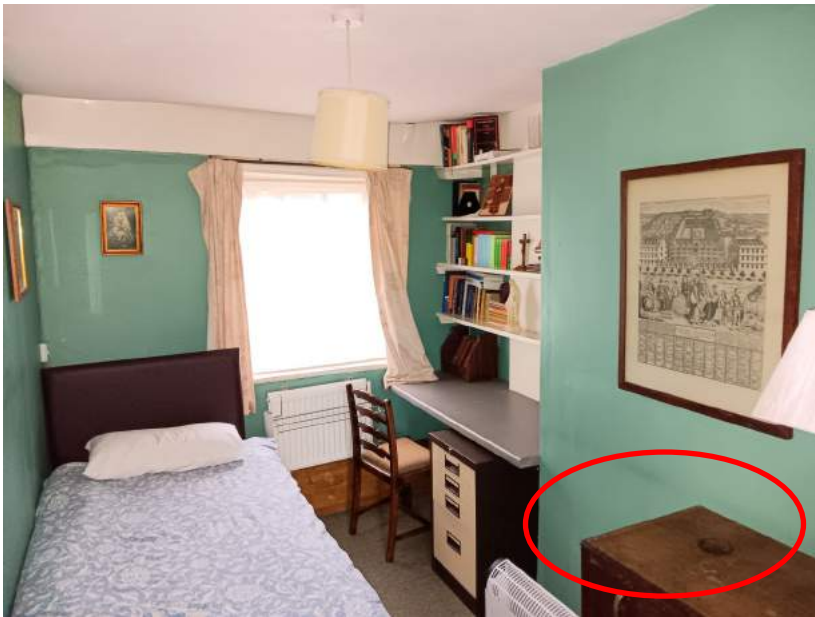
Fig 20:

First floor; showing lost fireplace vent in east room

SN1.3.2	Main house West chimney First floor	<p>Both (2no.) fireplaces have been infilled and plastered-over without ventilation. The chimneybreast itself appears to have dropped in relation to the perimeter walls, resulting in the timber floor structure sloping inwards. This seems to have been a historic issue (unknown if it may be incrementally ongoing, perhaps there are differential foundations below the facades/vs. chimneybreast?)</p>	<p><i>Structural Engineer to review movement in the structure</i></p> <p><i>Both fireplace apertures should be re-opened and all debris swept-out of the flues</i></p> <p><i>A traditional fireplace surround could be reinstated or an insulated board wall lining installed. In either case, a trickle vent airbrick should be installed to allow airflow to run up the flue (from interior fireplace to exterior pot). The fire officer should review detailing of this; intumescent closures for the vents may be needed</i></p>

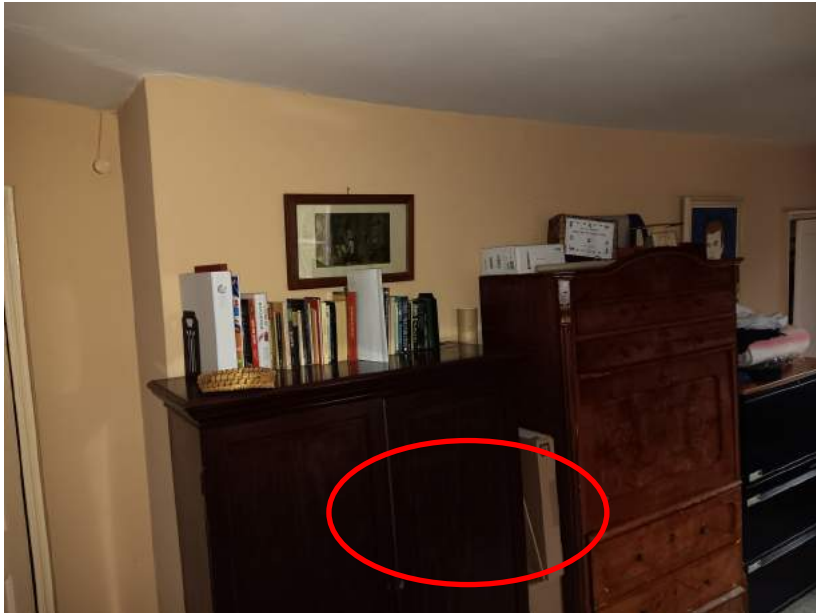
Fig 21:

First floor; showing lost fireplace vent in west room

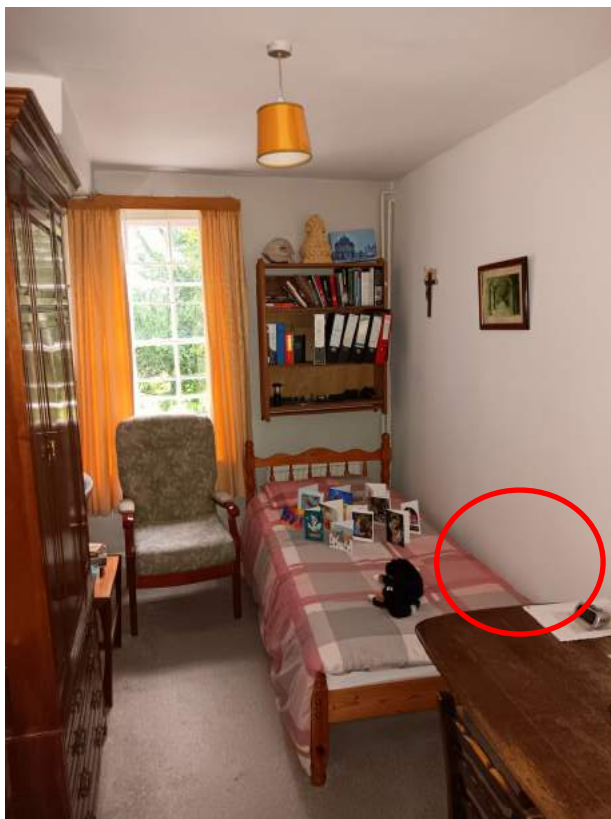
Fig 22:

Mezzanine above ground; showing lost fireplace vent in east room

SN1.3.3	Main house West chimney Mezzanine	Findings as per first floor	<i>Recommendations as per first floor</i>	
SN1.3.4	Main house West chimney Ground floor	<p>According to the original number of pots externally, H+R expected that there might be 4no. flues serving ground floor level. However, there was limited evidence of this at time of survey. A large fireplace (east side) has been infilled with a fitted cupboard. 2no. gas boilers had been ducted into a flue at the south side (unknown if the full height of the flue was steel-lined on the basis that no terminal was apparent at roof level)</p>	<p><i>At least 2no. fireplace apertures (east and west sides) should be re-opened and all debris swept-out of the flues. Traditional fireplace surrounds could be reinstated or an insulated board wall lining installed. In either case, trickle vent airbricks should be installed to allow airflow to run up the flues (from interior fireplace to exterior pot). The fire officer should review detailing of this; intumescent closures for the vents may be needed</i></p> <p><i>Given the deflection seen at first and mezzanine level, the Structural Engineer may consider if there is need to underpin the chimneybreast. Theoretically, and subject to LBC, an alternative option might be considered to totally demolish the west chimney system</i></p> <p><i>As part of the refurbishment scheme, H+R would suggest that the gas boilers and flue liners should either be removed, replaced or at least overhauled. Caution is required in relation to potential asbestos-containing materials within the boiler/liner installation</i></p> <p><i>H+R can provide further advice on the west chimney, if instructed. Any proposals to reinstate operation of chimney systems for combustion should be according to the design of a fire/heating engineer</i></p>
