Hutton + Rostron Environmental Investigations Limited

Grandpont House, Oxford: Chimney investigation

Site note 1 for December 2023-January 2024, job no. 160-42

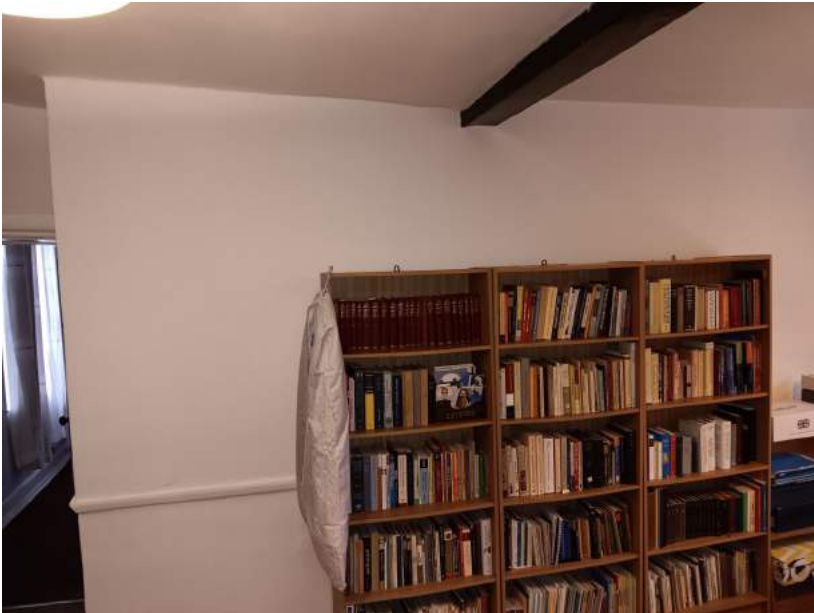
Fig 23:

Mezzanine above ground; showing lost fireplace vent in west room

SN1.3.3	Main house West chimney Mezzanine	Findings as per first floor	<i>Recommendations as per first floor</i>	
SN1.3.4	Main house West chimney Ground floor	<p>According to the original number of pots externally, H+R expected that there might be 4no. flues serving ground floor level. However, there was limited evidence of this at time of survey. A large fireplace (east side) has been infilled with a fitted cupboard. 2no. gas boilers had been ducted into a flue at the south side (unknown if the full height of the flue was steel-lined on the basis that no terminal was apparent at roof level)</p>	<p><i>At least 2no. fireplace apertures (east and west sides) should be re-opened and all debris swept-out of the flues. Traditional fireplace surrounds could be reinstated or an insulated board wall lining installed. In either case, trickle vent airbricks should be installed to allow airflow to run up the flues (from interior fireplace to exterior pot). The fire officer should review detailing of this; intumescent closures for the vents may be needed</i></p> <p><i>Given the deflection seen at first and mezzanine level, the Structural Engineer may consider if there is need to underpin the chimneybreast. Theoretically, and subject to LBC, an alternative option might be considered to totally demolish the west chimney system</i></p> <p><i>As part of the refurbishment scheme, H+R would suggest that the gas boilers and flue liners should either be removed, replaced or at least overhauled. Caution is required in relation to potential asbestos-containing materials within the boiler/liner installation</i></p> <p><i>H+R can provide further advice on the west chimney, if instructed. Any proposals to reinstate operation of chimney systems for combustion should be according to the design of a fire/heating engineer</i></p>

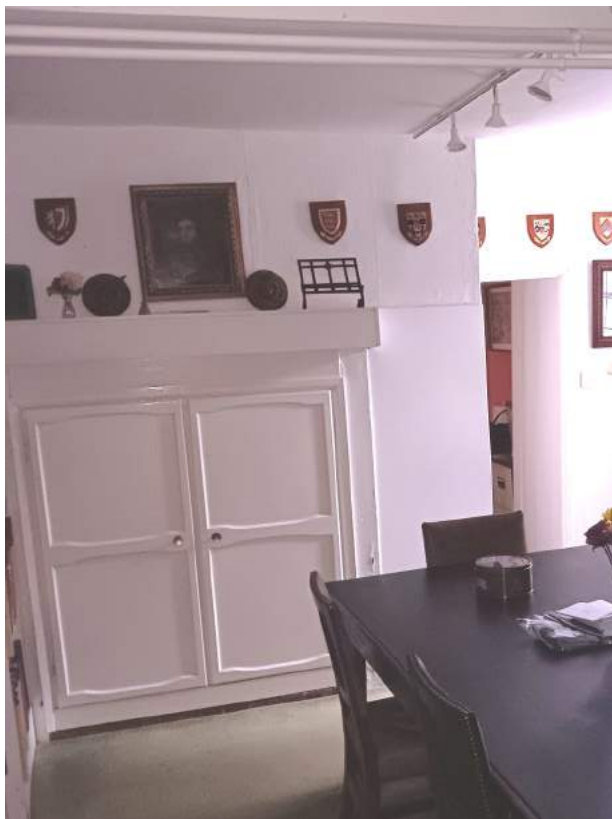
Fig 24:

Ground floor; showing fireplace in east room closed by cupboard lining

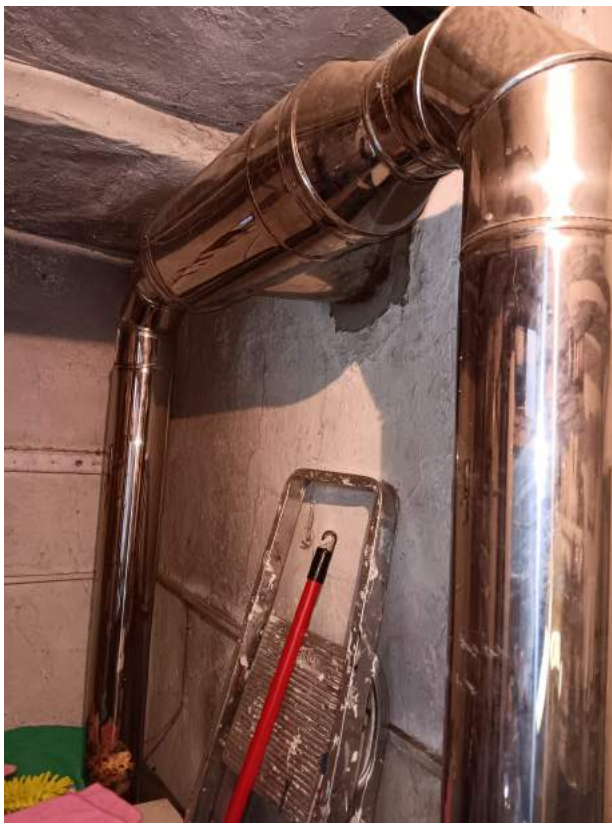
Fig 25:

Ground floor; showing boiler flues ducted into flue riser

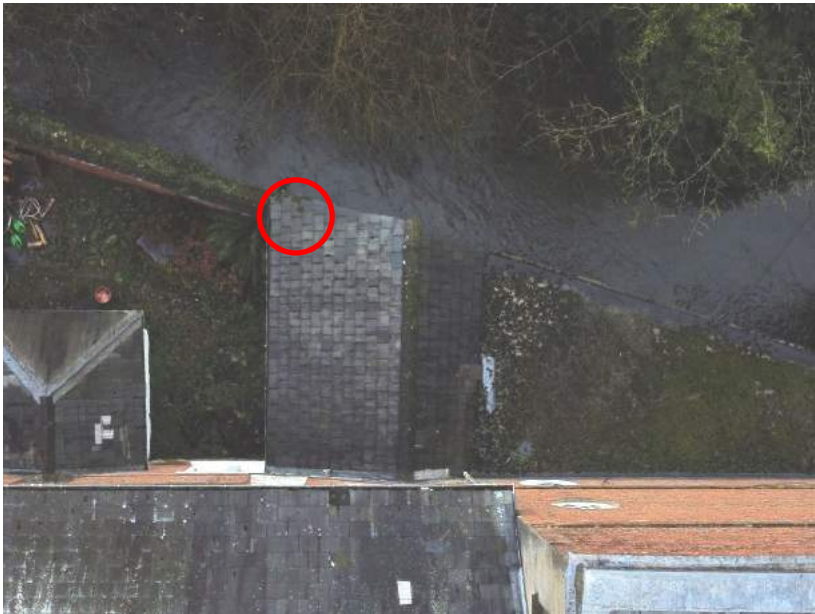
Fig 26:

Exterior; showing location of previously lost chimney stack

REFERENCE	ITEM	OBSERVATIONS	RECOMMENDATIONS	CLIENT COMMENTS
SN1.4 OTHER CHIMNEYS				
SN1.4.1	Main House North extension Lost chimney	As shown on drawings, a chamfer-wall fireplace has been closed and the external stack demolished in the past	<i>At this stage, H+R would suggest leaving this chimney system in its current form (there seems little benefit in attempting restoring it to operation)</i> <i>H+R can provide further advice, if instructed</i>	
SN1.4.2	Stables Cottage wing Derelict stack	As shown in photographs, the cottage at the east end of the stables (which has been purposefully 'ruined' by removing the roof) retains its original chimney. This presents as a freestanding brick shaft within the centre of the floorplan. The head of the flues within the chimneystack have been terminated at a mortar capping	<i>Depending on whether the cottage is to be revived into a habitable space on future refurbishment, the chimneystack could be restored by providing through-ventilation detailing and ensuring that internal plaster finishes are isolated from contact with the brickwork. Subject to LBC, the design team might consider an alternative option of entirely demolishing this chimney system</i> <i>H+R can provide further advice and comment upon detailing, if instructed</i>

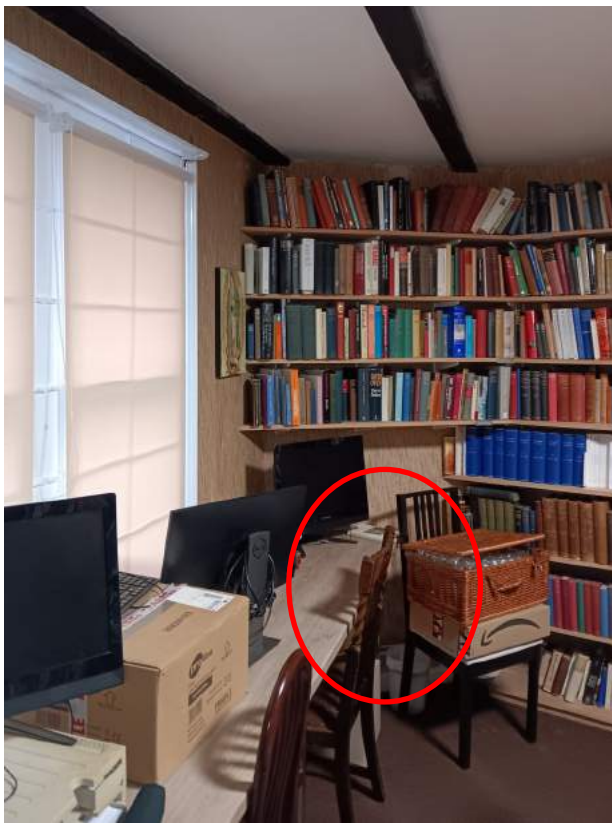
Fig 27:

Interior; showing location blocked fireplace below previously lost chimneystack

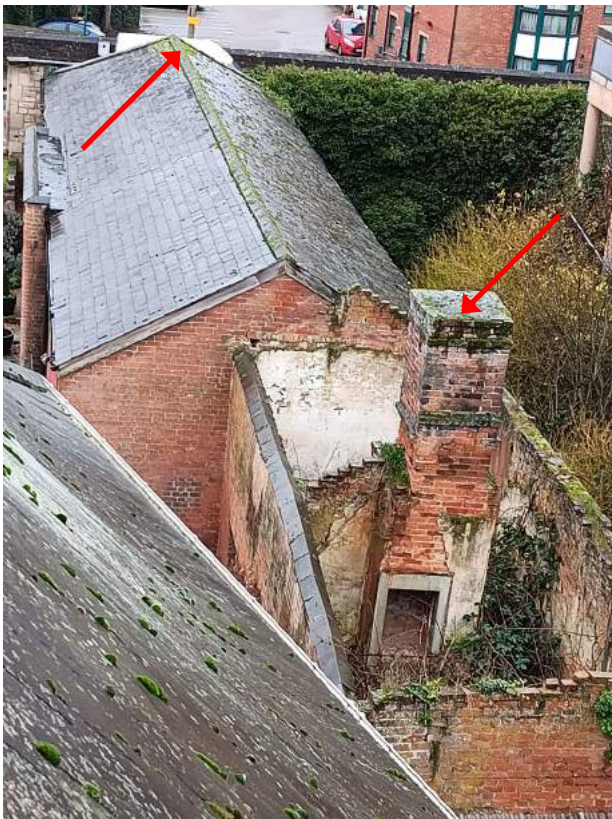
Fig 28:

Exterior; showing derelict chimney (foreground) and location of previously lost chimneystack (background)

SN1.4.3	Stables Lost chimney	As shown on drawings, there appears to have originally been a single-flue stack towards the east end of the stables (central to the ridgeline)	<i>At this stage, there seems little benefit in restoring this chimney to operation. Depending on proposed layouts internally upon refurbishment of the stables, it may be beneficial to consider demolishing the redundant chimneybreast</i> <i>H+R can provide further advice, if instructed</i>

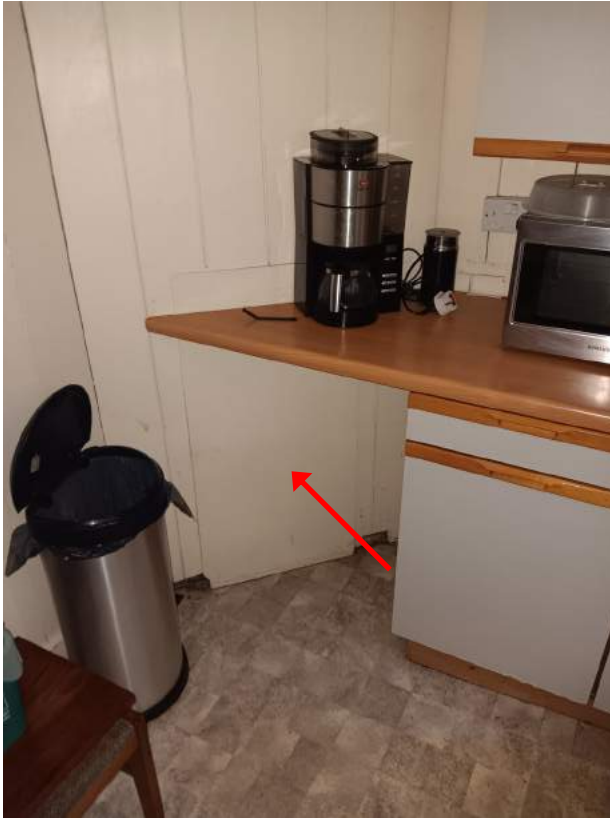
Fig 29:

Interior; showing boarded-over
fireplace below previously lost
chimneystack
