North Rotunda, Glasgow

Further to your recent enquiry and our subsequent site visits please find enclosed our roof report for your consideration.

Survey Date: 18/12/23

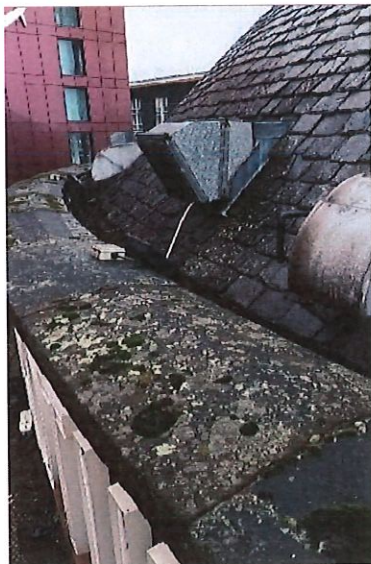
Fig 1.

Figure 1 – the ducting is to be removed which will necessitate the stripping of the existing slate around the duct.

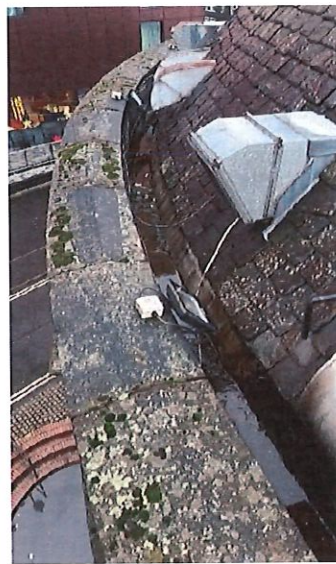
Fig 2.

Figure 2 – the ducting is to be removed which will necessitate the stripping of the existing slate around the duct.

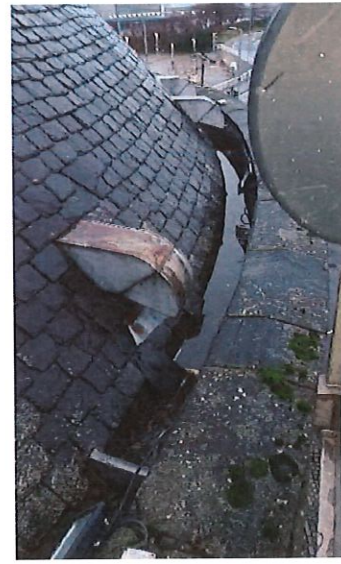
Fig 3.

Figure 3 - the ducting is to be removed which will necessitate the stripping of the existing slate around the duct.

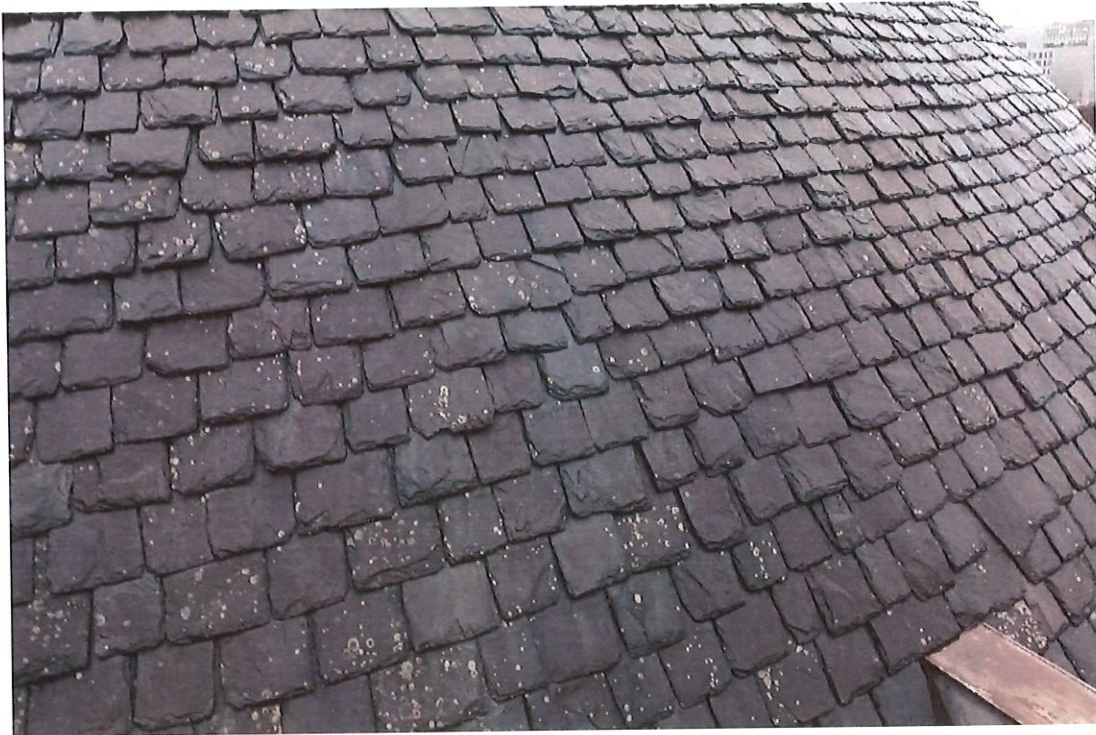
Fig 4.

Figure 4 (below) – The roof slope showing the slates turning on the nail. This highlights that the nail heads are failing. Photo also shows plumb bonds on the slate coursing.

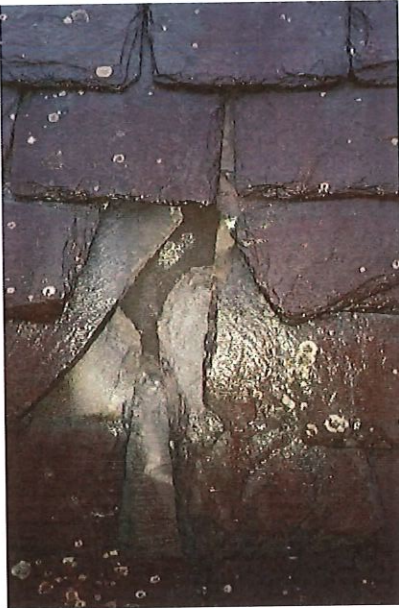
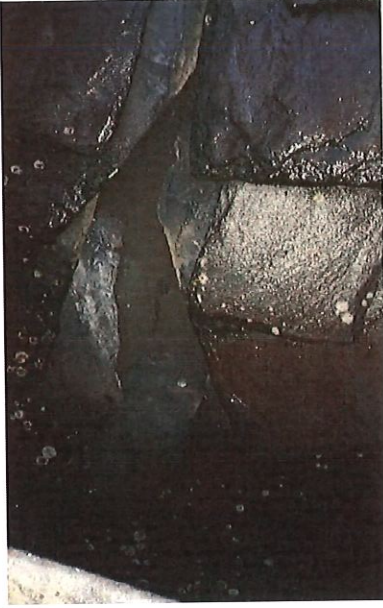
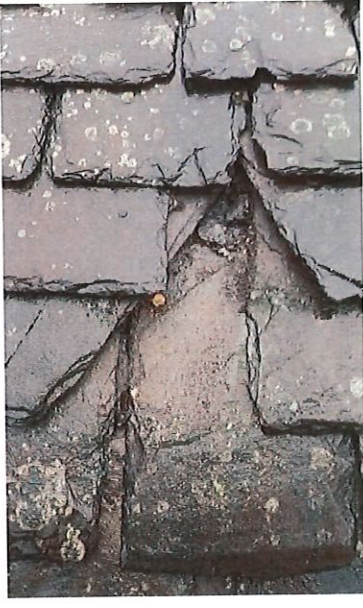
Figure 5 – The slate is on to a non-breathable felt
Figure 6 – The slate is on to a non-breathable felt
Figure 7 – The heads of the slate are showing signs of failure.

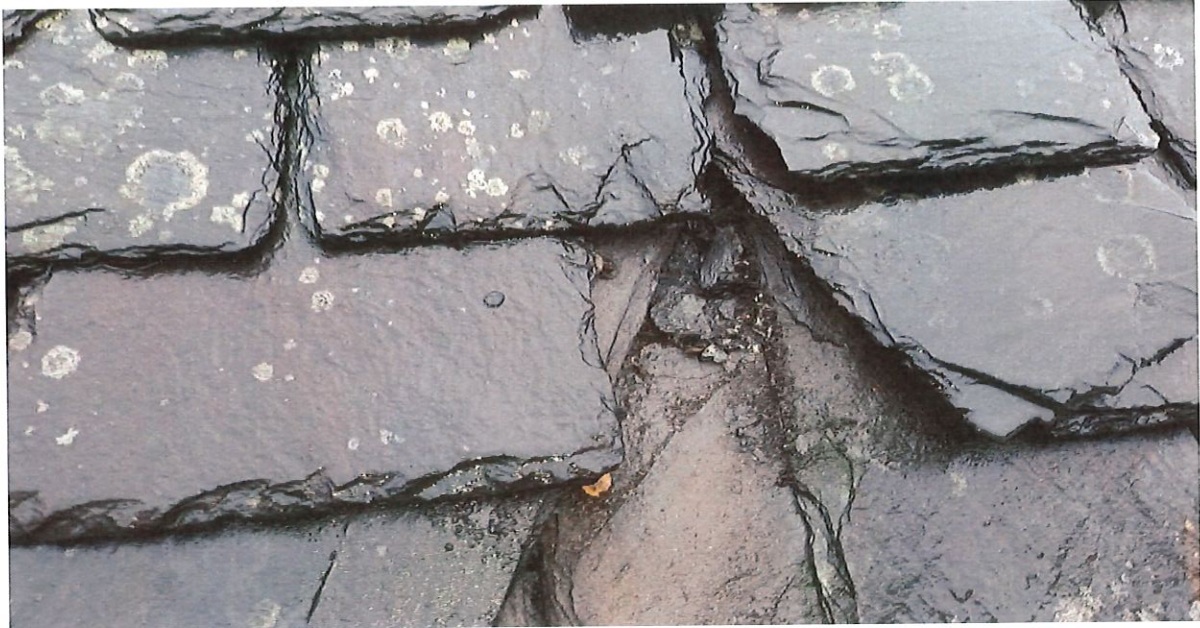
Fig 8.

Figure 8 - The head of the slate is showing signs of failure

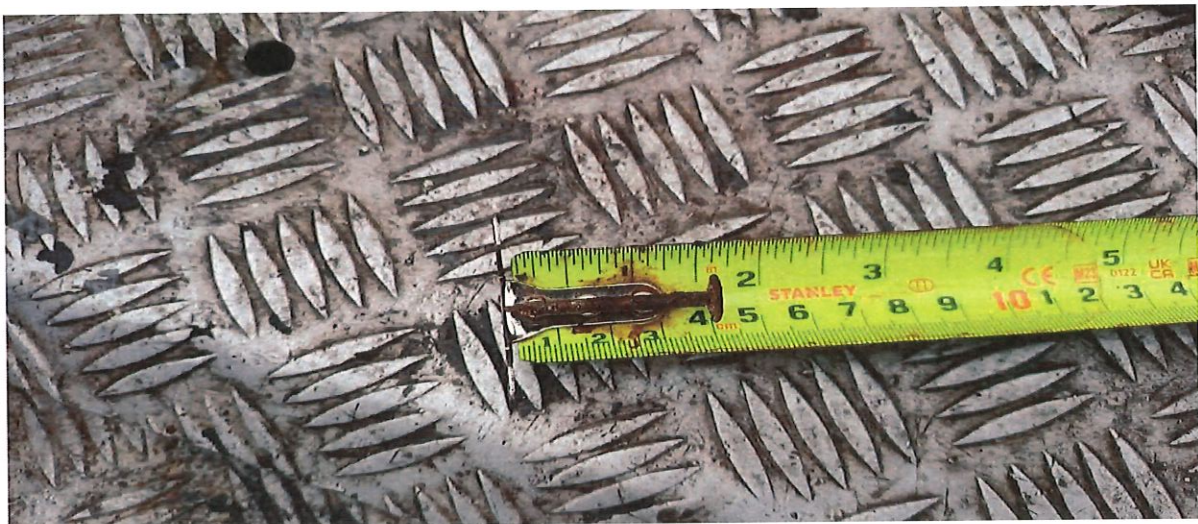
Fig 9.

The existing slate work is fixed to the timber substrate with 40mm clouted nail. Due to the pitch of the roof slope, the exposure and the detail a 50mm fixing should be utilised. The existing slate work is showing signs of nail sickness which was evident with the missing slates on the roof covering. It was also noted when the slate work was opened that the existing slates are showing signs of delamination and due to the shape of the roof structure and the slates hanging on head nails, the slates are fracturing at the head.

Figure 9 - This shows the size of the existing undersized nails being used.

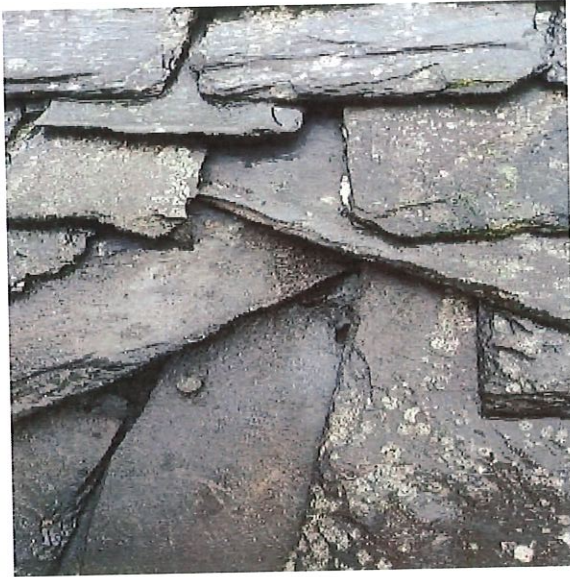
Fig 10.

Figure 10 – Highlights the poor quality of historic repairs carried out by others.

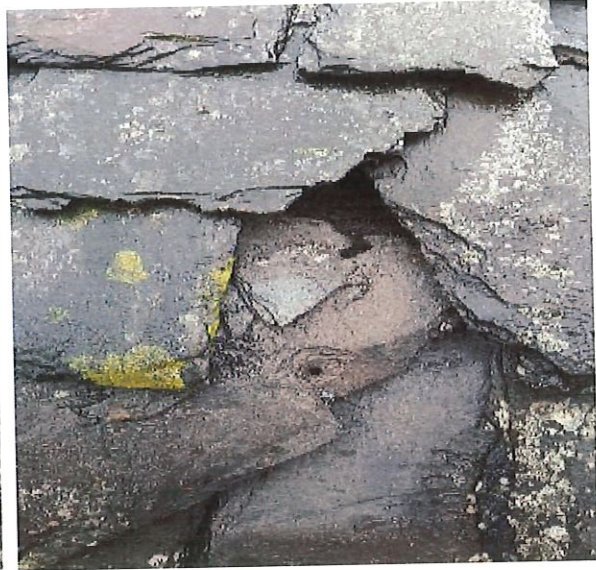
Fig 11.

Figure 11 - Highlights the poor quality of historic repairs carried out by others.

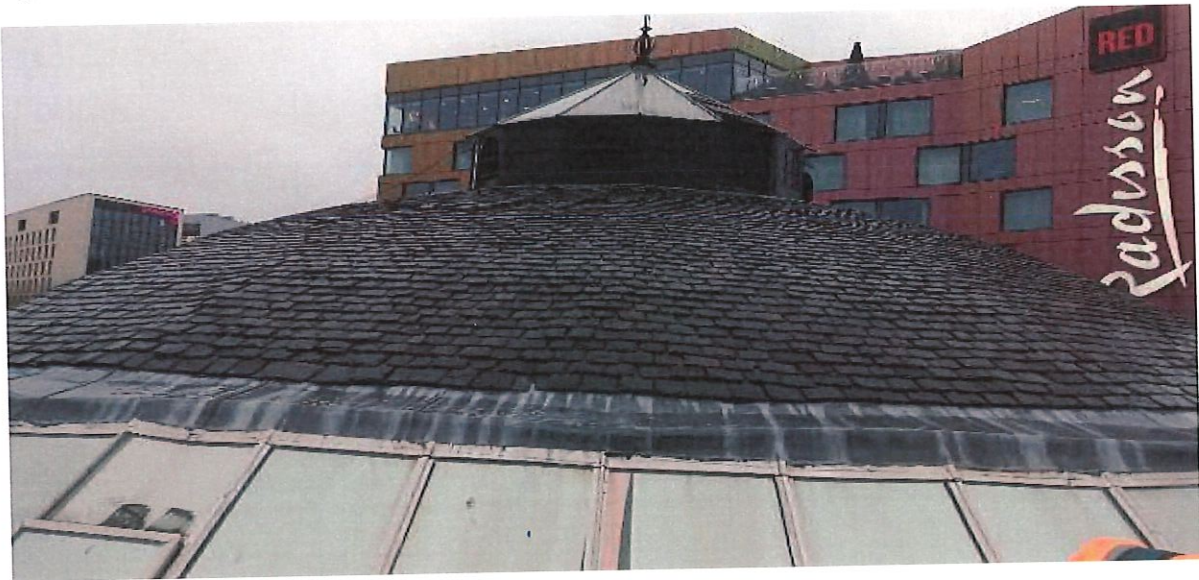
Fig 12.

Figure 12 – Shows that the previous works have been carried out incorrectly and to a poor standard. There was previously a window in this section and it has been infilled and slated incorrectly which has resulted in areas of plumb bond and courses not matching.

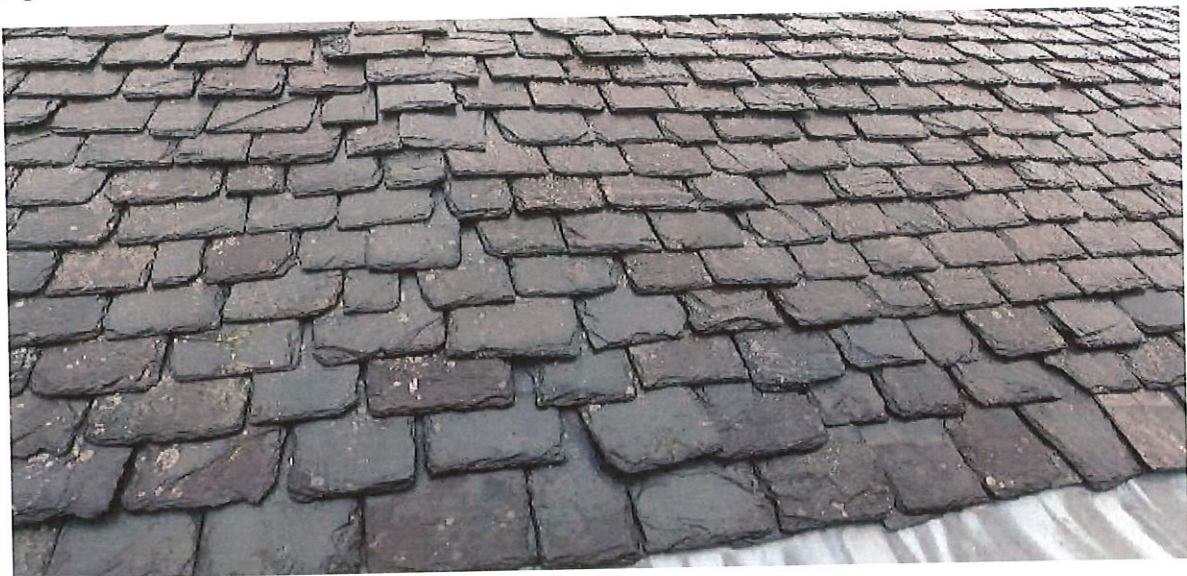
Fig 13.

Figure 13 - Shows that the previous works have been carried out incorrectly and to a poor standard. There was previously a window in this section and it has been infilled and slated incorrectly which has resulted in areas of plumb bond and courses not matching.

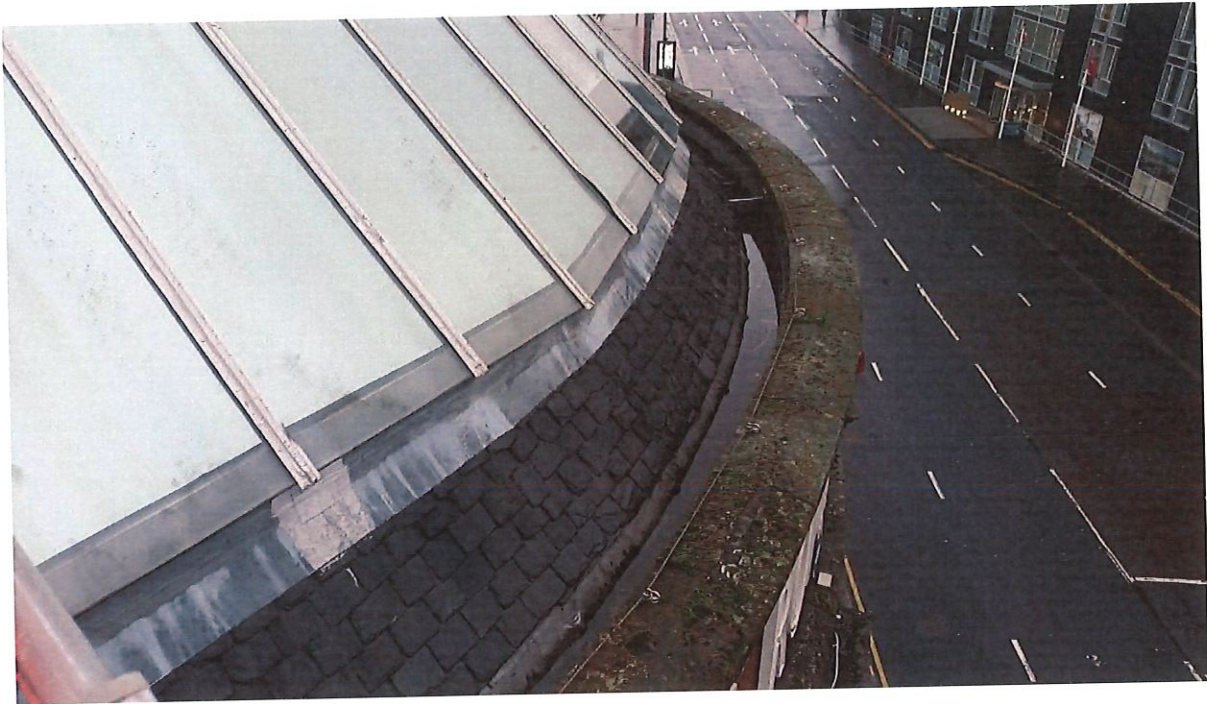
Fig 14.

Figure 14 – shows the gutters full of rainwater & the flashings at the rooflights have failed.

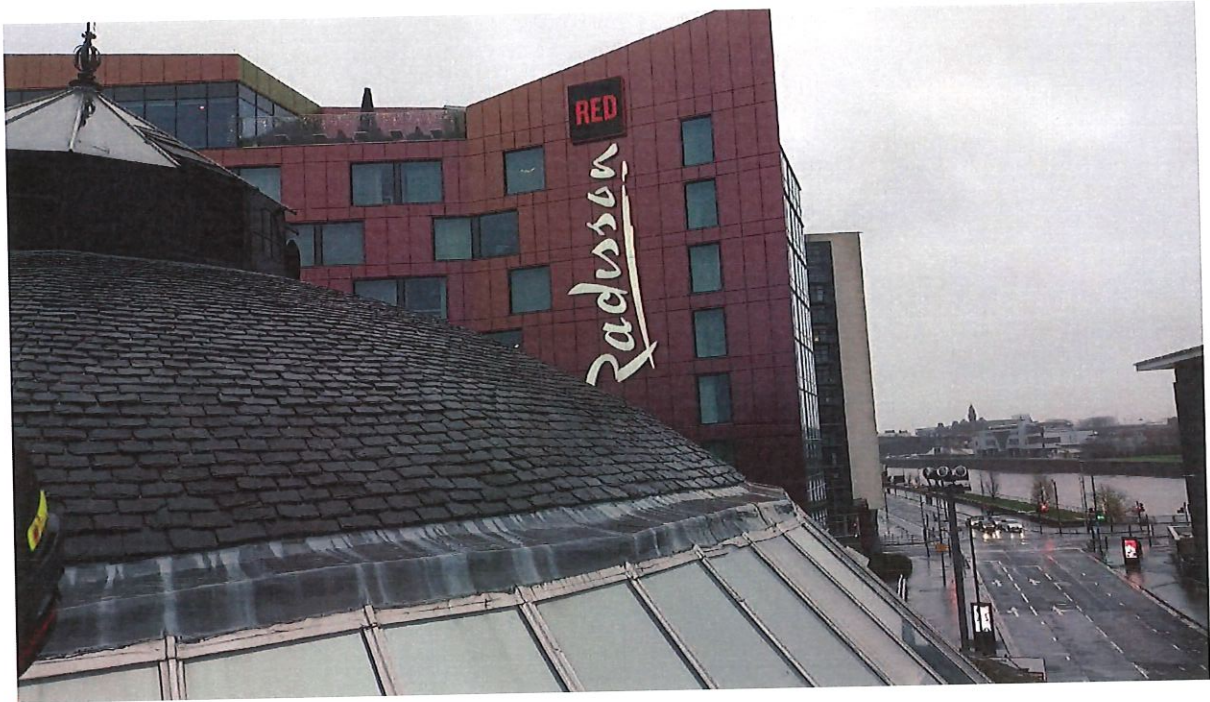
Fig 15.

Figure 15 – Shows that the previous works have been carried out incorrectly and to a poor standard. There was previously a window in this section and it has been infilled and slated incorrectly which has resulted in areas of plumb bond and courses not matching

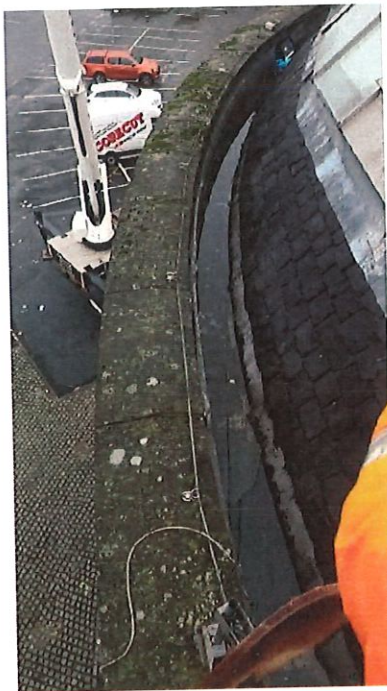
Fig 16.

Figure 16 – Shows that the gutters are failing. The outlets are failing and in some locations have been covered over. Temporary repairs are evident and a long term solution required.

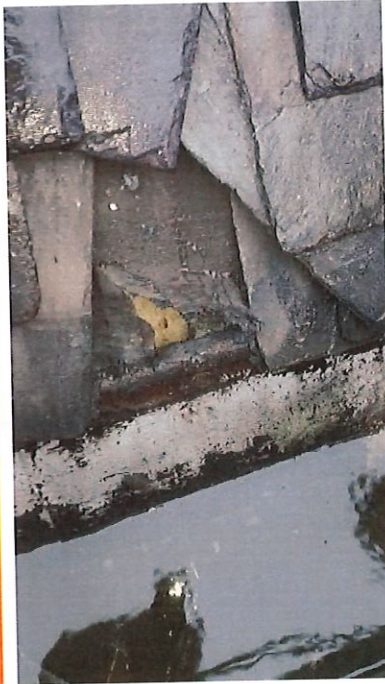
Fig 17.

Figure 17 – Bitumen felt has been installed to eaves which is not a breather membrane

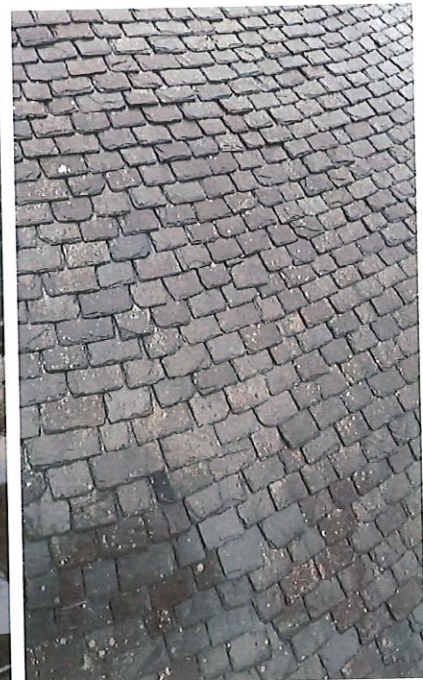
Fig 18.

Figure 18 – Roof slated with plumb joints throughout resulting in premature failure of roof.

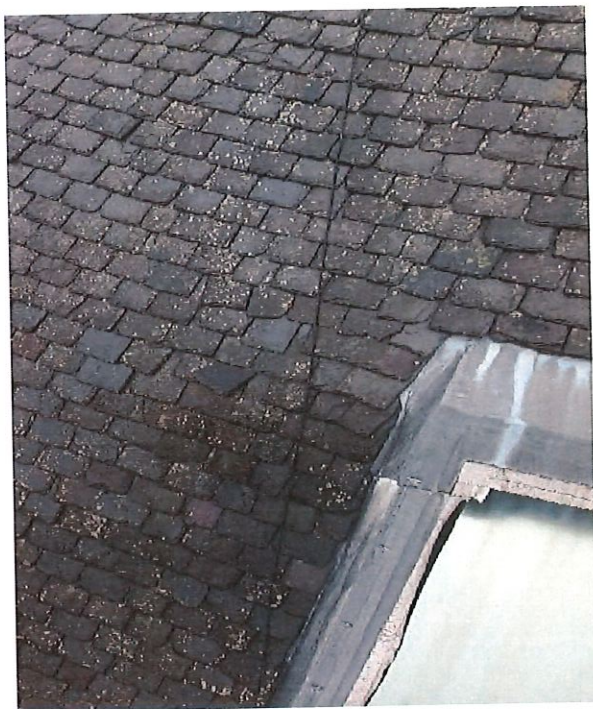
Fig 19.

Figure 19 – highlights that a number of different slate types have been used for previous repairs resulting in foreign body slate being installed into existing Scotch slate works.

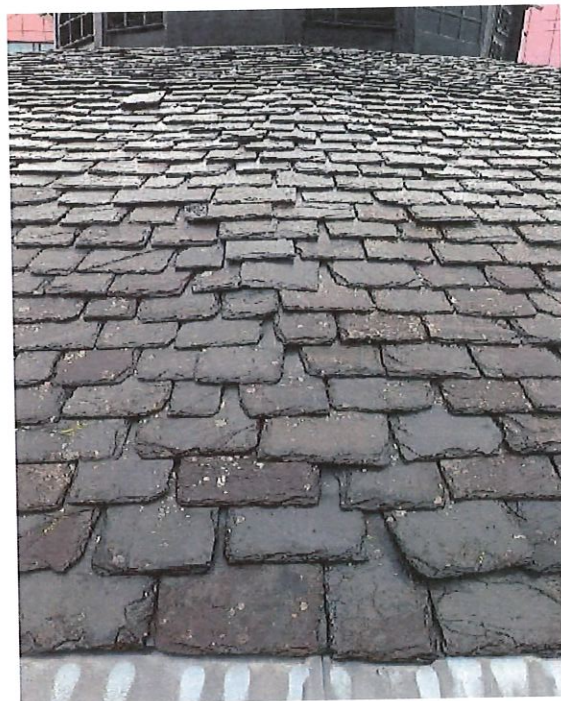
Fig 20.

Figure 20 – shows slates dislodged highlighting nail sickness and delamination.
